NASA Engineering and Safety Center Technical Report	Document #: RP-07-13	Version: 1.0
Title: Independent Review Support for Phoenix Mars Mission Robotic Arm Brush Motor Failure			Page #: 1 of 54

**Independent Review Support for Phoenix Mars Mission
Robotic Arm Brush Motor Failure**

March 8, 2007

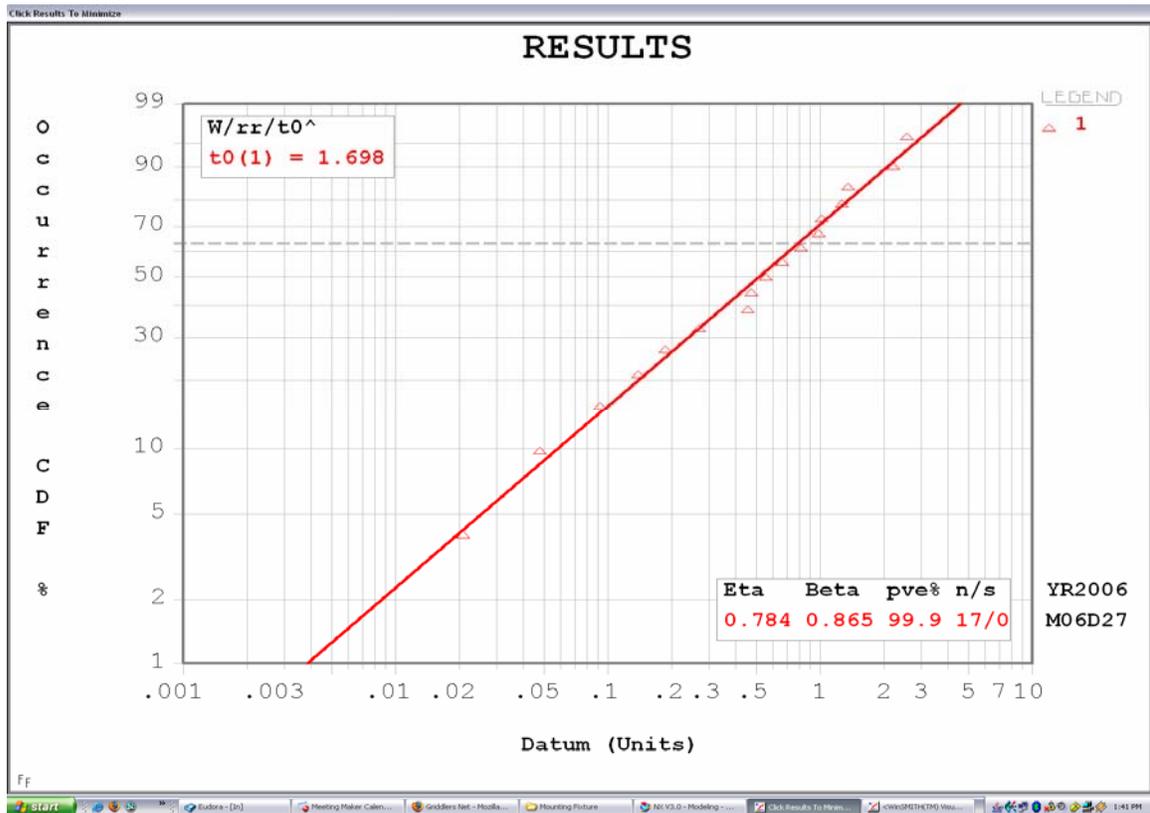
Figure 2. Three Parameter Weibull without Outlier

The data was reevaluated after omitting the indicated outlier. The data fit is shown in Figure 2, which in this case, had a pve% of 99.9.

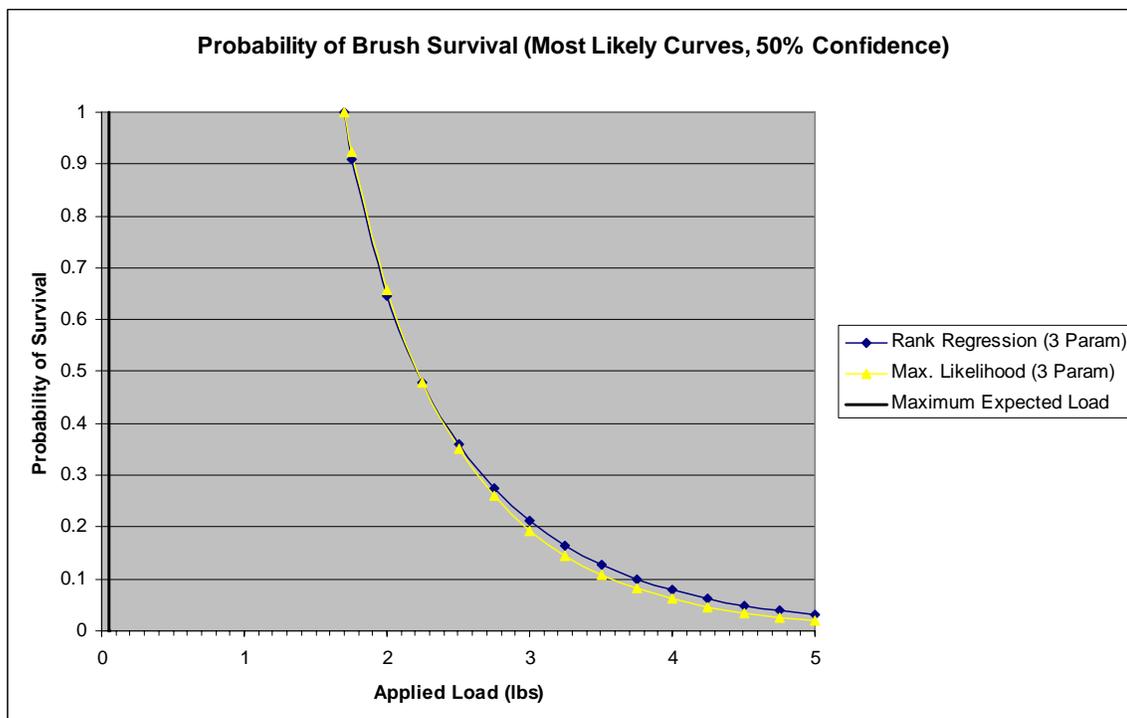
Figure 3. Probability of Survival

Inputting values for F_0 , η , and β , generated by the analysis software using both Rank Regression and Likelihood Ratio methods of into the above equation yielded the following results shown in Figure 3.

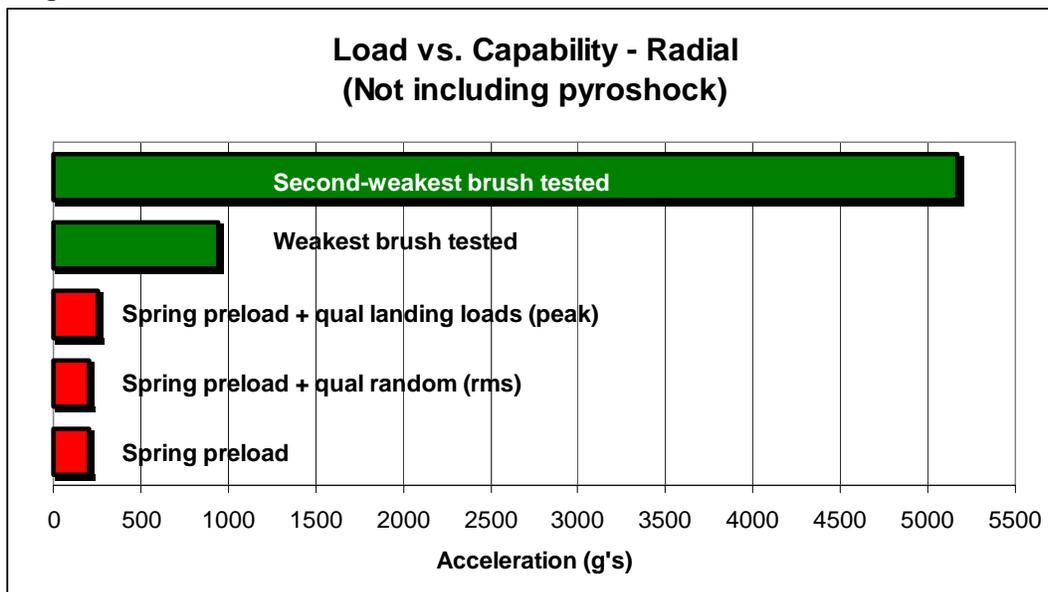
Graphical

Radial	g's	lb force
Spring Preload	200	0.041
Spring preload + Qual random	207.8	0.043
Spring preload + qual landing loads	258	0.053
Weakest brush found	945	0.196
Second weakest brush	5166	1.070
