STS-107 FLIGHT READINESS REVIEW

OV-102 MPS LH2 FEEDLINE FLOWLINER CRACKS

MPS 17" Feedline Ball Strut Tie Rod Assembly Ball Crack

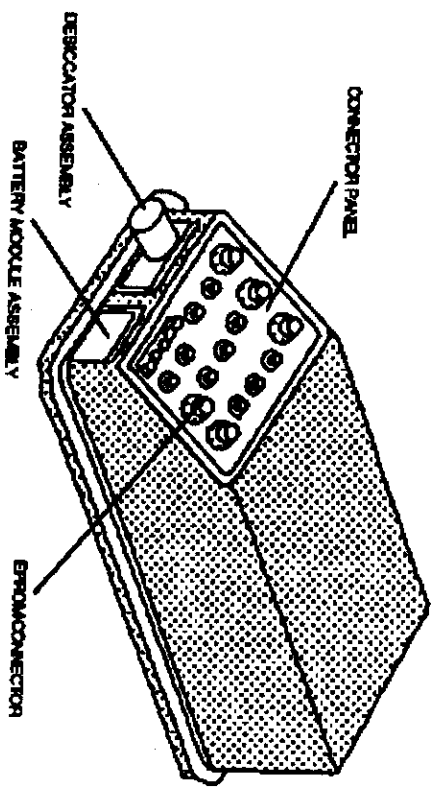
MCR 23061 New System Control Module Battery Flight Status

- The SCM is the main interface for all the inputs/outputs of data and control signals between the OEX Recorder and the Orbiter avionics/Modular Auxiliary Data System (MADS)
- The modification replaces expended obsolete GFE 2.8 VDC battery (Catalyst Research 3440) with a new 3.6 VDC battery (Tadiran TL 5134)
