STS-107 FLIGHT READINESS REVIEW

Presenter:
Organization/Date: Orbiter 01-09-03

SSVEO Is Ready to Fly STS-107

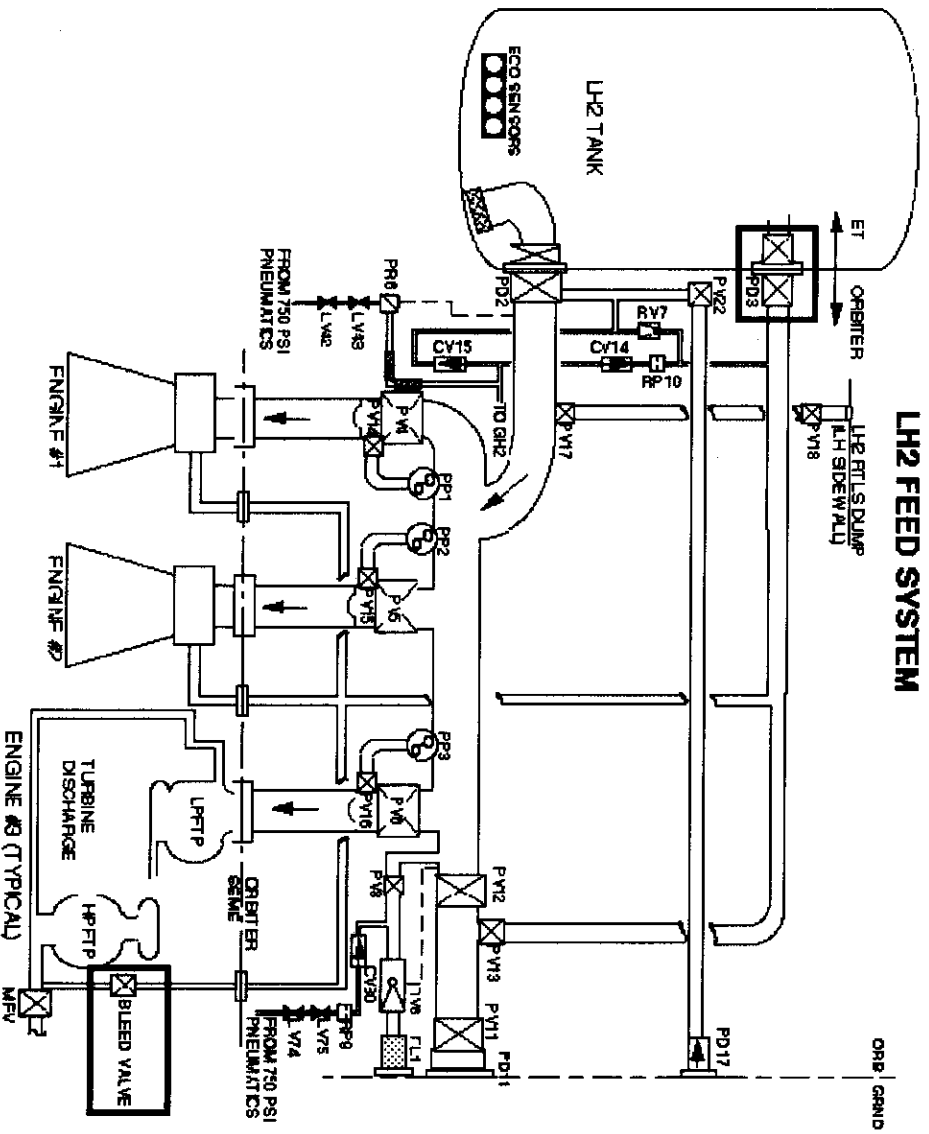
BU-21

- MPS LH2 4" disconnect failed to close pneumatically when commanded at MECO
 - Closed via back-up mechanical mode at ET/Orbiter umbilical separation

- Failure of the 4" disconnect to close pneumatically in the case of a pre-MECO SSME shutdown or pad-abort results in inability to isolate the affected SSME from the hydrogen in the ET
 - No concern for nominal mission
 - Minor helium loss during entry if disconnect fails to close in back-up mechanical mode

- Inspection of Orbiter disconnect post-landing for indications of failure
 - Initial runway inspection revealed nothing unusual
 - Borescope inspection found Flourogold spacer (spool which negator spring slides/rotates on) cut and bent in towards springs
 - Scuff mark found on back of housing
- Disconnect R&R complete
 - Borescoped new disconnect and verified no damage
 - Leak checks complete and good
 - Removed PD3 failure analysis to follow
 - Ambient & cryo cycle tests

- Disconnect failure to close pneumatically is only critical for uncontained SSME shutdown
 - Probability of SSME catastrophic shutdown is remote
- Borescoped new disconnect and verified no damage
- OMRS verification of disconnect function accomplished prior to propellant loading
- No history of disconnect failure to close via mechanical back-up separation mode
 - Prevents helium loss during entry
