Hypervelocity Impact Tests
on Space Shuttle Orbiter
Using Nylon and Glass Projectiles
Thermal Protection Material

OV-102 (STS-87) TPS Damage

Presenter	R. Gatto
Date	January 6, 1998

STS-107
Launch+4 Day
Consolidated Film/Video Report
KSC, JSC, MSFC and Program Integration
Film/Video Analysis Teams

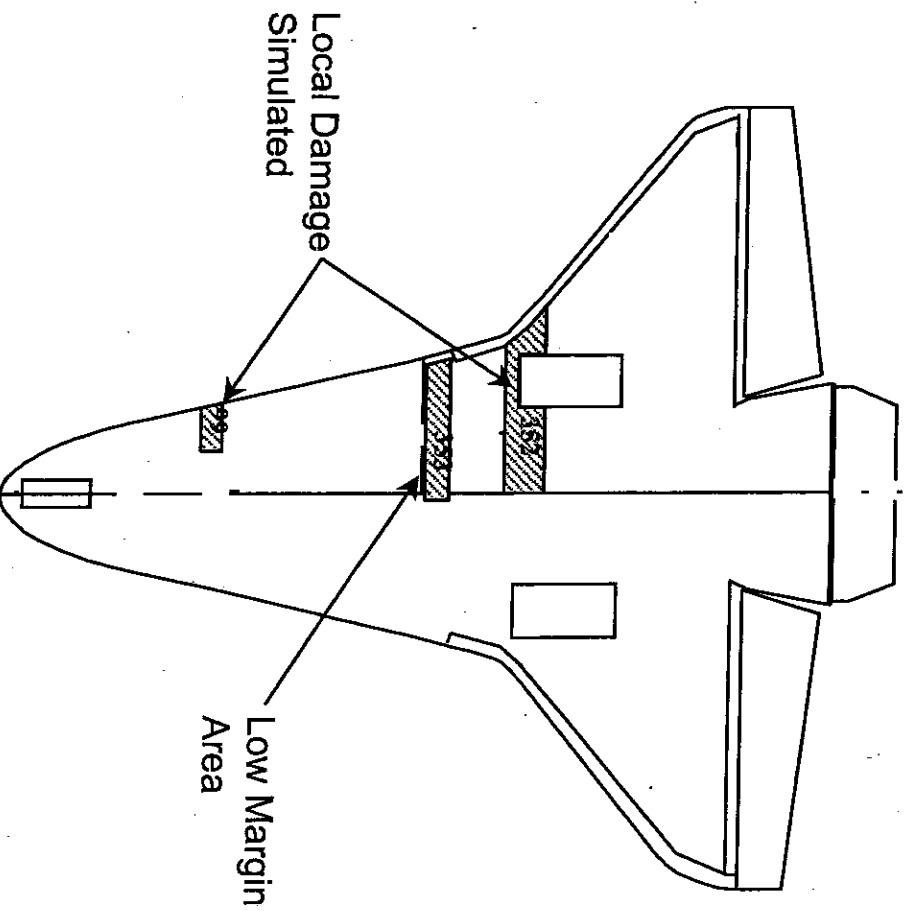
Thermal Math Model (TMM)
 Locations

- OV-102 TPS Sustained a Total Of 308 Hits During STS-87
 - Lower Surface had 244 Hits with 109 Hits > 1" in Length
- Major Damage Area on the Lower Surface Is Between the Nose Landing Gear and Main Landing Gear Doors
 - Largest Damage Located on the Glove Measuring 15"x 2"x.25"
 - Deepest Damage Located Forward of Left Main Gear Door Measuring 4"x 2"x1.5"

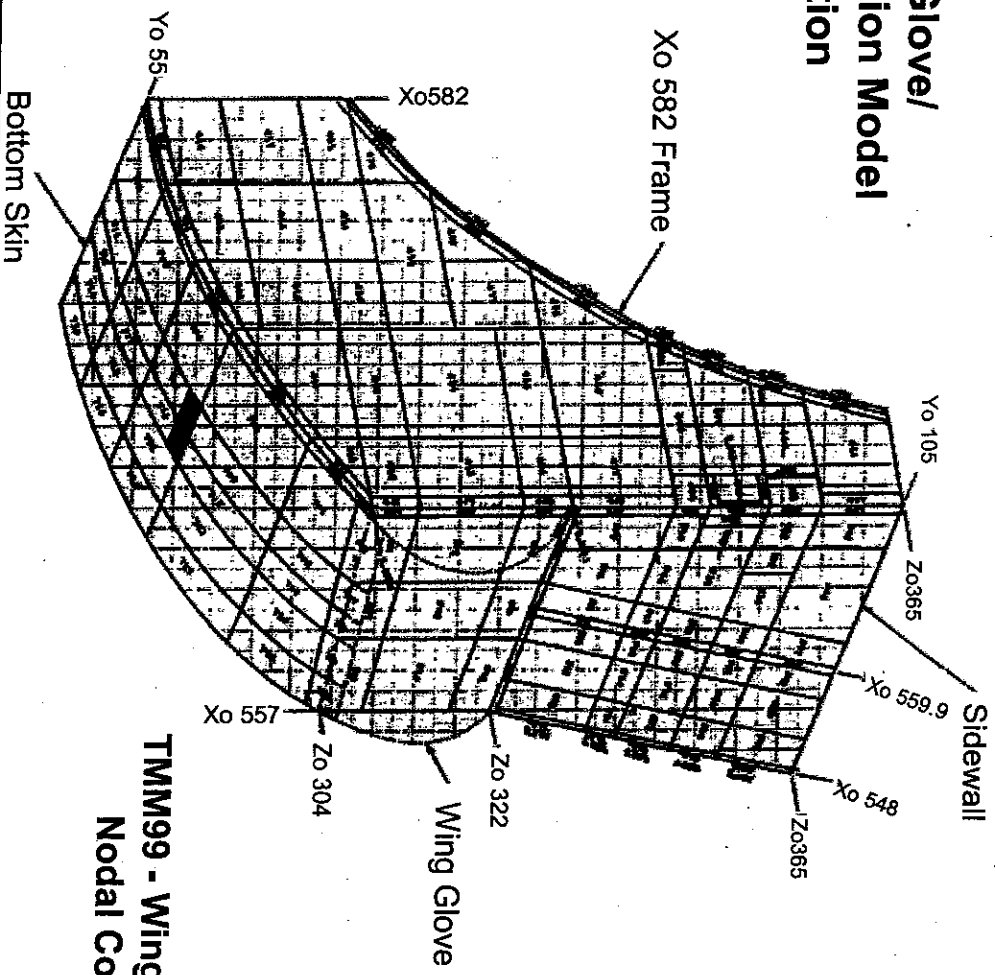
**TMM99 - Wing Glove at X_o 582
 Nodal Configuration**

Location	Tile Damage	Surface Temp	Structure Temp	Comments
TMM 99	Limited Fusing	3100°	276°	No Impact
TMM 352	Limited Fusing	2800°	309°	No Impact

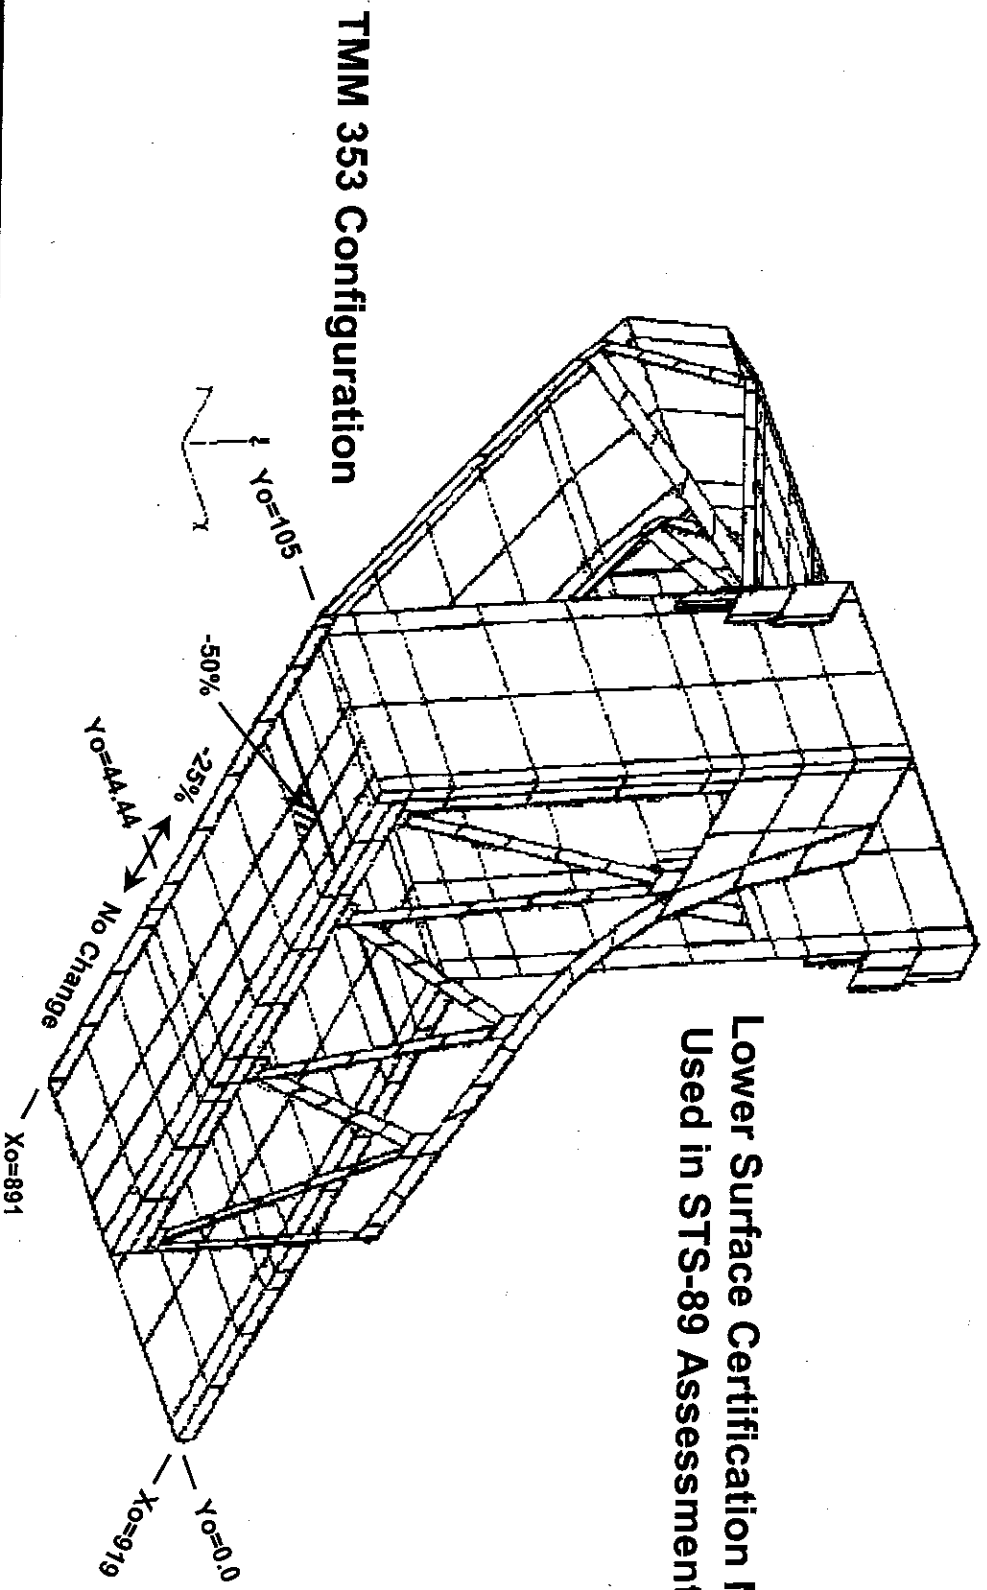
**Lower Surface Certification Model
Used in STS-89 Assessment**

- Simulation with Damage More Severe than STS-87 Significantly Degraded Safety Margins
- 25% Decrease in Tile Thickness in Out Board Panels Gives Large Increase in In-Plane Gradients and Thermal Stresses
- Cannot Achieve Required 1.40 Factor of Safety - Approximate Contingency Capability Is:
 - TAEM - F.S. = 1.0 at 1.8 g's
 - Land - F.S. = 1.2 at 5.5 feet/sec
 - = 1.4 at 3.0 feet/sec

- STS-87
 - No Local Temperatures Exceeding Structural Temperature Limits
 - Safety Margin of 1.40 Not Violated
- STS-87 Severity of Impacts on STS-89 Would Have Safe Vehicle Return But With Possible Local Structural Damage
 - Possible Structural Temperature Peaks to 500F in Thin Sandwich Parts Could Require Local Structural Repair
- Potential STS-89 Damage More Severe than STS-87 Could Significantly Degrade Safety Margins
 - Wider Area of Impact Damage on Bottom Panels Results In Unacceptable Margins
