So Close Yet So Far: The Jammed Airlock Hatch of STS-80

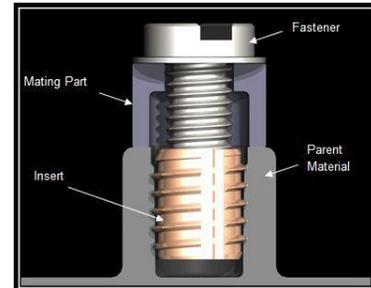
Engineers also concluded that improper thread inserts were used with the screws, which allowed them to loosen over time and eventually back out of the clutch assembly; non-locking thread inserts were used when design specifications called for locking thread inserts to be used. Additionally, appropriate torque values were not included in the engineering drawings of the assembly.

Figure 5: View of thread insert.
Source: Google Images

A detailed maintenance investigation was completed for the faulty actuator. Results determined that the screws were removed and re-installed five times without replacing the proper thread inserts. Investigations performed on the rest of the fleet identified another 12 actuators with improper inserts (some with one locking and one non-locking insert), all of which contained loose screws. As a result, all orbiters were re-fitted with the proper thread inserts and engineering drawings were updated to include torque specifications.
