## Executive Summary

# Mishaps

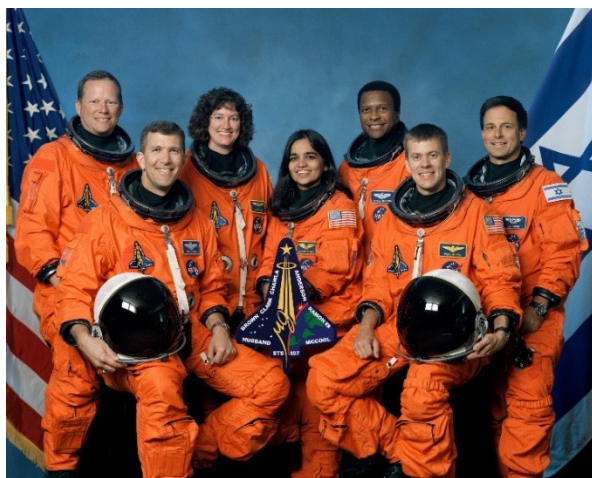
**STS-107:** Rear (L-R) David Brown, Laurel Clark, Michael Anderson, Ilan Ramon; Front (L-R) Rick Husband, Kalpana Chawla, William McCool

Damage to the Thermal Protection System from a debris strike on ascent resulted in the loss of crew and vehicle on entry.

At 81.7 seconds Mission Elapsed Time a piece of foam insulation from the External Tank (ET) left bipod ramp separated from the ET and struck the orbiter left wing leading edge in the vicinity of the lower half of reinforced carbon-carbon (RCC) panel #8, causing a breach in the RCC. During re-entry this breach allowed super-heated air to penetrate through the leading-edge insulation and progressively melt the aluminum structure of the left wing, resulting in a weakening of the structure until increasing aerodynamic forces caused loss of control, failure of the wing, and break-up of the orbiter. This breakup occurred in a flight regime in which, given the design of the orbiter, there was no possibility for the crew to survive.

- Depressurization of the crew module, which started at or shortly after orbiter breakup. Existing crew equipment protects for this type of lethal event, but inadequate time existed to configure the equipment for the environment encountered. The crew would have only had about 40 seconds to don gloves and helmets.

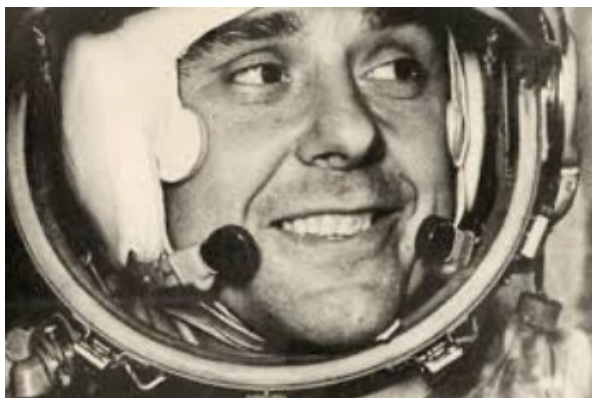
**Soyuz 1:** Vladimir Komarov

On the maiden flight of the Russian Soyuz spacecraft, the cosmonaut encountered an anomaly with the parachute system. During the descent, the drag chutes successfully deployed, but the **main chutes failed to deploy properly**. Detecting increasing speeds, the computer deployed a backup parachute. Because the drag chute was still attached and failed to release, the backup chute became tangled with the drag chute, preventing the deployment of the backup chute and resulting in a high-speed impact with the ground. **Vladimir Komarov died on impact**.

- Exhaust residue from the attitude control jets fouled the craft's ion orientation sensors, making control difficult
- Drag and main parachutes malfunctioned, entangling the backup parachute as it deployed
- Underlying issues included manufacturing oversight, external political pressures and inadequate preparation

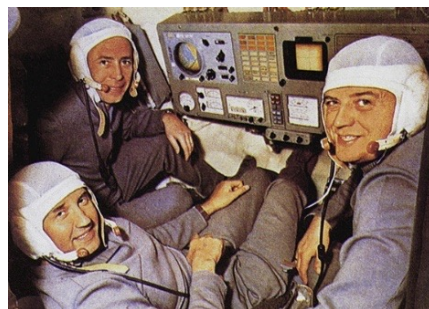
During separation of the orbital and service modules from the descent module, the pyrotechnic system did not operate as intended. All of the pyrotechnics fired simultaneously rather than the designed sequential firing mode, which was believed to be due to the excessive vibration loads on the vehicle. This caused a pressure equalization seal to open in the descent module at a higher-than-designed altitude, resulting in the rapid depressurization of the crew module. The rapid depress led to loss of consciousness of the crew despite attempts by one of the crew to block the leakage of air from the vehicle. The spacecraft otherwise made a nominal automatic touchdown with no known anomalies at the time of the recovery team.

Contributing factors:

- Absence of an open-valve warning system
- Absence of an emergency valve-choking system
- No structural shock testing performed for a worst-case scenario
- Crew were not wearing pressurized suits for re-entry

**Soyuz 11:** (L-R) Georgi Dobrovolski, Viktor Patsayev and Vladislav Volkov
