# Investigation of Shuttle and Orion Reentry Temperature Anomalies

MIKE SQUIRE – NASA ENGINEERING AND SAFETY CENTER (NESC) SPACECRAFT ANOMALIES AND FAILURES WORKSHOP MARCH 29, 2023

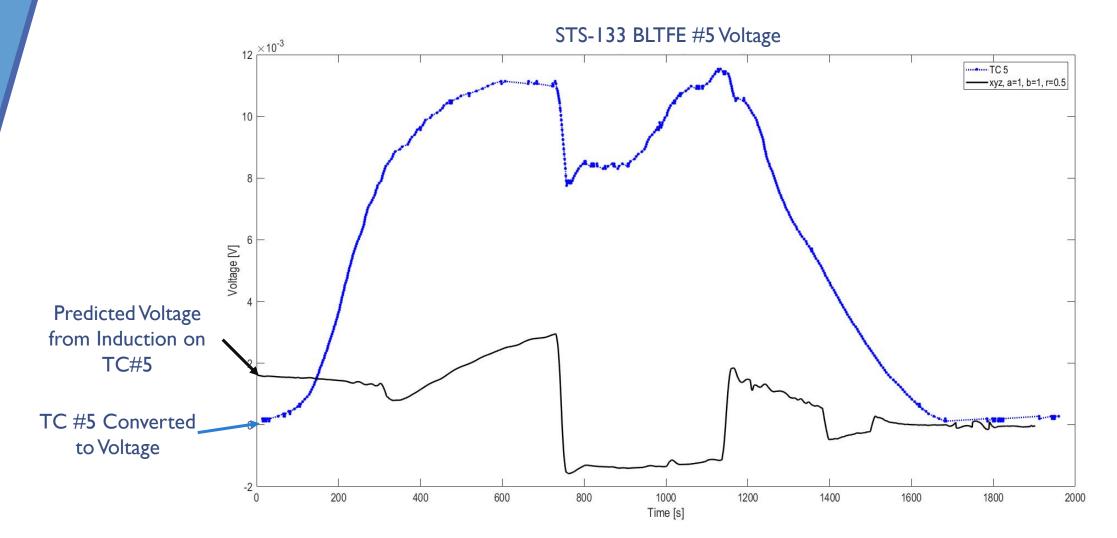
# Earth's Magnetic Field Induction Analysis

Faraday's Law: electromotive force (voltage) produced when conductor moves through a magnetic field

Earth's magnetic field is weak, but Shuttle velocity is high

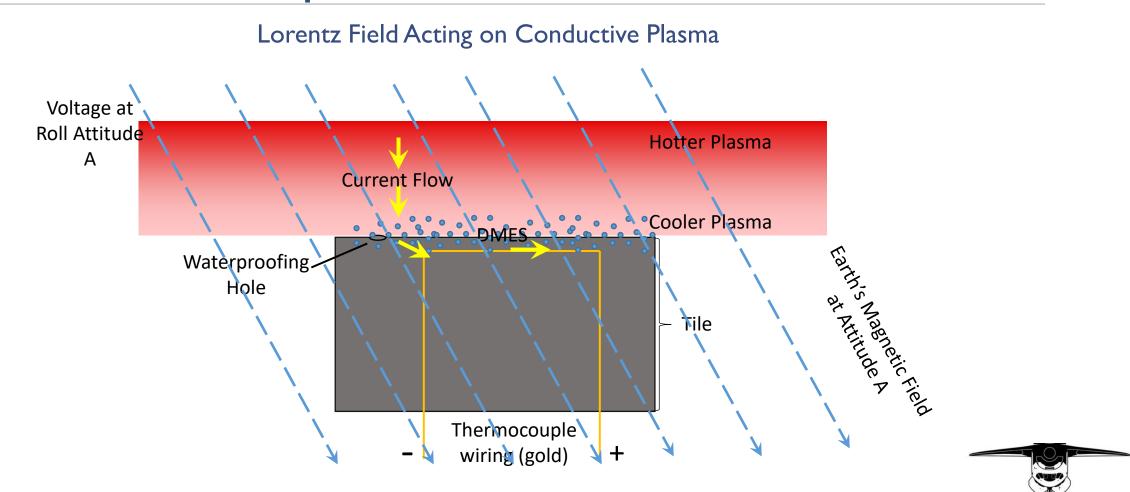
### **Alternative Explanation**

Like the Shuttle anomaly, probable cause was introduction of direct current

Mechanism driven by turbulent flow over TCs

Electrical path provided by products from heat shield ablation
