# **Space Shuttle Independent Assessment Team**

Report to Associate Administrator  
Office of Space Flight

October - December 1999

March 7, 2000

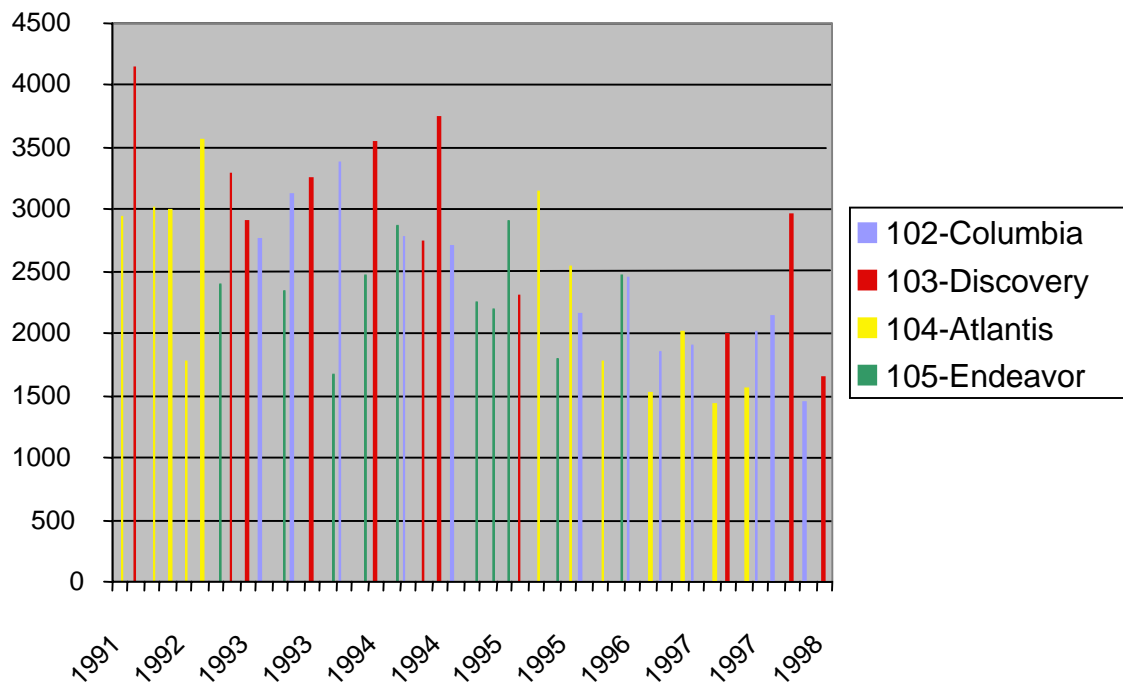
Figure 4 -- Problem Reports by Orbiter

Report count, it is clear from the data shown in *Figure 4 -- Problem Reports by Orbiter* that there is a decline in the average number of Problem Reports after 1995. This decline may reflect changes in reporting requirements, such as the increase in allowable discrepancies due to Fair, Wear and Tear, and improvements in process or hardware. However, the decline may also reflect the reduction in Government Mandatory Inspection Reports, quality assurance personnel (“second set of eyes”), and/or other checks and balances on the system. This finding is corroborated by the audit (draft) of the Marshall Space Flight Center Problem Resolution and Corrective Action system by Safety & Mission Assurance personnel: “Recent numbers of problems being reported by the contractors into the Marshall Space Flight Center Problem Resolution and Corrective Action system ... are down....” The report went on to state the concern that “these reductions do not seem to be completely justified by test schedules, revision from in-family screening and similar requirements adjustments, or improved hardware.” The decline in Problem Report reports requires deeper investigation to ascertain its true cause and acceptability.

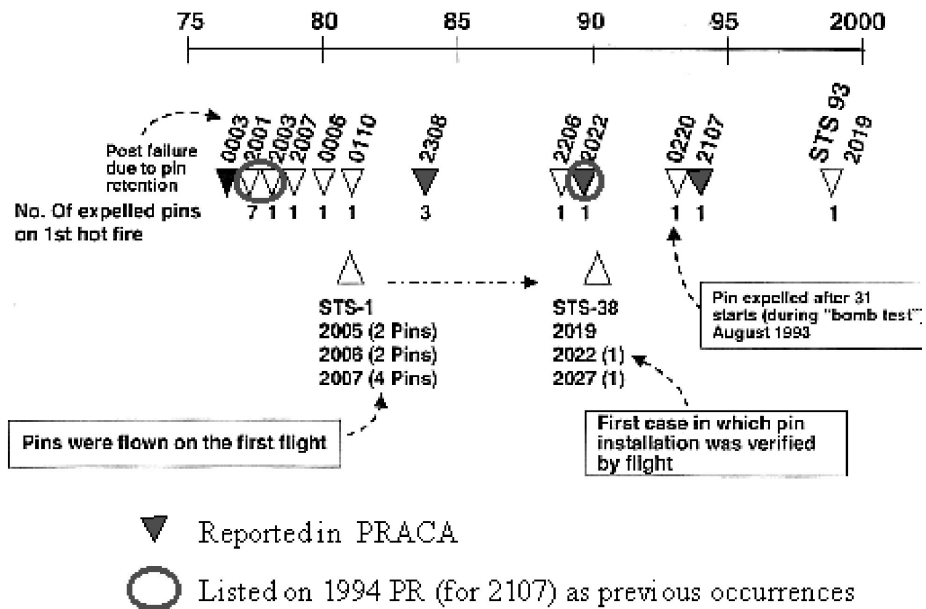
Figure 5 -- Problem Tracking Example: SSME Liquid Oxygen Post Pins

A second quantitative assessment of the data in the Problem Resolution and Corrective Action system was made by tracking a known problem, namely that of the Main Injector liquid oxygen pin ejection. Both the Marshall Space Flight Center Problem Resolution and Corrective Action system and the data warehouse ADAM were searched for Problem Reports addressing pins in the Space Shuttle Main Engine. Only three of the ten known occurrences of Main Injector liquid oxygen pin ejection were recorded in either system. As shown in *Figure 5 -- Problem Tracking Example: SSME Liquid Oxygen Post Pins*, which is the Rocketdyne-Boeing analysis of the pin ejection history, only occurrences on engines 2308 in 1984, 2022 in 1990, and 2107 in 1994 were reported in the Problem Resolution and Corrective Action system. In contrast, the historical record provided by Rocketdyne-Boeing for problem close-out on the Problem Report for the 1994 occurrence listed a different set of three occurrences: two that occurred before 1980 and the occurrence on engine 2022 in 1990. Further examination of the Problem Report records for Main Injector liquid oxygen pin ejection indicated that the CRIT levels assigned to the functionality and the hardware associated with pin ejection varied from 3/\_, 3/1, to 1/1. Also varying in degree and fidelity was the resolution description provided on each Problem Report.

It is clear from the results of this test of the Problem Resolution and Corrective Action system that the data concerning the occurrence of pin ejection was both incomplete and inconsistent. Confusion concerning the reportability of the problem of pin ejection was still evident during discussions held with engineers as part of this assessment. Pinning of the liquid oxygen post was clearly considered a standard repair and pin ejection understood to be a benign condition. So although the criticality of the hardware (CRIT 1) and the timing of the ejection (during first hot-fire after pinning) require the occurrence to be reported in the Problem Resolution and Corrective Action system, problem reports concerning pin ejection were not always made. Had they consistently been reported, the 1 in 10 probability of occurrence may have raised concern over flying a pinned post on STS-93 without prior hot-firing.

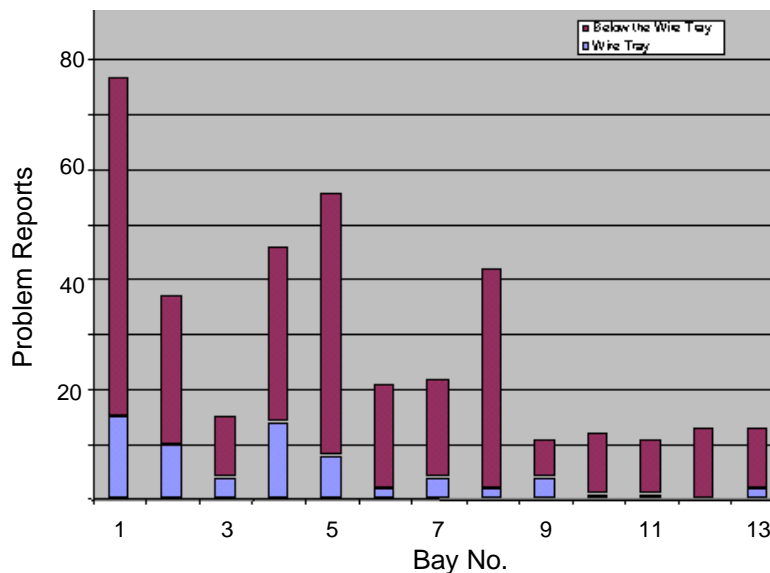
Figure 6 -- Kennedy Space Center Wiring Trending

In all cases, trending is rudimentary; very little numerical or statistical analysis is performed. Furthermore, no automated flags exist within the problem reporting system to alert engineers or Safety & Mission Assurance personnel to high incidences of problem recurrence.

In addition to assessing general trending capabilities, two trending studies made with data in the Kennedy Space Center and Marshall Space Flight Center Problem Resolution and Corrective Action systems were examined in detail. The first such study concerned wire damage problems. In order to assess the root cause of wire damage, trends were needed that distinguished the type of wire damage (i.e., insulation damage, exposed conductors, conductor damage) as a function of location of occurrence in the Shuttle. An example trend report is shown in *Figure 6 -- Kennedy Space Center Wiring Trending*. To provide this information, a team of 10 engineers and 3 quality inspectors worked for 1 week reviewing Problem Reports in the Kennedy Space Center Problem Resolution and Corrective Action system. This intense effort was needed because the data contained in the system lacked standardization and fidelity and needed to be assessed and interpreted by the engineers in order to be meaningful. In some cases, the data did not exist or could not be resurrected.

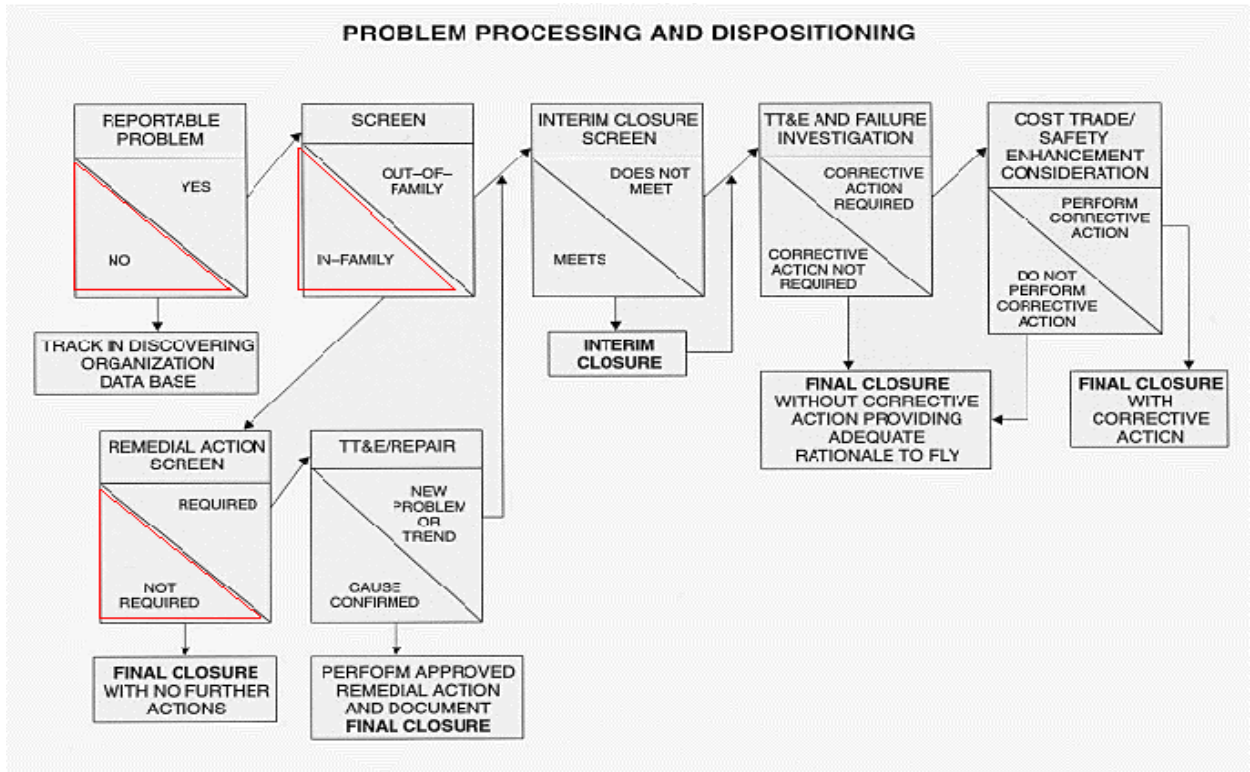
Figure 7 -- Problem Processing & Dispositioning

Problem processing procedures were also examined for potential weaknesses. It was found that several decision points (see *Figure 7 -- Problem Processing & Dispositioning*) exist in the procedures in which a problem and important attendant information can fail to enter the Problem Resolution and Corrective Action system. First, a problem has to be judged reportable, a judgment subject to the problems of uncertainty, interpretation, and lack of information described above. Decisions concerning problem reportability may occur at the technician level, with little engineering and/or Safety & Mission Assurance oversight or review.

These observations cause concern that processing procedures do not provide sufficient visibility of problem occurrence and resolution and may allow problems to be lost from the system.

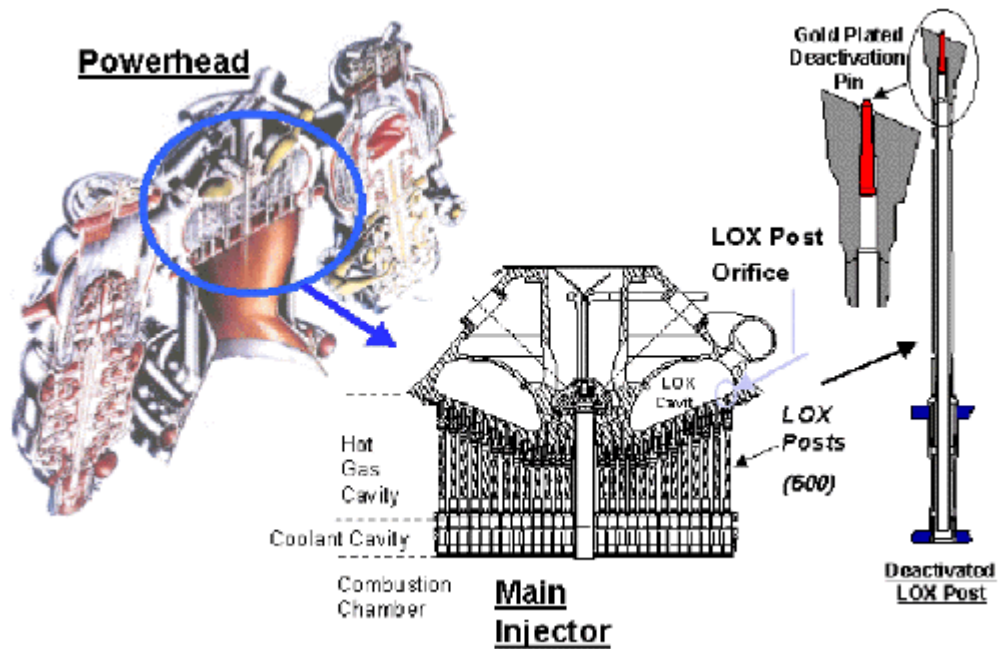
Figure 14 -- Powerhead, Main Injector and Liquid Oxygen Post Details

It has been common practice to deactivate Main Injector Lox Posts, when they are determined to be life limited because of manufacturing or operational damage. When a post life limit is reached, a pin is inserted in the liquid oxygen post supply orifice (*Figure 14 -- Powerhead, Main Injector and Liquid Oxygen Post Details*). The pin shuts off the liquid oxygen flow through the post, reducing high cycle fatigue loading. The tapered pin is about 1" long, 0.100 inches in diameter, gold coated, and is pressed with interference fit into the orifice.

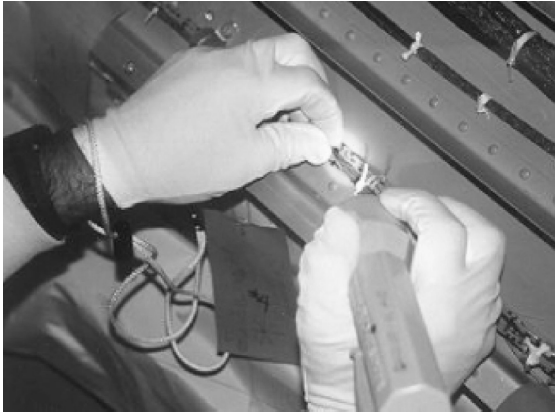
Figure 22 -- Wire Defect Inspection Process

6. The current inspection process requires inspectors to examine wiring using flashlights, mirrors, and up to 10X magnification (*Figure 22*). This typically requires damage to be visible from the top of the wire bundle or in an area known to be susceptible to damage (*Figure 24*). There have been at least two instances where wire damage was inside a bundle and not obvious during external inspections.

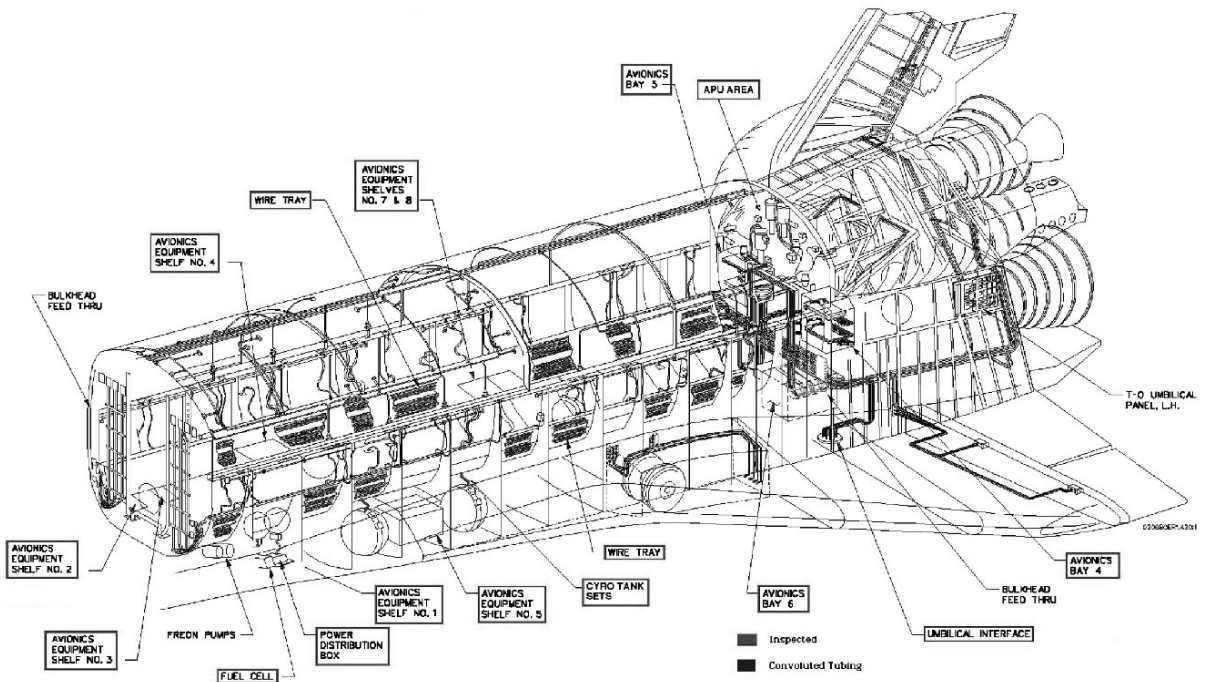
Figure 26 -- Inspected Areas

Inspectors have been encouraged not to conduct intrusive inspections to minimize induced wire damage. The most intense inspection has been conducted in the mid-body bays. A summary of the areas inspected in the mid-body and aft areas is shown graphically in. An examination of the Problem Resolution and Corrective Action system data prior to recent inspections shows the mid-body area to be the fourth highest area with wire damage (*Figure 30*). The data as of November 18, 1999 shows that since the recent inspections in late August 1999, there have been 485 PRs written related to wiring in the mid-body area (see Table 4). Examples of the type of wire damage being found are shown in *Figure 23* and *Figure 24*. Note that in *Figure 23* the conductor is exposed and has broken strands.

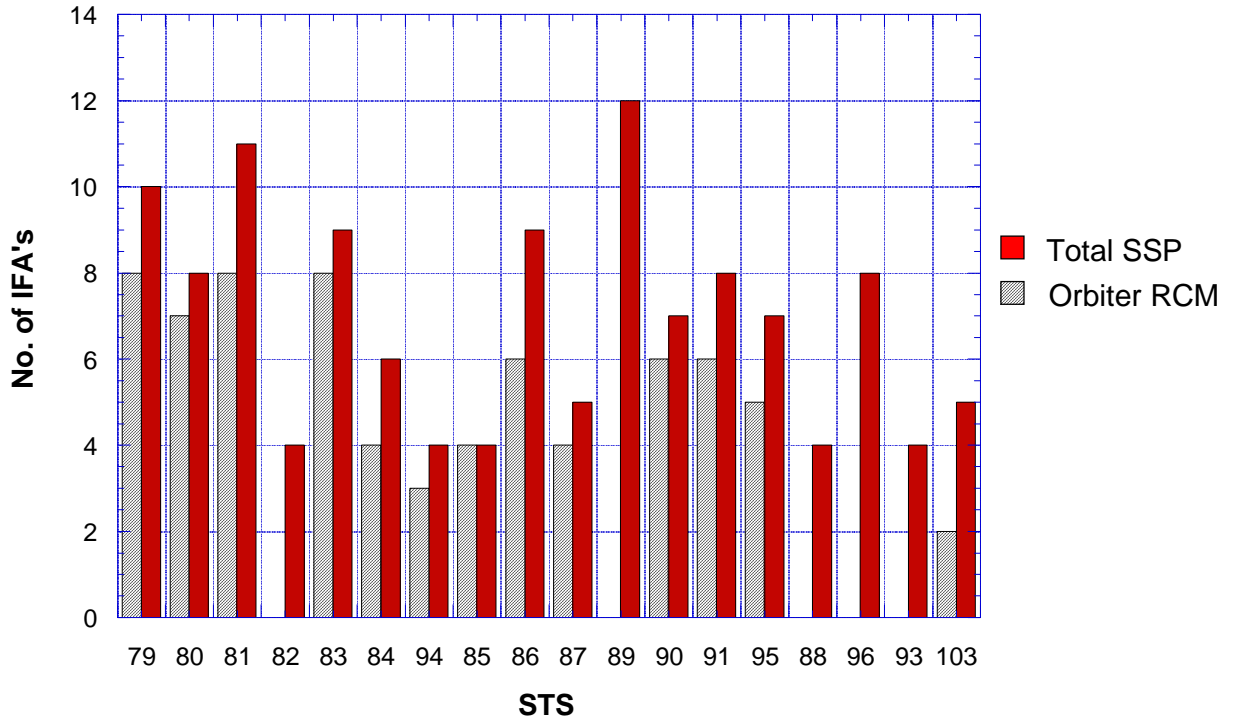
Figure 35 -- Space Shuttle In-Flight Anomalies

The SIAT did not identify a single, ideal metric in the information presented by the SSP to indicate the effects of aging and the adequacy of maintenance efforts in addressing these effects. IFA's (see *Figure 35*) were used as an indication of how many actual problems develop during flight that may affect flight safety and mission completion. The number of Problem Reports generated during Shuttle maintenance periods was also examined (see **Problem Reporting & Tracking Process**); however, PR generation is affected by a number of factors, including the number of inspectors and inspection points and the adherence to reporting procedures, that may obscure the number of actual problems. A third metric, the history of open Corrective Action Reports (CAR's) was studied as well (see *Figure 36*). The number of open CAR's is indicative of both the number of problems and the effectiveness of the resolution process. Missing from all three indicators is explicit information concerning the severity of the problems. As a consequence, some combination of these metrics (and others) should be examined, with the appropriate analyses to identify the true trends and their root causes.
