**Michoud Assembly Facility**  
**Rigging Crane Rails Employee Injury**  
**Type B Mishap**  
**NMIS Case Number: 23-101175**

**Date of Mishap: September 22, 2023**

**Date of Report: November 17, 2023**

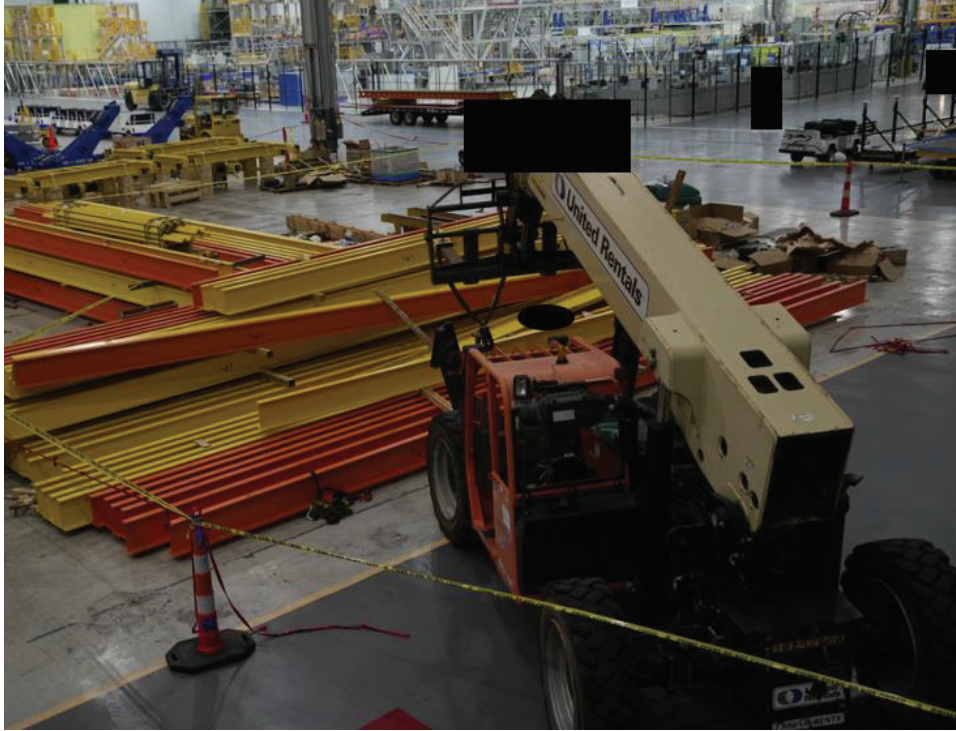
*Figure 2: 20- and 40-foot beams.*

An upgrade of the steel structure in Building 103 was being undertaken to allow a crane to run along the rails [Twin City (T/C) American rail type] in order to move and assemble flight hardware throughout the facility. The subcontractor was awarded a contract on October 17, 2022, to replace cranes 34, 35, 36 and runways in Building 103 with 20-foot and 40-foot (Figure 2) steel beams that measured 12.5 inches in height.

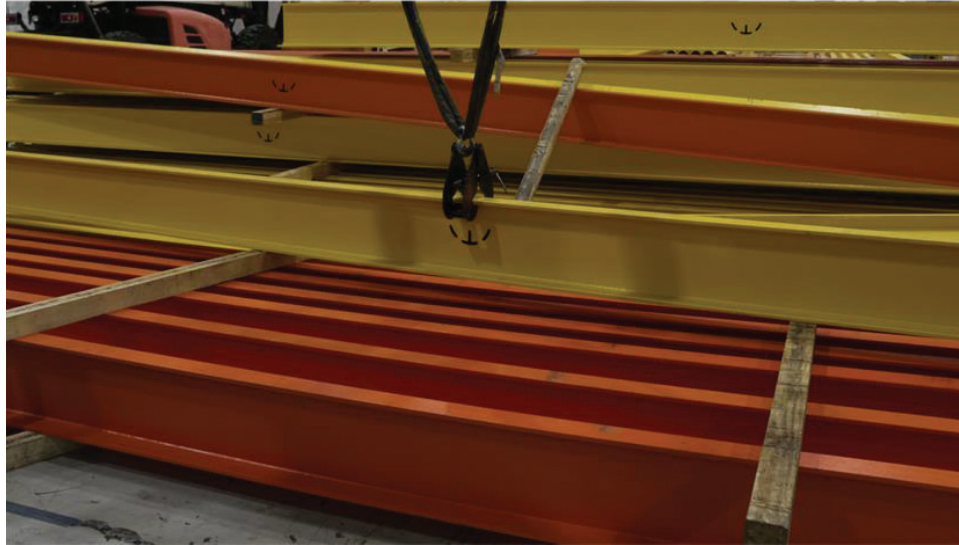
*Figure 4: Beam clamp attached to the beam.*

The subcontractor moving the beams was told by the prime contractor's safety personnel to no longer use the forks of the forklift to remove steel from the stack; therefore, the subcontractor opted to use a beam clamp to move beams and have a more secure load. Since the beams were stacked to a height of approximately five high (~6'8"), a subcontractor employee needed to walk on the steel beam stack and manually use the beam clamp to tighten the jack screw to secure the clamp prior to that beam being lowered to the ground and the beam clamp removed (Figure 4).

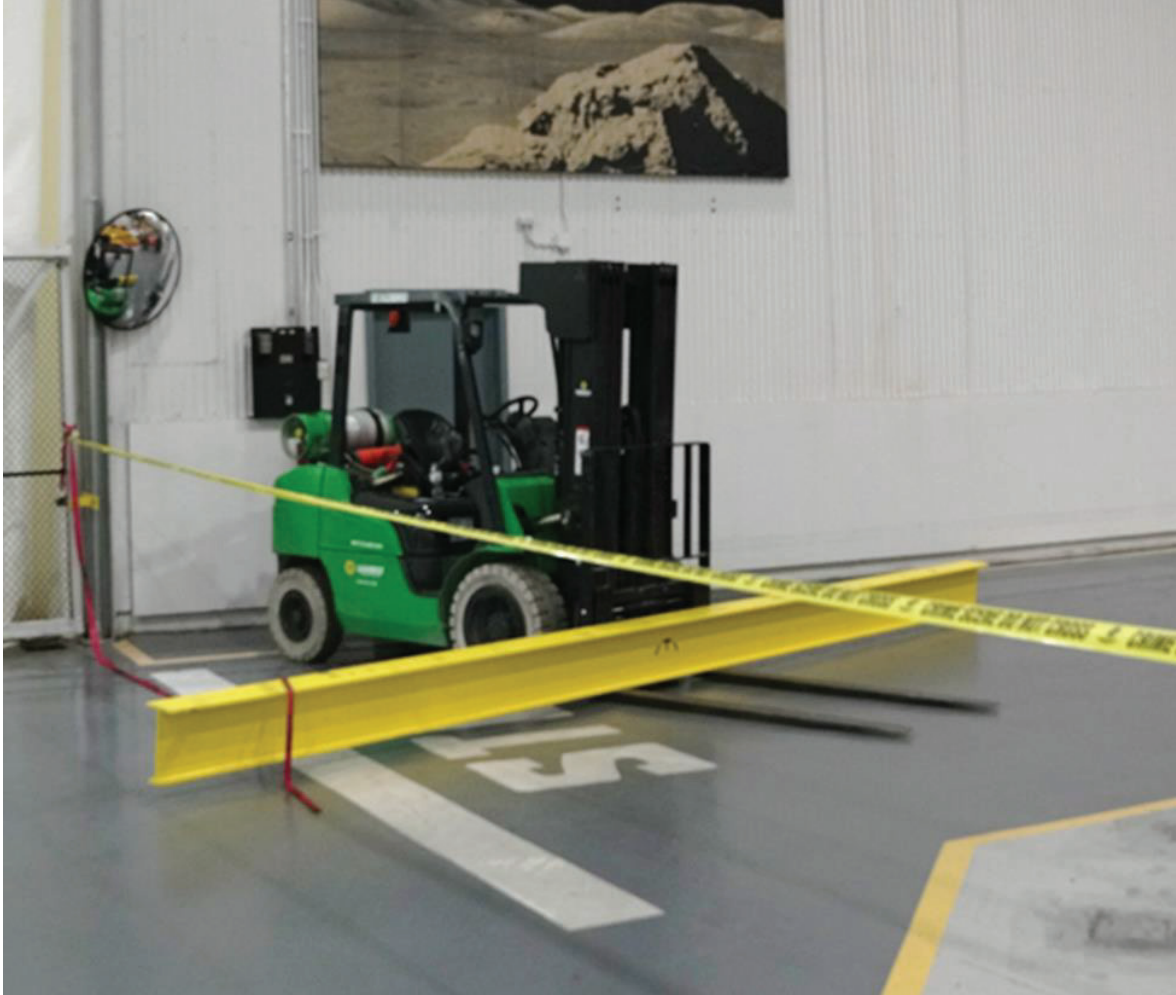
*Figure 5: Beam flipped 180 degrees on forklift.*

The beam would then be flipped 180 degrees (Figure 5), such that the wider portion of the beam was facing the rooftop for assembly into the ceiling beam matrix, and placed on the forklift in preparation for moving the beam into position prior to being installed. The subcontractor raised concerns about the lack of square footage of the lay-down stack (Figure 6). The MIT learned from interviews the subcontractor requested more floor space from the prime contractor, but the subcontractor never received a response that approved or denied their request. In order to meet the scheduled deadline, the subcontractor allowed the beams to be stacked above the normal maximum height of a 2-beam stack, which is approximately 32 inches. The previously site-specific health and safety plan was not updated after the change in procedure.

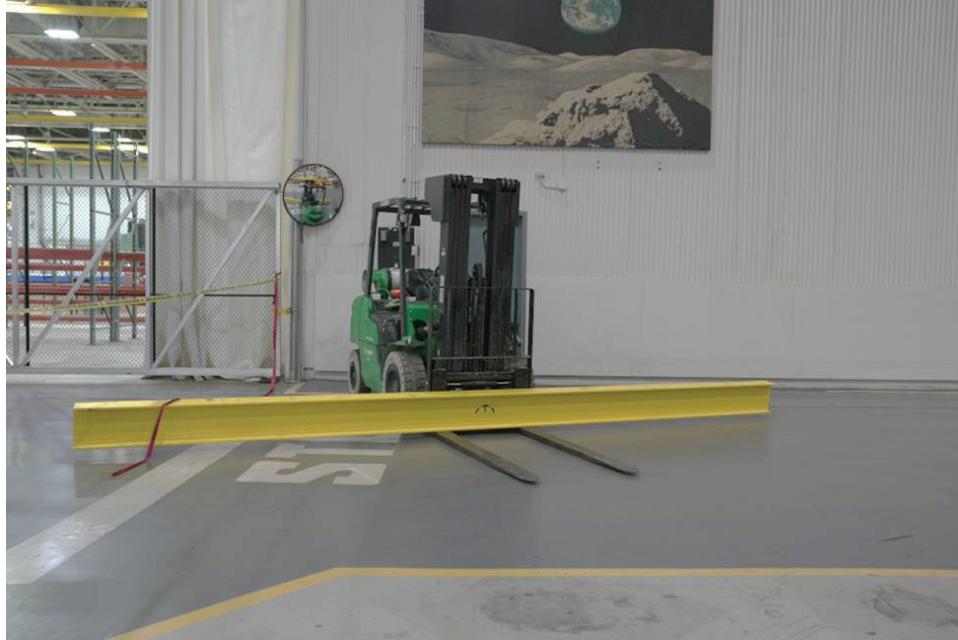
*Figure 7: Different angle of beam flipped 180 degrees on forklift.*

On the morning of Friday, September 22, 2023, subcontractor employees in the immediate area in Building 103, G5/G6 consisted of the forklift driver, the spotter, and the rigger, who is the IP. Additional subcontractor employees were located nearby in the machine shop in Building 103 in preparation for raising the steel beams in that location. From video footage evidence, taken with a camera located at E4, at 8:46 a.m., the forklift driver positions the lull (with the clamp attached) while the spotter directs the forklift driver for clearance; the IP climbs up the stack of beams and clamps the beam. After the IP successfully clamped the beam at 8:48 a.m., the forklift driver lifted and lowered the beam to the floor. After the beam was lowered to the floor, IP walked to the end of the beam to exit down the stack of beams to the floor level and unclamp the beam, which was lowered to the floor, rotated 180 degrees, and placed on the forklift (Figure 7).

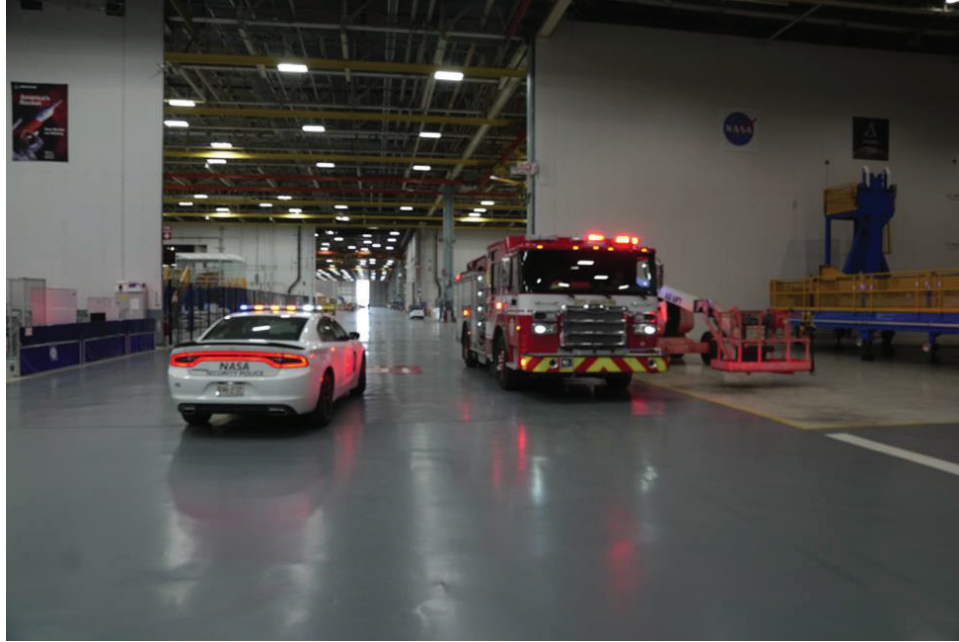
*Figure 11: MAF security at the mishap site.*

The forklift driver ran to get help from coworkers located in the machine shop area to help assist. The spotter, forklift driver, and additional workers lifted the steel beam from IP's leg by hand and placed cribbing under the beam to prevent it from falling back onto the IP's leg. IP picked up right leg by the pants leg and moved it out from under the beam. At 8:55 a.m., calls were received by 911 dispatch. Security was en route to Building 103 (Figure 11) and arrived at 8:56 a.m.

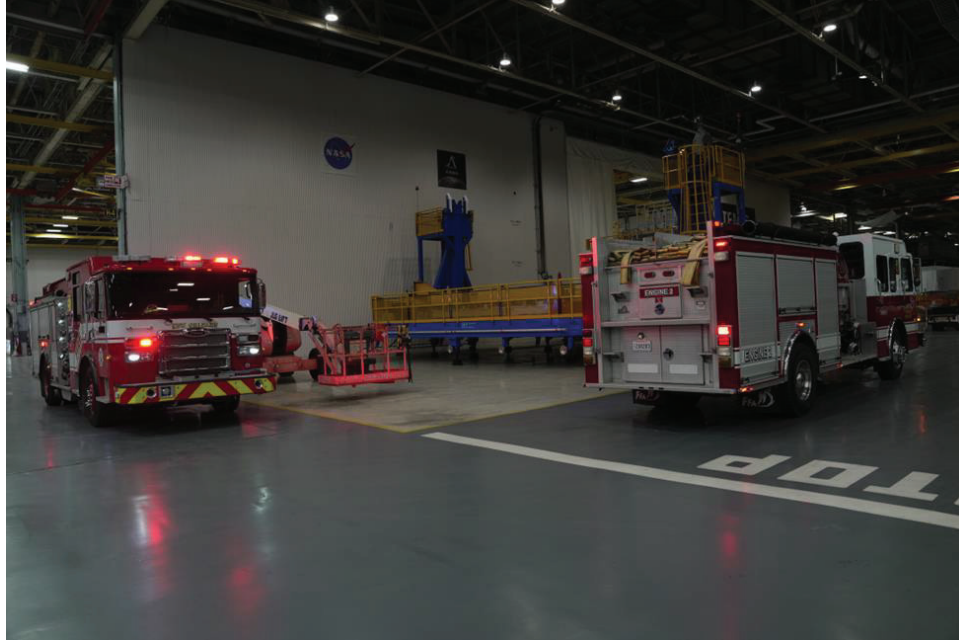
*Figure 12: St. Bernard Fire Department at the mishap site.*

At 8:58:40 a.m., two MAF security officers responded to the mishap site. Security Officer 1 recognized the bright red arterial bleeding and extent of the injury and subsequently used a bystander's belt and their own police baton to devise a makeshift tourniquet. The tourniquet was placed above the injury, but below the knee, and was tightened until the bleeding slowed. Bleeding was slowed substantially but continued. Upon arrival of the St. Bernard Fire Department at 9:07 a.m. (Figure 12), emergency personnel replaced the makeshift tourniquet with a commercial medical tourniquet device. Bleeding continued, so a second tourniquet was placed just above the knee. A third tourniquet, higher up the thigh, was utilized and bleeding ceased.

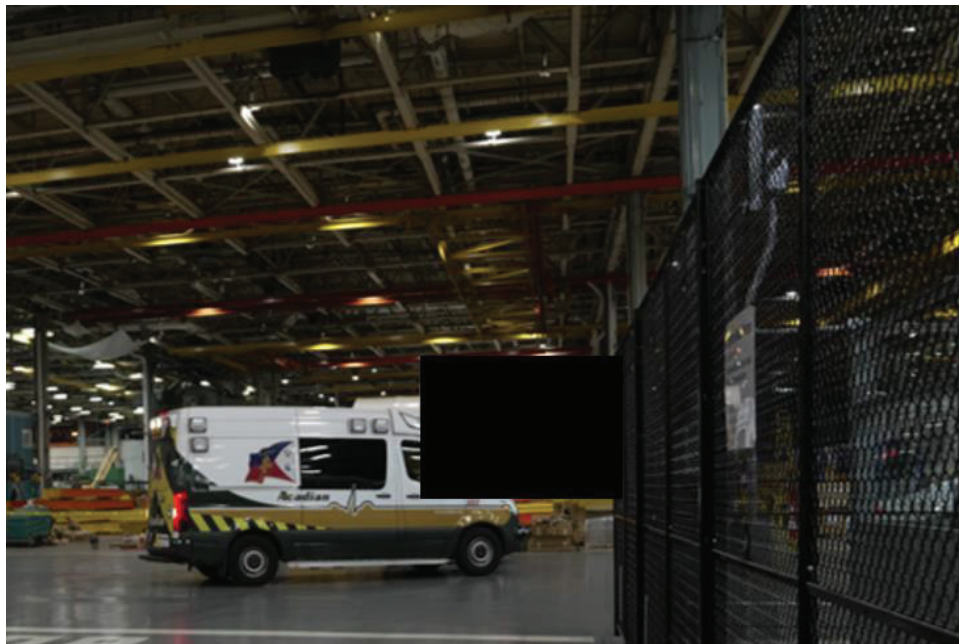
*Figure 13: Ambulance arriving to the mishap site.*

The injury to the right arm was unknown at this time, most likely due to the distracting extensive right lower extremity injury, so no splint was applied. IP was placed on a “man-bag,” a soft-sided stretcher with handles used to extricate patients from difficult terrain or areas, in order to remove IP from the scene and load them onto a cot. The IP was loaded into an ambulance (Figure 13), which then transported them to the designated helicopter landing area.

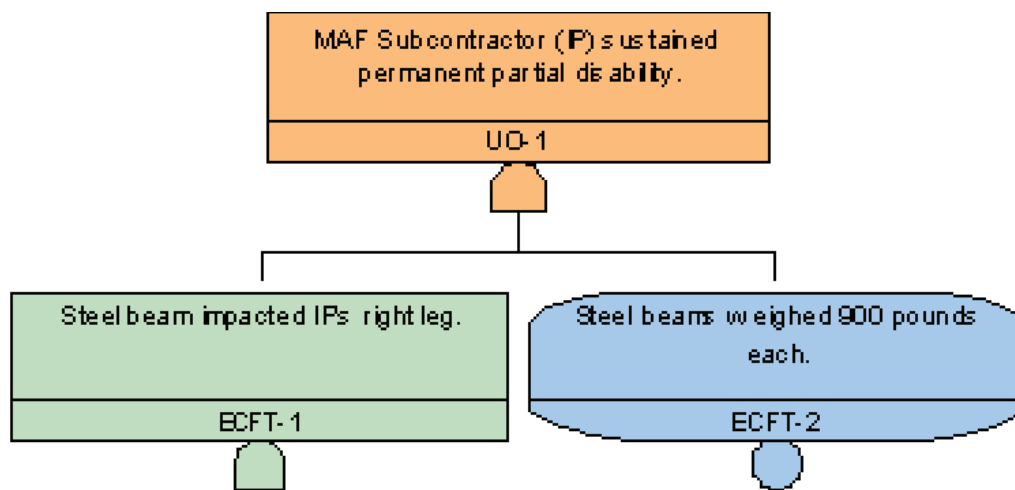
Figure 17: Proximate Causes

#### ECFT-1 - Steel beam impacted IP's right leg.

**Supporting Evidence:** MIT learned from the interviews and data evidence that the beams had a minimum weight of 900 pounds. The subcontractors were working with 20-foot and 40-foot beams, which weighed 900 pounds and 1,800 pounds respectively. The height of each beam is 12.5 inches. Interviews indicated a 20-foot beam struck IP's right leg.

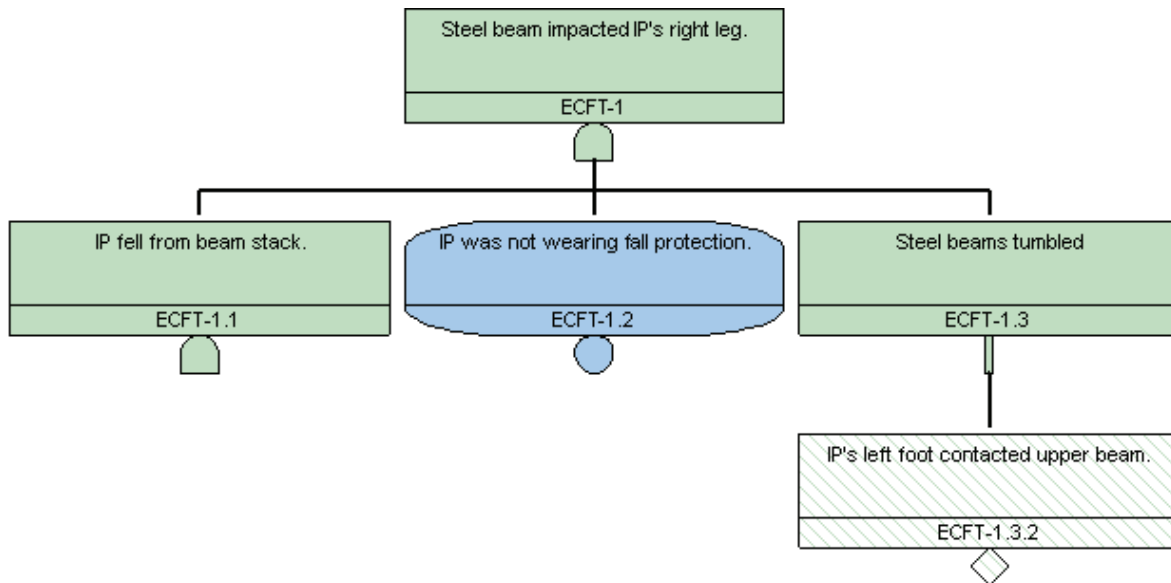
Figure 18: Proximate Cause 1 breakdown.

#### ECFT-1.1 - IP fell from beam stack.

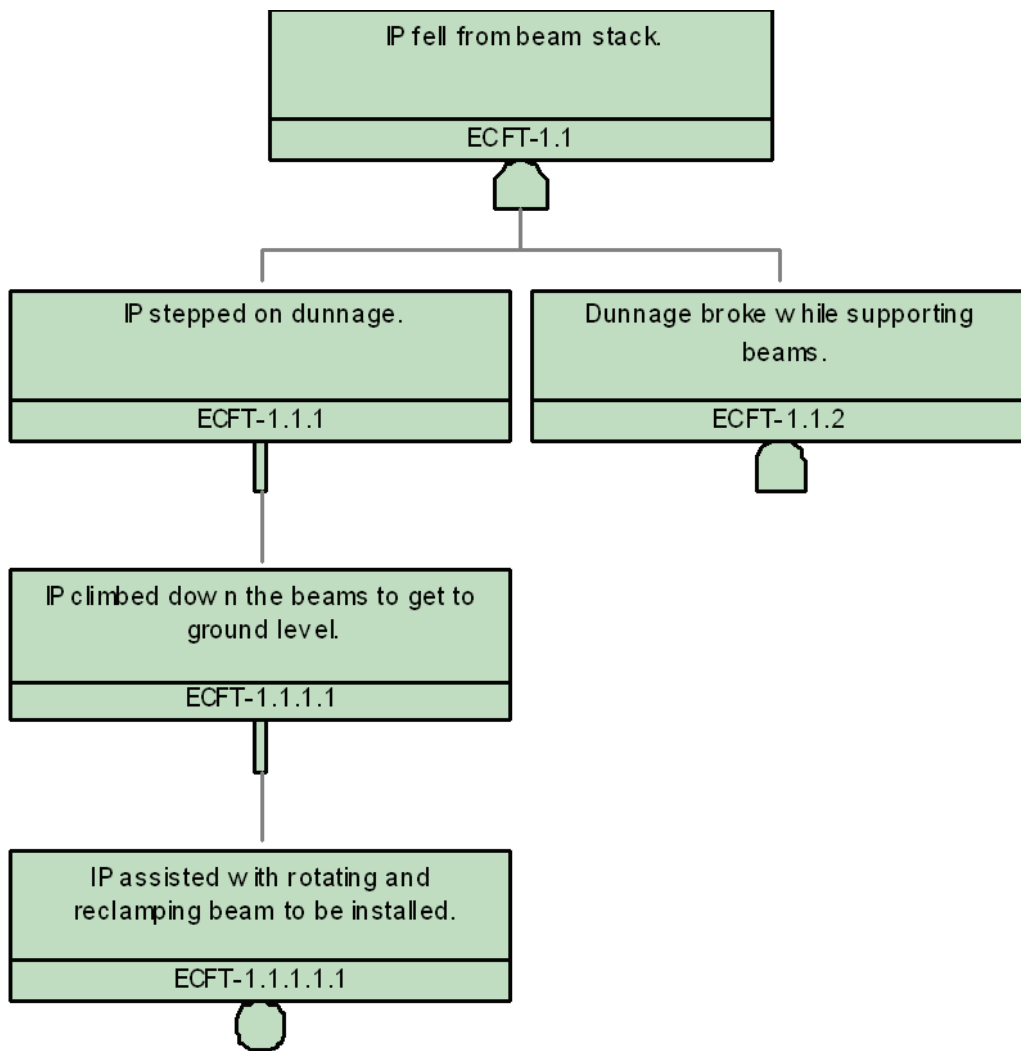
Figure 20: Causes of the IP falling from beam stack.

#### ECFT-1.1.1 - IP stepped on dunnage.

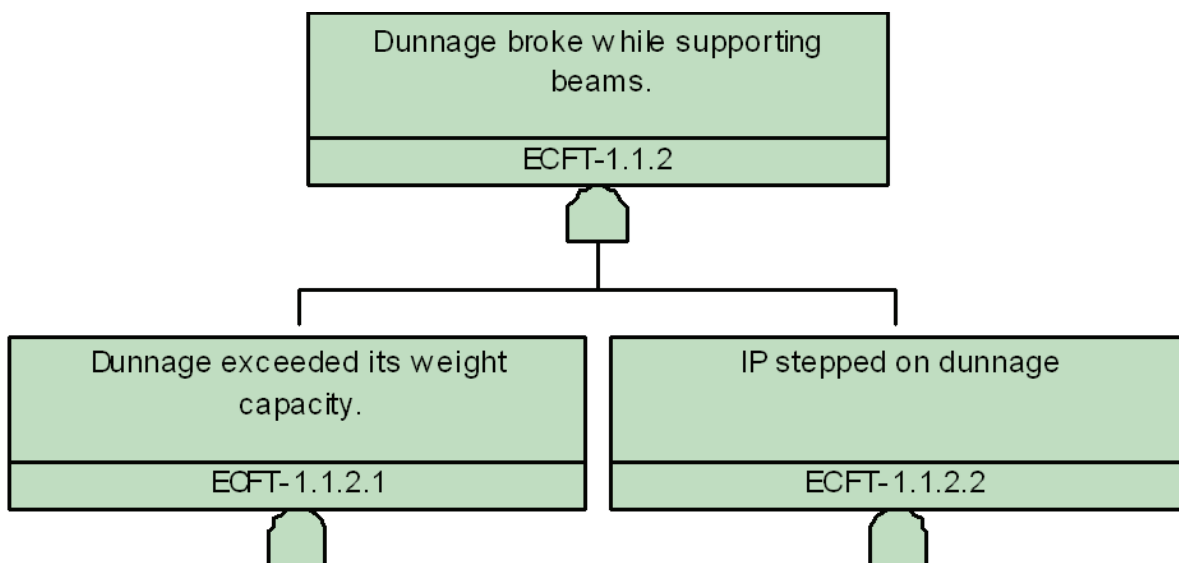
*Figure 21: Causes to the dunnage breaking.*

#### **ECFT-1.1.2 - Dunnage broke while supporting beams.**

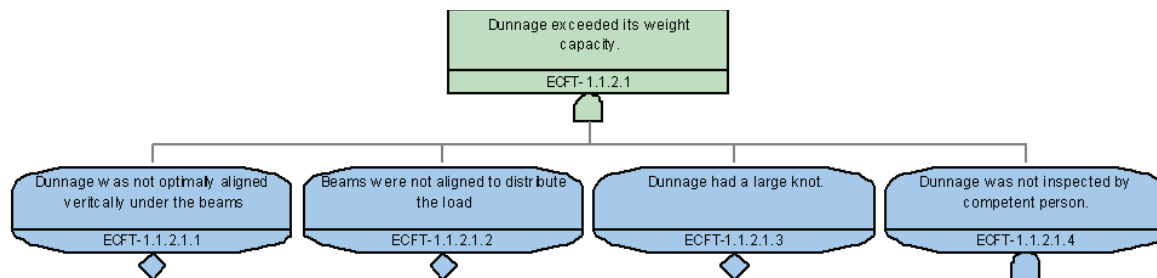
Figure 23: Causes to the dunnage exceeding its weight capacity.

**ECFT-1.1.2.1.1 - Dunnage was not optimally aligned vertically under the beams.**

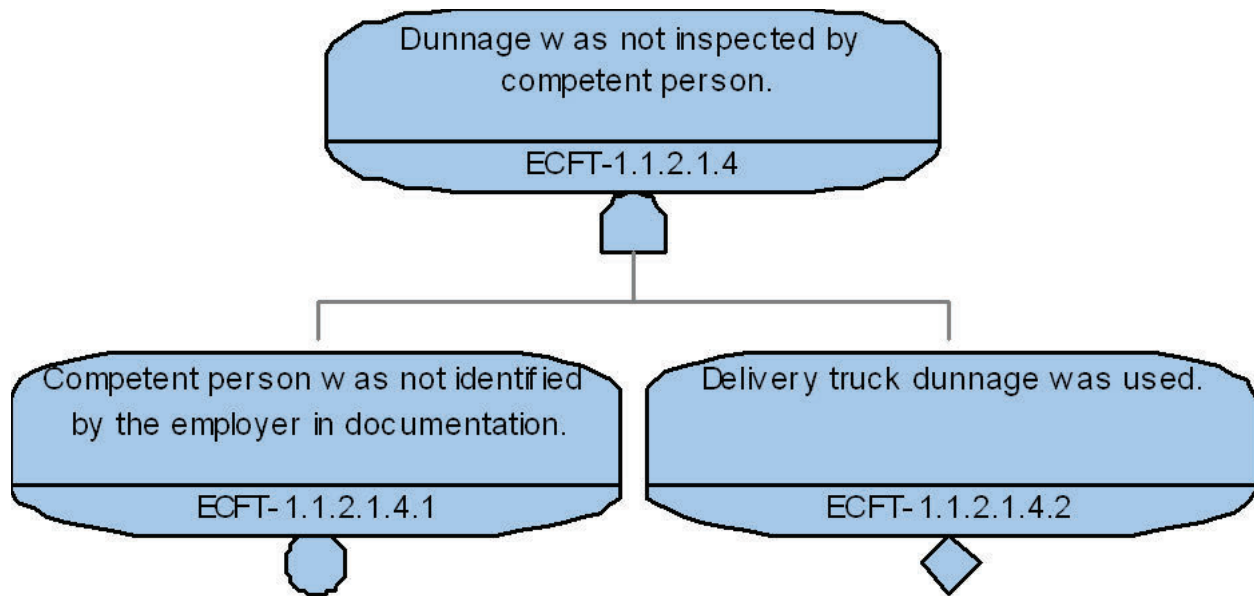
Figure 25: Additional causes of the dunnage breaking.

**ECFT-1.1.2.1.4 - Dunnage was not inspected by competent person.**

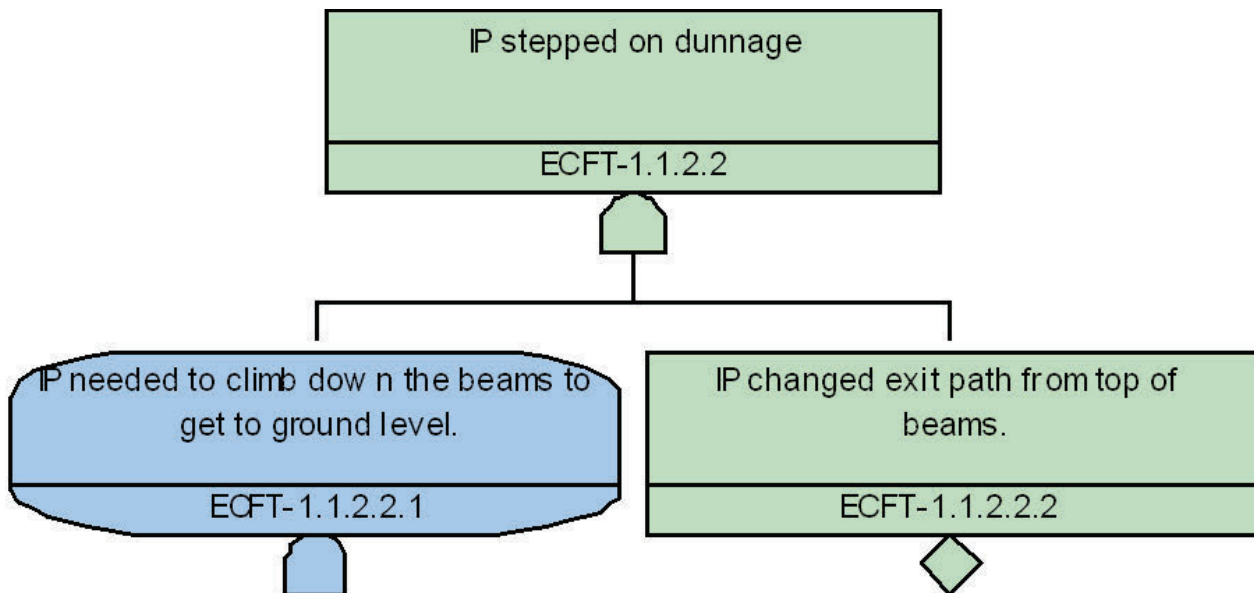
Figure 26: Causes to the IP stepping on dunnage.

#### **ECFT-1.1.2.2.1 - IP needed to climb down the beams to get to ground level.**

#### **ECFT-1.1.2.2.2 - IP changed exit path from top of beams.**

**Supporting Evidence:** Video footage illustrated that IP walked to the end of beams on previous movement on beams. However, MIT learned from the mishap site, witness statements, and interviews, IP was standing on level 4 beams and climbed down the beams to exit the beams. It was also noted that walking down the beams was a norm and it was done often. Interviews did not indicate why IP changed his exit path off the beams. Interviews indicated that ladders, scaffolds, and/or aerial lift are infeasible and unsafe methods to go up or down the unsecured beams.

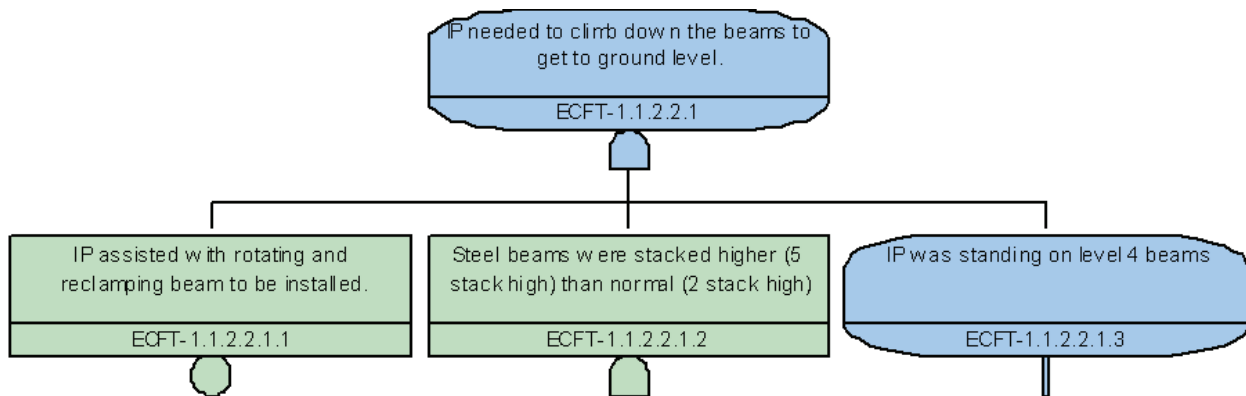
Figure 27: Causes why the IP needed to climb down to ground level.

#### ECFT-1.1.2.2.1.1 - IP assisted with rotating and reclamping beam to be installed.

#### ECFT-1.1.2.2.1.3 – IP was standing on level 4 beams.

**Supporting Evidence:** MIT learned from video footage, witness statements, and interviews, the IP was working with beams stacked five high and stood on level 4 (~5'4" from floor level) beams to clamp attachment to beams.

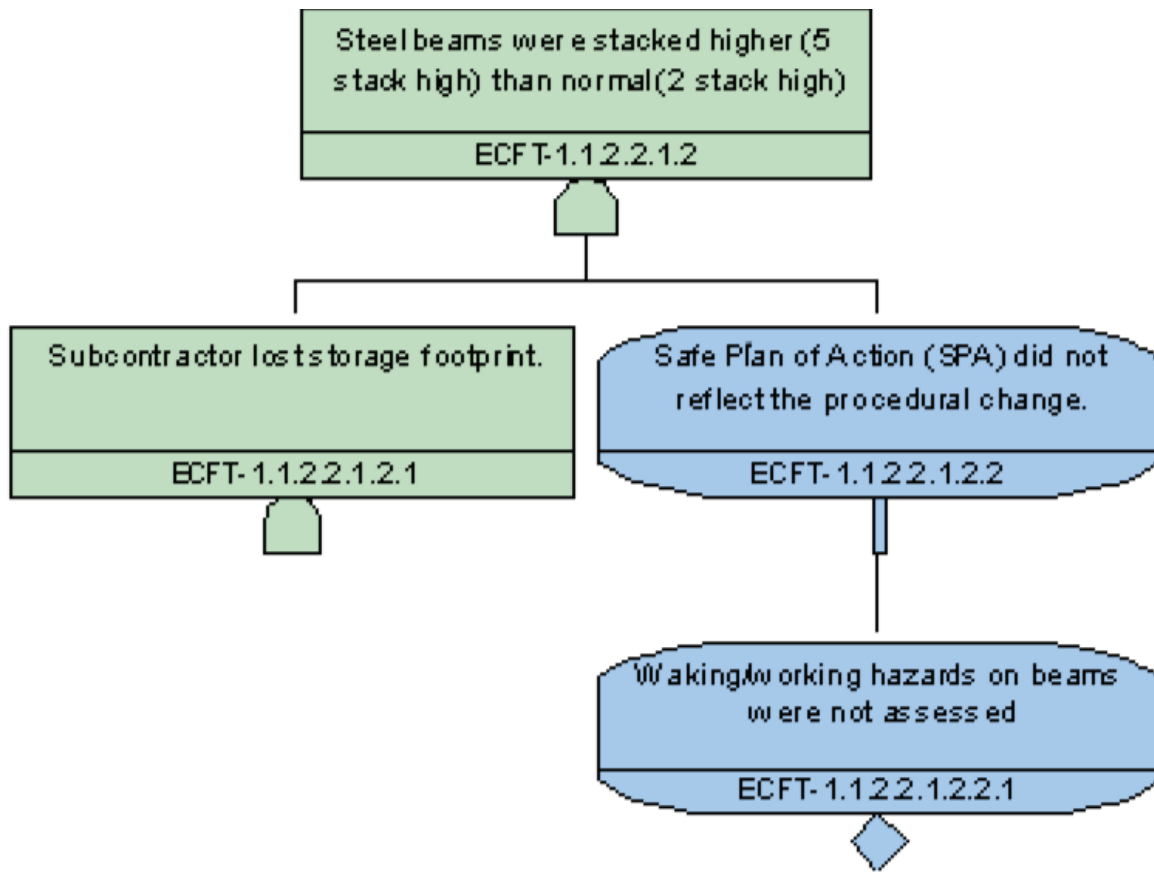
Figure 28: Additional causes to why IP was on stack of beams.

#### ECFT-1.1.2.2.1.2.1 - Subcontractor lost storage footprint.

**ECFT-1.1.2.2.1.2.2.1 - Walking/working hazards on beams were not assessed.**

**Supporting Evidence:** Interviews indicated walking the beams was a norm, and subcontractors did not see it as a hazard. MIT reviewed the SPA and JHA and did not see any hazards related to walking on the beams identified.

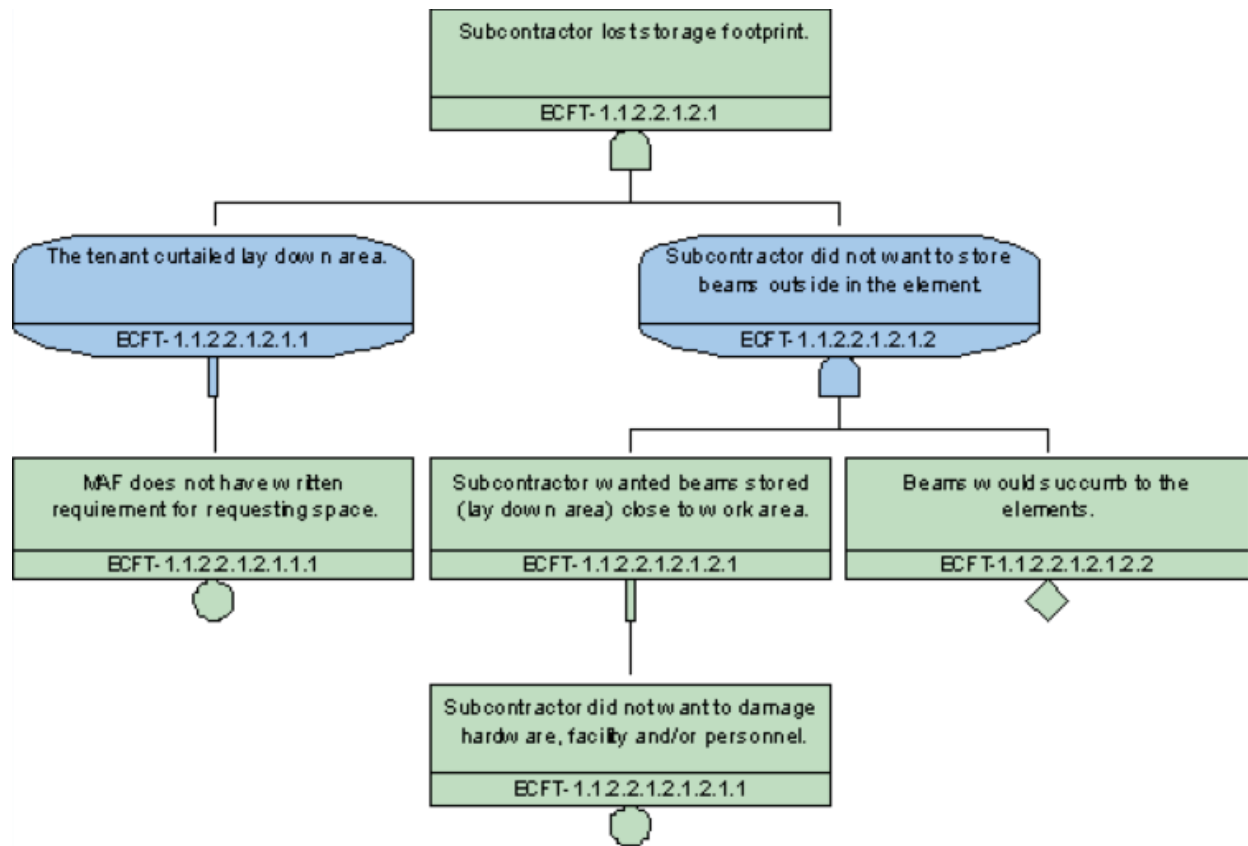
Figure 29: Causes to why the beams were stacked higher than 2 beams.

#### **ECFT-1.1.2.2.1.2.1.1 - Tenant curtailed lay-down area.**

**ECFT-1.1.2.2.1.2.1.2.2 - Beams would succumb to the elements.**

**Supporting Evidence:** Interviews indicated beams will rust quickly if stored in the Louisiana atmosphere and would then need to be sandblasted and repainted, which would require more work, time, and money.

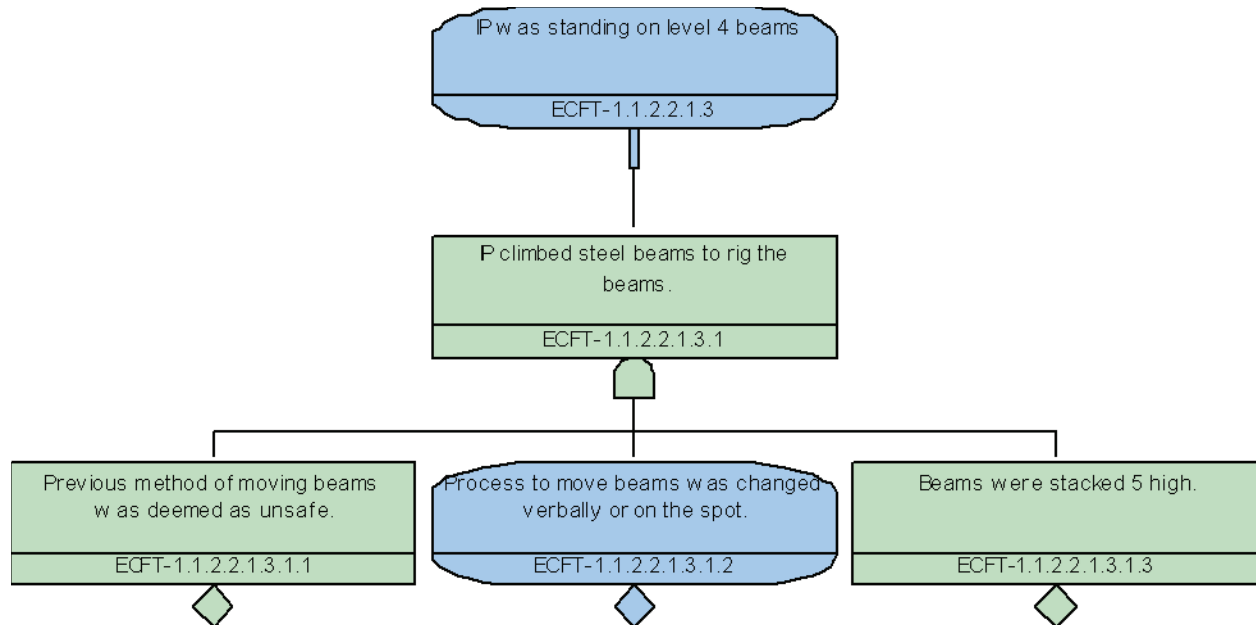
Figure 30: Causes as to why the IP was on the beams.

**ECFT-1.1.2.2.1.3.1 - IP climbed steel beams to rig the beams.**
