NOAA-17 Breakup Engineering Investigation

Spacecraft Anomalies and Failures (SCAF) Workshop 2024

March 27th, 2024

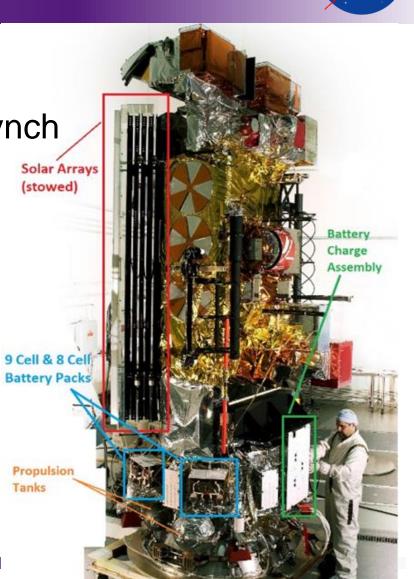
NOAA-17 Overview

- Polar weather satellite
- Launched on 6/24/2002 to approx. 800 km Sun-synch
- Very similar to DMSP Block 5D3 design
- Mass is 1430 kg in orbit
- Operated nominally until 2013, when it was passivated
 - 4.98 kg hydrazine remained after isolation
 - Nitrogen cold-gas propulsion system was nominally depleted before decommissioning
 - Two batteries isolated, one left connected to the discharge path
