Starliner Propulsion System Anomalies during the Crewed Flight Test - Investigation Report

02/05/2026

Executive Summary

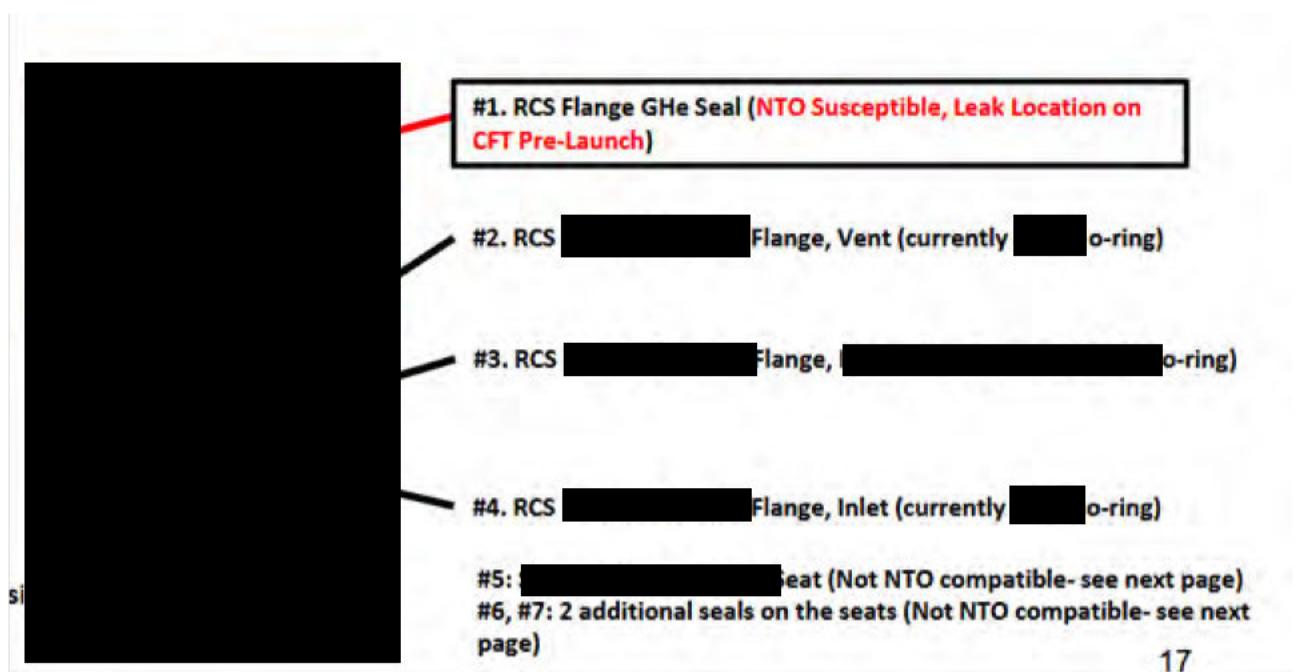
Figure 42: RCS Flange with NTO, MMH, and Helium Ports Here

The RCCA fault tree lists the possible proximate cause¹ of the helium leakage to be material incompatibility of the [REDACTED] O-ring with NTO within the RCS flange. Lack of design incorporating redundant seals in the RCS & OMAC, correct requirement flow down, and insufficient qualification testing specifically lack of NTO exposure are all listed as likely contributors. The O-rings for the [REDACTED] are listed as possible contributors, citing that the O-rings in these locations could be compromised by NTO exposure. O-ring [REDACTED] tolerances, seals in thruster solenoid valves, moisture, material temperature life limits, excessive lubricants, and wrong fasteners installed area listed as possible contributors. The Starliner PIT concurs with the RCCA regarding the most probable mechanism that resulted in the helium leakage.

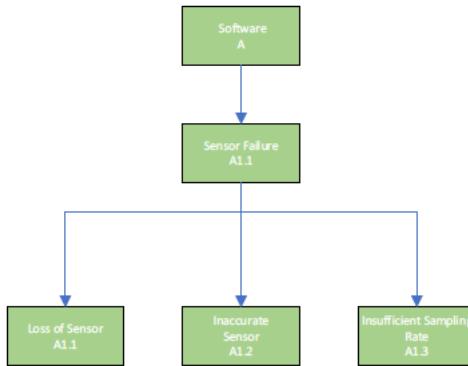
Figure 48: Software Section of the Helium Leaks Fault Tree

The main node of the **A Software** section is the **A1 Sensor Failure** branch, as shown in Figure X. Software section of the Helium Leaks Fault Tree, A1 Sensor failures cover **A1.1 Loss of a Sensor**, **A1.2 Inaccurate Sensor**, or **A1.3 Insufficient Sample Rate** could produce or contribute to what was observed during the CFT mission.

In this consideration there were no sensors lost, the sensors were deemed healthy and capable or relaying accurate sample data, and due to the extended periods of time required to observe the leakage by observing the pressure difference, it was determined that software did not contribute or in any way cause the helium leakage.

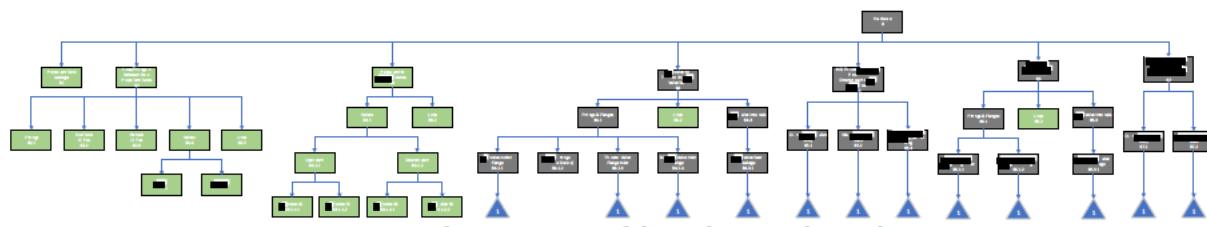
Figure 49: Hardware Section of the Helium Leaks Fault Tree

The B1 Pressurant Tank, the B2 Lines/fittings in between the pressurant tank to the propellant tanks, and B3 Pressurant to the [REDACTED] were determined to not be leaking from inflight data, as there were no observed pressure decays/changes to the components upstream of the helium manifold [REDACTED]. Based on the sensor data available, there was no leakage from the helium tanks to the doghouse manifold [REDACTED]. The source of the leakage is within the helium manifolds of each doghouse, which is represented in the fault tree from branches B4 [REDACTED] Valve to the Thruster RCS [REDACTED] Seat, B5 RCS Thruster [REDACTED]

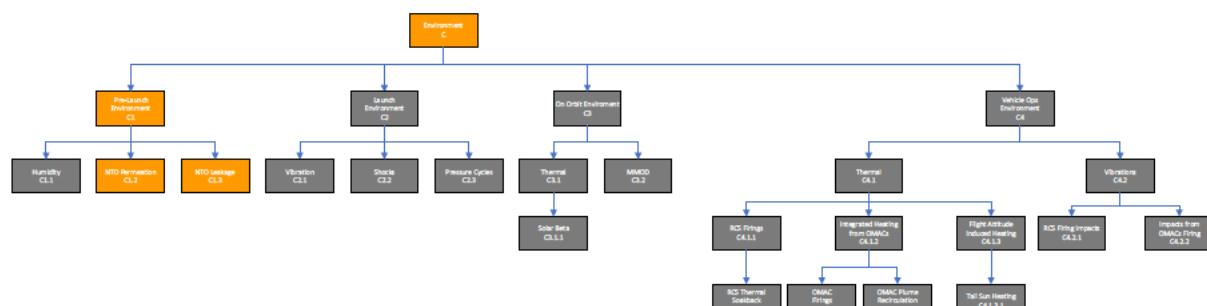
Figure 57: Environmental Section of the Helium Leaks Fault Tree

C1 Pre-Launch Environment details **C1.1 Humidity**, **C1.2 NTO permeation**, and **C1.3 NTO leakage** as possible faults/contributors to leakage. **C1.2 NTO permeation** is believed to be possible throughout the course of the mission, as the thruster flange sealing surface which allows for NTO vapor to travel, and its effects are present from pre-launch to SM jettison. **C1.3 NTO leakage** is considered as only a small amount of leakage could occur within the flange that would be greater than NTO permeation but is limited to the pre-launch timeframe. **C1.2 NTO permeation** and **C1.3 NTO Leakage** were deemed to be credible contributors to the observed leakage.

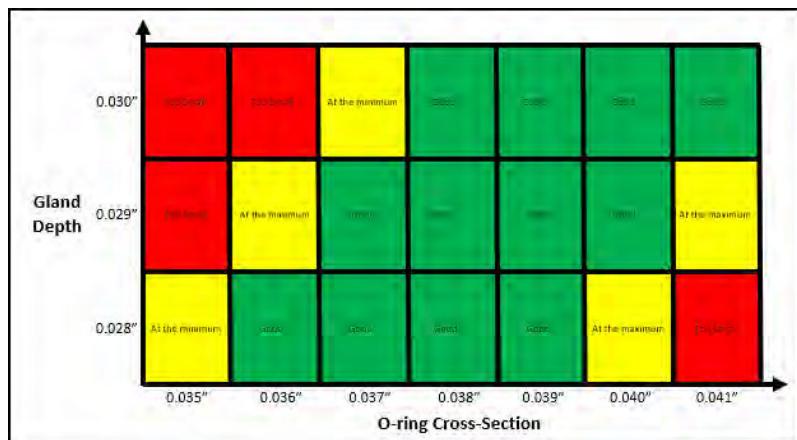
Figure 59: Sizing Constraints Based on Parker Handbook for Starliner

O-ring gland fill/gland squeeze is a potential contributing factor of this failure and should be considered until testing has validated proximate cause.

O-ring sizing was insufficient due to assumed design tolerance which was outside of the standards set in the Parker Handbook, as showcased in Figure 64 below. However, without a hardware change of the RCS/OMAC flange, there is no change in seal sizing that would meet all criteria for an O-ring in this location (gland fill, tolerance, squeeze, etc).

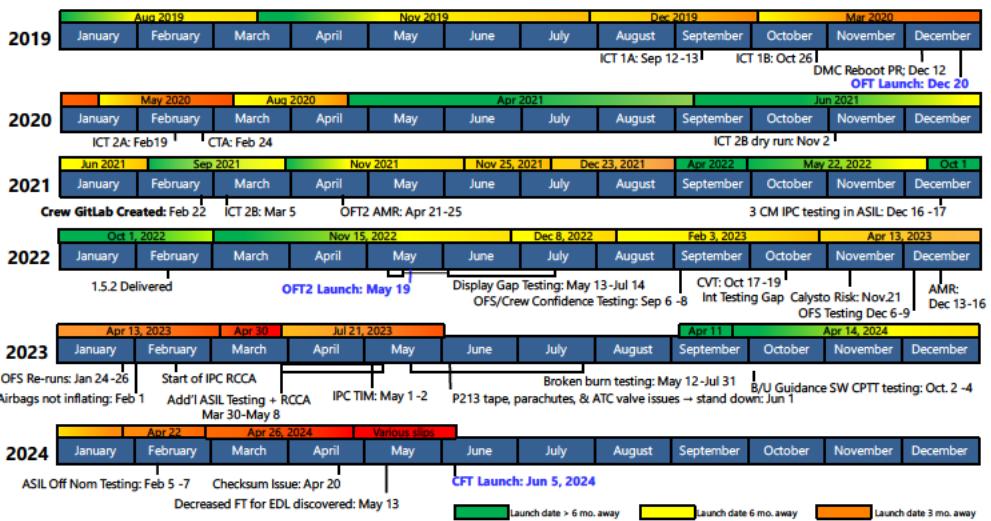
Figure 73: Heatmap of CFT Launch Schedule

Figure 73 shows a heatmap of CFT proximity to launch over a five-year period. For 41 months out of that period, CFT was within six months of the published launch date. In comparison, Artemis II, a comparable developmental first-crewed test flight that has incurred launch slips for hardware and software issues, came within six months to launch for the first time in the Fall of 2025 for a February 2026 launch.

Flexibility with launches and moving schedules to accommodate work is a delicate balance, but repeatedly moving launch dates a little at a time will have a negative impact on team dynamics.

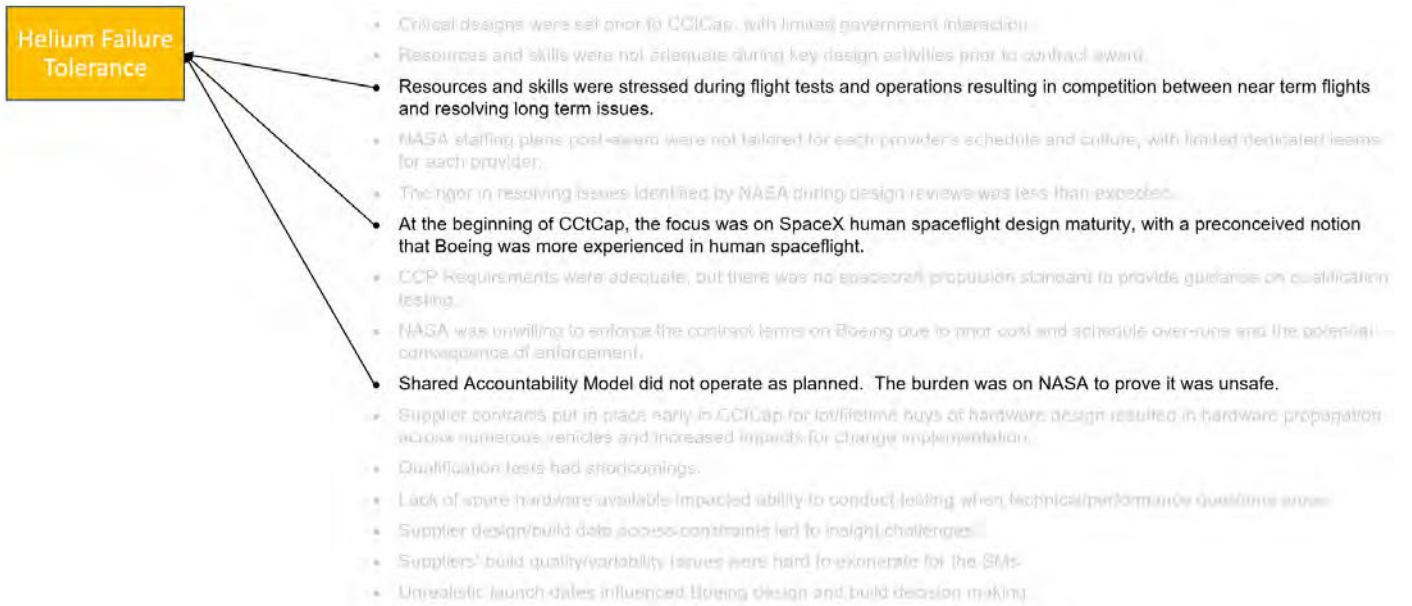
Figure 98 - General Findings Matrix - Helium FT

- Focus of channelization that was performed was the hypergolic propellant system, not the helium pressurant system.
- Quantity of helium available to support ascent aborts led many to consider a leakage impacting nominal operations, including SM disposal, as a non-credible failure scenario.

- CCTS-16.01 Cause 9 Verification 1a – The artifacts referenced do not verify the Hazard Control's assertion that the system was 2 FT.
- Boeing submitted CCTS-16.01 Cause 9 Verification 1a for approval with incomplete verification evidence.

- NASA approved CCTS-16.01 with incomplete verification evidence for Cause 9 verification 1a.
- Failure tolerance concern was raised to Boeing several times but was not addressed.

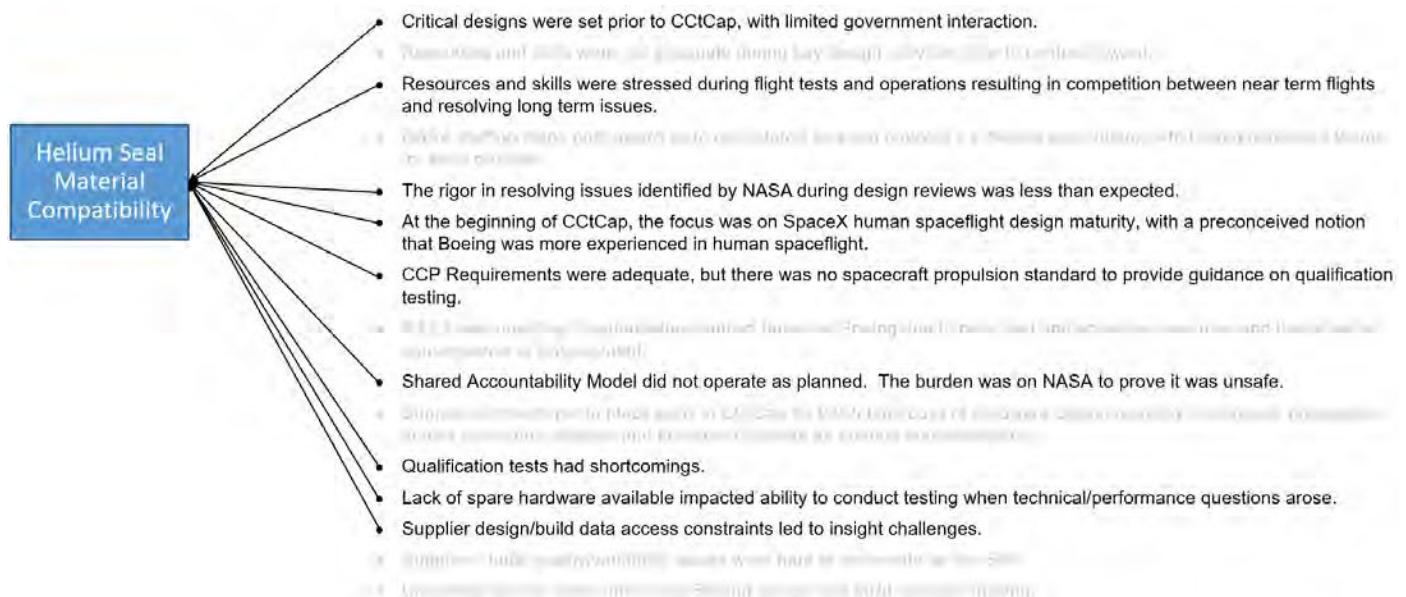
Figure 99 - General Findings Matrix - Helium Seal Material Compatibility

The SM propulsion system is designed with [REDACTED] flanges that are not compatible with Nitrogen Tetroxide (NTO) which contributed to the helium leaks seen on CFT.

A helium leak was identified during the OFT-2 flight but an IFA was not declared. The issues was closed out at a Boeing Prime Material Review Board (PMRB) without elevating to a NASA board.

- Tear down test articles and inspect them post-test within a timeframe that does not invalidate inspection results.
- Strengthen materials compatibility requirements for hypergol exposure. There is no substitute for long term exposure testing. In the absence of suitable environmental testing a Material Usage Agreement (MUA) is required to assess gaps.
- Propulsion system components that are exposed to hypergolic propellants (including permeation through seals) should be required to have long term hypergolic exposure testing as an assembled component with encompassing environments applied. Material coupon testing is insufficient.

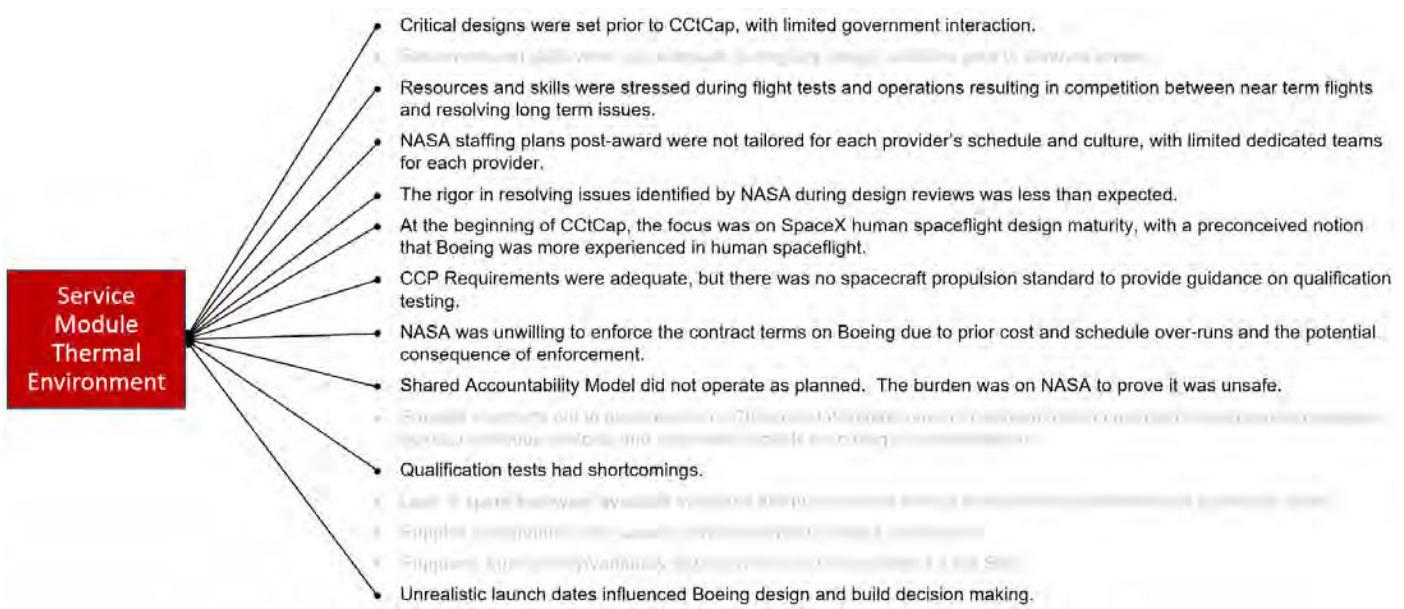
Figure 100 - General Findings Matrix - SM Thermal Environment

During CFT, extreme Reaction Control System (RCS) injector temperatures were observed and multiple SM RCS jets failed during the approach to ISS leading to loss of 6-degrees of freedom (DOF) control.

Unexpected heating of the SM RCS thrusters, leading to thruster failures, was observed on the OFT-1 and OFT-2 flight tests but the hardware failure modes and temperature capability/tolerance of the hardware components was not explored through additional ground testing, except for the pressure transducers and valve solenoids. The fact that higher temperatures were resulting in deformation of the RCS thruster internal soft-goods was not understood until ground testing was performed during CFT.

- Document the limitations of vehicle thermal models for both hot and cold cases.
- Invest in ground testing to validate critical models, particularly when flight experience or IFAs show that induced environments are exceeding pre-flight expectations.
- Ensure FTOs address hot and cold cases for propulsion systems.
