National Aeronautics and Space Administration

Deep Space Station 14 (DSS-14) Azimuth Over-Rotation Mishap

Mishap Classification: Mishap Type A

Date of Mishap: September 16, 2025

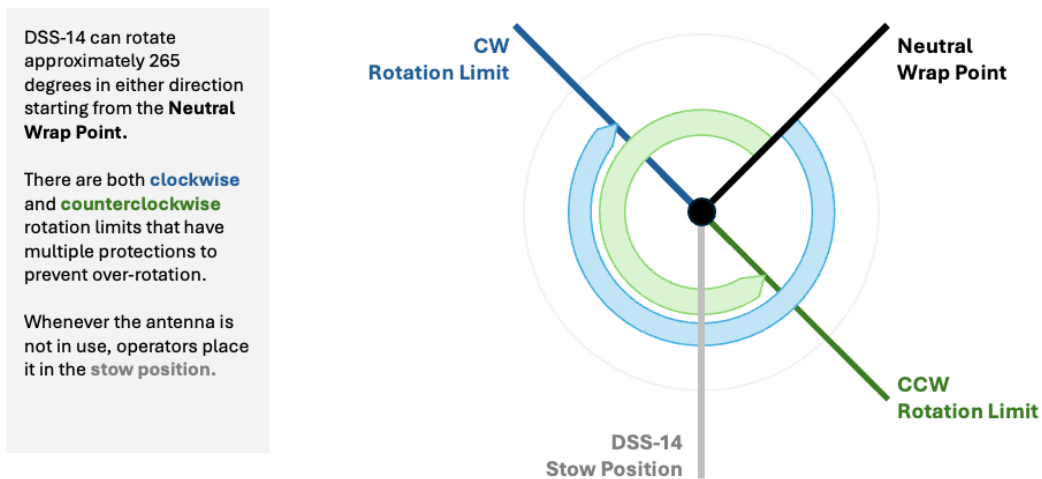
Figure 3: DSS-14 Rotation Diagram

A collection of flexible hoses and cables runs between the static and rotating structures, carrying power, data, and working fluids (e.g., fire-suppression water and coolant). This set of hoses and cables, along with supporting structural elements, comprises the “cable wrap.” The slack in these hoses and cables allows azimuth rotation in either the clockwise (CW) or counterclockwise (CCW) direction, measured from a “neutral” point where the hoses and cables hang vertically (see Figure 3). The slack length constrains how far the antenna can rotate CW and CCW from neutral in the azimuth direction without damaging the hoses and cables. When not in use, DSS-14 is moved to a stow position of 180 degrees in the CW wrap.

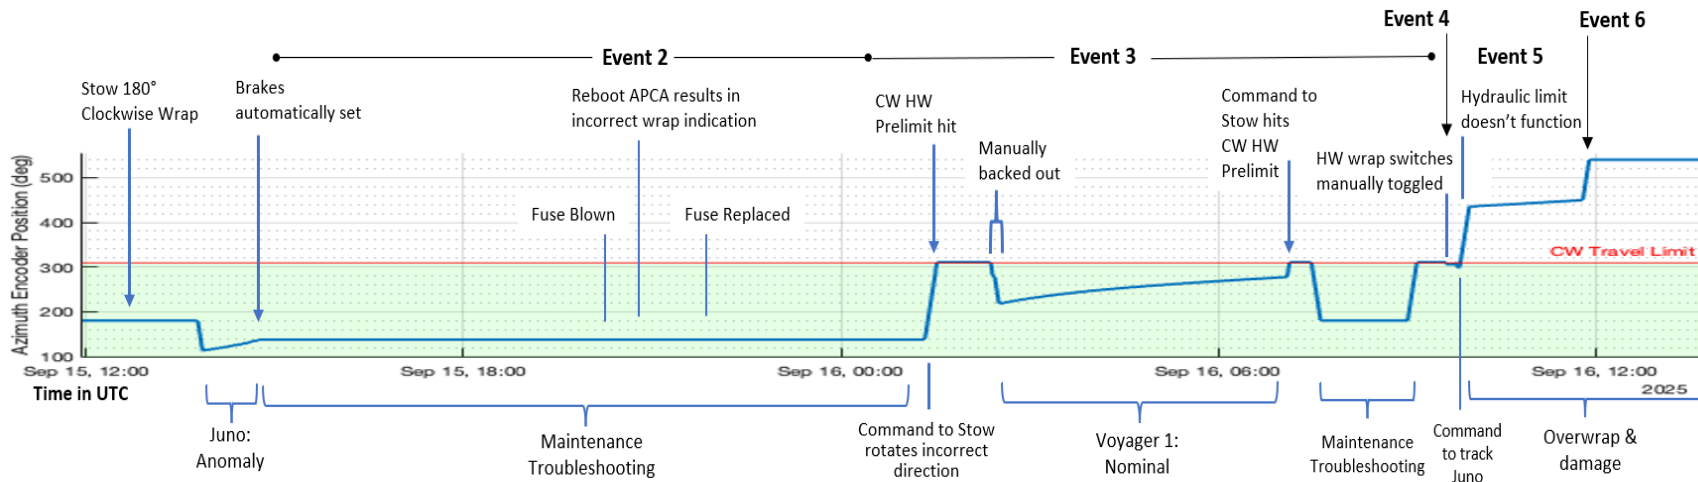
Figure 8: Mishap Timeline

Over the course of the investigation, the MIB identified six critical events leading up to and including the mishap itself.

Event 1 occurs before the period of this timeline
