MSC-00126

APOLLO 10 MISSION REPORT

AUGUST 1969

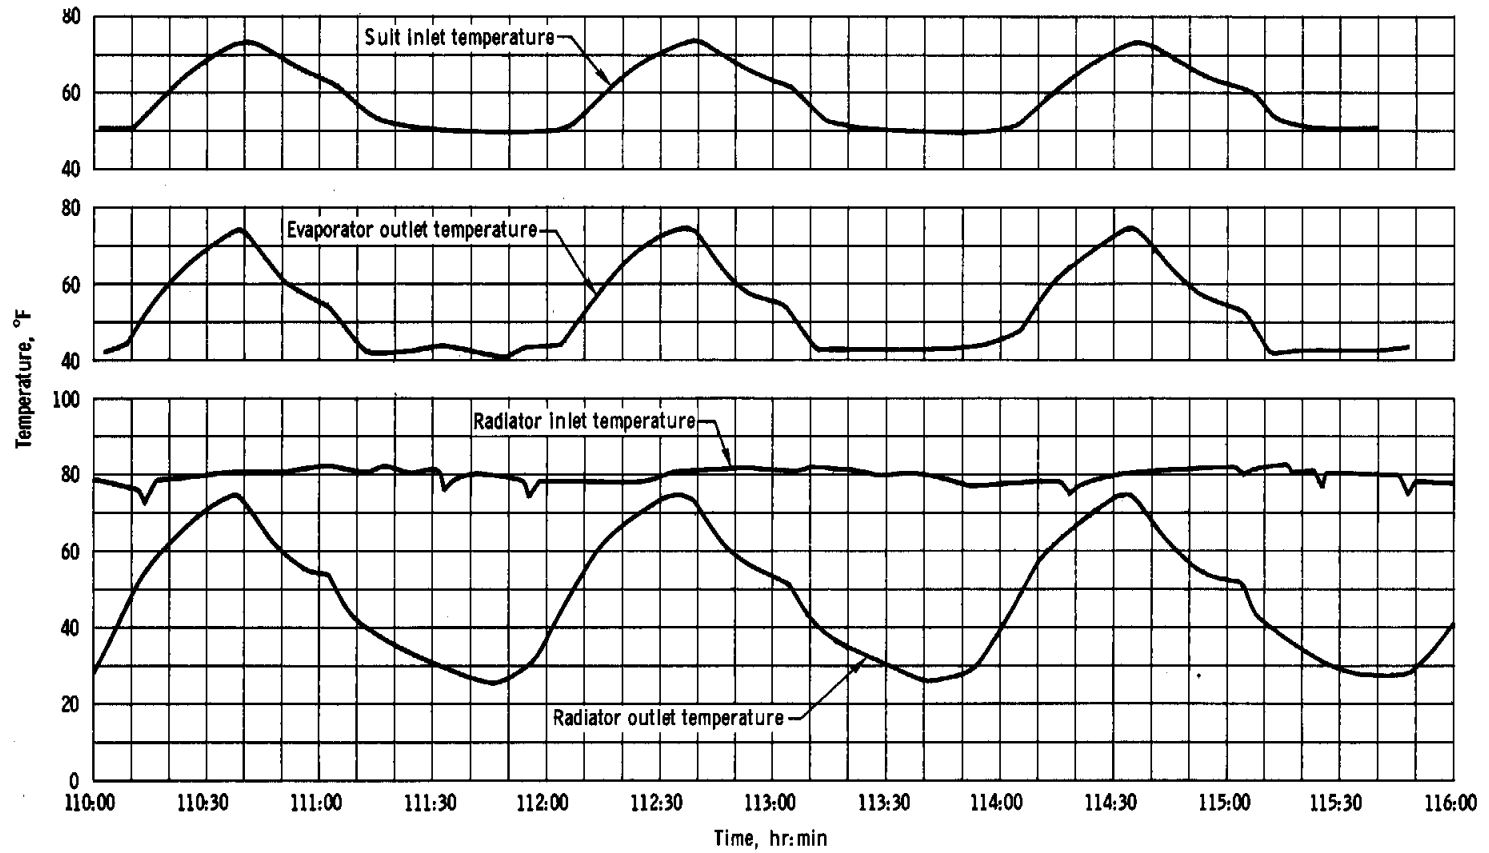
Figure 7.9-1. - Typical primary coolant loop parameters during lunar orbit.

During most of the translunar and transearth coasts, the spacecraft was maintained in a passive thermal control mode, and the primary radiators provided excellent spacecraft cooling. During lunar orbit coast, the primary radiators provided all spacecraft cooling, except for the brief period when the primary evaporator was operating. The maximum radiator outlet temperature during each revolution ranged between 61° and 75° F. This caused the peak suit inlet and water/glycol inlet temperatures for the electronic-equipment cold-plate network to increase approximately 18° F above normal for brief periods but caused no crew discomfort. Typical coolant system operation during lunar orbit is shown in figure 7.9-1.

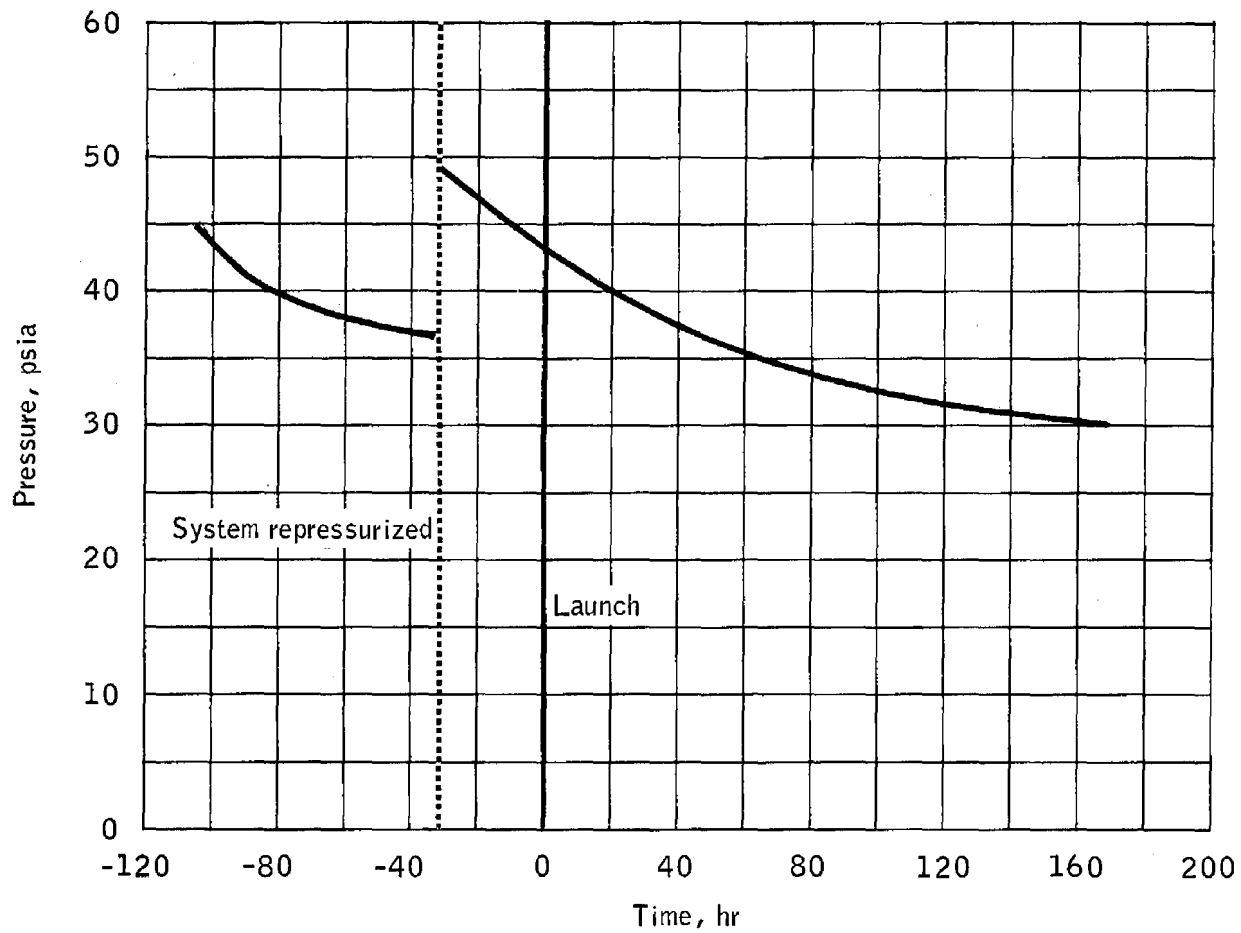
Figure 15-1.- Helium manifold pressure in reaction control system A.

Figure 15-1 shows the system pressures for both the prelaunch and mission periods. The leak rate decreased as the mission progressed, reaching 0.04 psi/hr by the end of the mission. Only part of this decrease resulted from the reduced system pressure; thus, the leak corrected itself to some extent and/or the characteristics of the helium changed as it became diluted by propellant permeating the bladder.

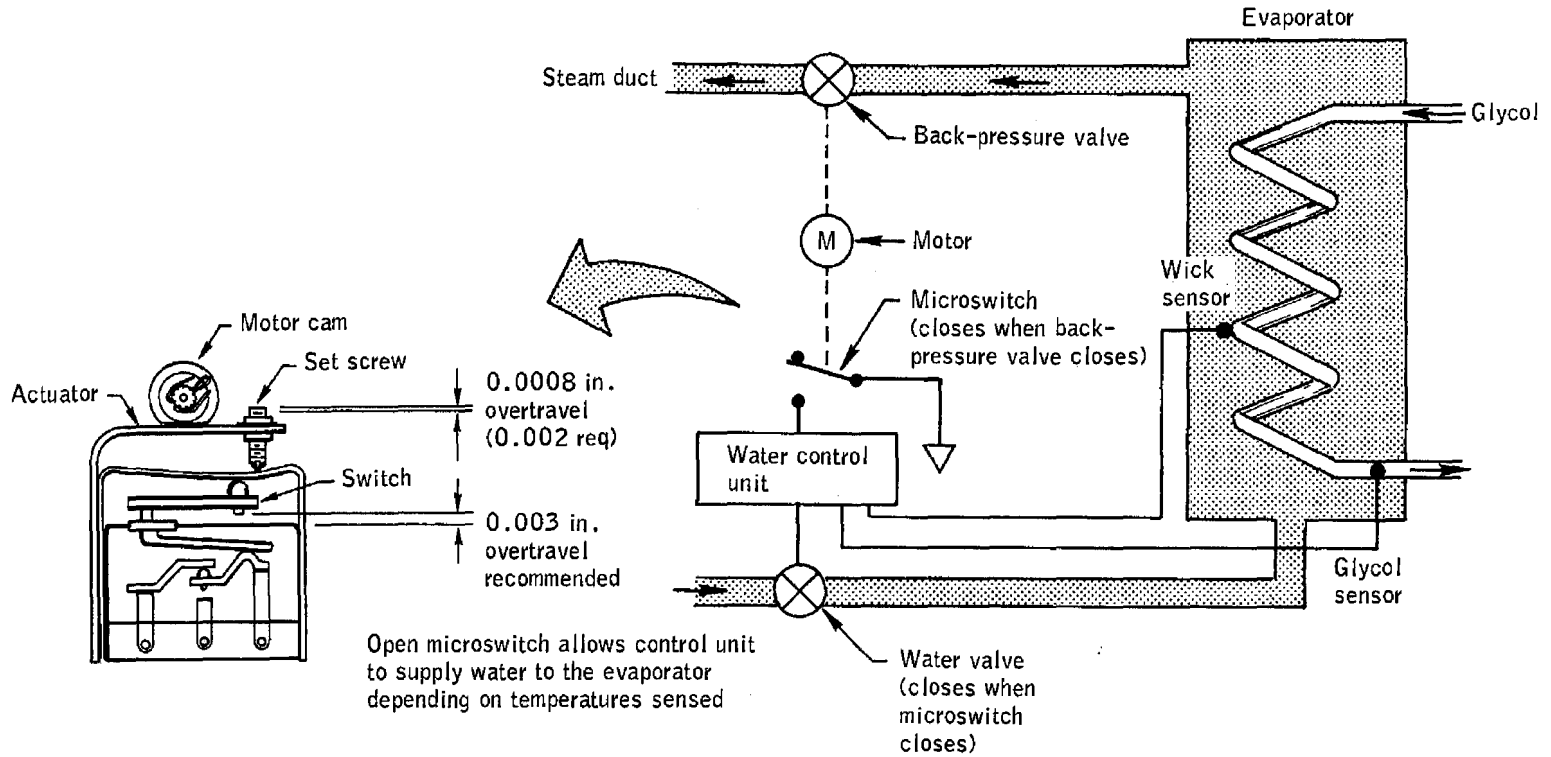
Figure 15-2.- Water control circuit.

After the mission, the spacecraft wiring and control circuits were checked. Continuity and resistance measurements were normal. Further tests of the system duplicated the inflight condition and revealed that the water control circuit operated intermittently. When a microswitch in this circuit opens, the water section of the environmental temperature control unit is activated and begins to supply water to the evaporator on demand (fig. 15-2).

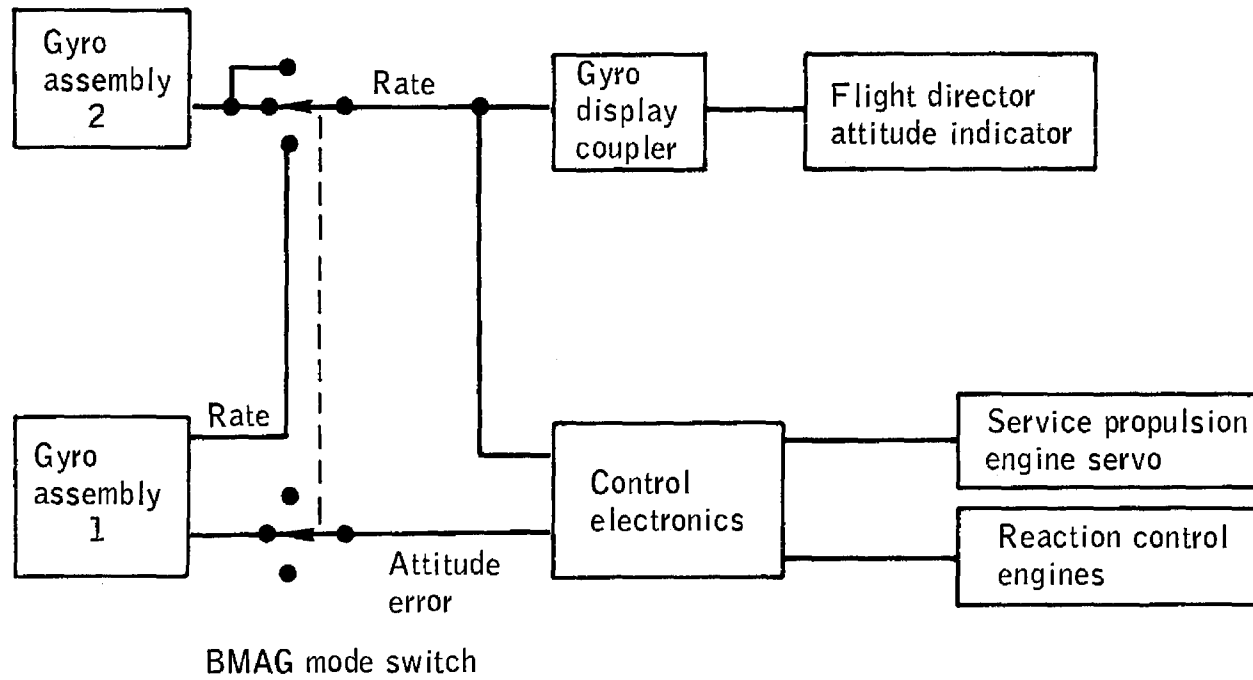
Figure 15-9.- Stabilization and control system.

A simplified block diagram of the stabilization and control system showing the functions of the gyro display coupler and the spacecraft control loops is shown in figure 15-9. One of the two gyro assemblies provides only rate information and is normally used to drive the gyro display coupler. The other gyro assembly can provide either rate or attitude error, at crew option, and can be selected to drive the gyro display coupler.

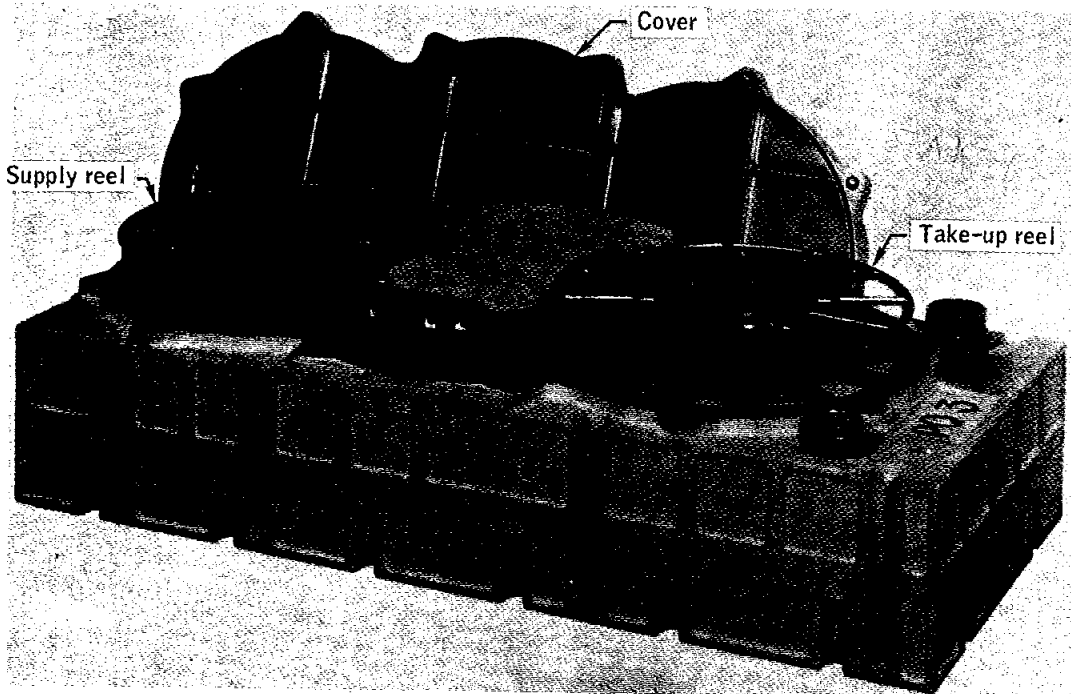
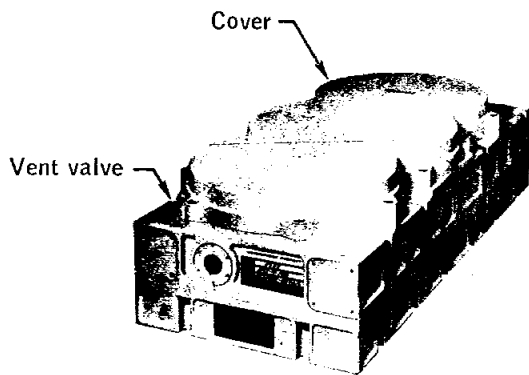
Figure 15-10.- Data storage equipment.

Testing of the recorder has revealed that an outside-to-inside pressure differential of 2.25 psi is sufficient to deform the cover, causing it to contact the tape reels (fig. 15-10).

Clearance between cover and reel hubs is 0.058 to 0.053 in.

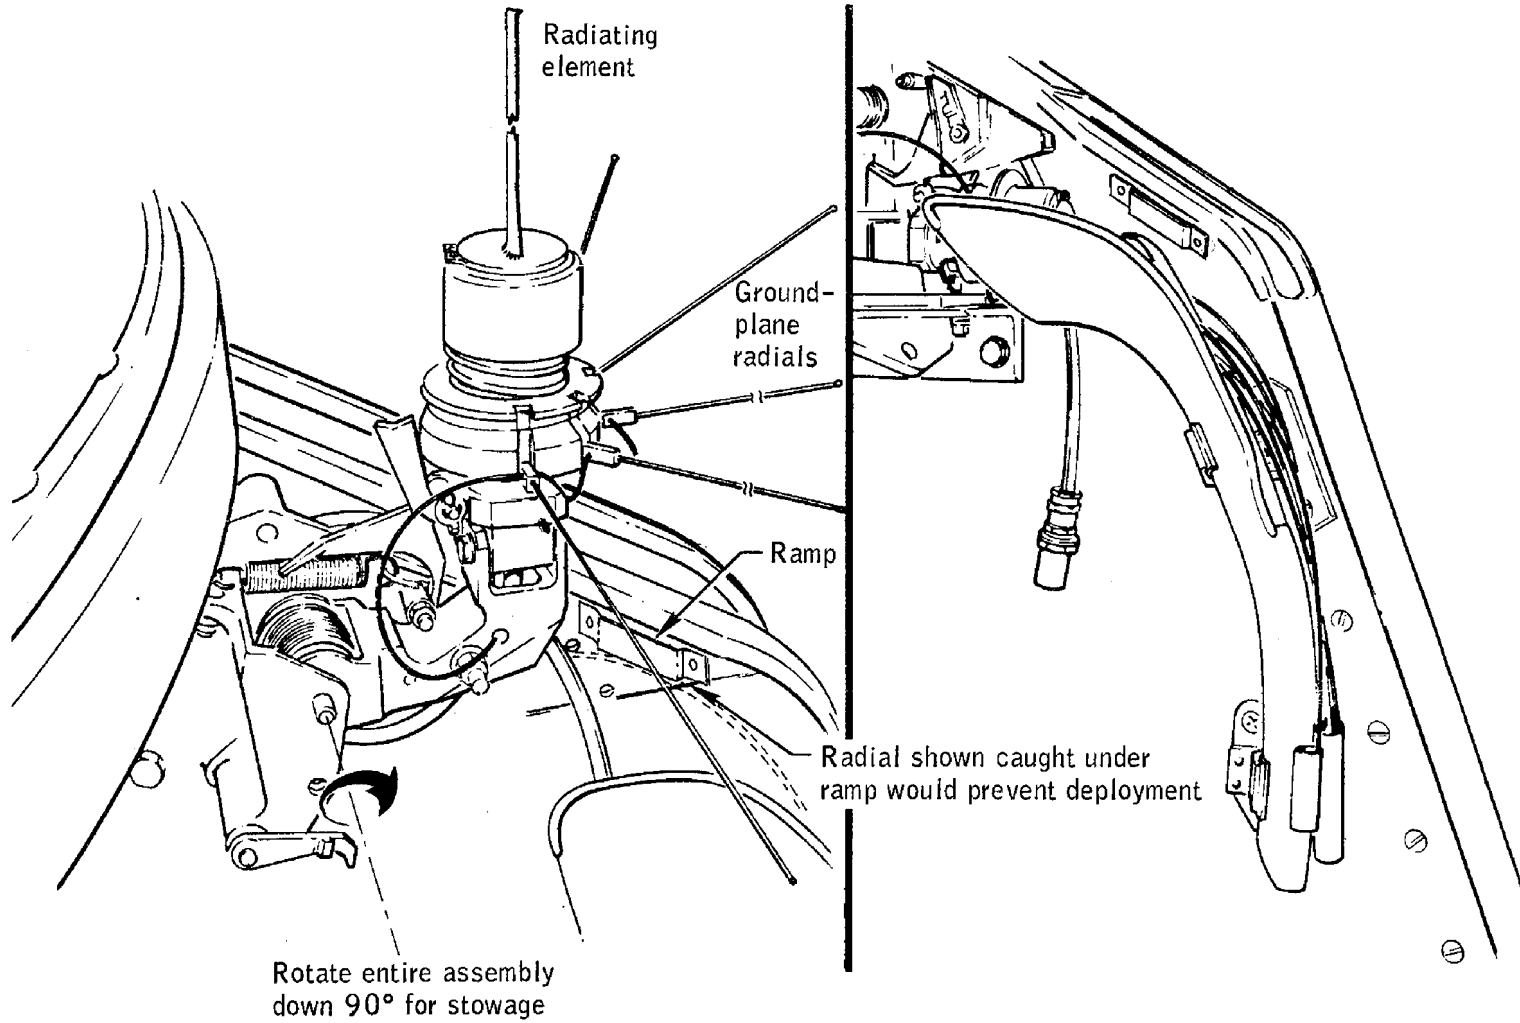
Figure 15-11.- VHF recovery beacon antenna deployed.

The antenna did not deploy because one radial was caught under the outboard edge of the ramp shown in figure 15-11.

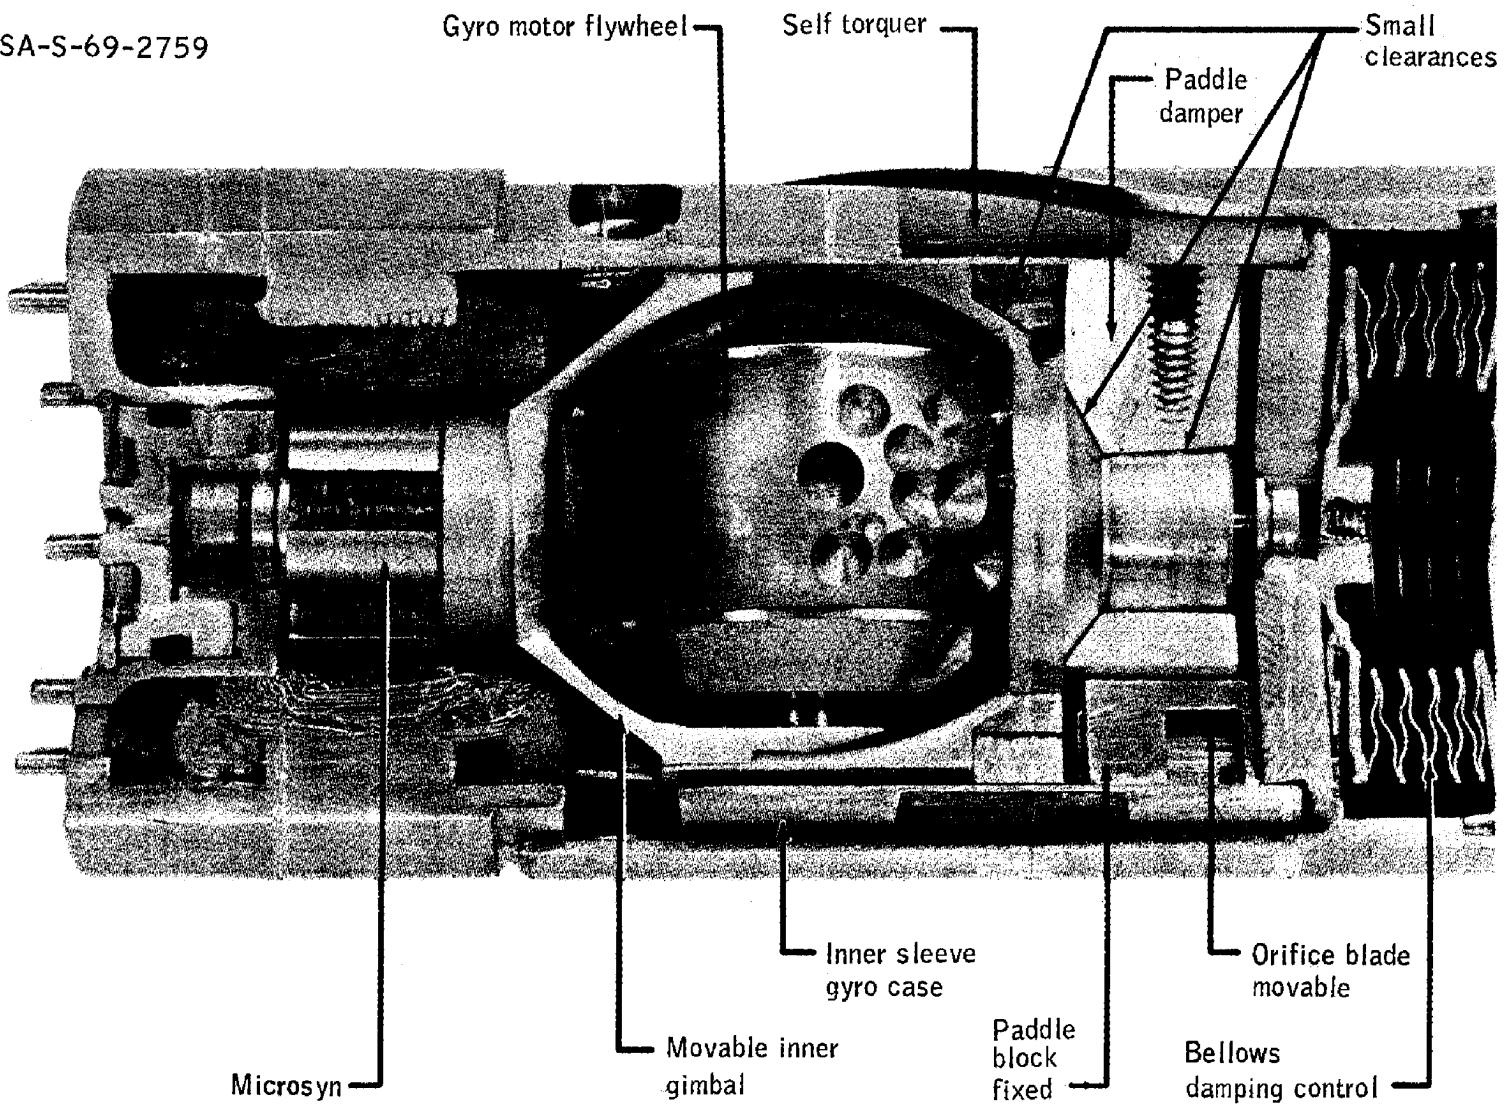
Figure 15-31.- Cross sectional view of rate gyro.

The rate gyro is a spring-restrained, single-degree-of-freedom unit with the spring force being supplied by a torsion bar (fig. 15-31). The wheel assembly is partially floated in a silicon damping fluid. Damping is supplied by a paddle wheel which pumps fluid through a temperature-controlled orifice. Three gyros are mounted orthogonally in a rigid block and placed in the spacecraft such that each gyro input axis is parallel to a spacecraft axis.

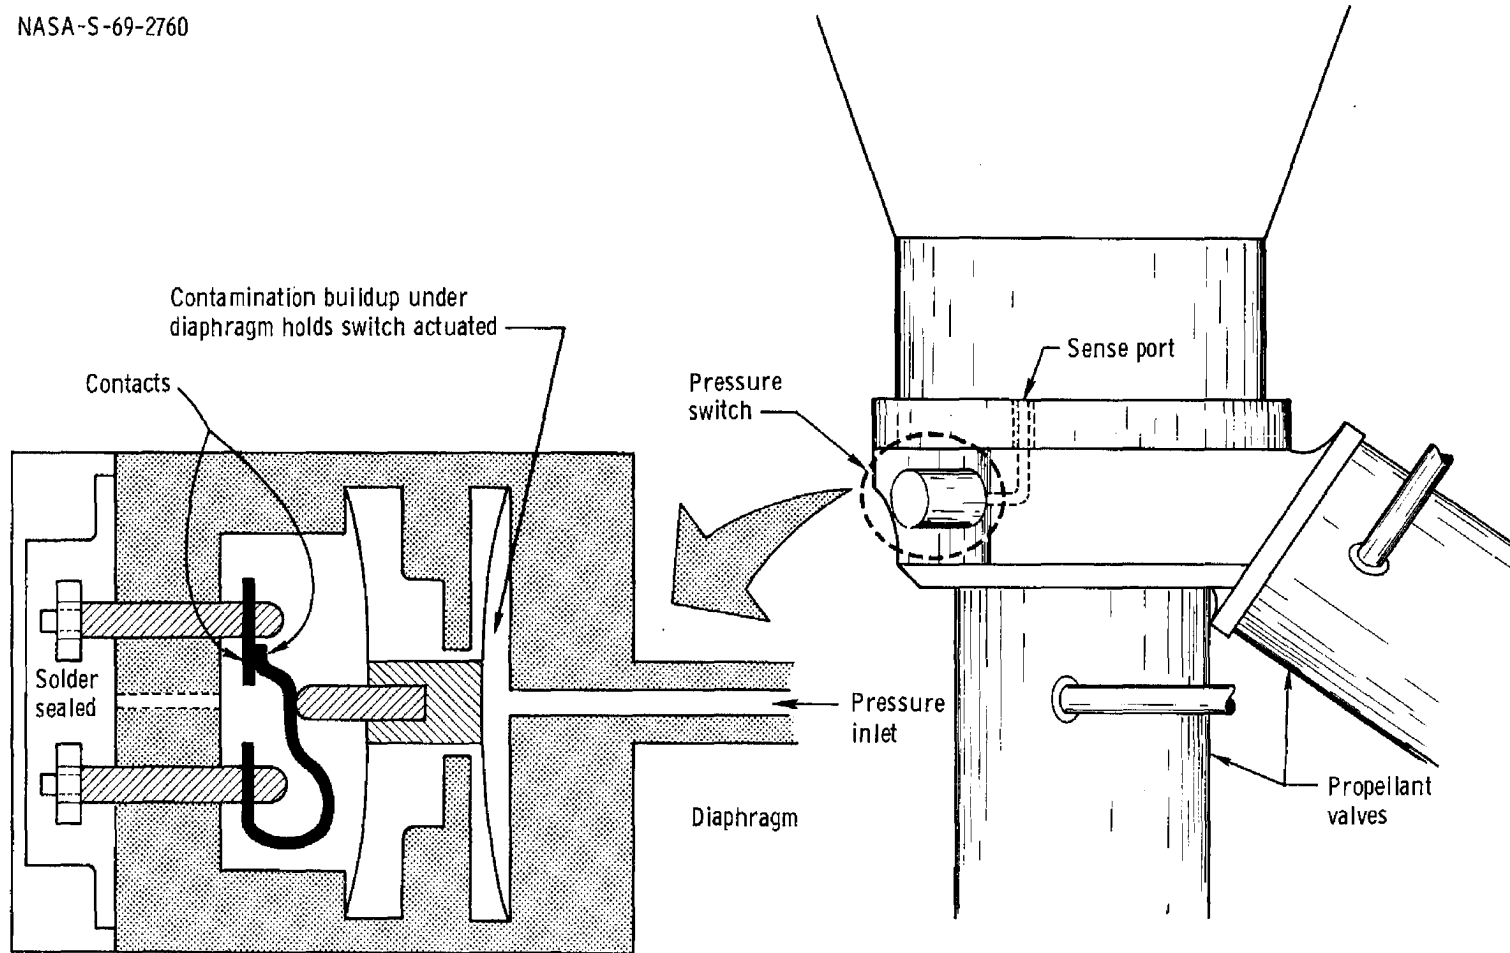
Figure 15-32. - Lunar module reaction control system thrust chamber switch.

The failure mode for these five switches is believed to be the same as that of one LM-3 unit and several others during ground testing. Particulate contamination and/or propellant residue is forced under the switch diaphragm by chamber pressure and holds the diaphragm deflected and the electrical contacts closed (fig. 15-32). The small stroke of the diaphragm (0.007 inch) and the low diaphragm restoring force generated by the return spring make the switch extremely susceptible to failure by contamination.

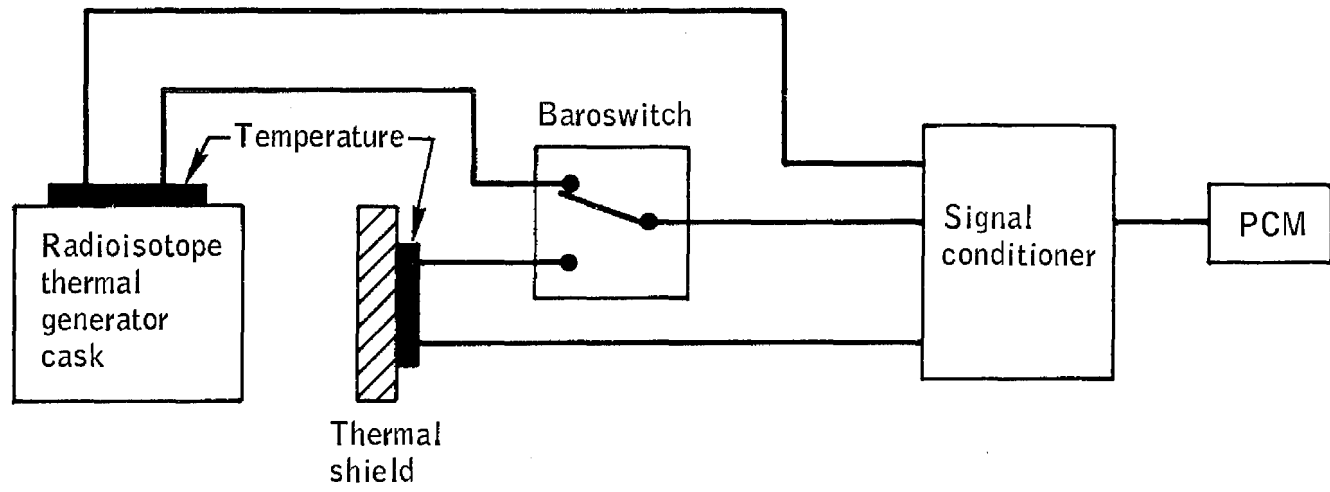
Figure 15-33.- Cask temperature.

Cask thermal shield temperature.- The temperature measurement of the thermal shield for the radioisotope thermal generator cask read upper limit throughout the lunar module portion of the flight. The telemetry is switched to this measurement from cask temperature by a baroswitch at 10 000 foot altitude (fig. 15-33).

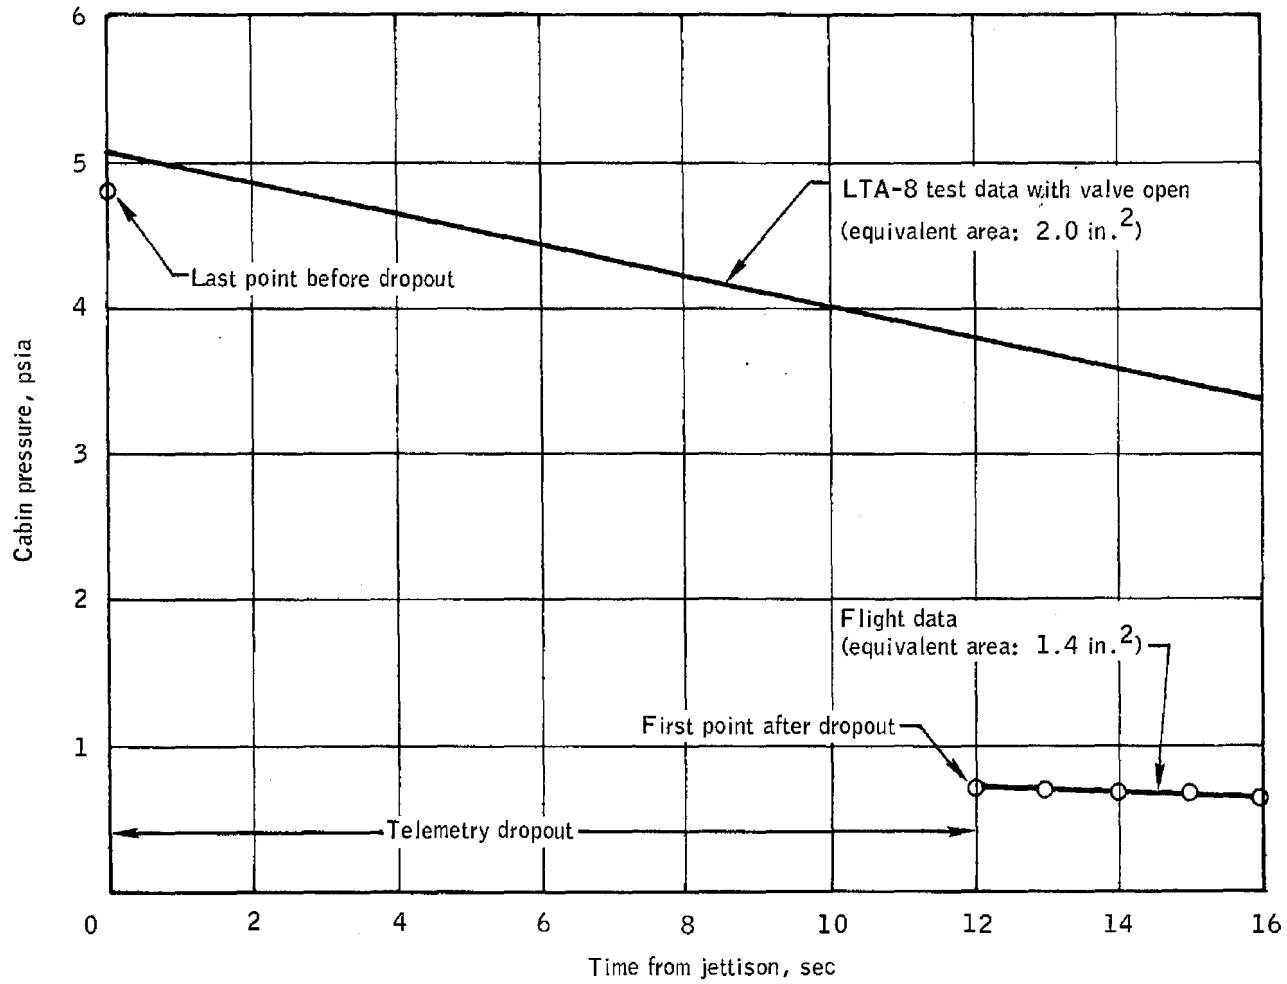
Figure 15-34.- Measured cabin pressure during jettison.

During the ascent stage separation from the command module, the lunar module cabin pressure dropped rapidly, as measured by three separate transducers. Telemetry data were lost for 12 seconds beginning at the initiation of separation. As shown in figure 15-34, the cabin pressure was 4.86 psia at the initiation of separation and 0.70 psia at the end of the telemetry dropout and continued to decay slowly.

In summary, the analyses indicate that the loading on the lunar module hatch at separation exceeded the capability of the latch. The hatch then opened and closed resulting in a cabin pressure decay as shown in figure 15-34 and separation distance and relative accelerations as shown in figures 15-35 and 15-36.

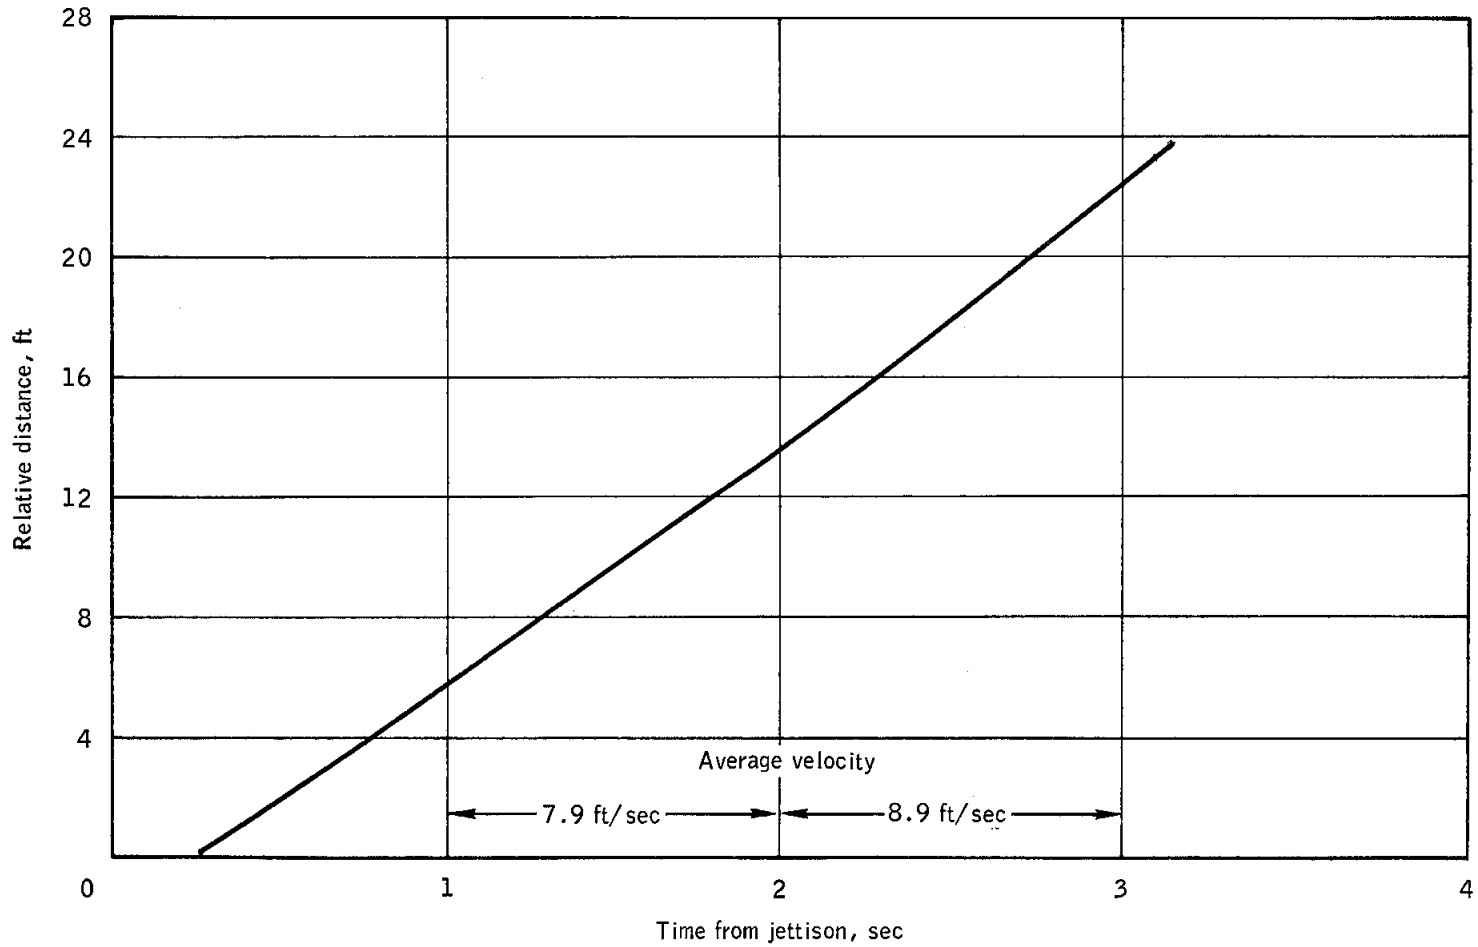
Figure 15-35.- Relative separation distance.

The film was used for determining a history of relative separation distance between the command module and the lunar module (fig. 15-35). A time history of relative acceleration, or the required pressure force, was then estimated from the data, as shown in fig. 15-36. The maximum acceleration of 50 ft/sec/sec shown is considerably in excess of the acceleration caused by separation pyrotechnic effects. However, the acceleration history shown in figure 15-36 can be obtained by dumping the cabin pressure in the first 0.3 second of separation. A 4-psi drop in cabin pressure in 0.3 second requires a constant venting area of 290 square inches. The impulse from dumping cabin pressure through the hatch is consistent with the direction and magnitude of the lunar module velocity change (5 ft/sec in minus X direction) noted from the flight data. Further, the upper hatch is the only item on top of the lunar module that could open and close, allowing the cabin to vent while satisfying the pressure history. The hatch has a maximum area of 838 square inches, which is more than enough to vent the cabin from 4.8 to less than 1.0 psia in 0.3 second.

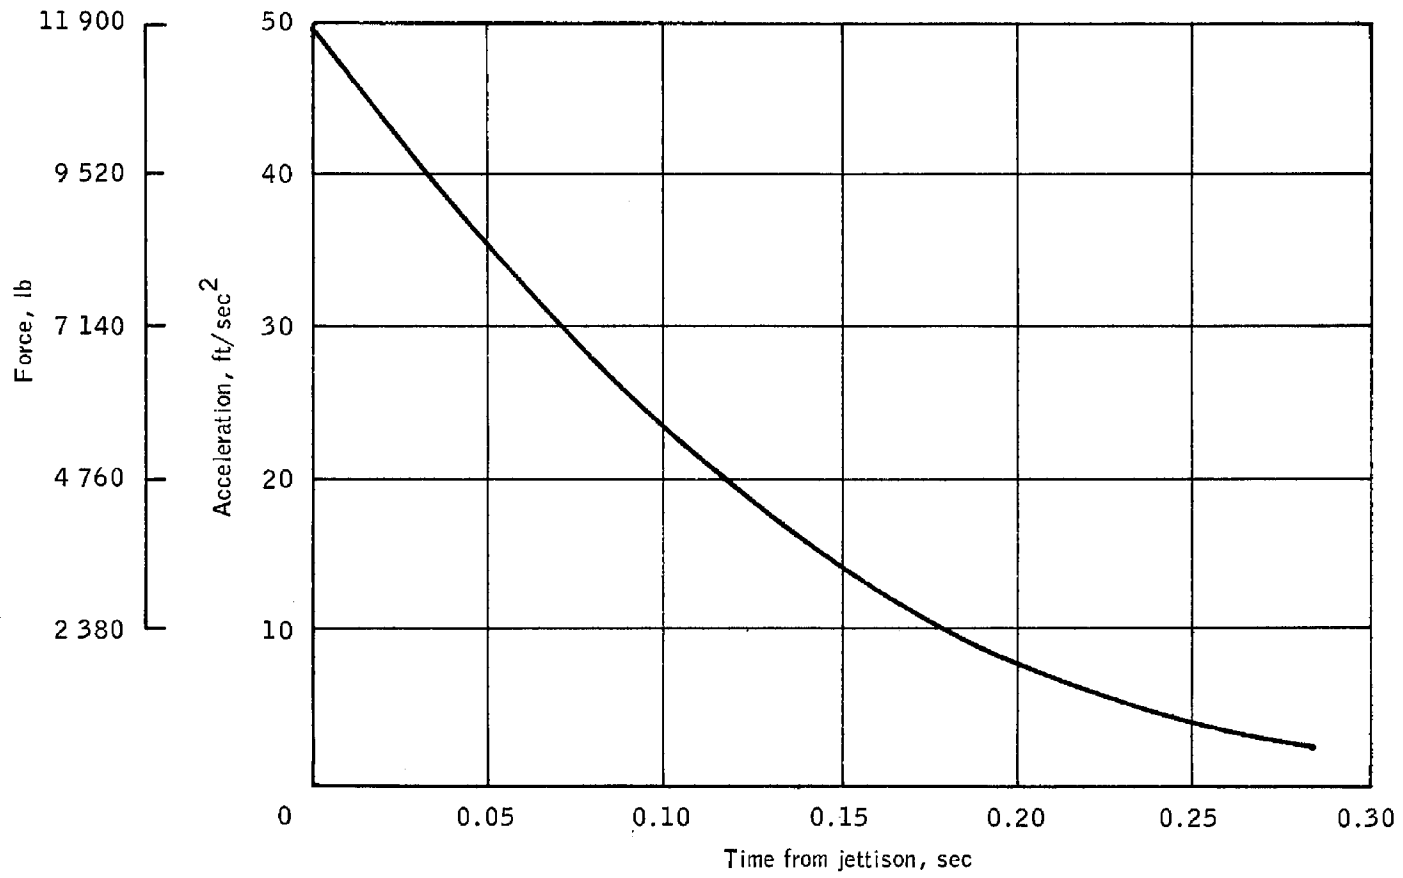
Figure 15-36.- Lunar module/command module relative acceleration after staging.

it completely. The remaining gap of about 1.4 square inches allowed a slight pressure decrease, as indicated by cabin pressure data. Figure 15-37 presents a history of hatch area that allows the cabin pressure to decrease rapidly and also yields an acceleration time history which agrees with figure 15-36.

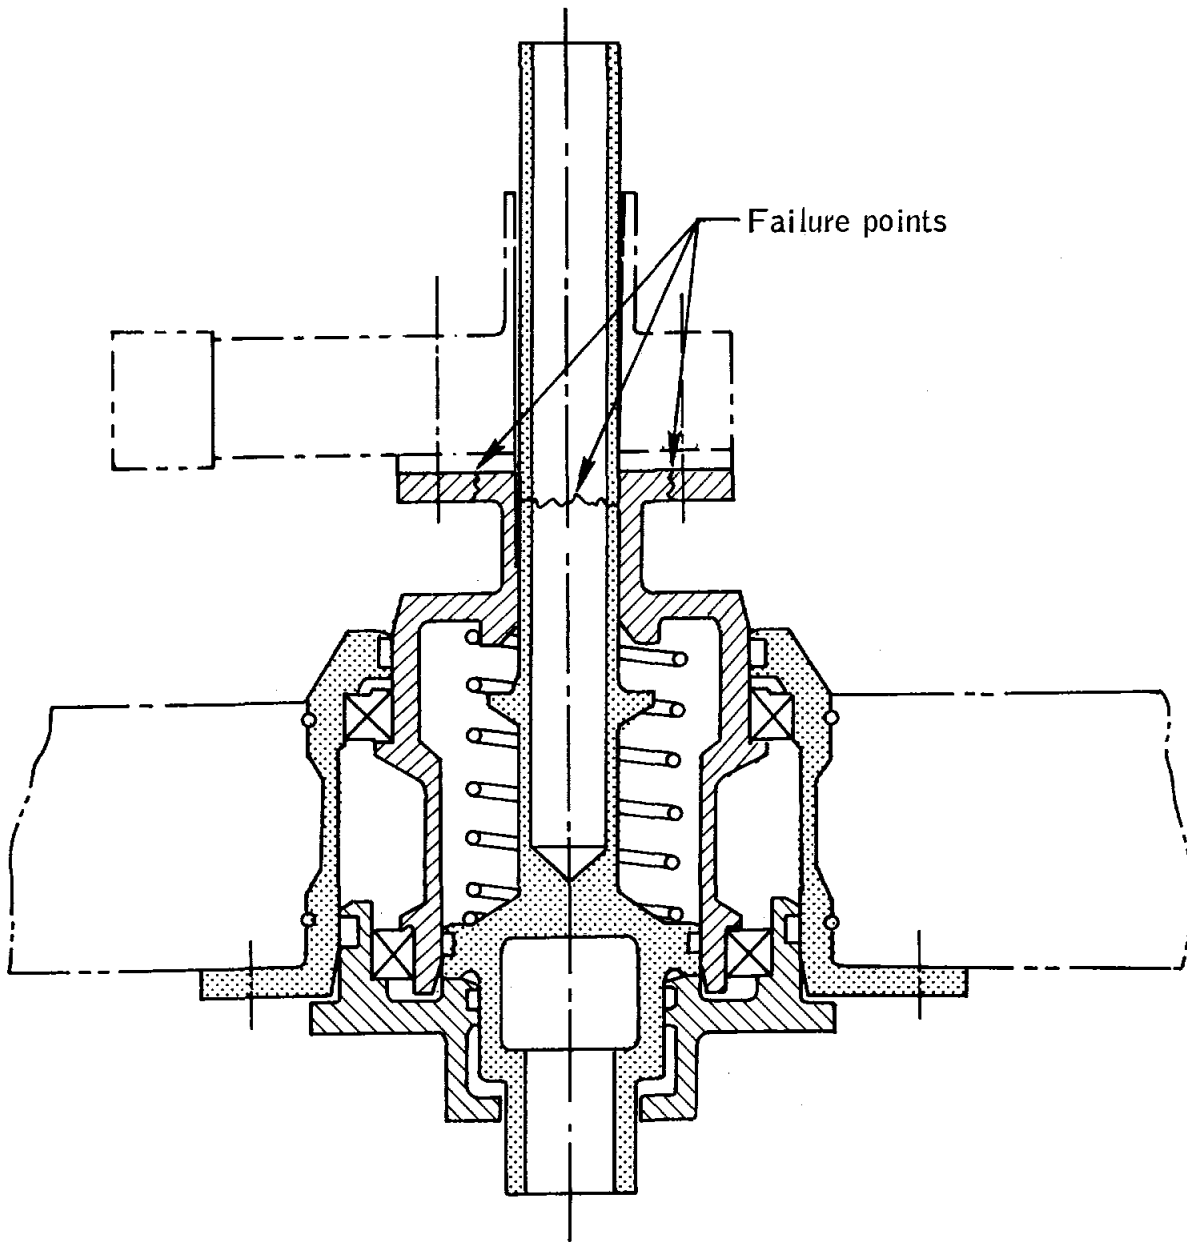
Figure 15-38.- Lunar module hatch latch.

The hatch and latch assembly was statically pressure-tested to failure. At a differential pressure of 4.1 psi, the latch failed as indicated in figure 15-38.

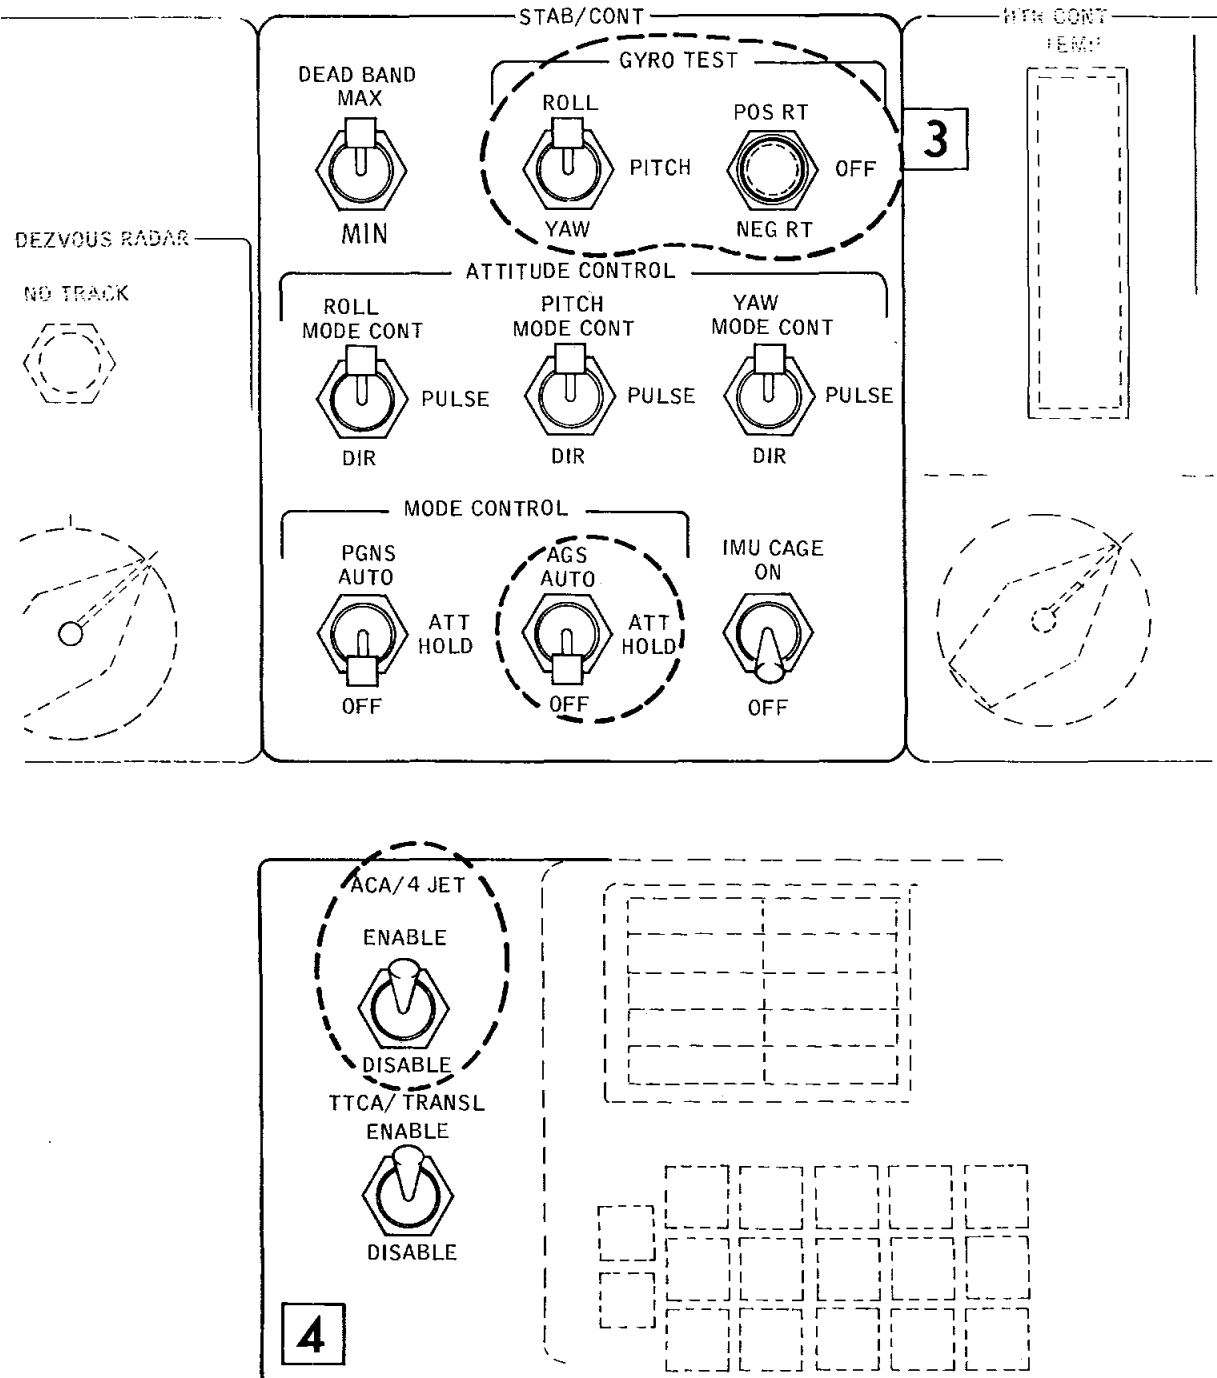
Figure 15-41. - Lunar module guidance switch locations.

The attitude control switches on panels 3 and 4 are shown in figure 15-41, and a simplified functional switching diagram is shown in figure 15-42. Approximately 4 minutes before staging, with the guidance select switch in AGS and the attitude control switches in PULSE, the crew verified that the abort guidance mode control switch was in ATT HOLD since the intent was to perform staging in AGS ATT HOLD. After some discussion, they selected MAX deadband to save propellant.

Switches.- Functions in each of the anomalous areas are controlled by switches (see fig. 15-41).

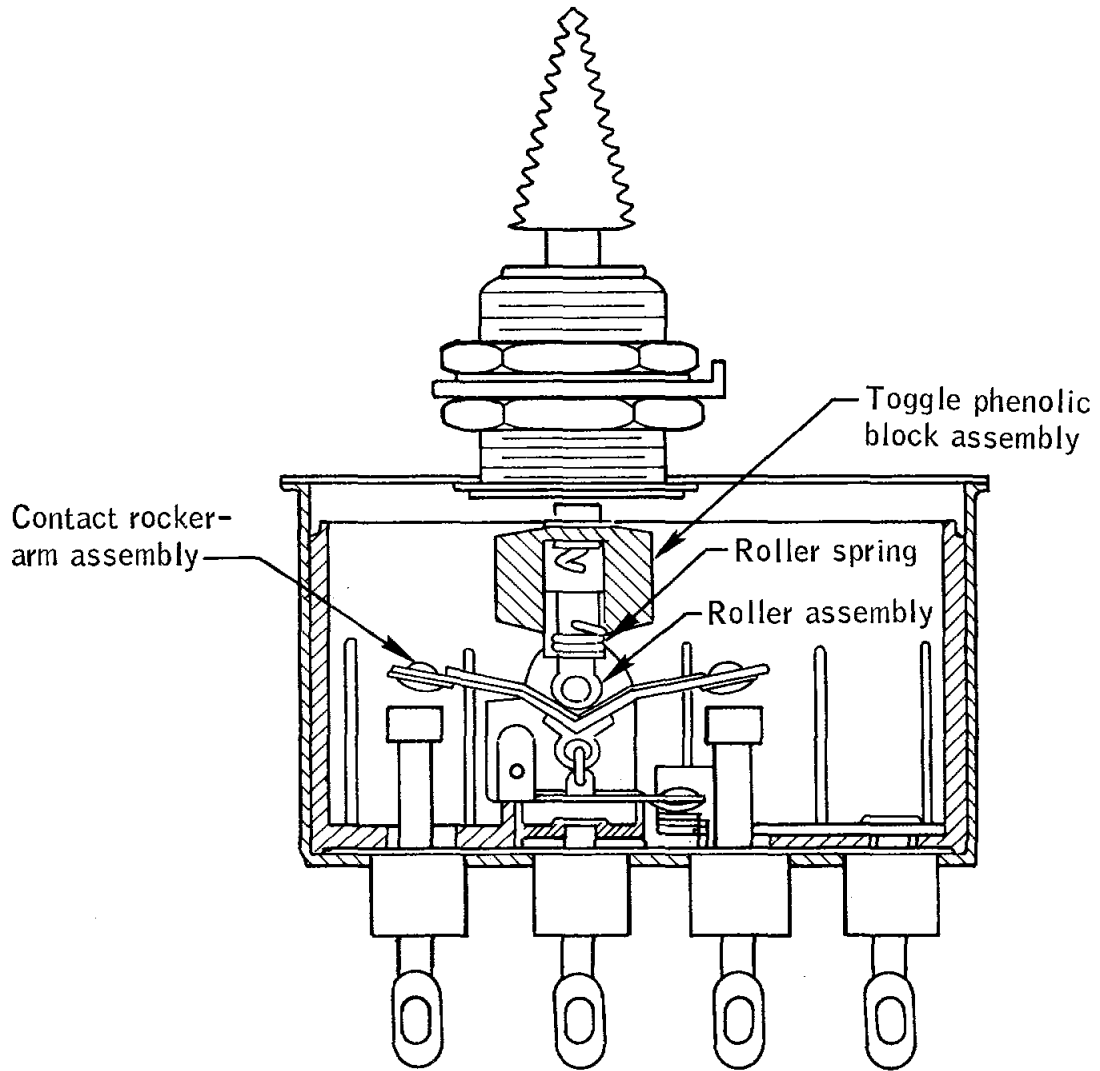
Figure 15-43.- Abort guidance mode control switch.

The abort guidance system mode control switch, on panel 3, was used several times before and after staging with no evidence of abnormality. To produce the flight results requires the contacts to transfer on at least two of the three poles of this switch. No known failure modes in the switch would produce this type of failure. Two failure modes postulated would allow the contact rocker arms to become free-floating. However, testing under a simulated flight environment has shown that because of frictional forces at the contact arm pivot point, the free-floating contacts will not transfer (see fig. 15-43). The observed anomaly would have required the simultaneous motions of two rocker arms.

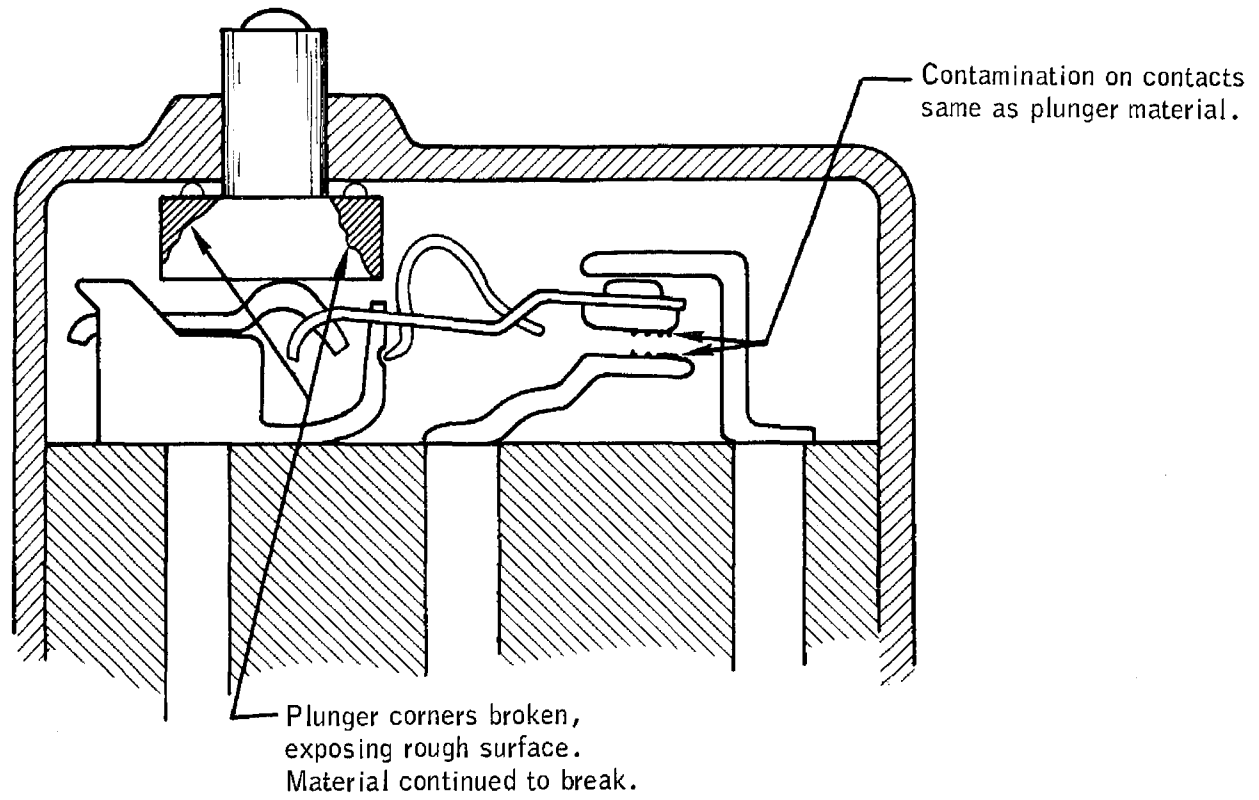
Figure 15-47.- Magazine interlock switch.

At approximately 173 hours, during transearth coast, the command module 16-mm camera ceased to operate in the pulse mode because the magazine interlock microswitch failed. The switch was not a high reliability item and failed because of internal contamination and a faulty plunger (fig. 15-47).
