REPORT OF APOLLO 13 REVIEW BOARD

NATIONAL AERONAUTICS AND SPACE ADMINISTRATION

June 15, 1970

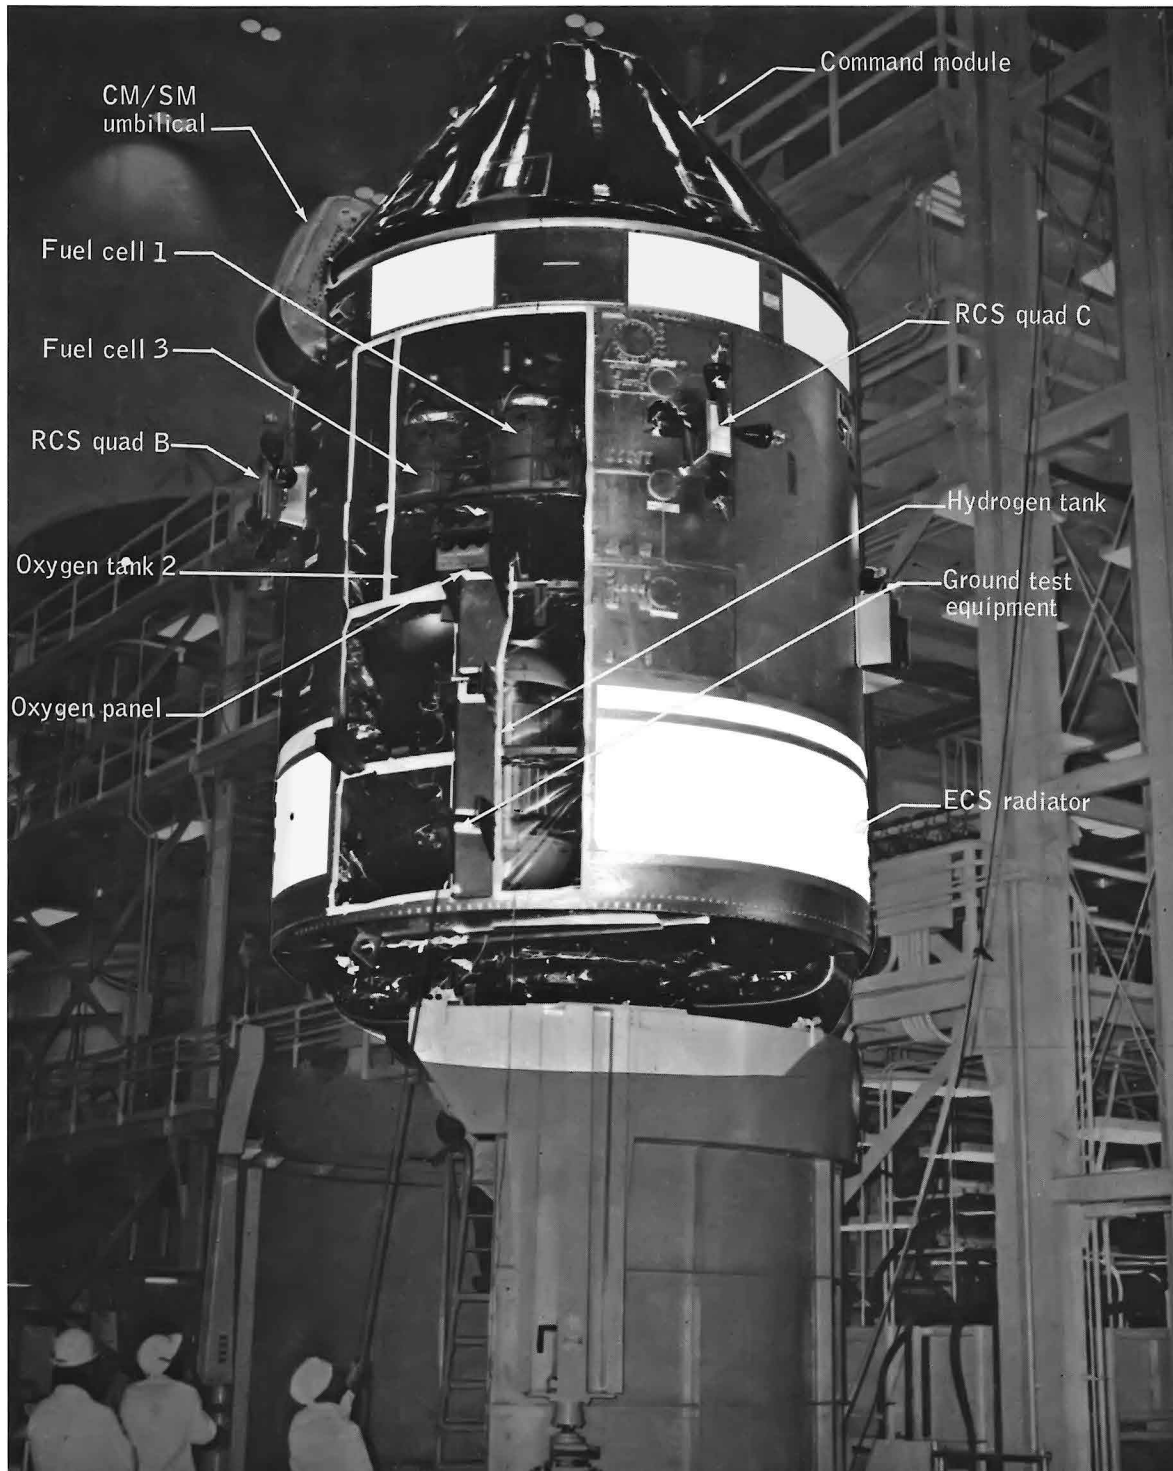
CSM in ground test with bay 4 panel removed.

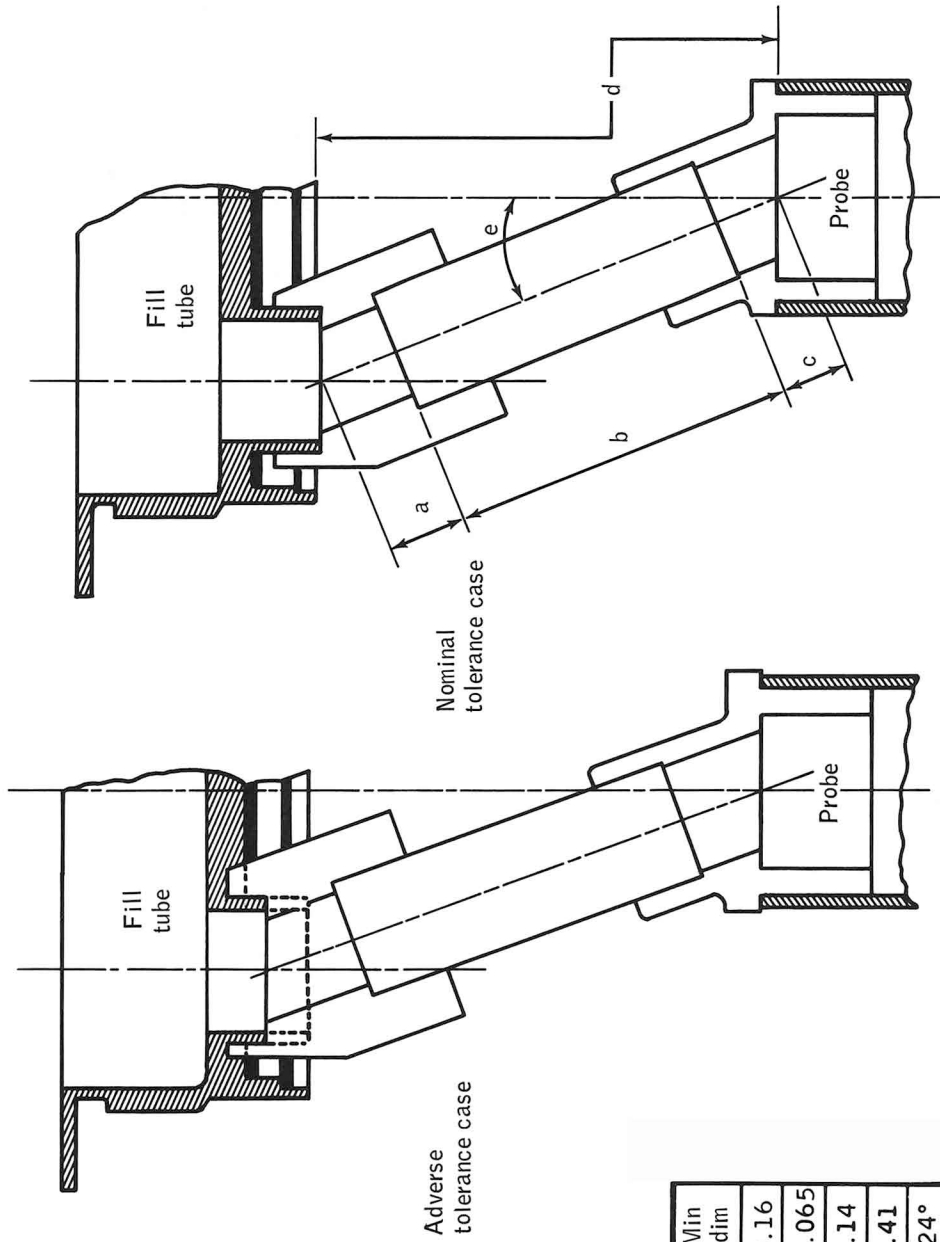
As shown in figure 4-2, the fill line from the exterior of the SM enters the oxygen tank and connects to the inner cylinder of the capacitance gage through a coupling of two Teflon adapters or sleeves and a short length of Inconel tubing. The dimensions and tolerances selected are such that if "worst case" variations in an actual system were to occur, the coupling might not reach from the fill line to the gage cylinder (fig. 4-3). Thus, the variations might be such that a very loose fit would result.
