# **REPORT OF APOLLO 13 REVIEW BOARD**

**APPENDIX F - SPECIAL TESTS AND ANALYSES**

**APPENDIX F**  
**SPECIAL TESTS AND ANALYSES**

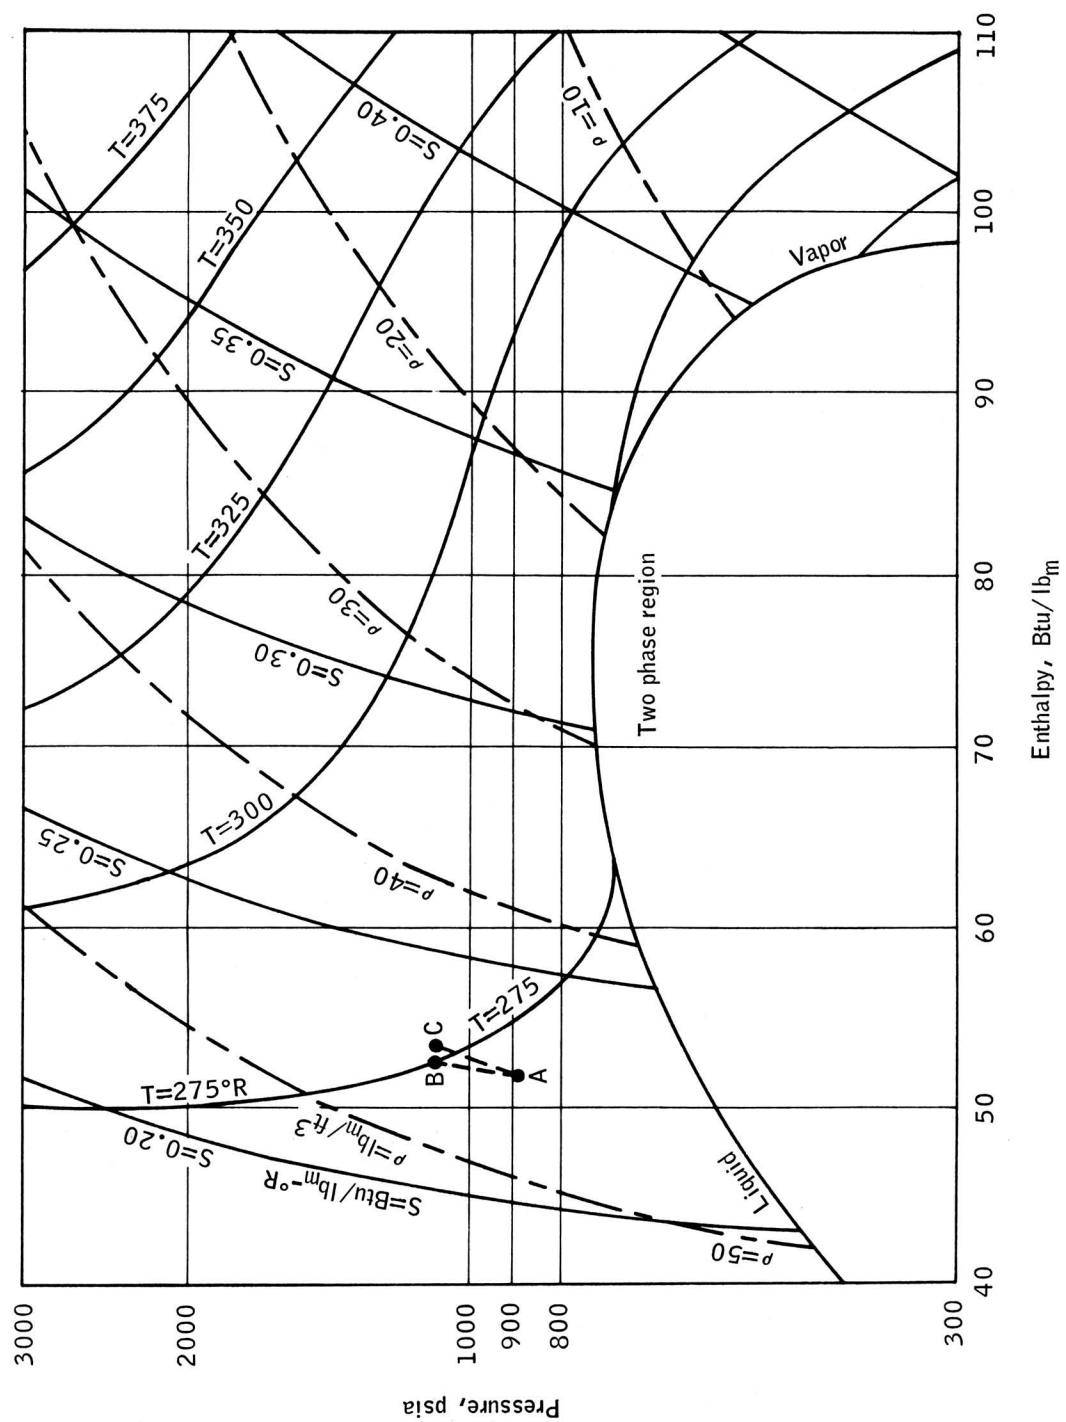
Figure F3.3-1.- Thermodynamic processes on pressure-enthalpy diagram.

Figure F3.3-1 also shows the constant density path along line AC from 887 psia to 1008 psia. This process could be achieved by complete mixing of the tank contents. The internal energy increase for this case (maximum energy) is about 130 Btu. The temperature increase for this process is  $2.6^{\circ}\text{F}$ . It should be noted that this energy addition is to the oxygen in the tank. It does not include energy that might be added to other tank components such as metal parts.

The measured temperature rise of  $38^{\circ}\text{F}$  (indicated by figure B5-3 in Appendix B) during the pressure rise to 1008 psia cannot be explained by

either of the above-mentioned thermodynamic processes because they give a rise of only 1.8° and 2.6° F. As figure B5-3 shows, the measured temperature rise lagged the pressure rise. Both this lag and the magnitude of the temperature rise can be explained by the passage of a combustion front near the temperature sensor.

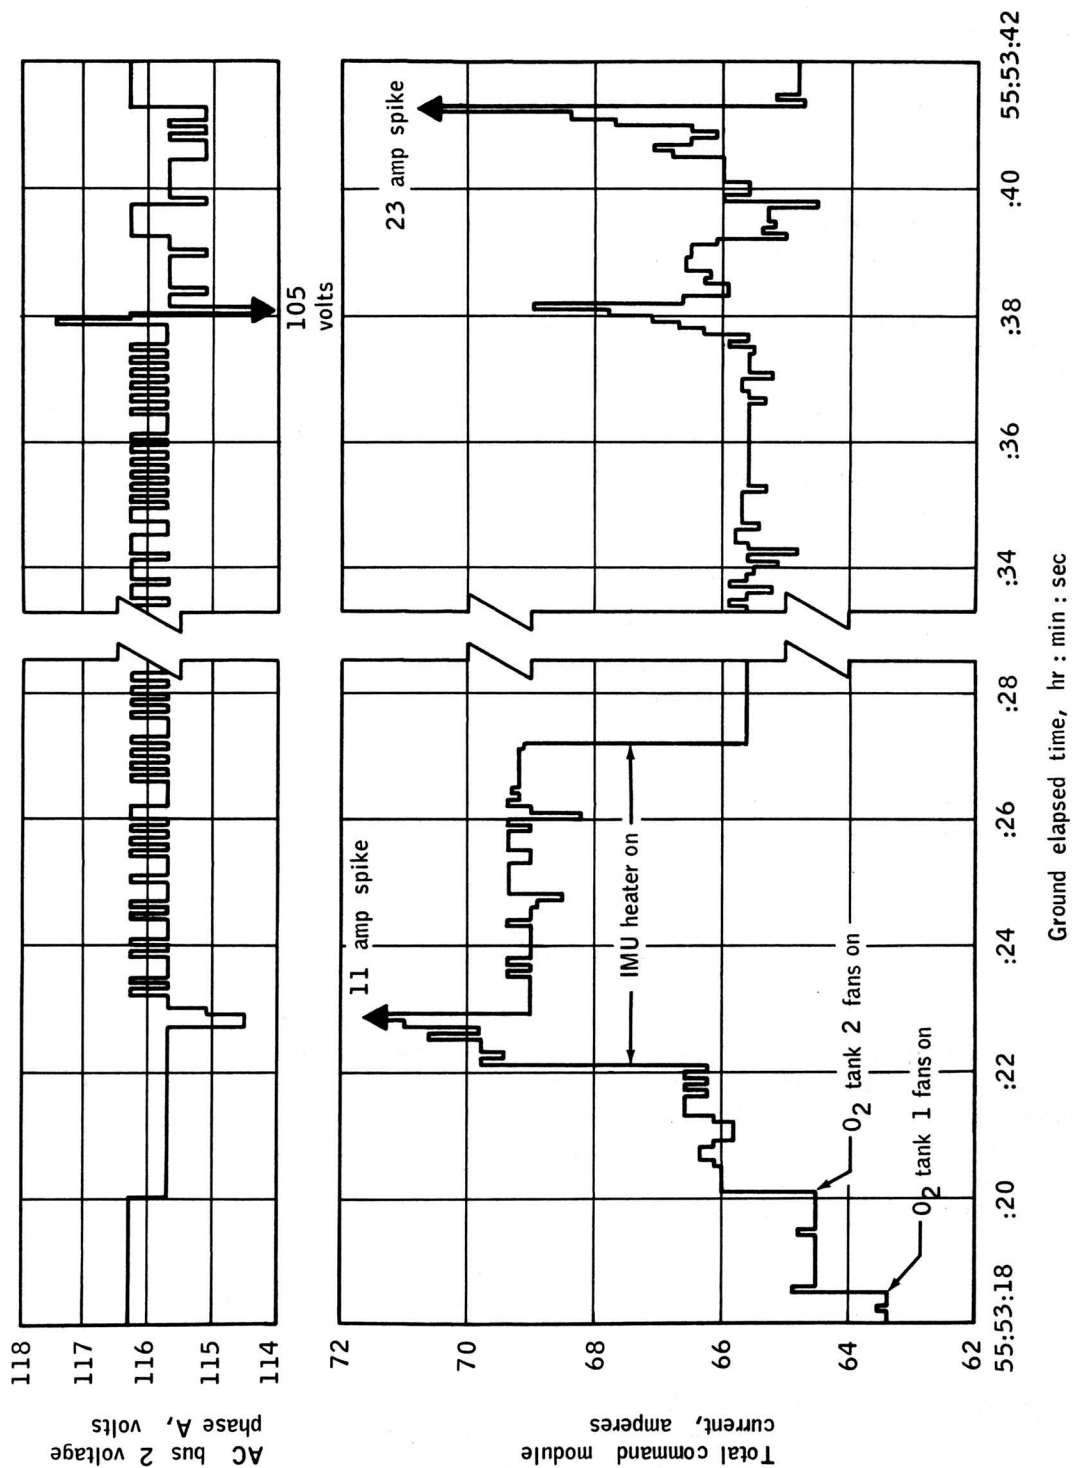
Figure F3.3-2.- Telemetry data for ac bus 2 voltage phase A and total CM current.

The 115-volt fan motor circuit is shown in figure D3-5 of Appendix D. The power for the motor comes from an inverter producing three-phase, 400-cycle, 115-volt power. The motors are operated in parallel, each phase to each motor being separately fused with a 1-ampere fuse (there are a total of six fuses in the circuit). The important portions of the telemetry traces are shown in figure F3.3-2. The sequence of events postulated is as follows:

1. Fan turnon occurs at 55:53:20 g.e.t. and the phase A voltage drops from 116.3 to 115.7 volts. This is normal. The telemetry granularity is  $\pm 0.3$  volt.
2. At 55:53:23, an ac voltage drop from 115.7 to 114.5 volts is observed, coincident with a fuel cell current increase of 11 amperes. This is the first short circuit that occurred after fan turnon. Since the ac voltage rose from 115.7 to 116.0 volts (as indicated by "togglng")

between 115.7 and 116.3 volts) after the event, it is probable that the short circuit involved phase A of the motor drive circuit, and all power may have been lost to one of the two fan motors at this time. This hypothesis is further supported by the coincident decrease in fuel cell current of 0.7 ampere, approximately half of the 1.5 amperes drawn by both motors.

4. A final short circuit occurs at 55:53:41 as indicated by the 22.9-ampere spike on the dc current telemetry. No voltage drop is observed on the ac bus, probably because the short was of such short duration that it was not picked up by the telemetry samples. All the remaining fuses are blown (or the leads open-circuited) by this short circuit since the ac bus voltage and dc current return to the levels observed prior to initial energizing of the fans in oxygen tank no. 2.

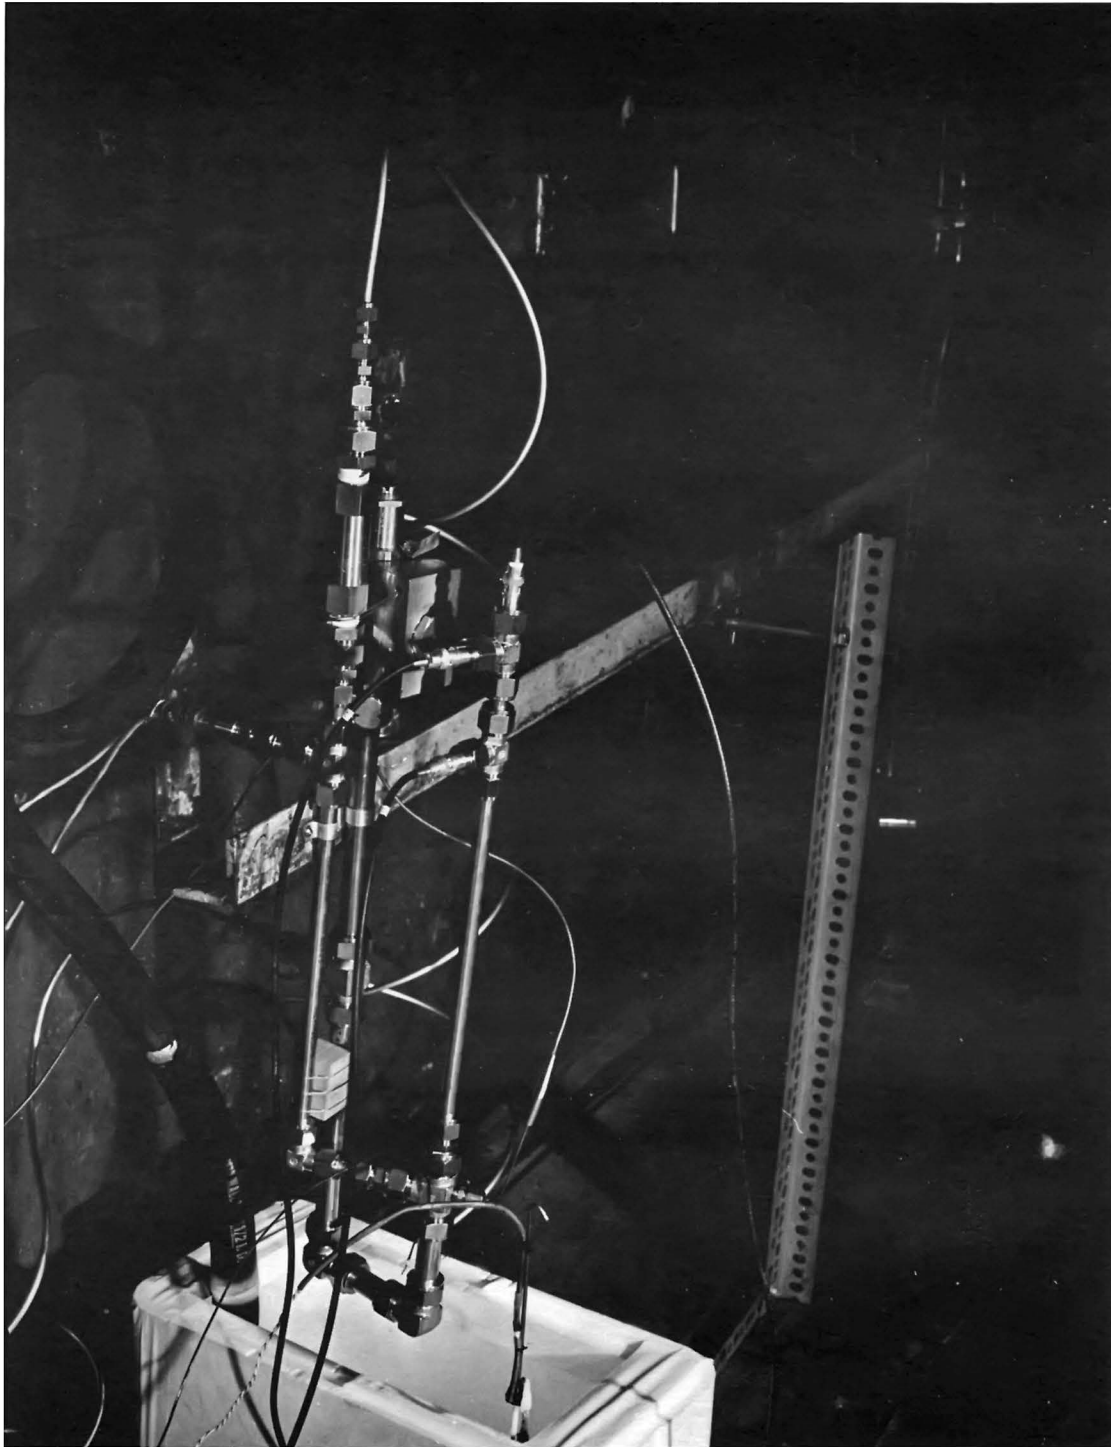
Figure F3.4-2.- Stainless steel test rig.

The specimen was immersed in liquid oxygen (as before) inside the stainless steel tubing test rig shown in figure F3.4-2. The initial pressure was 920 psi.

The test assembly withstood three firing pulses, 115 volts, 60 cycles, before igniting on the fourth. The 1-ampere fuse was blown each time. The short resistance was measured after each trial and was found to reduce progressively from about 5 ohms to 2 ohms, at which level ignition occurred on the next try. Approximately 1/2 second later the pressure gage showed the start of a 7-1/2 second pressure rise from 920 to 1300 psi. A thermocouple placed about 1 to 2 inches from the ignition point showed a small rise about 1 second after ignition and a large rise about 1/2 second later as the flame swept by. Much of the main conductor wire was consumed; all of the small thermocouple wire was gone. Virtually all of the Teflon was burned--Teflon residue was found only in the upper fitting where the electrical leads are brought into the test chamber. All but one of the alumina insulators vanished.

From the fuse energy tests and these ignition tests, it is clear that from 3.5 to 7.5 joules are adequate to initiate combustion of heat-degraded Teflon insulation. This is essentially the same as is required for unheated wire.

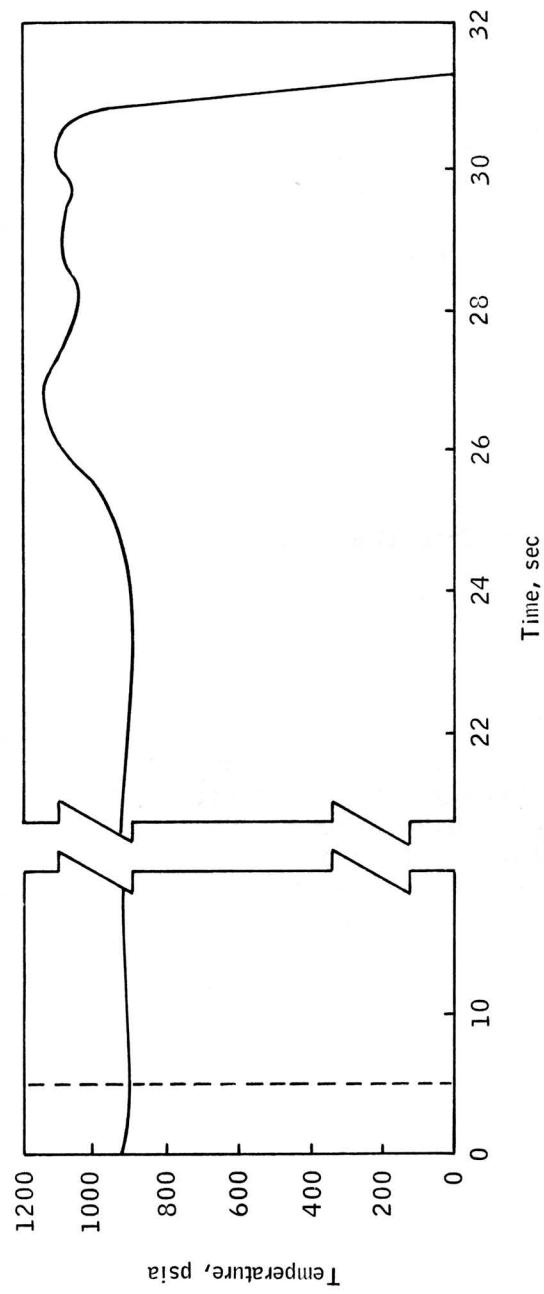
Figure F3.5-3.- Quantity probe and conduit assembly test pressure history.

Pressure history of the chamber is shown in figure F3.5-3. The first relief valve opening occurred at approximately 28 seconds. It subsequently reopened 15 times before failure occurred. Fusion of the ignitor is shown on the graph to indicate ignition of the insulation.

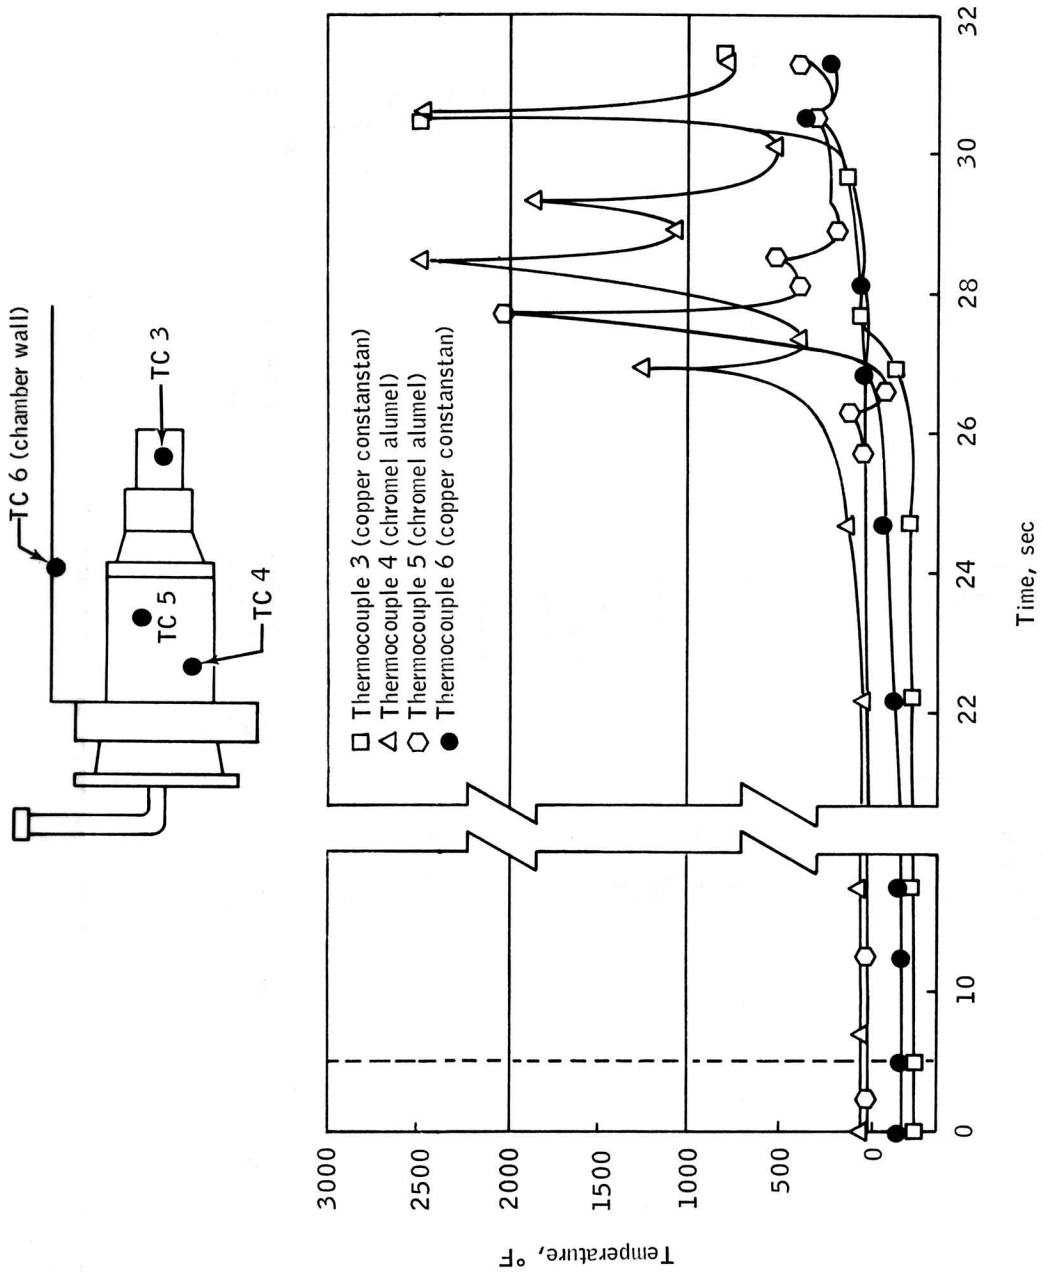
Figure F3.5-4.- Temperature history of quantity probe and chamber wall.

Temperature histories of both internal and external portions of the test apparatus are shown in figures F3.5-4 and F3.5-5. Thermocouple placements in each of these areas are included in the legend figures of each of these graphs. It should be noted that two types of thermocouples were used, one with good sensitivity at low temperatures, copper-constantan, and one with good sensitivity at high temperatures, chromel-alumel. These two types are also indicated in figures F3.5-4 and F3.5-5.

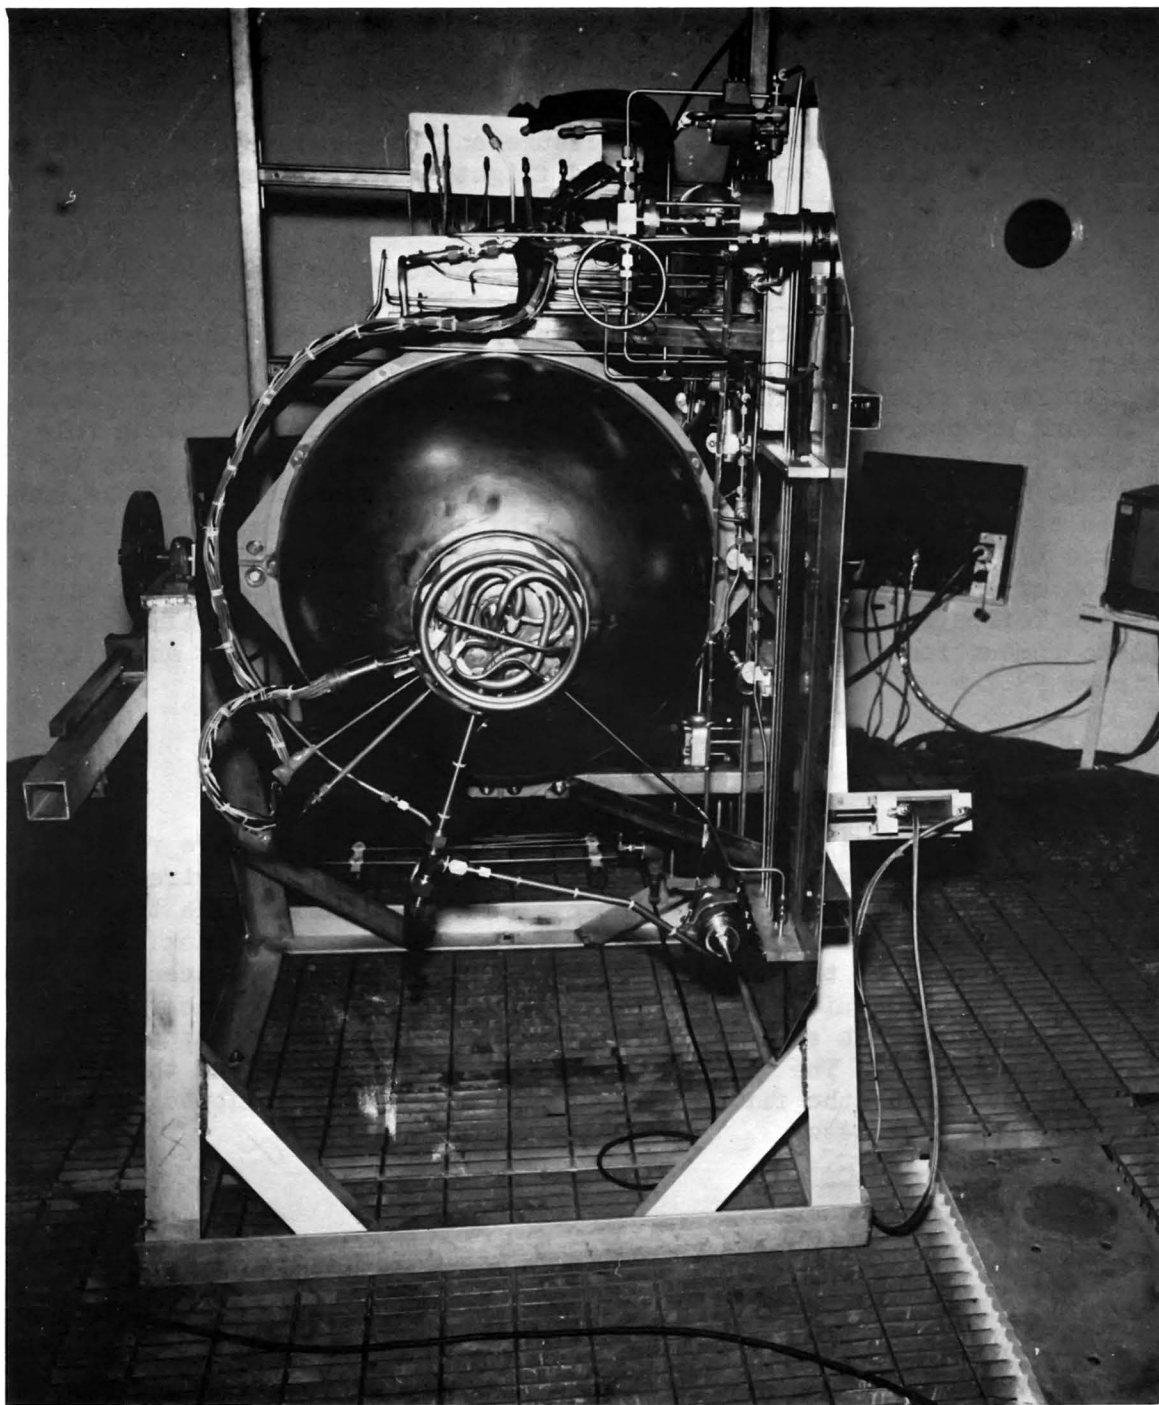
Figure F3.7-1.- Posttest oxygen tank setup.

The conduit failed close to where it attaches to the tank closure plate about 57 seconds after ignition (fig. F3.7-3). The two 250-frame/sec cameras and the 64-frame/sec camera failed to operate during this test. However, the 400-frame/sec camera suggests that the first material to issue from the ruptured conduit was accompanied by bright flame. The tank pressure declined from 1175 psia to 725 psia in 1 second following conduit rupture. High oxygen flow rates were observed from the conduit breach for about 15 seconds. A posttest examination of the ruptured conduit showed that the expulsion of the tank contents was limited by the 1/2-inch-diameter aperture in the tank closure plate. An examination of the internal components of the tank showed complete combustion of the Teflon insulation on the motor lead wires as well as almost complete combustion of the glass-filled Teflon sleeve. This is shown in figure F3.7-4.

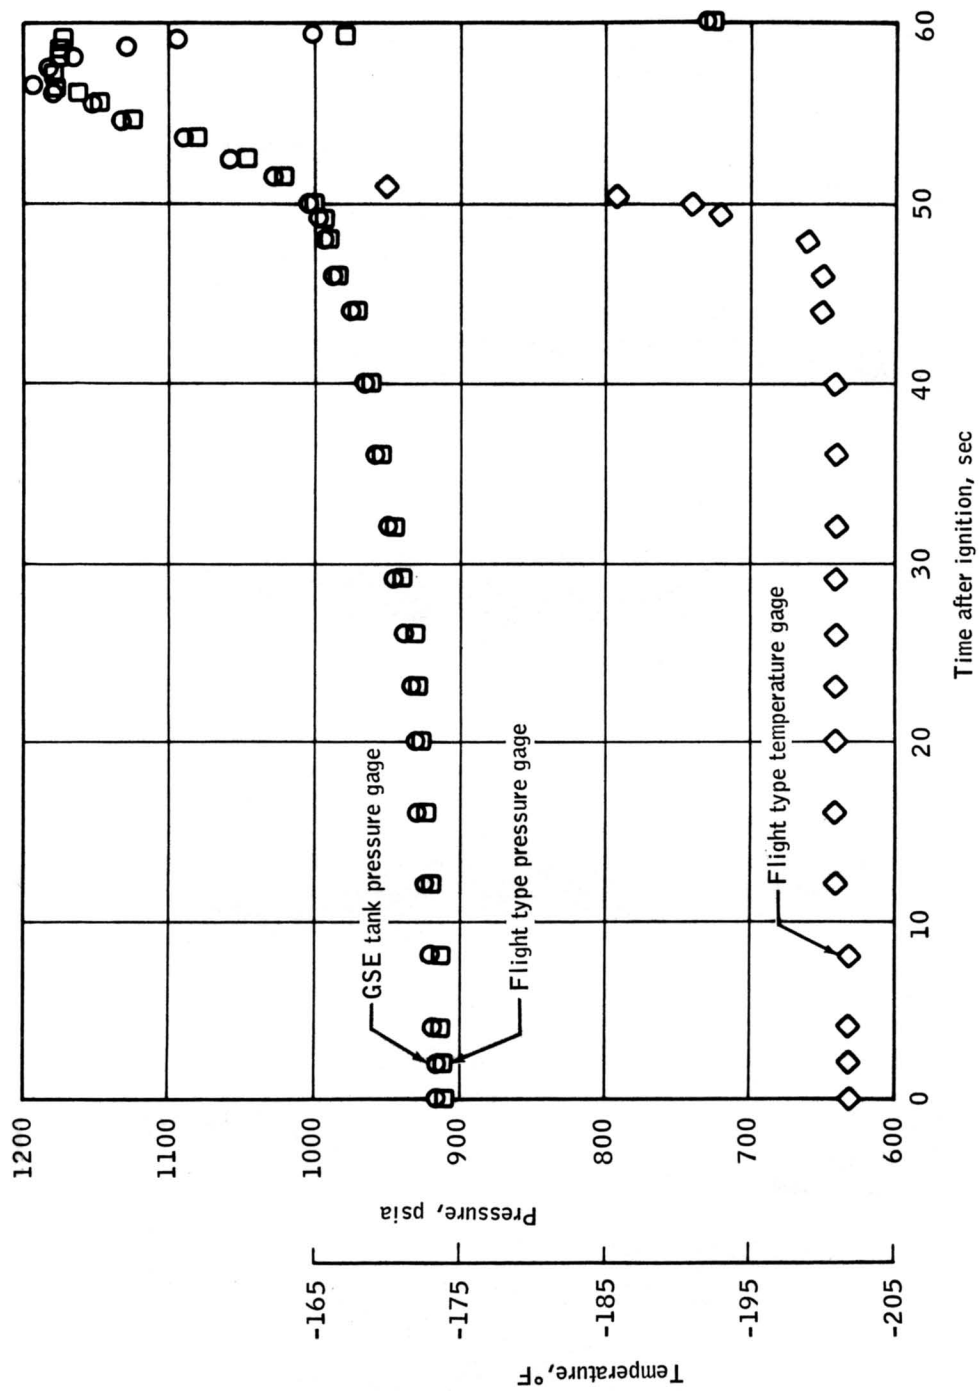
Figure F3.7-2.- Measured pressure and temperature time histories  
(preliminary data as of June 4, 1970).

2000° F. Failure of the temperature measuring wiring is indicated by the erratic readings that followed. These data are shown in figure F3.7-2. The pressure data shown beyond 56 seconds represent the venting of the tank contents. These pressure and temperature histories are qualitatively similar to the measured flight data but occur more rapidly than observed in flight.

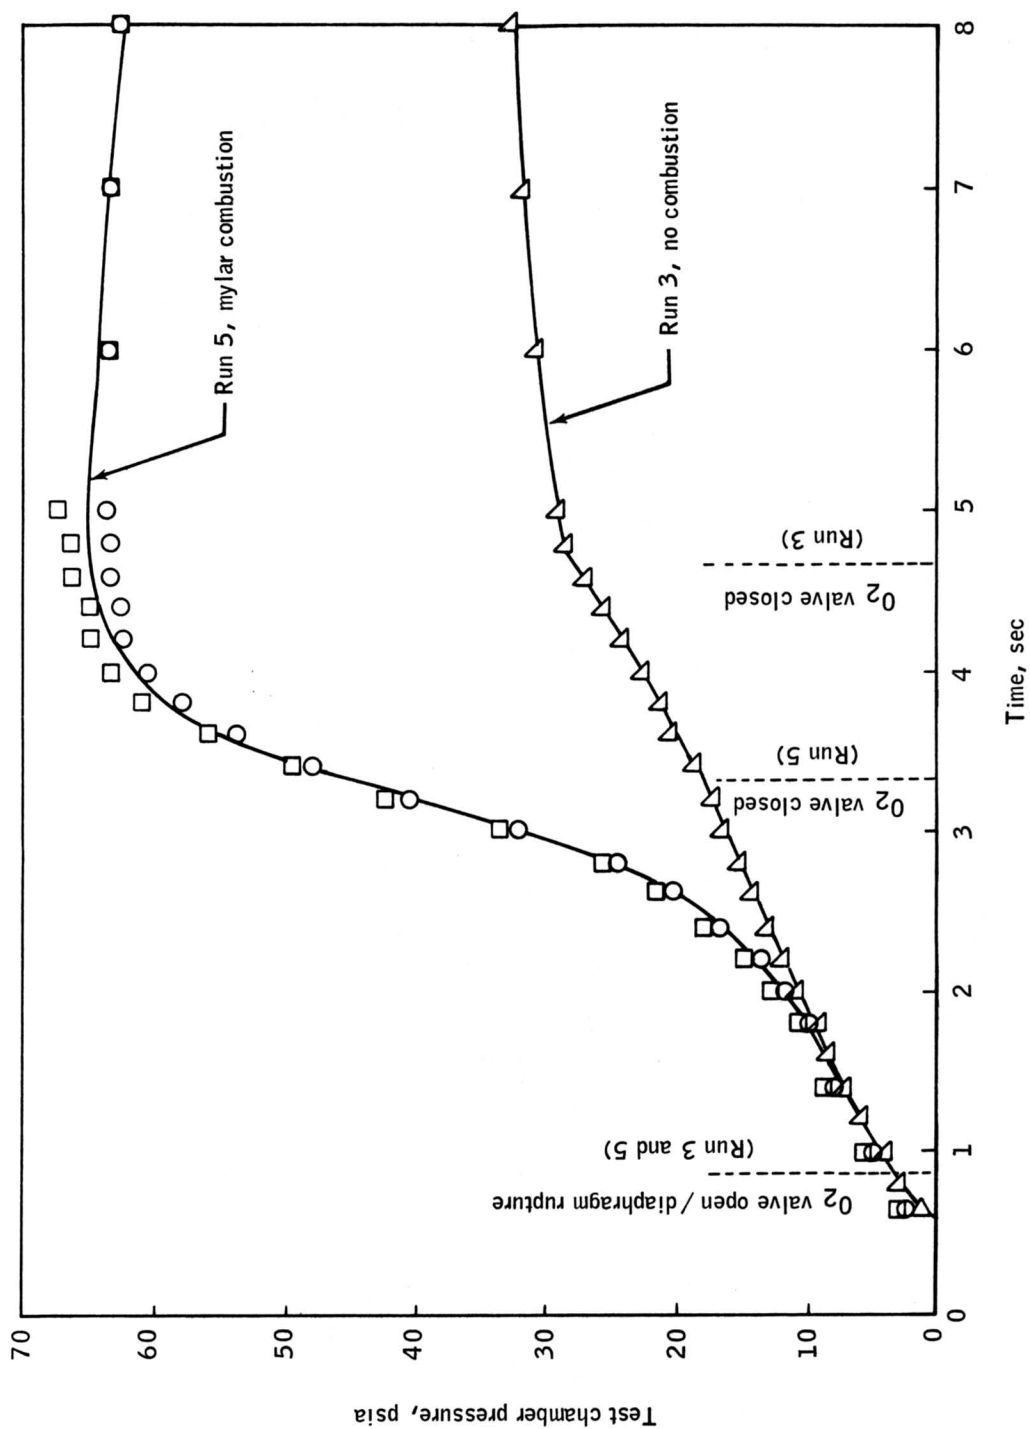
Figure F3.9-3.- Measured pressure histories for runs with and without Mylar combustion (initial oxygen tank temperature for Run 3 was -186° F and for Run 5 was -192° F).

The Mylar insulation blanket burns completely when ignited locally and exposed simultaneously to oxygen from a 1000 psi/-190° F source. The pressure rise rate increases from 6 psi/sec without combustion to about 42 psi/sec with the combustion of Mylar. A substantial increase in the pressure rise rate in the oxygen tank shelf space due to Mylar combustion might therefore be expected. From tests conducted elsewhere, it is further concluded that an ignition source is required to achieve Mylar/oxygen combustion.

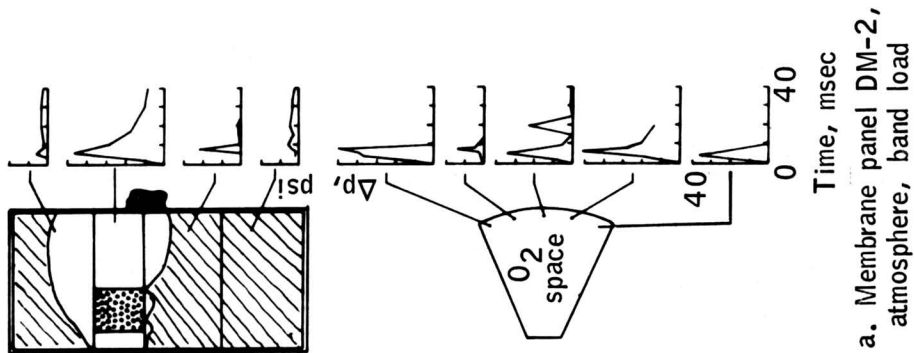
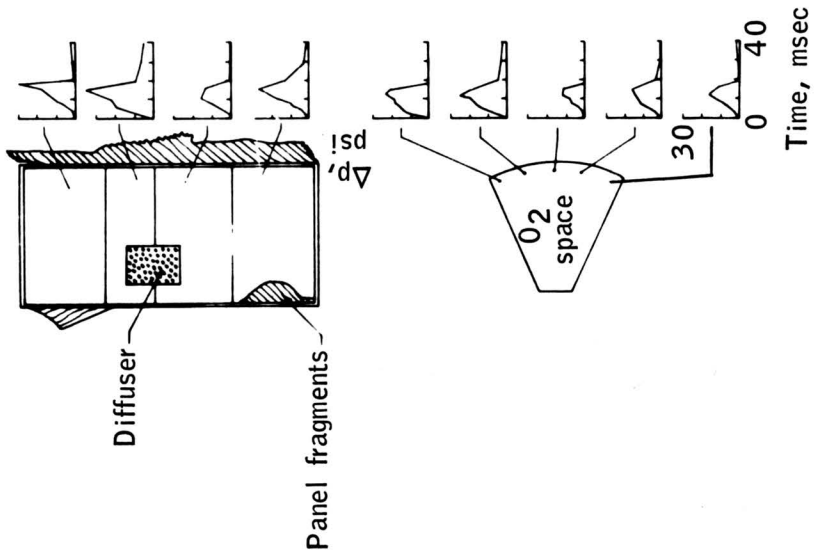
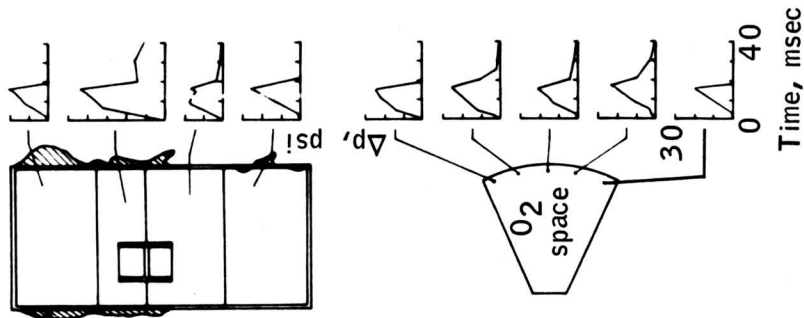
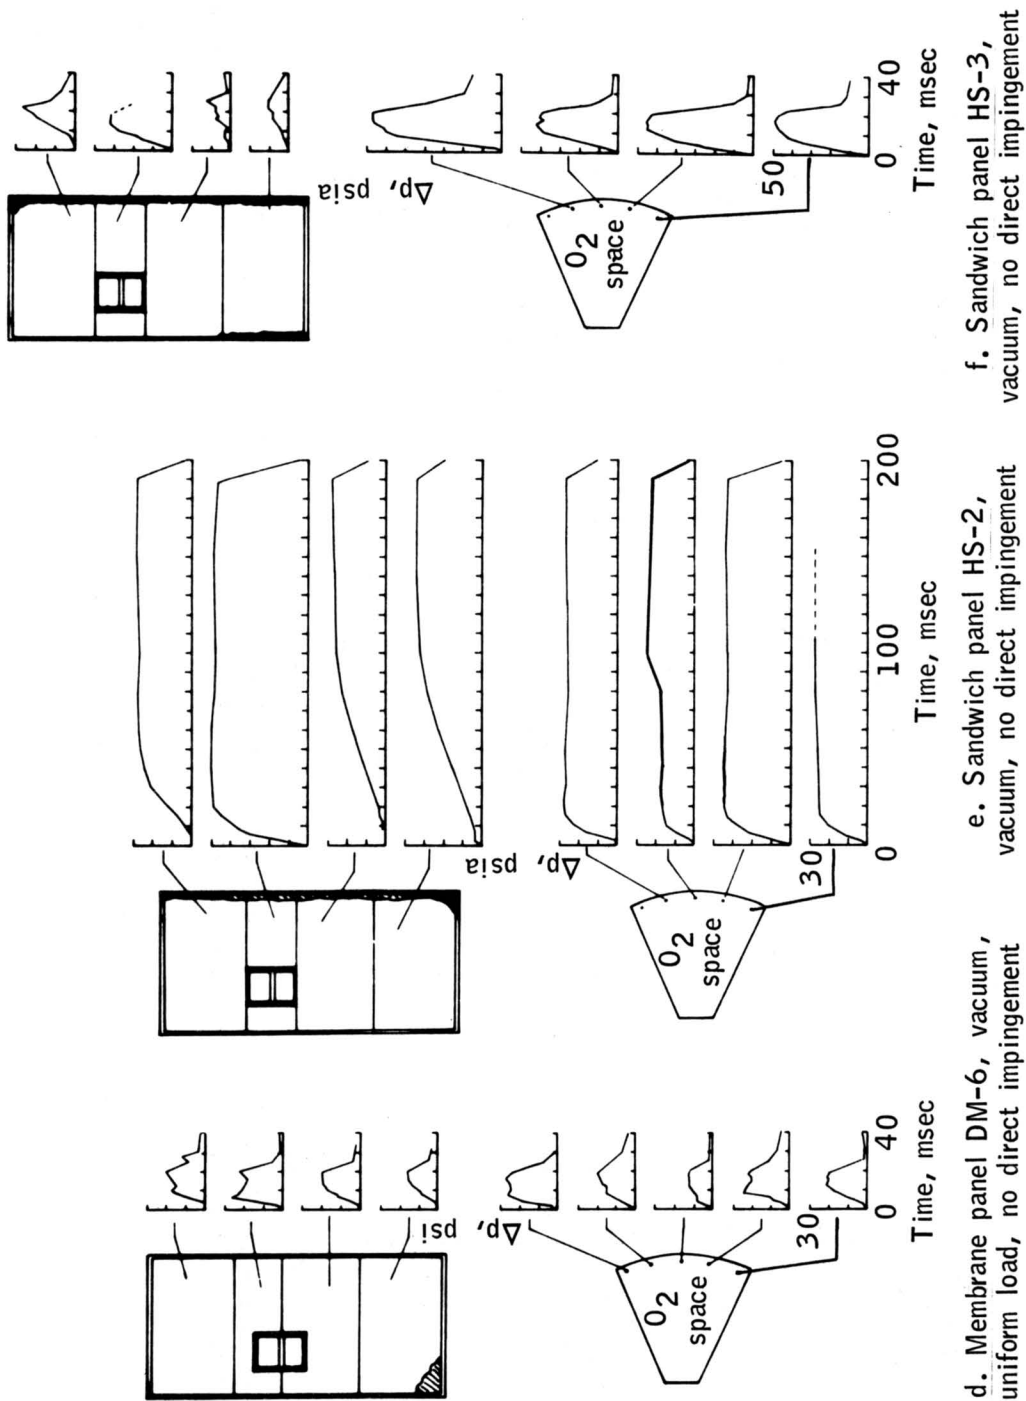
Figure F3.10-4.- Failure modes and pressure-time histories.

Demonstration of panel separation.- Panel separation has been demonstrated with both membrane and sandwich panels. Two sandwich panels separated completely from the test fixture during vacuum tests. Two membrane panels, although less representative of flight conditions, also separated completely in vacuum tests. However, similar tests with membrane panels in atmosphere left portions of panels attached to the test fixture as illustrated in figures F3.10-4(b) and (c). Complete separation in atmosphere could not be achieved due to mass and drag of the air.

Pressure distributions.- Complete membrane panel separation was achieved only with nearly uniform pressure distribution over the entire bay 4 panel cover, shown in figure F3.10-4(d). When just the oxygen shelf space experienced high pressures, membrane panel separation was localized to the area of the panel over the oxygen shelf space as shown in figure F3.10-2(a). This type of local failure occurred in both atmosphere and vacuum. When scaled internal venting was introduced, model DM-10 lost a slightly larger portion of panel due to high pressure experienced by both the oxygen shelf and fuel cell shelf spaces while the rest of bay 4 was at low pressure.

of the Apollo 13 SM shown in figure F3.10-2 and have been verified in these experiments. Peak pressure levels were varied from test to test but the curve shape was always similar. One sandwich panel separated after about 0.02 second during the initial pressure rise in the oxygen shelf space, while overall panel loading was highly nonuniform as shown in figure F3.10-4(b). The other sandwich panel did not separate until about 0.19 second after all bay 4 compartments had time to fill with gas and arrive at a much more uniform loading, as shown in figure F3.10-4(e).

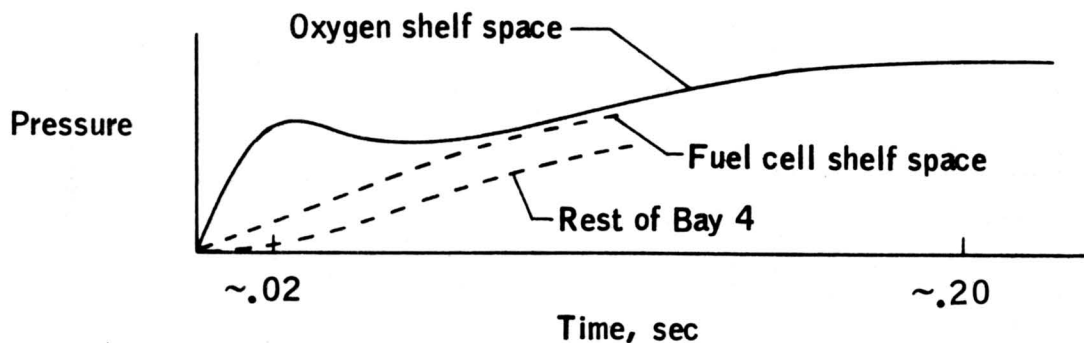
Figure F3.10-8.- Pressure build-up in bay 4.

Complete separation of sandwich panels has been obtained with both uniform and nonuniform pressure distributions. Figure F3.10-8 shows the type of pressure time histories experienced by various sections of the panels. The pressure predictions are based on the internal flow model
