MSC APOLLO 13 INVESTIGATION TEAM

SPACECRAFT INCIDENT INVESTIGATION

VOLUME I ANOMALY INVESTIGATION

FINAL REPORT

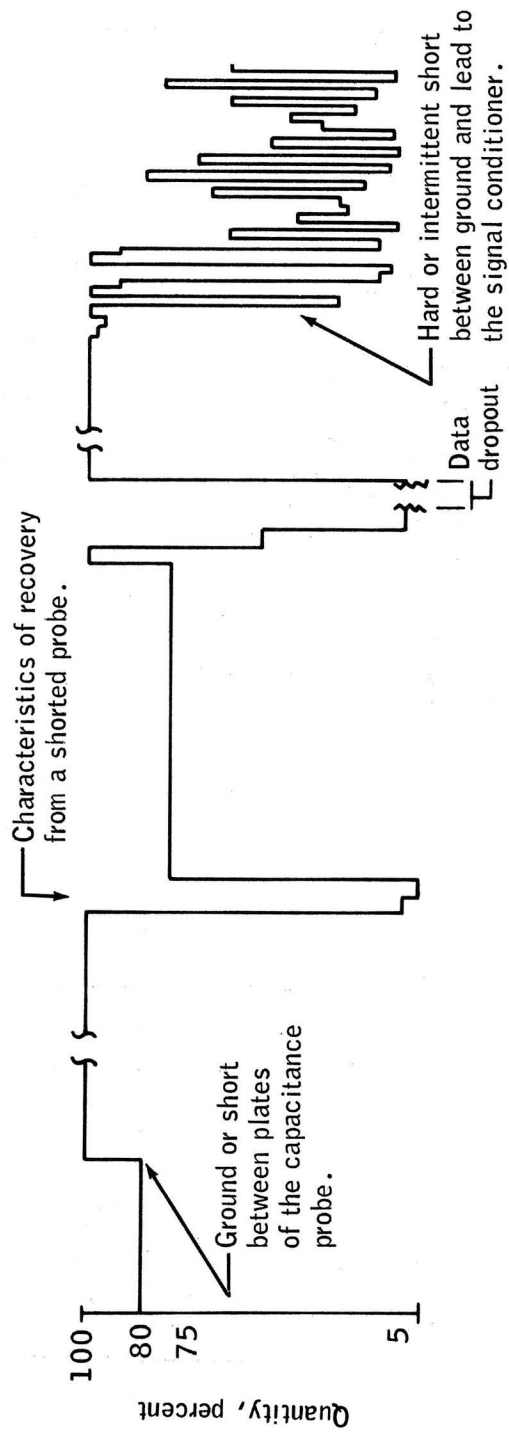
Figure 4-2.- Correlation of cryogenic oxygen tank 2 quantity flight data with measurement failure modes .

The first anomalous inflight condition associated with the cryogenic oxygen tank 2 occurred at 46:40:06 when the ac-powered destratification fans in both cryogenic oxygen tanks were turned on. Within about 3 seconds after fan activation, the quantity measurement for cryogenic oxygen tank 2 abruptly indicated full-scale high. This system indicates density of the cryogenic oxygen by measuring its dielectric constant, which is a function of density. This instrument is a capacitor which consists of two concentric aluminum tubes inside the tank (fig. 4-1).

Tests have shown that an open-circuit in the leads to the capacitor assembly or a short across the capacitor or its leads will drive the output to full scale. If this short-circuit is removed, the output signal drops abruptly from full scale to zero, and then in about a second, it settles out to the proper reading, as noted in the data of figure 4-2. This agrees with the flight data from the quantity probe. Tests also show that if the inner tube is shorted to ground, the output may oscillate in a random manner. Such an oscillation was noted several minutes after data recovery following the incident. It should be noted that with a short-circuit in the quantity gaging system inside the tank, the maximum current that could be drawn is 15 milliamperes.

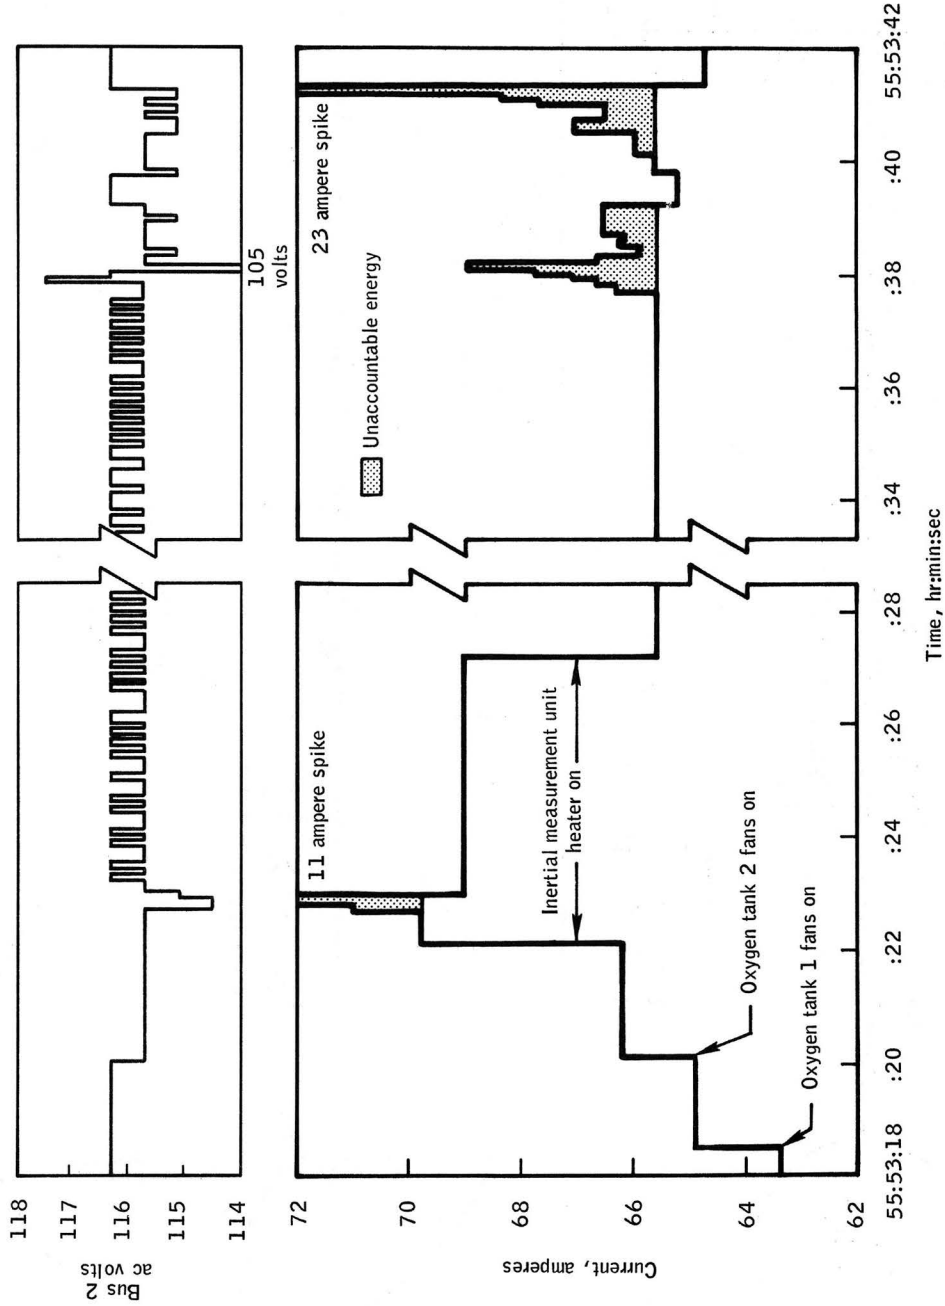
Figure 4-5.- Spacecraft current and ac voltage during period of interest.

The first indication of a short on ac bus 2 appeared about 2-1/2 seconds after activation of the cryogenic oxygen tank 2 fans. The ac bus 2 voltage dropped 1.2 volts, the fuel cell 3 current increased 11 amperes (fig. 4-5), and the stabilization and control system gimbal command data experienced a transient. Subsequent to the short, the spacecraft current data show a decrease of 0.8 ampere from the level just prior to the short. Also, the ac bus 2 voltage started to toggle-up 0.6 volt, or one data bit (fig. 4-5). These data indicate that a load was removed from ac bus 2 and that it was approximately one-half the load normally applied when the cryogenic oxygen tank 2 fans were turned on. This indicates that a short in one of the two fan motor circuits in cryogenic oxygen tank 2 caused its fuses to blow.

Approximately 200 milliseconds later, the ac bus 2 voltage momentarily decreased 11 volts (fig. 4-5), and the total spacecraft current increased 3.5 amperes, indicating an increased load. After the momentary decrease, the ac bus 2 voltage reading was 0.6 volt less than the previous indication. This could be an indication that a single phase short on phase B or C was removed by blowing a fuse.

About 20 seconds after the first short, the third ac bus 2 short occurred. Fuel cell 3 current increased 23 amperes, and the stabilization and control system data again indicated a transient (fig. 3-1). Subsequently, the total spacecraft current level decreased to the same level as it was prior to turning on the cryogenic oxygen tank 2 fans. This indicates that power to the remaining cryogenic oxygen tank 2 fan was removed by blowing its fuses due to this short. Also, the ac bus 2 voltage increased to the same level as that prior to turning the tank 2 fans on (fig. 4-5).

The electrical energy that could not be accounted for by normal spacecraft loads (fig. 4-5) is attributed to the shorts. Calculations were made of the maximum energy levels that could have been transmitted through the circuit during these shorted conditions and that would still meet the constraints imposed by the flight data resolution and sampling times, inverter performance, fuse clearing time, and dc and ac bus voltage sensor performance. Inverter performance and fuse clearing time tests were performed to provide data for the energy calculations. The energy calculations are summarized in table 4-I.

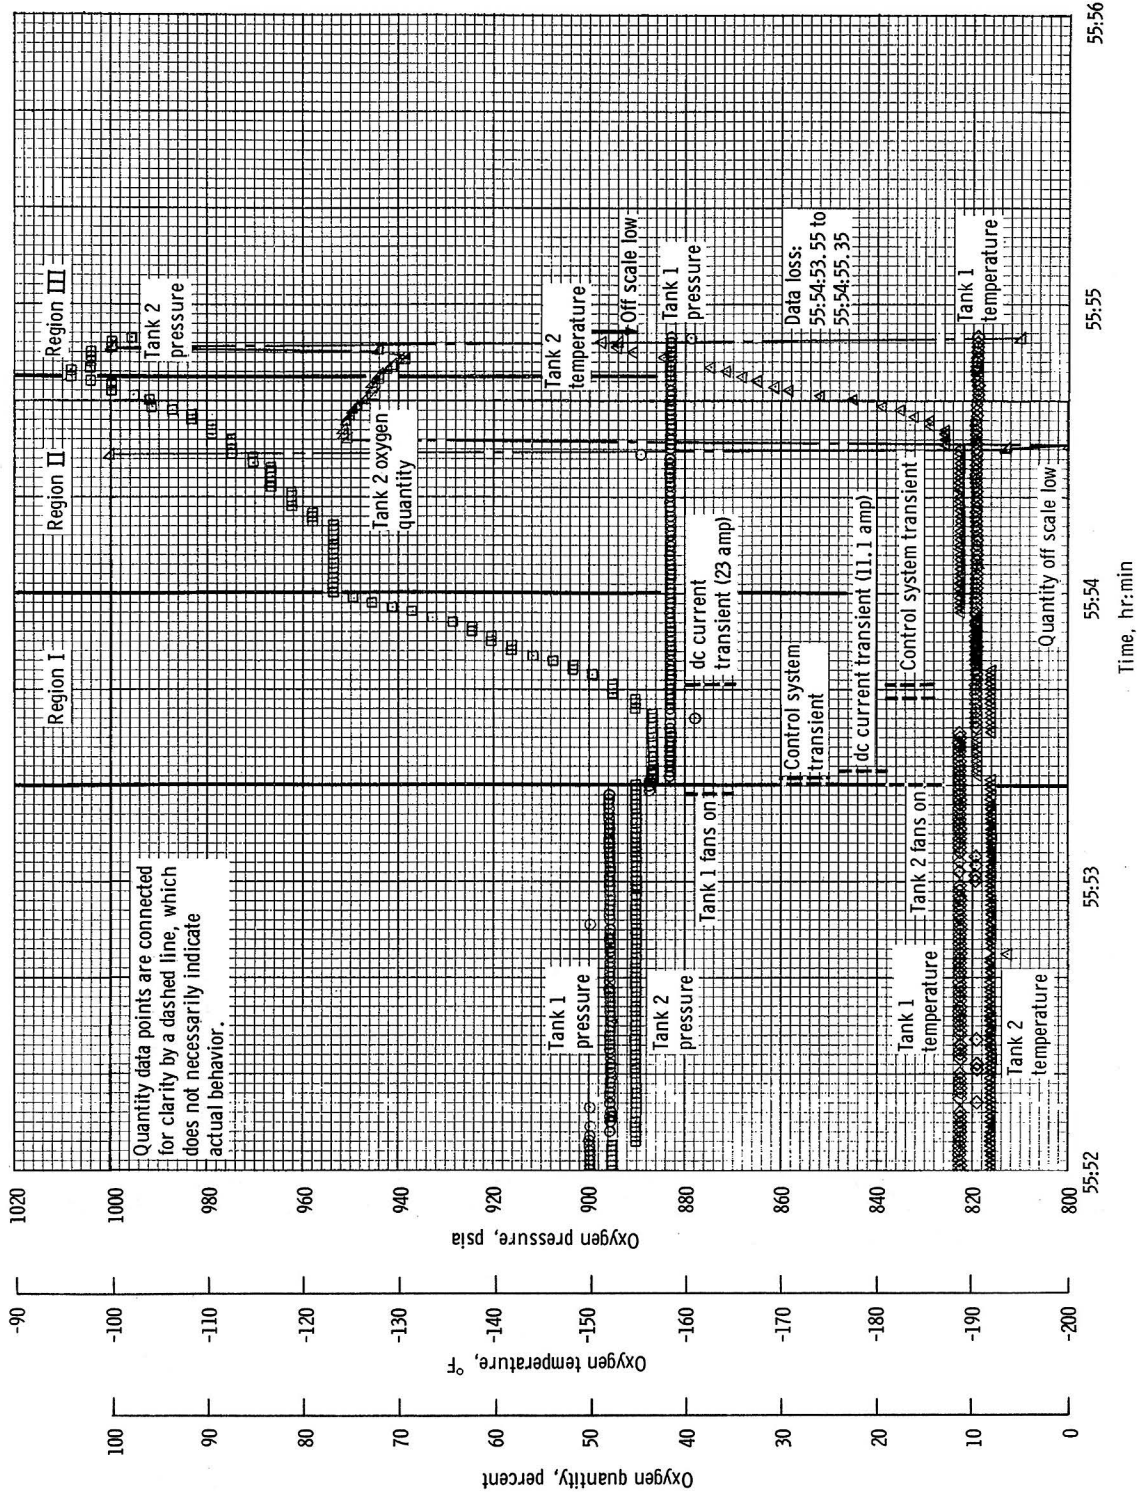
Figure 4-10. - Pressures, temperatures, and quantities during period of interest.

While the pressure was rising sharply in cryogenic oxygen tank 2, changes occurred in the temperature indication (fig. 4-10). The temperature data are obtained from a sensor located on the quantity probe assembly (fig. 4-8) within the tank. The temperature increased about 2° F during the first pressure rise (region I). A temperature increase of this magnitude is in accord with that expected due to the pressure rise alone.

The significant aspect of the temperature data is the rapid rise rate commencing approximately 24 seconds prior to loss of data (fig. 4-10). Several analyses were performed to interpret the data. The results indicated that a temperature range of 600° to 2900° F could produce the observed response. This wide temperature span is a result of the geometric configurations which are possible. The significant results from these analyses confirmed that the combustion source was near the sensor during the period of rapid temperature rise. Just prior to the loss of data, the temperature dropped to zero, indicating an open circuit failure in the measurement circuit.

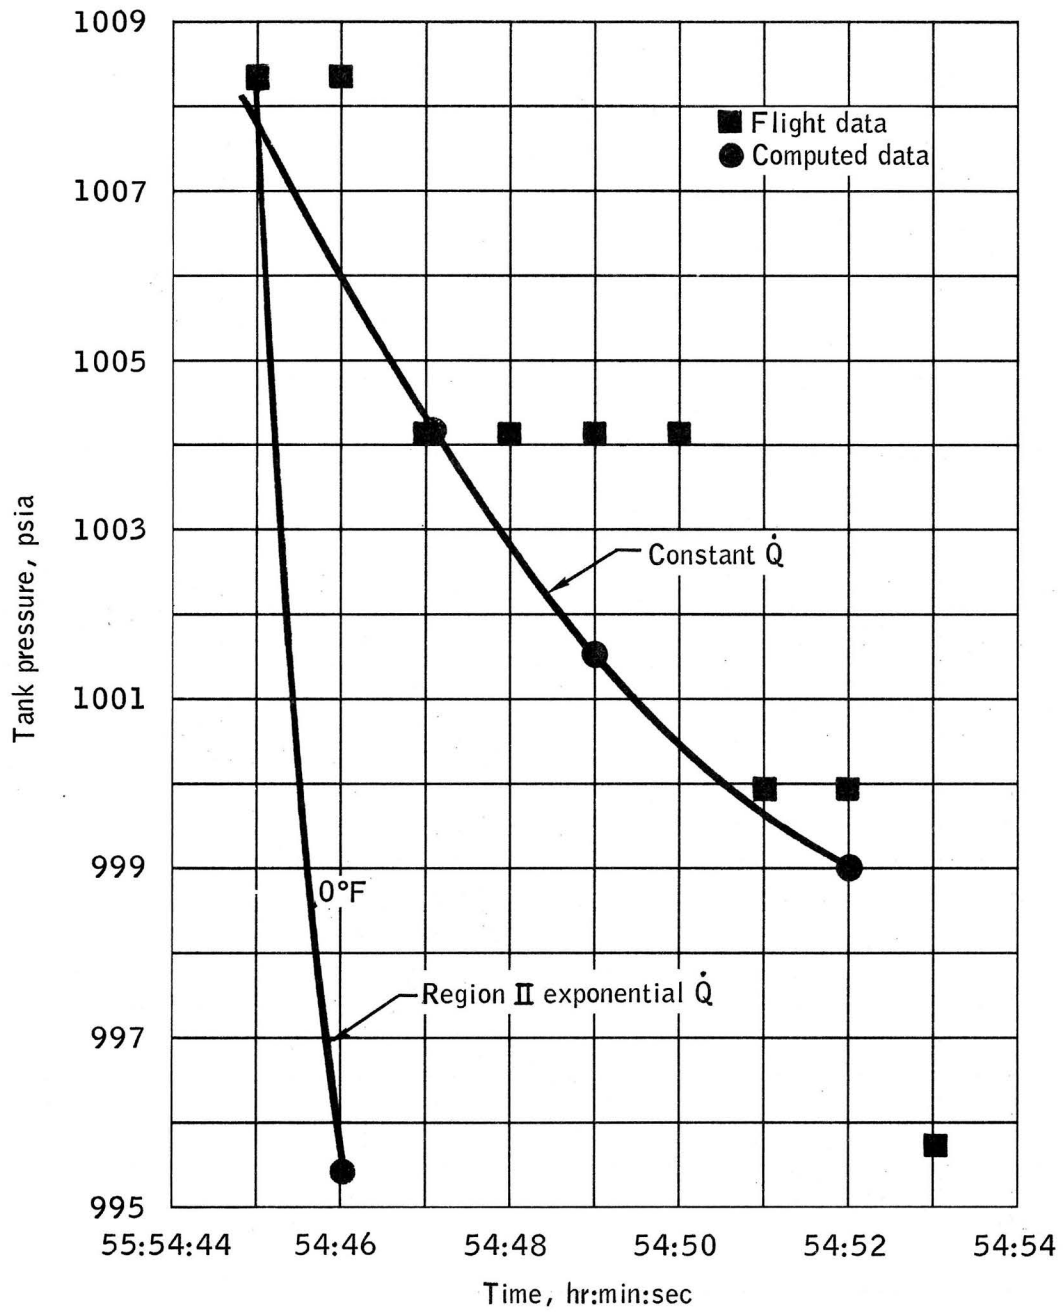
Figure 4-15.- Relief valve response in region III.

There are at least two possible ways to explain the observed pressure response. One is a partial restriction of the flow and the other is a change in the combustion rate within the tank. There are several conditions which could lead to partial restriction of the flow, but the simplest of these is a restriction in the relief valve itself.

A change in the combustion rate could easily account for the slower-than-expected pressure decay after the relief valve opened. In order to properly account for the increase in combustion rate, it is necessary to consider about the last 2 seconds of region II. At this point, the pressure is 1004 psia, the relief valve crack pressure. When the relief valve opens, the velocity at the filter (inside the oxygen tank) increases. It is hypothesized that this increase in velocity provides both a convective force field and additional oxygen to the combustion source. When the relief valve opens fully the local velocity increases to a maximum. A further postulation is that this yields a maximum burning rate which raises the pressure to 1008 psia. The relief valve flow then decreases the pressure, although the combustion rate remains high. A heat input rate of approximately 2 Btu/sec will raise the pressure from 1004 psia to 1008 psia with the relief valve open. A constant heat rate of approximately 1-1/4 Btu/sec will match the observed pressure decay in region III (fig. 4-15). This energy input rate is about two and one-half times larger than the exponential rate of region II.

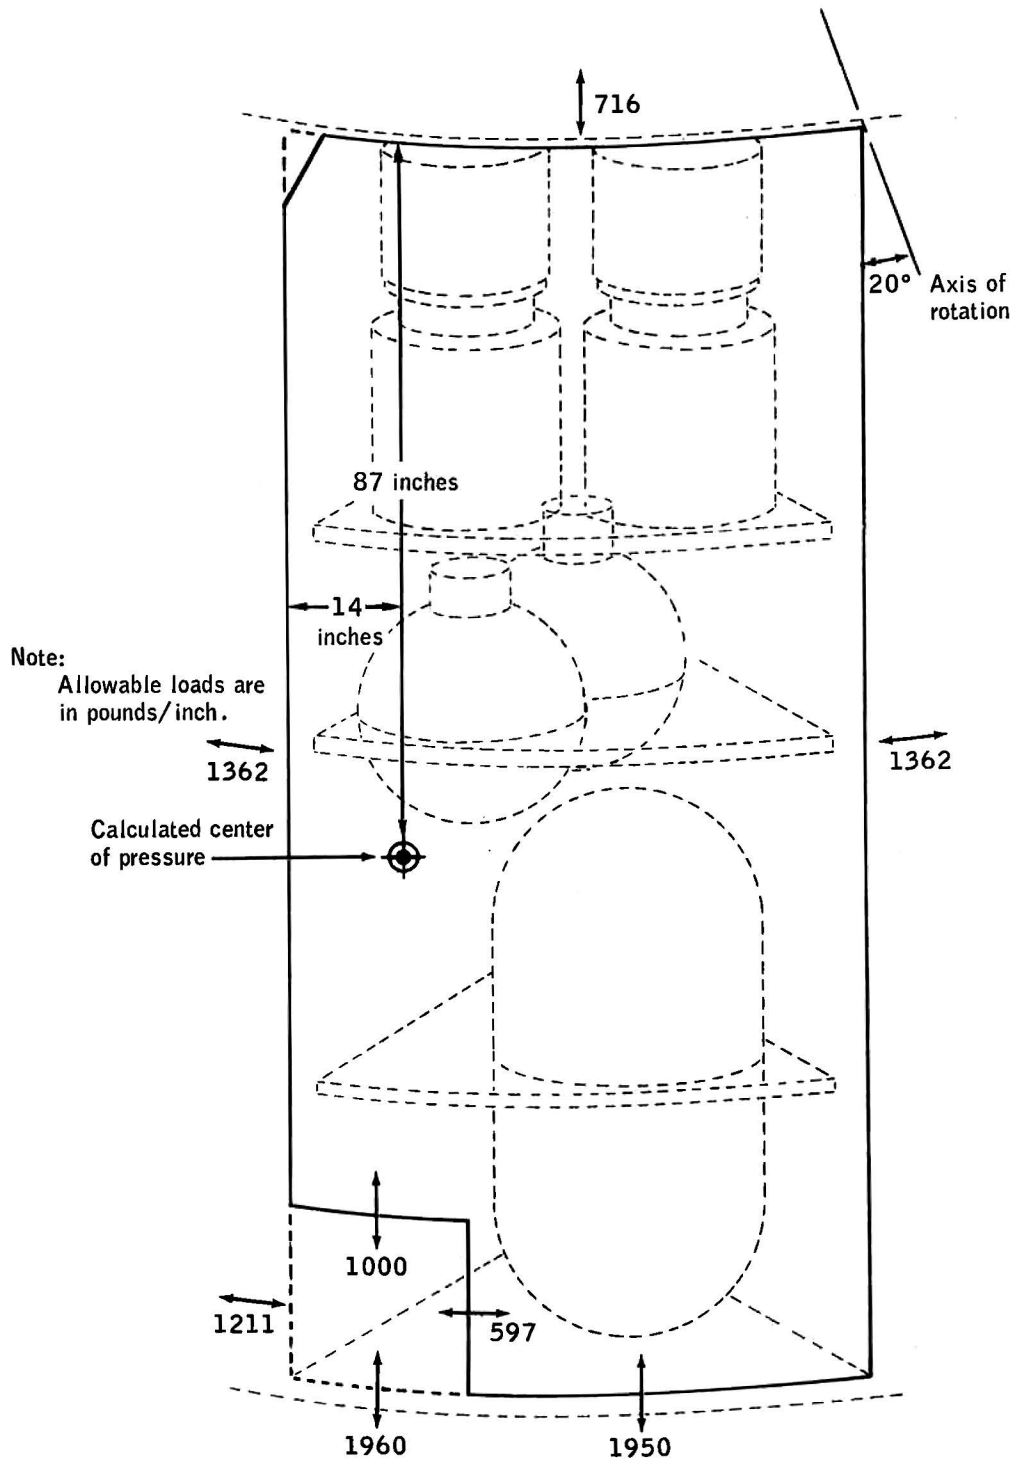
Figure 4-23.- Joint design allowables and axis of rotation.

Because of the evidence which suggested primarily membrane behavior, simplified representations of the structure were used to investigate its behavior. Structural analyses were performed for numerous pressure distributions as well as for temperature gradients for both hot and cold inner facesheets. The results show that the peak pressure must exceed 20 psi and that temperature gradients of interest result in small edge loads. The static allowables for failure with a failure mode of shear tearout are shown in figure 4-23.

c. The foregoing analysis is consistent with the available strength (fig. 4-23). The axis of rotation required to satisfy the kinematics of panel separation, the available strength, and the photographic evidence support the origin of failure on the left side of the panel as viewed from the exterior. The response of the Y and Z axes accelerometers noted at 55:54:53.531 is consistent with a minus Y and minus Z force applied over 15 to 20 milliseconds. Analysis of the vehicle dynamics indicates a 900 to 1500 lb-sec impulse was experienced by the spacecraft. Such an impulse would require an initial total force greater than 60 000 pounds. The variation in strength with a failure mode of shear tearout in the panel is shown for loads applied perpendicular to the boundary. The allowable load applied parallel to the boundary is bounded by shear of the fastener at approximately 2200 lb/in.

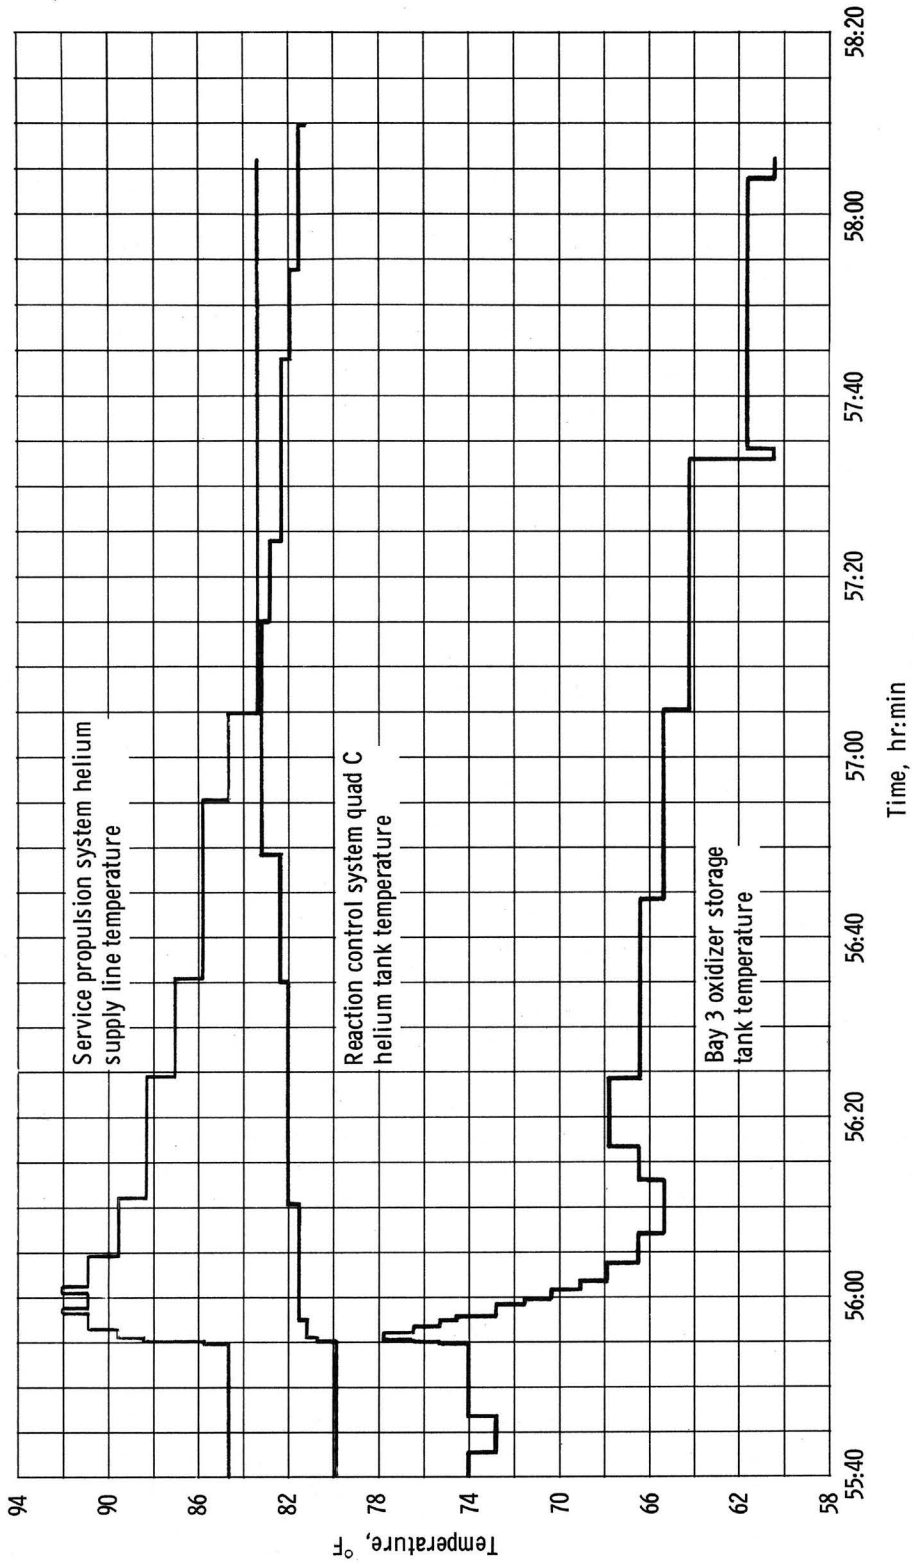
Figure 4-32. - Bay 3 and 4 structural temperatures.

The bay 3 oxidizer tank surface temperature increased from 73.4° to 77.7° F in about 20 seconds (fig. 4-32). The temperature then decreased to 60° F about 2-1/4 hours later. Data received during the two command and service module power-up cycles at 101:55:54 and 123:05:25 showed 60° and 65.3° F, respectively. The rise rate of bay 3 service propulsion system oxidizer surface temperature is indicative of direct heating in the vicinity of the transducer, which is attached to the tank skin and covered with 30 layers of insulation.

Heat inputs to the bay 3 service propulsion tank surface transducer depend on the thermal integrity of the multilayer insulation blanket covering the transducer. To obtain the noted response requires severely degraded insulation, probably because of burning of the insulation or pressurization of the bay with hot gas.

The service propulsion helium line temperature (fig. 4-32) increased from 84.6° to 89° F in about 37 seconds. In 2 more minutes, the temperature had increased to 92.2° F. A gradual cooling trend followed, and 10 minutes later, the temperature had decreased to 83.4° F. During the two command and service module power-up cycles at 101:55:54 and 123:05:19, the helium line temperatures were 72.1° and 65.9° F, respectively. The initial rise rate is again indicative of direct heating in the vicinity of the transducer. However, unlike the oxidizer tank surface temperature, the gradual decrease in helium line temperature, after the initial rise, is indicative of a cool-down response to radiant heat loss. The helium line cooled gradually because of the lower temperature levels with the fuel cells shut down and the bay 4 panel missing.

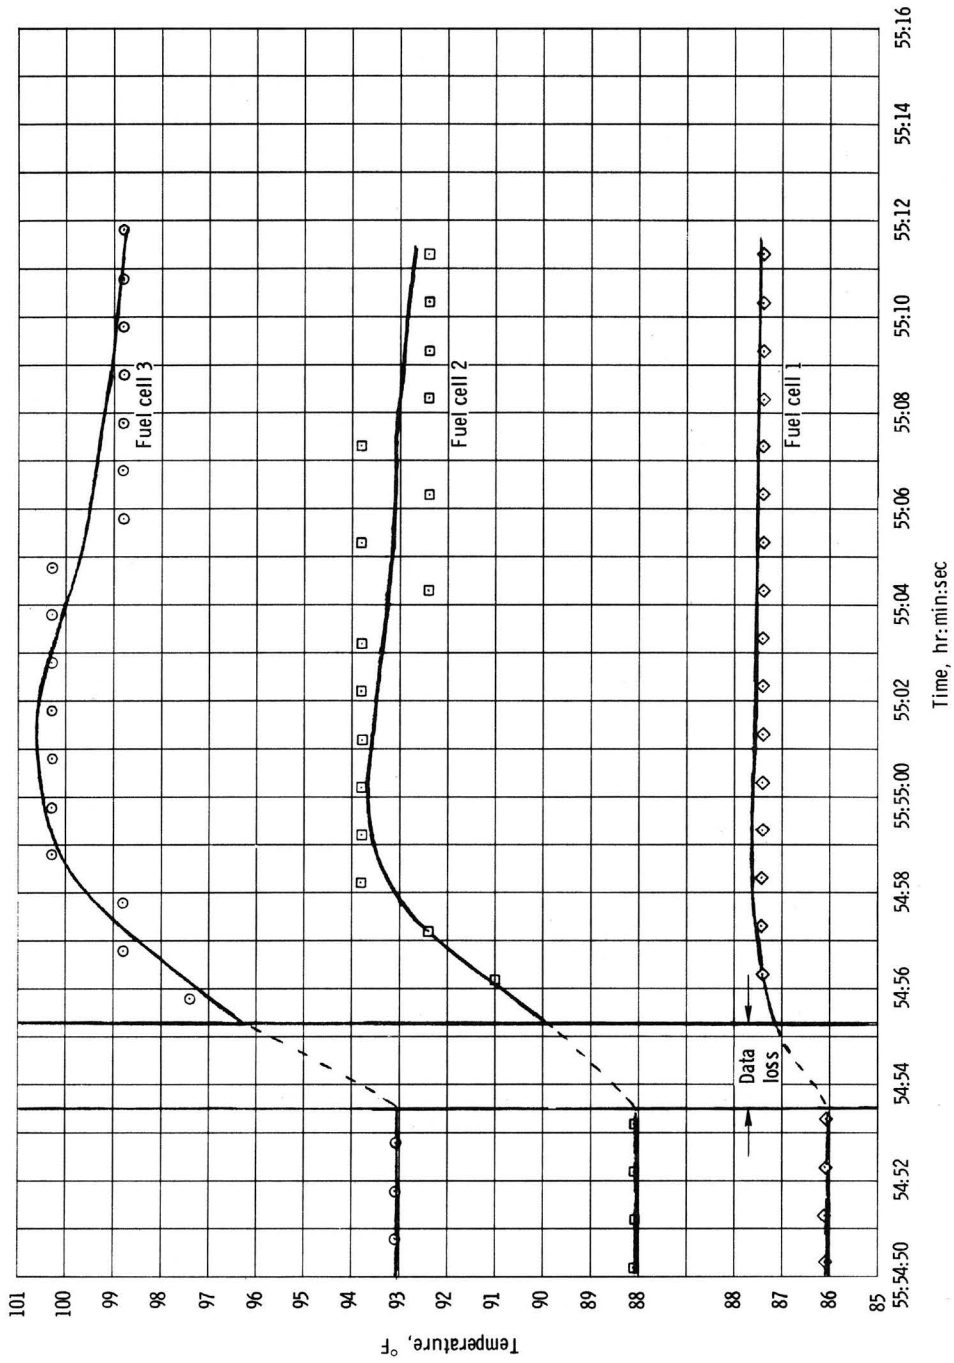
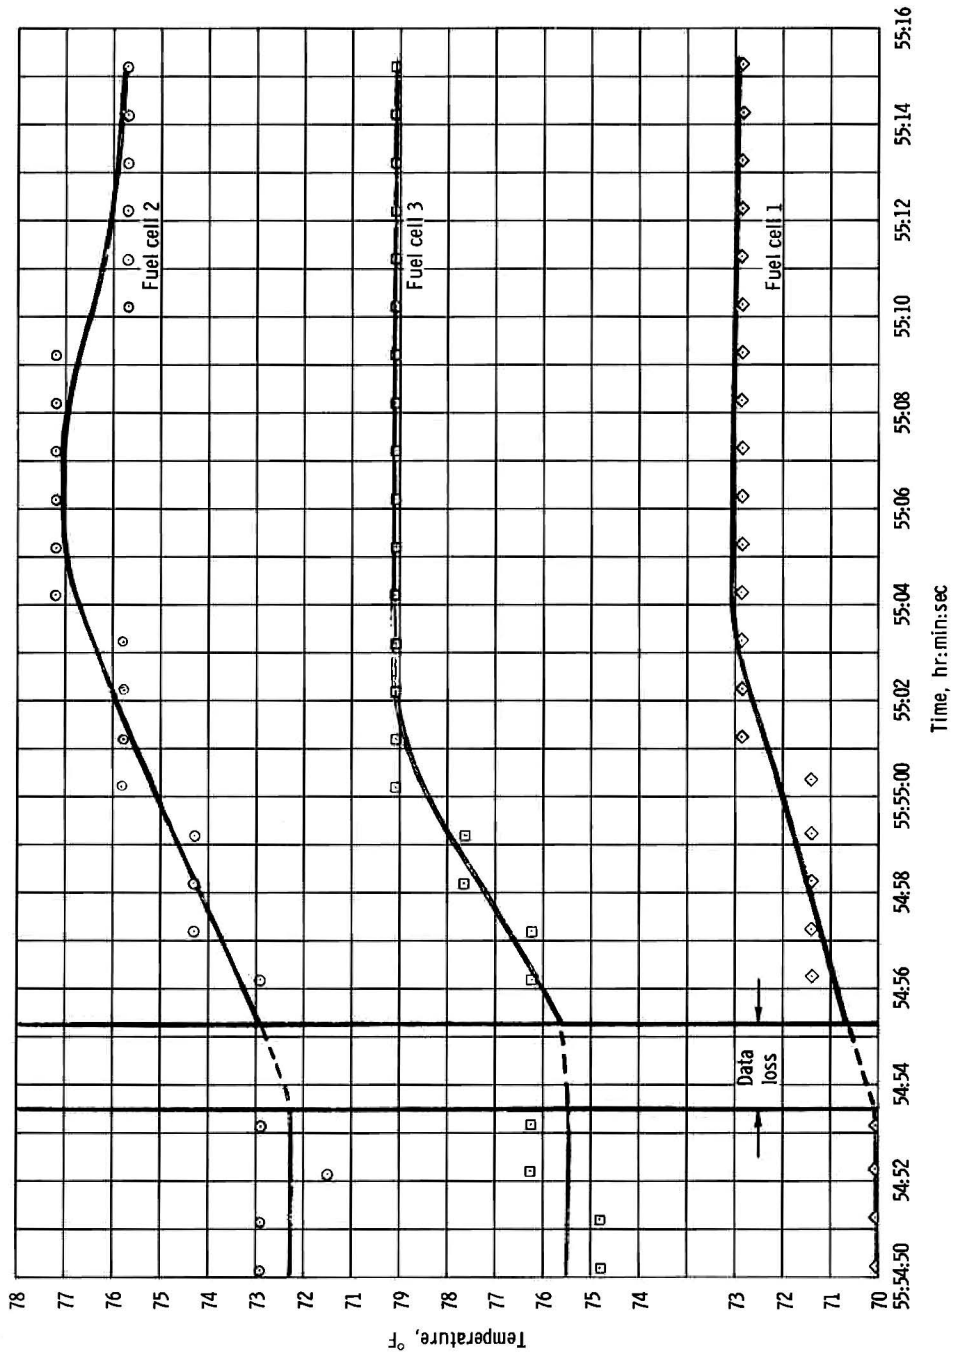
Figure 4-33. - Fuel cell glycol temperatures.

Although all fuel cell radiator glycol inlet and outlet temperatures showed perturbations, the fuel cell 3 radiator inlet temperatures exhibited the largest response. The temperature increased from 93.1° to 97.4° F in 3 seconds or less. This represents the highest response rate noted from any of the transducers at the time of the incident. The data for fuel cell 3 radiator inlet temperature, and for other transducers, are shown in figure 4-33. A correlation of these data has been performed and it is concluded that these transducers could have been exposed to a sudden change in temperature environment prior to the data loss. An extrapolation can be made which would support the response noted at the time of the heat pulse (fig. 4-33), but it would depend on the heat input function. Tests performed with the temperature sensor installed on the glycol line and with glycol flowing indicate that the heat pulse would lead the rise point by about 0.25 second. The rise point can reasonably be extended to any time during the data loss. Assuming the rise point started at the time of the data loss, then the heat pulse would have started at approximately the same time as the accelerometer disturbances, indicating that the high heating rate started before the bay 4 panel separated. The data indicate that the high-heating environment extended throughout bays 3 and 4.

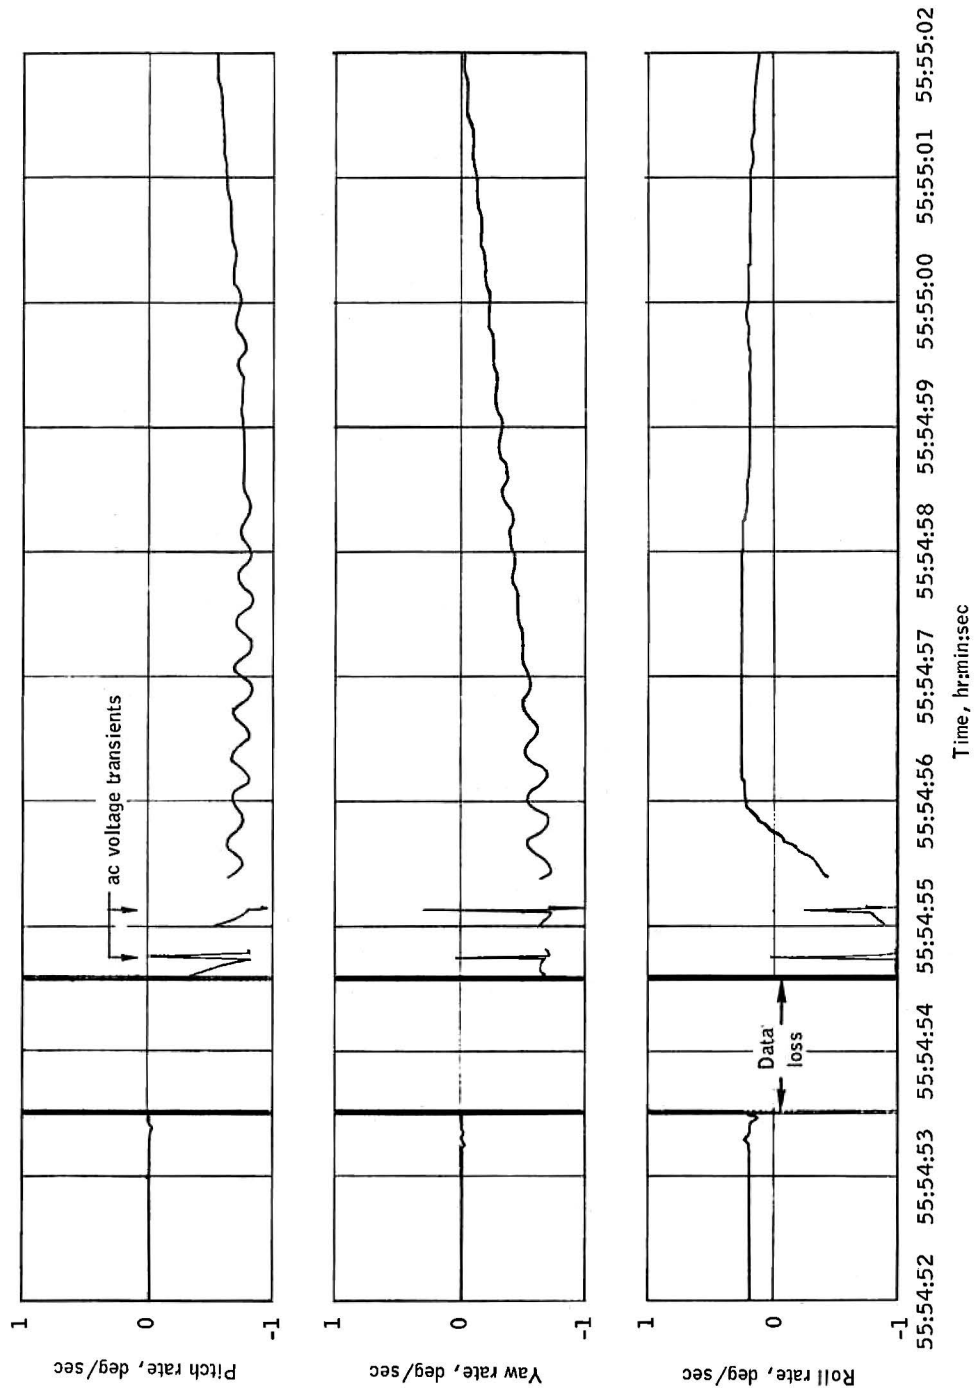
Figure 4-34.- Spacecraft dynamics during cryogenic oxygen tank 2 anomaly.

The stabilization and control system recorded the small body rate oscillations described in section 4.6, at 0.28 second before the loss of data. When data were regained, negative rates were present in all three axes (fig. 4-34). The oscillations shown in the pitch and yaw axes on the figure are predominantly due to excitation of the first bending mode (2.7 hertz). The reaction control engine firings which occurred following resumption of data were proper for the conditions that existed. The resulting angular accelerations in pitch and roll, however, indicate that only one thruster was acting in each axis and that quad C was inoperative. The total attitude change was small (fig. 4-35).

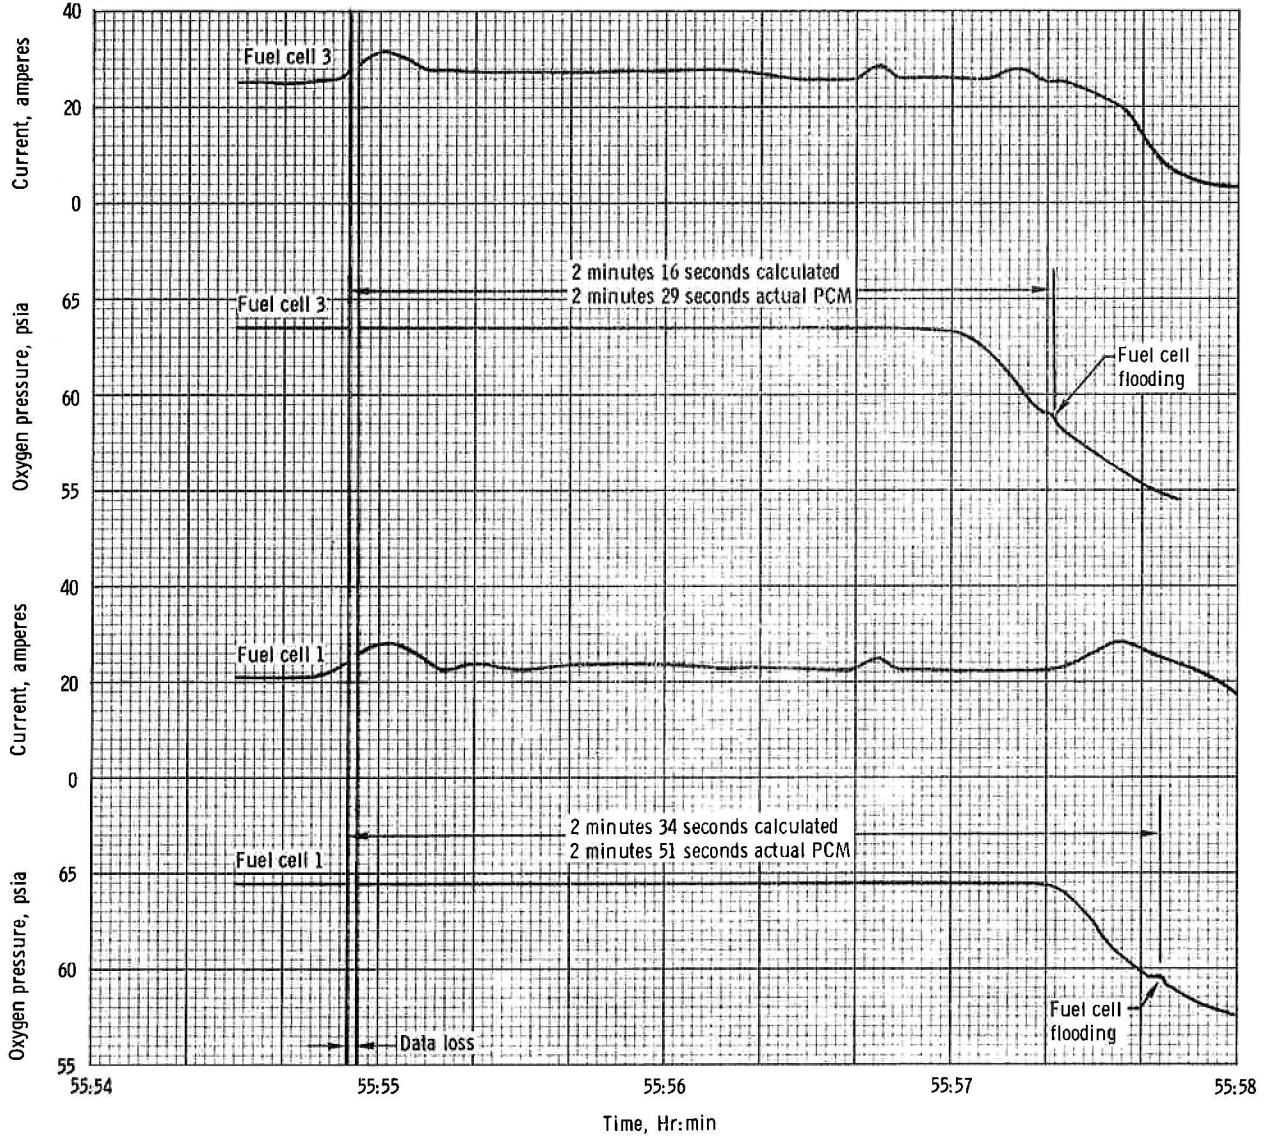
Figure 4-40. - Fuel cells 1 and 3 performance loss.

and the fuel cell oxygen regulators. This oxygen was sufficient for fuel cell operation for about 2.5 minutes, the time required to deplete the trapped supply. The agreement between the calculated and actual operating time after valve closure (fig. 4-40) verifies that fuel cells 1 and 3 were starved of oxygen and eventually could not support an electrical load.

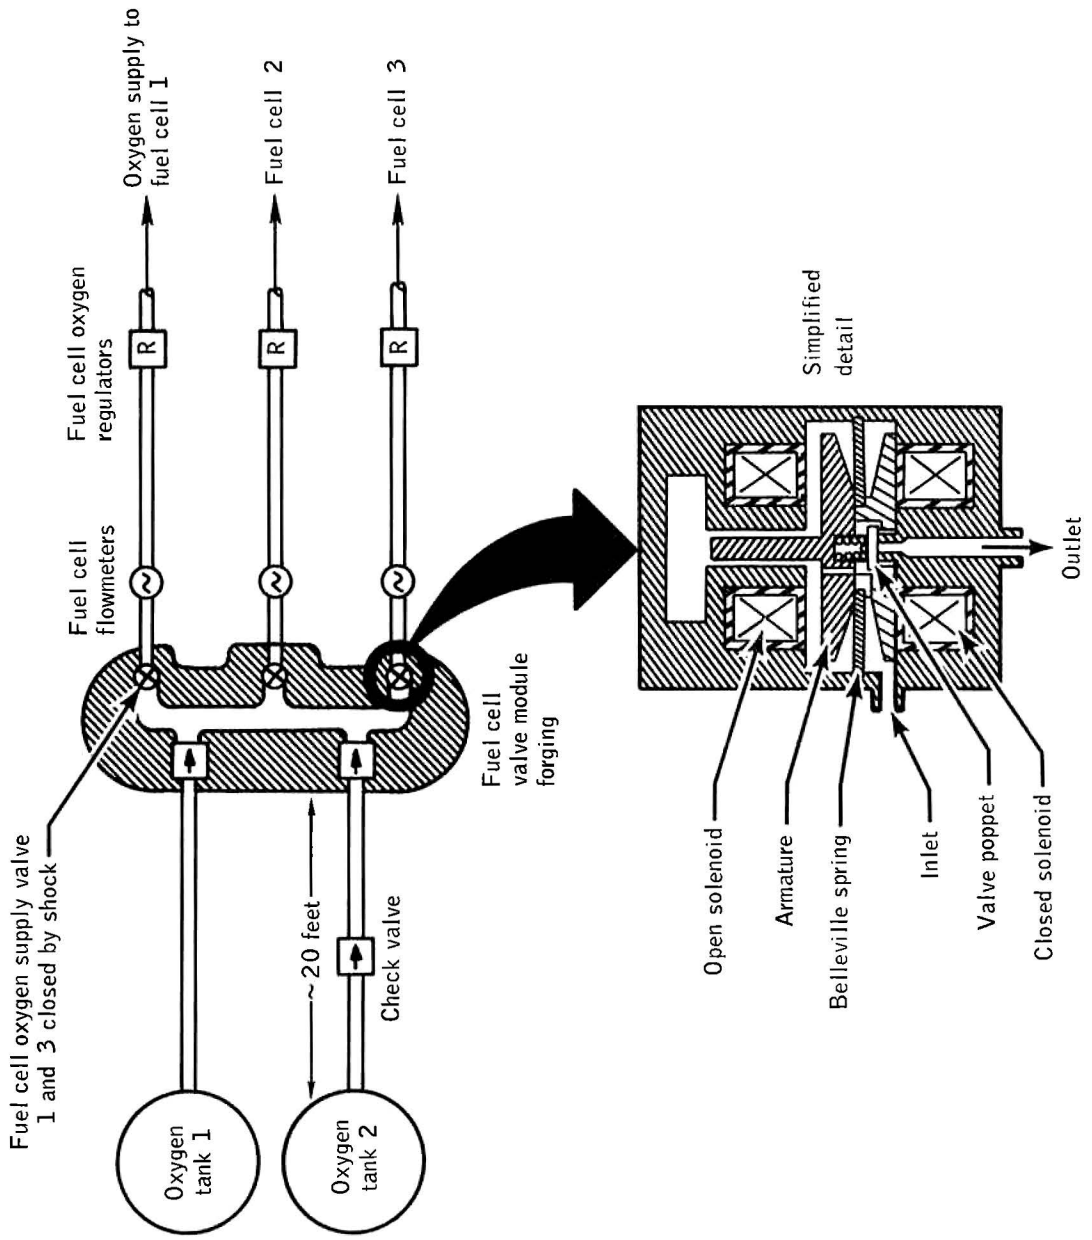
Figure 4-41.- Solenoid valves for oxygen supply.

Impact tests on the oxygen solenoid valves (fig. 4-41) show that a shock in excess of 86g for 11 milliseconds duration can be expected to cause valve closure under operating conditions.

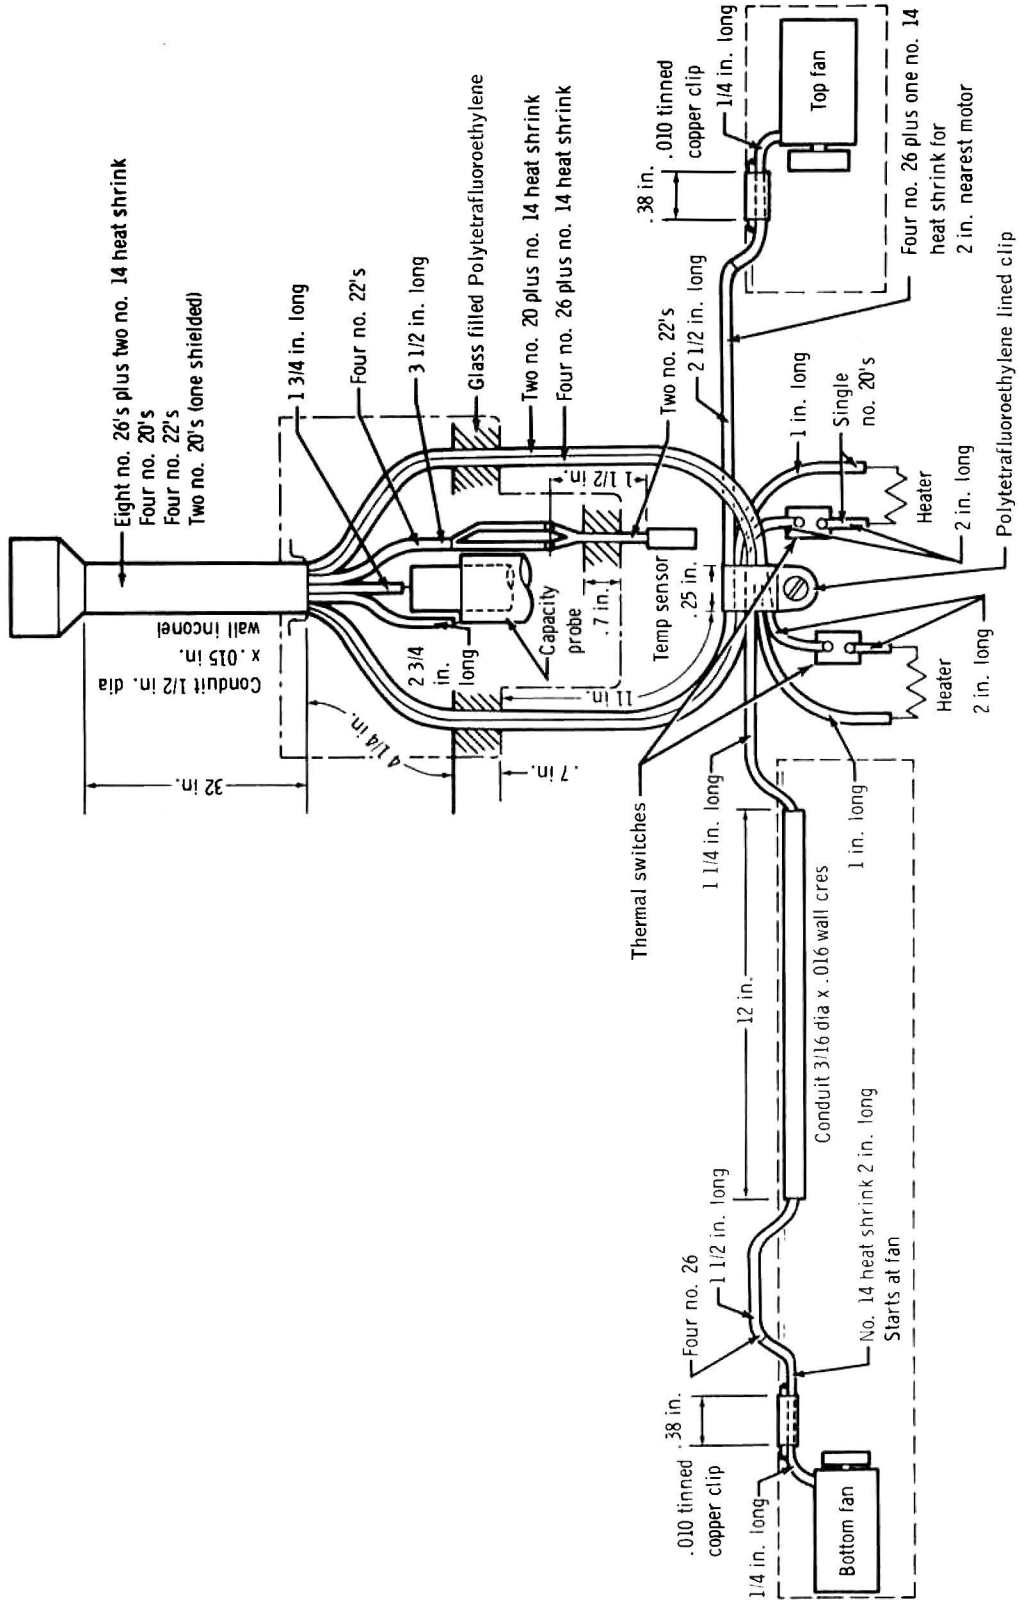
Figure 4-42.- Wiring distribution within cryogenic oxygen tank.

The fan wiring leads consist of two harnesses of four wires each for the two 3-phase fan motors. Wires (MIL-W-16878, type E) are 26-gage nickel and are coated with 0.010-inch polytetrafluoroethylene insulation. Also, each harness of four wires is covered in some regions with a polytetrafluoroethylene sleeve of approximately 0.012-inch thickness. Wire runs of the two fan harnesses are as indicated in figure 4-42 and are identical, except that the lower fan harness is routed through a tube in the heater assembly.

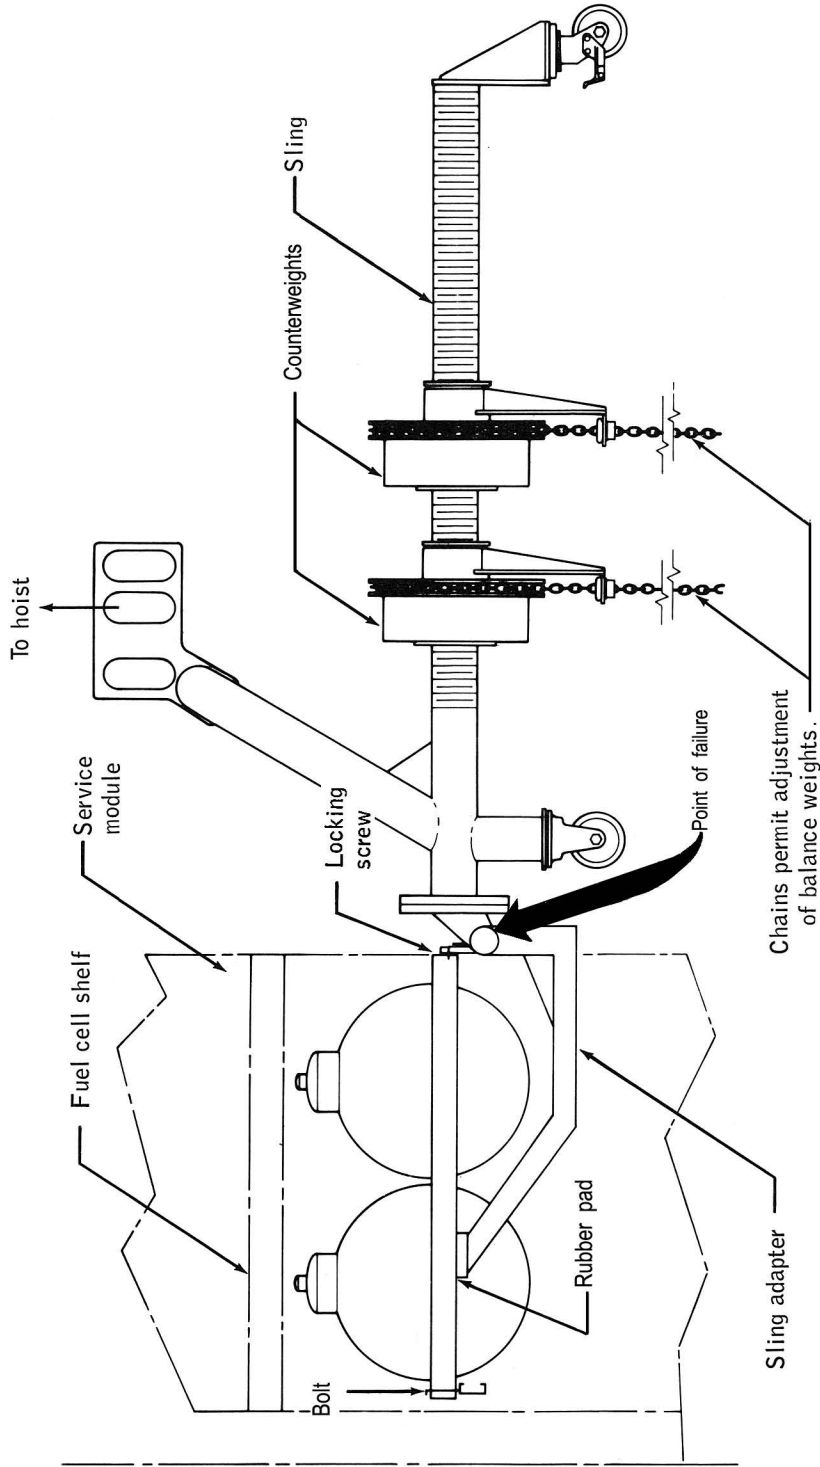
Figure 5-1.- Oxygen shelf and hoist assembly.

A detailed assessment was also made of the incident where the oxygen shelf hoist assembly failed during the factory removal of the tank shelf (fig. 5-1). Analysis and test show that the maximum shock upward would be about 7 g's, and the maximum shock downward would be about 15 g's. Analytically, the components within the tank would be expected to withstand 100 g's shock. Consequently, this condition is not believed to have contributed to the ultimate failure of the tank in flight.

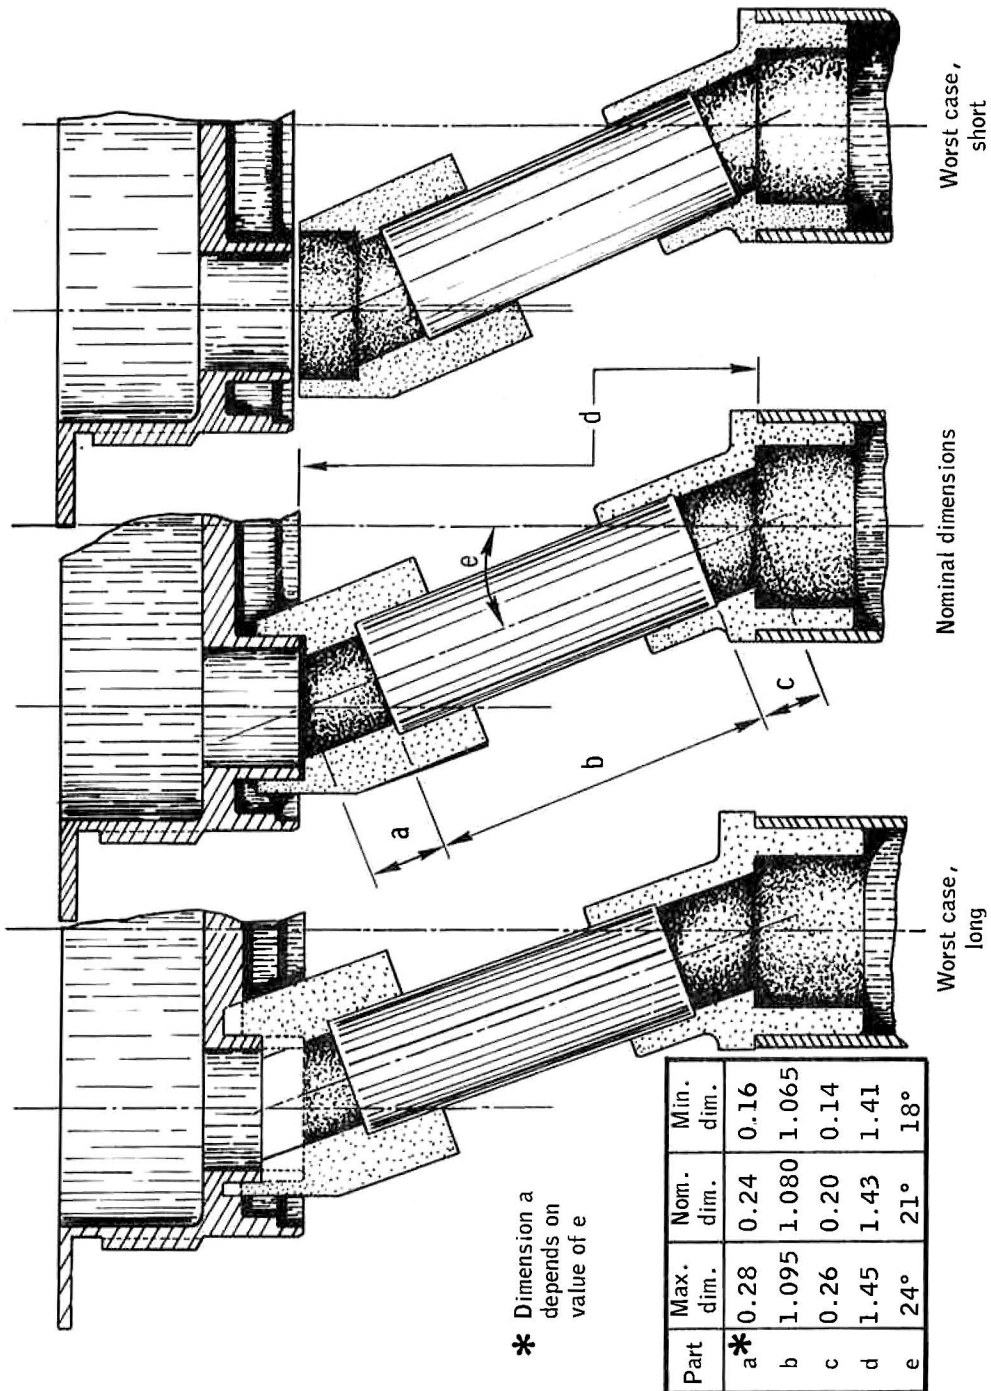
Figure 5-2.- Manufacturing tolerance study.

The cryogenic oxygen tank 2 could not be off loaded after the initial filling during the countdown demonstration test using the normal procedures. The problem resulted from loose or misaligned plumbing components in the dog-leg portion of the tank fill path (fig. 5-2). Allowable manufacturing tolerances are such that the tank may not be detanked normally under these conditions. A test has verified this fact. The condition of loose plumbing in the probe assembly, which existed in the tank before the detanking, was judged to be safe for flight in every aspect.
