MSC APOLLO 13 INVESTIGATION TEAM

SPACECRAFT INCIDENT INVESTIGATION

VOLUME I ANOMALY INVESTIGATION

FINAL REPORT

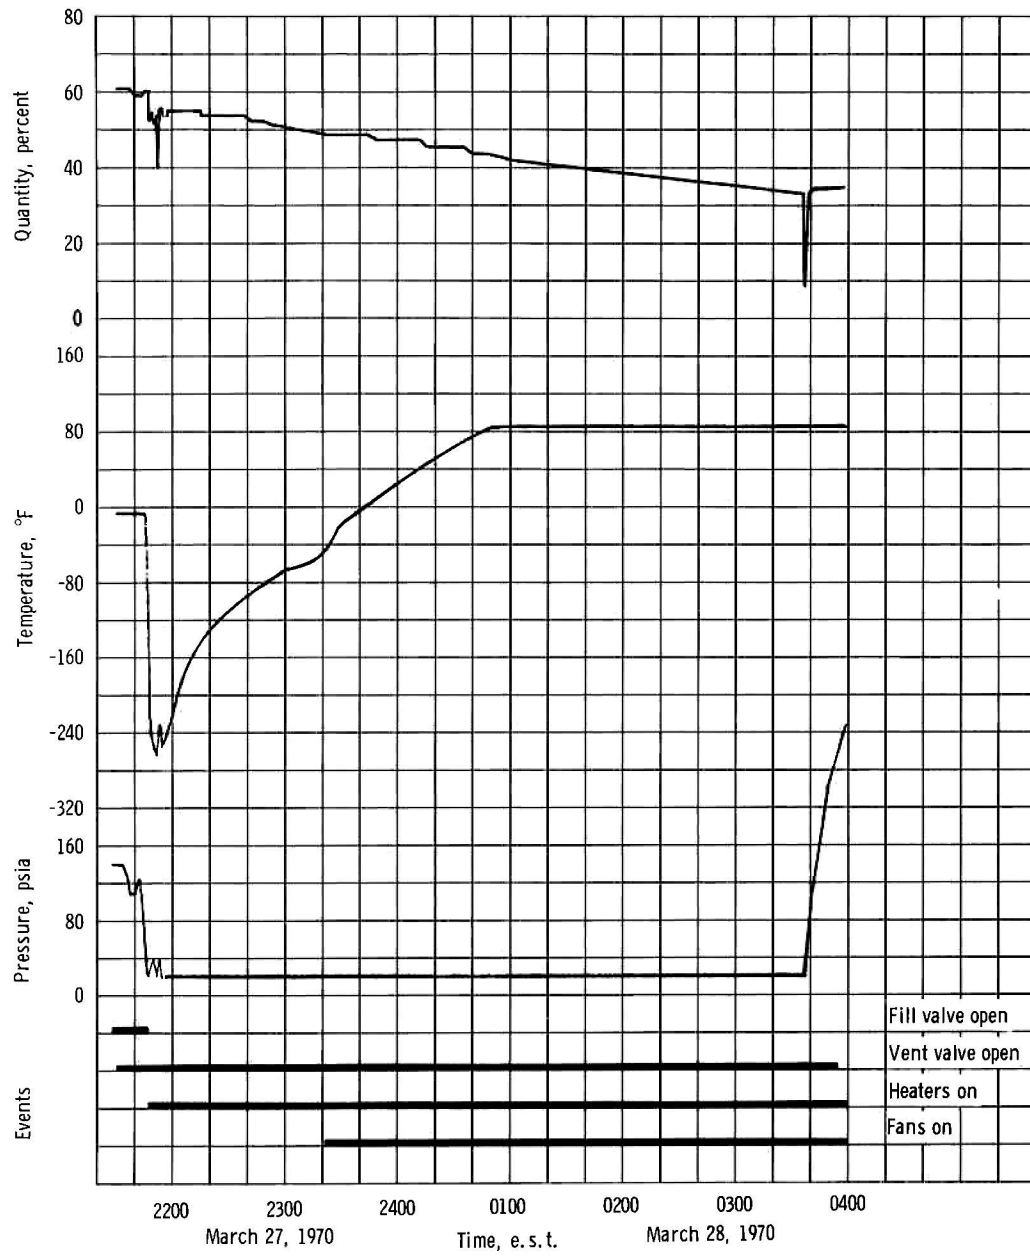
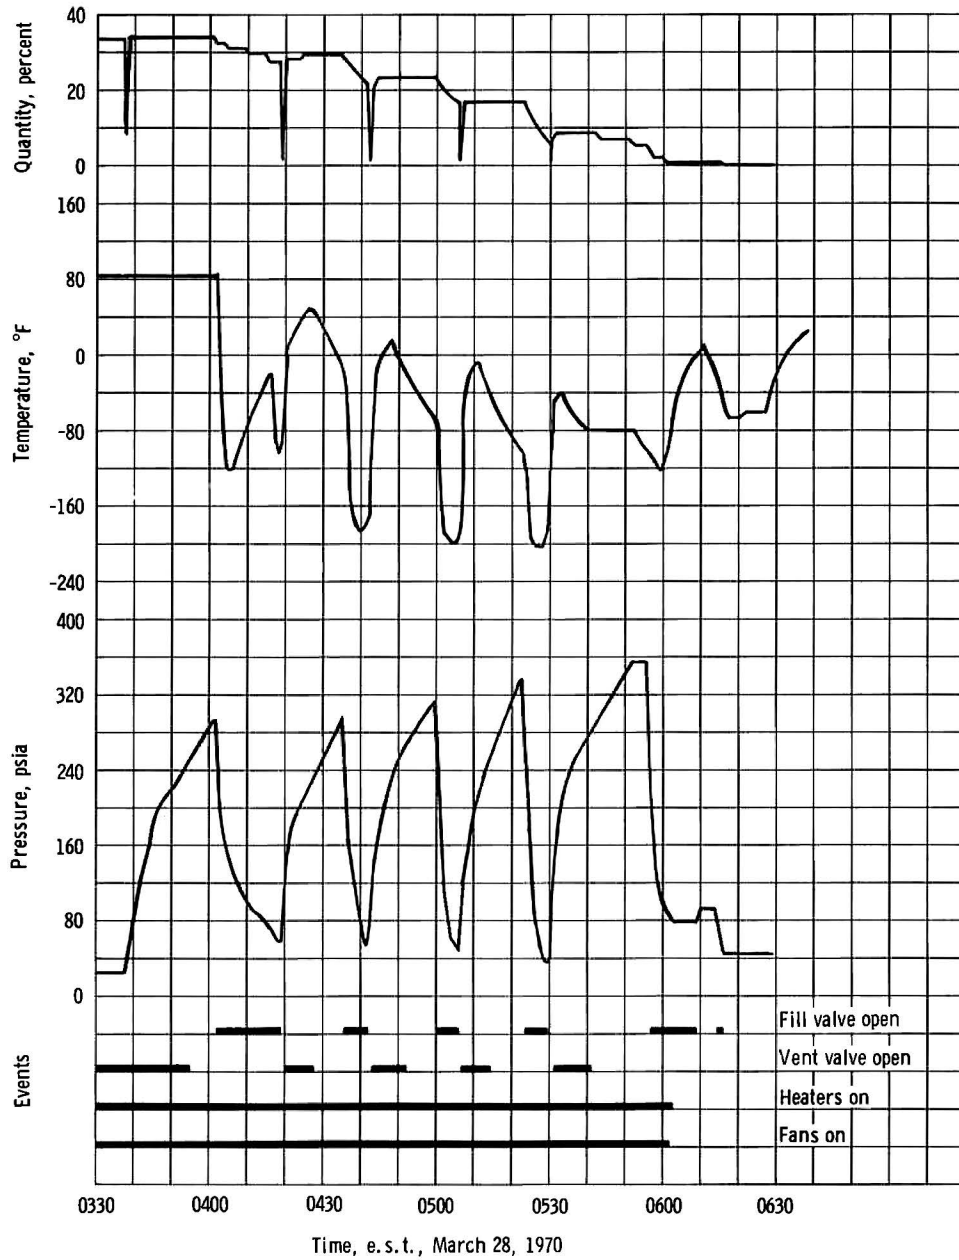
After numerous attempts with gaseous oxygen purges and higher expulsion pressures in an attempt to remove the fluid, the fluid was boiled off through the use of tank heaters and fans, assisted by pressure cycling. The sequence of detanking is shown in figures 5-3 and 5-4. The heater-on time was about 8 hours. It was thought that no damage would be sustained by the tank or its components because of the protection afforded by the internal thermal switches.

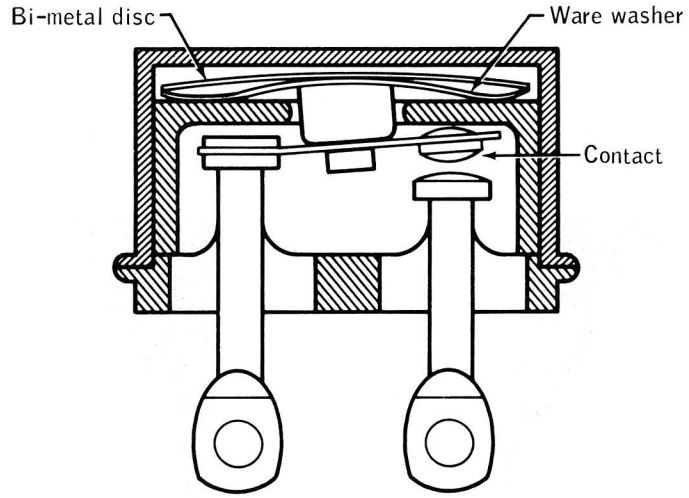
Figure 5-5.- Heater thermal switch.

The thermal switches, which normally open at about 80° F, show no sign of operation from the heater voltage data. Inflight, these switches have not operated due to the temperatures in the tank. Further, the switches in the past have not operated under a load on the ground, and they were not designed or tested for this condition.

In the case of Apollo 13, the use of the heaters to assist in detanking required the switches to open under load. This is the first time the switches were operated with 65 V dc and 6 amperes which is twice the normal flight operating conditions for each heater. Tests show that opening the switches under these ground power conditions will fuse the contacts closed at the instant of power interruption (fig. 5-5). Tests have verified that when the heaters are on for the duration experienced during pre-launch operations (approximately 8 hours), the fan motor wire insulation is severely degraded (fig. 4-43).

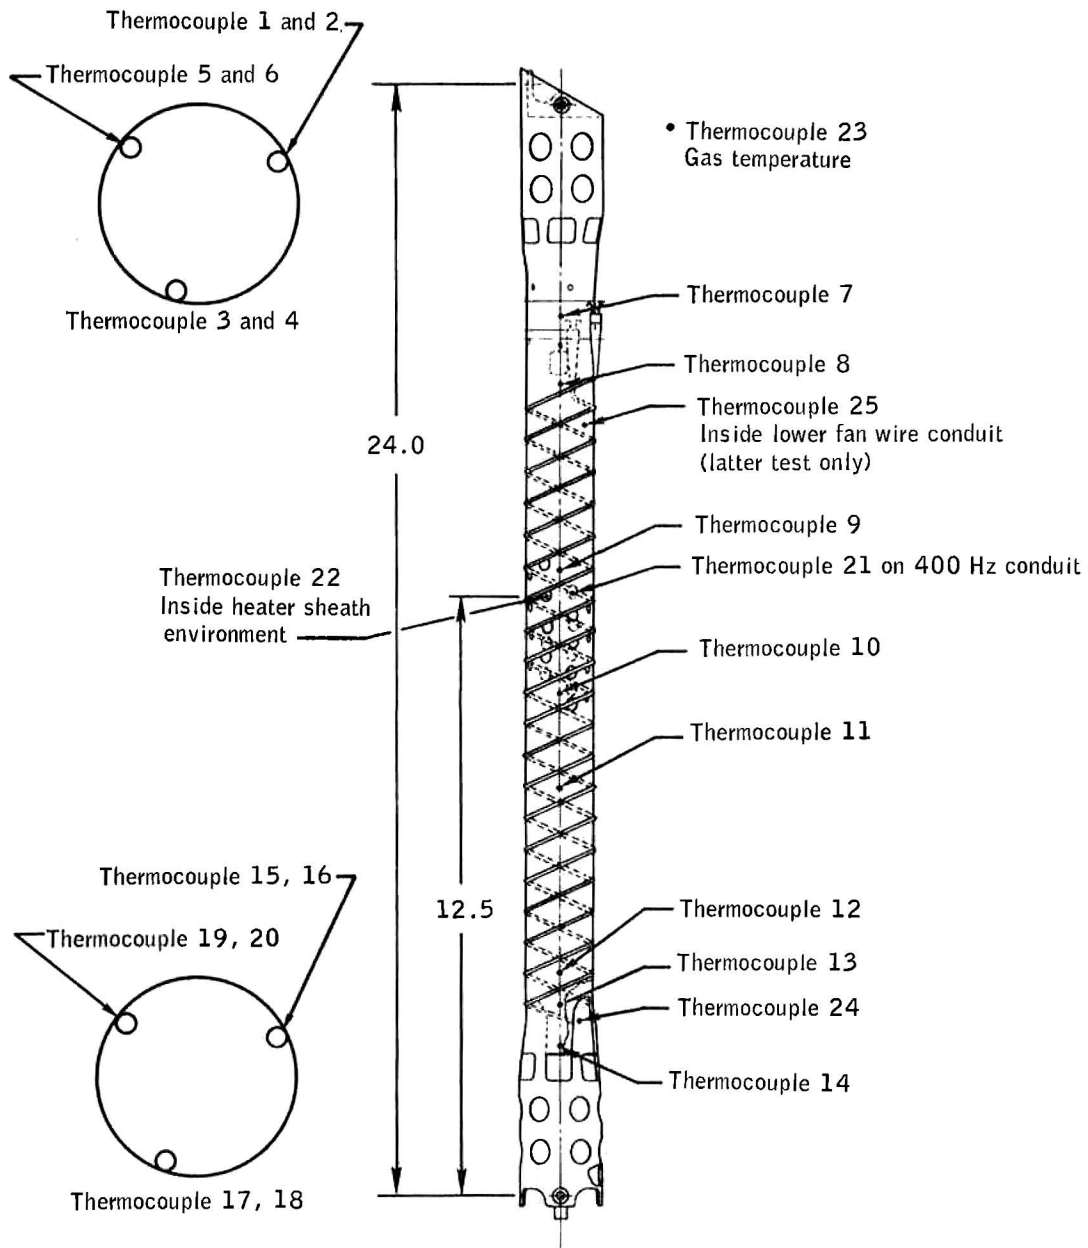
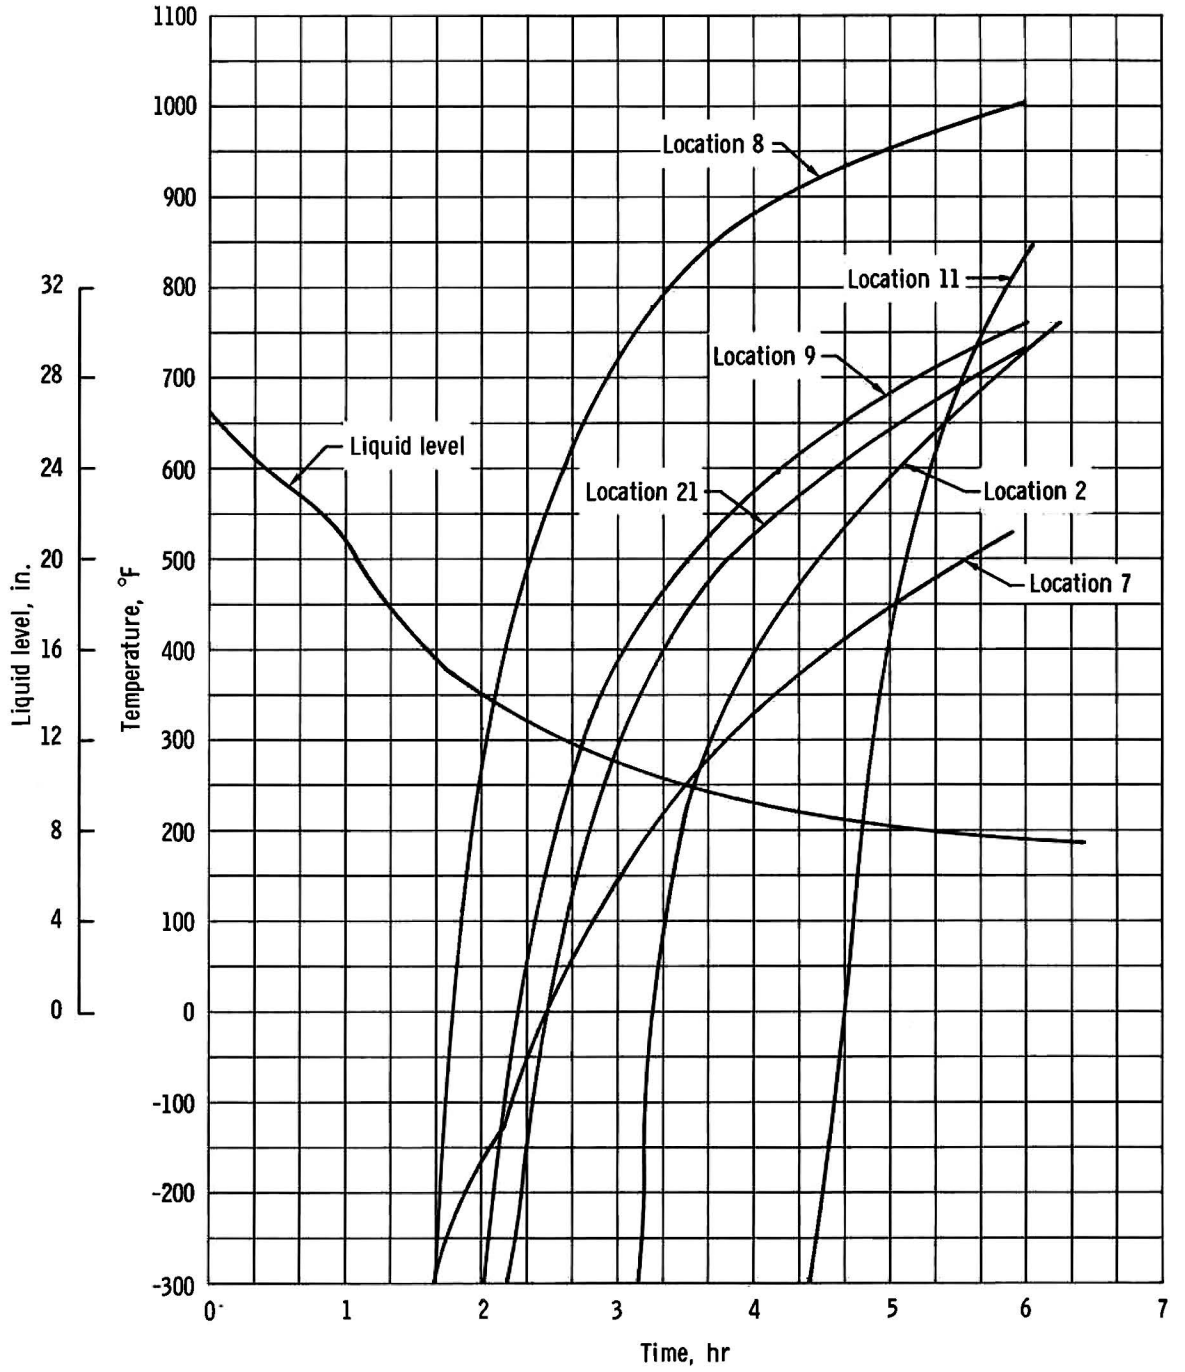
Wiring can be damaged within a couple of hours, with the heaters being "on" continuously as evidenced by the temperature on the heater assembly (figs. 5-6 and 5-7).
