MSC APOLLO 13 INVESTIGATION TEAM

SPACECRAFT INCIDENT INVESTIGATION

VOLUME II MANUFACTURING AND TEST HISTORY OF OXYGEN TANK

FINAL REPORT

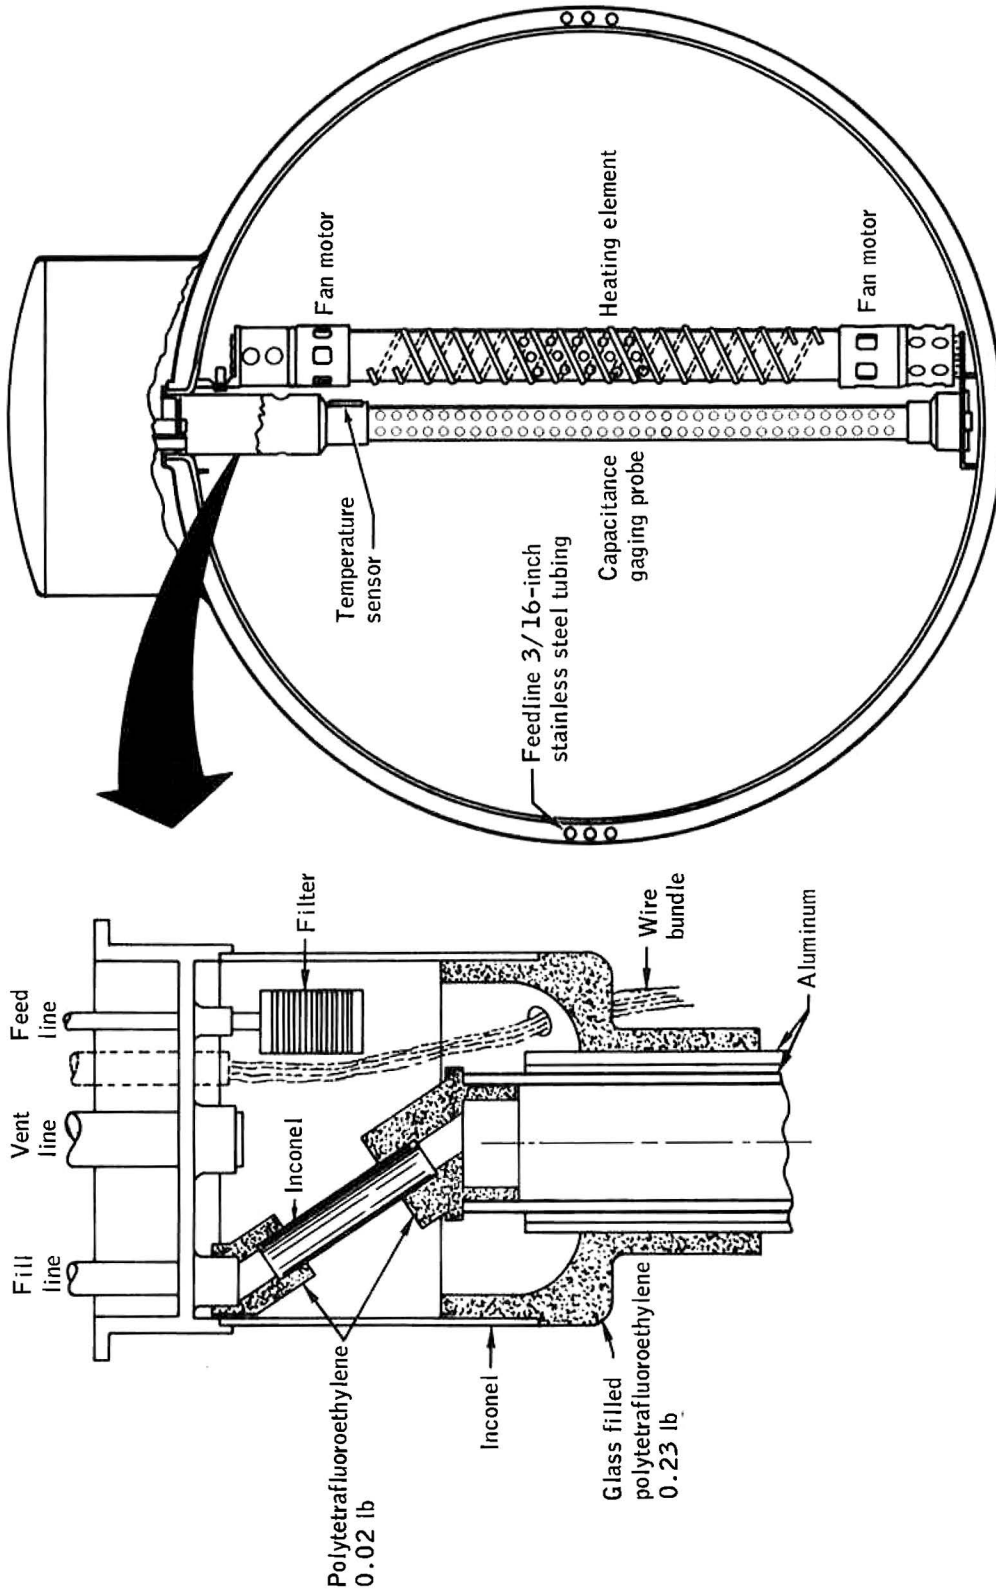
Figure 3-1. - Arrangement of components within oxygen tank.

In general, liquid oxygen tank 2 could not be off loaded after its initial filling during countdown demonstration test. The problem was assumed to be due to missing or broken pieces, or to a tolerance buildup under cryogenic conditions, within the dog leg portion of the tank fill path (reference Figure 3-1).

The effect of this damage on the tank in-flight performance was judged to be inconsequential since all other aspects of tank performance were nominal. In addition, the available energy was determined to be minimal both from small Teflon particle fan impeller impacting and from probe plate-to-plate shorting by the inconel tube.

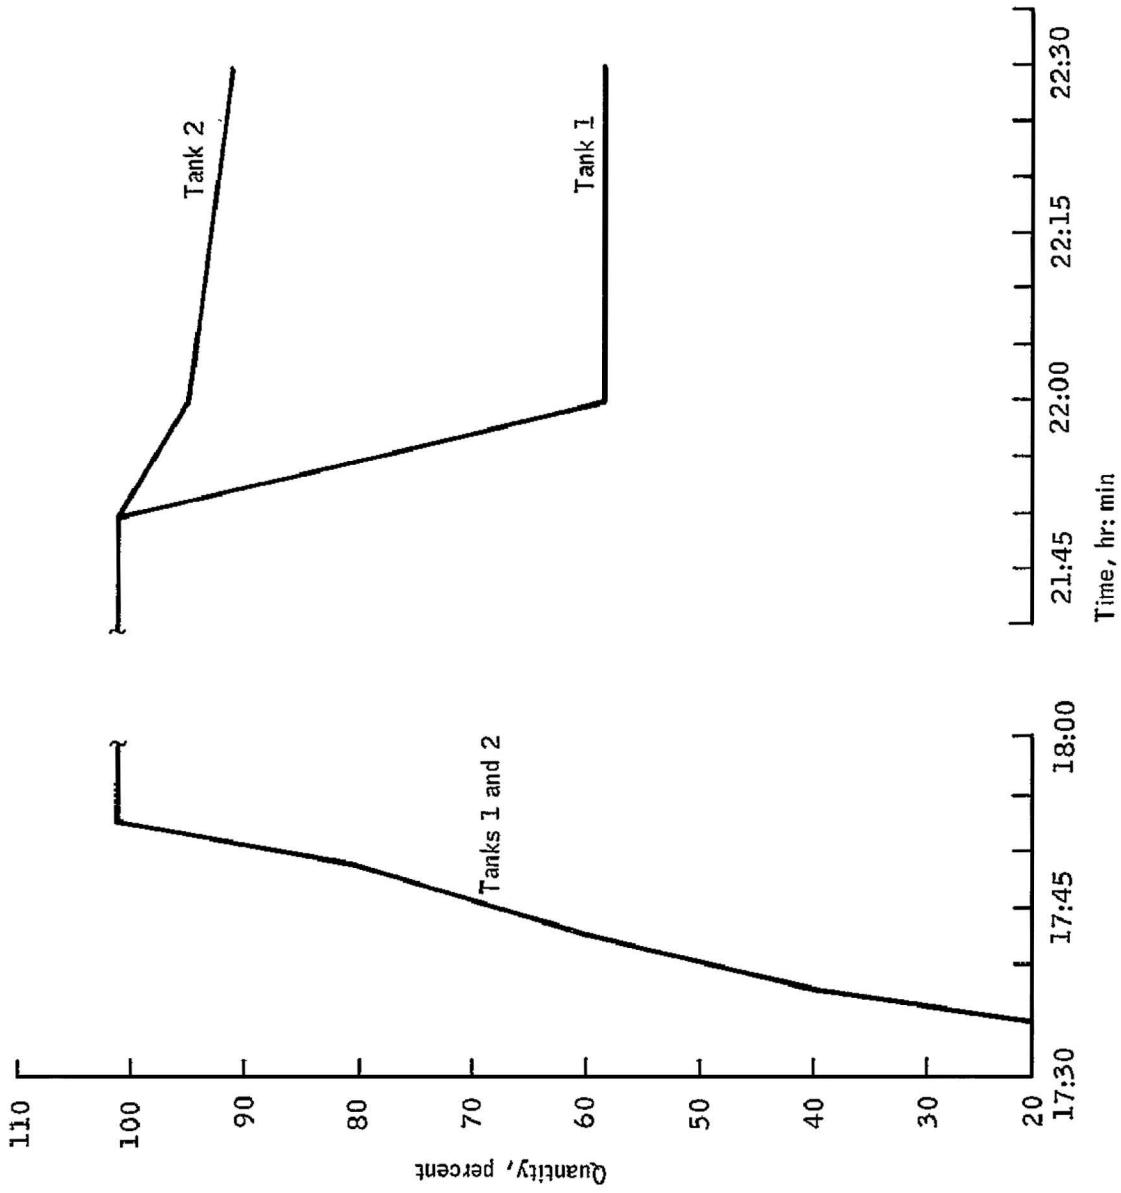
Figure 3-7.- Oxygen tank 2 quantity adjust (CDDT).

In the ten-minute period required by tank no. 1, the quantity in tank no. 2 had decreased to only 96% (fig. 3-7). Several cycles were attempted to insure no stuck valves.

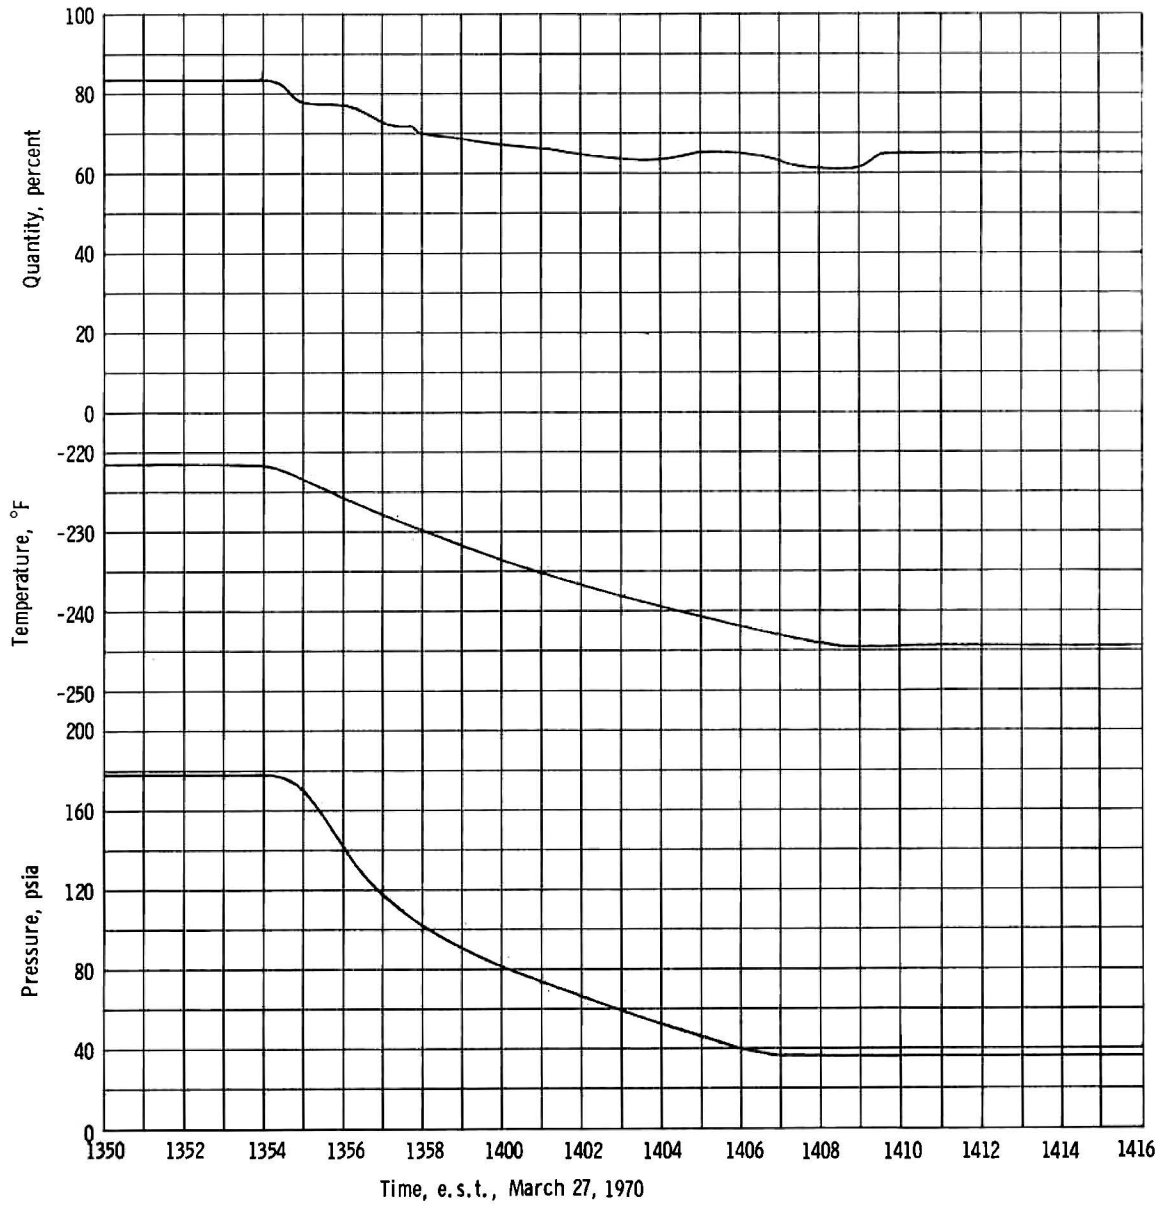
Figure 3-8. - Oxygen tank 2 detanking characteristics (pressure decay through the fill line - CDDT).

By 2 PM EST, the MSS had been returned to position on the launch pad (it was moved to the park site for CDDT T-0) and the cryogenic tank fill and vent lines connected. With Downey personnel monitoring from their mission operations room via the operational intercom system (OIS), the tank at 178 psia was vented through its fill line (fig. 3-8). Onboard quantity decreased from 84% to 65%. Pad personnel viewing the vent outlet on the MSS did not see white vapor unusually present when liquid oxygen is expelled. Further troubleshooting was delayed until the normal post CDDT GSE purge could be completed.

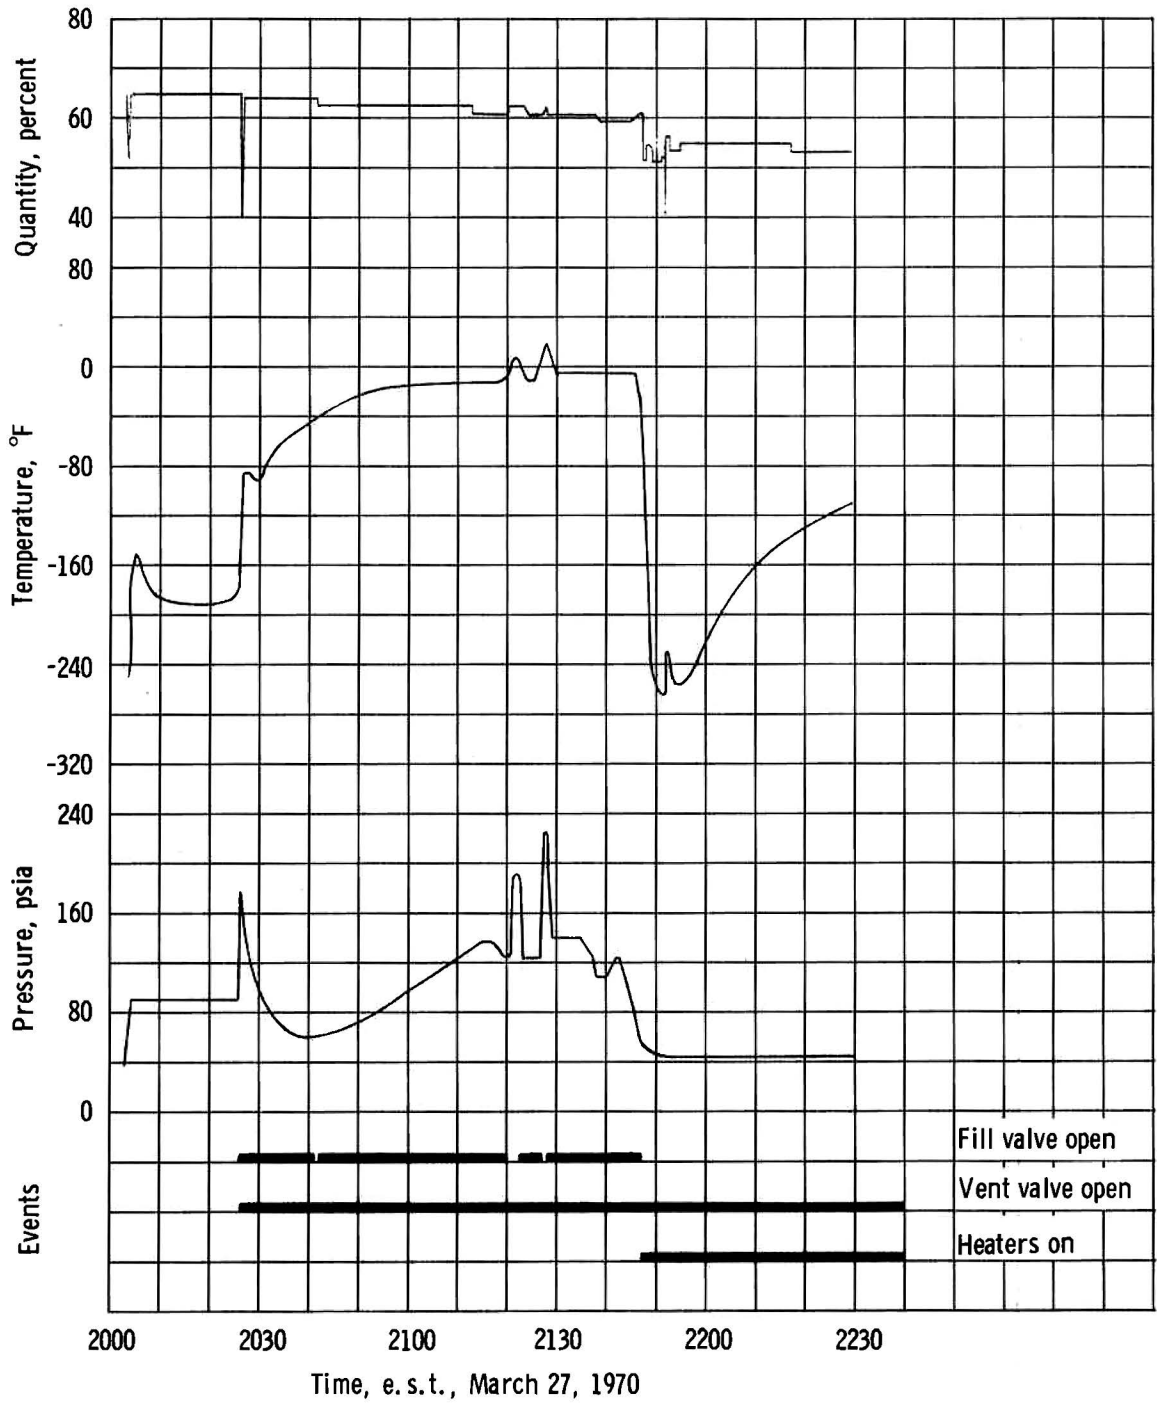
Figure 3-9. - Characteristics of oxygen tank 2 detanking using GSE pressure (CDDT).

First, the GSE regulator controlling the vent line pressure was adjusted to its detanking set point. Pressure in tank no. 2, at approximately 36 psia, increased to 90 psia (fig. 3-9) due to back flow through OV2, while tank no. 1 with 250 psia left over from CDDT remained stable. At 20:25:42 OF1 and OF2 were opened. Tank no. 1 began to empty while tank no. 2 received the inflow from the higher manifold pressure. Twenty seconds later OV1 and OV2 were opened and both tanks equalized while tank no. 1 continued dumping. Seven minutes later, tank no. 1 was empty and an 8 minute GOX purge was begun. Blowing through both tanks, the vent line pressure stabilized at 75 psia.

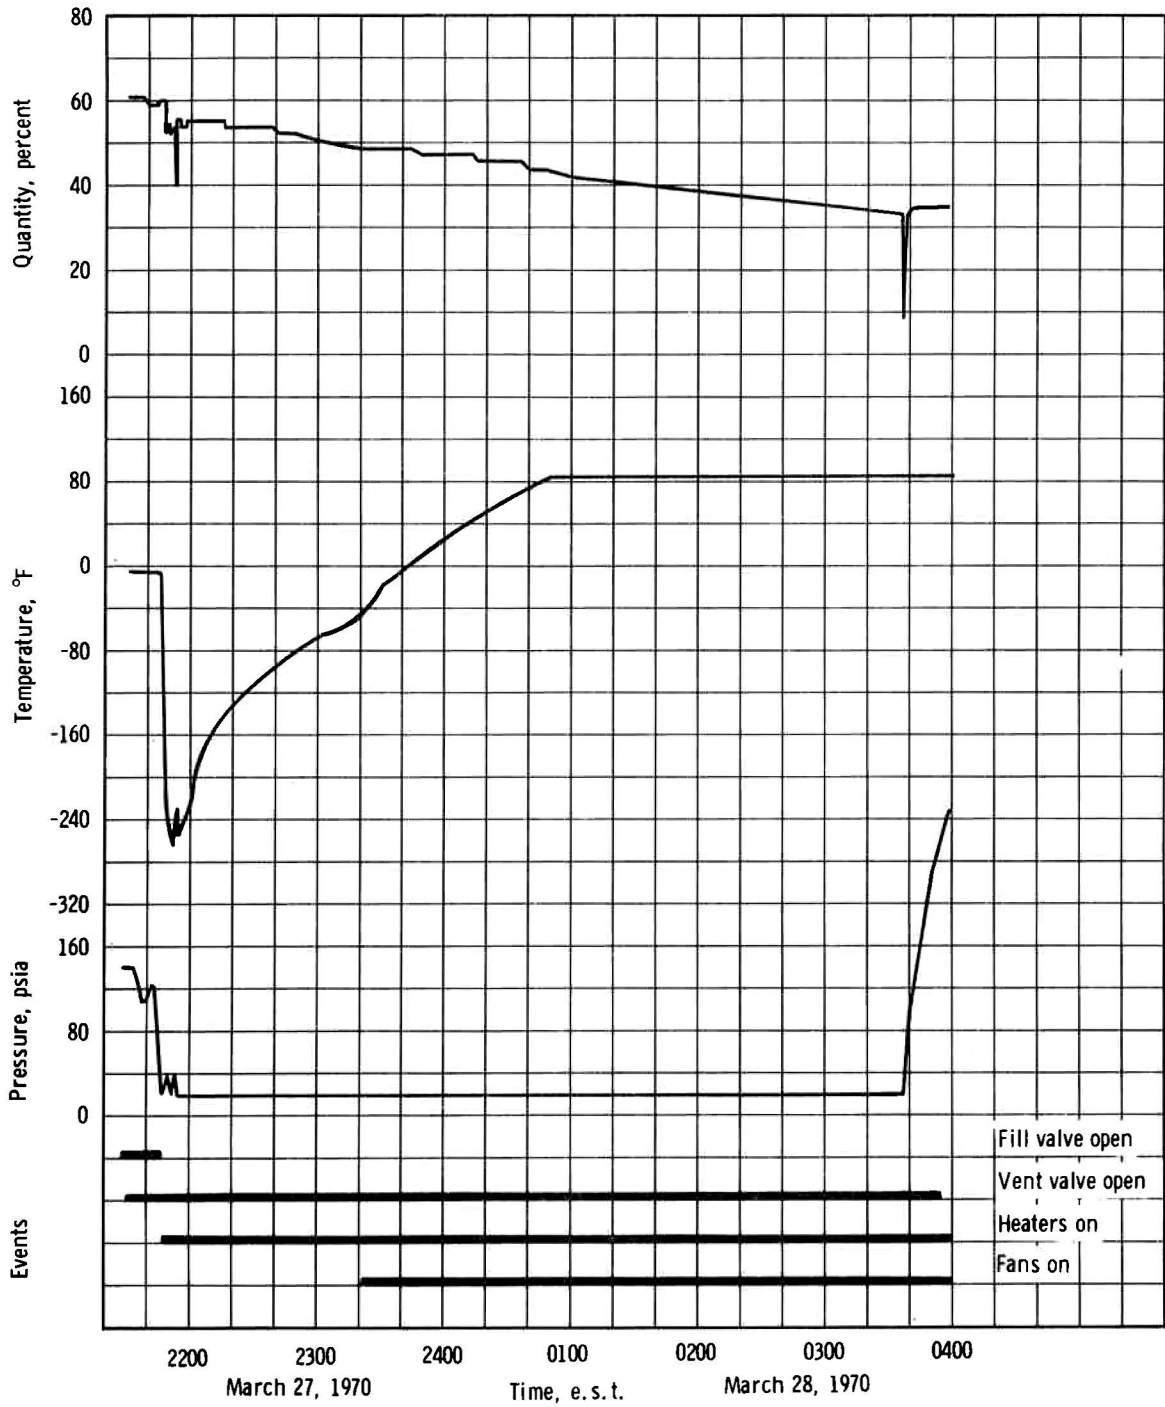
Figure 3-10.- Characteristics of oxygen tank 2 detanking using fans and heaters (CDDT).

At Houston, the Acting MSC Subsystem Manager had been established as a communications point for the MSC MGR Apollo Spacecraft Program Office, and called the KSC NASA engineer on duty in the control room. He was informed of the lack of progress and given the heater on times and currents. He then suggested that the fans be utilized to add more heat and mixing. This was accomplished by 23:20 (fig. 3-10), and by 00:55 the tank temperature had reached upper limits (84° F).

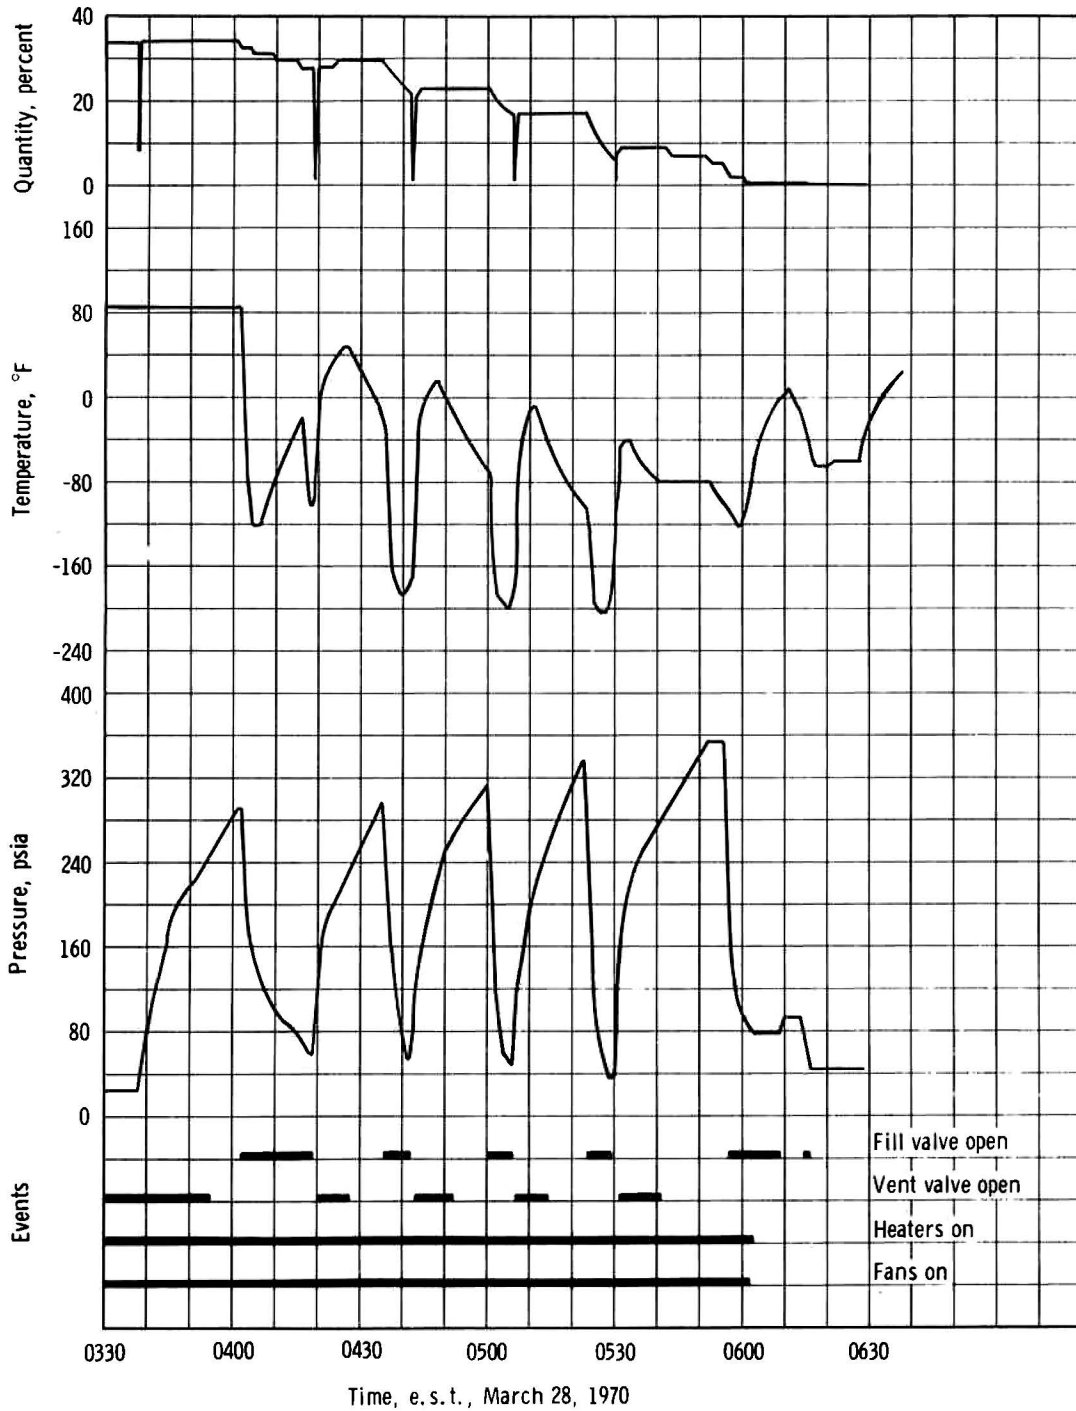
Figure 3-11.- Characteristics of oxygen tank 2 detanking using fans, heaters, and GSE pressure (CDDT).

7% (from 35% to 28%). The results were considered excellent and the tank was emptied with four additional cycles. Tank behavior and valve cycles can be found in figure 3-11.

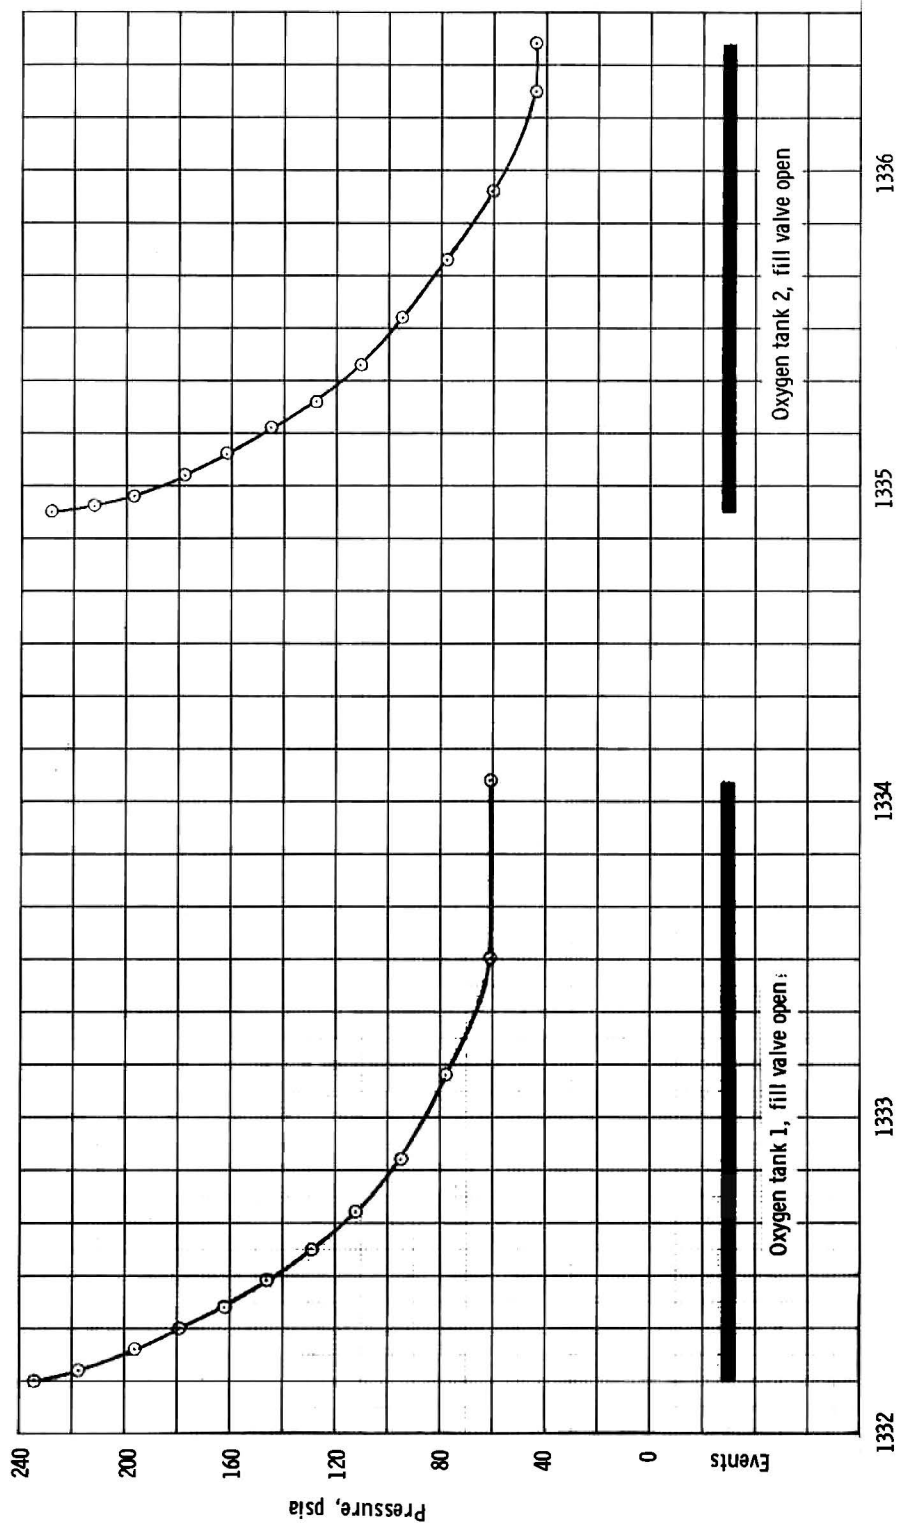
At 13:30 both tanks were pressurized to approximately 250 psia and vented through the fill lines (tank no. 1 and then tank no. 2). With the exception of an apparent leak from tank no. 2 vent POD that caused a slight increase in tank no. 1 final pressure (this POD was capped for launch to stop the leak) both curves were essentially identical (fig. 3-12). Tank no. 1 dropped 135 psi, in 40 seconds while tank no. 2 dropped 140 psi, indicating no permanent line restrictions.

Figure 3-12. - Gaseous oxygen blowdown test, spacecraft 109.

From figure 3-12, the blowdown test conducted at Kennedy Spacecraft Center, and using the tank volume with the measured pressures, the flow rate and media density at the time were 0.09 lbs/sec and 1.1 lbs/ft³. During the venting period discussed above, the flow rate was 0.07 lbs/sec. Since velocity is a function of pressure, and since pressure is controlled by friction line losses, then velocity becomes a function of viscosity and flow rates. The viscosity of oxygen does not change appreciably with temperature, and since the flow rates were approximately equal, it then follows that the velocities in both cases were approximately equal.

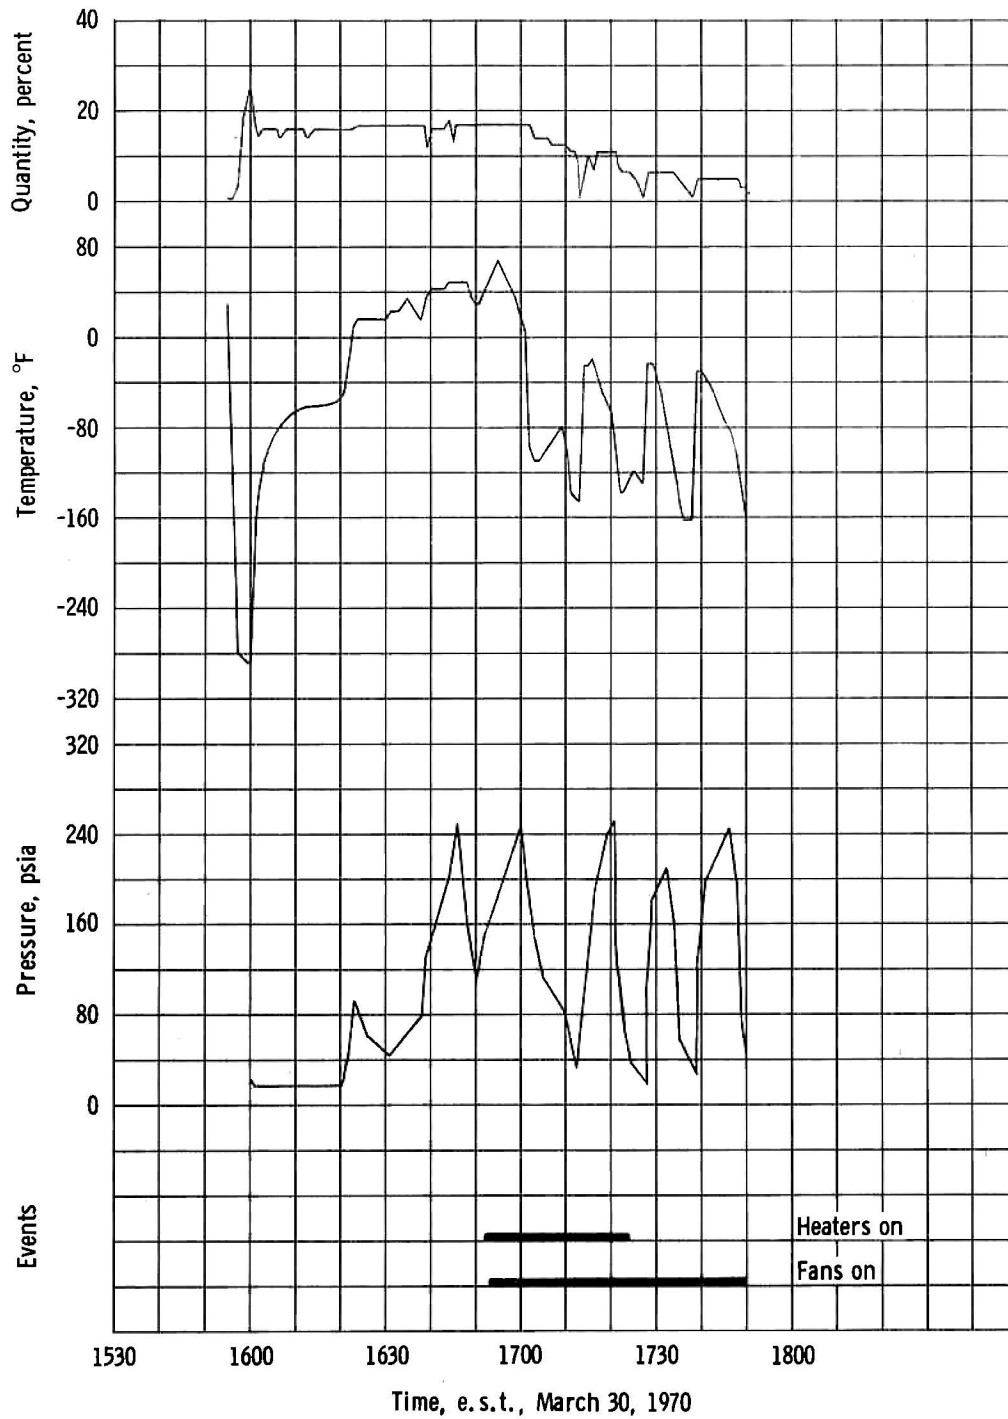
At 15:50, O₂ tank no. 2 was successfully filled to 17% with liquid oxygen. Detanking was accomplished over the next two hours (fig. 3-13) with five pressure cycles. Heaters remained on for approximately 32 minutes.

Figure 3-13. - Characteristics of oxygen tank 2 detanking using fans, heaters, and GSE pressure (post CDDT).

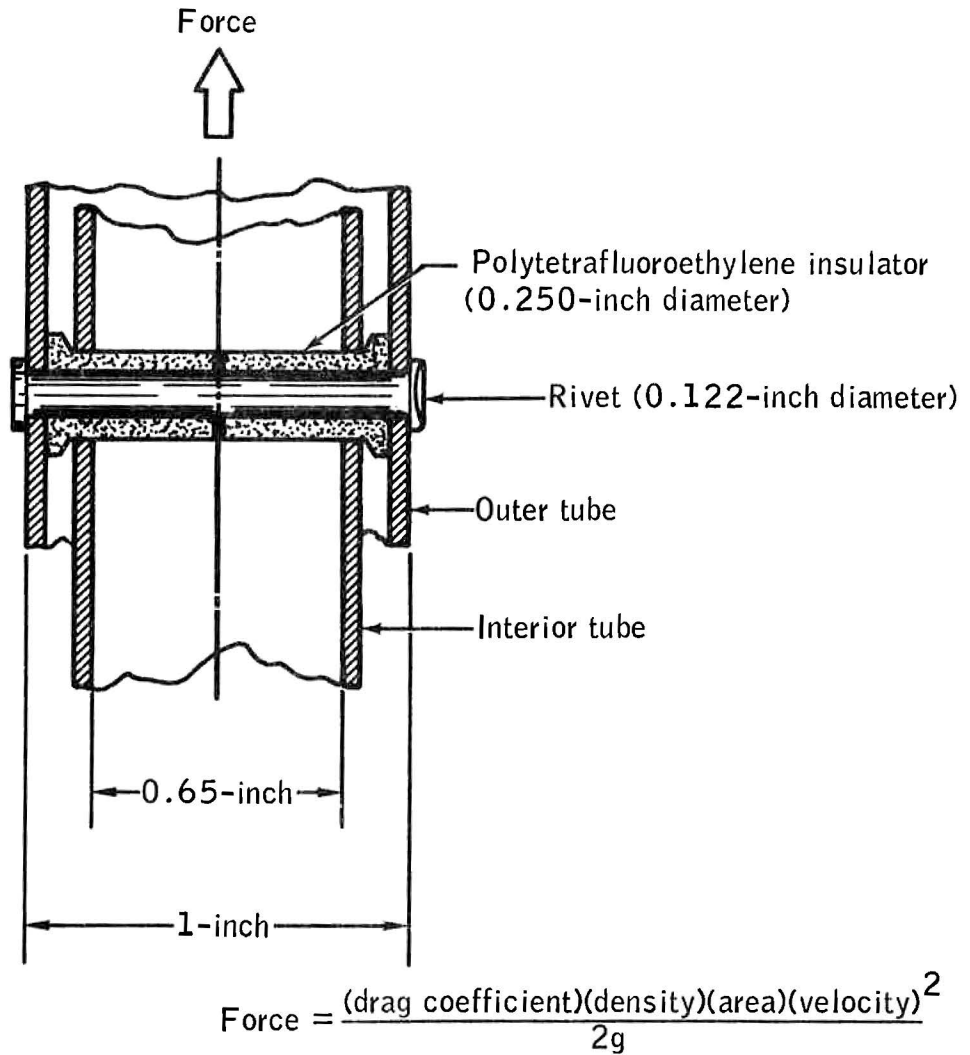
Fluid Dynamics Effects.- The damage potential of high velocity fluid was investigated with regard to the internal parts of the density probe (the center supporting rivet was established as the weakest element) and also with regard to its effect on the upper dog-leg assembly. The rivet failure point was established by static load test.

Assuming liquid flow, the maximum pressure differential used, and assuming no significant velocity in the tank bulk fluid, then, for the configuration shown in figure 3-16, the velocity will be 238 ft/sec. Computing a Reynolds number to establish a drag coefficient of 1.2, the force on the rivet can be calculated to be 63.0 pounds.

Figure 3-16.- Density probe cross section showing fluid force on the rivet.

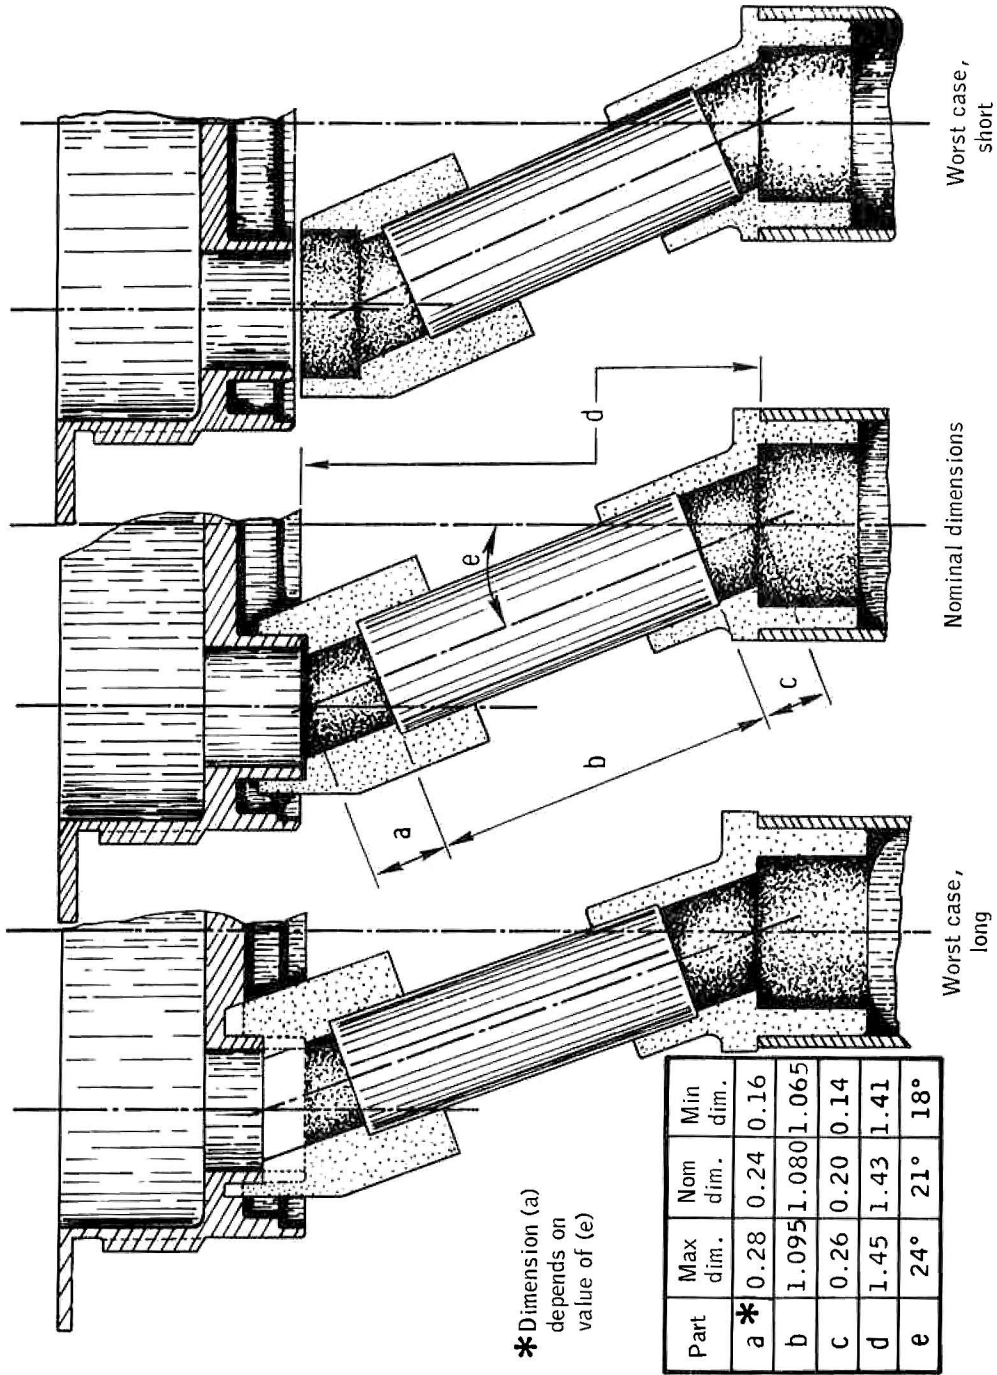
Torque on Probe Dog-Leg.- This analysis shows that the normal fluid-produced torque on the probe dog-leg assembly would be sufficient to dislodge it under the correct manufacturing tolerance conditions (fig. 3-17).

Assuming the maximum pressure differential that would occur during normal detanking (as the fluid interface rises to contact the first bend) (fig. 3-18) and with no velocity in the tank bulk fluid, then the stand pipe velocity is calculated to be 139 ft/sec. Equating the upward force to the sum of the momentum force and the pressure force, F_u is calculated to be 58.0 pounds, with the moment 32.4 in-lbs. Utilizing measured flow rates during a normal detanking, the moment can be reduced to 5.3 in-lbs. This is still adequate to produce motion. Detanking tests at Beech Aircraft have shown that fluid will be expelled in the worst case short (fig. 3-17) only if the assembly is exactly aligned.

Figure 3-17.- Manufacturing tolerance study.

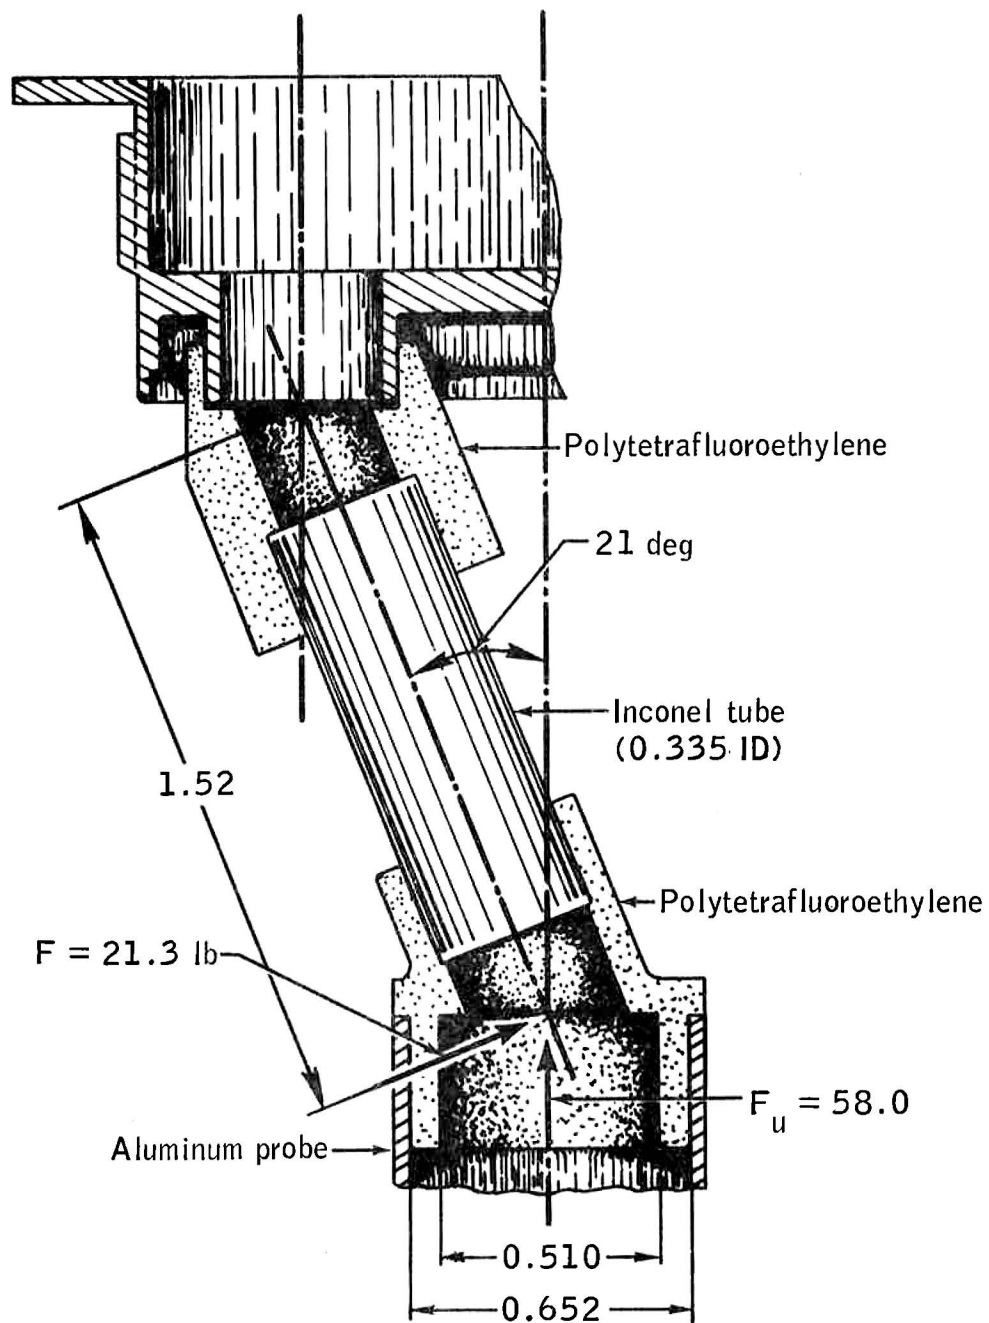
Figure 3-18.- Standpipe assembly at the top of the tank.
