MANNED SPACECRAFT CENTER INTERNAL NOTE

APOLLO 13 CRYOGENIC OXYGEN TANK 2 ANOMALY

ANOMALY REPORT NO. 1

July 1970

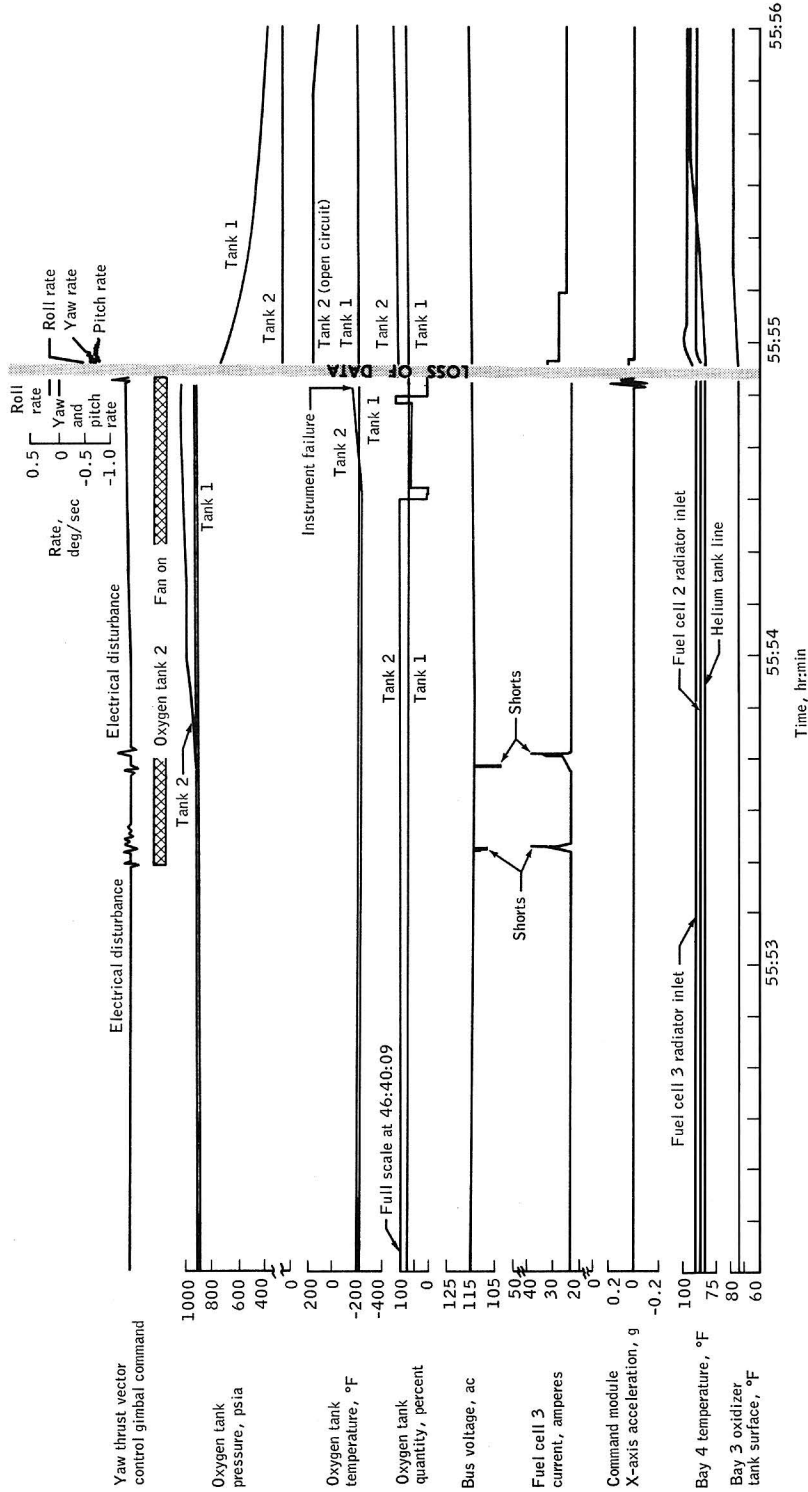
Figure 3-1.- Significant event timeline.

Approximately 9 hours prior to the period of interest, the quantity gage in cryogenic oxygen tank 2 failed to full scale during a fan cycle.

At 55:53:20, the electrical fan circuits for cryogenic oxygen tank 2 were energized. Approximately 2 seconds later, a momentary short was indicated in the current from fuel cell 3. Within several seconds, two other momentary shorted conditions occurred.

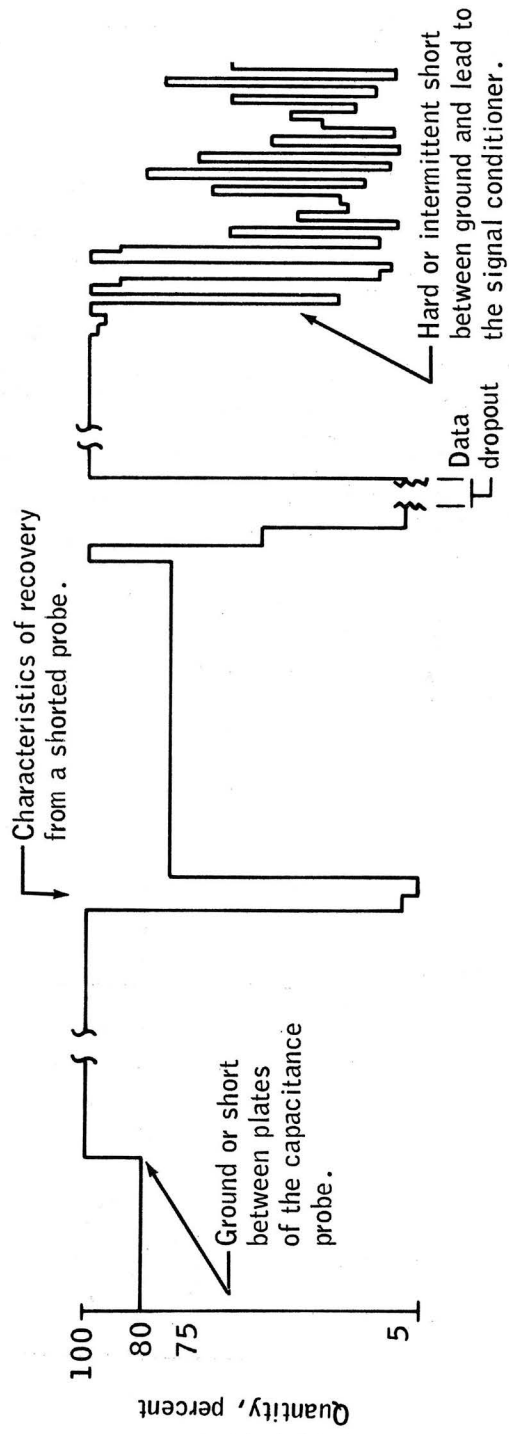
Figure 4-2.- Correlation of cryogenic oxygen tank 2 quantity flight data with measurement failure modes.

The first anomalous inflight condition associated with the cryogenic oxygen tank 2 occurred at 46:40:06 when the ac-powered destratification fans in both cryogenic oxygen tanks were turned on. Within about 3 seconds after fan activation, the quantity measurement for cryogenic oxygen tank 2 abruptly indicated full-scale high. This system indicates density of the cryogenic oxygen by measuring its dielectric constant, which is a function of density. This instrument is a capacitor which consists of two concentric aluminum tubes inside the tank (fig. 4-1).

Tests have shown that an open-circuit in the leads to the capacitor assembly or a short across the capacitor or its leads will drive the output to full scale. If this short-circuit is removed, the output signal drops abruptly from full scale to zero, and then in about a second, it settles out to the proper reading, as noted in the data of figure 4-2. This agrees with the flight data from the quantity probe. Tests also show that if the inner tube is shorted to ground, the output may oscillate in a random manner. Such an oscillation was noted several minutes after data recovery following the incident. It should be noted that with a short-circuit in the quantity gaging system inside the tank, the maximum current that could be drawn is 15 milliamperes.

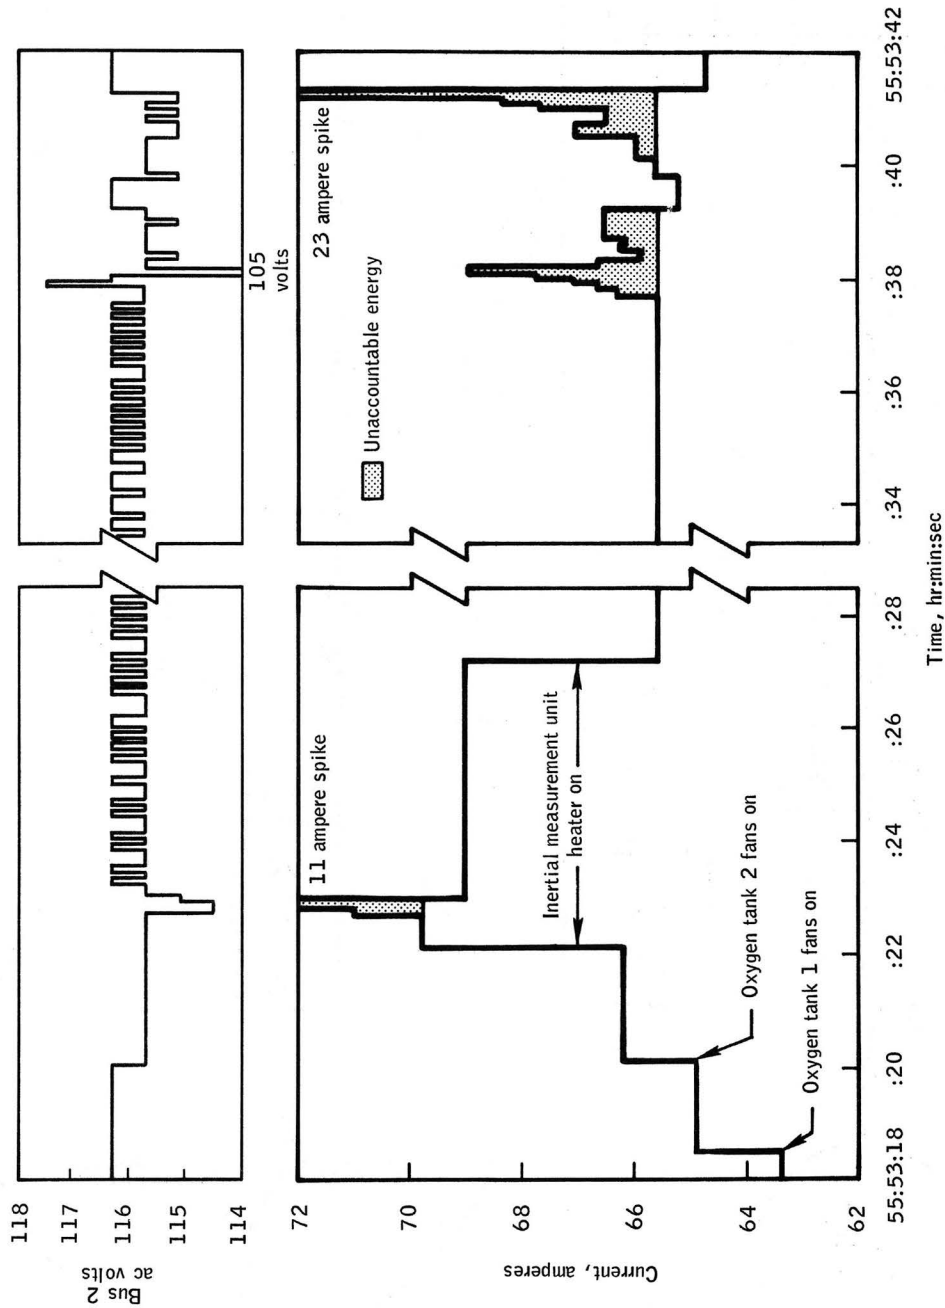
Figure 4-5.- Spacecraft current and ac voltage during period of interest.

The first indication of a short on ac bus 2 appeared about 2-1/2 seconds after activation of the cryogenic oxygen tank 2 fans. The ac bus 2 voltage dropped 1.2 volts, the fuel cell 3 current increased 11 amperes (fig. 4-5), and the stabilization and control system gimbal command data experienced a transient. Subsequent to the short, the spacecraft current data show a decrease of 0.8 ampere from the level just prior to the short. Also, the ac bus 2 voltage started to toggle-up 0.6 volt, or one data bit (fig. 4-5). These data indicate that a load was removed from ac bus 2 and that it was approximately one-half the load normally applied when the cryogenic oxygen tank 2 fans were turned on. This indicates that a short in one of the two fan motor circuits in cryogenic oxygen tank 2 caused its fuses to blow.

The second indication of shorting occurred about 15 seconds later when phase A of ac bus 2 voltage increased 1.8 volts. Since the inverter attempts to maintain a constant average 3-phase voltage, this increase in phase A indicates a voltage decrease on phase B or C of the ac bus 2 caused by an increased load.

Approximately 200 milliseconds later, the ac bus 2 voltage momentarily decreased 11 volts (fig. 4-5), and the total spacecraft current increased 3.5 amperes, indicating an increased load. After the momentary decrease, the ac bus 2 voltage reading was 0.6 volt less than the previous indication. This could be an indication that a single phase short on phase B or C was removed by blowing a fuse.

About 20 seconds after the first short, the third ac bus 2 short occurred. Fuel cell 3 current increased 23 amperes, and the stabilization and control system data again indicated a transient (fig. 3-1). Subsequently, the total spacecraft current level decreased to the same level as it was prior to turning on the cryogenic oxygen tank 2 fans. This indicates that power to the remaining cryogenic oxygen tank 2 fan was removed by blowing its fuses due to this short. Also, the ac bus 2 voltage increased to the same level as that prior to turning the tank 2 fans on (fig. 4-5).

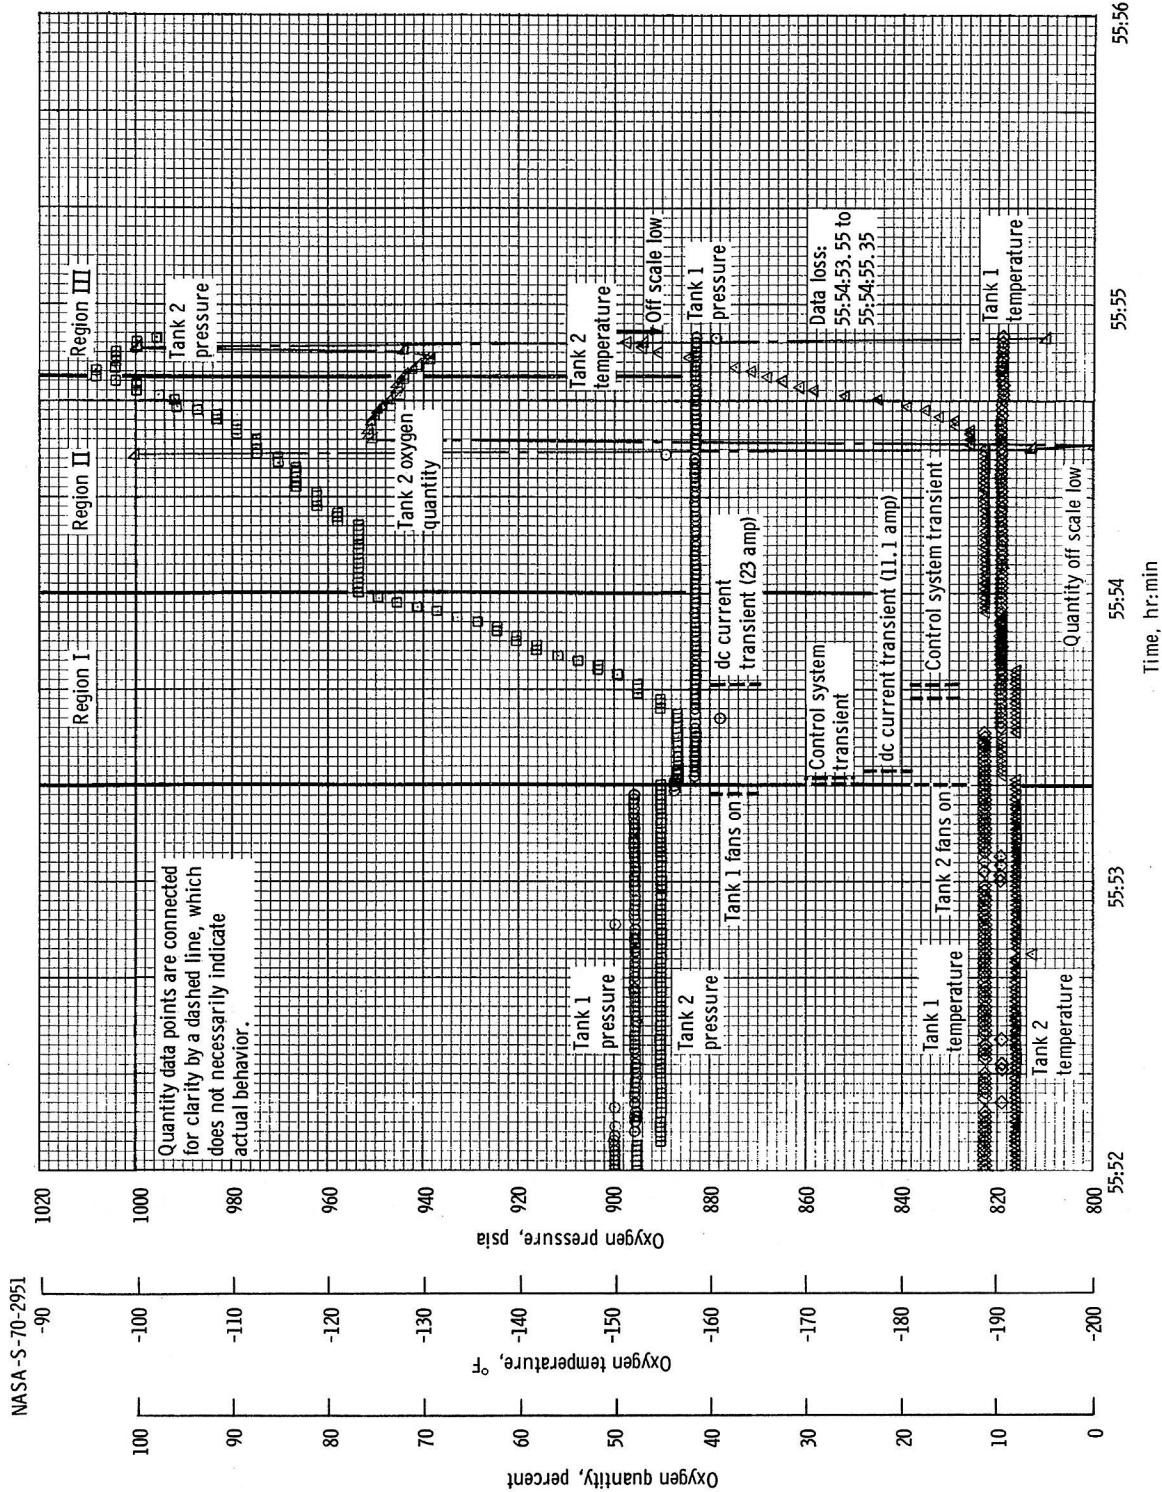
Figure 4-10. - Pressures, temperatures, and quantities during period of interest.

While the pressure was rising sharply in cryogenic oxygen tank 2, changes occurred in the temperature indication (fig. 4-10). The temperature data are obtained from a sensor located on the quantity probe assembly (fig. 4-8) within the tank. The temperature increased about 2° F during the first pressure rise (region I). A temperature increase of this magnitude is in accord with that expected due to the pressure rise alone.

The significant aspect of the temperature data is the rapid rise rate commencing approximately 24 seconds prior to loss of data (fig. 4-10). Several analyses were performed to interpret the data. The results indicated that a temperature range of 600° to 2900° F could produce the observed response. This wide temperature span is a result of the geometric configurations which are possible. The significant results from these analyses confirmed that the combustion source was near the sensor during the period of rapid temperature rise. Just prior to the loss of data, the temperature dropped to zero, indicating an open circuit failure in the measurement circuit.

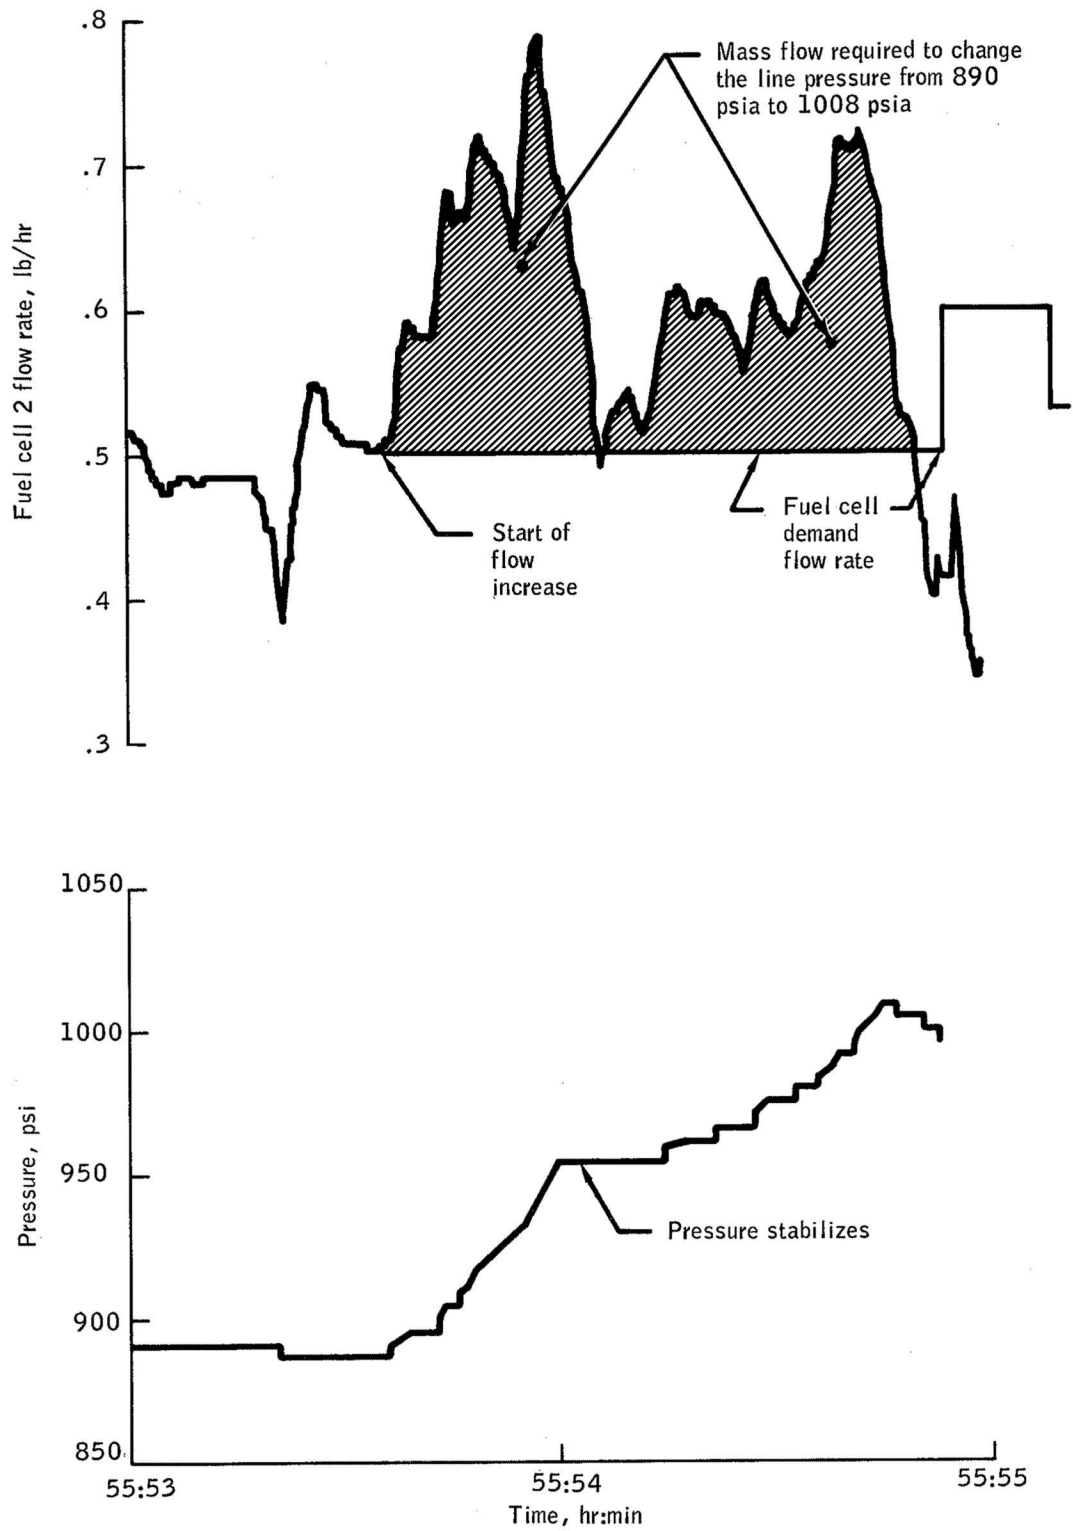
Figure 4-11.- Effect of oxygen pressure on fuel cell flow rates.

Another validation of the pressure transducer under dynamic pressure conditions consisted of integrating the flow rate change to the fuel cell (fig. 4-11). This calculation substantiated the tank pressure peak as about 1008 psia. Throughout the mission, both tank pressures were read- ing as expected, further substantiating their validity.

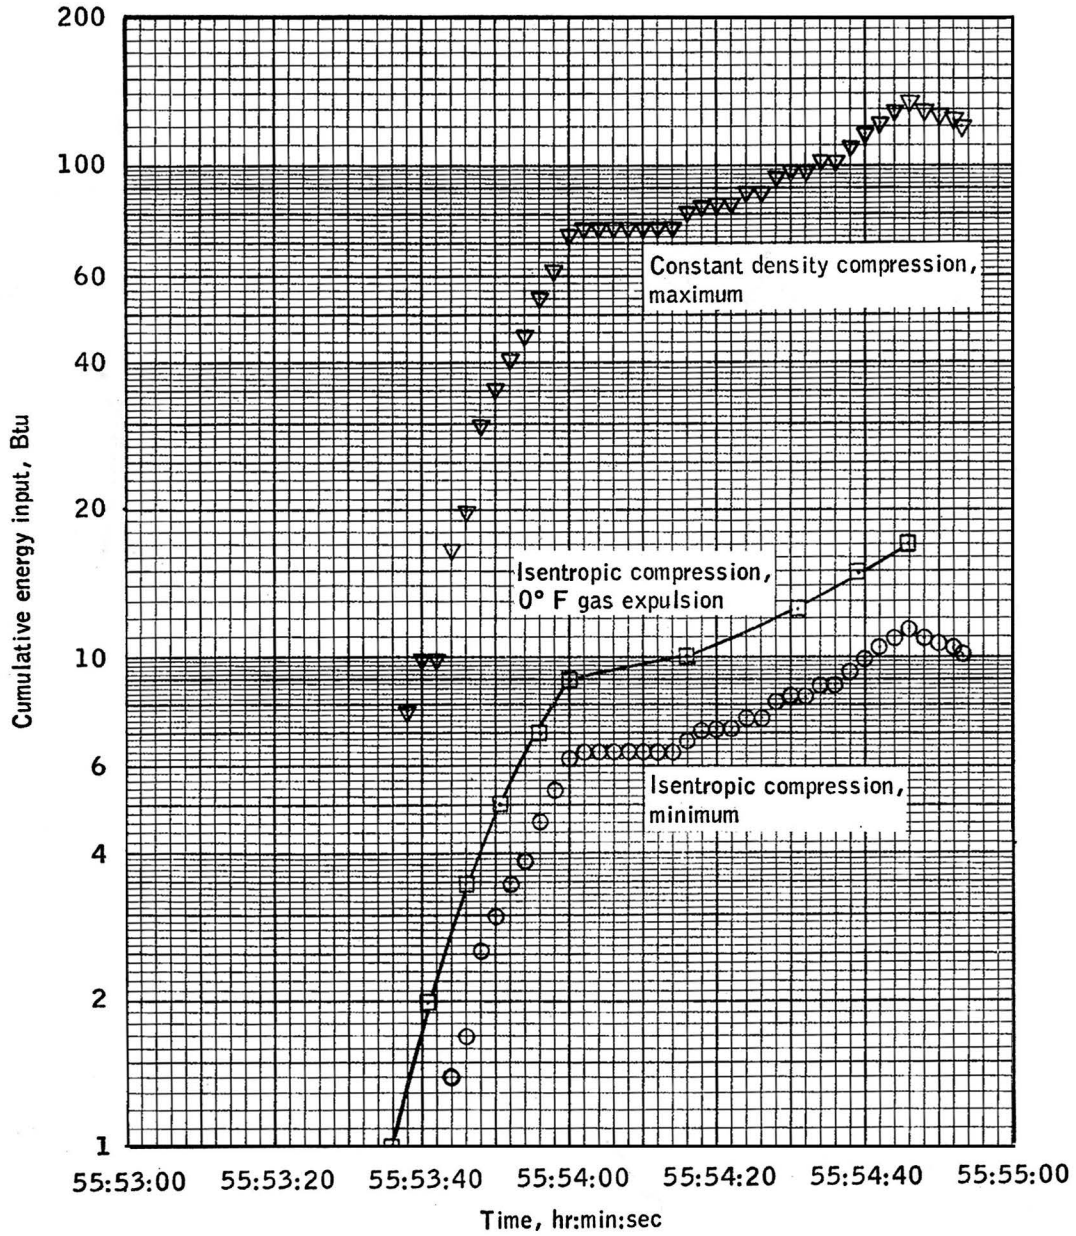
Figure 4-12.- Cryogenic oxygen tank 2 energy addition.

The maximum energy input to satisfy the observed pressure rise is a constant density heating process. This condition is shown by the upper curve of figure 4-12. A second process, which establishes the minimum energy input, is an isentropic compression of the fluid. This compression is represented by all the energy input being confined to a small bubble, which has no mass. The resulting thermodynamic state is one of higher pressure in the tank. The result of this process is depicted by the lower curve of figure 4-12.

In actuality, the energy input into the tank lies somewhere between the maximum and minimum energy input curves shown in the figure. The process is modeled by a hot oxygen bubble of constant uniform tempera- ture, growing at a rate sufficient to isentropically compress the sur- rounding cryogenic oxygen. This formulation accounts for mass transfer both to the hot mass (to increase the volume) and from the hot mass (tank outflow). This mass transfer requires a larger energy input to sustain the pressure rise. The center curve of figure 4-12 shows a comparison of this model with the maximum and minimum energy models. The results (fig. 4-13) are dependent upon the temperature of the hot mass. Note that while the energy input increases by approximately 300 percent, the hot mass volume changes only 10 percent. Therefore, the energy source is confined to a small region within the tank, and is essentially independ- ent of the temperature of the burning material.

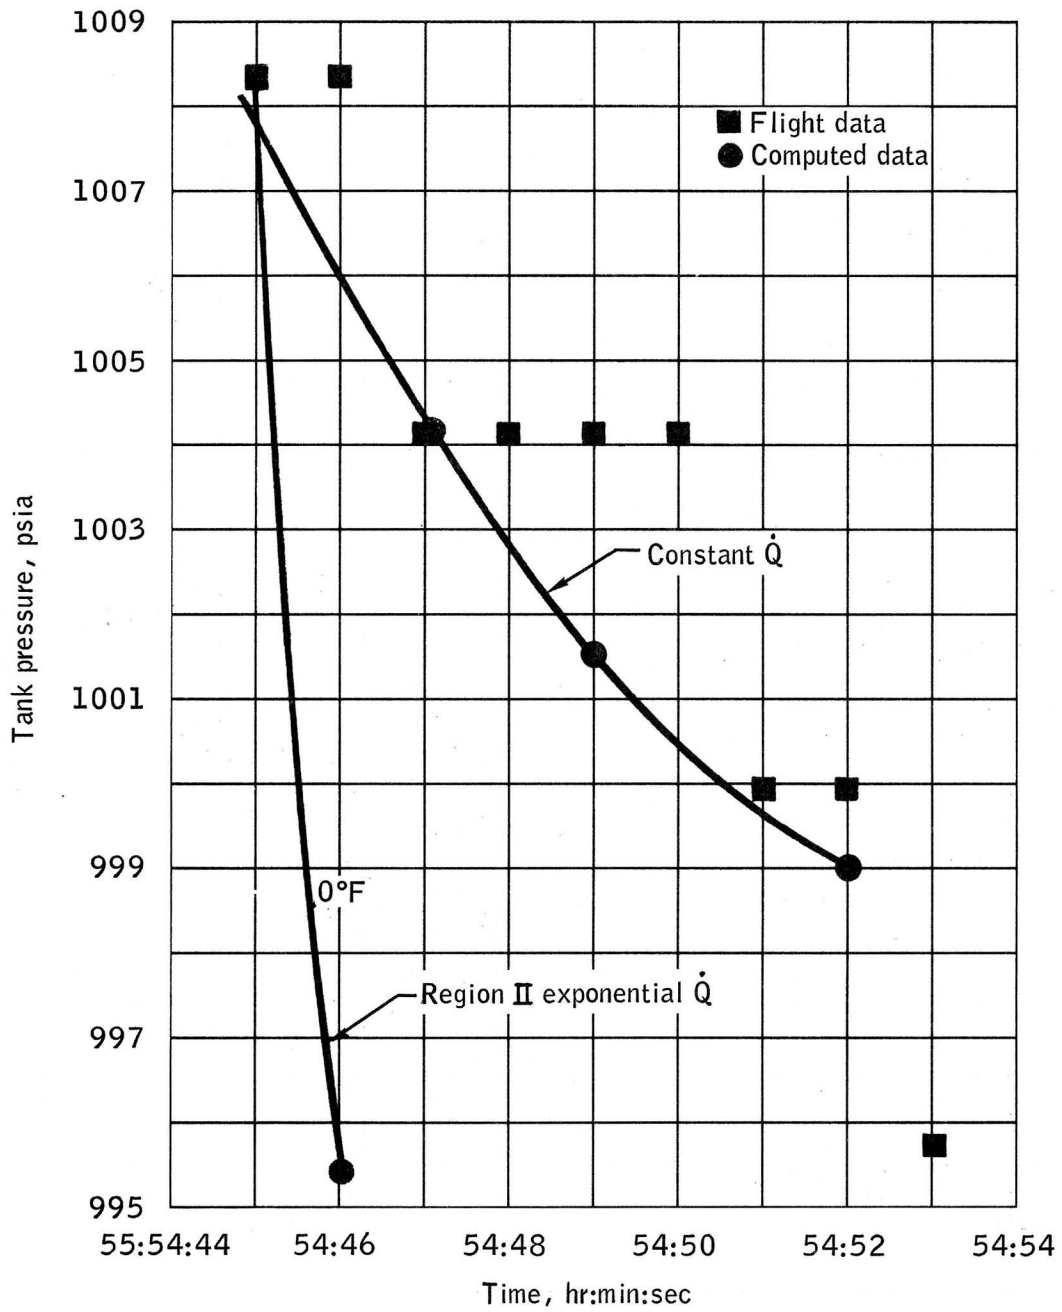
Figure 4-15.- Relief valve response in region III.

There are at least two possible ways to explain the observed pressure response. One is a partial restriction of the flow and the other is a change in the combustion rate within the tank. There are several conditions which could lead to partial restriction of the flow, but the simplest of these is a restriction in the relief valve itself.

A change in the combustion rate could easily account for the slower-than-expected pressure decay after the relief valve opened. In order to properly account for the increase in combustion rate, it is necessary to consider about the last 2 seconds of region II. At this point, the pressure is 1004 psia, the relief valve crack pressure. When the relief valve opens, the velocity at the filter (inside the oxygen tank) increases. It is hypothesized that this increase in velocity provides both a convective force field and additional oxygen to the combustion source. When the relief valve opens fully the local velocity increases to a maximum. A further postulation is that this yields a maximum burning rate which raises the pressure to 1008 psia. The relief valve flow then decreases the pressure, although the combustion rate remains high. A heat input rate of approximately 2 Btu/sec will raise the pressure from 1004 psia to 1008 psia with the relief valve open. A constant heat rate of approximately 1-1/4 Btu/sec will match the observed pressure decay in region III (fig. 4-15). This energy input rate is about two and one-half times larger than the exponential rate of region II.

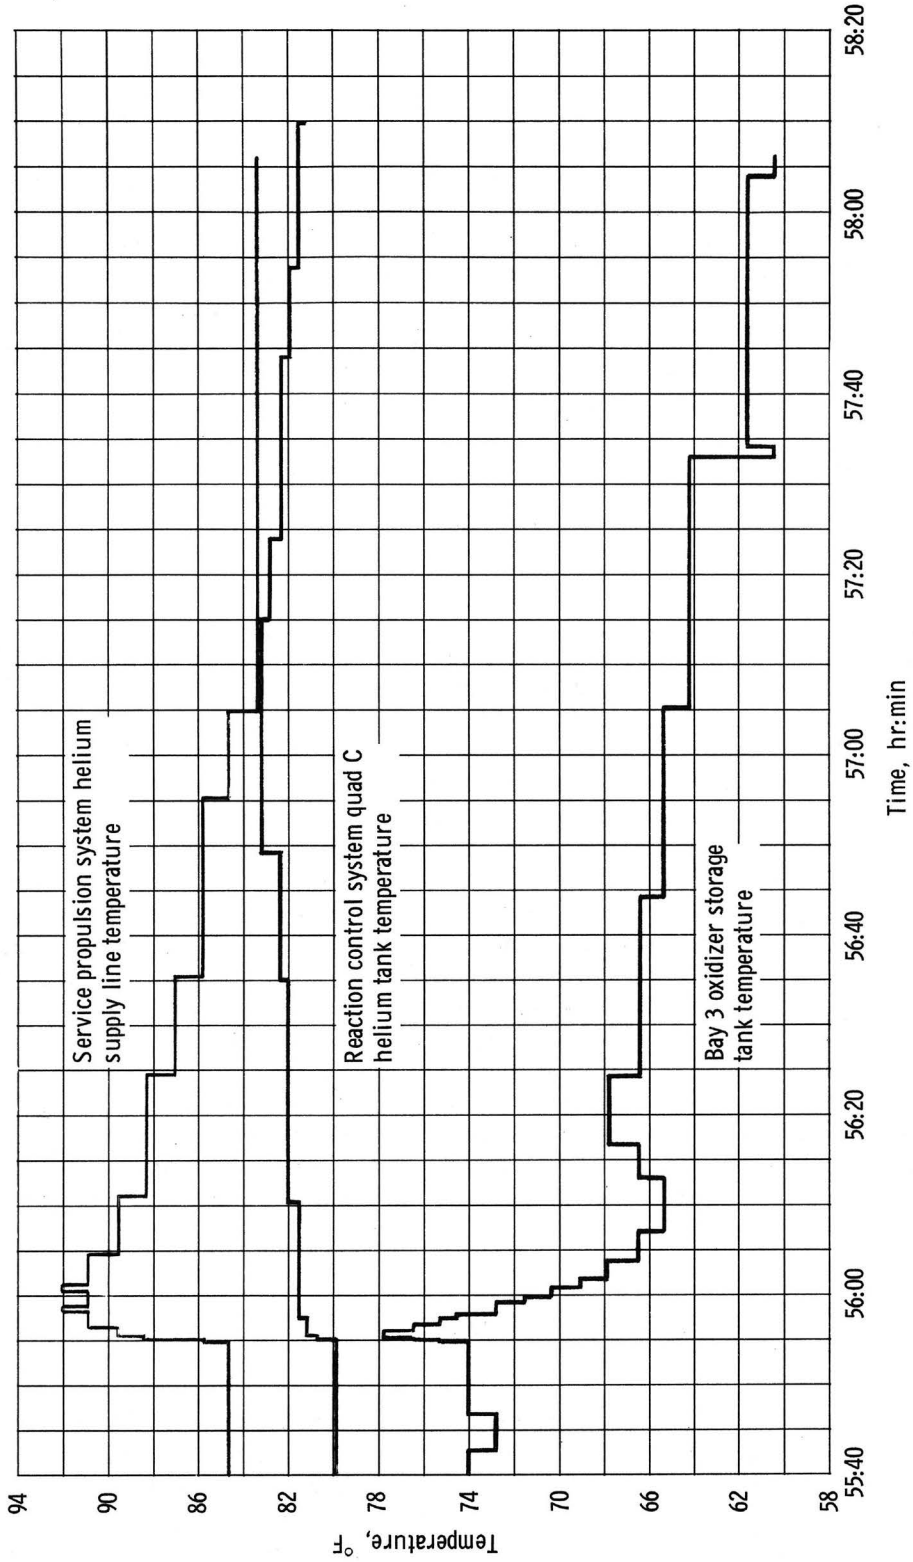
Figure 4-32. - Bay 3 and 4 structural temperatures.

The bay 3 oxidizer tank surface temperature increased from 73.4° to 77.7° F in about 20 seconds (fig. 4-32). The temperature then decreased to 60° F about 2-1/4 hours later. Data received during the two command and service module power-up cycles at 101:55:54 and 123:05:25 showed 60° and 65.3° F, respectively. The rise rate of bay 3 service propulsion system oxidizer surface temperature is indicative of direct heating in the vicinity of the transducer, which is attached to the tank skin and covered with 30 layers of insulation.

Heat inputs to the bay 3 service propulsion tank surface transducer depend on the thermal integrity of the multilayer insulation blanket covering the transducer. To obtain the noted response requires severely degraded insulation, probably because of burning of the insulation or pressurization of the bay with hot gas.

The service propulsion helium line temperature (fig. 4-32) increased from 84.6° to 89° F in about 37 seconds. In 2 more minutes, the temperature had increased to 92.2° F. A gradual cooling trend followed, and 10 minutes later, the temperature had decreased to 83.4° F. During the two command and service module power-up cycles at 101:55:54 and 123:05:19, the helium line temperatures were 72.1° and 65.9° F, respectively. The initial rise rate is again indicative of direct heating in the vicinity of the transducer. However, unlike the oxidizer tank surface temperature, the gradual decrease in helium line temperature, after the initial rise, is indicative of a cool-down response to radiant heat loss. The helium line cooled gradually because of the lower temperature levels with the fuel cells shut down and the bay 4 panel missing.

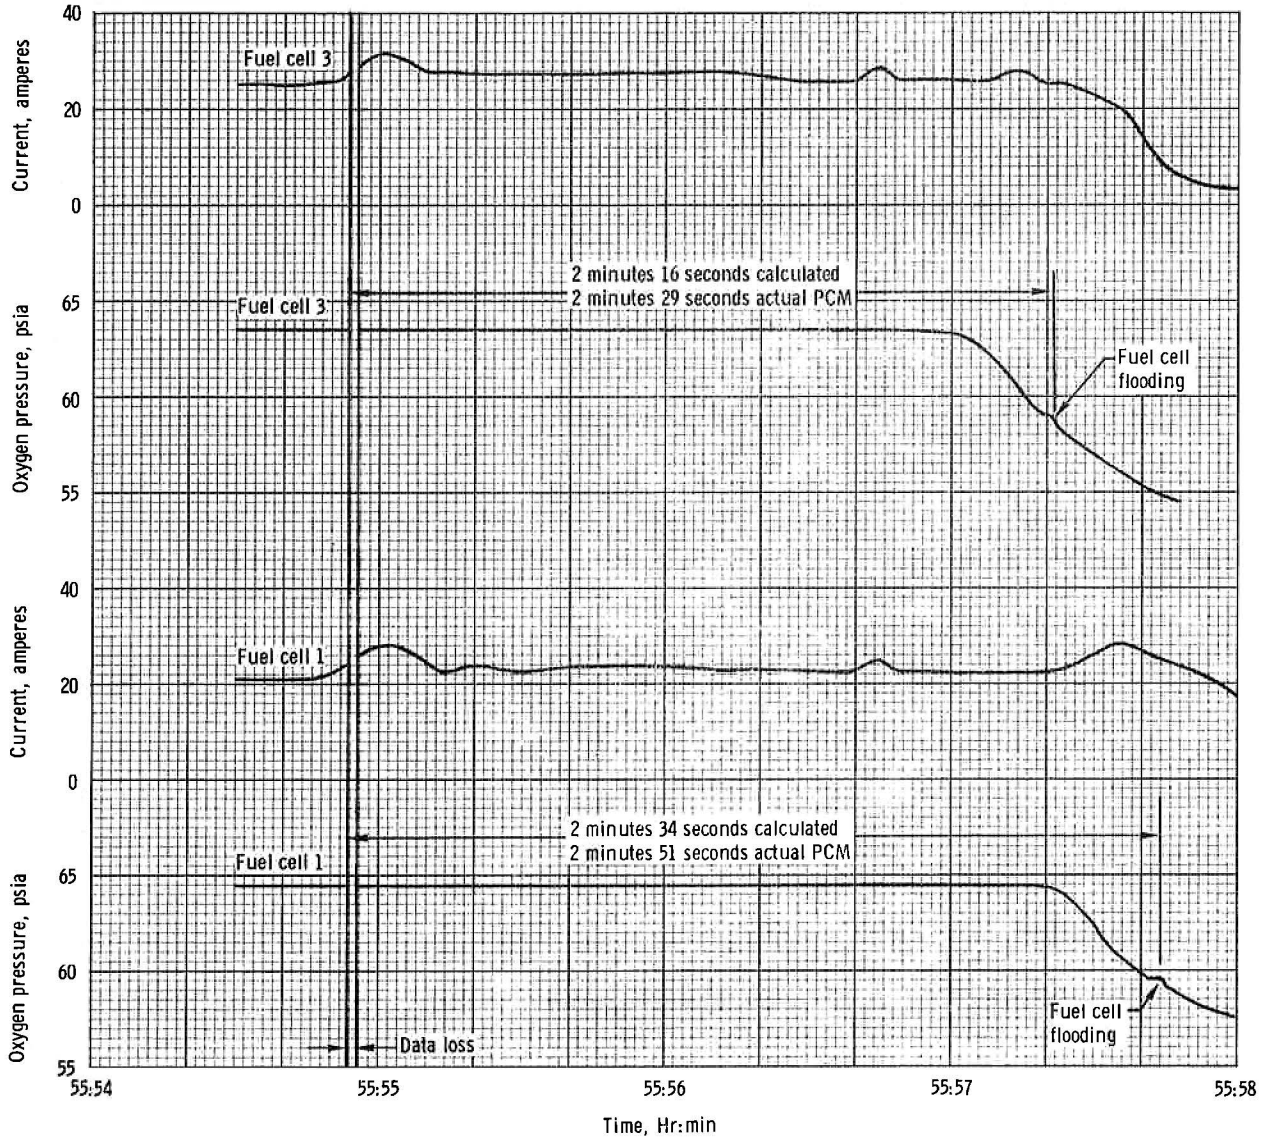
Figure 4-40. - Fuel cells 1 and 3 performance loss.

The pressure decays on fuel cells 1 and 3 were caused by closure of the fuel cell oxygen reactant shutoff valves. When the valves closed, a volume of high pressure oxygen was trapped between the reactant valves

and the fuel cell oxygen regulators. This oxygen was sufficient for fuel cell operation for about 2.5 minutes, the time required to deplete the trapped supply. The agreement between the calculated and actual operating time after valve closure (fig. 4-40) verifies that fuel cells 1 and 3 were starved of oxygen and eventually could not support an electrical load.

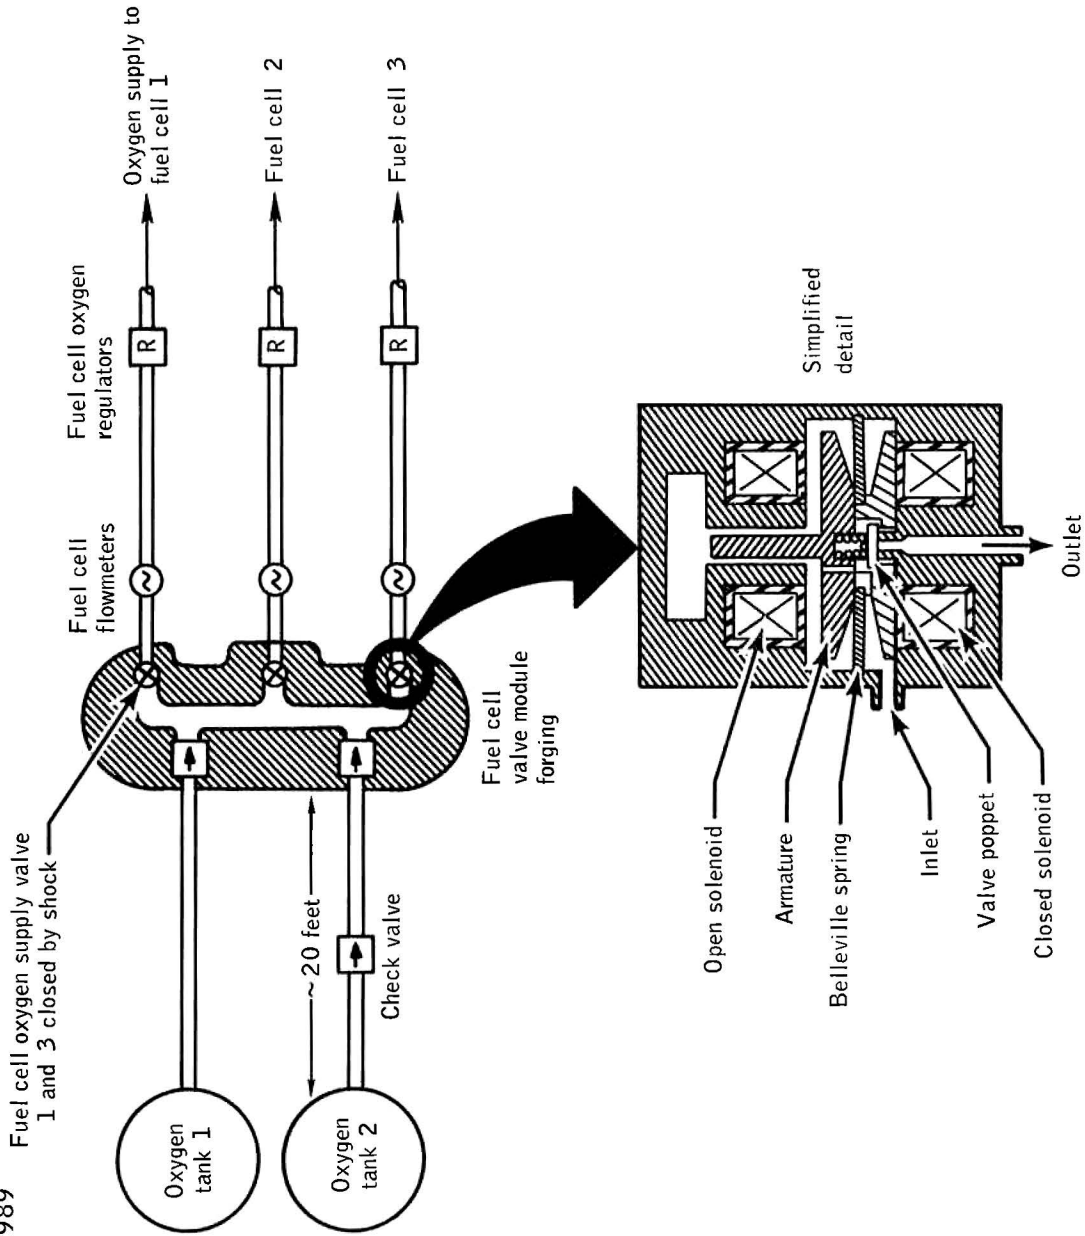
Figure 4-41.- Solenoid valves for oxygen supply.

Impact tests on the oxygen solenoid valves (fig. 4-41) show that a shock in excess of 86g for 11 milliseconds duration can be expected to cause valve closure under operating conditions.

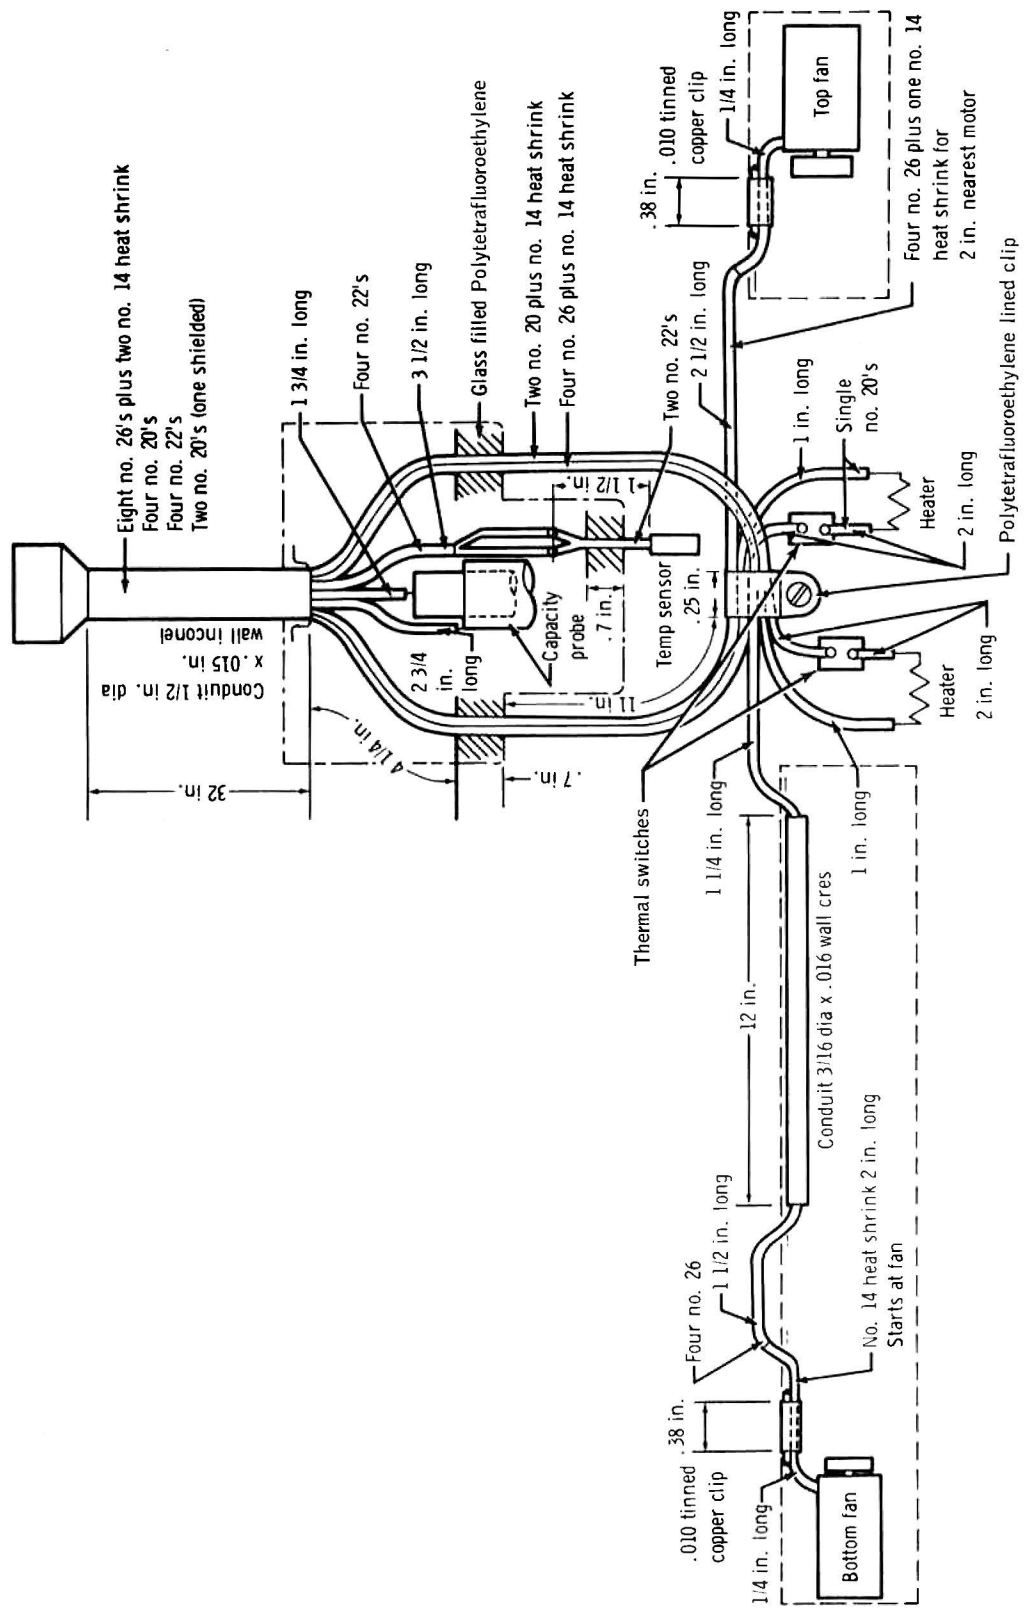
Figure 4-42.- Wiring distribution within cryogenic oxygen tank.

The fan wiring leads consist of two harnesses of four wires each for the two 3-phase fan motors. Wires (MIL-W-16878, type E) are 26-gage nickel and are coated with 0.010-inch polytetrafluoroethylene insulation. Also, each harness of four wires is covered in some regions with a polytetrafluoroethylene sleeve of approximately 0.012-inch thickness. Wire runs of the two fan harnesses are as indicated in figure 4-42 and are identical, except that the lower fan harness is routed through a tube in the heater assembly.

The fan motor power leads internal to, and near, the heater assembly are extremely vulnerable to heat damage in abnormal operations. This has been demonstrated dramatically in a test employing approximately 8 hours of continuous heater operation. The insulation degradation caused in a test simulating the detanking cycle used on oxygen tank 2, (discussed in section 5.0) is seen in pictures of the wiring which failed (fig. 4-43).

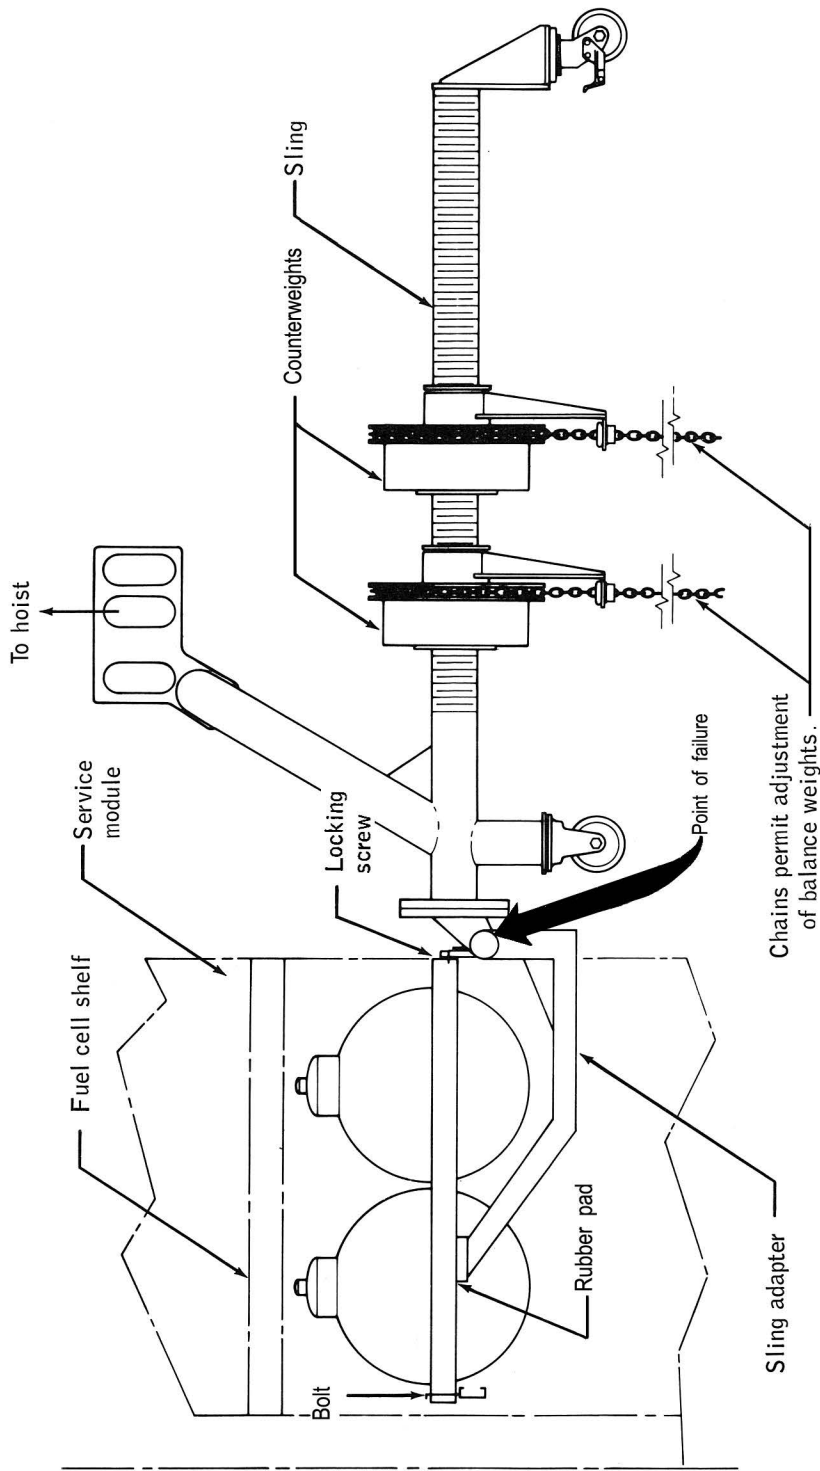
Figure 5-1.- Oxygen shelf and hoist assembly.

A detailed assessment was also made of the incident where the oxygen shelf hoist assembly failed during the factory removal of the tank shelf (fig. 5-1). Analysis and test show that the maximum shock upward would be about 7 g's, and the maximum shock downward would be about 15 g's. Analytically, the components within the tank would be expected to withstand 100 g's shock. Consequently, this condition is not believed to have contributed to the ultimate failure of the tank in flight.

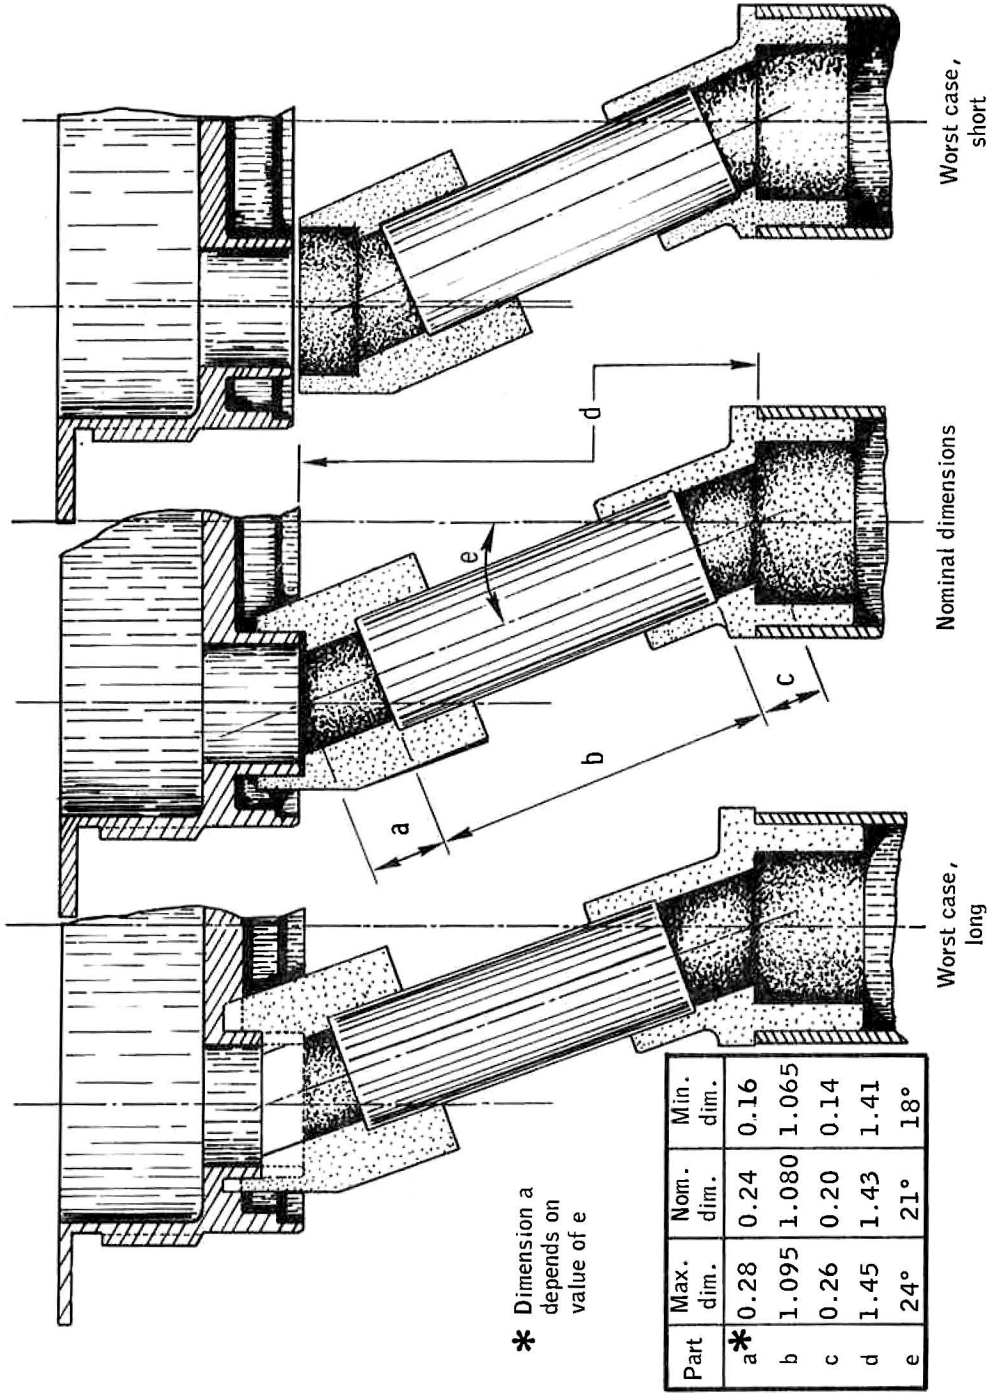
Figure 5-2.- Manufacturing tolerance study.

The cryogenic oxygen tank 2 could not be off loaded after the initial filling during the countdown demonstration test using the normal procedures. The problem resulted from loose or misaligned plumbing components in the dog-leg portion of the tank fill path (fig. 5-2). Allowable manufacturing tolerances are such that the tank may not be detanked normally under these conditions. A test has verified this fact. The condition of loose plumbing in the probe assembly, which existed in the tank before the detanking, was judged to be safe for flight in every aspect.

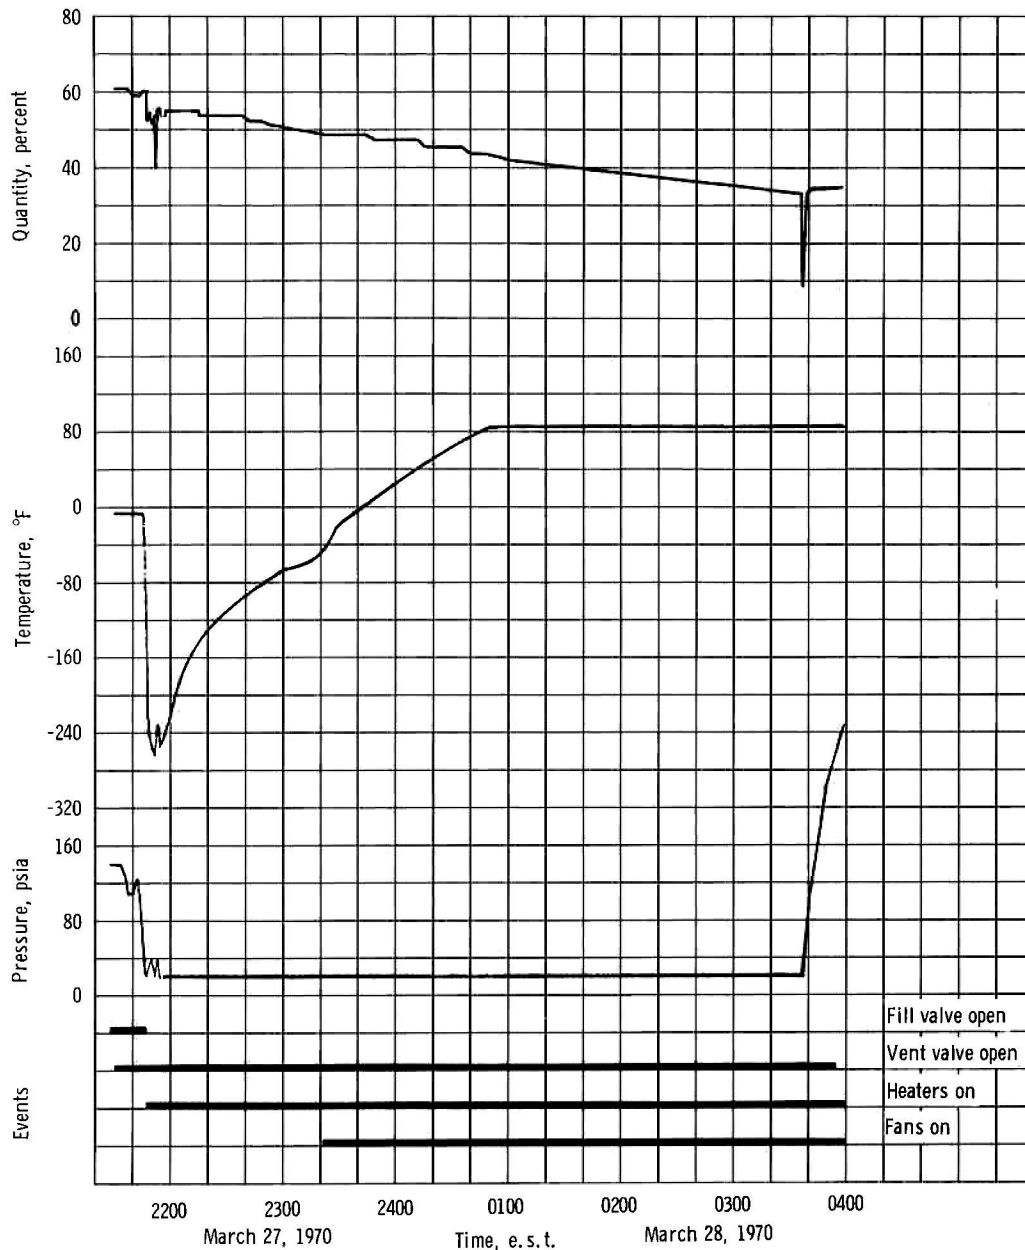
Figure 5-3. - Characteristics of oxygen tank 2 detanking using fans and heaters (CDDT).

After numerous attempts with gaseous oxygen purges and higher expulsion pressures in an attempt to remove the fluid, the fluid was boiled off through the use of tank heaters and fans, assisted by pressure cycling. The sequence of detanking is shown in figures 5-3 and 5-4. The heater-on time was about 8 hours. It was thought that no damage would be sustained by the tank or its components because of the protection afforded by the internal thermal switches.
