MANNED SPACECRAFT CENTER INTERNAL NOTE

APOLLO 13 CRYOGENIC OXYGEN TANK 2 ANOMALY

ANOMALY REPORT NO. 1

July 1970

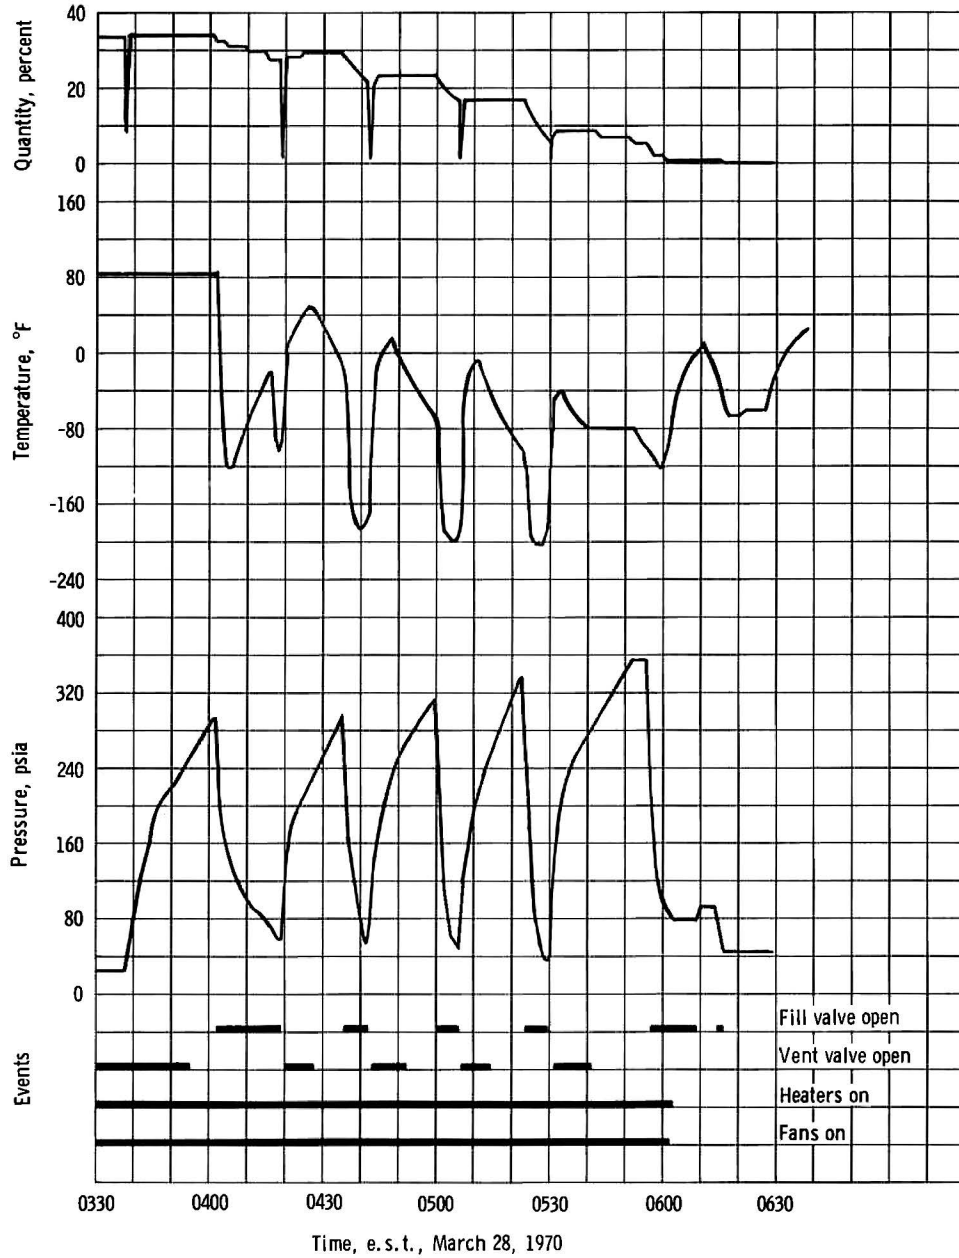
Figure 5-4. - Characteristics of oxygen tank 2 detanking using fans, heaters, and GSE pressure (CDDT).

After numerous attempts with gaseous oxygen purges and higher expulsion pressures in an attempt to remove the fluid, the fluid was boiled off through the use of tank heaters and fans, assisted by pressure cycling. The sequence of detanking is shown in figures 5-3 and 5-4. The heater-on time was about 8 hours. It was thought that no damage would be sustained by the tank or its components because of the protection afforded by the internal thermal switches.

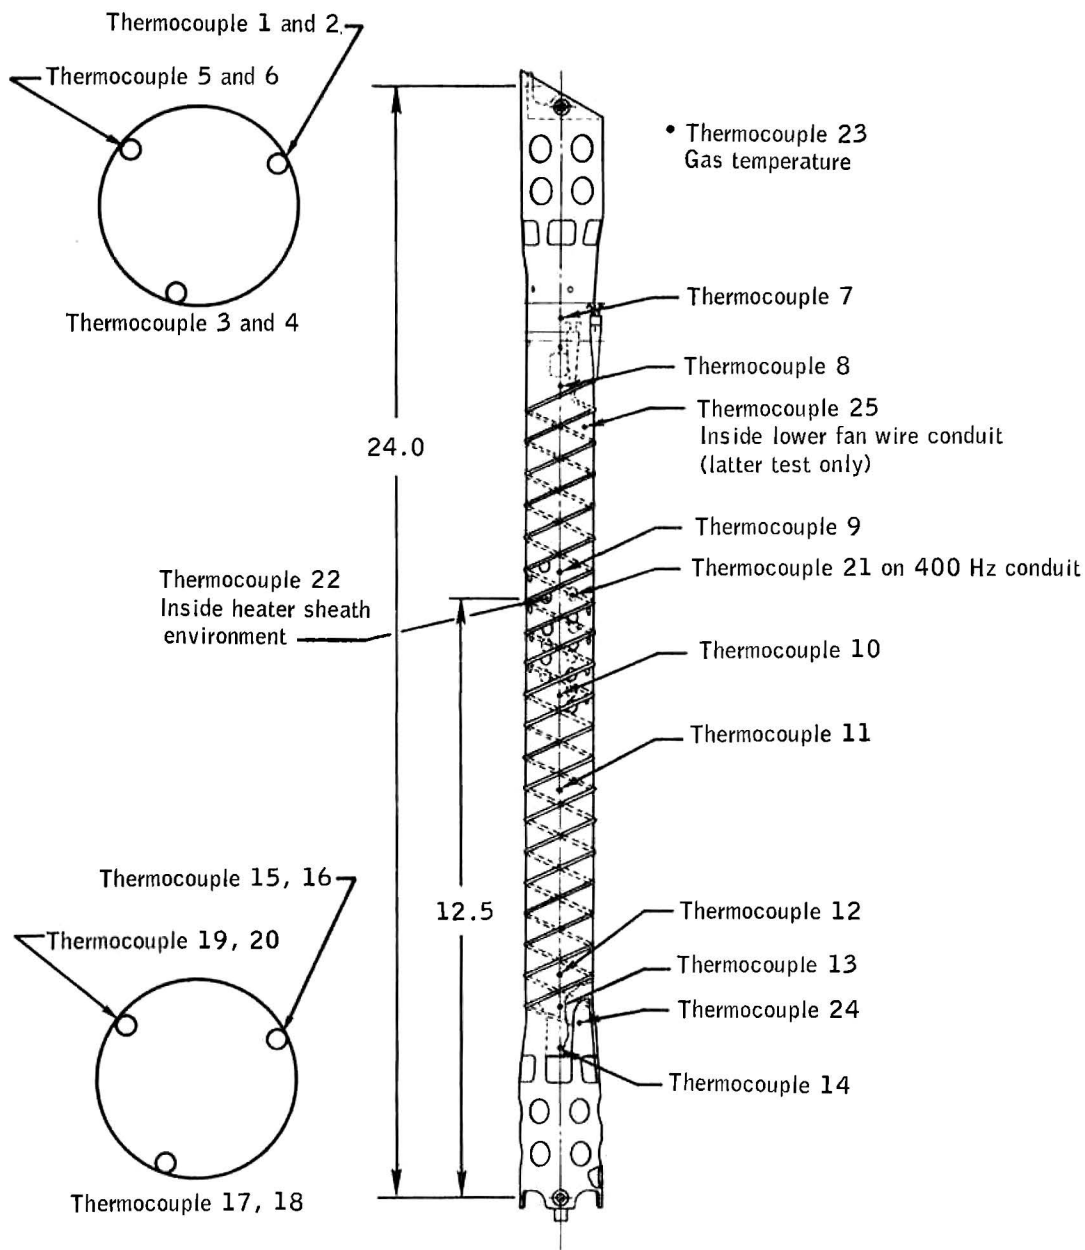
Figure 5-6.- Heater/fan temperature sensor locations

Wiring can be damaged within a couple of hours, with the heaters being "on" continuously as evidenced by the temperature on the heater assembly (figs. 5-6 and 5-7).
