APOLLO 13 MISSION
HIGH-GAIN ANTENNA ACQUISITION PROBLEM

ANOMALY REPORT 2

MANNED SPACECRAFT CENTER
HOUSTON, TEXAS
December 1970

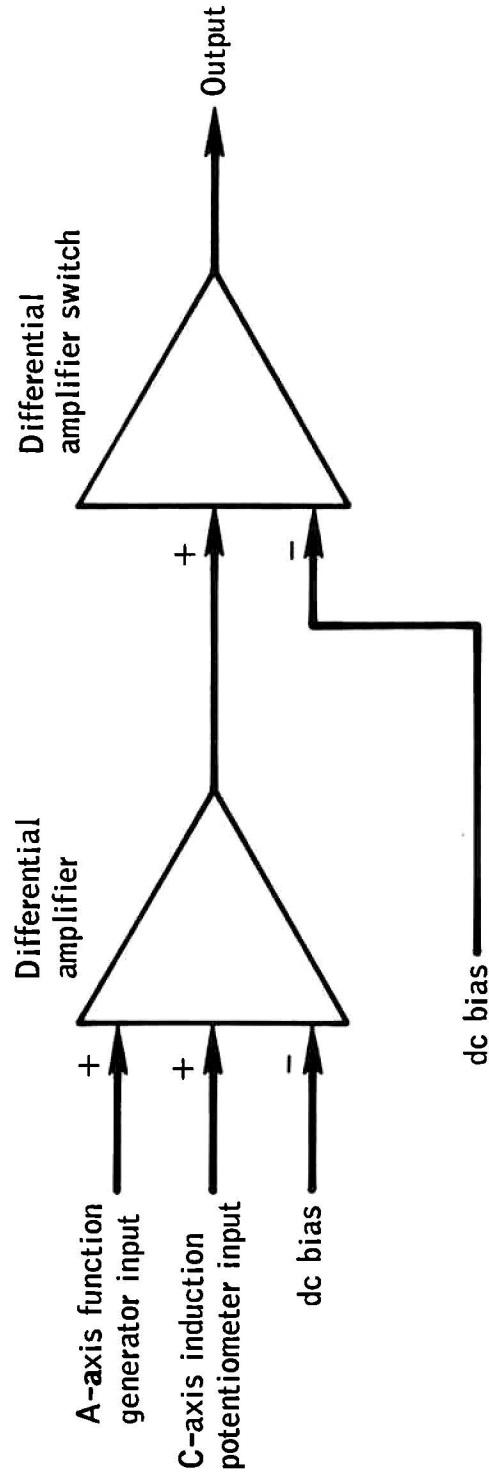
Figure 5.- Limit logic circuit .

The scan-limit and scan-limit-warning functions are generated by the C- and A-axis angles. The C- and A-axes are shown in figure 3. Figure 4 shows the scan-limit and scan-limit-warning function lines in the antenna coordinate (C- and A-axes) system. The C-axis and A-axis angle signals are generated in the high-gain antenna gimbals by two separate induction transducers. The C-axis signal comes from a linear induction potentiometer. The A-axis signal comes from a device similar to a synchro resolver. The A-axis signal is then half-wave, phase-sensitive demodulated, and the C-axis signal is half-wave rectified. The two signals and a dc bias are then summed by a differential amplifier shown on figure 5. The output of this summing amplifier is then compared to another dc bias voltage in a second differential amplifier. When the output of the first amplifier exceeds the dc bias supplied to the second amplifier, the second amplifier switches, indicating to the antenna logic that the scan-limit line has been reached. A similar circuit implements the scan-limit-warning line.

c. Elements in the scan-limit and scan-limit-warning circuits were shorted and opened to determine the effect on the scan-limit functions. The results of this test shifted the scan-limit functions, but did not produce the necessary change in the scan-limit slope. Consequently, a failure in the electronic box is ruled out.
