NATIONAL AERONAUTICS AND SPACE ADMINISTRATION

APOLLO 13
30-DAY FAILURE AND ANOMALY LISTING REPORT

MANNED SPACECRAFT CENTER
HOUSTON, TEXAS
MAY 1970

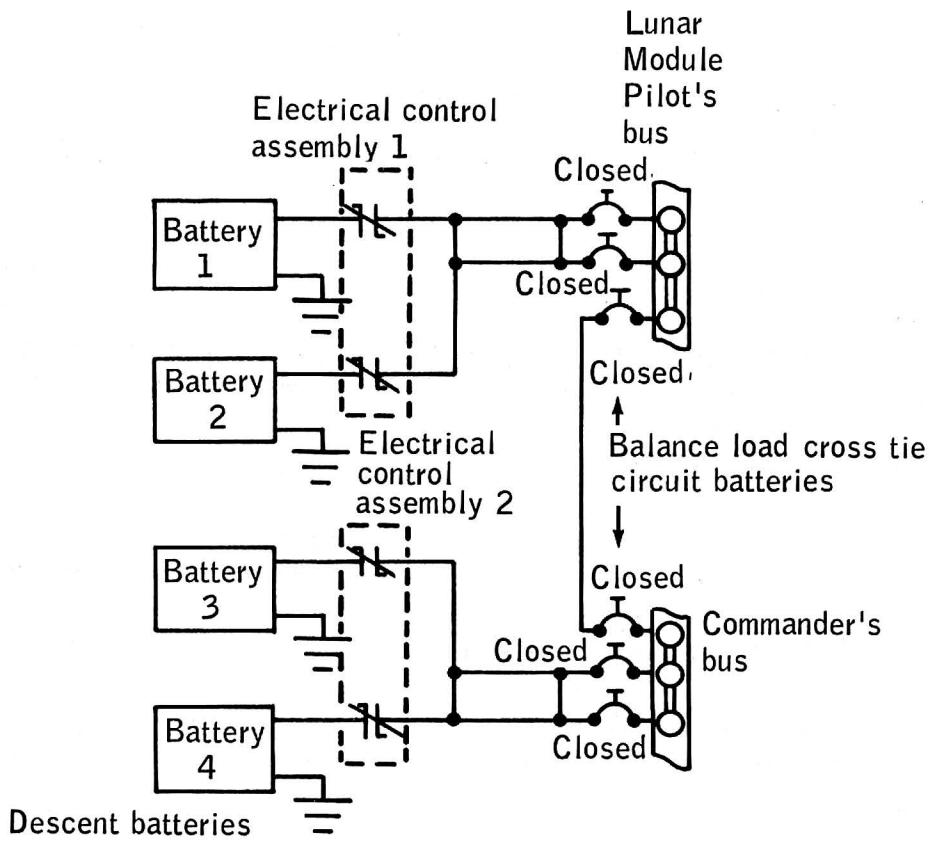
Figure 10.- Descent batteries/bus configuration.

At 97:14:42, the crew reported a thumping noise and snowflakes venting from quadrant 4 of the lunar module descent stage. All four descent batteries experienced current transients at 97:13:53 for about 2 seconds, with corresponding drops in dc bus voltage (fig. 9). Also, the glycol pressure differential for the heat transport system decreased momentarily, indicating that the glycol pump slowed down for a brief period.

The crew stated that the current spikes occurred not more than 30 seconds before the thumping noise, and not afterwards, and that there was no activity in the vehicle at that time. The current spikes were probably caused by a momentary short circuit in the Lunar Module Pilot side of the dc electrical system, which includes descent batteries 1 and 2 (fig. 10). The current surge was not high enough to open the balance load cross-tie circuit breakers nor to trip a battery off the bus as a result of an overcurrent or reverse current condition.

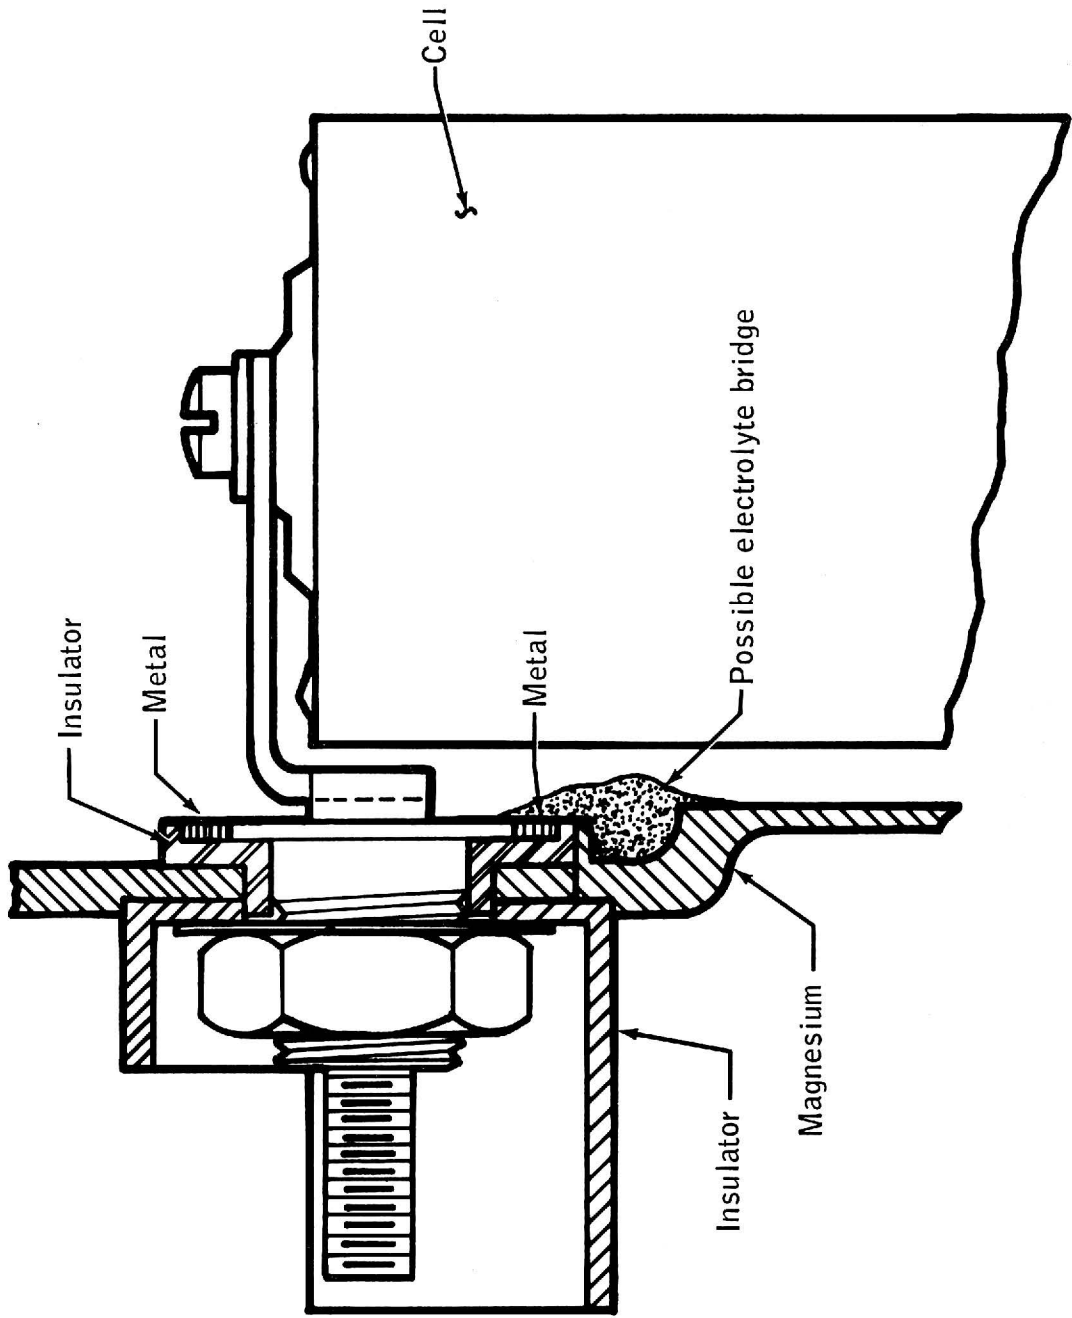
Figure 11.- Descent battery terminal.

At 99:51:09, battery 2 gave an indication of a battery malfunction (discussed in more detail in a subsequent section). One possible cause of this problem is the battery electrolyte bridging either the temperature switch terminals or the wiring. All available evidence indicates that battery 2 experienced an electrical fault of some type. The most probable condition is electrolyte leaking from one or more cells and bridging the high-voltage or low-voltage terminal to the battery case (fig. 11). This and other types of faults will be introduced into a descent battery to determine what faults could produce similar current surges. These tests should indicate if a current surge could cause the battery to make a thumping noise or to vent and produce solid particles similar to those observed.
