NATIONAL AERONAUTICS AND SPACE ADMINISTRATION

APOLLO 13 MISSION REPORT

SEPTEMBER 1970

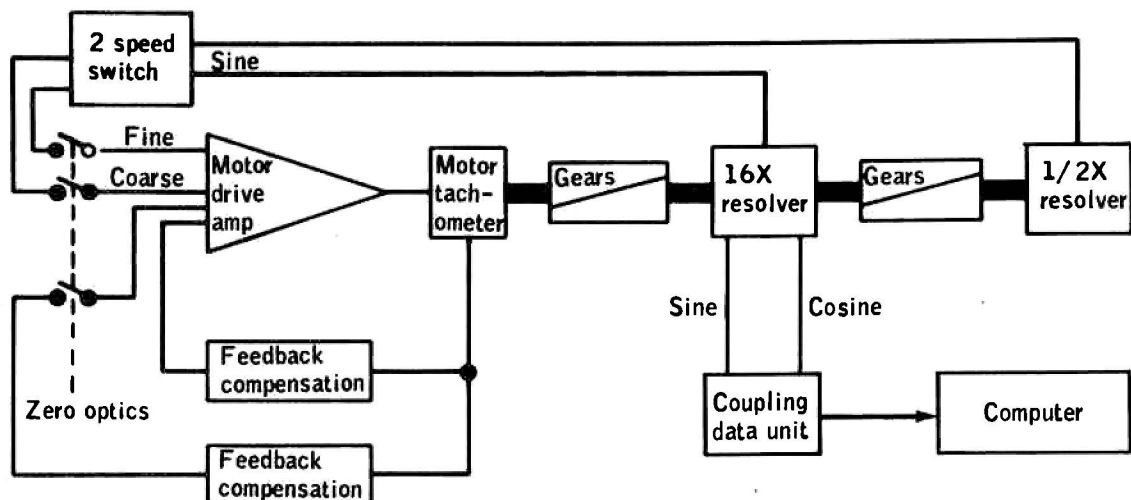
Figure 14-2.- Zero optics mode circuitry.

A simplified schematic of the optics shaft servo loop mechanization is shown in figure 14-2. In the zero optics mode, the sine outputs of

the half-speed and 16-speed resolvers are routed through a coarse/fine switching network to the motor drive amplifier and are used to null the system. Rate feedback from the motor tachometer is routed to the drive amplifier through a compensation network which removes any bias in the signal. When the zero optics mode is selected, the coupling-data-unit counter and the computer register which contains the shaft angle are zeroed for 15 seconds and then released to follow the 16-speed resolver. The half-speed resolver, the fine/coarse switching network, and the tachometer feedback compensation are used only in the zero optics mode.

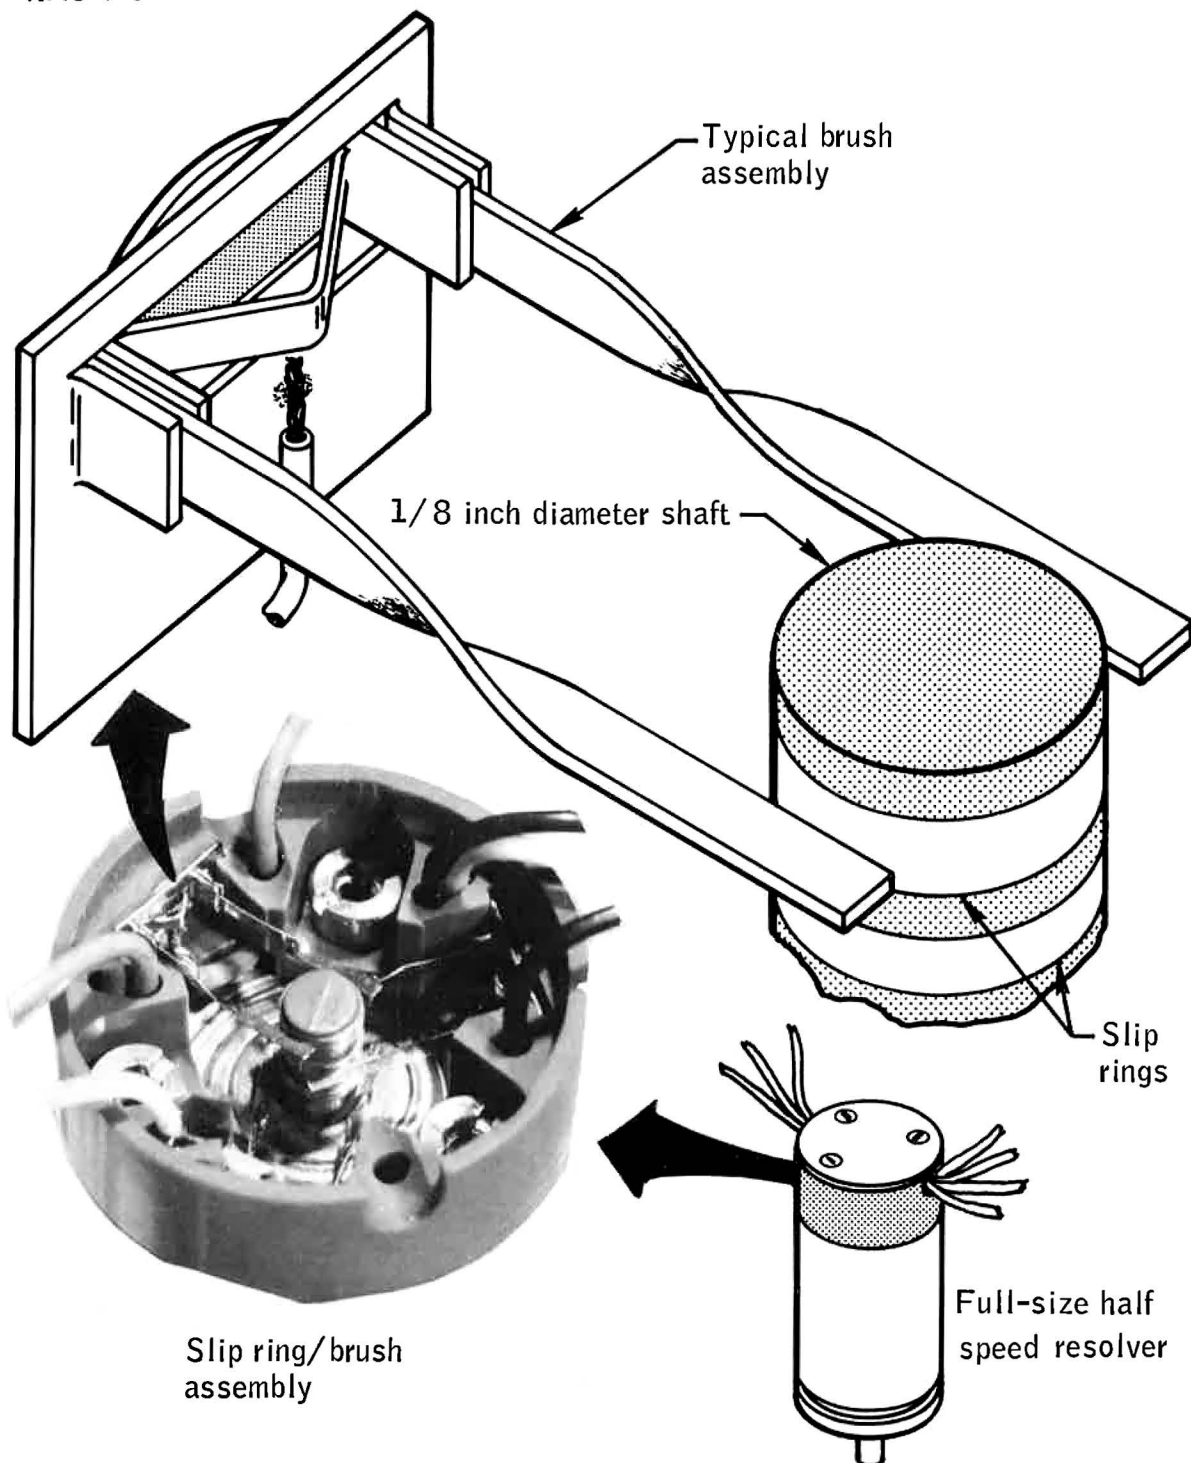
Figure 14-3.- Details of half speed resolver.

The most likely candidate is the half-speed resolver, which is used only for the shaft axis and only to provide an unambiguous zero reference. The reference voltage is applied to the rotor through slip rings (fig. 14-3), connected as shown in figure 14-4. If any resistance is present in the common ground path through the slip ring, a portion of the reference voltage will appear across the quadrature winding and induce a finite output (different than zero). Zero output is equivalent to zero degrees in shaft rotation.

Simulated changes in slip ring impedance were made on the half-speed resolver in the shaft loop (fig. 14-4). An impedance of 50 ohms produced an offset of approximately plus 0.5 degree in sextant shaft angle. The trunnion loop does not use this type of resolver or connection.

Some evidence of susceptibility to vacuum was exhibited in this class of resolvers during qualification testing when variations of approximately 5 ohms were observed in the slip ring resistance during thermal

vacuum testing. The tests were run with the units rotating at 1 rpm, however, and the momentary resistance changes disappeared with the wiping action.

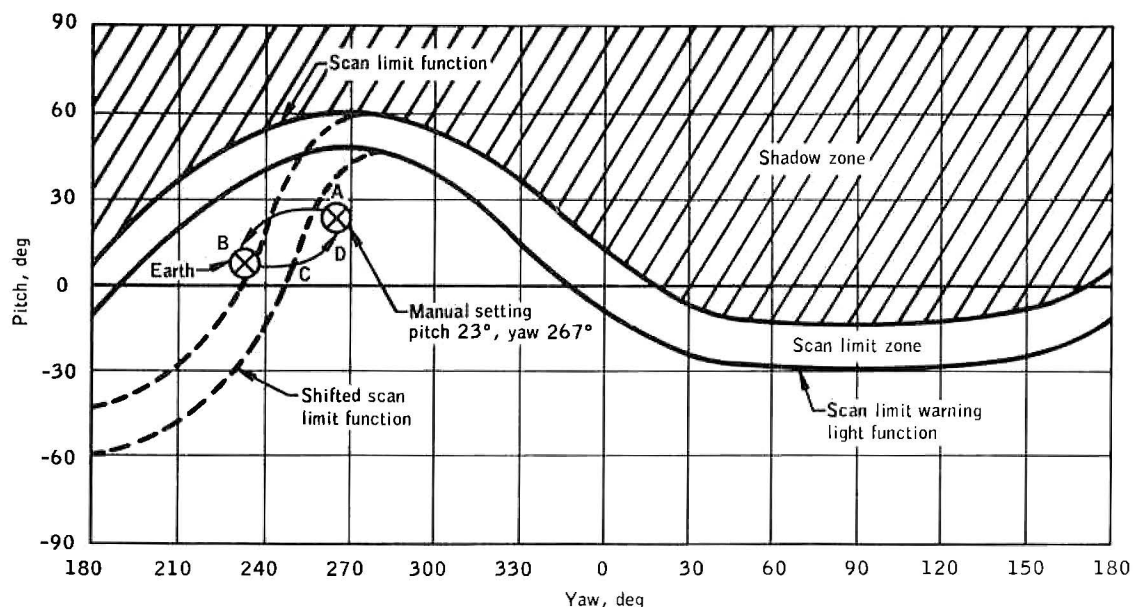
Figure 14-5.- Shift in scan-limit, scan-limit-warning illustrated.

Starting at 55:00:10 and continuing to 55:00:40, deep repetitive transients approximately every 5 seconds were noted on the phase modulated downlink carrier (fig. 14-5). This type of signature can be caused by a malfunction which would shift the scan-limit and scan-limit-warning function lines, as illustrated in figure 14-5. These function lines would have to shift such that they are both positioned between the antenna manual settings and the true line of sight to earth. Also, the antenna would have to be operating in the auto-reacquisition mode to provide these signatures. The antenna functions which caused the cyclic inflight RF signatures resulting from a shift in the function lines can be explained with the aid of figures 14-5 and 14-6, with the letters A, B, C, and D corresponding to events during the cycle. Starting at approximately 55:00:10, the antenna was switched from manual to auto reacquisition with the beamwidth switch in the medium-beam position. From point A to the scan limit function line just prior to point B, the antenna acquired the earth in wide beam. When the antenna reached the scan limit function line, the antenna control logic would switch the system to the manual

mode and drive back toward the manual settings until the scan limit warning function line at point C was reached, thereby maintaining wide-beam operation. When the antenna reaches the scan limit warning function line, the system would automatically switch to the medium-beam mode and continue to drive in the manual mode until the manual setting error was nulled out at point A. The antenna would then switch to the auto-track mode and repeat the cycle. The most important feature of this cycle is that the antenna moves at the manual scan rate between points B and D, which is confirmed by the rapid changes in the downlink signal strength.

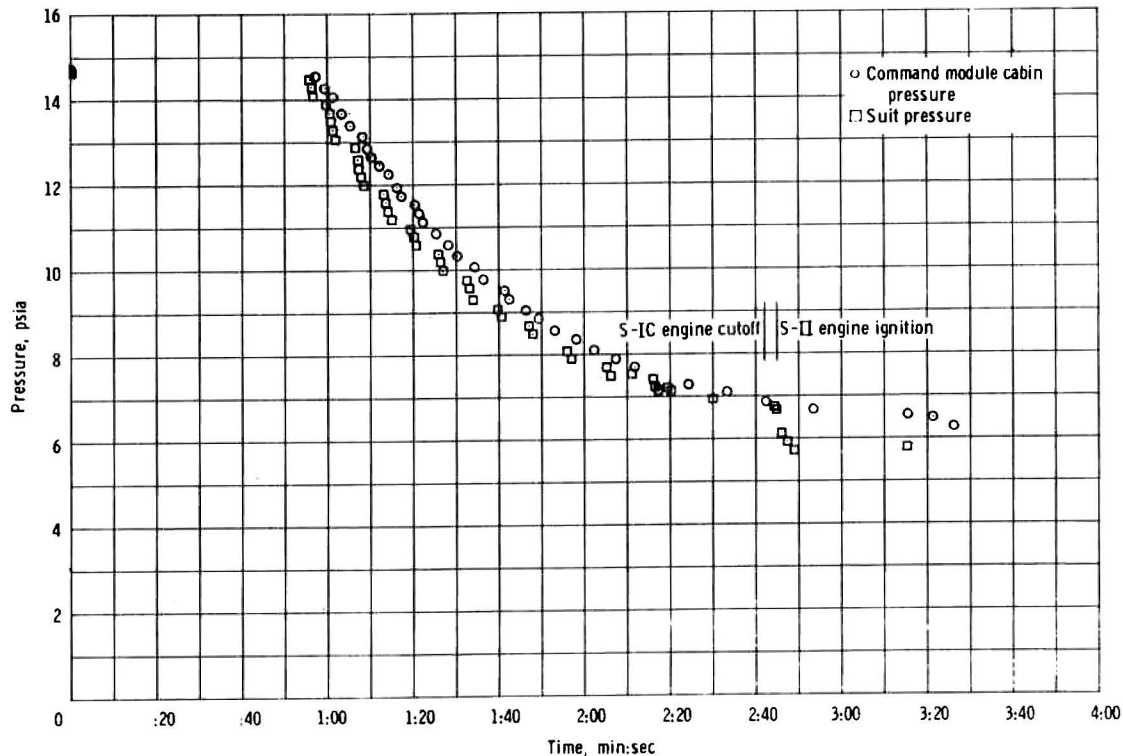
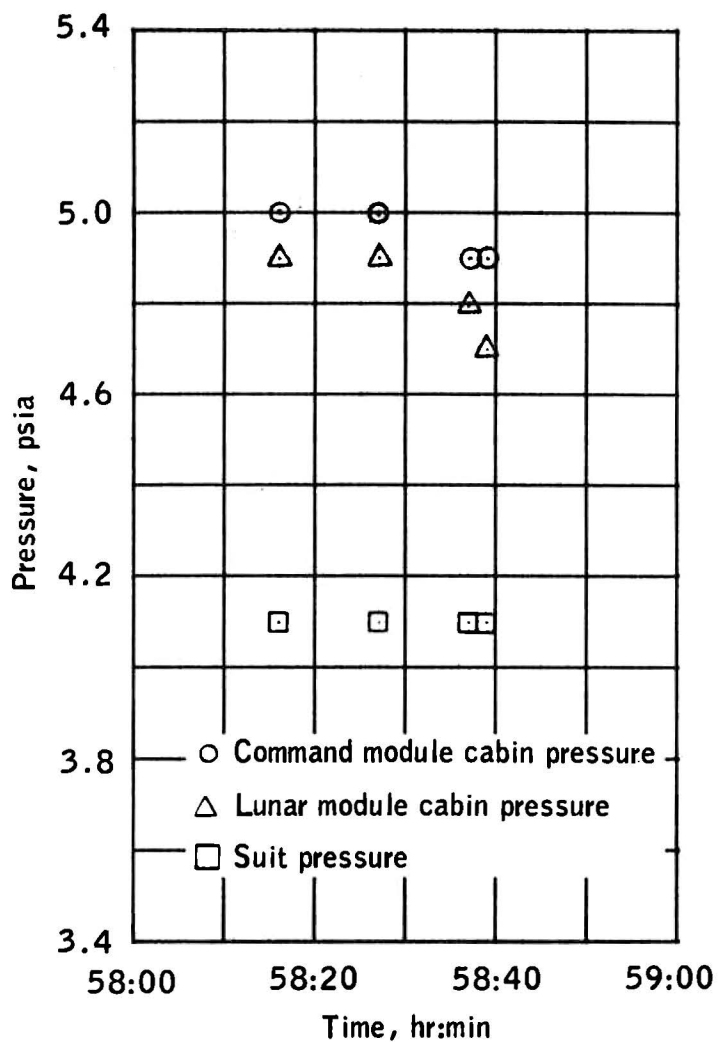
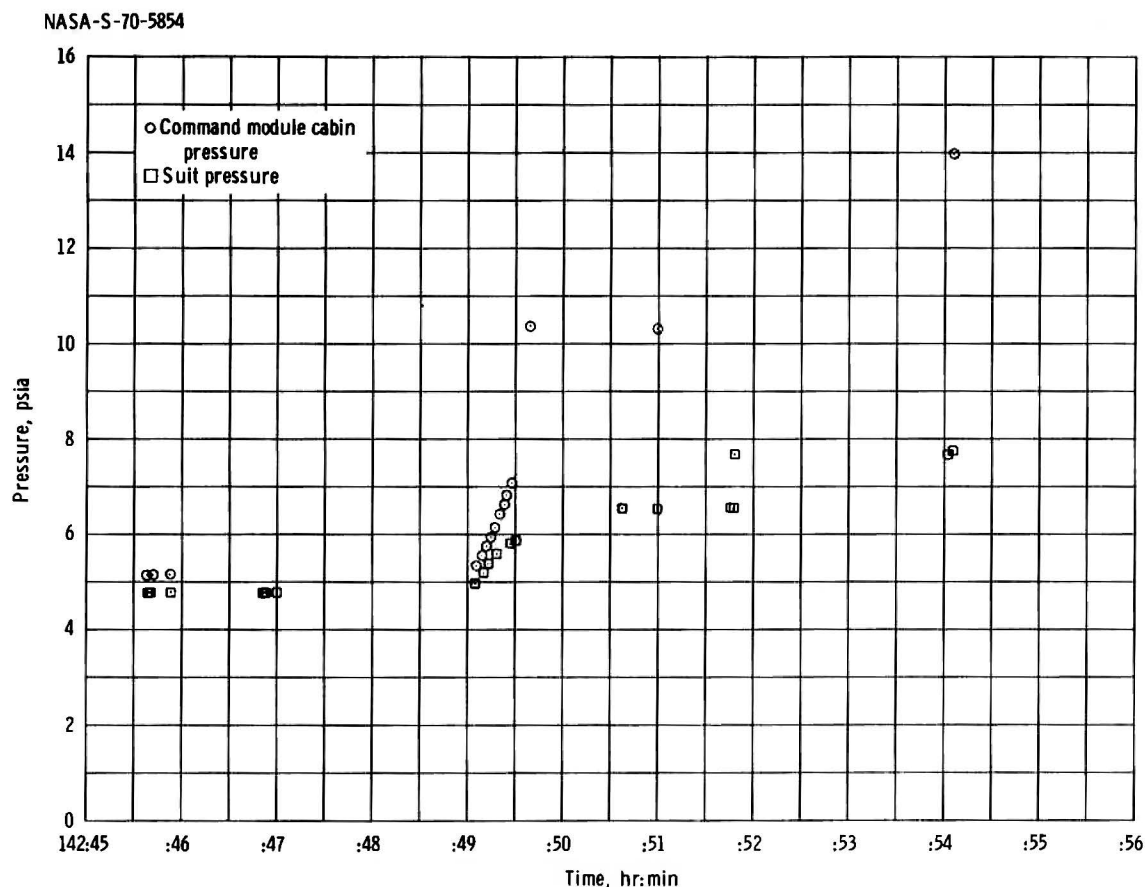
Figure 14-12.- Suit and cabin pressure.

During launch the suit pressure transducer reading remained consistent with cabin pressure until 00:02:45, then suddenly dropped from 6.7 to 5.7 psia coincidentally with S-II engine ignition (fig. 14-12). The difference between the two measurements decreased to only 0.2 by 1-1/2 hours, when the cabin reached its nominal regulated pressure of 5.0 psia. For this shirtsleeve mode, the suit and cabin pressure readings should be nearly equal. During normal variations in the command module cabin pressure, the suit pressure measurement responded sluggishly and indicated as much as 1 psi low. Subsequently, the measurement output decayed and remained in the 4.1 to 4.3 psia range for a cabin pressure of 5.0 psia until system deactivation at about 59 hours (fig. 14-12).

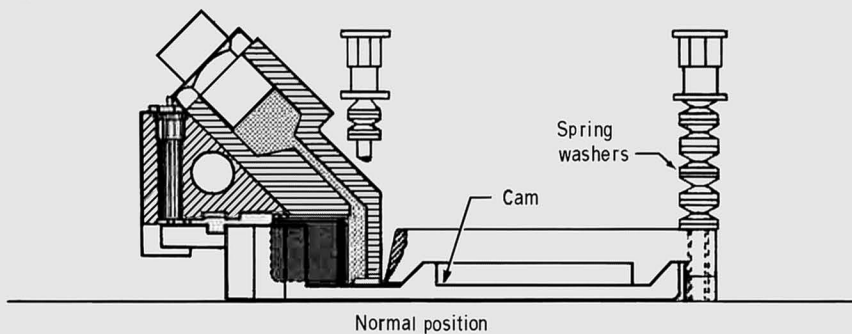
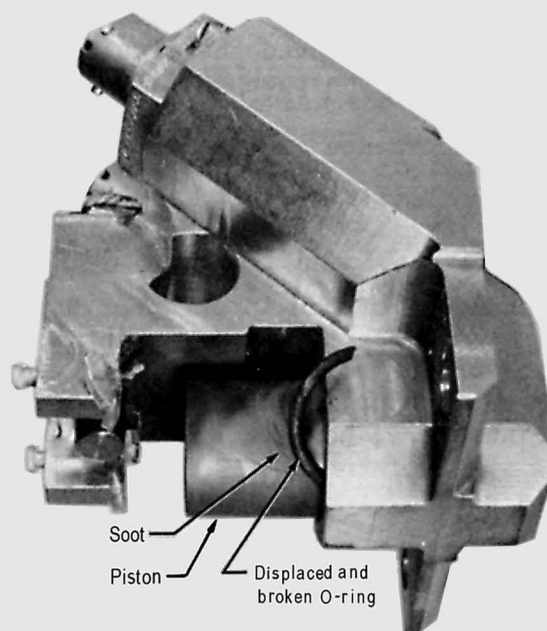
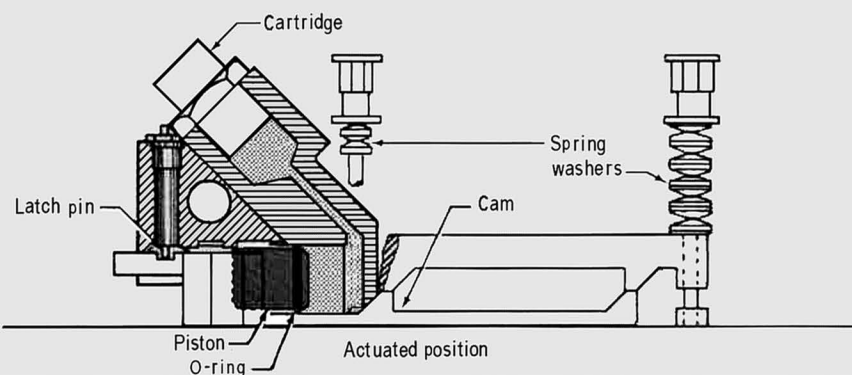
Figure 14-13.- Circuit interrupter.

During postflight inspection of the command module, propellant gas was noted to have escaped from the left-hand electrical circuit interrupter, mounted in the lower equipment bay, and deposited soot on adjacent equipment. The right-hand circuit interrupter showed no evidence of a gas leakage. The removed breech, showing the displaced O-ring and crushed attenuator block, is shown in figure 14-13.

The two interrupters open the electrical circuits about 30 milliseconds before the wires are severed by the command module/service module umbilical guillotine. As illustrated in the figure, a cam fork is moved by a piston, which is operated by propellant gas from redundant cartridges, to function a lift plate. Motion of this plate disconnects the male and female portions of electrical connectors located, respectively, in the lift plate and in the base plate of the interrupter. At the completion of the stroke, the fork is brought to rest by impacting and crushing an aluminum block mounted on the interrupter housing.

The worse-case tolerance buildup is when the fork contacts the attenuator block and the piston O-ring is 0.075 inch from entering the chamfer in the breech assembly. The O-ring enters this chamfer when the block has been crushed about 94 percent, at which point an O-ring displacement and accompanying gas escape could be expected. The factors which affect the degree of attenuator crushing are generally uncontrollable within narrow limits and include:

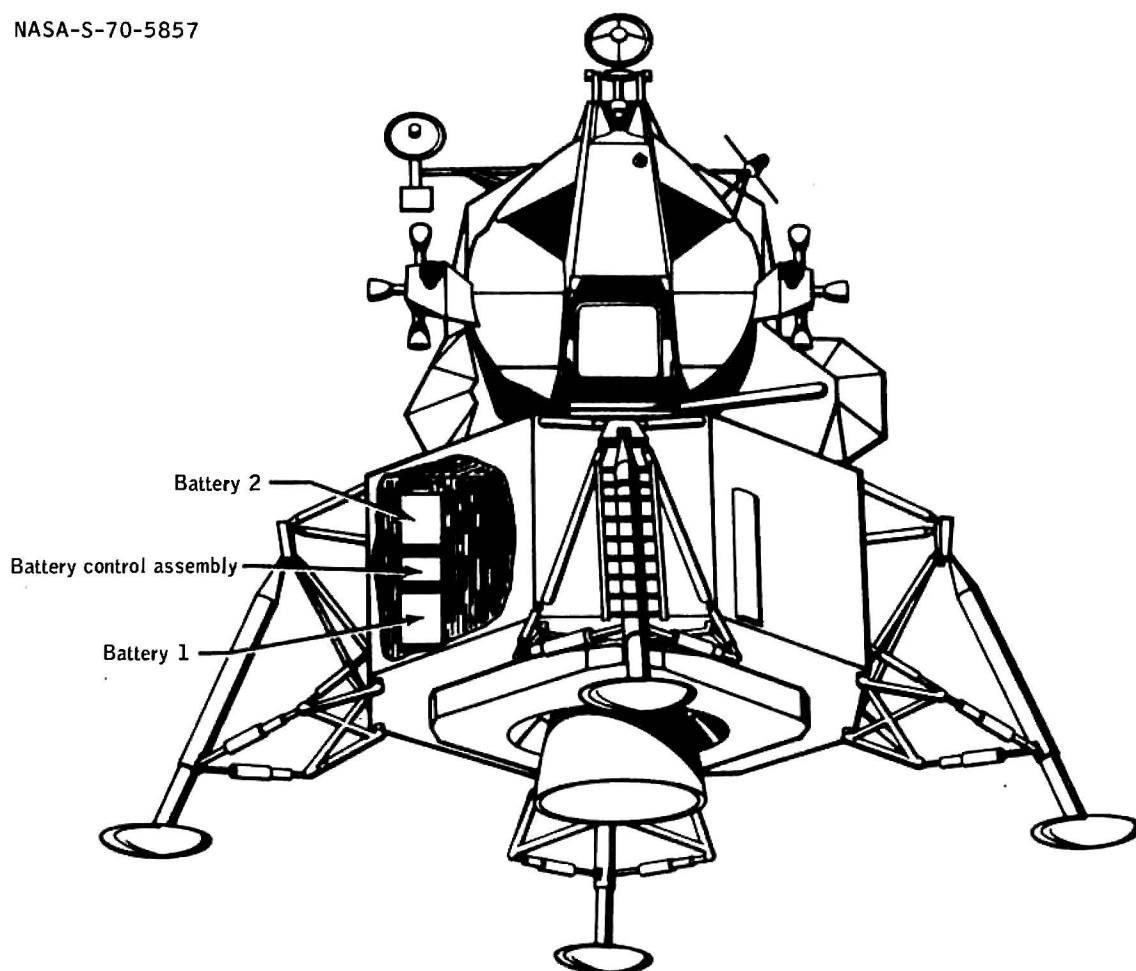
Figure 14-15.- Descent stage battery location.

At 97 hours 14 minutes, the crew reported a thumping noise and snowflakes venting from quadrant 4 of the lunar module descent stage (fig. 14-15). All four descent batteries experienced current transients at 97:13:53 for about 2 seconds, with corresponding drops in dc bus voltage (fig. 14-16). Also, the water glycol pressure differential for the heat transport system decreased momentarily, indicating that the glycol pump momentarily slowed down.

Evidence indicates that battery 2 may have experienced an electrical fault of some type. The most probable condition is electrolyte leaking from one or more cells and bridging the high-voltage or low-voltage terminal to the battery case (fig. 14-17). This bridging results in water electrolysis and subsequent ignition of the hydrogen and oxygen so generated. The accompanying "explosion" would then blow off or rupture the seal of the battery lid and cause both a thump and venting of the free liquids in the battery case, resulting in "snowflakes."

- a. Electrolyte can leak past the Teflon retention screens installed in each cell to prevent leakage.
- b. The descent battery cells contain an excessive amount of free electrolyte.
- c. The potting does not adhere to the battery case, consequently, any free electrolyte can readily penetrate the interface between the potting and the case and bridge between the terminals and case.
- d. Once an electrolyte bridge is formed, electrolysis will produce hydrogen and oxygen gas.
- e. A bridge at the positive terminal can produce a current surge of as much as 150 amperes.

For Apollo 14 and subsequent missions, the descent batteries will be modified to minimize the hazards associated with electrolyte leakage.

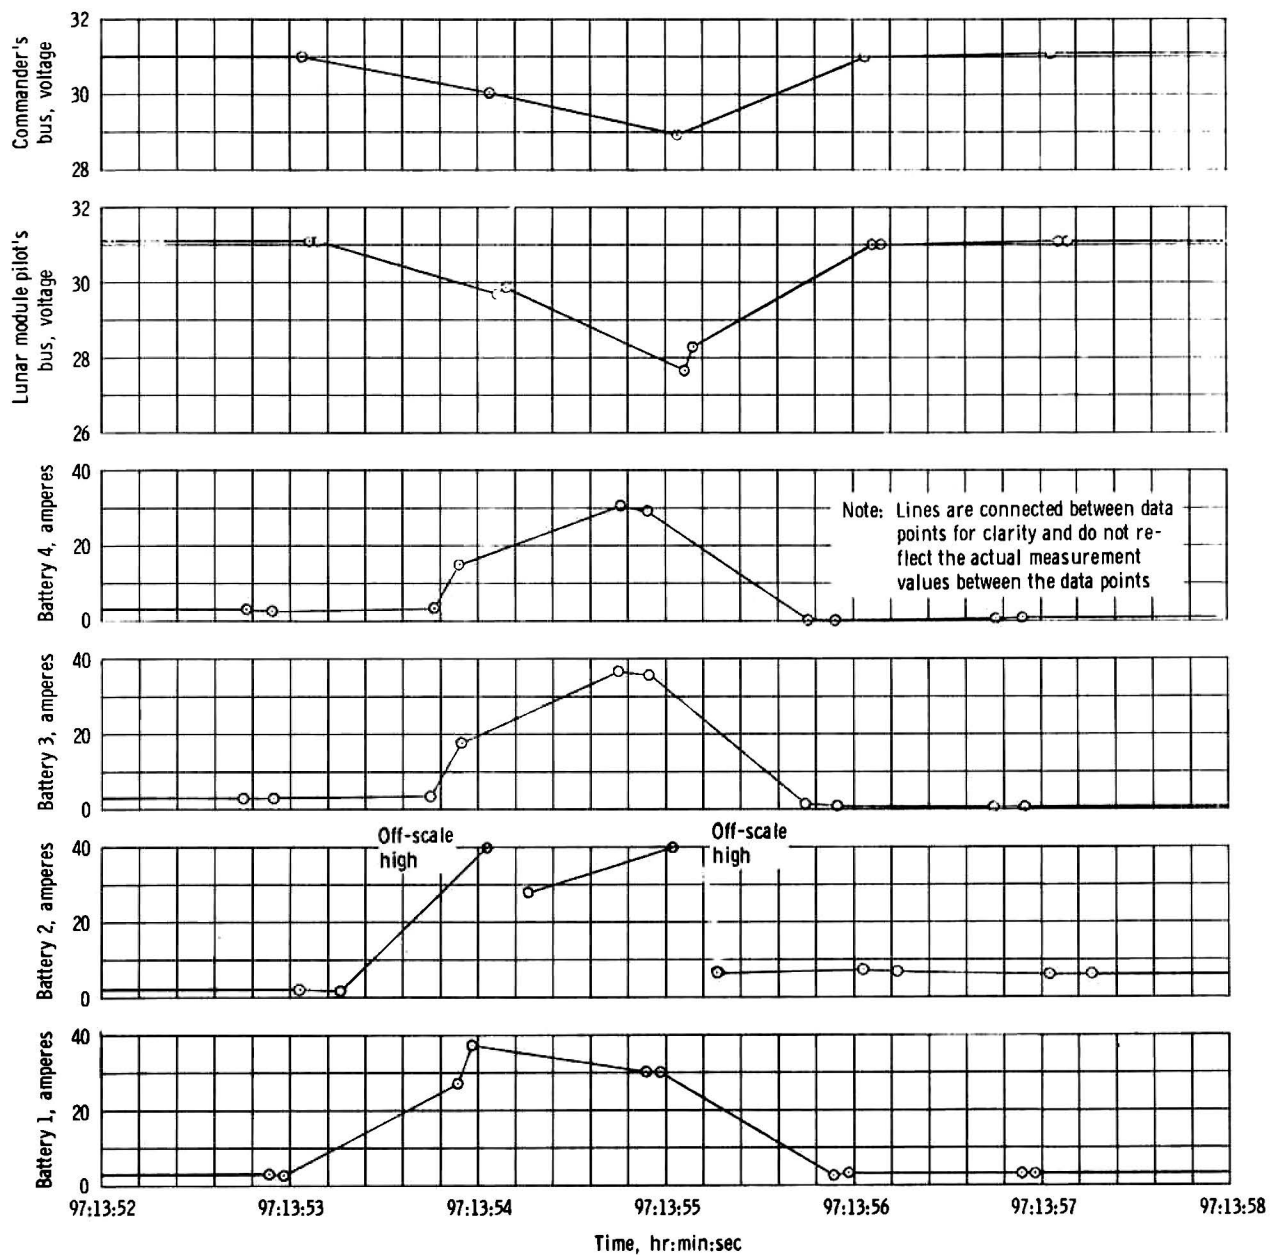
Figure 14-16.- Battery electrical transients.

The thumping noise occurred at about the same time as the current spikes. The current spikes show that a momentary short circuit existed in the Lunar-Module-Pilot side of the dc electrical system, which includes descent batteries 1 and 2 (fig. 14-16). The current surge was not of sufficient duration either to open the balance-load cross-tie circuit breakers, to display a reverse current indication, or to trip a battery-off relay as a result of an overcurrent condition.

The data show that descent battery 2 experienced at least a 60-ampere current surge. This condition could have been a reverse current into the battery, since the instrumentation system does not indicate the direction of current. Immediately after the current surges, battery 1 current returned to its original value while battery 2 provided about 80 percent of the total current load. After sustaining a surge load, the battery terminal voltage normally increases for a short period of time. Since battery 2 experienced the highest surge, it should have temporarily assumed the most load. Within 10 minutes all batteries were properly sharing the current load, and no subsequent abnormal performance was observed. At 99:51:09, battery 2 gave an indication of a battery malfunction, discussed in more detail in the next section.

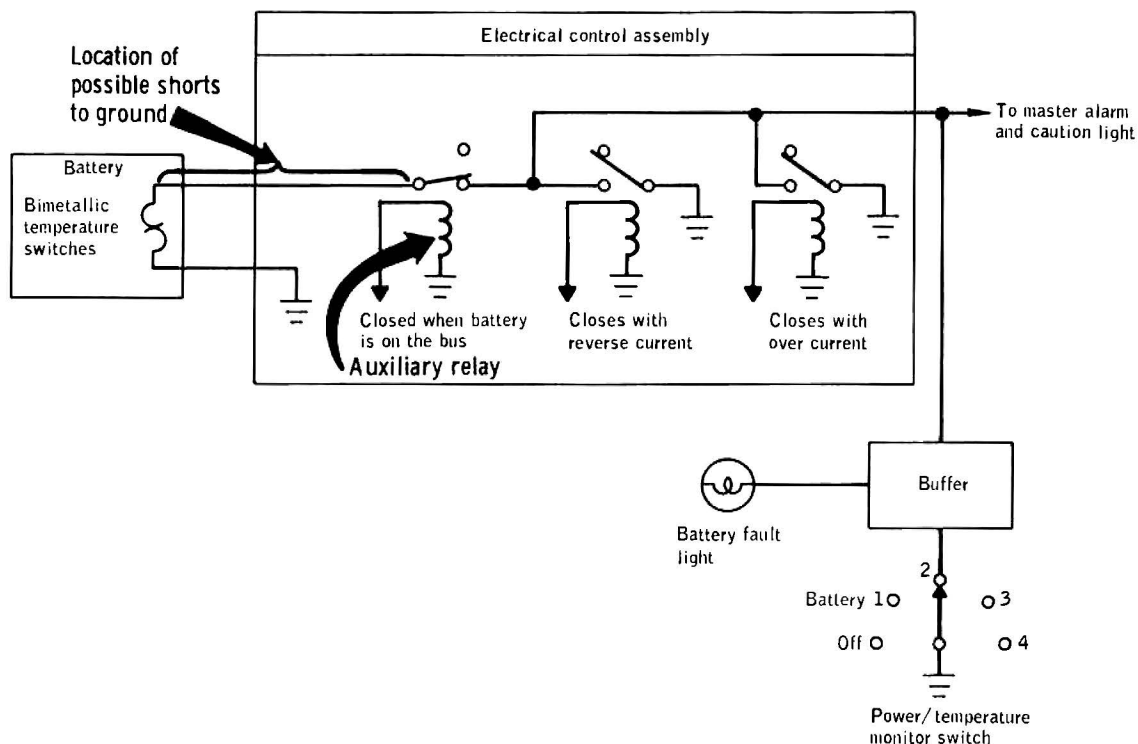
Figure 14-18.- Battery 2 malfunction circuit.

The battery malfunction light illuminated at about 100 hours with a corresponding master alarm. The malfunction, isolated to battery 2, could have been caused by an overcurrent, a reverse-current condition, an over-temperature condition, or possibly an erroneous indication. The logic for these malfunction conditions is shown in figure 14-18.

A battery overcurrent can be ruled out because automatic removal of the battery from the bus would have occurred.

A reverse-current condition can be ruled out because, if the battery is removed from and reapplied to the bus, the reverse-current circuit has a built-in delay of about 5 seconds before the reverse-current relay is again activated to illuminate the light. Battery power was removed from and replaced on the bus in flight, and the light immediately illuminated again when the battery was reconnected.

An over-temperature condition can be ruled out because, after the battery was replaced on the bus, the light remained illuminated for a brief period and then began flickering intermittently. A flickering light cannot be caused by the temperature sensing switch because of a temperature hysteresis of approximately 20° F in the switch. The water glycol loop temperature also indicated that the battery temperature was normal.

Either a short between the temperature switch wires to ground or a contamination in the auxiliary relay would actuate the light. The shorted condition could have resulted from electrolyte shorting within the battery case associated with the current surges discussed in the previous section. Contamination of the auxiliary relay has occurred in the past, and relays already packaged were not retrofitted since a false over-temperature indication can be identified as it was here.

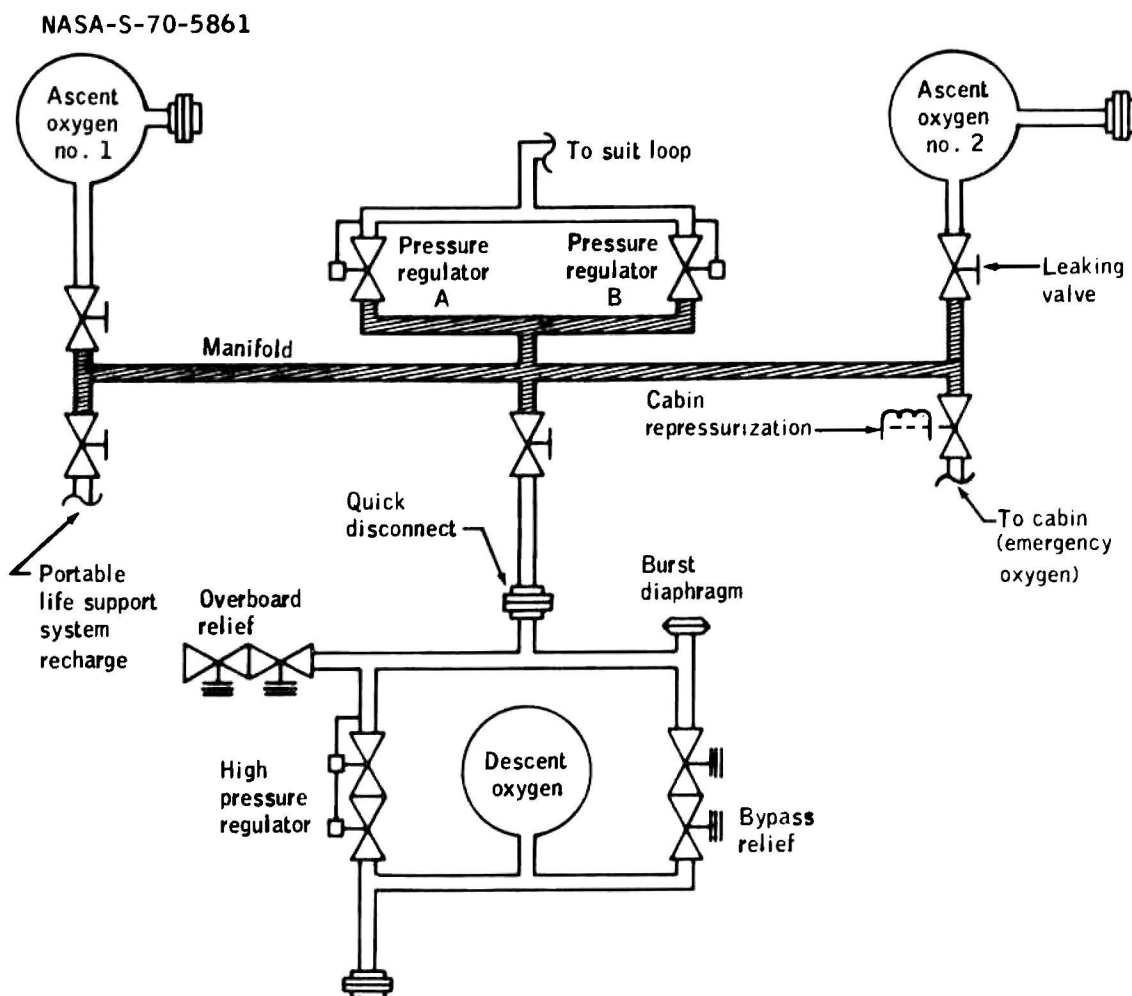
Figure 14-19.- Oxygen-supply system.

During the flight, the pressure in the ascent stage oxygen tank 2 increased, indicating a reverse leakage through the shutoff valve from the oxygen manifold (fig. 14-19) into the tank. The leak rate, with a maximum differential pressure of 193 psi, varied from about 0.22 lb/hr (70 000 scc/hr) to zero when the tank pressure reached manifold pressure. Allowable leakage for the valve in either direction is 360 scc/hr. Pre-flight test data indicate a reverse leakage of 360 scc/hr and no excessive leaking in the forward direction.

The internal portion of three valves of this type had been replaced previously on the spacecraft because of excessive leakage through the ascent oxygen tank 1 shutoff valve. In one valve, a rolled O-ring

(fig. 14-20) caused the leakage. When the valve is installed, the forward O-ring can be rolled and damaged when it passes the manifold port. In the other two valves, the cause was not identified and was assumed to be contamination.

The production tolerances of the valve and bore were examined to determine if a tolerance buildup problem existed. The manufacturer's specification to which the valve was designed requires that the O-ring be subjected to a compression of between 0.0115 and 0.0225 inch, whereas the O-ring supplier recommends between 0.011 and 0.017 inch. The added

Leak tests previously performed on the valve were inadequate, in that only reverse leakage at high pressure was determined. For future vehicles, forward and reverse leakage at both high and low pressures will be measured to detect any defective valves.
