**MSC APOLLO 13 INVESTIGATION TEAM**

## SPACECRAFT INCIDENT INVESTIGATION

### ANOMALY INVESTIGATION

June 10, 1970

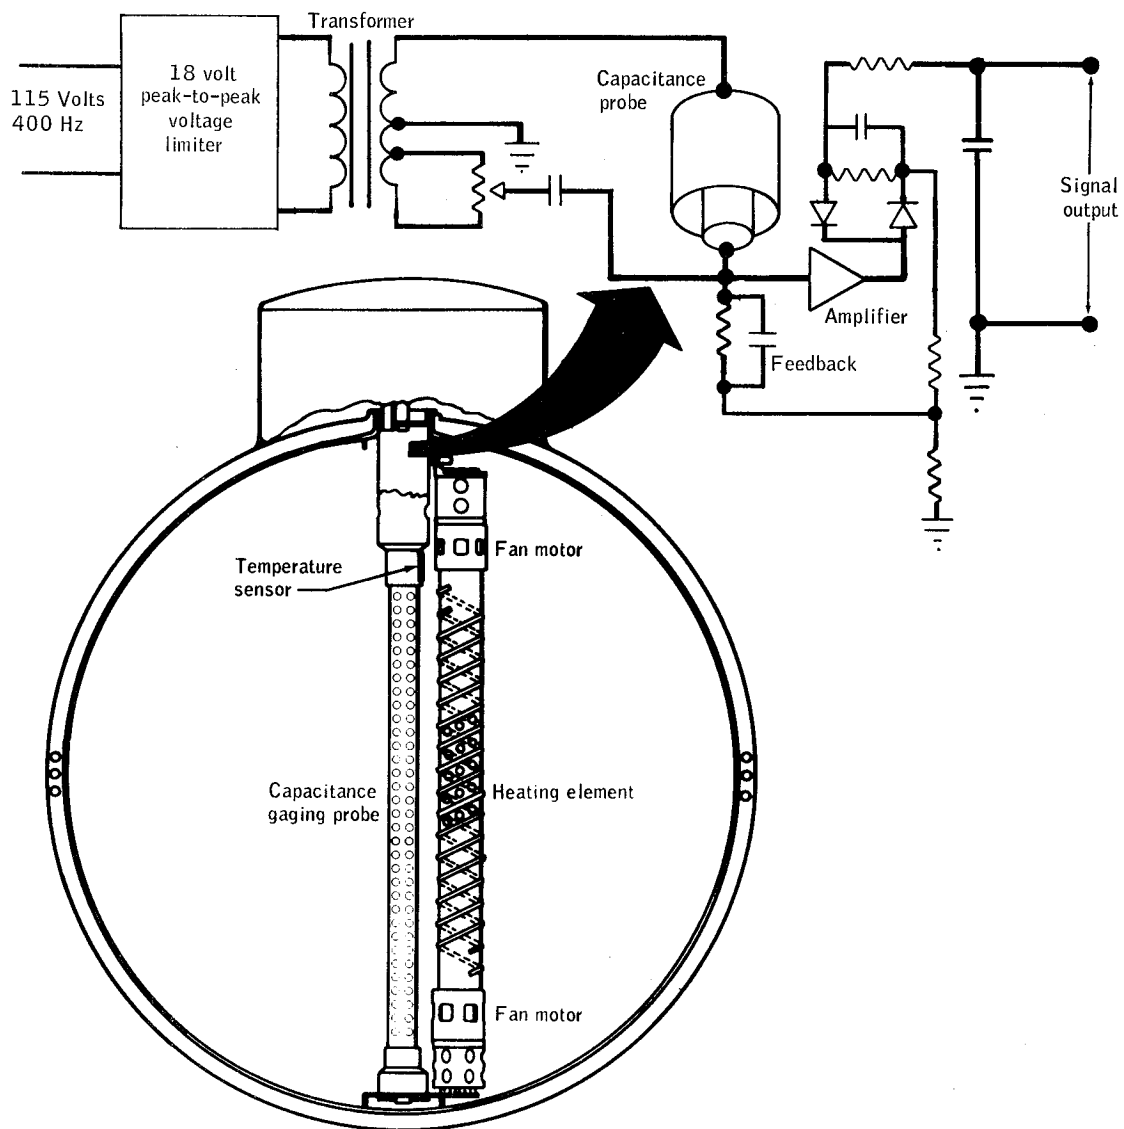
Figure 4-1.- Quantity gage.

The first anomalous inflight condition associated with the cryogenic oxygen tank 2 occurred at 46:40:06 when the ac-powered destratification fans in both cryogenic oxygen tanks were turned on. Within about 3 seconds after fan activation, the quantity measurement for cryogenic oxygen tank 2 abruptly indicated full-scale high. This system indicates density of the cryogenic oxygen by measuring its dielectric constant, which is a function of density. This instrument is a capacitor which consists of two concentric aluminum tubes inside the tank (fig. 4-1).

Tests have shown that an open-circuit in the leads to the capacitor assembly or a short across the capacitor or its leads will drive the output to full scale. If this short-circuit is removed, the output signal drops abruptly from full scale to zero, and then in about a second, it settles out to the proper reading, as noted in the data of figure 4-2. This agrees with the flight data from the quantity probe. Tests also show that if the inner tube is shorted to ground, the output may oscillate in a random manner. Such an oscillation was noted several minutes after data recovery following the incident. It should be noted that with a short-circuit in the quantity gaging system inside the tank, the maximum current that could be drawn is 15 milliamperes.

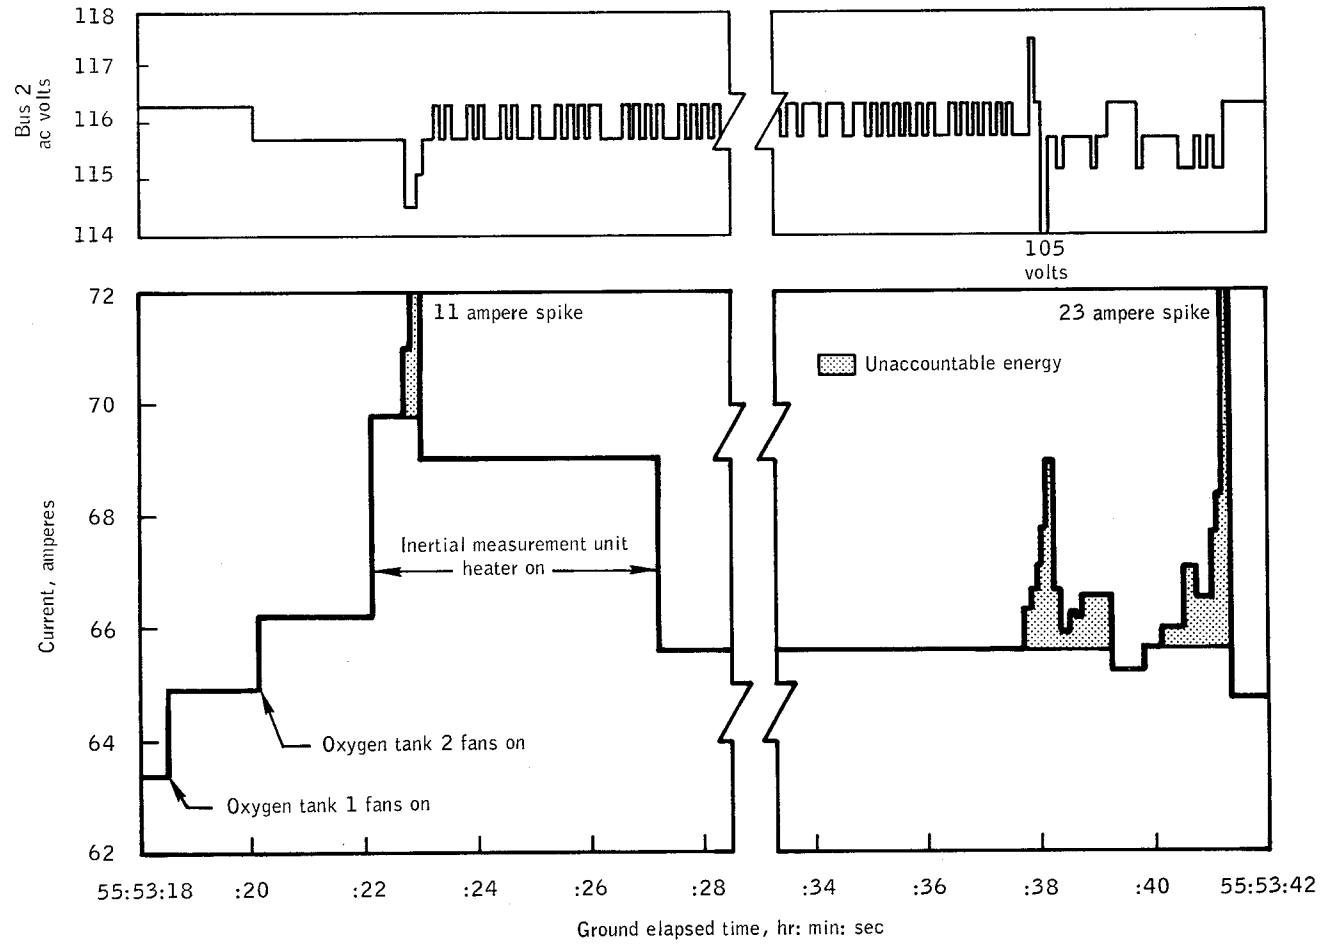
Figure 4-5.- Spacecraft current and ac voltage during period of interest.

The first indication of a short on ac bus 2 appeared about 2-1/2 seconds after activation of the cryogenic oxygen tank 2 fans. The ac bus 2 voltage dropped 1.2 volts, the fuel cell 3 current increased 11 amperes (fig. 4-5), and the stabilization and control system gimbal command data experienced a transient. Subsequent to the short, the spacecraft current data show a decrease of 0.8 ampere from the level just prior to the short. Also, the ac bus 2 voltage started to toggle-up 0.6 volt, or one data bit (fig. 4-5). These data indicate that a load was removed from ac bus 2 and that it was approximately one-half the load normally applied when the cryogenic oxygen tank 2 fans were turned on. This indicates that a short in one of the two fan motor circuits in cryogenic oxygen tank 2 caused its fuses to blow.

Approximately 200 milliseconds later, the ac bus 2 voltage momentarily decreased 11 volts (fig. 4-5), and the total spacecraft current increased 3.5 amperes, indicating an increased load. After the momentary decrease, the ac bus 2 voltage reading was 0.6 volt less than the previous indication. This could be an indication that a single phase short on phase B or C was removed by blowing a fuse.

About 20 seconds after the first short, the third ac bus 2 short occurred. Fuel cell 3 current increased 23 amperes, and the stabilization and control system data again indicated a transient (fig. 3-1). Subsequently, the total spacecraft current level decreased to the same level as it was prior to turning on the cryogenic oxygen tank 2 fans. This indicates that power to the remaining cryogenic oxygen tank 2 fan was removed by blowing its fuses due to this short. Also, the ac bus 2 voltage increased to the same level as that prior to turning the tank 2 fans on (fig. 4-5).

The electrical energy that could not be accounted for by normal spacecraft loads (fig. 4-5) is attributed to the shorts. Calculations were made of the maximum energy levels that could have been transmitted through the circuit during these shorted conditions and that would still meet the constraints imposed by the flight data resolution and sampling times, inverter performance, fuse clearing time, and dc and ac bus voltage sensor performance. Inverter performance and fuse clearing time tests were performed to provide data for the energy calculations. The energy calculations are summarized in table 4-I.

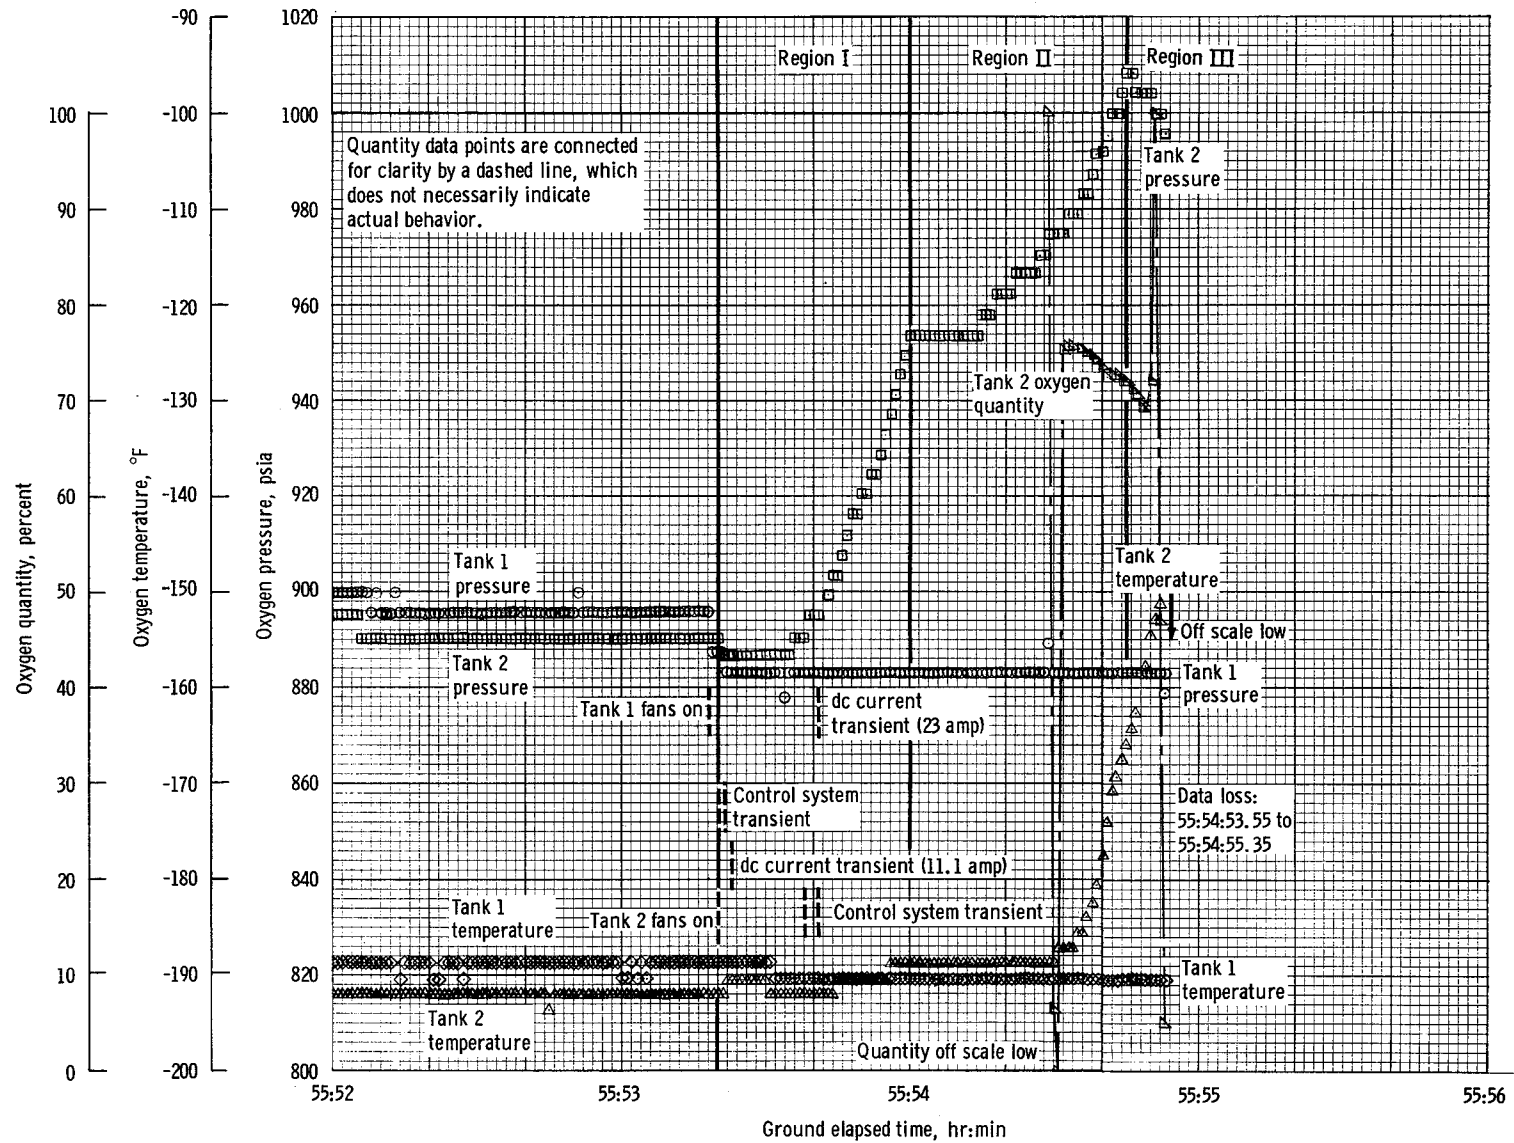
Figure 4-10. - Pressures, temperatures, and quantities during period of interest.

While the pressure was rising sharply in cryogenic oxygen tank 2, changes occurred in the temperature indication (fig. 4-10). The temperature data are obtained from a sensor located on the quantity probe assembly (fig. 4-8) within the tank. The temperature increased about 2° F during the first pressure rise (region I). A temperature increase of this magnitude is in accord with that expected due to the pressure rise alone.

The significant aspect of the temperature data is the rapid rise rate commencing approximately 24 seconds prior to loss of data (fig. 4-10). Several analyses were performed to interpret the data. The results indicated that a temperature range of 600° to 2900° F could produce the observed response. This wide temperature span is a result of the geometric configurations which are possible. The significant results from these analyses confirmed that the combustion source was near the sensor during the period of rapid temperature rise. Just prior to the loss of data, the temperature dropped to zero, indicating an open circuit failure in the measurement circuit.

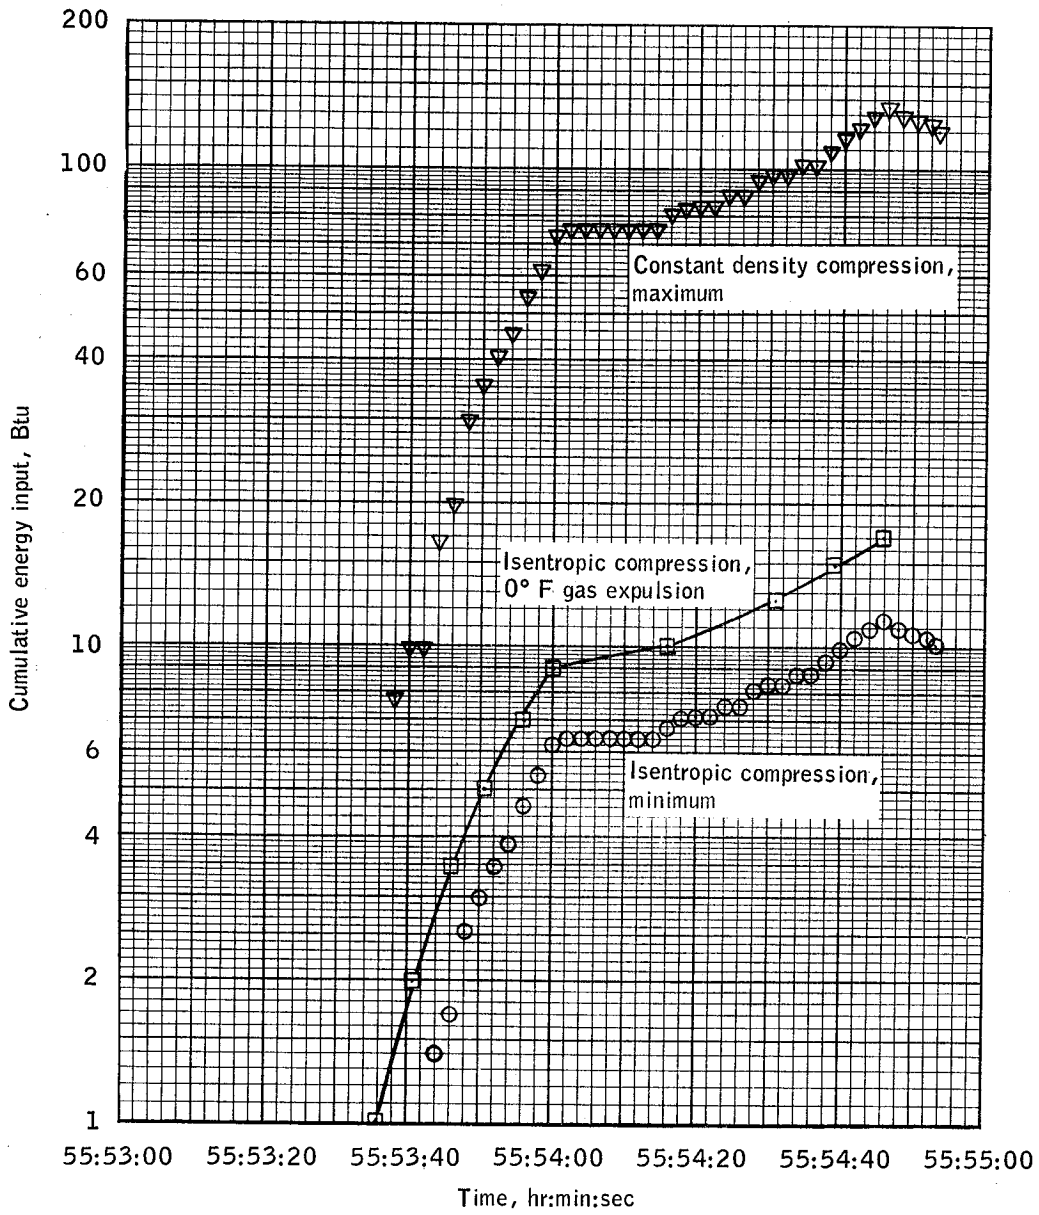
Figure 4-12.- Oxygen tank 2 energy addition.

The maximum energy input to satisfy the observed pressure rise is a constant density heating process. This condition is shown by the upper curve of figure 4-12. A second process, which establishes the minimum energy input, is an isentropic compression of the fluid. This compression is represented by all the energy input being confined to a small bubble, which has no mass. The resulting thermodynamic state is one of higher pressure in the tank. The result of this process is depicted by the lower curve of figure 4-12.

In actuality, the energy input into the tank lies somewhere between the maximum and minimum energy input curves shown in the figure. The process is modeled by a hot oxygen bubble of constant uniform temperature, growing at a rate sufficient to isentropically compress the surrounding cryogenic oxygen. This formulation accounts for mass transfer both to the hot mass (to increase the volume) and from the hot mass (tank outflow). This mass transfer requires a larger energy input to sustain the pressure rise. The center curve of figure 4-12 shows a comparison of this model with the maximum and minimum energy models. The results (fig. 4-13) are dependent upon the temperature of the hot mass. Note that while the energy input increases by approximately 300 percent, the hot mass volume changes only 10 percent. Therefore the energy source is confined to a small region within the tank, and is essentially independent of the temperature of the burning material.

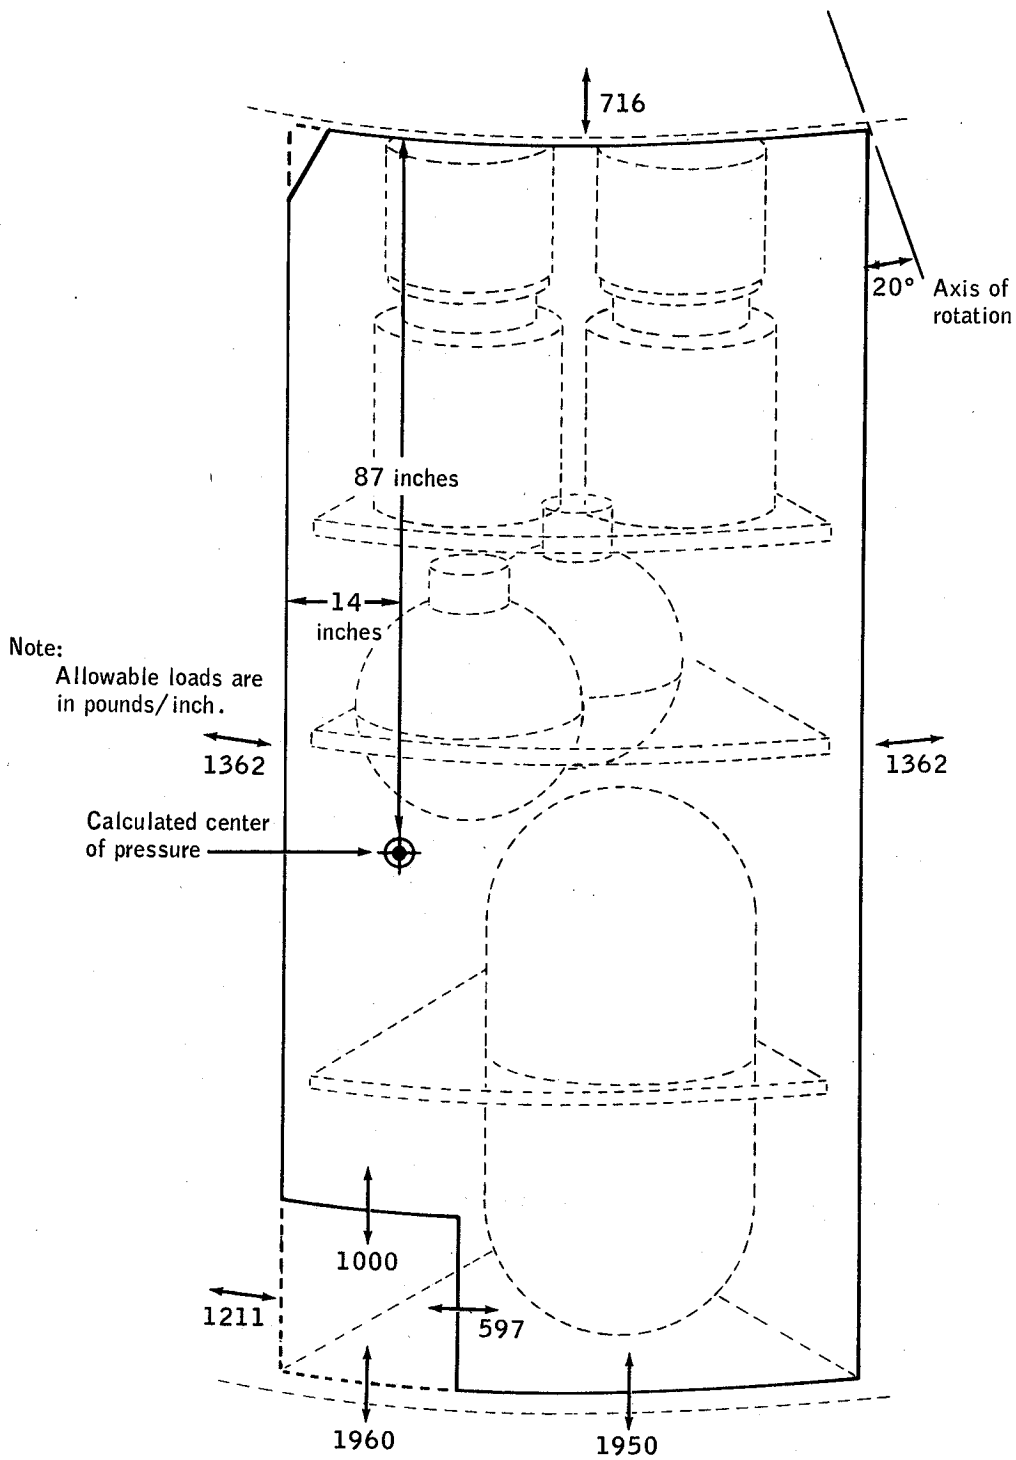
Figure 4-23.- Joint design allowables and axis of rotation.

Because of the evidence which suggested primarily membrane behavior, simplified representations of the structure were used to investigate its behavior. Structural analyses were performed for numerous pressure distribution as well as for temperature gradients for both hot and cold inner facesheets. The results show that the peak pressure must exceed 20 psi and that temperature gradients of interest result in small edge loads. The static allowables for failure with a failure mode of shear tearout are shown in figure 4-23.

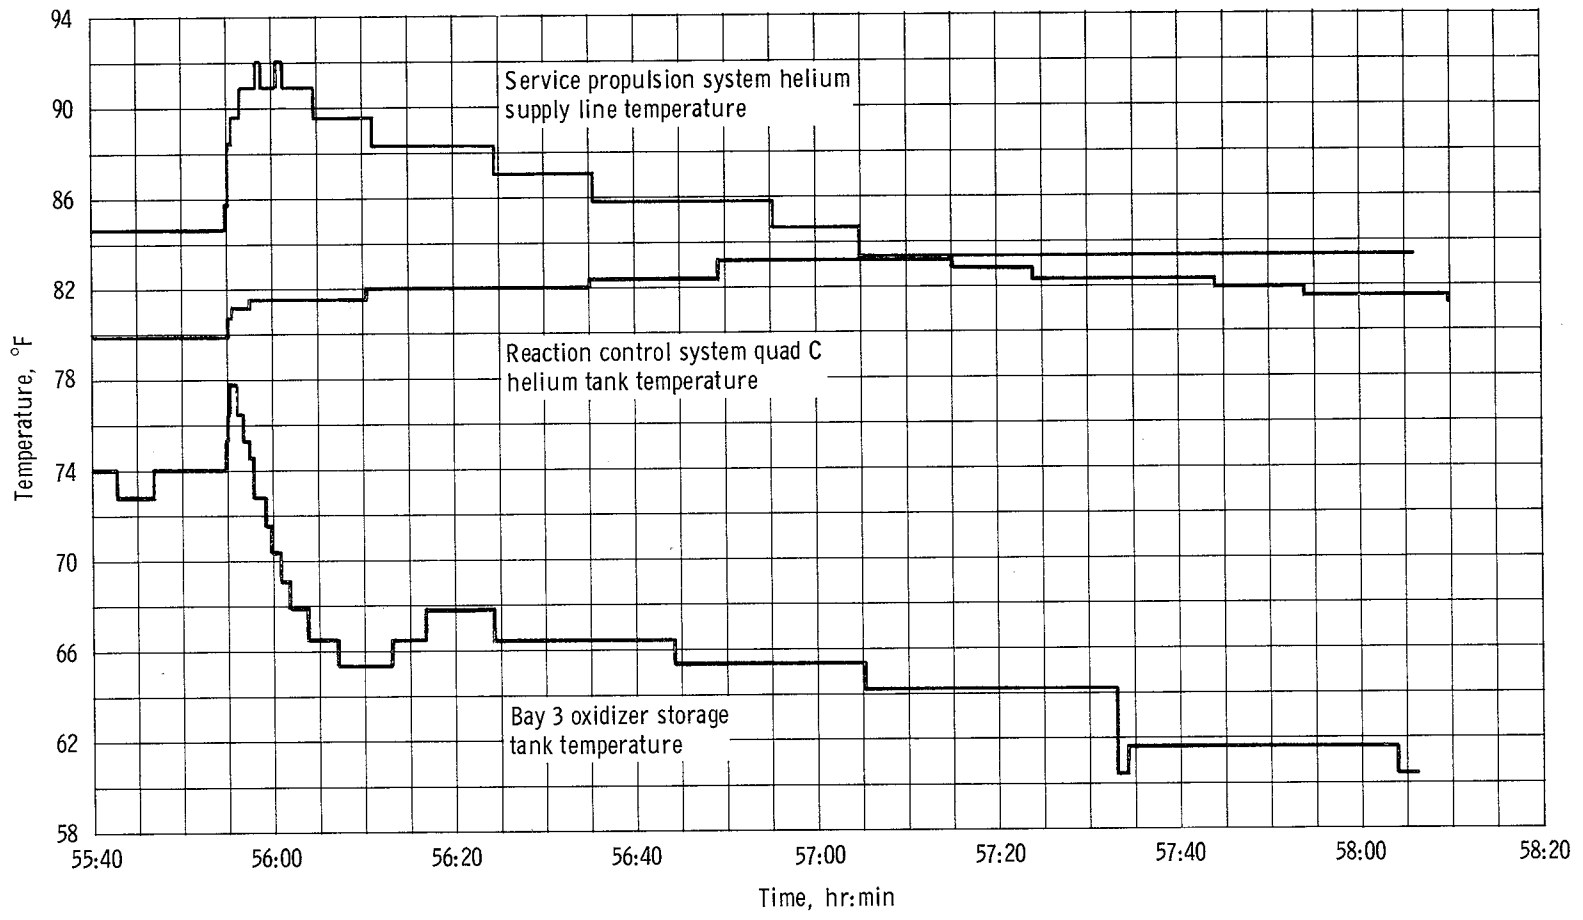
Figure 4-32. - Bay 3 and 4 structural temperatures.

The bay 3 oxidizer tank surface temperature increased from 73.4° to 77.7° F in about 20 seconds (fig. 4-32). The temperature then decreased to 60° F about 2-1/4 hours later. Data received during the two command and service module power-up cycles at 101:55:54 and 123:05:25 showed 60° and 65.3° F, respectively. The rise rate of bay 3 service propulsion system oxidizer surface temperature is indicative of direct heating in the vicinity of the transducer, which is attached to the tank skin and covered with 30 layers of insulation.

Heat inputs to the bay 3 service propulsion tank surface transducer depend on the thermal integrity of the multilayer insulation blanket covering the transducer. To obtain the noted response requires severely degraded insulation, probably because of burning of the insulation or pressurization of the bay with hot gas.

The service propulsion helium line temperature (fig. 4-32) increased from 84.6° to 89° F in about 37 seconds. In 2 more minutes, the temperature had increased to 92.2° F. A gradual cooling trend followed, and 10 minutes later, the temperature had decreased to 83.4° F. During the two command and service module power-up cycles at 101:55:54 and 123:05:19, the helium line temperatures were 72.1° and 65.9° F, respectively. The initial rise rate is again indicative of direct heating in the vicinity of the transducer. However, unlike the oxidizer tank surface temperature, the gradual decrease in helium line temperature, after the initial rise, is indicative of a cool-down response to radiant heat loss. The helium line cooled gradually because of the lower temperature levels with the fuel cells shut down and the bay 4 panel missing.

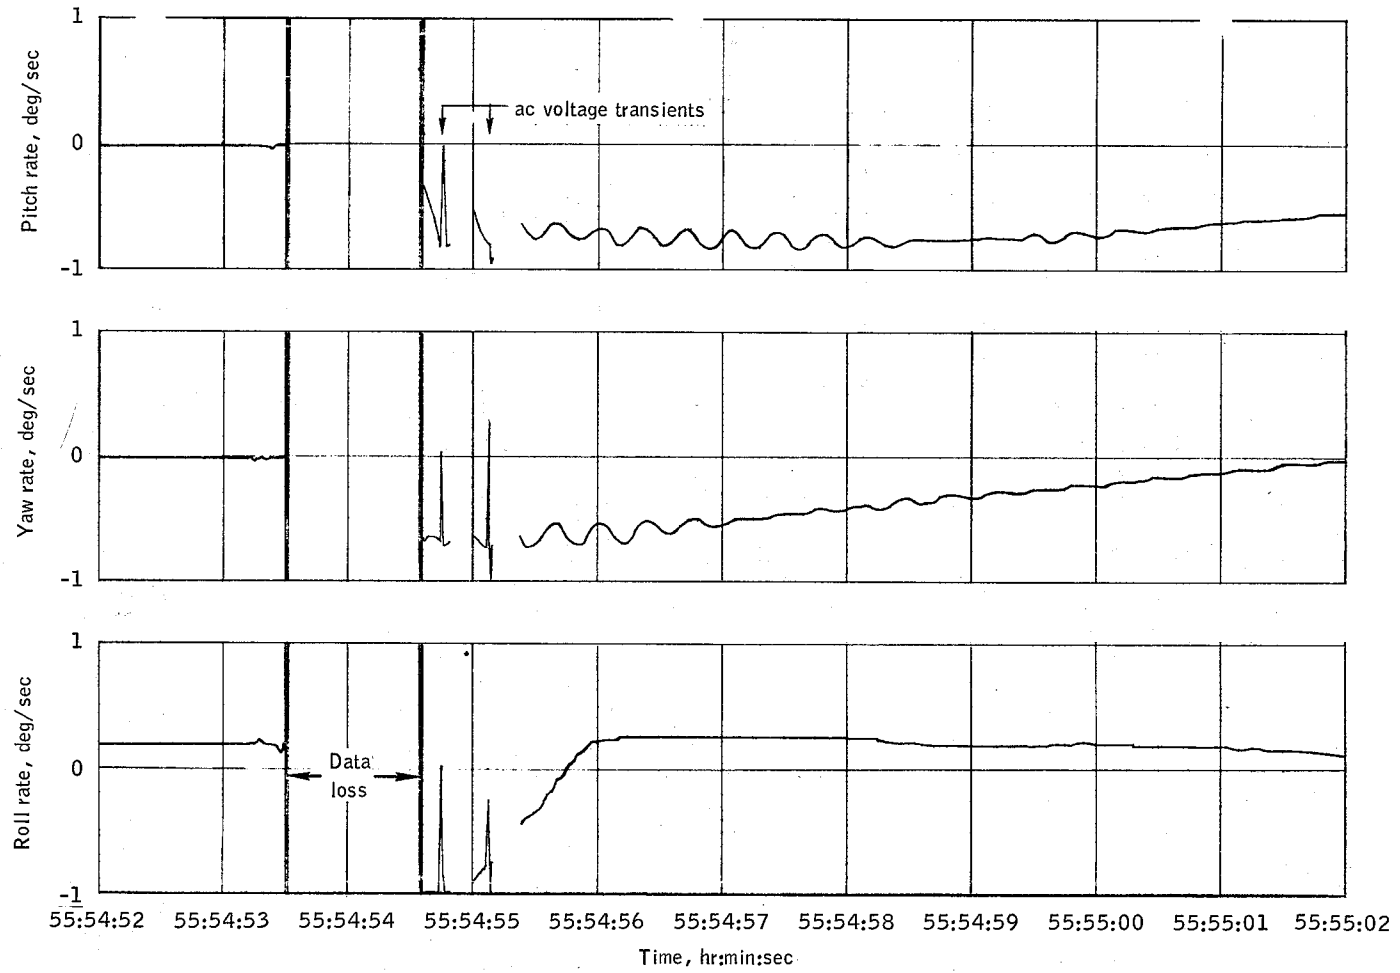
The stabilization and control system recorded the small body rate oscillations described in section 4.6, at 0.28 second before the loss of data. When data were regained, negative rates were present in all three axes (fig. 4-34). The oscillations shown in the pitch and yaw axes on the figure are predominantly due to excitation of the first bending mode (2.7 hertz). The reaction control engine firings which occurred following resumption of data were proper for the conditions that existed. The resulting angular accelerations in pitch and roll, however, indicate that only one thruster was acting in each axis and that quad C was inoperative. The total attitude change was small (fig. 4-35).

Figure 4-34.- Spacecraft dynamics during cryogenic oxygen tank 2 anomaly.

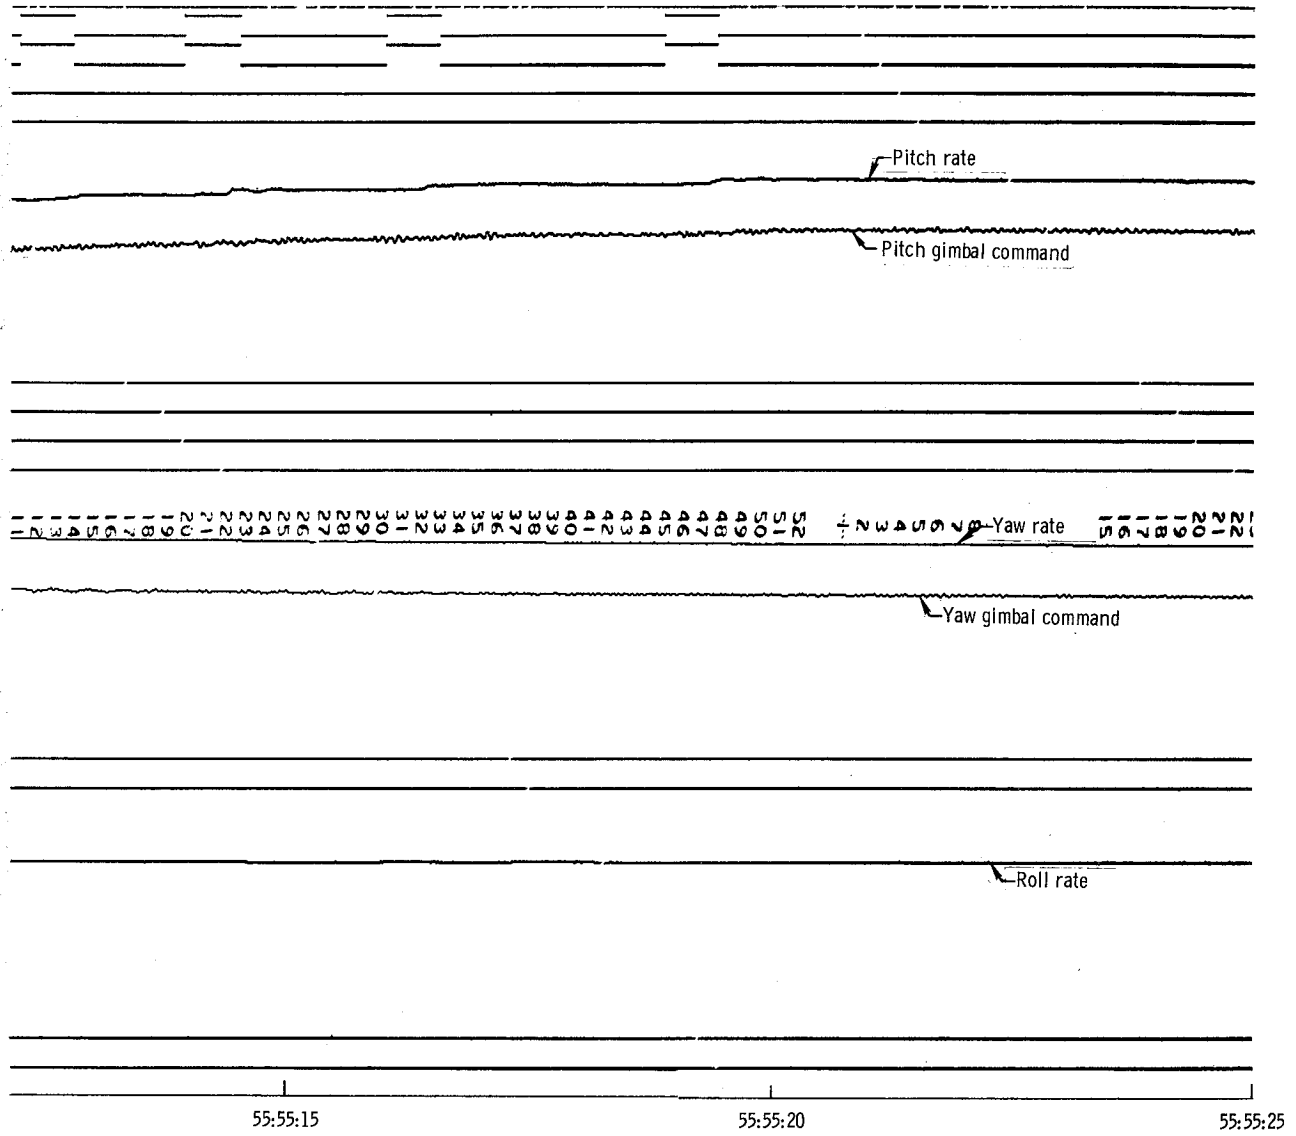
Figure 4-35. - Spacecraft dynamics during period of interest.

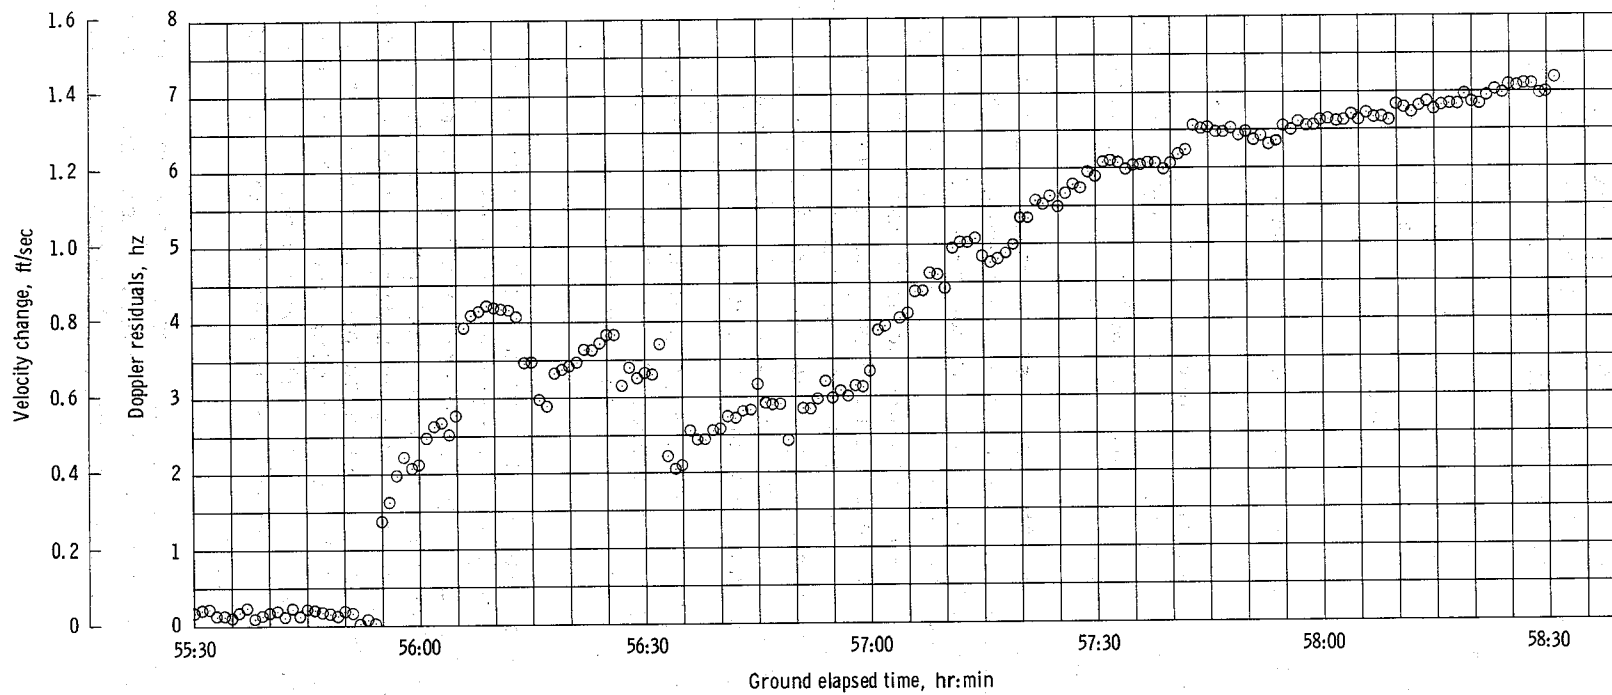
Venting followed the incident and attitude control was maintained automatically by the digital autopilot until the loss of main bus B when the last minus pitch thruster was disabled. Periodic attempts were made to reestablish attitude control manually using the thruster emergency coils until the thrusters were reconfigured to main A. The venting disturbance torque is shown in figure 4-36. Figure 4-37 contains a time history of network doppler data and shows the effect of venting as well as uncoupled thruster firings.

Figure 4-37. - Network doppler data during period of interest.

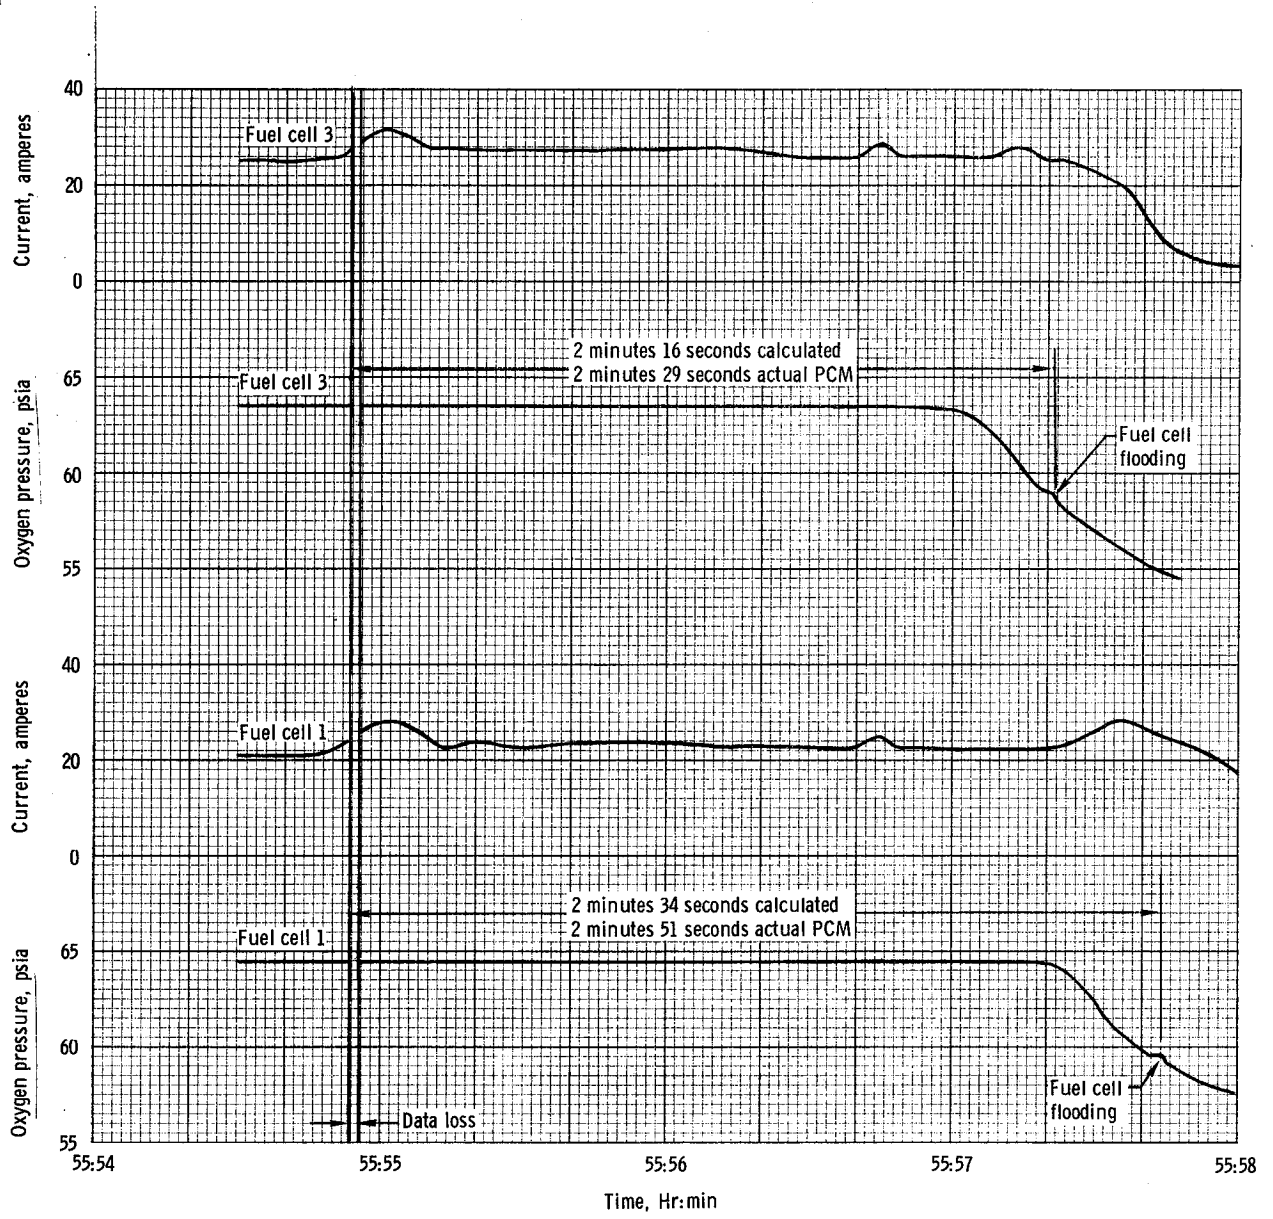
and the fuel cell oxygen regulators. This oxygen was sufficient for fuel cell operation for about 2.5 minutes, the time required to deplete the trapped supply. The agreement between the calculated and actual operating time after valve closure (fig. 4-40) verifies that fuel cells 1 and 3 were starved of oxygen and eventually could not support an electrical load.

Figure 4-40. - Fuel cells 1 and 3 performance loss.

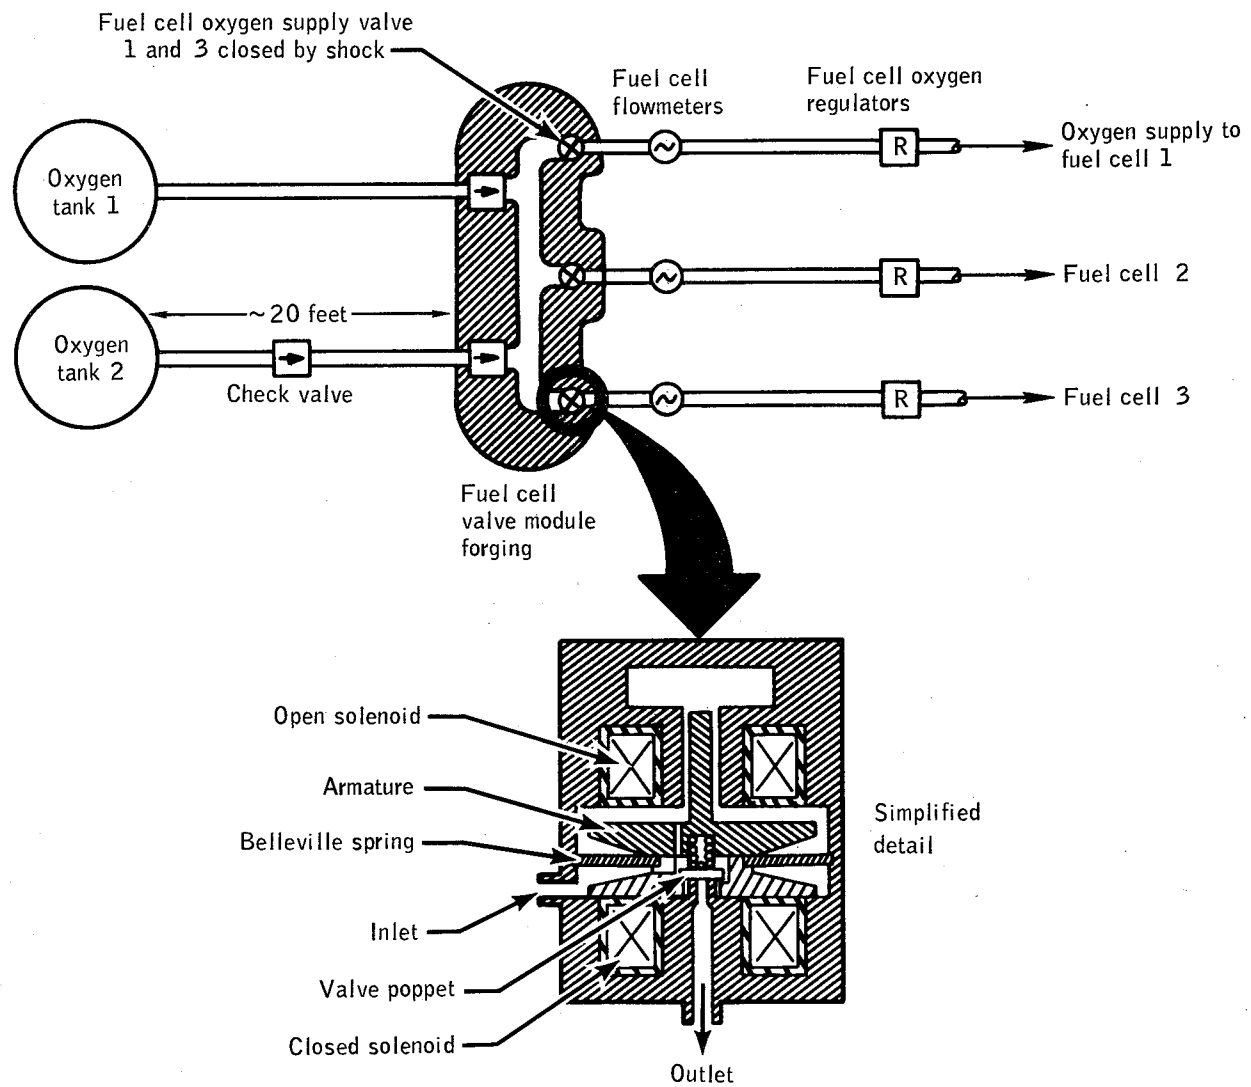
Impact tests on the oxygen solenoid valves (fig. 4-41) show that a shock in excess of 86g for 11 milliseconds duration can be expected to cause valve closure under operating conditions.

Figure 4-41.- Solenoid valves for oxygen supply.

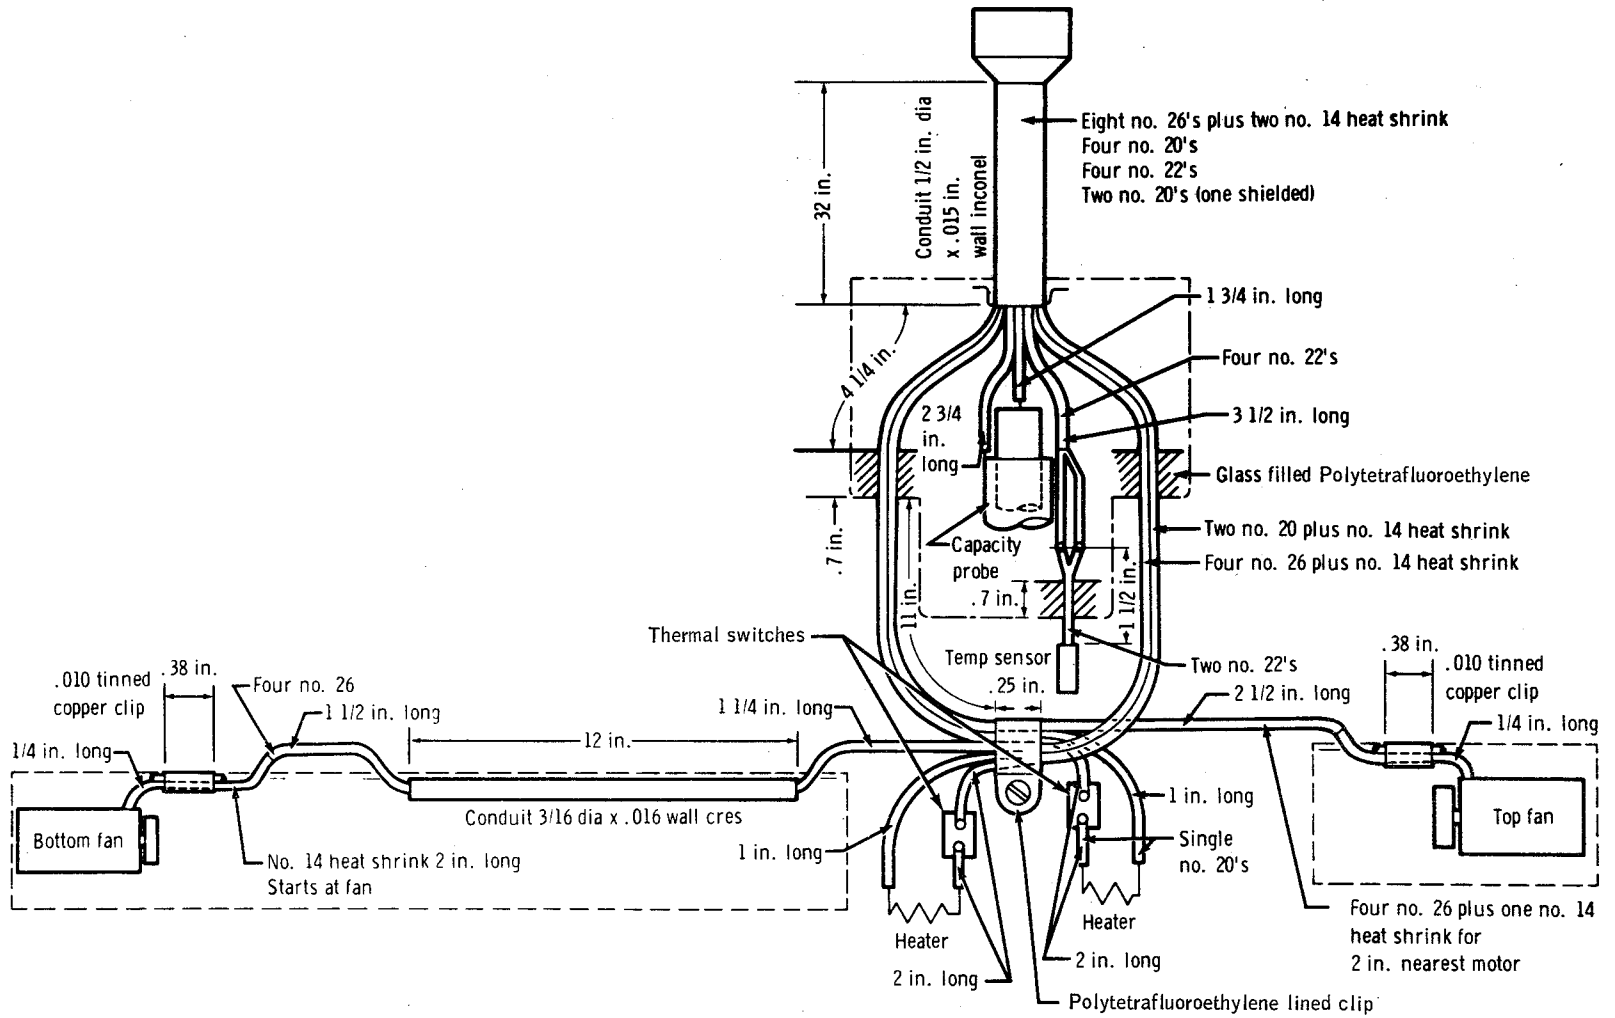
The fan wiring leads consist of two harnesses of four wires each for the two 3-phase fan motors. Wires (MIL-W-16878, type E) are 26-gage nickel and are coated with 0.010-inch polytetrafluoroethylene insulation. Also, each harness of four wires is covered in some regions with a polytetrafluoroethylene sleeve of approximately 0.012-inch thickness. Wire runs of the two fan harnesses are as indicated in figure 4-42 and are identical, except that the lower fan harness is routed through a tube in the heater assembly.

Figure 4-42.- Wiring distribution within cryogenic oxygen tank.

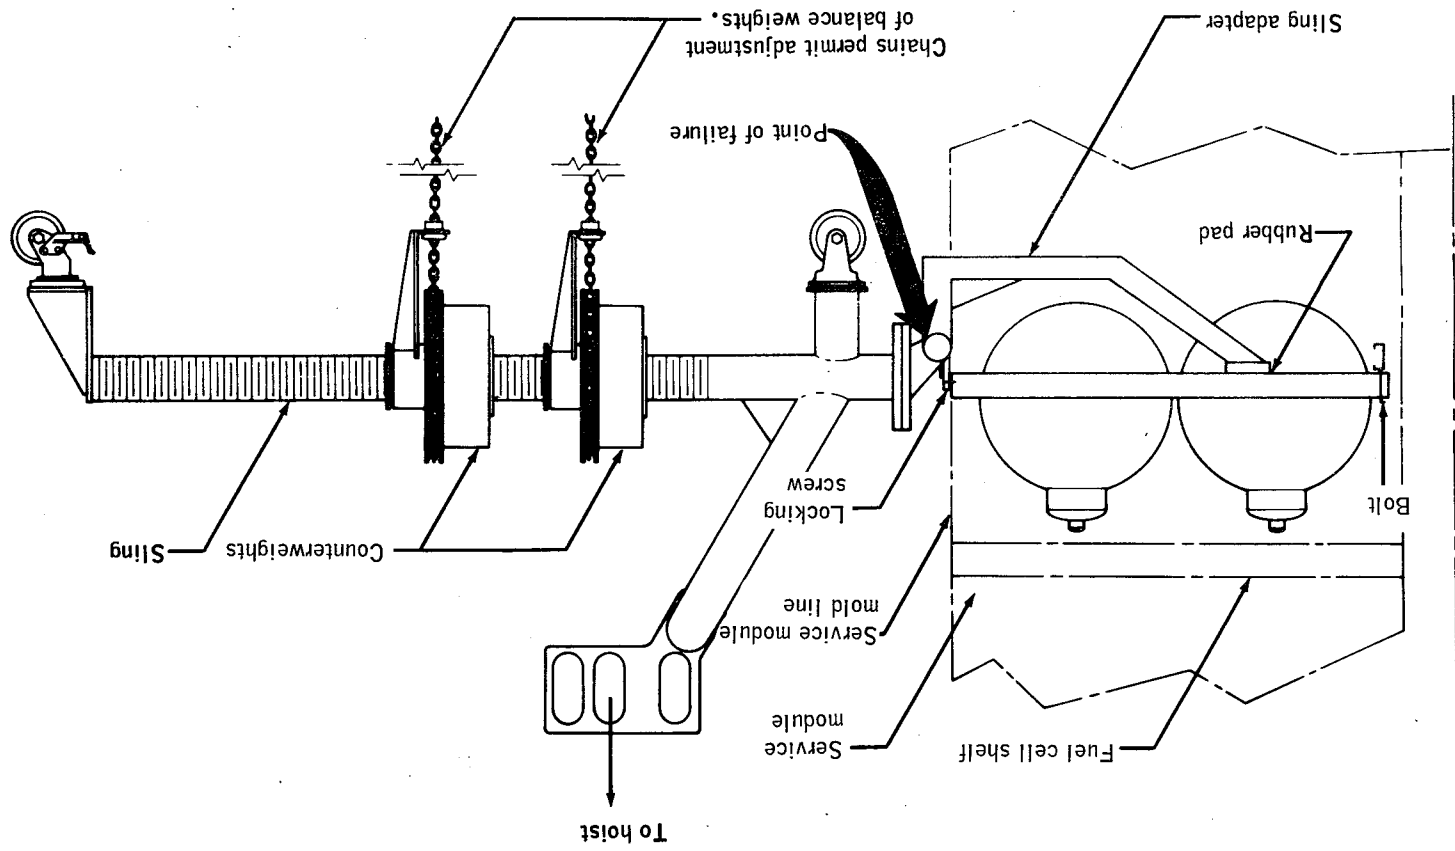
A detailed assessment was also made of the incident where the oxygen shelf hoist assembly failed during the factory removal of the tank shelf from the Apollo 10 spacecraft (fig. 5-1). Analysis and test show that the maximum shock upward would be about 7 g's, and the maximum shock downward would be about 15 g's. Analytically, the components within the tank would be expected to withstand 100 g's shock. Consequently, this condition is not believed to have contributed to the ultimate failure of the tank in flight.

Figure 5-1. - Oxygen shelf and hoist assembly.
