**MSC APOLLO 13 INVESTIGATION TEAM**

## SPACECRAFT INCIDENT INVESTIGATION

### ANOMALY INVESTIGATION

June 10, 1970

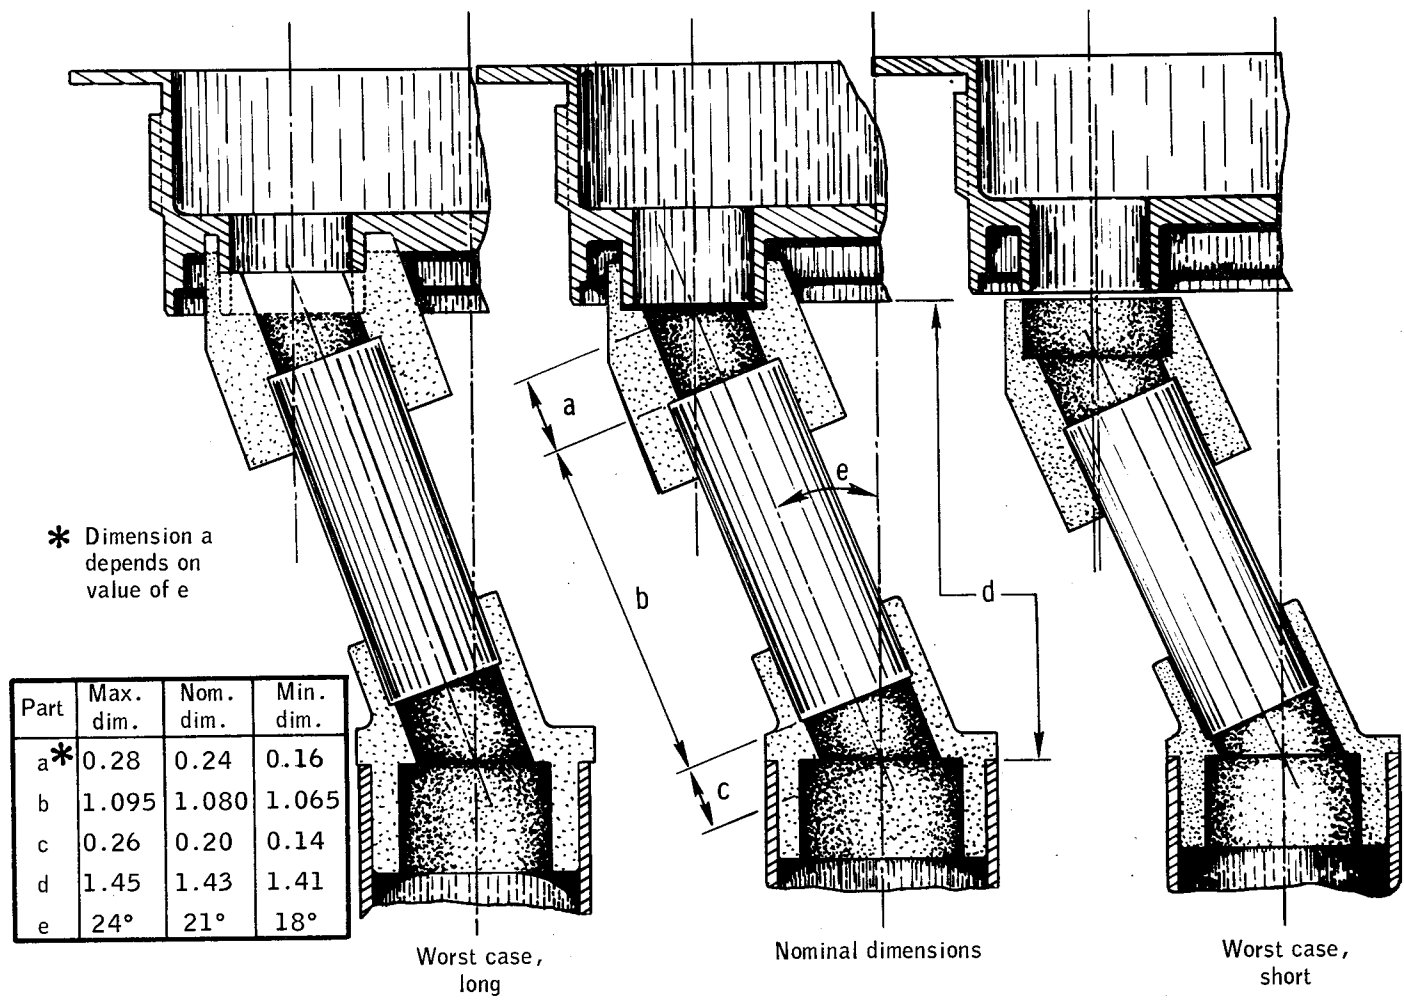
The cryogenic oxygen tank 2 could not be off loaded after the initial filling during the countdown demonstration test using the normal procedures. The problem resulted from loose or misaligned plumbing components in the dog-leg portion of the tank fill path (fig. 5-2). Allowable manufacturing tolerances are such that the tank may not be detanked normally under these conditions. A test has verified this fact. The condition of loose plumbing in the probe assembly, which existed in the tank before the detanking, was judged to be safe for flight in every aspect.

Figure 5-2.- Manufacturing tolerance study.

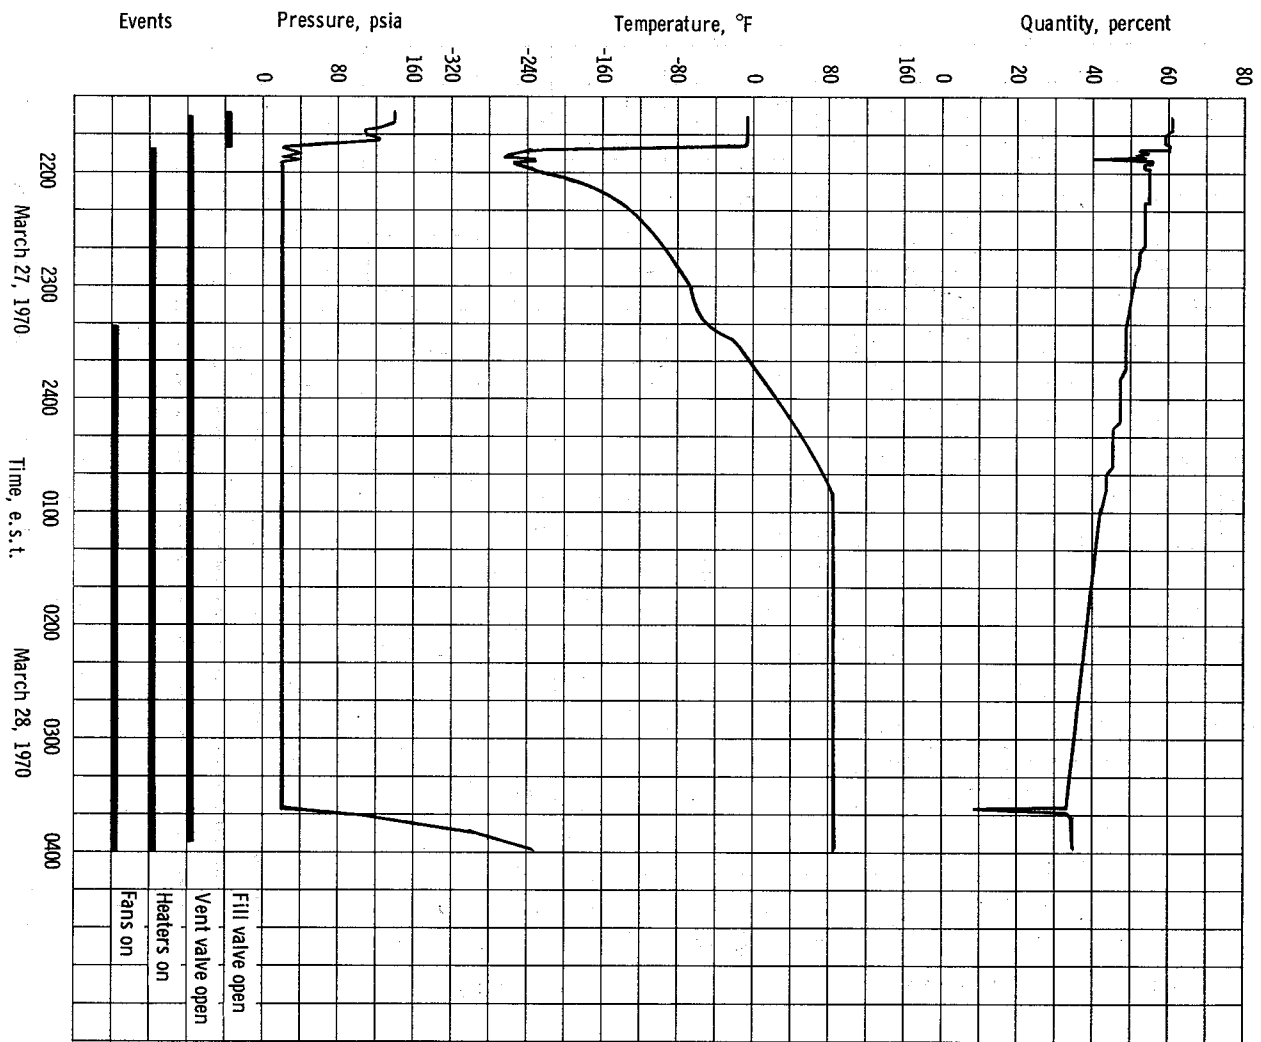
After numerous attempts with gaseous oxygen purges and higher expulsion pressures in an attempt to remove the fluid, the fluid was boiled off through the use of tank heaters and fans, assisted by pressure cycling. The sequence of detanking is shown in figures 5-3 and 5-4. The heater-on time was about 8 hours. It was thought that no damage would be sustained by the tank or its components because of the protection afforded by the internal thermal switches.

Figure 5-3. - Characteristics of oxygen tank 2 detanking using fans and heaters (CDDT).

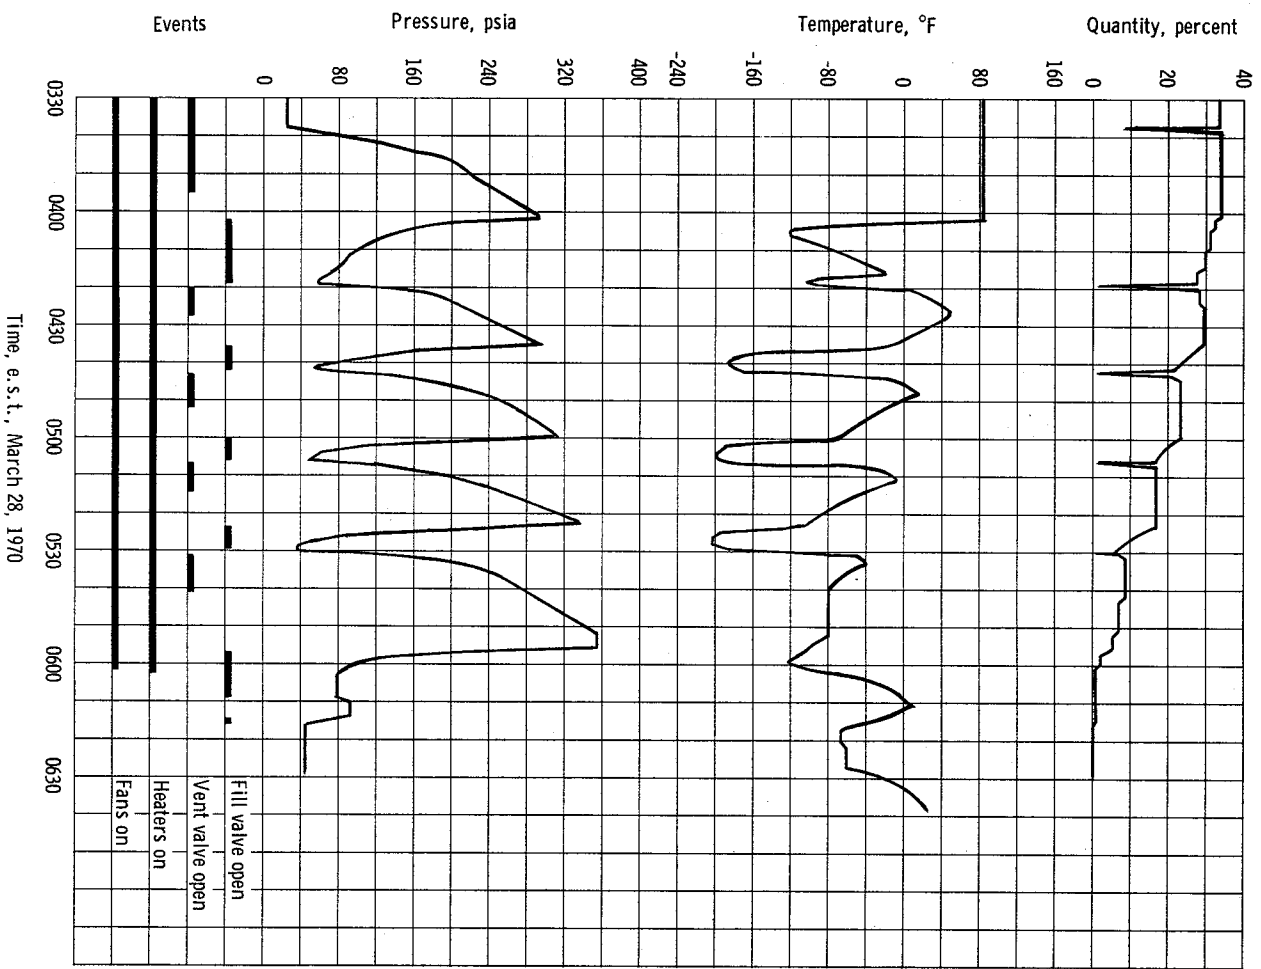
Figure 5-4. - Characteristics of oxygen tank 2 detanking using fans, heaters, and GSE pressure (CDDT).
