MANNED SPACECRAFT CENTER INTERNAL NOTE

APOLLO 13 CRYOGENIC OXYGEN TANK 2 ANOMALY

ANOMALY REPORT NO. 1

APOLLO 13 MISSION
CRYOGENIC OXYGEN TANK 2 ANOMALY REPORT

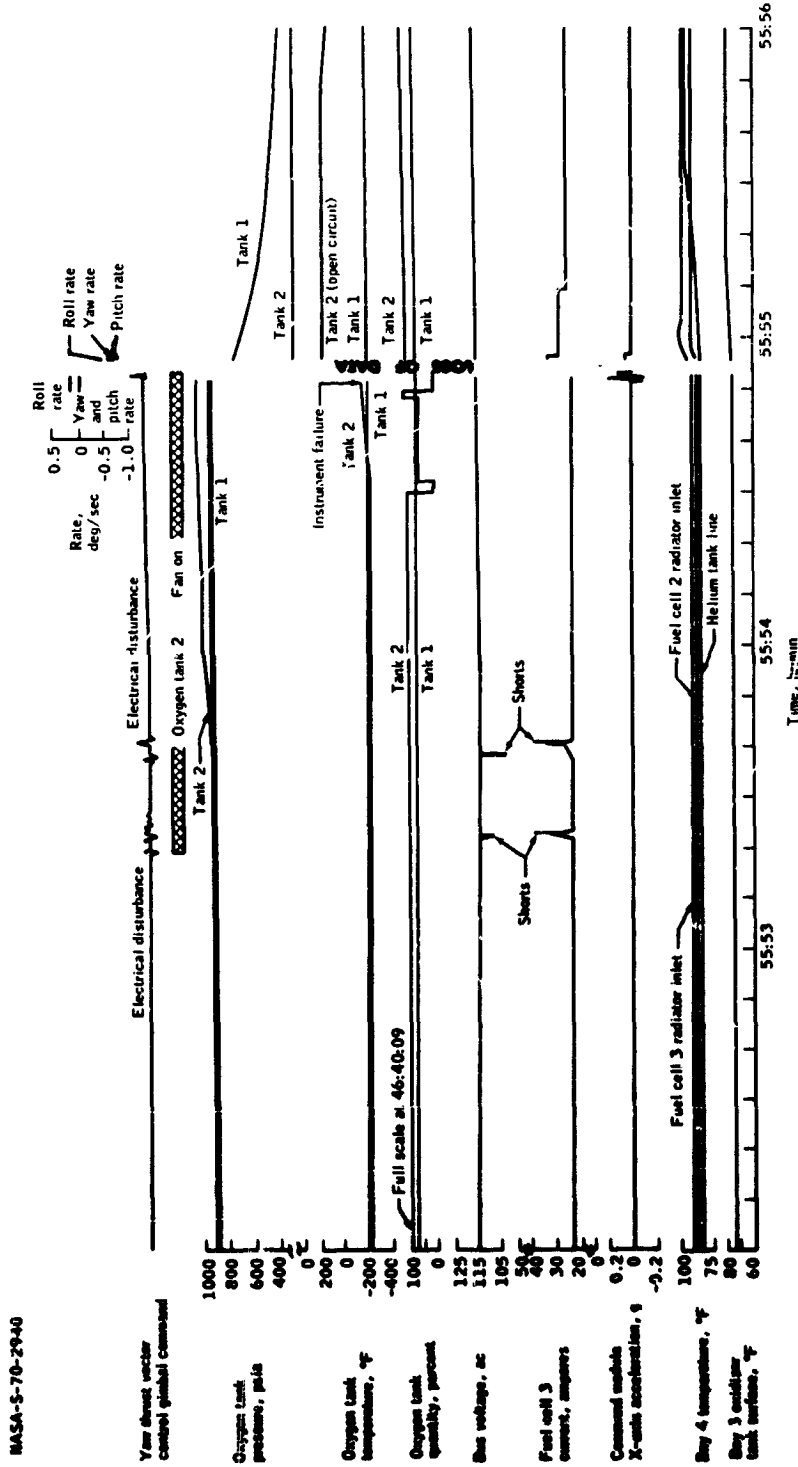
Figure 3-1.- Significant event timeline.

At 55:53:20, the electrical fan circuits for cryogenic oxygen tank 2 were energized. Approximately 2 seconds later, a momentary short was indicated in the current from fuel cell 3. Within several seconds, two other momentary shorted conditions occurred.

About 20 seconds after the first short, the third ac bus 2 short occurred. Fuel cell 3 current increased 23 amperes, and the stabilization and control system data again indicated a transient (fig. 3-1). Subsequently, the total spacecraft current level decreased to the same level as it was prior to turning on the cryogenic oxygen tank 2 fans. This indicates that power to the remaining cryogenic oxygen tank 2 fan was removed by blowing its fuses due to this short. Also, the ac bus 2 voltage increased to the same level as that prior to turning the tank 2 fans on (fig. 4-5).

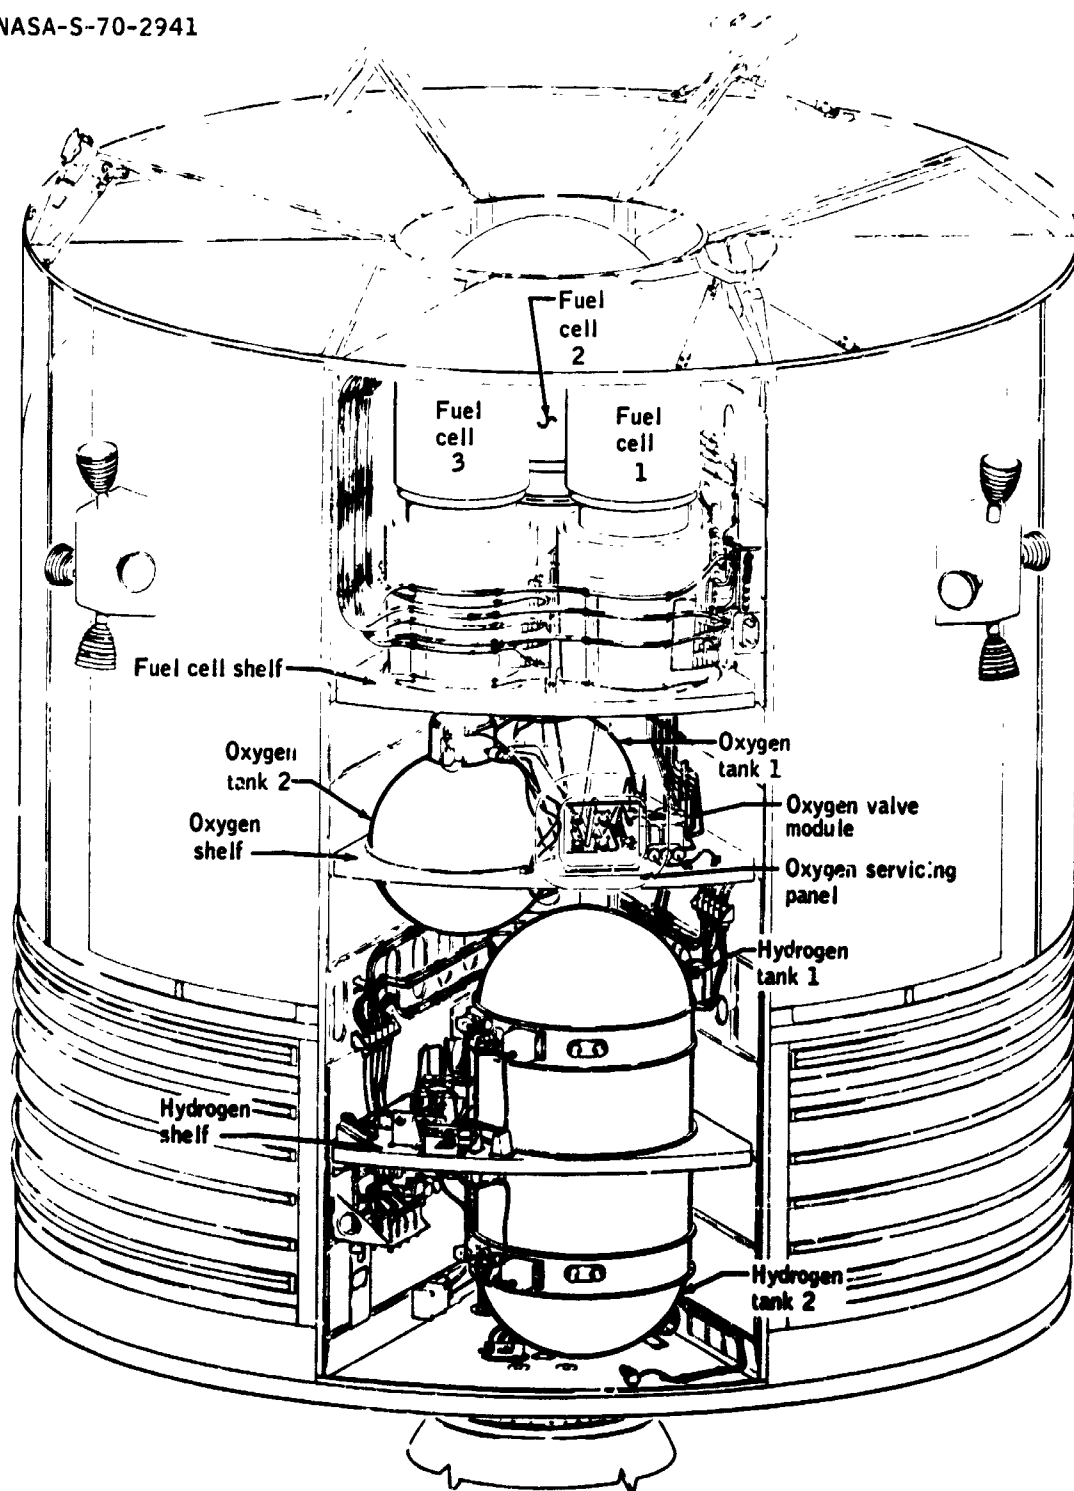
Figure 3-2.- Arrangement of fuel cells and cryogenic systems in bay 4.

The significant system parameters for the period of interest are shown in figure 3-1. Bay 4 of the service module and the hardware mounted in this area are shown in figure 3-2.

Photographs taken after service module separation showed that the bay 4 panel was missing and that one high-gain antenna horn was damaged.

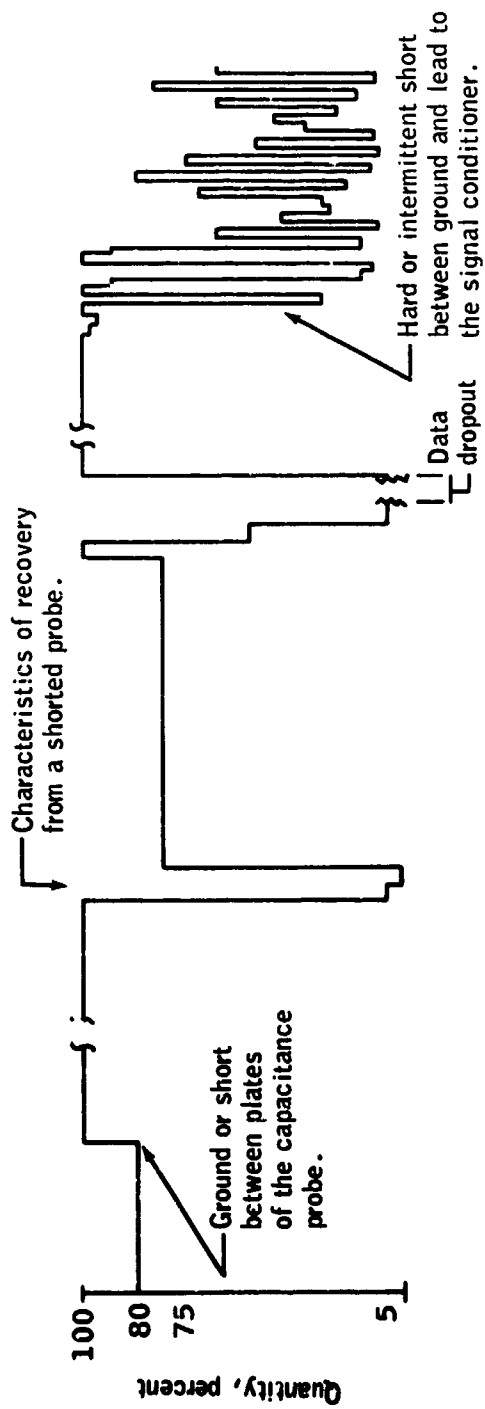
Figure 4-2.- Correlation of cryogenic oxygen tank 2 quantity flight data with measurement failure modes.

The first anomalous inflight condition associated with the cryogenic oxygen tank 2 occurred at 46:40:06 when the ac-powered destratification fans in both cryogenic oxygen tanks were turned on. Within about 3 seconds after fan activation, the quantity measurement for cryogenic oxygen tank 2 abruptly indicated full-scale high. This system indicates density of the cryogenic oxygen by measuring its dielectric constant, which is a function of density. This instrument is a capacitor which consists of two concentric aluminum tubes inside the tank (fig. 4-1).

Tests have shown that an open-circuit in the leads to the capacitor assembly or a short across the capacitor or its leads will drive the output to full scale. If this short-circuit is removed, the output signal drops abruptly from full scale to zero, and then in about a second, it settles out to the proper reading, as noted in the data of figure 4-2. This agrees with the flight data from the quantity probe. Tests also show that if the inner tube is shorted to ground, the output may oscillate in a random manner. Such an oscillation was noted several minutes after data recovery following the incident. It should be noted that with a short-circuit in the quantity gaging system inside the tank, the maximum current that could be drawn is 15 milliamperes.

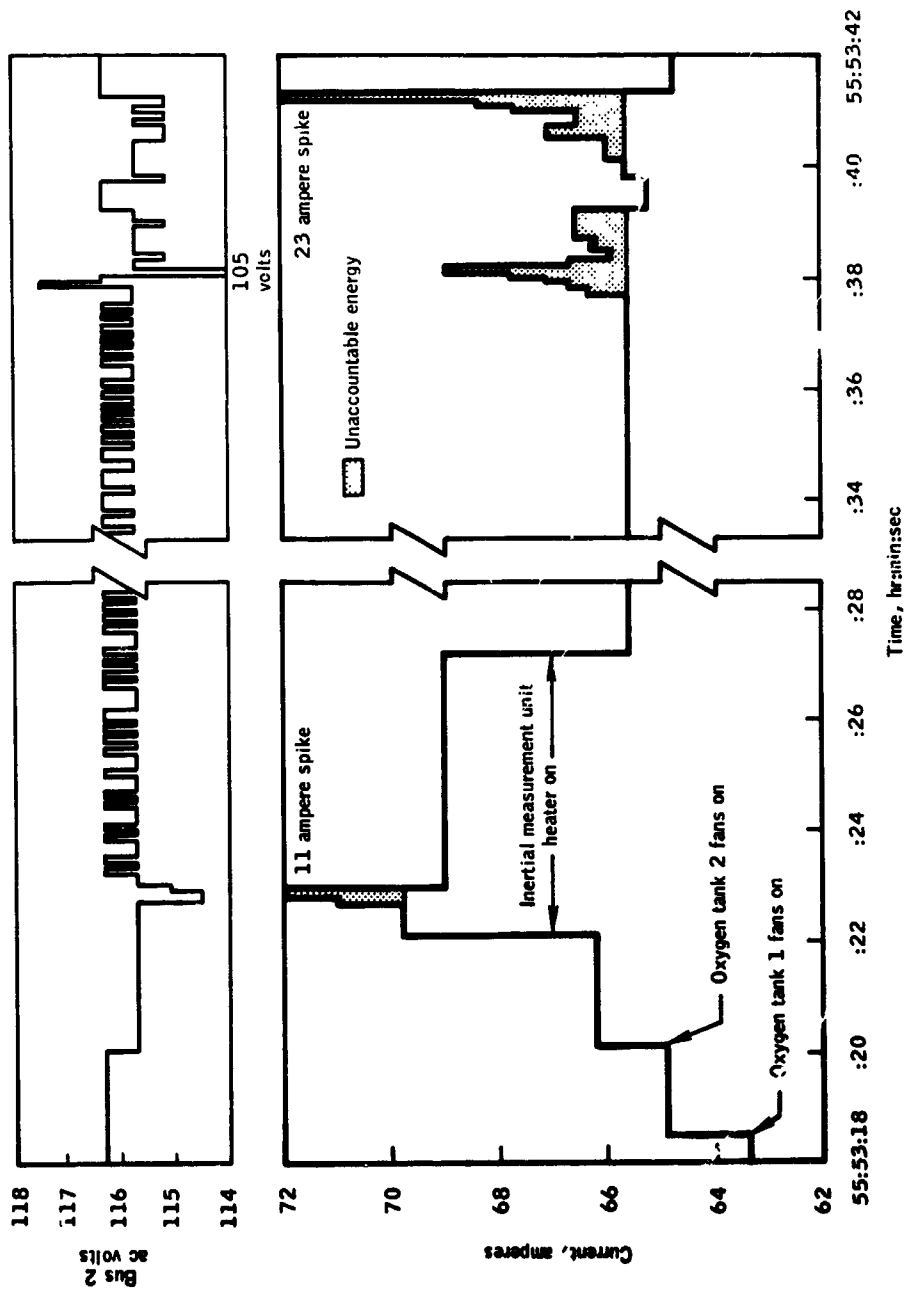
Figure 4-5.- Spacecraft current and ac voltage during period of interest.

The first indication of a short on ac bus 2 appeared about 2-1/2 seconds after activation of the cryogenic oxygen tank 2 fans. The ac bus 2 voltage dropped 1.2 volts, the fuel cell 3 current increased 11 amperes (fig. 4-5), and the stabilization and control system gimbal command data experienced a transient. Subsequent to the short, the spacecraft current data show a decrease of 0.8 ampere from the level just prior to the short. Also, the ac bus 2 voltage started to toggle-up 0.6 volt, or one data bit (fig. 4-5). These data indicate that a load was removed from ac bus 2 and that it was approximately one-half the load normally applied when the cryogenic oxygen tank 2 fans were turned on. This indicates that a short in one of the two fan motor circuits in cryogenic oxygen tank 2 caused its fuses to blow.

Approximately 200 milliseconds later, the ac bus 2 voltage momentarily decreased 11 volts (fig. 4-5), and the total spacecraft current increased 3.5 amperes, indicating an increased load. After the momentary decrease, the ac bus 2 voltage reading was 0.6 volt less than the previous indication. This could be an indication that a single phase short on phase B or C was removed by blowing a fuse.

The electrical energy that could not be accounted for by normal spacecraft loads (fig. 4-5) is attributed to the shorts. Calculations were made of the maximum energy levels that could have been transmitted through the circuit during these shorted conditions and that would still meet the constraints imposed by the flight data resolution and sampling times, inverter performance, fuse clearing time, and dc and ac bus voltage sensor performance. Inverter performance and fuse clearing time tests were performed to provide data for the energy calculations. The energy calculations are summarized in table 4-I.

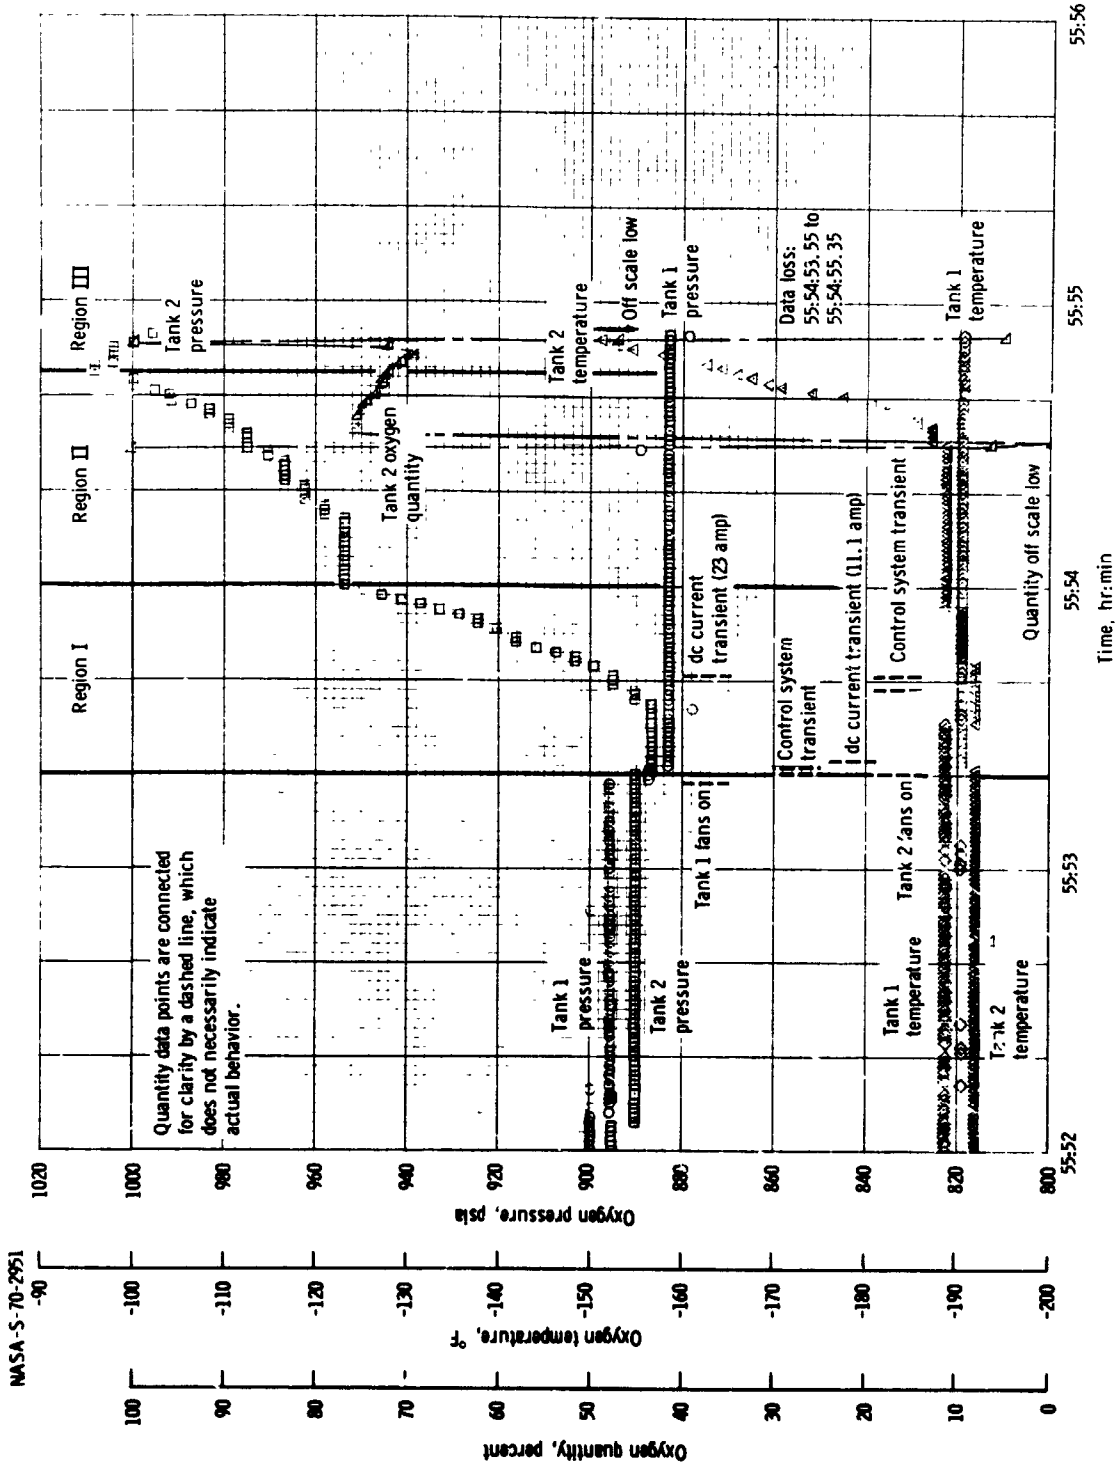
Figure 4-10. - Pressures, temperatures, and quantities during period of interest.

While the pressure was rising sharply in cryogenic oxygen tank 2, changes occurred in the temperature indication (fig. 4-10). The temperature data are obtained from a sensor located on the quantity probe assembly (fig. 4-8) within the tank. The temperature increased about 2° F during the first pressure rise (region I). A temperature increase of this magnitude is in accord with that expected due to the pressure rise alone.

The significant aspect of the temperature data is the rapid rise rate commencing approximately 24 seconds prior to loss of data (fig. 4-10). Several analyses were performed to interpret the data. The results indicated that a temperature range of 600° to 2900° F could produce the observed response. This wide temperature span is a result of the geometric configurations which are possible. The significant results from these analyses confirmed that the combustion source was near the sensor during the period of rapid temperature rise. Just prior to the loss of data, the temperature dropped to zero, indicating an open circuit failure in the measurement circuit.

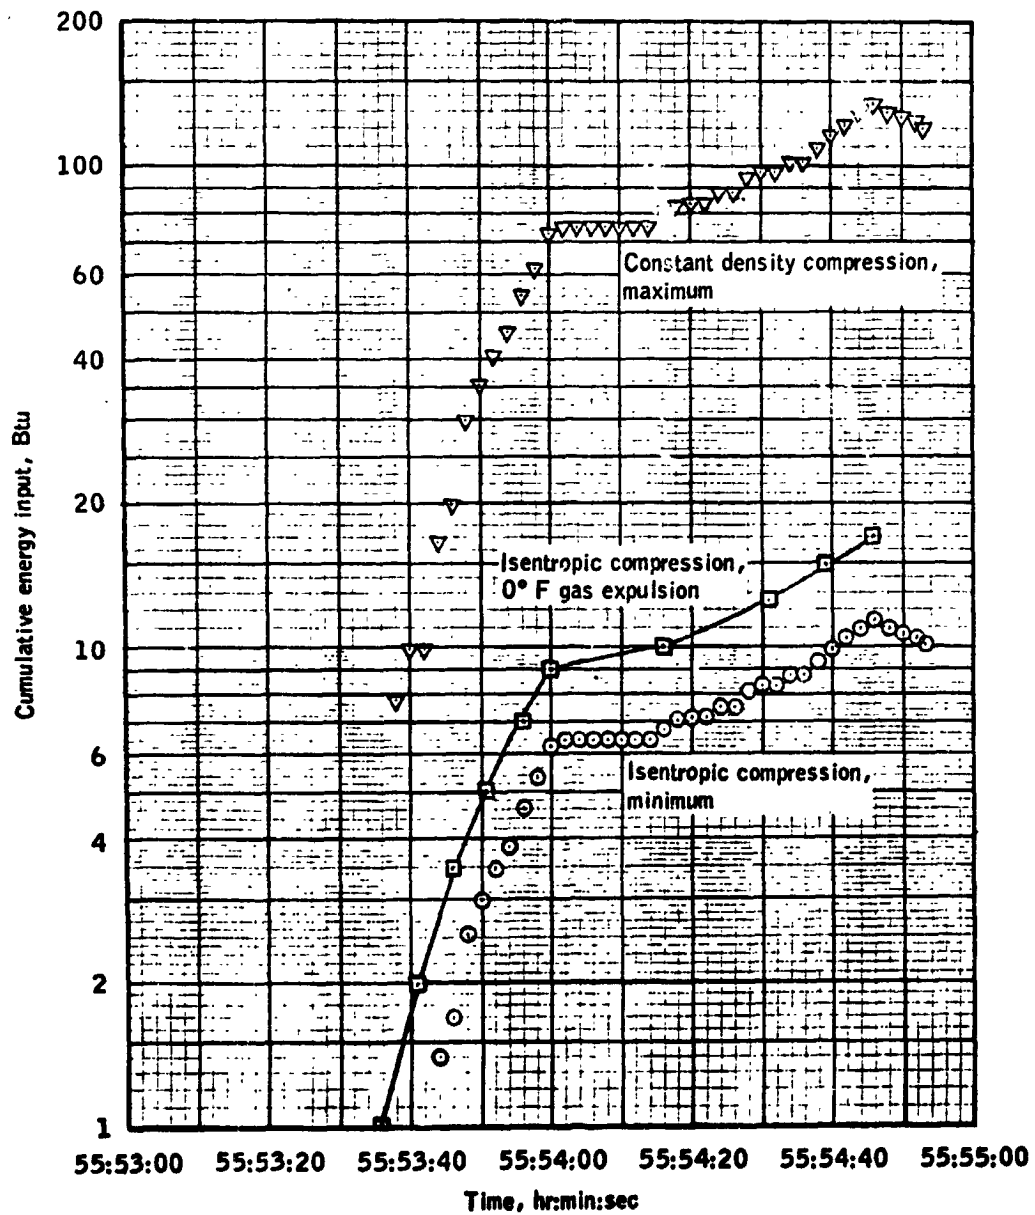
Figure 4-12.- Cryogenic oxygen tank 2 energy addition.

The maximum energy input to satisfy the observed pressure rise is a constant density heating process. This condition is shown by the upper curve of figure 4-12. A second process, which establishes the minimum energy input, is an isentropic compression of the fluid. This compression is represented by all the energy input being confined to a small bubble, which has no mass. The resulting thermodynamic state is one of higher pressure in the tank. The result of this process is depicted by the lower curve of figure 4-12.

In actuality, the energy input into the tank lies somewhere between the maximum and minimum energy input curves shown in the figure. The process is modeled by a hot oxygen bubble of constant uniform tempera- ture, growing at a rate sufficient to isentropically compress the sur- rounding cryogenic oxygen. This formulation accounts for mass transfer both to the hot mass (to increase the volume) and from the hot mass (tank outflow). This mass transfer requires a larger energy input to sustain the pressure rise. The center curve of figure 4-12 shows a comparison of this model with the maximum and minimum energy models. The results (fig. 4-13) are dependent upon the temperature of the hot mass. Note that while the energy input increases by approximately 300 percent, the hot mass volume changes only 10 percent. Therefore, the energy source is confined to a small region within the tank, and is essentially independ- ent of the temperature of the burning material.

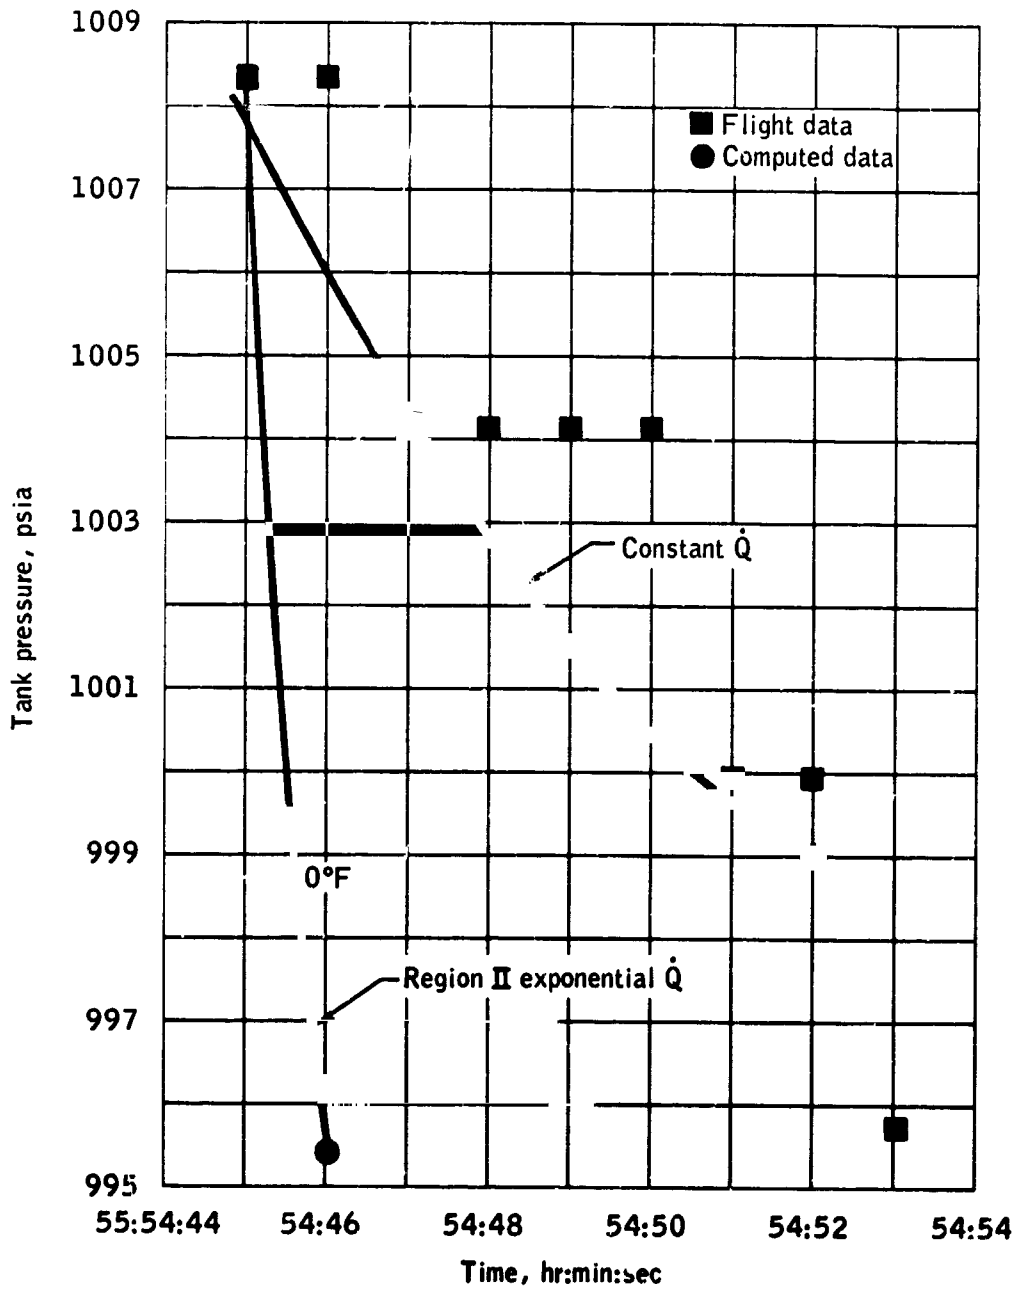
Figure 4-15.- Relief valve response in region III.

A change in the combustion rate could easily account for the slower-than-expected pressure decay after the relief valve opened. In order to properly account for the increase in combustion rate, it is necessary to consider about the last 2 seconds of region II. At this point, the pressure is 1004 psia, the relief valve crack pressure. When the relief valve opens, the velocity at the filter (inside the oxygen tank) increases. It is hypothesized that this increase in velocity provides both a convective force field and additional oxygen to the combustion source. When the relief valve opens fully the local velocity increases to a maximum. A further postulation is that this yields a maximum burning rate which raises the pressure to 1008 psia. The relief valve flow then decreases the pressure, although the combustion rate remains high. A heat input rate of approximately 2 Btu/sec will raise the pressure from 1004 psia to 1008 psia with the relief valve open. A constant heat rate of approximately 1-1/4 Btu/sec will match the observed pressure decay in region III (fig. 4-15). This energy input rate is about two and one-half times larger than the exponential rate of region II.

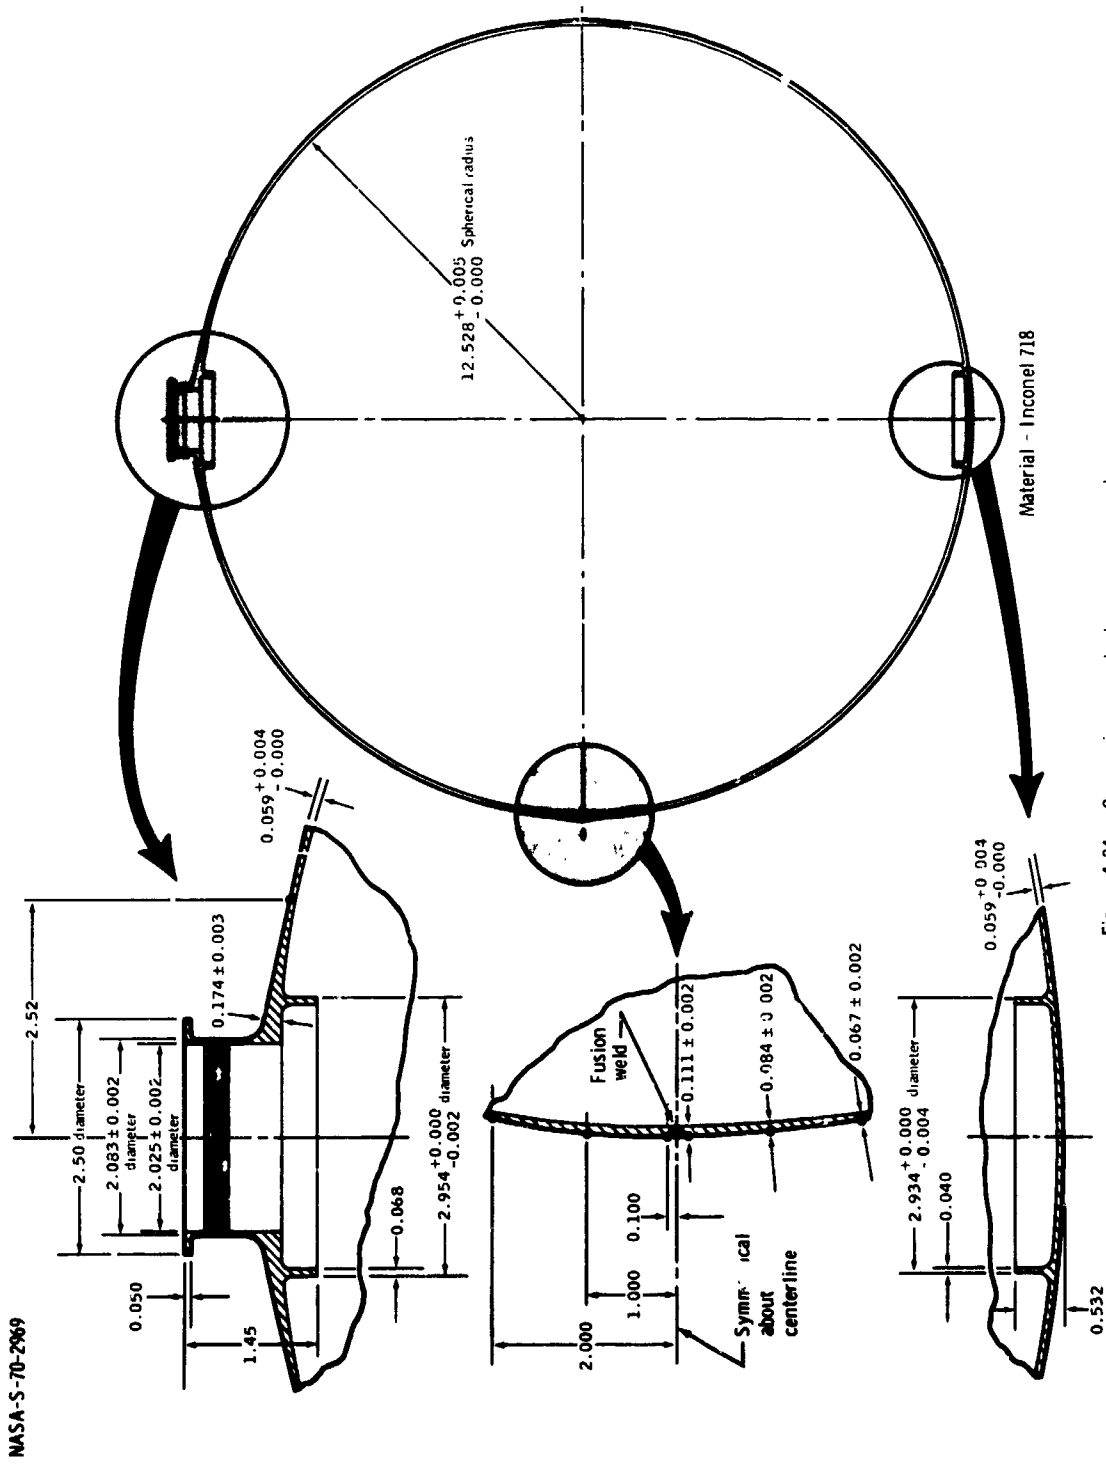
Figure 4-24. - Cryogenic oxygen tank, pressure vessel.

Localized heating of the tank material is the probable mode of the loss of tank pressure integrity and is supported by all known test analyses and by telemetry data. Considering that only polytetrafluoroethylene was burning in the tank, then the only place where the polytetrafluoroethylene comes close to, or touches, the pressure vessel wall is in the electrical conduit. Tests of burning insulation in the electrical conduit shows that in a few seconds the generated heat fails the tube. Following the tube failure, the pressure in the annulus region would rapidly rise until the exterior shell burst disk (approximately 3 square inches) would rupture at approximately 80 psia.

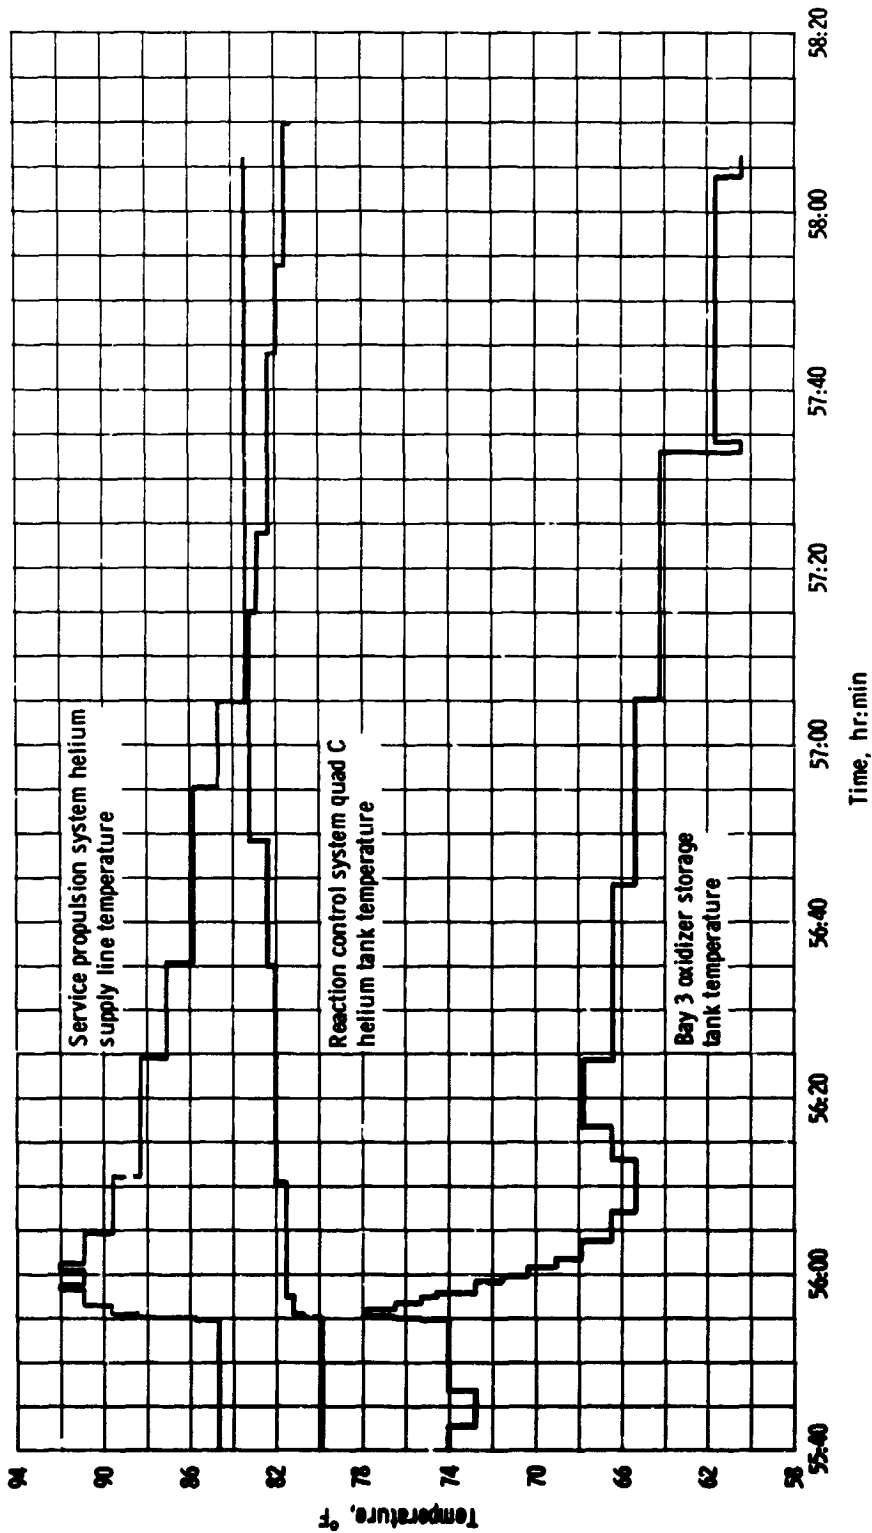
Figure 4-32. - Bay 3 and 4 structural temperatures.

The bay 3 oxidizer tank surface temperature increased from 73.4° to 77.7° F in about 20 seconds (fig. 4-32). The temperature then decreased to 60° F about 2-1/4 hours later. Data received during the two command and service module power-up cycles at 101:55:54 and 123:05:25 showed 60° and 65.3° F, respectively. The rise rate of bay 3 service propulsion system oxidizer surface temperature is indicative of direct heating in the vicinity of the transducer, which is attached to the tank skin and covered with 30 layers of insulation.

Heat inputs to the bay 3 service propulsion tank surface transducer depend on the thermal integrity of the multilayer insulation blanket covering the transducer. To obtain the noted response requires severely degraded insulation, probably because of burning of the insulation or pressurization of the bay with hot gas.

The service propulsion helium line temperature (fig. 4-32) increased from 84.6° to 89° F in about 37 seconds. In 2 more minutes, the temperature had increased to 92.2° F. A gradual cooling trend followed, and 10 minutes later, the temperature had decreased to 83.4° F. During the two command and service module power-up cycles at 101:55:54 and 123:05:19, the helium line temperatures were 72.1° and 65.9° F, respectively. The initial rise rate is again indicative of direct heating in the vicinity of the transducer. However, unlike the oxidizer tank surface temperature, the gradual decrease in helium line temperature, after the initial rise, is indicative of a cool-down response to radiant heat loss. The helium line cooled gradually because of the lower temperature levels with the fuel cells shut down and the bay 4 panel missing.

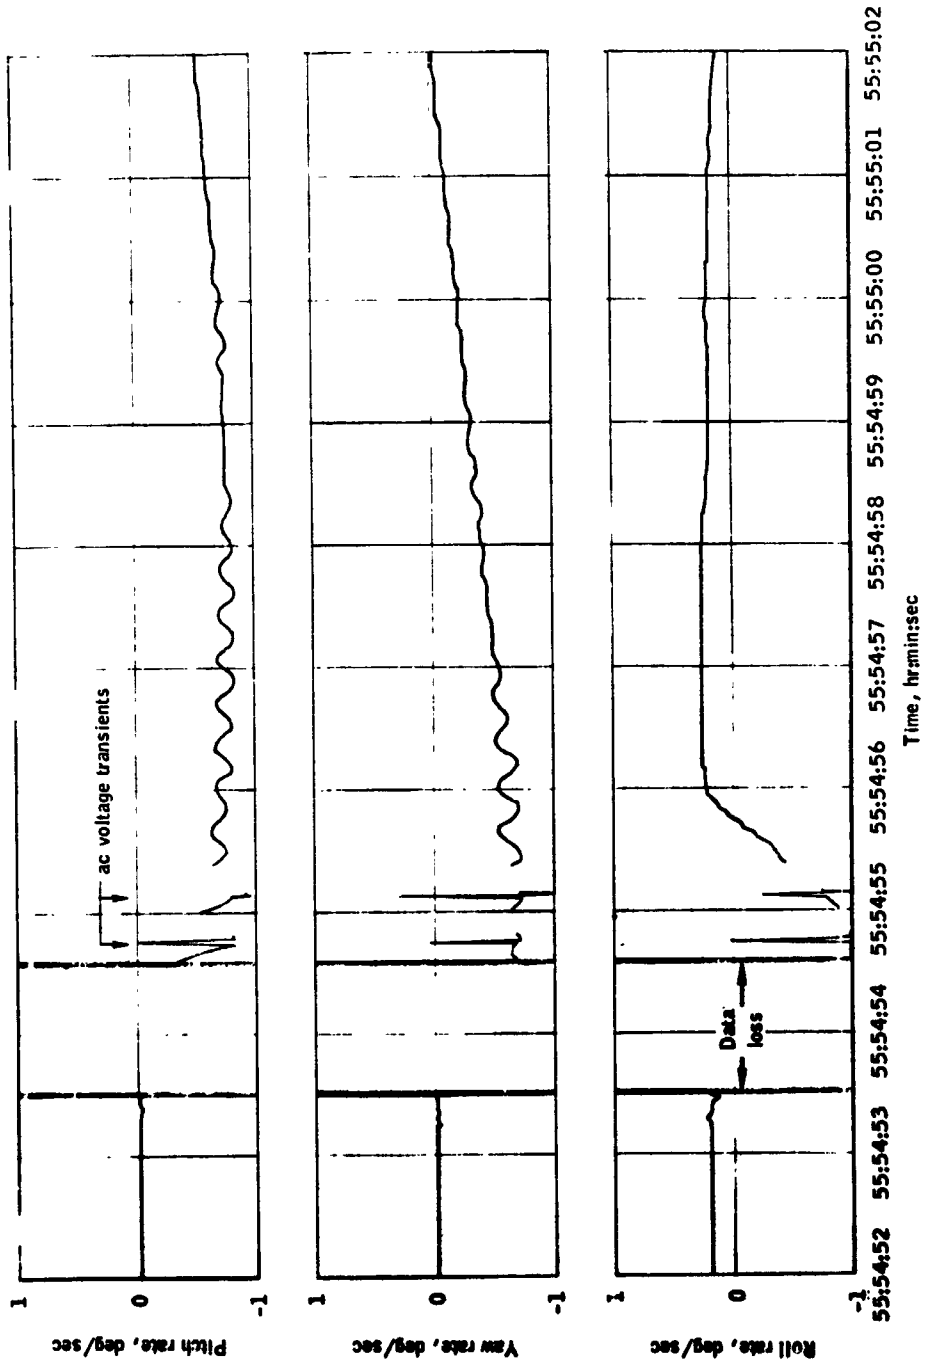
Figure 4-34.- Spacecraft dynamics during cryogenic oxygen tank 2 anomaly.

The stabilization and control system recorded the small body rate oscillations described in section 4.6, at 0.28 second before the loss of data. When data were regained, negative rates were present in all three axes (fig. 4-34). The oscillations shown in the pitch and yaw axes on the figure are predominantly due to excitation of the first bending mode (2.7 hertz). The reaction control engine firings which occurred following resumption of data were proper for the conditions that existed. The resulting angular accelerations in pitch and roll, however, indicate that only one thruster was acting in each axis and that quad C was inoperative. The total attitude change was small (fig. 4-35).

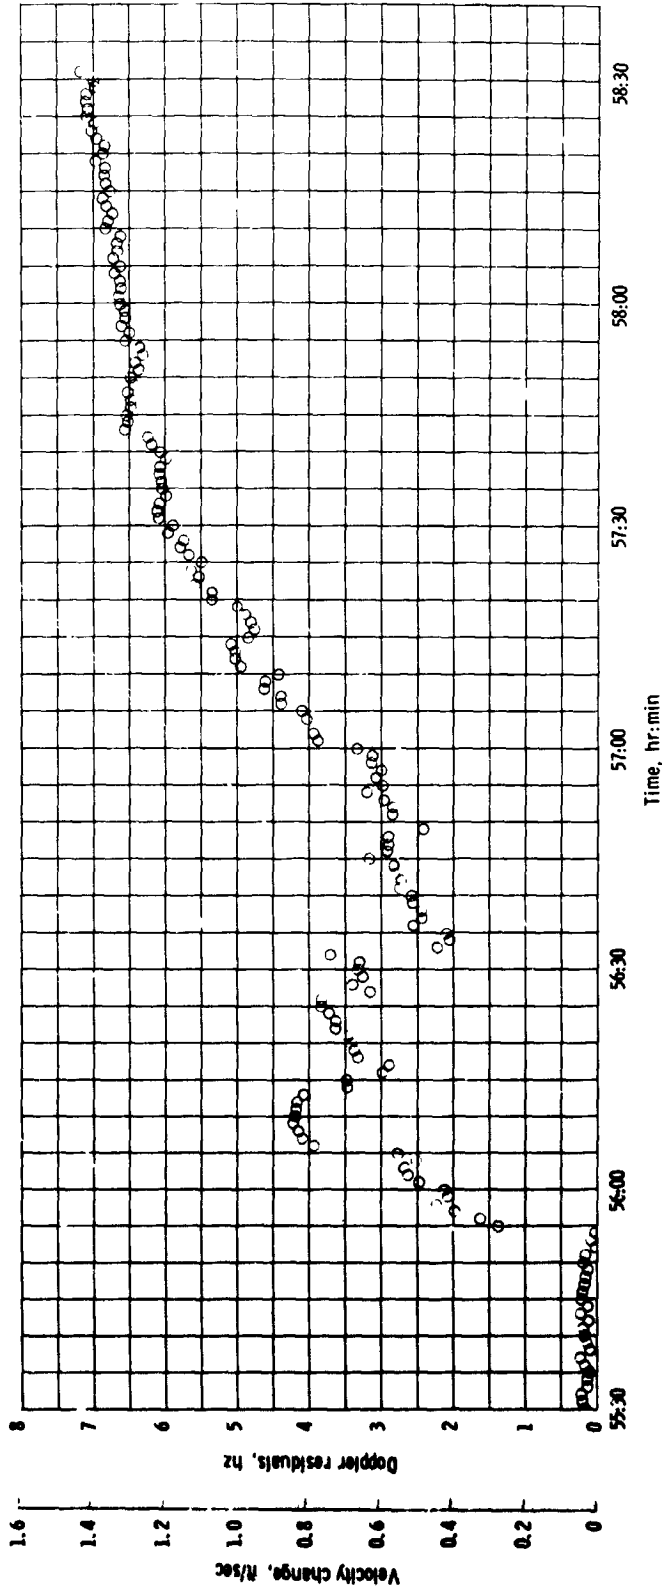
Figure 4-37. - Network doppler data during period of interest.

Venting followed the incident and attitude control was maintained automatically by the digital autopilot until the loss of main bus B when the last minus pitch thruster was disabled. Periodic attempts were made to reestablish attitude control manually using the thruster emergency coils until the thrusters were reconfigured to main A. The venting disturbance torque is shown in figure 4-36. Figure 4-37 contains a time history of network doppler data and shows the effect of venting as well as uncoupled thruster firings.

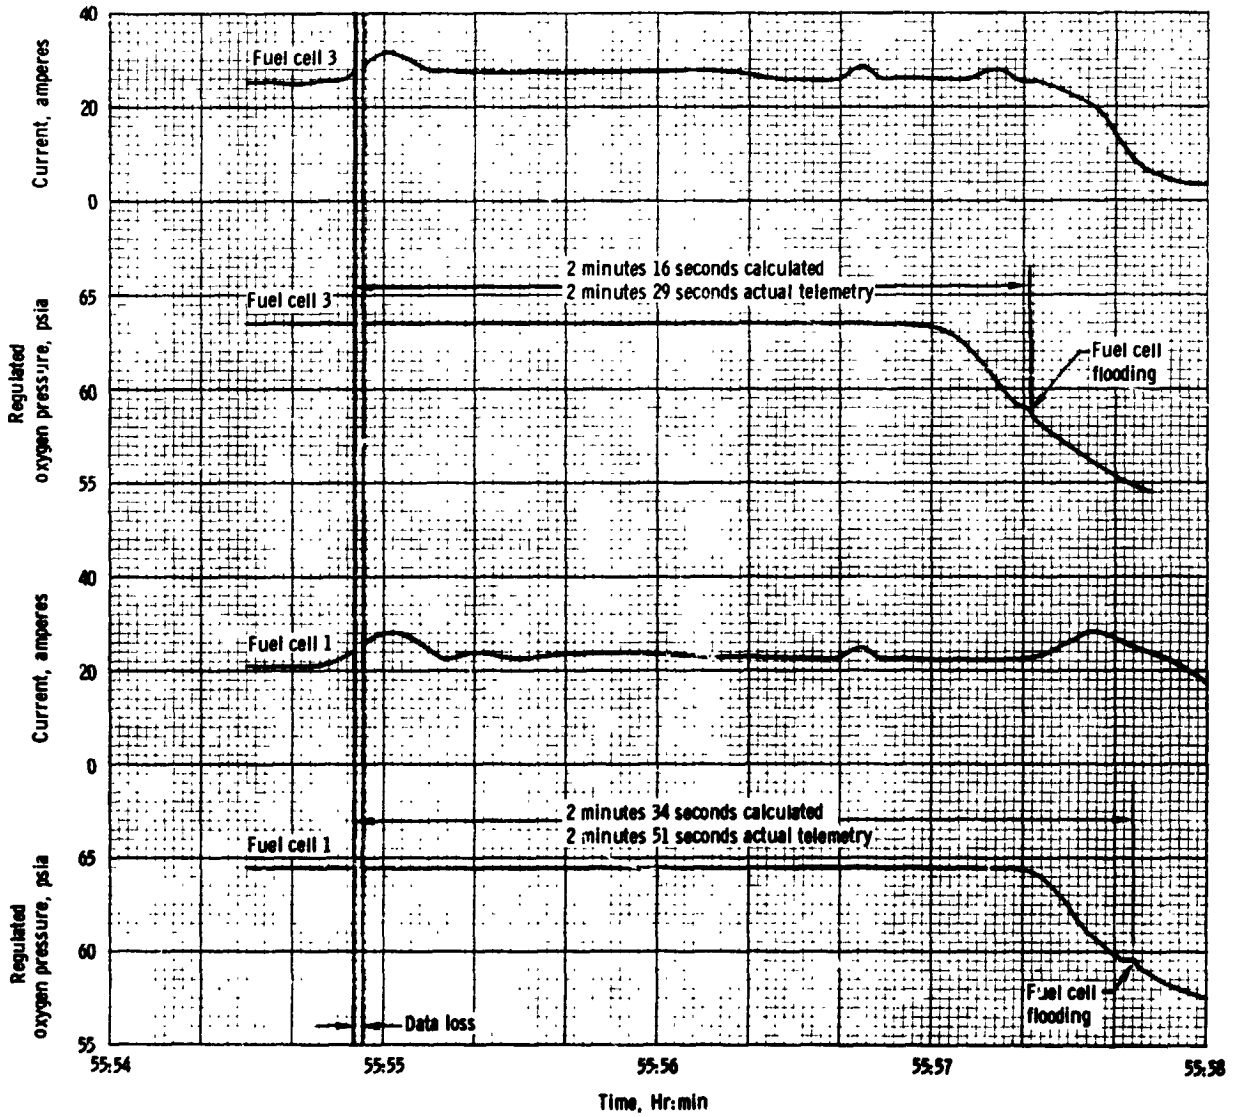
Figure 4-40. - Fuel cells 1 and 3 performance loss.

The pressure decays on fuel cells 1 and 3 were caused by closure of the fuel cell oxygen reactant shutoff valves. When the valves closed, a volume of high pressure oxygen was trapped between the reactant valves

and the fuel cell oxygen regulators. This oxygen was sufficient for fuel cell operation for about 2.5 minutes, the time required to deplete the trapped supply. The agreement between the calculated and actual operating time after valve closure (fig. 4-40) verifies that fuel cells 1 and 3 were starved of oxygen and eventually could not support an electrical load.

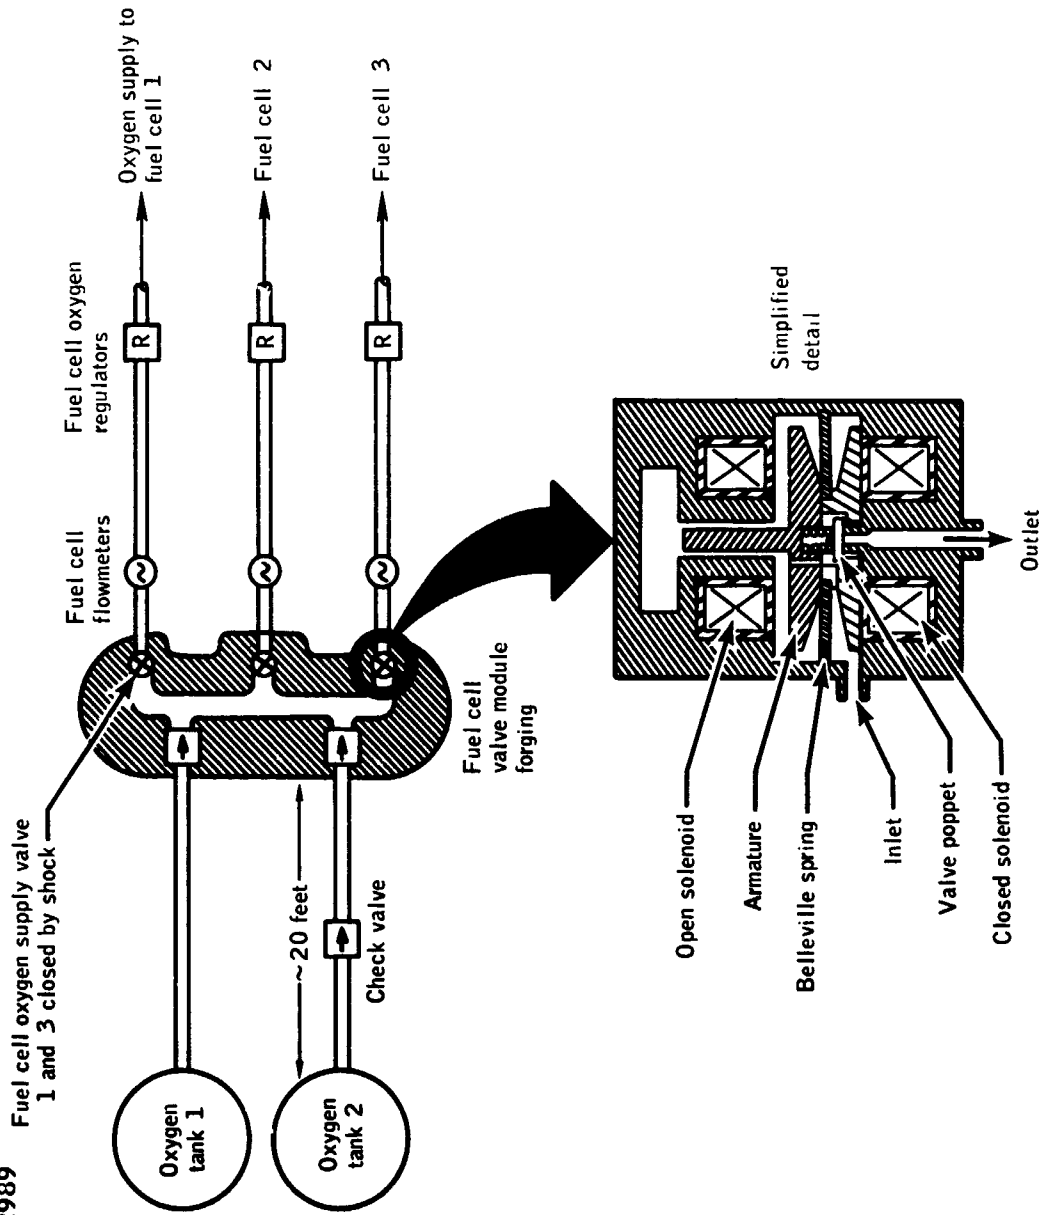
Figure 4-41.- Solenoid valves for oxygen supply.

Impact tests on the oxygen solenoid valves (fig. 4-41) show that a shock in excess of 86g for 11 milliseconds duration can be expected to cause valve closure under operating conditions.

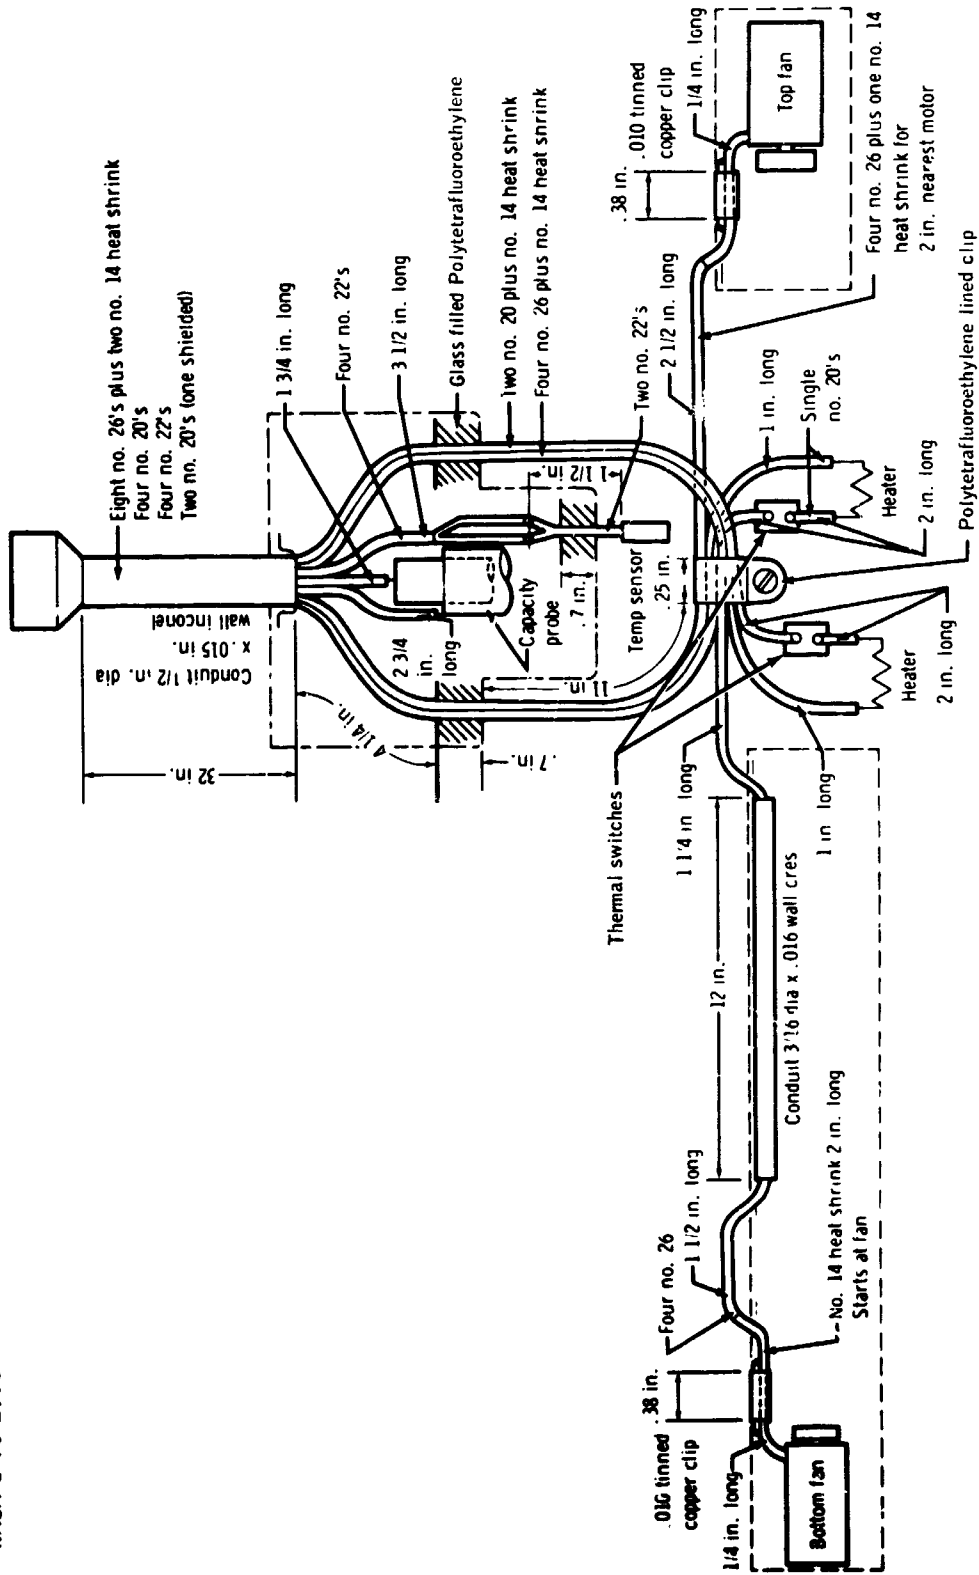
Figure 4-42.- Wiring distribution within cryogenic oxygen tank.

The fan wiring leads consist of two harnesses of four wires each for the two 3-phase fan motors. Wires (MIL-W-16878, type E) are 26-gage nickel and are coated with 0.010-inch polytetrafluoroethylene insulation. Also, each harness of four wires is covered in some regions with a polytetrafluoroethylene sleeve of approximately 0.012-inch thickness. Wire runs of the two fan harnesses are as indicated in figure 4-42 and are identical, except that the lower fan harness is routed through a tube in the heater assembly.

The fan motor power leads internal to, and near, the heater assembly are extremely vulnerable to heat damage in abnormal operations. This has been demonstrated dramatically in a test employing approximately 8 hours of continuous heater operation. The insulation degradation caused in a test simulating the detanking cycle used on oxygen tank 2, (discussed in section 5.0) is seen in pictures of the wiring which failed (fig. 4-43).
