MANNED SPACECRAFT CENTER INTERNAL NOTE

APOLLO 13 CRYOGENIC OXYGEN TANK 2 ANOMALY

ANOMALY REPORT NO. 1

APOLLO 13 MISSION
CRYOGENIC OXYGEN TANK 2 ANOMALY REPORT

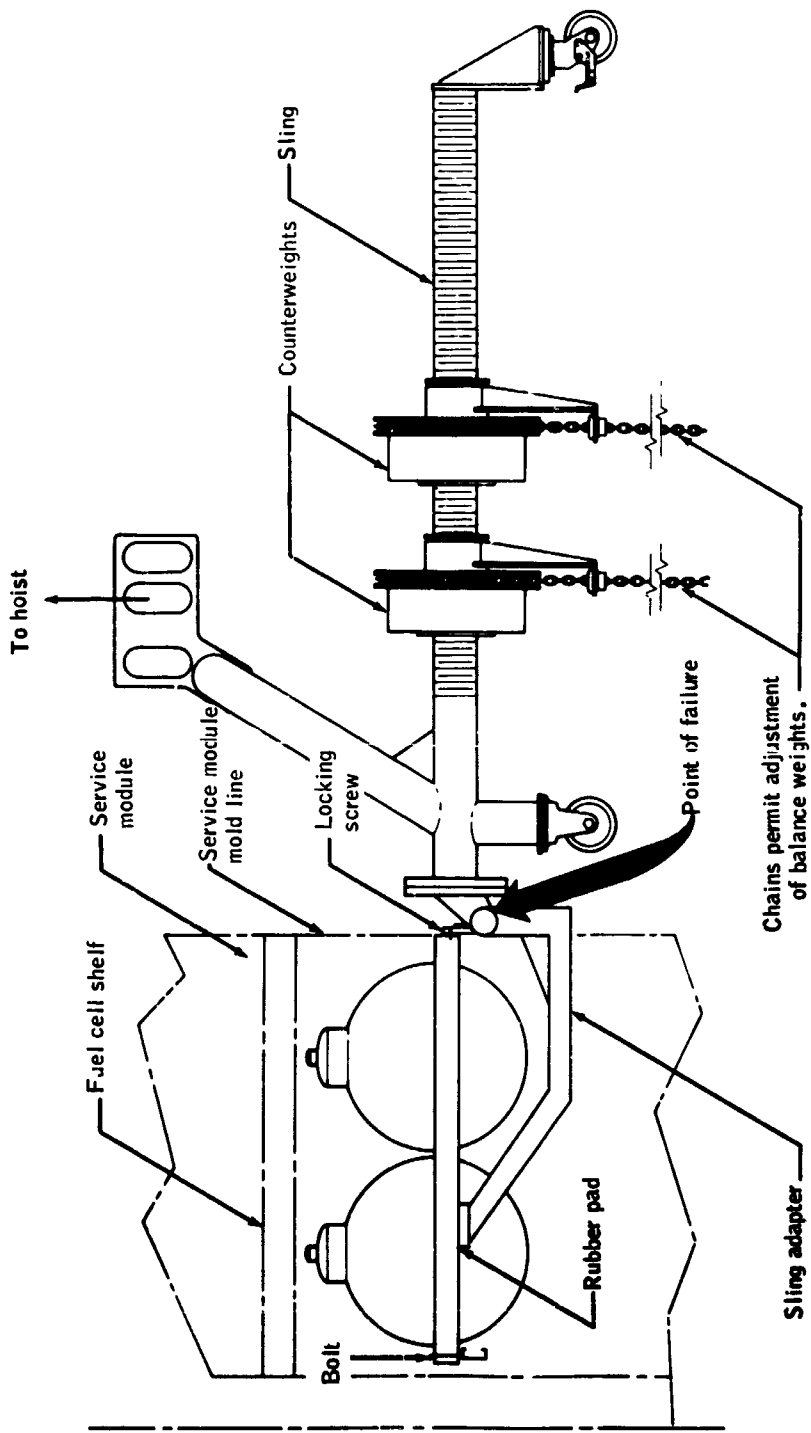
Figure 5-1.- Oxygen shelf and hoist assembly.

A detailed assessment was also made of the incident where the oxygen shelf hoist assembly failed during the factory removal of the tank shelf (fig. 5-1). Analysis and test show that the maximum shock upward would be about 7 g's, and the maximum shock downward would be about 15 g's. Analytically, the components within the tank would be expected to withstand 100 g's shock. Consequently, this condition is not believed to have contributed to the ultimate failure of the tank in flight.

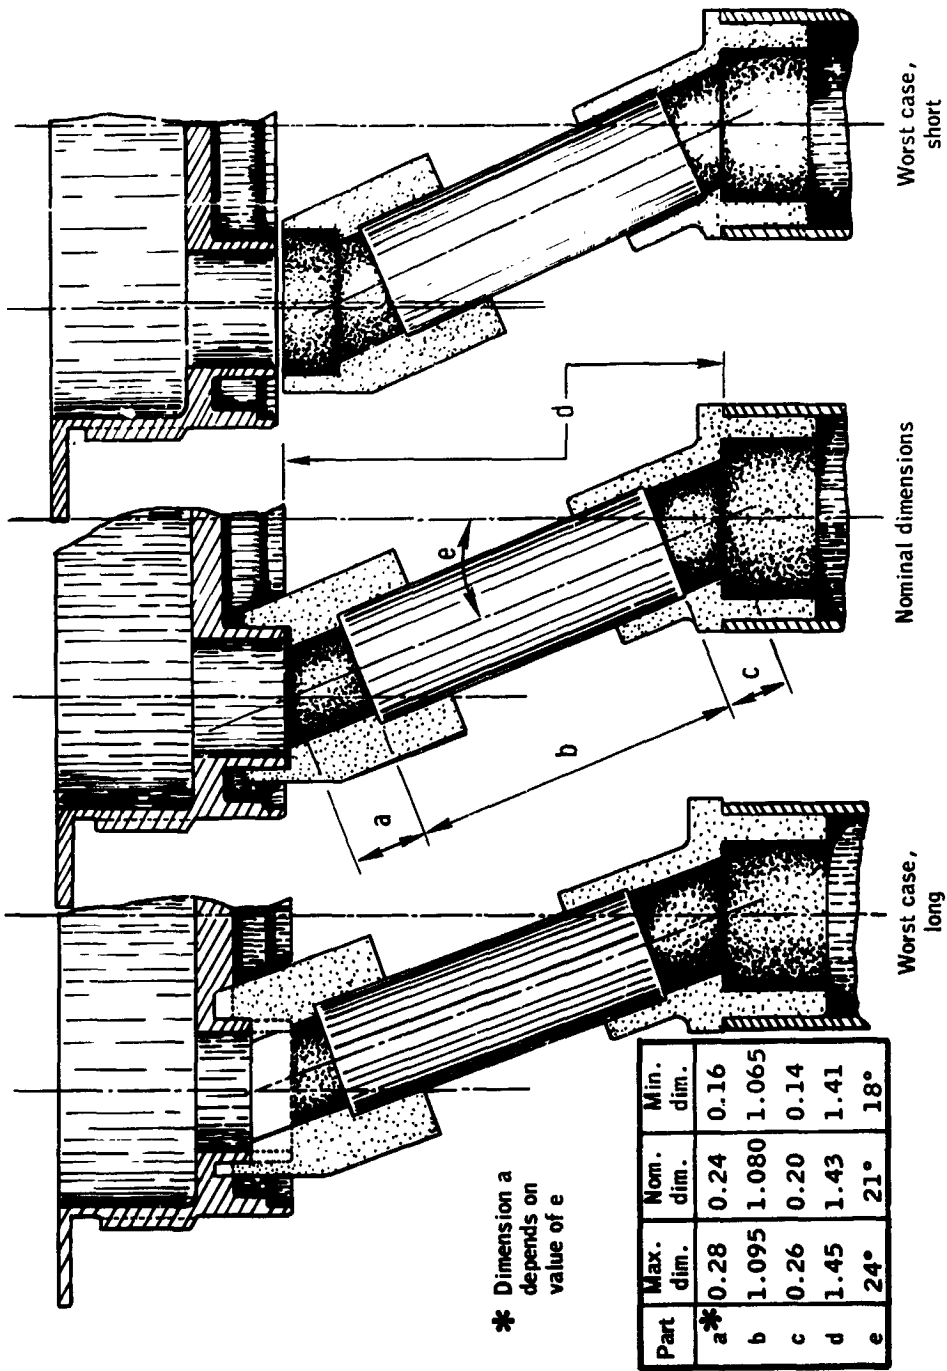
Figure 5-2.- Manufacturing tolerance study.

The cryogenic oxygen tank 2 could not be off loaded after the initial filling during the countdown demonstration test using the normal procedures. The problem resulted from loose or misaligned plumbing components in the dog-leg portion of the tank fill path (fig. 5-2). Allowable manufacturing tolerances are such that the tank may not be detanked normally under these conditions. A test has verified this fact. The condition of loose plumbing in the probe assembly, which existed in the tank before the detanking, was judged to be safe for flight in every aspect.

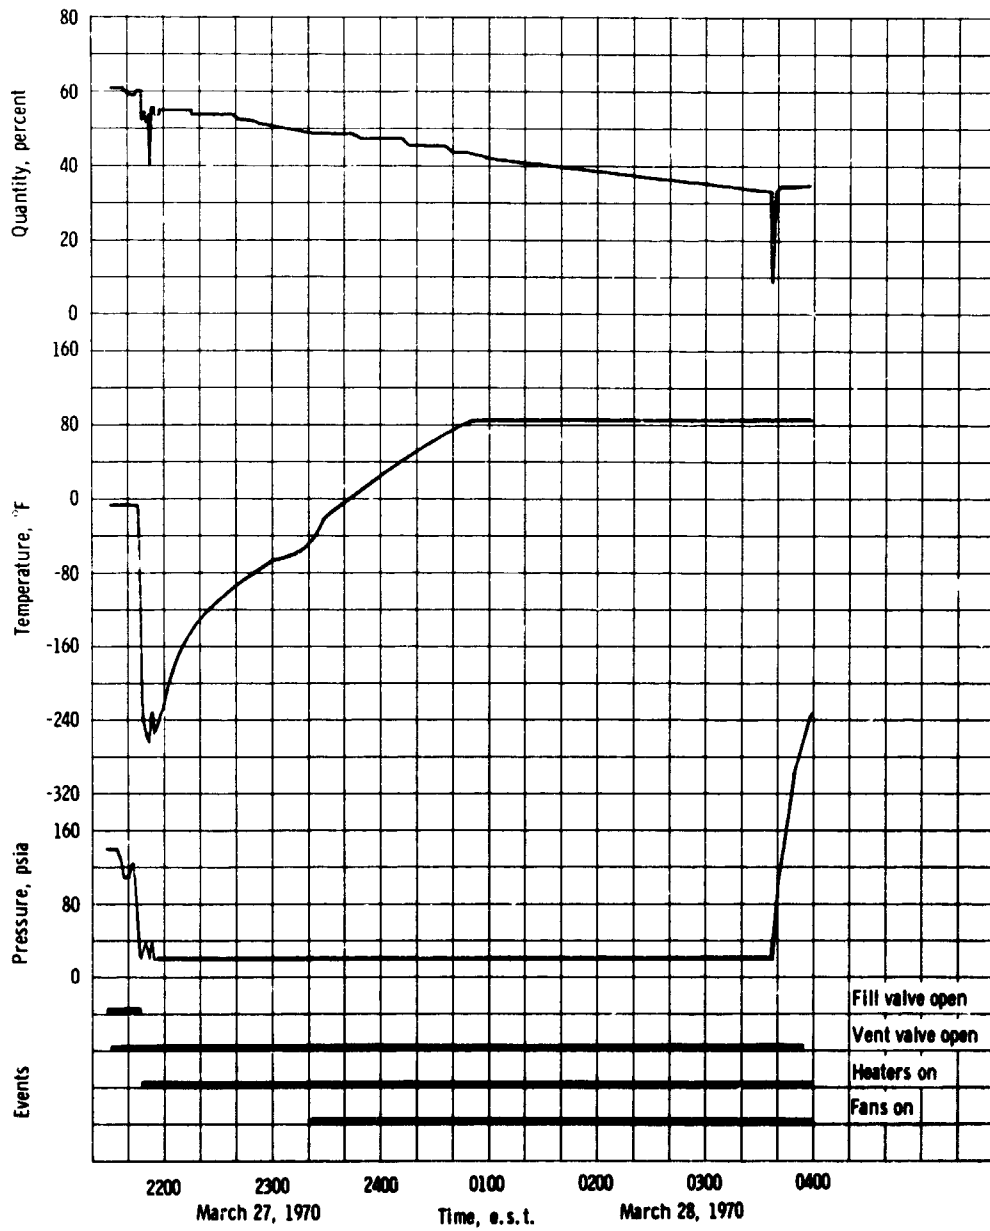
Figure 5-3. - Characteristics of oxygen tank 2 detanking using fans and heaters (CDDT).

After numerous attempts with gaseous oxygen purges and higher expulsion pressures in an attempt to remove the fluid, the fluid was boiled off through the use of tank heaters and fans, assisted by pressure cycling. The sequence of detanking is shown in figures 5-3 and 5-4. The heater-on time was about 8 hours. It was thought that no damage would be sustained by the tank or its components because of the protection afforded by the internal thermal switches.

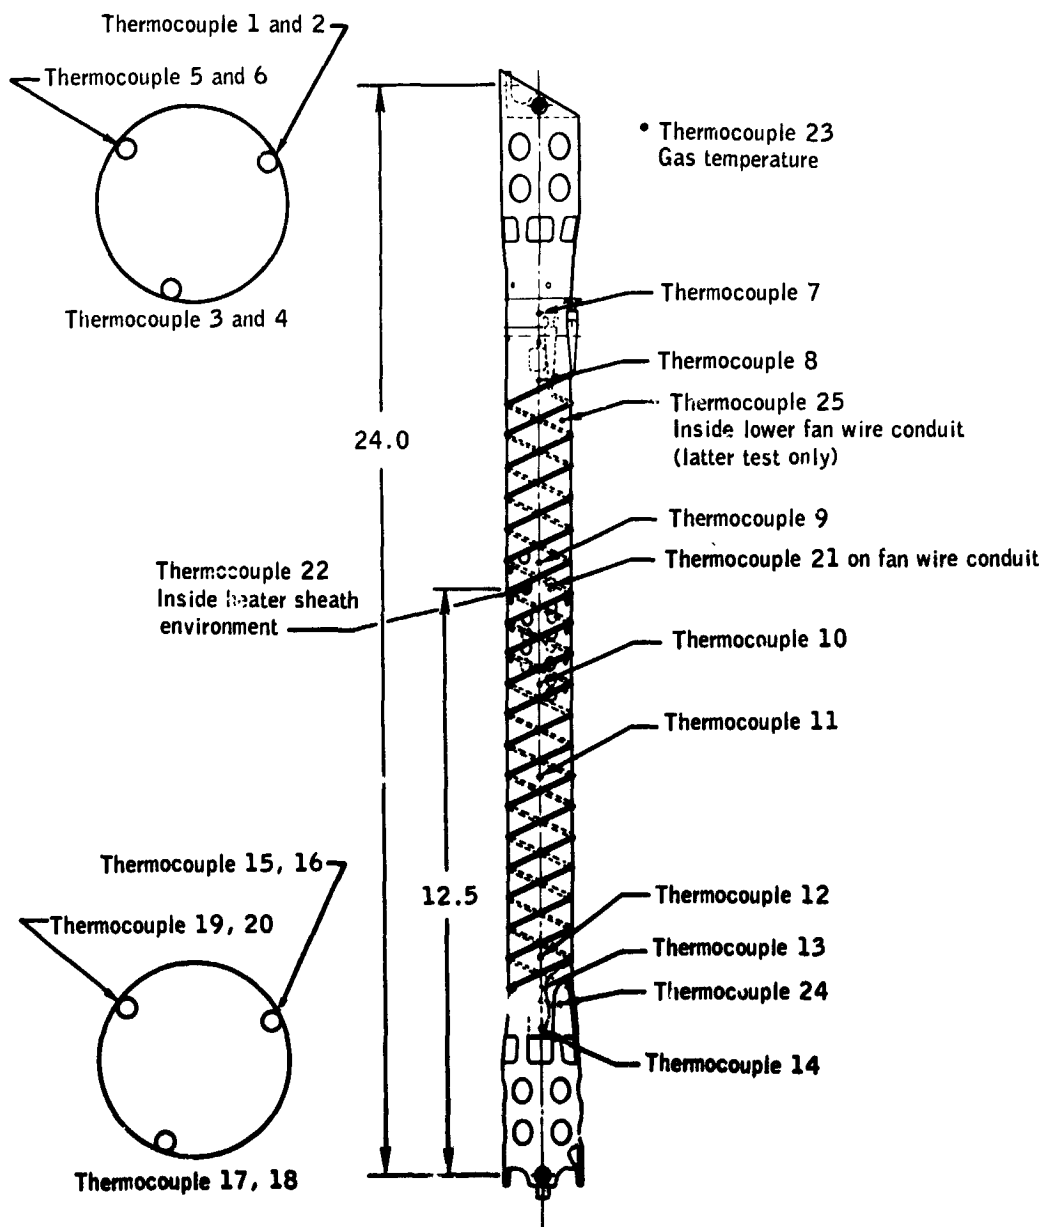
Figure 5-6.- Heater/fan temperature sensor locations

Wiring can be damaged within a couple of hours, with the heaters being "on" continuously as evidenced by the temperature on the heater assembly (figs. 5-6 and 5-7).
