REPORT OF APOLLO 13 REVIEW BOARD

**APPENDIX B - REPORT OF MISSION
EVENTS PANEL**

**APPENDIX C - REPORT OF MANUFACTURING
AND TEST PANEL**

APPENDIX D - REPORT OF DESIGN PANEL

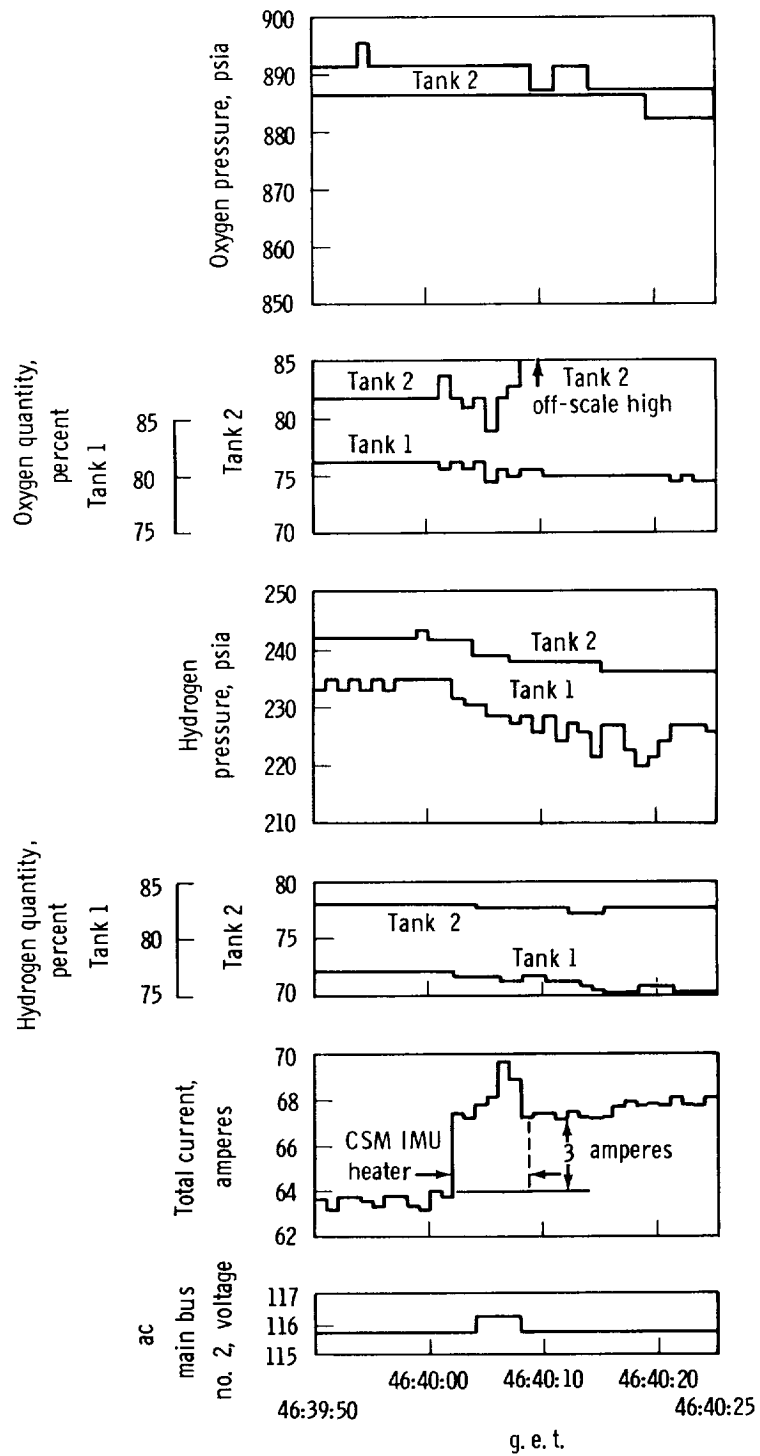
Figure B4-12.- Fan cycle at 46:40.

At 47:40:08 the oxygen quantity changed from approximately 82 percent to 100 percent, or full-scale high. This change in reading or quantity system malfunction occurred just after or at the time the oxygen tank no. 2 fans were turned on. Because of the way the system recovered at the time of the accident, the data indicate that the probe or its associated wiring shorted. Since the instrumentation system was in low bit rate, it is possible to determine exactly when the oxygen

tank no. 1 and no. 2 fans were turned on. The electrical data indicate that the oxygen tank no. 1 and no. 2 fans were turned on between the times of 47:40:05 and 47:40:08. A plot of cryogenic pressures, quantities, total CSM current, and ac main bus 2 is shown in figure B4-12. Therefore, the oxygen tank no. 1 and no. 2 fans were turned on in a period of time between 3 seconds prior to the probe malfunction and the time that the probe malfunctioned.

When the oxygen tank no. 2 fans were turned on the next time at 47:54:50, the ac main bus 2 decreased 1.8 volts for one sample (0.1 second). At the same time the TVC command parameters indicated a negative initial transient. Because of the sampling rate (10 samples per second) of the instrumentation system and the small number of fan cycles examined in the high bit rate mode, it cannot be determined if this negative initial transient is characteristic of other fan turnon's or is an indication of a deteriorating fan or wiring.

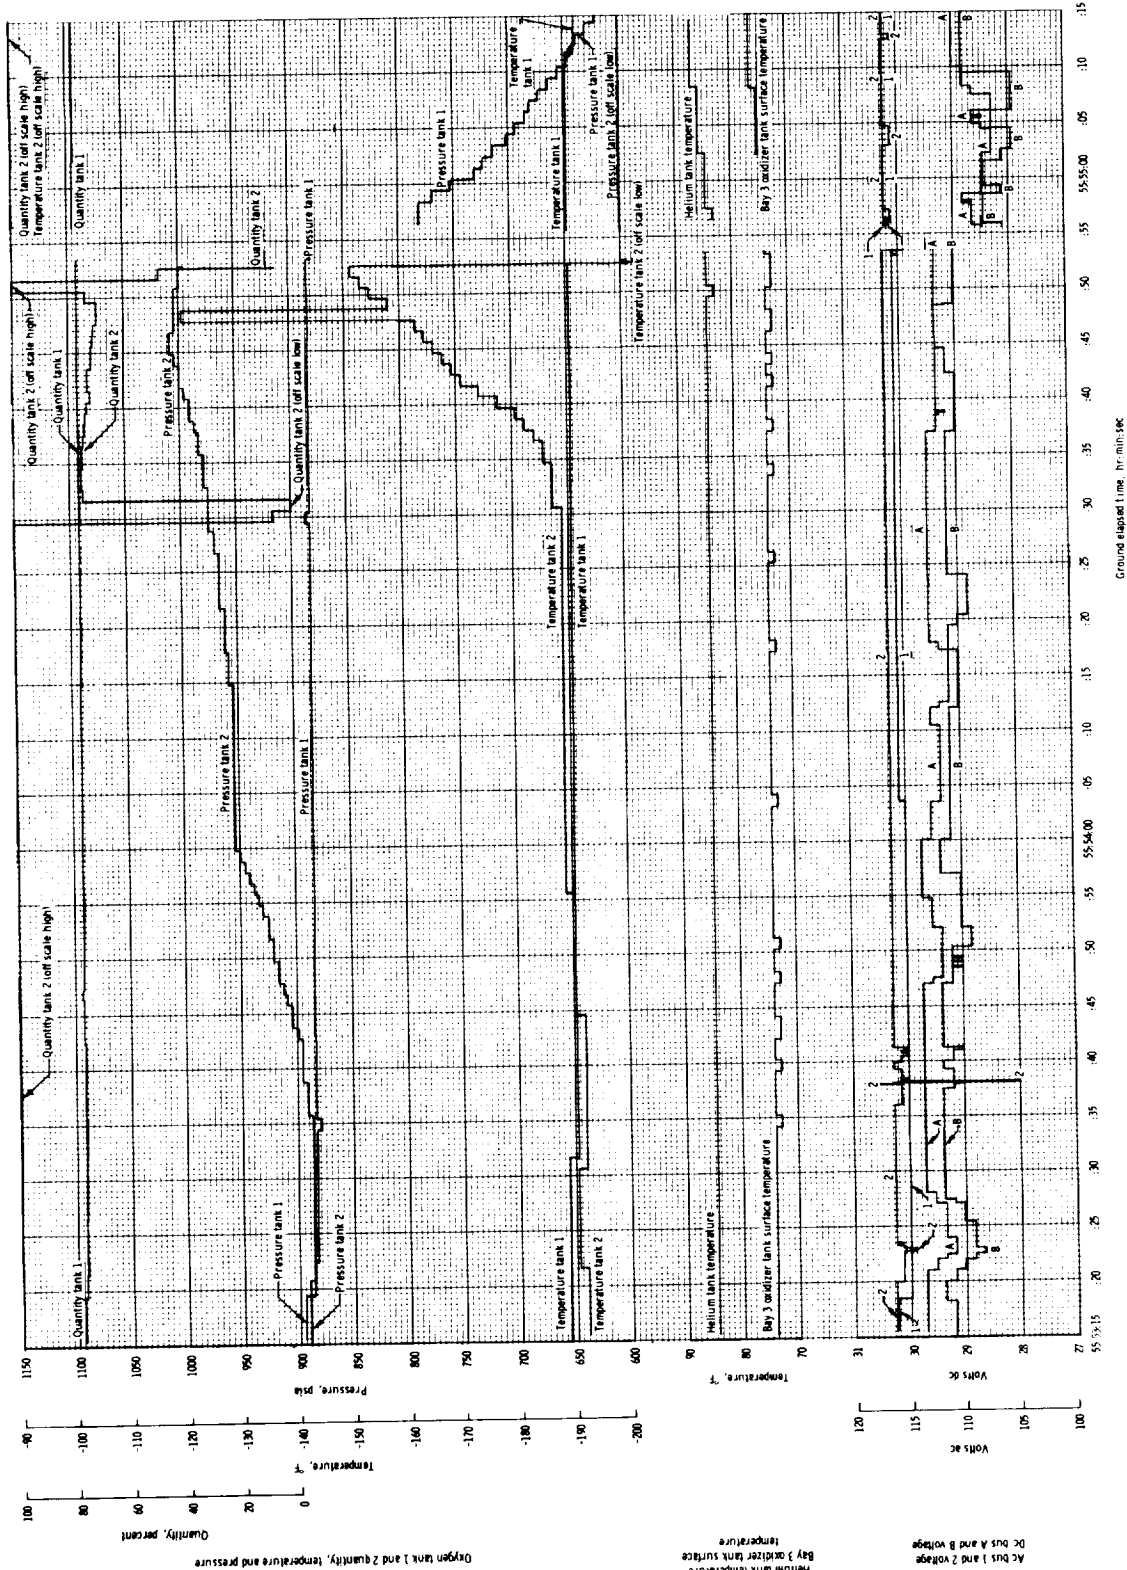
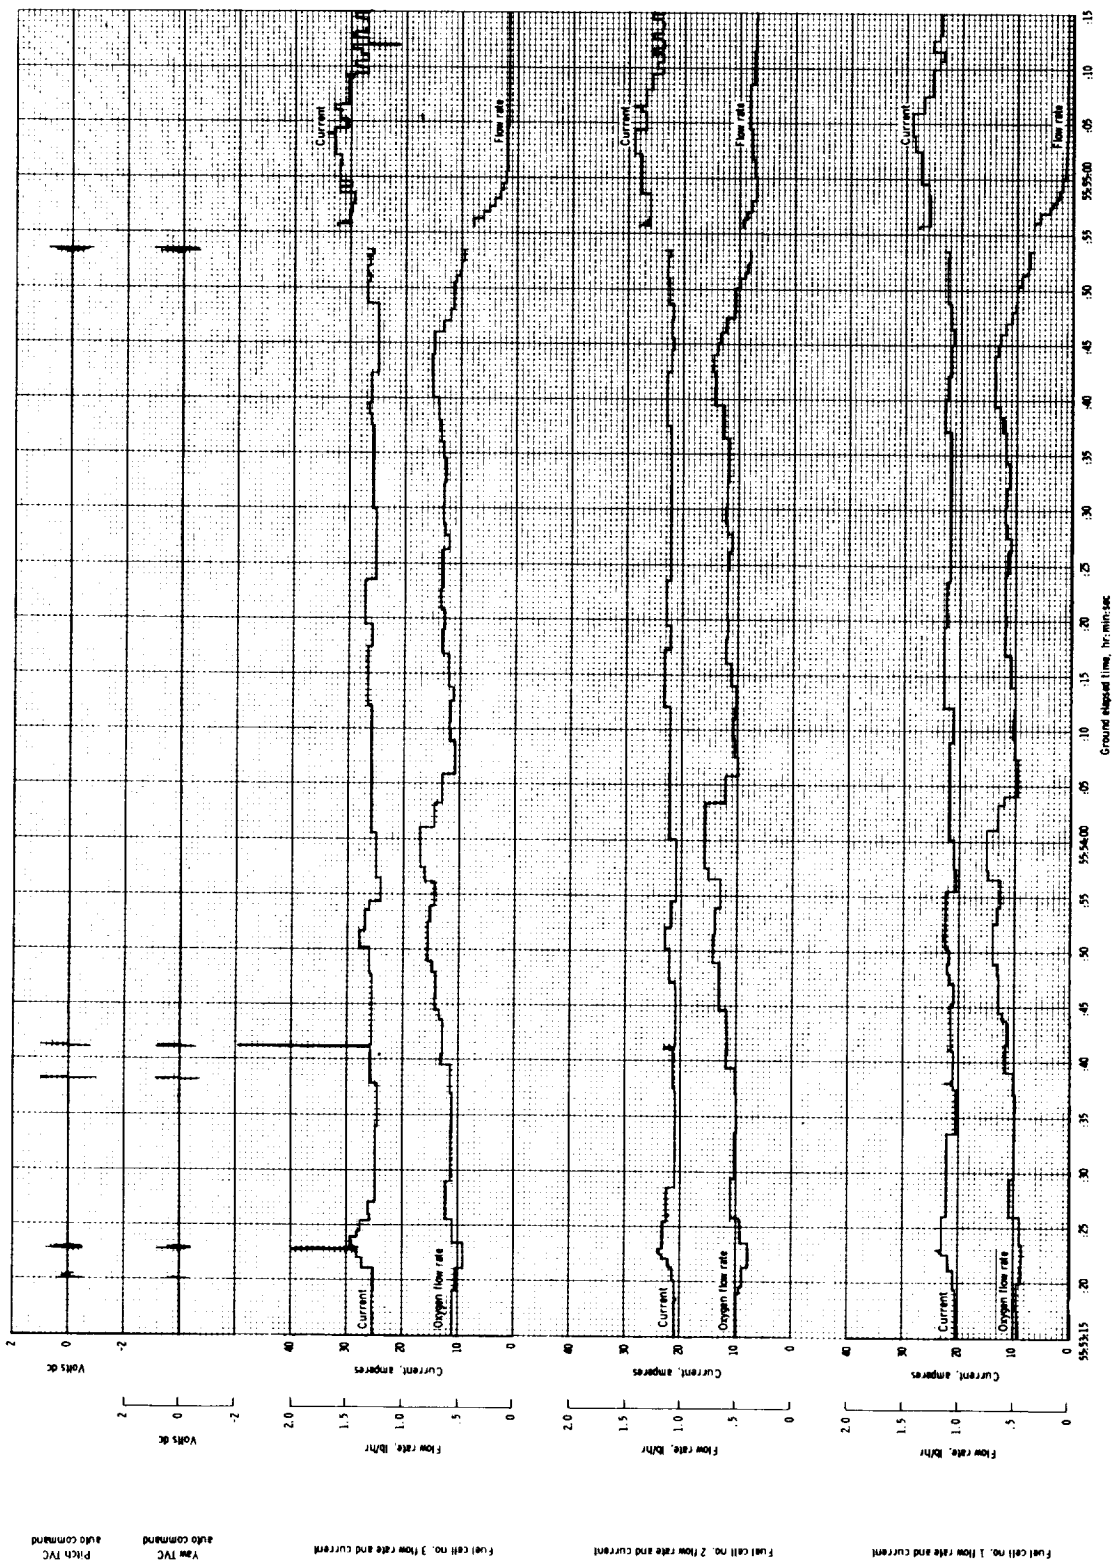
Figure B5-3(a).-- Telemetered parameters during anomaly.

At 55:53:18 when the two fans in cryogenic oxygen tank no. 1 were turned on by the crew, a drop in ac bus 1 voltage (fig. B5-3) and an increase of 1 ampere in total command module current indicated that the fans had been electrically energized. (Total command module current, plotted in figure B5-4, is obtained by adding the current outputs of all three fuel cells and subtracting the current drain of the lunar module.) A subsequent decrease in tank pressure and oscillations in the fuel cell flowmeters indicated that the fans had begun to stir the oxygen (fig. B5-3).

The quantity gage for oxygen tank no. 2, which had been in a failed state ever since the 46th hour, suddenly dropped to 6.6 percent and then to off-scale low at 55:54:30. These readings do not correlate with other telemetered data and are, consequently, thought to be erroneous. The gage then jumped to a 75-percent reading, which may be reliable data since it is about the value to be expected. Afterwards the quantity decreased gradually for 19 seconds until 3 seconds before telemetry loss, at which time an erratic gage output occurred. The behavior of this type of gage when a short across the capacitor probe is removed is to drop to zero for several seconds and then return to a correct reading. However, the gage has other failure modes which result in a wandering false indication. See Part B7 of this Appendix for a discussion of the quantity gage. Because of the gage's erratic behavior, it cannot be stated with complete confidence that the 75-percent reading obtained at 55:54:32 is reliable.

The temperature in cryogenic oxygen tank no. 2 remained at -190° F $\pm 2^{\circ}$ until 55:54:31 when a steady rise in temperature commenced. At 55:54:48 a single data sample indicated a reading 40 degrees higher than the adjacent readings. The last data sample before loss of telemetry was off-scale low, probably indicating a short circuit in the gage or wiring. As discussed in Part B7 of this Appendix, the time constant of the temperature sensor is in the order of at least tens of seconds, which means that the 40-degree jump in reading at 55:54:48 and the final off-scale reading were both due to sensor failure or telemetry system errors. Also, because of the slow gage response, the indicated rate at which the temperature rose between 55:54:31 and 55:54:52 could have been caused by an actual temperature rise of greater magnitude.

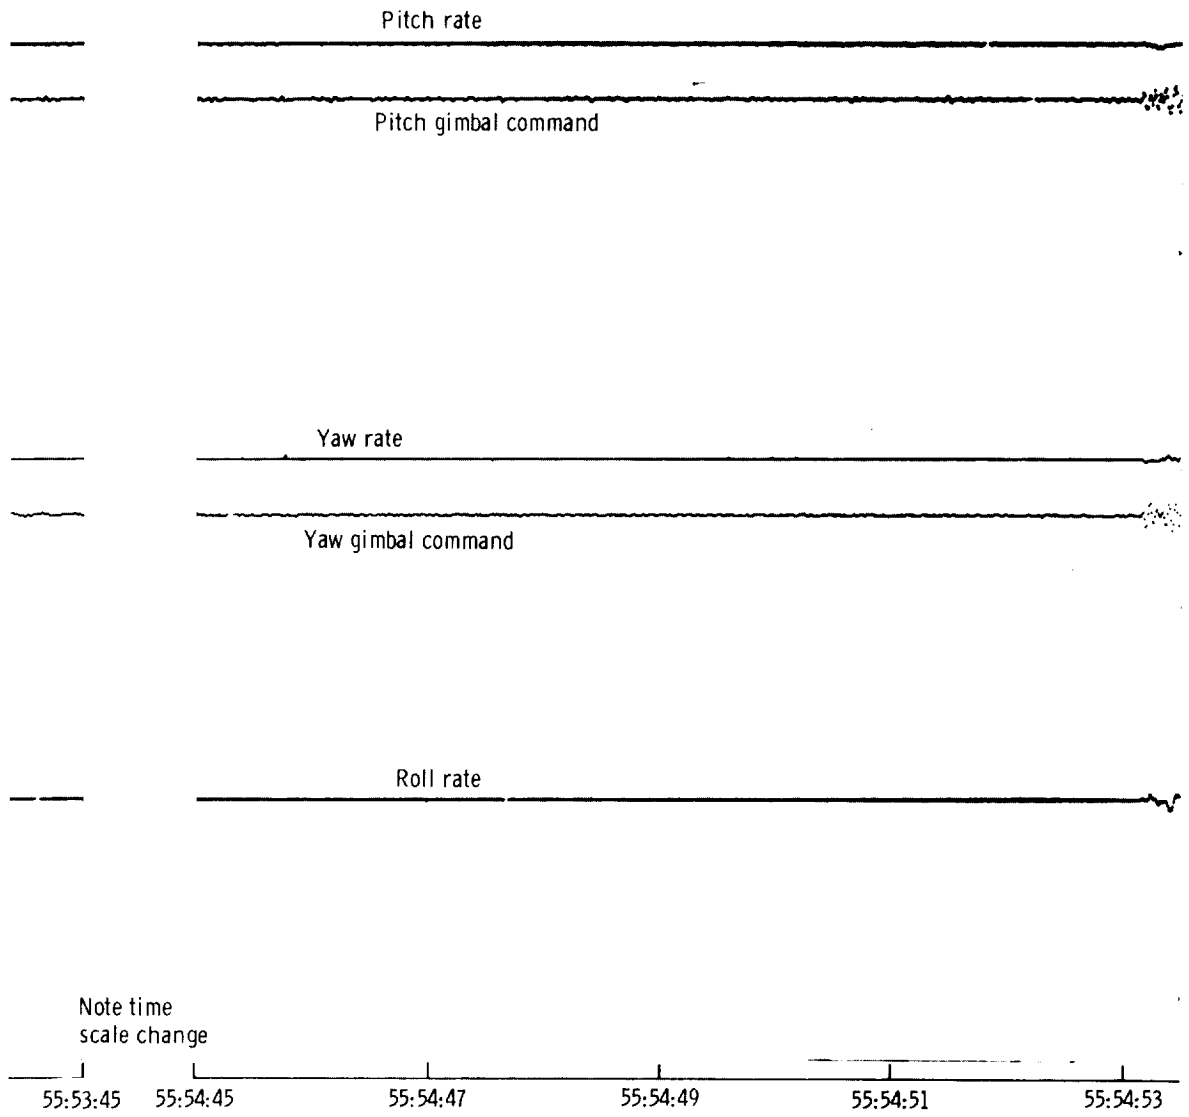
Figure B5-5.- Disturbances observed on thrust vector control gimbal command signals.

voltage of 0.6 volt, and a glitch in the stabilization control system telemetry indicated that the fans had been electrically energized. These events are shown in figures B5-4 and B5-5. However, it is not certain that the fans began rotating at this time, since the tank no. 2 pressure showed a minimum observable drop and the fan motor stall current does not significantly differ from the running current. The quantity gage in tank no. 2 was already in a failed condition, and the fuel cell flowmeters were already being affected by the fan operation in tank no. 1. so that neither of these instruments could positively verify rotation of the fans in tank no. 2. During the next 20 seconds a series of electrical anomalies occurred which cannot be explained as a result of known loads in the spacecraft. These anomalies are shown in figure B5-4. The first, at 55:53:23 was an 11-amp positive spike in the output current of fuel cell 3. Several events were associated with this spike:

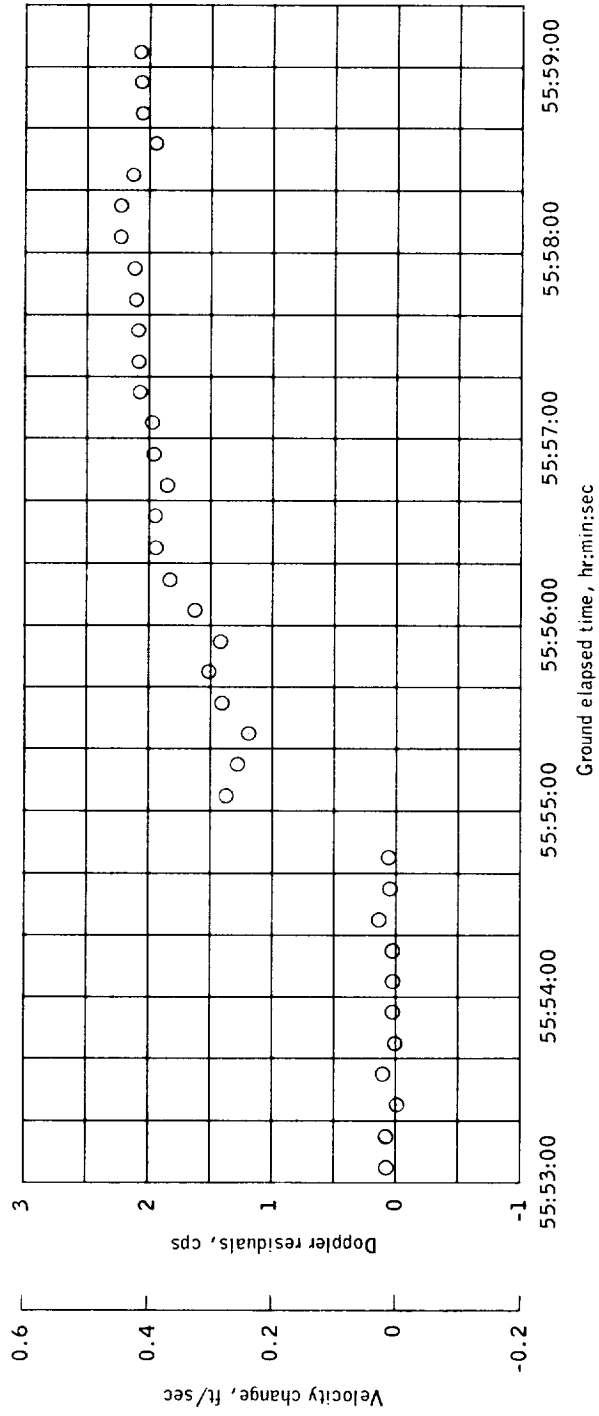
Figure B5-12.- Velocity increment at 55:54:53.

Between 55:54:45 and 55:55:05 doppler measurements indicated a radial velocity increment of 0.26 fps. This is shown in figure B5-12. Following this abrupt change in velocity at approximately the time of telemetry loss, additional velocity changes were observed, as shown in figure B5-13. These velocity increments were caused in part by venting from the spacecraft and in part by firings of reaction control system jets.

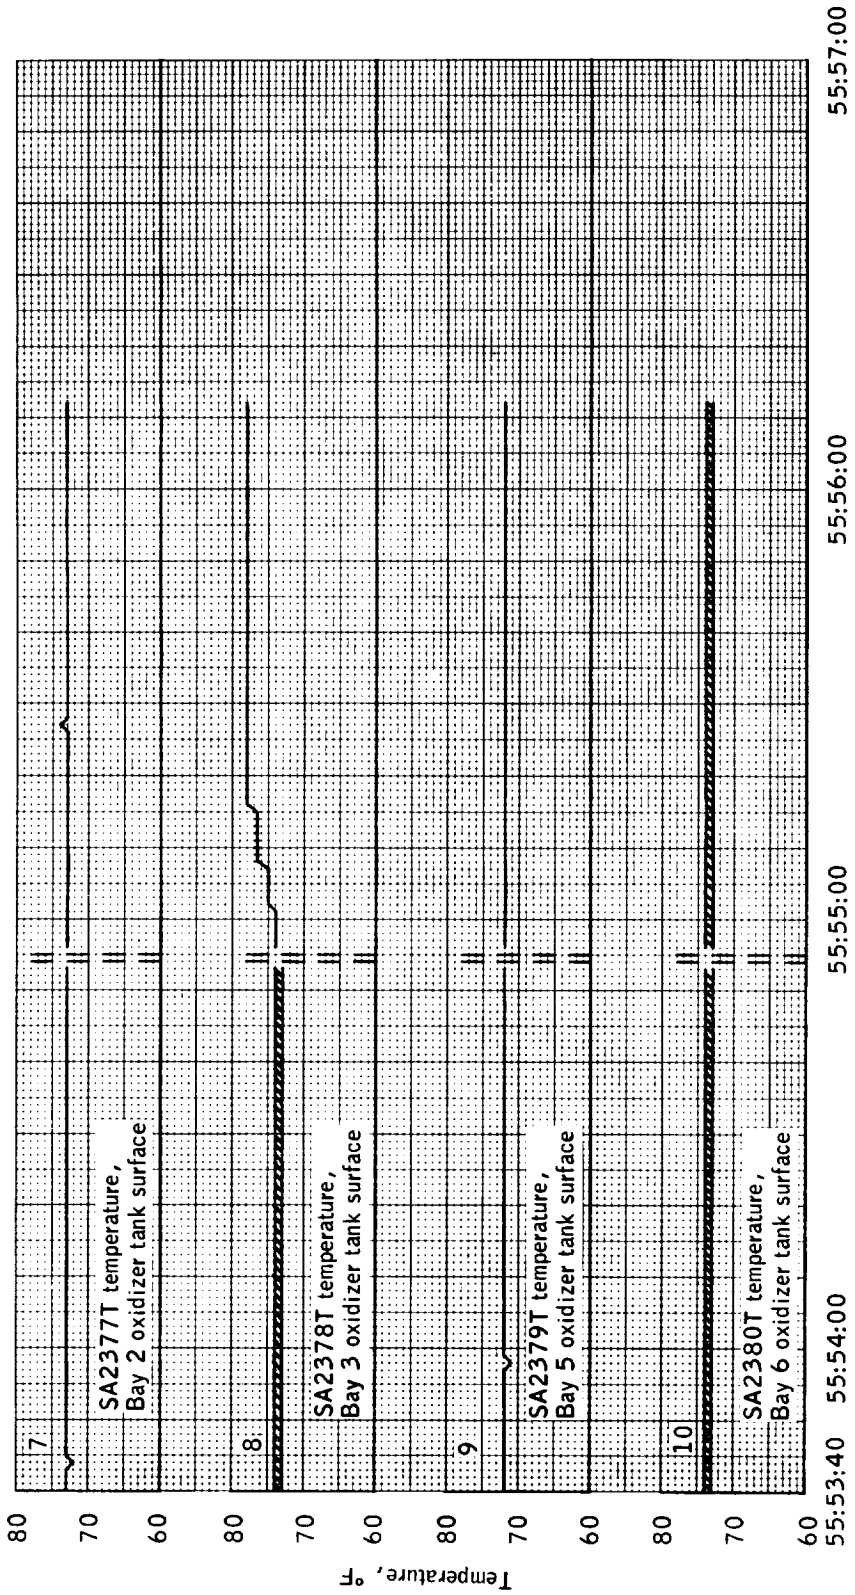
(c) Tank surface temperatures.

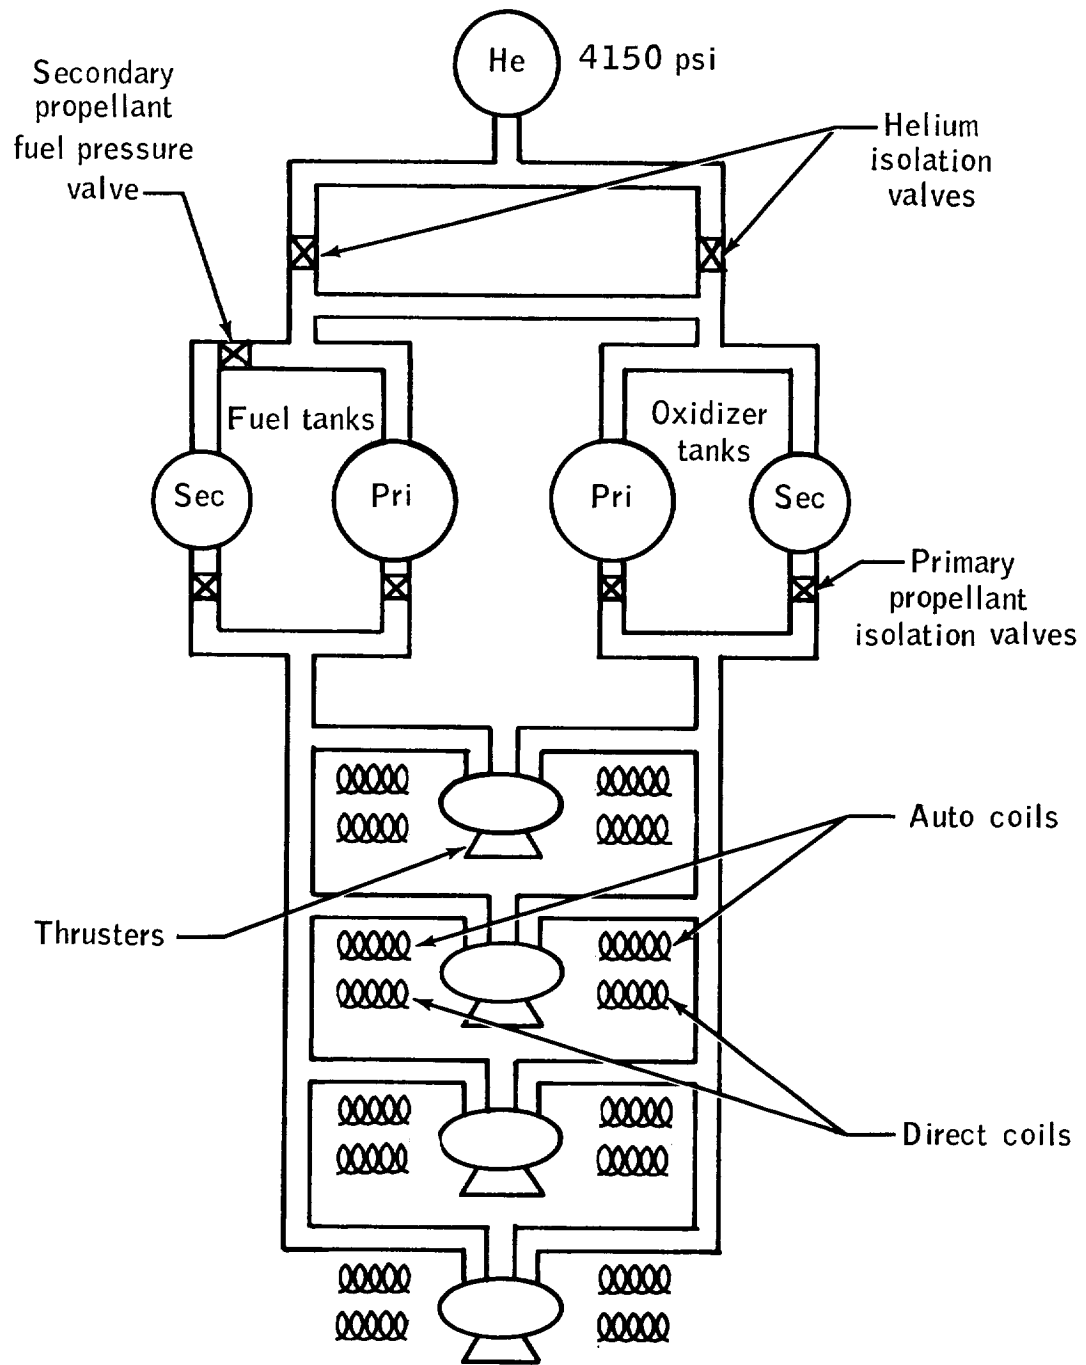
Figure B6-1.- Service module reaction control system one quad (typical of all four).

Jet-firing signals, received at each individual thruster, open fuel and oxidizer valves by energizing a coil. There are two coils at each thruster. One, called "Auto," receives its signal from either the computer or the two rotational hand controllers (RHC's) and can be powered from either main dc bus, selected by the "Auto RCS Select" switches. There are 16 switches; one for each individual thruster that can be positioned to "off," "main A," or "main B." The other coil at the thruster is called "Direct" and receives its signal from the rotational hand controllers when they are rotated sufficiently far from the null detent. There are several ways of configuring the RHC's to power the Direct coils. Each RHC is limited as to which main bus and thruster combination it can be tied. Typically, the RHC's are powered so that half the jets are fired by main bus B and the other half by main bus A. As per normal procedure, the auto RCS select switches were configured so that single-jet authority in roll, pitch, and yaw attitude control would be available without reconfiguring if either main bus were lost. This protection can only be obtained if all four quads are functional. The loss of capability resulting from the failure of a main bus would be compounded by the concurrent closing of propellant isolation valves. Control about one or more axes would be lost

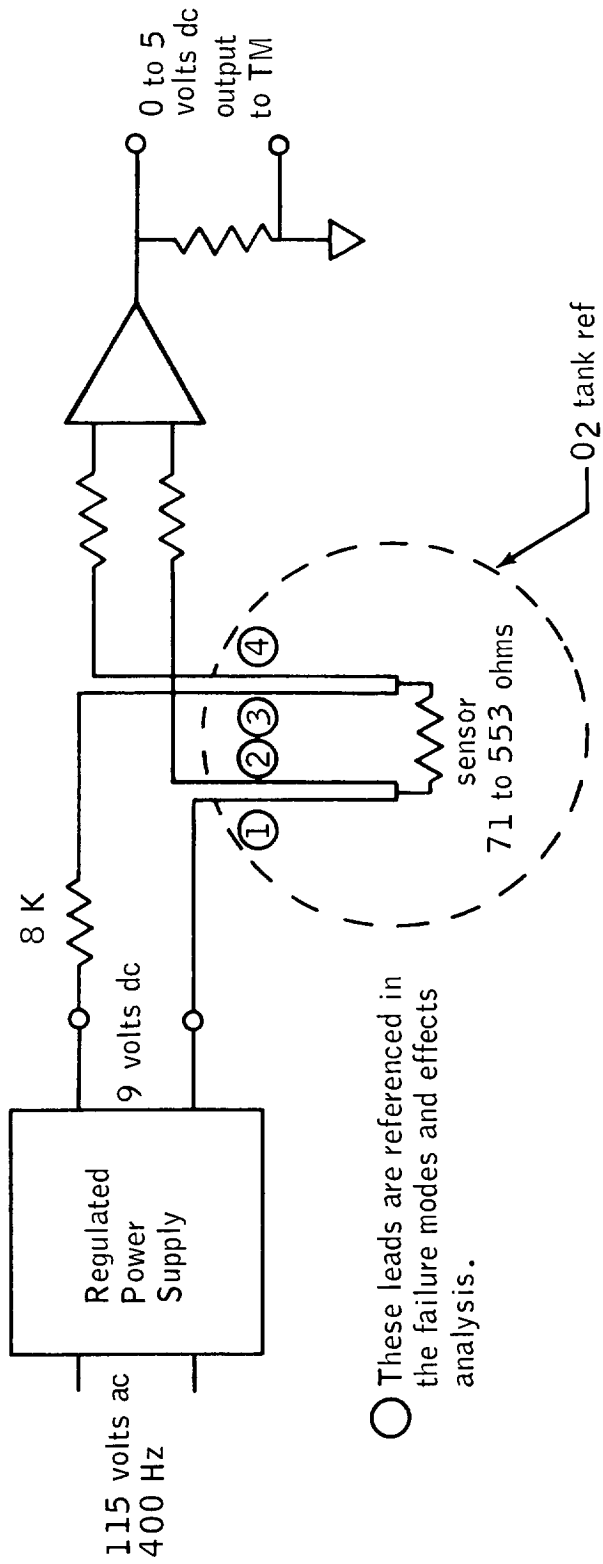
Figure B7-2.- Oxygen tank temperatures sensing circuit.

○ These leads are referenced in the failure modes and effects analysis.

Failure mode	Indication	Resulting damage
Any of the four temperature sensor leads shorted to 115 V ac line (1, 2, 3, 4)	Full scale output followed by zero output	Would fail signal conditioner amplifier, sensor element, and pulse code modulation gate
Temperature sensor shorted to the density probe element	*No change in output	Probably no circuit element damage
Temperature sensor shorted to ground (either side)	*Zero output signal	No circuit damage
Dc power shorted to temperature sensor	Full scale output	Would fail signal conditioner output
Either or both sensor leads open	Full scale output	None
400 Hz power input to power supply disconnected.	Output drifts to zero as charge in power supply filter capacitors discharge.	None
Temperature sensor leads shorted to each other	*Zero output	None
Any one of leads 1, 3, or 4 broken (open) (fig. B7-2)	Zero output	No circuit damage
Open lead 2 (fig. B7-1)	*Immediate rise to full scale followed by a linear decay to zero in approx. 10 msec	No circuit damage

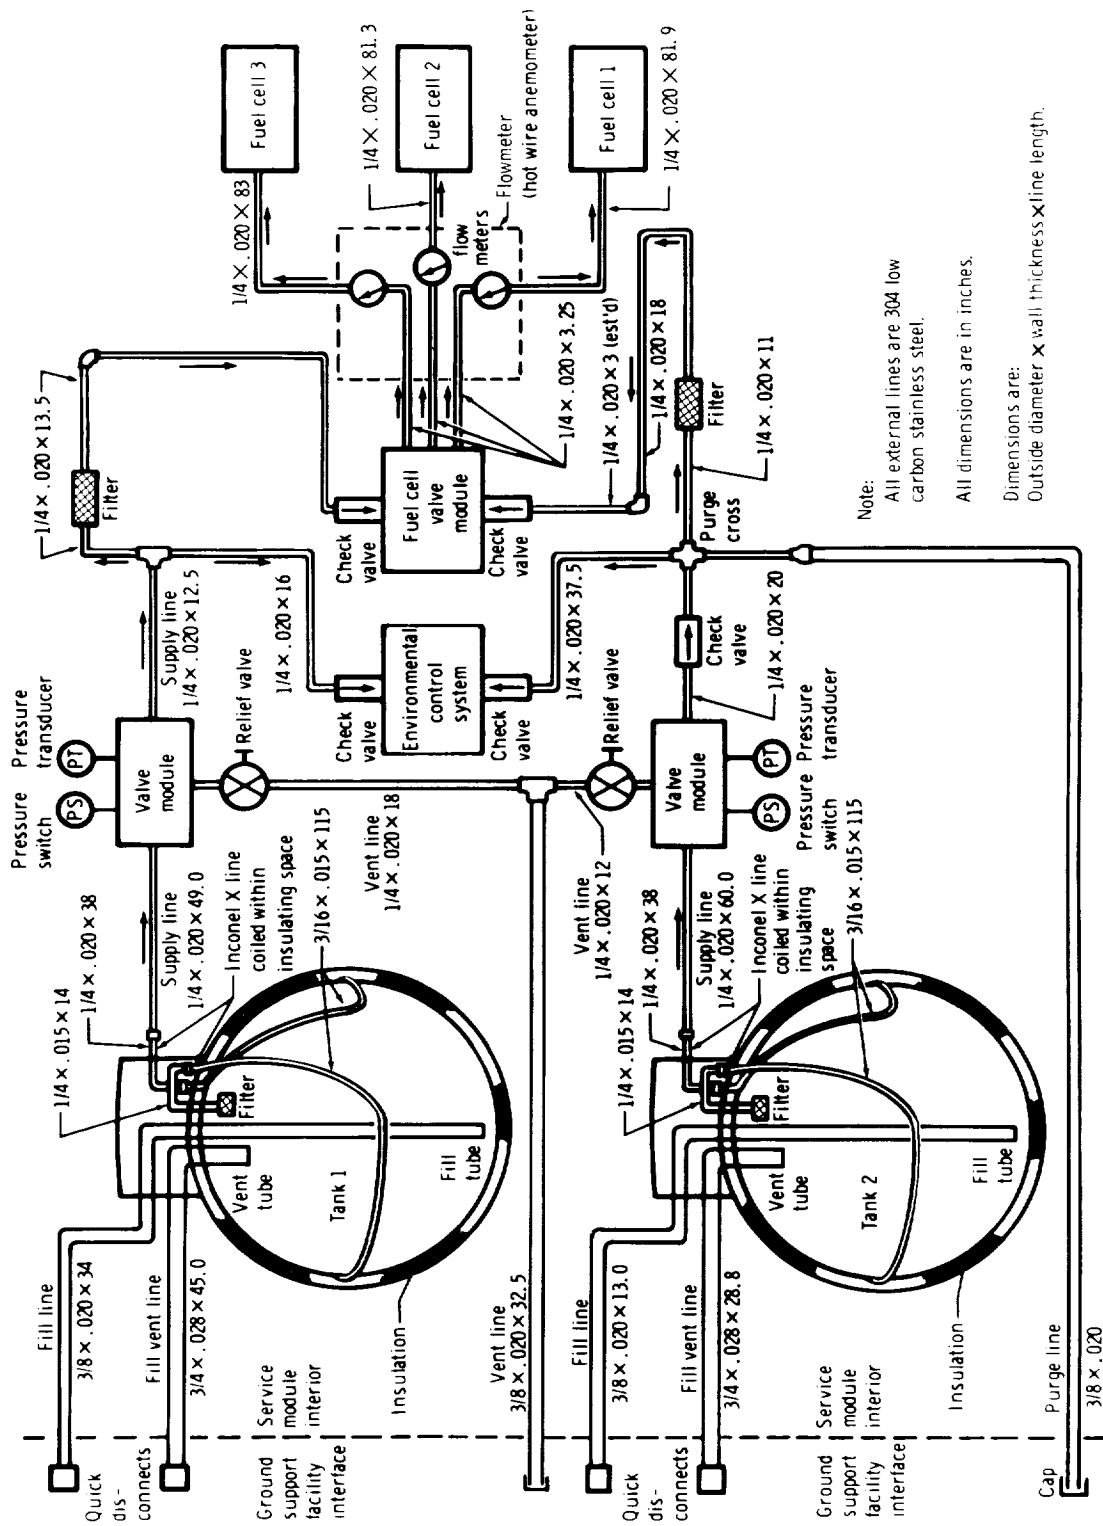
Figure B7-4.- Oxygen system.

The location of the oxygen tank pressure measuring instrumentation is shown schematically in figure B7-4. Pressure transducers for both tanks are located in a valve module assembly along with the pressure switches and pressure relief valves as shown in figure B7-5. The valve module assembly is connected to the oxygen tanks by 19-foot lengths of 1/4-inch and 3/16-inch OD tubing.

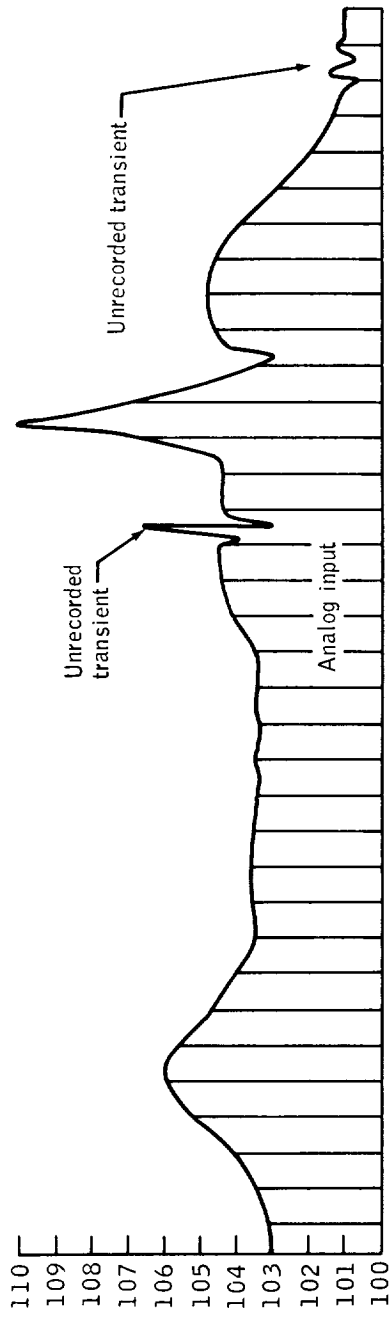
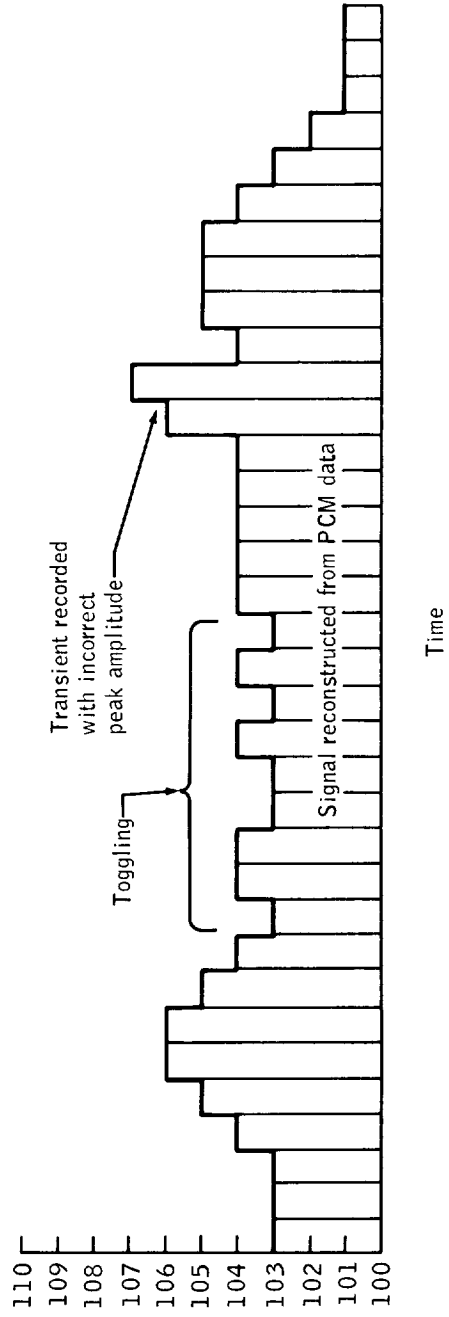
Figure B7-6.- Digital coding and reconstruction of analog signal.

6. In addition to the phenomena illustrated in figure B7-6, it must be recognized that noise in the RF link may cause erroneous data to be received on the ground. Such errors usually appear in the data as values which differ greatly from adjacent outputs from the same channel.

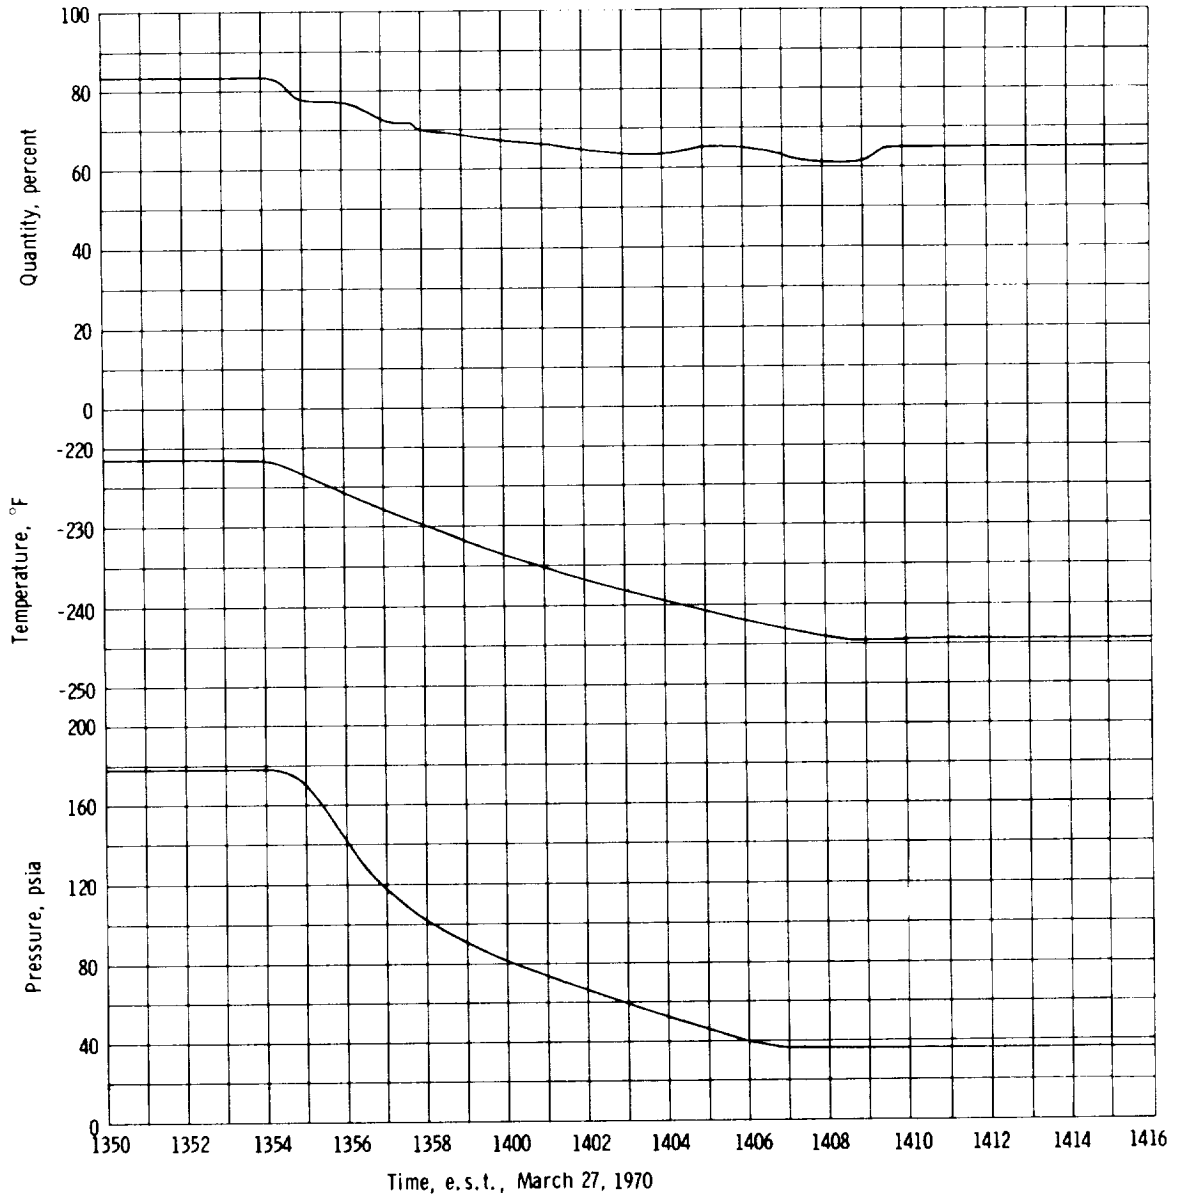
Figure C4-58.- Oxygen tank 2 detanking characteristics (pressure decay through the fill line - CDDT).

During these CDDT operations on March 23, tank no. 1 was detanked to the normal 50 percent within less than 10 minutes. Over the space of 45 minutes, tank no. 2 did not detank normally but was observed to retain more than 90 percent of its oxygen. Detanking was suspended until the completion of CDDT.

Next, during detanking attempts for both tanks, a comparison of tank no. 1 and tank no. 2 performance was made. The indicated oxygen quantity of tank no. 1 depleted from 48 percent to zero in less than 10 minutes. The indicated quantity in tank no. 2 remained above 60 percent over a 20-minute period.

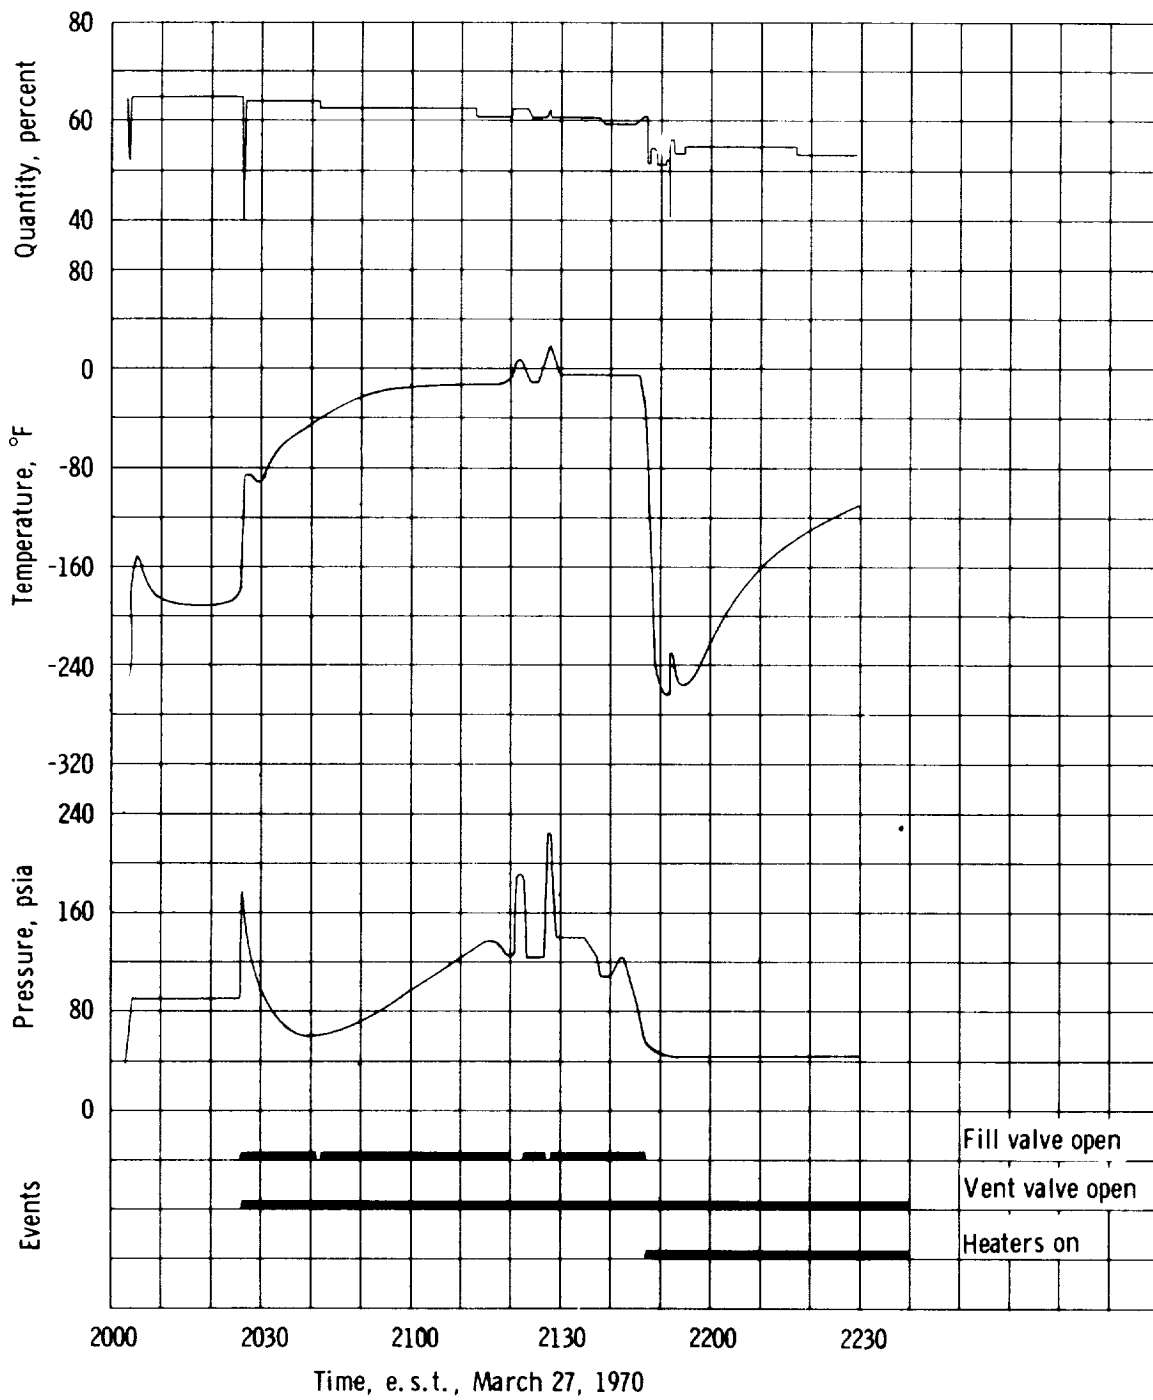
Figure C4-59.- Oxygen detanking attempt using varying purge pressure.

Attempts were made over an 80-minute period to deplete the oxygen content of tank no. 2 by cycling up to various pressures and down, but did not reduce the indicated quantity below 54 percent (fig. C4-59). An attempt was made to expedite oxygen expulsion through the use of the tank heaters operated at maximum voltage and the fans. These were turned on for nearly 6 hours while the vent port remained open (fig. C4-60). Still the indicated quantity remained above 30 percent.

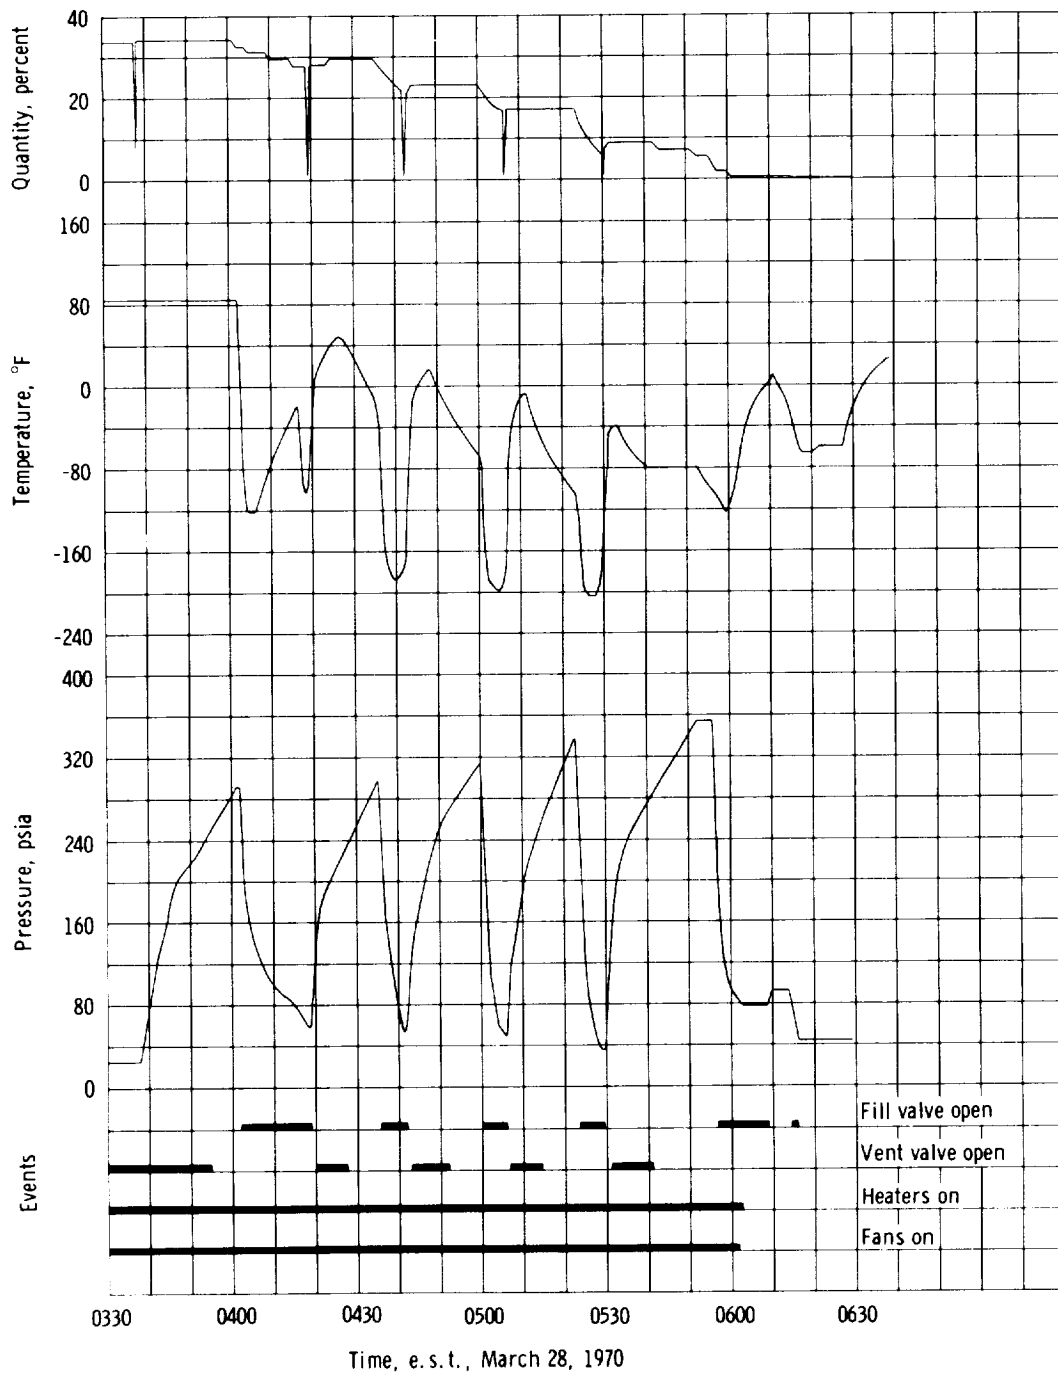
Figure C4-61.- Oxygen detanking using pressure cycles and tank heaters.

Then a pressure cycling technique was employed over a 2-1/2 hour period with maximum power being applied continuously to both tank heaters and fan circuits (fig. C4-61). This technique involved raising the tank pressure by external gaseous oxygen to approximately 300 psia and then opening the fill line to induce rapid boil-off. After five cycles, the oxygen tank quantity indicated zero.

Fan responses were observed to be normal throughout these operations. The temperature sensor on the quantity probe reached its indicating limit (+84 F) halfway through the 6-hour heating period. No observations of whether the heaters cycled on and off were made and subsequent review of the power supply voltage recording showed no indication of heater cycling.

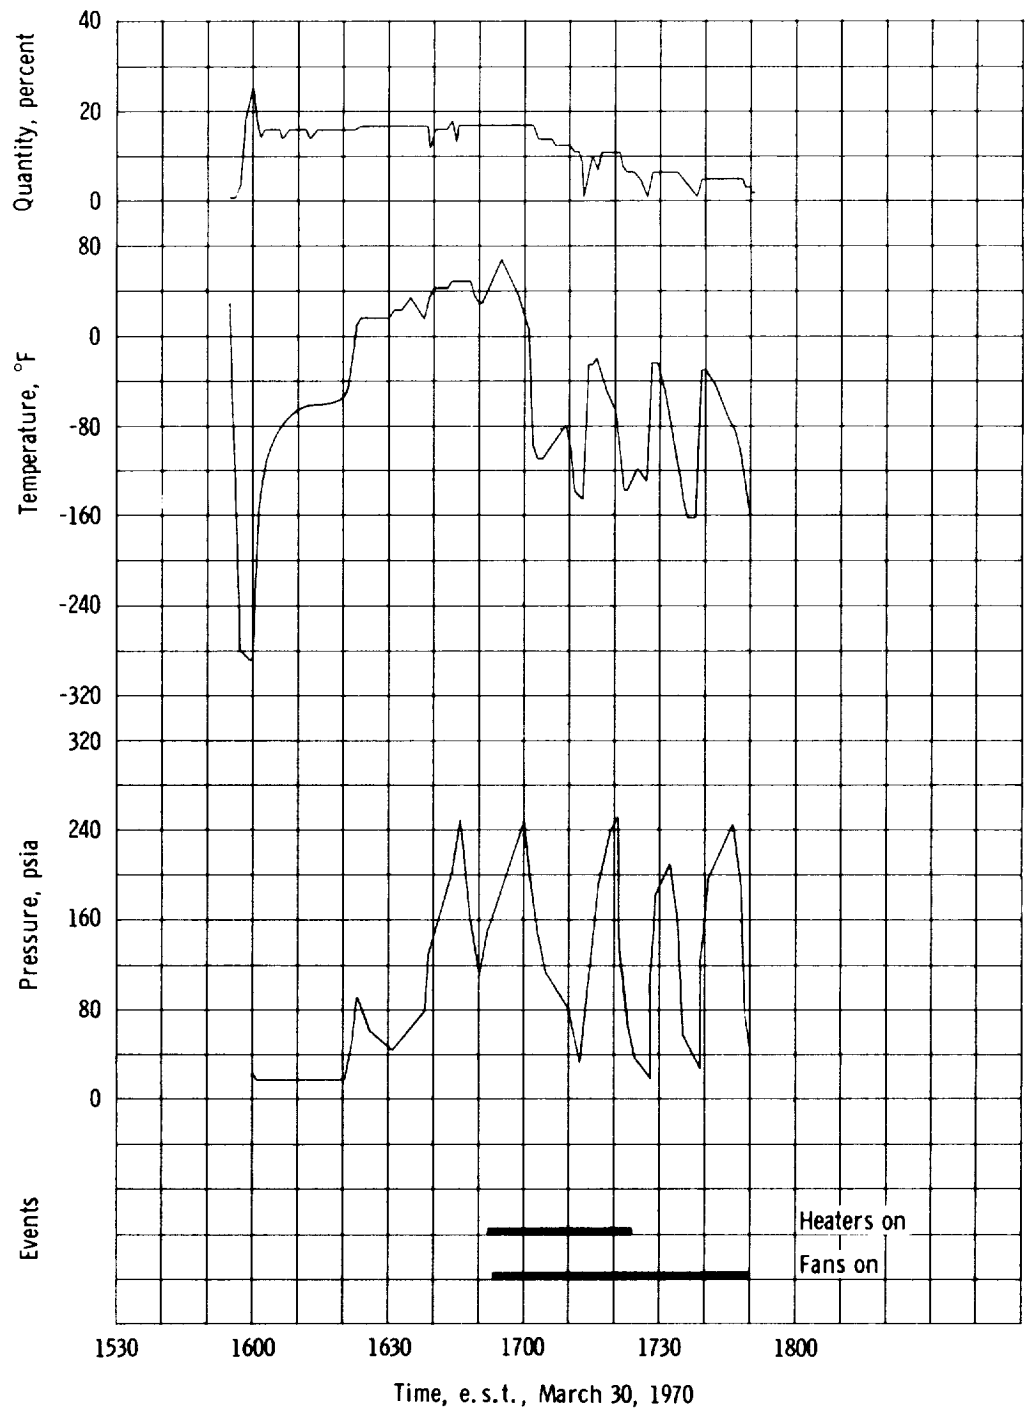
Figure C4-63.- Oxygen detanking using pressure cycles and tank heaters.

To verify this judgment and to assure countdown operability, both tanks were filled on March 30 to about 20 percent in approximately 2.5 minutes. Tank no. 1 detanked normally; tank no. 2 did not. Again the procedure of applying heat at maximum voltage and the cyclic application of gas pressure of approximately 250 psia and then venting was used. Five cycles were applied in a 1-1/4 hour period and tank no. 2 was emptied (fig. C4-63). The fan responses were observed to be normal and no indications of heater cycling were observed.
