REPORT OF APOLLO 13 REVIEW BOARD

**APPENDIX B - REPORT OF MISSION
EVENTS PANEL**

**APPENDIX C - REPORT OF MANUFACTURING
AND TEST PANEL**

APPENDIX D - REPORT OF DESIGN PANEL

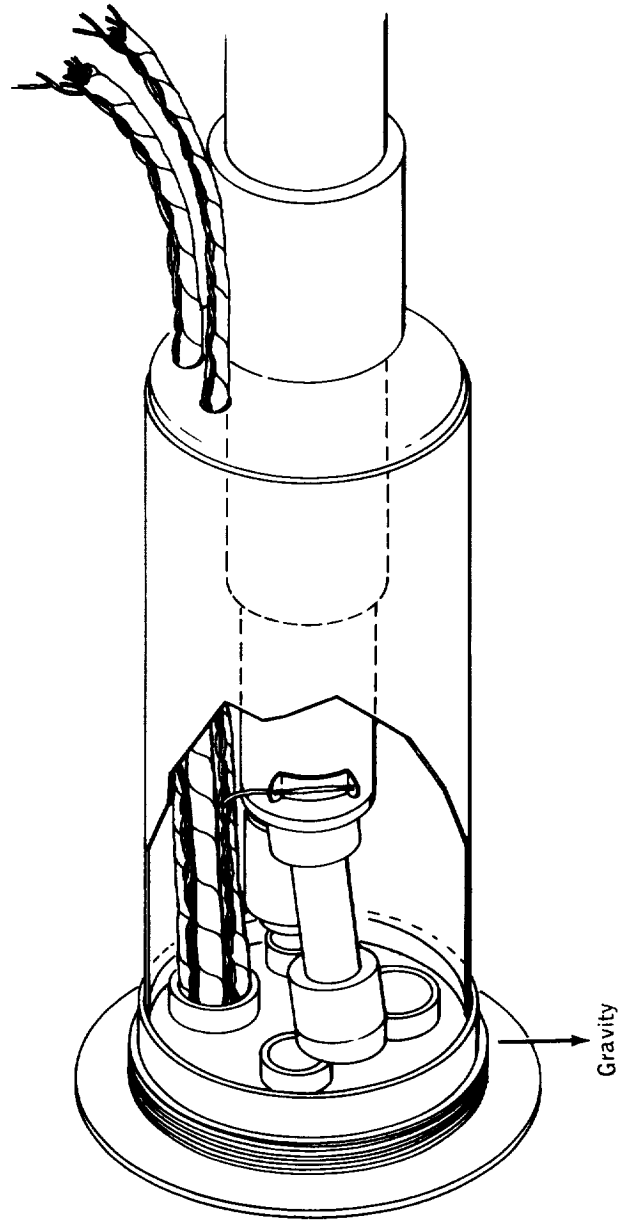
Figure C4-64.- Isometric sketch of quantity probe head as oriented during SM transportation.

It appears pertinent to this review to note that during SM transportation the fill tube segments within the upper portion of the oxygen tank no. 2 quantity probe assembly lay with the tank-exit end of the fill tube segments about 20 degrees above the horizontal, if they were still in place after previous handling and the "shelf drop." Neither the wires nor the feed line filter were below it to restrict rotation of the fill tube about the central tube of the quantity probe (fig. C4-64).

This history of exposure of the tank fill tube segments to an unusual dislodgment environment sequence was not recorded during the detanking incidents at KSC nor during the presentation of CSM 109 history reviews to the Apollo Spacecraft Program Manager through either reliability and quality assurance or engineering channels at MSC. However, it does corroborate the recorded real-time judgment of Beech, MSC, and KSC engineers that the tank fill line parts may have been out of place in tank 10024XTA0008 during the detanking problems of March 23-30, 1970.

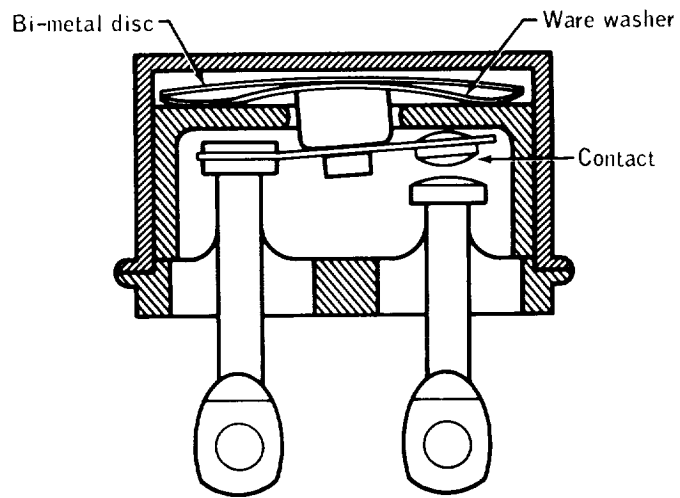
(a) Switch cross section.

The test was started and after a few cycles in this mode the previously nonfunctioning (open) thermostat started indicating normal function. At this time it was decided to revert to the originally intended test configuration, i.e., the thermostats directly controlling the heaters. Data from that point on indicated that the thermostats were not cycling the heaters. The heater tube temperature data looked just like the nonthermostat test run. The test terminated at this point and the thermostats were removed and X-rayed. The X-rays indicated that the contact gap was bridged. One thermostat had its case carefully removed to examine the conditions of the contacts (fig. C4-67).

At no time during standard checkout, prelaunch, and launch operations are these thermostats required to interrupt the 65 V dc ground power supply current. As far as could be determined, the special detanking operation was the only time that any thermostats were ever called upon to interrupt this load.

Melted silver contacts

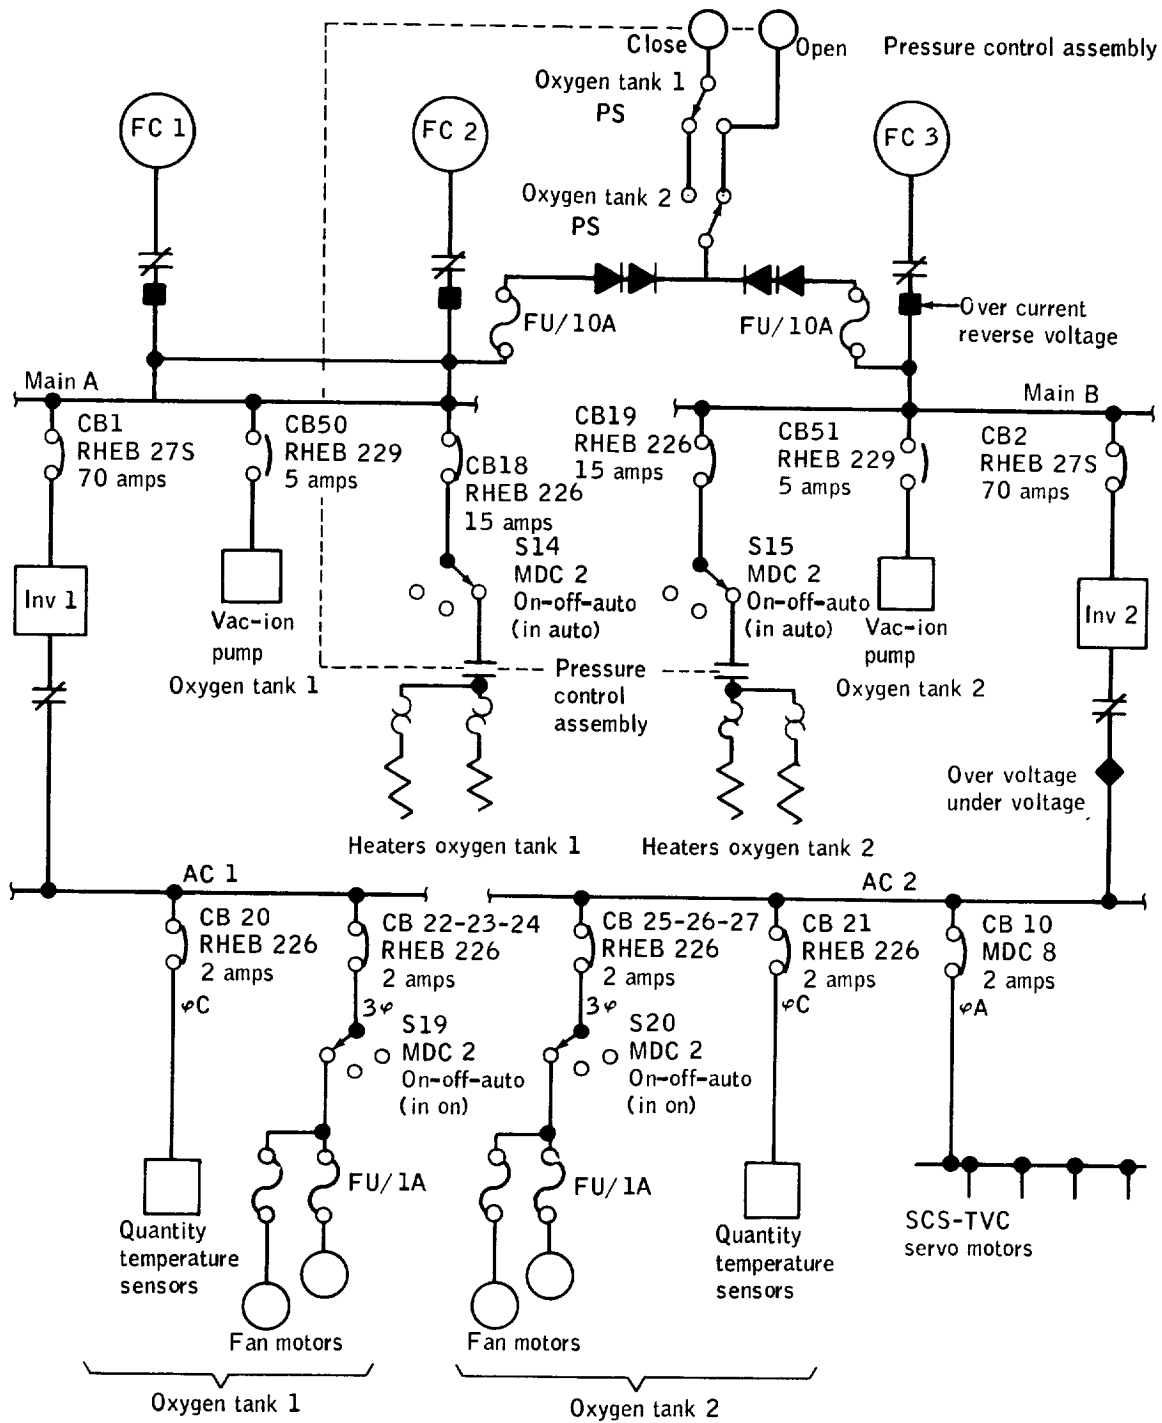
Figure D3-5.- Electrical schematic of relevant portions of electrical power system at 55:53:21.

The electrical power system, in general, provides multiple power busses with switching options for selecting an operating configuration. At 55:53:21, the electrical system was configured in accordance with reference 1, as shown in figure D3-5, with fuel cells 1 and 2 connected to main bus A and fuel cell 3 connected to main bus B. Inverter 1 was connected to main bus A and powering ac bus 1. Inverter 2 was connected to main bus B and powering ac bus 2. Inverter 3 was not connected. Battery busses A and B were not connected to main bus A or B. The switches controlling heater operation for both oxygen tanks were in the "automatic" position, controlling heater operation through the pressure control assembly. Pressures in the oxygen tanks were at levels which did not demand operation of the heaters. Temperature and quantity sensors on oxygen tank no. 2 were energized from ac bus 2. The quantity gage

had remained off-scale high from 46:40:06, indicating a probable short circuit either on the leads or the probe assembly. Operation of the fan motors in the oxygen tanks was accomplished throughout the mission using manual control in lieu of the automatic operation afforded by the logic of the pressure control assembly. A routine operation of the fans was requested by the ground at 55:52:58 and acknowledged by the crew at 55:53:06. Energizing of the fans in oxygen tank no. 1 is confirmed by a drop in voltage of ac bus 1 and an increase in total fuel cell current at 55:53:18. Energizing of the fans in oxygen tank no. 2 is confirmed by a drop in voltage of ac bus 2 and an increase in total fuel cell current at 55:53:20. Data substantiating operation and operation times are presented in Appendix B.

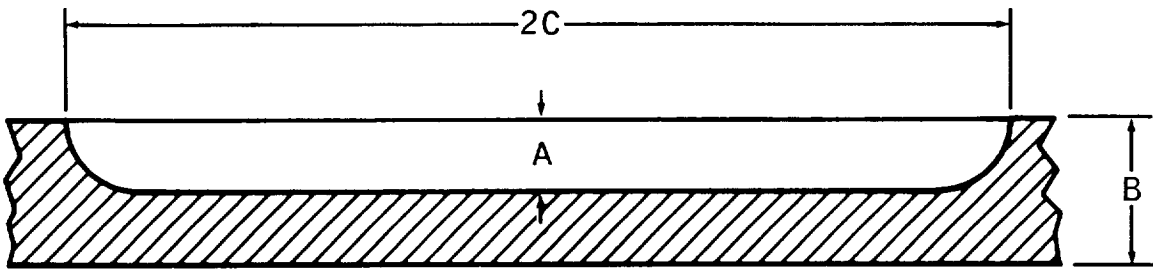
Figure D3-9.- Ligament model for ductile fracture of pressure vessel.

The proof test is the last, and should be the best, flaw detection procedure applied to a pressure vessel. Ideally, the proof test should cause failure if there are any flaws present that could grow to a critical size during subsequent pressurization. For the oxygen tanks in question, a fracture mechanics analysis cannot be made to assess the adequacy of the proof test because of the high toughness of the material and the thin sections used. These factors in themselves, of course, contribute to the confidence that can be placed in the integrity of the pressure vessel and, as discussed in the previous section, essentially rule out the possibility of brittle failure. However, it is worthwhile to estimate the effectiveness of the proof test in identifying those pressure vessels which might develop leaks during pressure cycles subsequent to proof. The failure model proposed considers the plastic instability fracture of a ligament of material produced by incomplete fusion during electron beam welding. The main features of this model are illustrated in figure D3-9. It essentially represents a long flaw in the tank wall at the

Area of lack of fusion produces
an effective crack of depth A
& length 2C in tank wall of
thickness B. $2C \gg A$

equatorial weld. It is postulated that the ligament will fail when its stress reaches the tensile strength of the material. Calculations show that the ligament stress σ_l is related to the average wall stress

where F_{tu} is the ultimate tensile strength. Failure will occur by tearing of the ligament accompanied by rapid decompression of the tank. It should be appreciated that this is a rather crude model of ductile fracture, and will probably overestimate the failure stresses in a spherical vessel. However, it should be useful in assessing the effectiveness of the proof tests in light of subsequent service, because of the very large margins between proof and operating pressures.

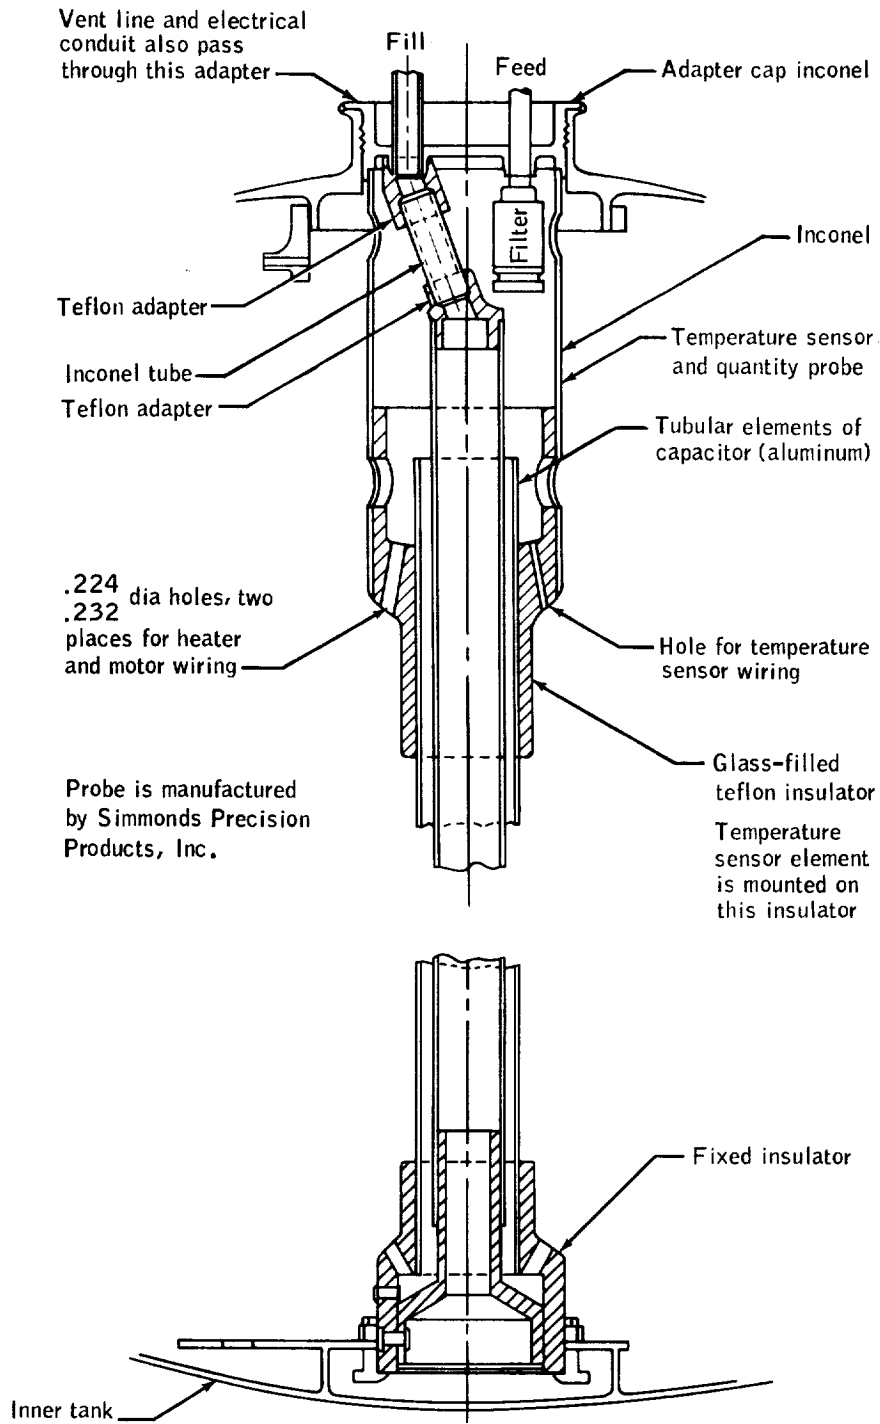
Figure D3-12.- Quantity gage.

The quantity gage capacitor (fig. D3-12) consists of two concentric aluminum tubes which are adequately mounted and supported. The inner tube of the capacitor constitutes the extension of the fill line. The outer tube is perforated to insure access of the oxygen to the space between the capacitor plates. The relative position of the two plates is maintained by insulating Teflon separators. Shorting of the capacitor at the plates within the tank requires bridging of the gap between the tubes by a conductive material. Shorting could also be induced by the contact of bare lead wires resulting from insulation damage. The power input to the quantity gage is regulated and limited by the high impedance source of the signal conditioner. The spark that could be

generated is at the 7- to 10-millijoule level. The evidence provided by the data can be construed to indicate that the effects of the probe failure during flight were limited to data loss.

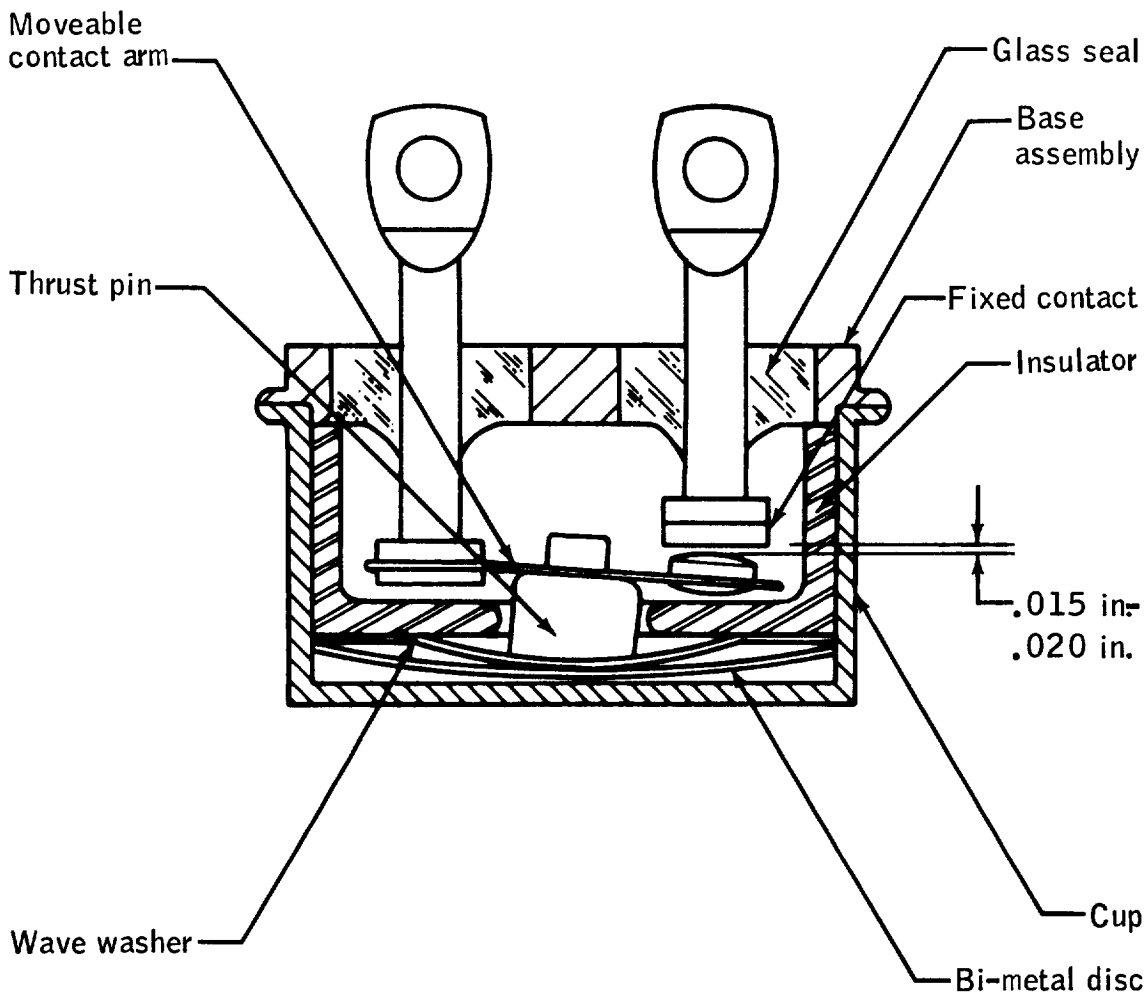
Figure D3-14.- Cross section of thermostat.

The specifications established by North American Rockwell for the Block II EPS cryogenic storage system (ref. 24) provide a requirement for operation of the heater circuit at 65 V dc from a GSE source for initial pressurization of the oxygen tank. For flight, the specification calls for operation from a 28 V dc source. The specifications established by Beech Aircraft Corporation for the thermostat (ref. 26) stipulate a current-carrying requirement of 7 amperes without specifying voltage level or type of source (i.e., ac or dc). Acceptance test requirements imposed on the supplier by this latter document include dielectric testing, thermal shock, verification of operating temperatures of the thermostat, helium leak test, insulation resistance test, and visual and dimensional inspection. No requirement is imposed for acceptance test verification of the operational characteristics of the thermostat with respect to current-carrying capability or ability to open under load at any of the several voltages (65 V dc, 65 V ac, or 28 V dc) to which the thermostat will normally be subjected.

All qualification and acceptance tests identified were primarily concerned with the repeatability of the thermostat actuation at the specified temperatures. No qualification or acceptance tests have been identified which would verify the ability of the thermostats to open the heater circuit when energized at 65 V dc.

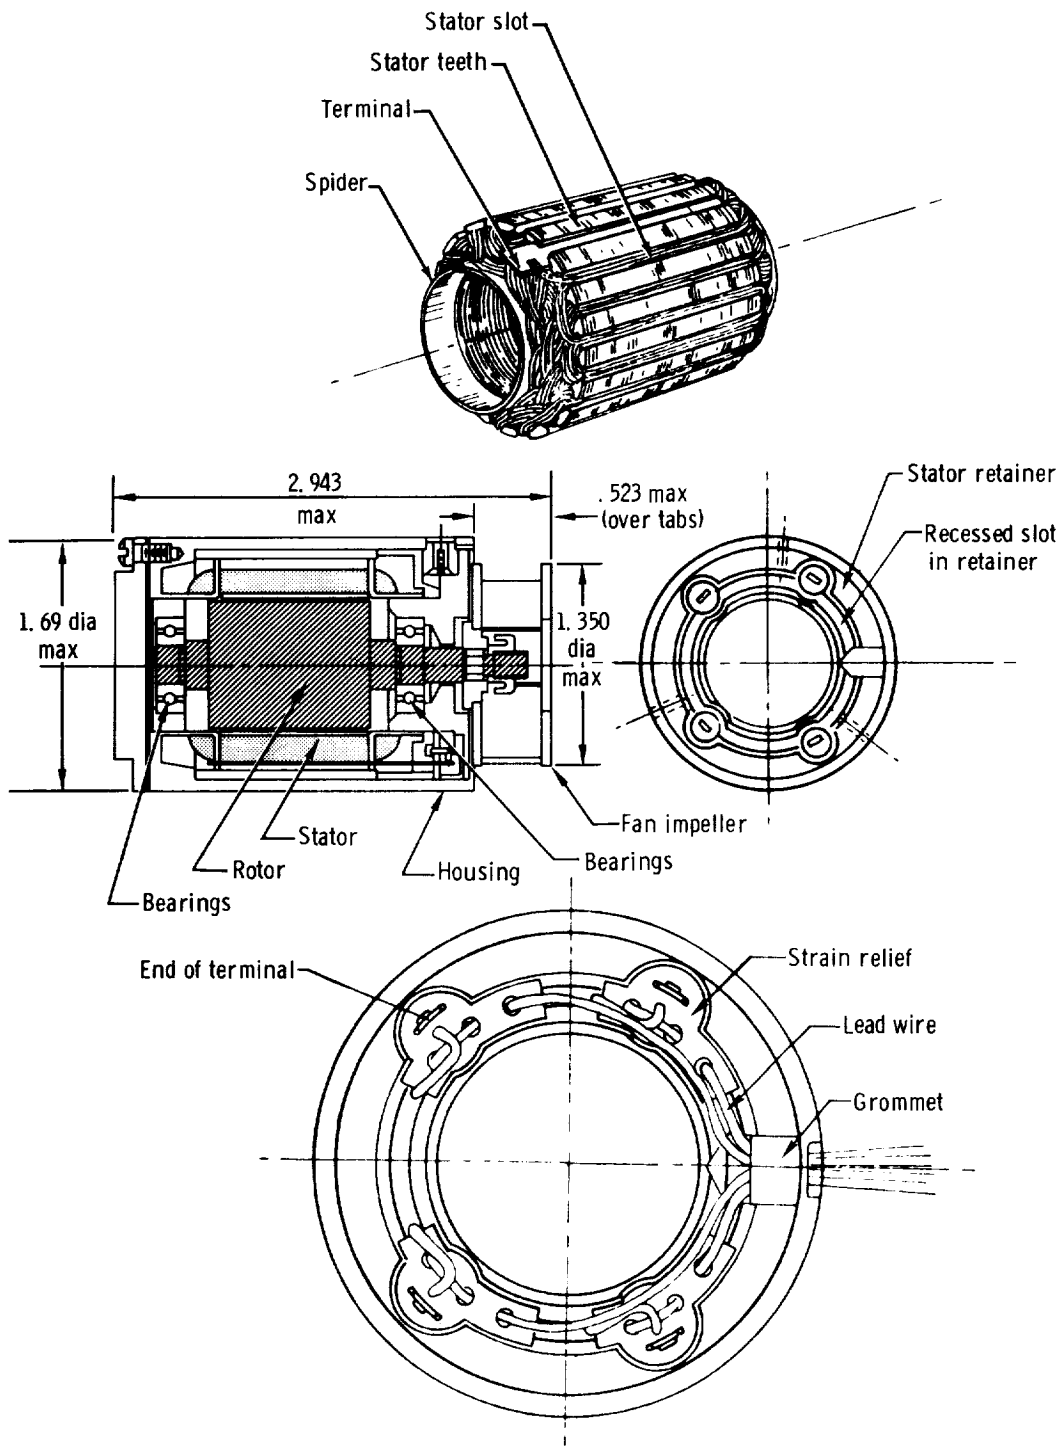
Figure D3-15.- Oxygen fan motor.

The two oxygen fan motors (fig. D3-15) are three-phase, four-wire, 200/115-volt, 400-hertz, miniature, open induction motors, driving centrifugal flow impellers. The minimum speed of the motors is 1800 revolutions per minute at a torque output of 0.9 ounce-inches. The motors are mounted at each end of the motor-heater support tube by a cantilevered attachment joined to the motor back plate. The motor clearance within the support tube wall is a nominal 0.01 inch. The stator windings and bearings of the motors are exposed to oxygen.

The stator windings are fabricated with number 36 American Wire Gage (AWG) wire, using a Teflon-coated ceramic insulation. The ceramic insulation is brittle and subject to breakage if proper tension is not used in fabricating windings or if sharp bends are made at the winding

end turns. Acceptance testing of the wire is conducted on the first 100 feet of each reel. The wire is considered acceptable if no more than 10 breaks in insulation are exhibited in the sample when pulled through mercury at 25 feet per minute. The rejection rate for stator winding faults for motors processed early in the production run was substantial. Improved yield was achieved only by rigid adherence to the winding tension process control used in fabricating the windings, proper assembly techniques, and frequent in-process dielectric testing. Phase-to-phase short circuits or shorted turns within a single phase are more likely than phase-to-ground faults. A limited amount of insulation is provided between windings and ground. Phase-to-phase insulation is limited to the end turns. Considerable improvement was accomplished in the acceptance rate of motors built after the fabrication control techniques were developed (Appendix C). No problem was exhibited in the testing of the two motors finally installed for flight in oxygen tank S/N XTAA0008.

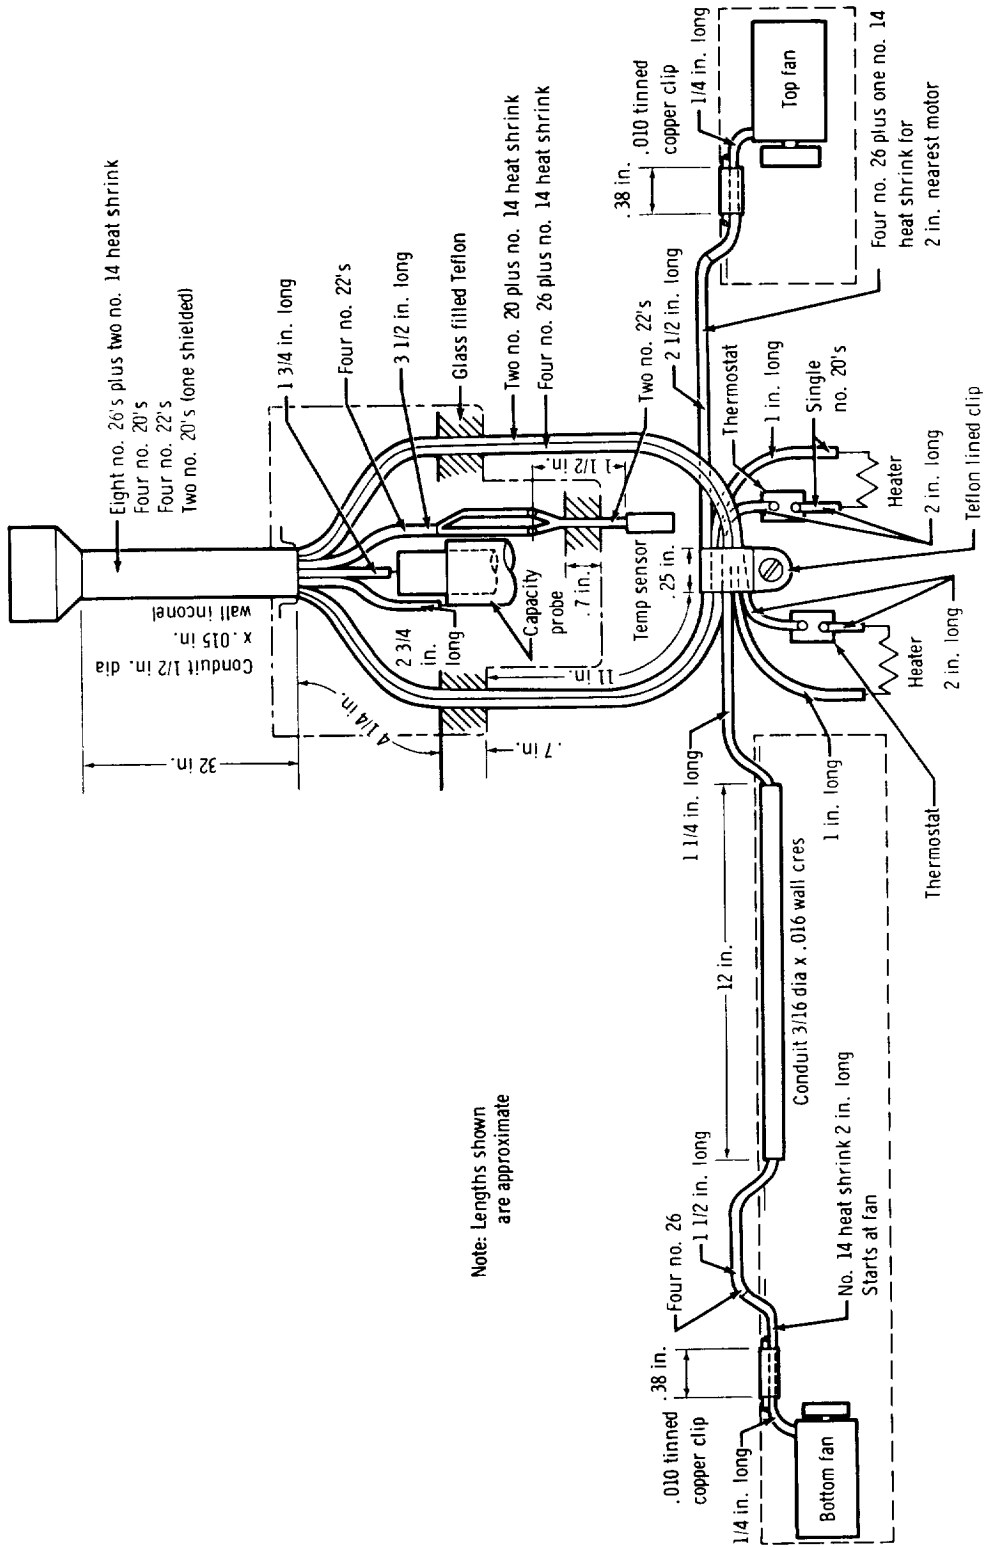
Figure D3-16.- Oxygen tank wiring distribution.

The mechanical design of the tank with respect to provisions for wiring is considered deficient. Damage to the wiring may be either insulation damage or conductor damage, portions of which cannot be inspected or adequately tested during or after assembly.

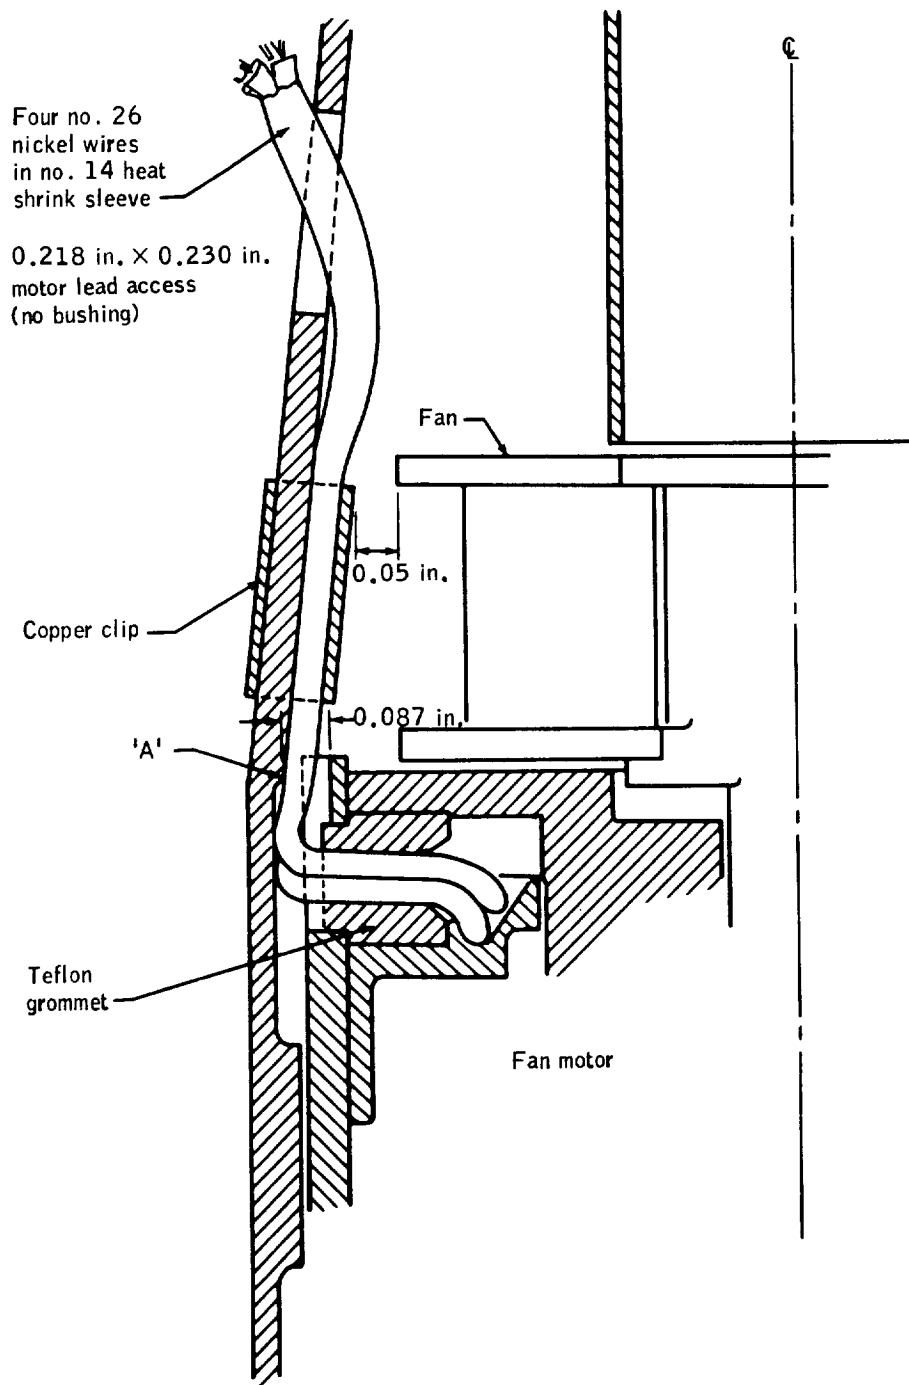
Figure D3-17.- Typical wire routing for fan motor (four times full size).

During assembly of the tank, three bundles of six wires each are sequentially pulled through the conduit. The first bundle, consisting of the two quantity gage wires and the four temperature sensor wires, is pulled through the conduit along with the pull wires for the other bundles. The second and third bundles each consist of one set of motor leads encased in 0.012-inch shrink-fit tubing and one set of heater leads. The pull wires have a break-strength of 65 pounds. Since the third bundle of wire must be forceably pulled through the conduit, damage to wires in this bundle or the others may result which may not be detectable without physical inspection. Physical inspection cannot be accomplished with this design.

The calculated break strength of a number 26 AWG nickel wire is 11 pounds and elongation of 28 percent can be experienced before break. If the number 26 AWG wires do not share the load associated with pulling the bundle through the conduit, damage to the wire(s) will result before the pull wire breaks. Stretching of the wire results in local neck-down of both the conductor and insulation. In subsequent operation of the circuit, the locally smaller gage conductor can produce local hot spots and progressive deterioration of the insulation.

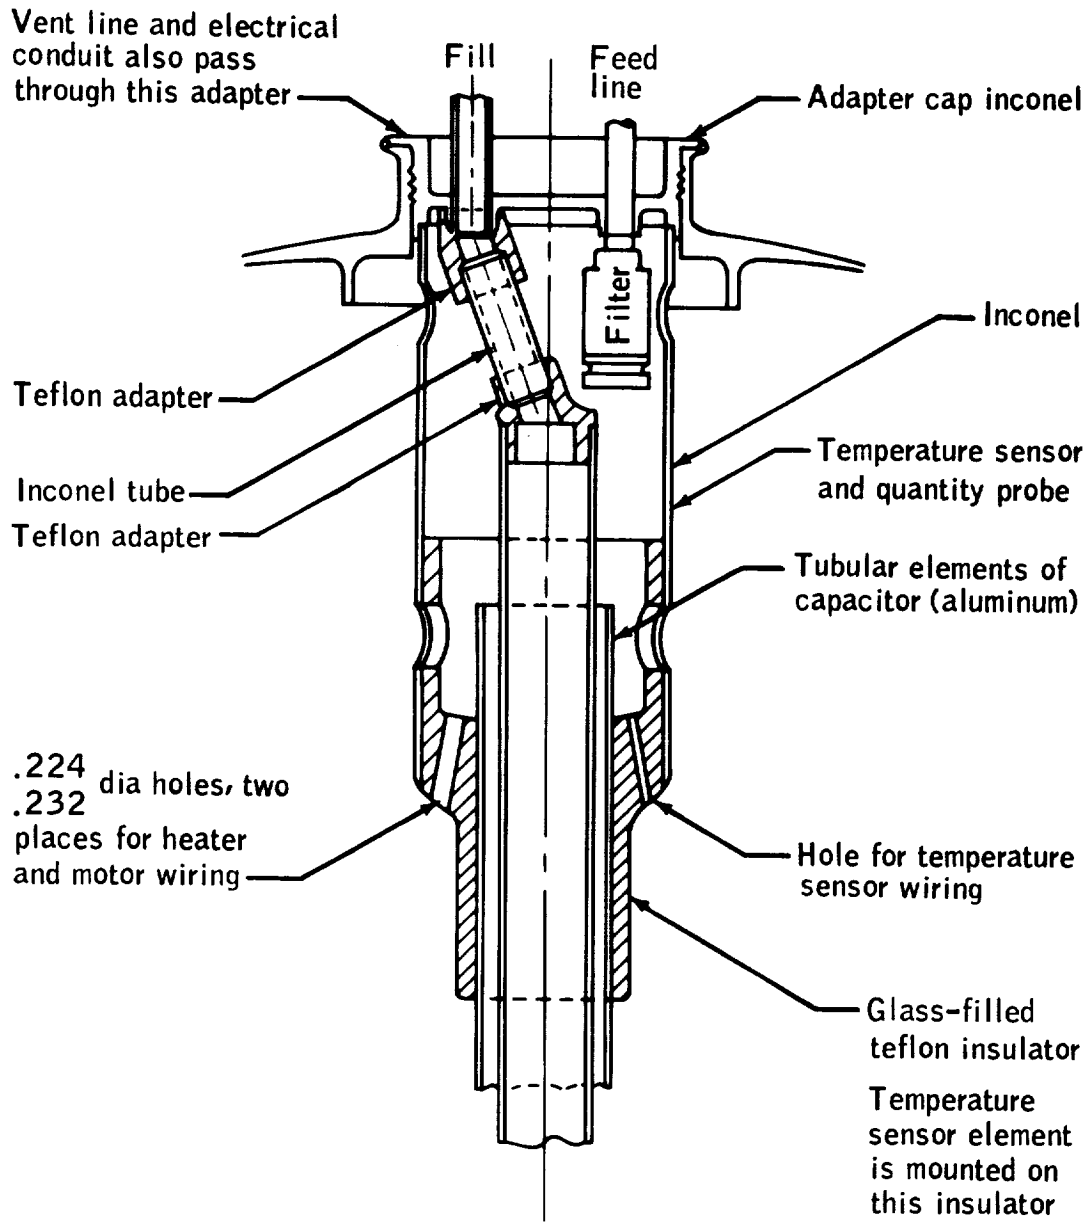
Figure D3-18.- Arrangement of head end of tank.

The head ends of the tank and the temperature sensor and quantity probe are shown in figure D3-18. One of the more significant features of the design is the arrangement of the connections in the fill line which routes the cryogenic fluid to the bottom of the tank, via the inner element of the quantity gage capacitor, and which permit the fluid to flow from the bottom of the tank during ground detanking. The manufacturing drawings of the elements of this connection, two Teflon adapters and an Inconel tube, allow a tolerance stack which is excessive. One combined worst case results in a connection which cannot reach from the fill tube connection in the tank head to the center element of the quantity gage capacitor. The other results in a connection length which prevents assembly of the probe to the adapter in the head of the tank. These are shown in figure D3-19. The tolerances on concentricity between the inner element of the capacitor and the outer shell of the probe are not known and are omitted from this figure. Inclusion would show an even worse situation than shown.

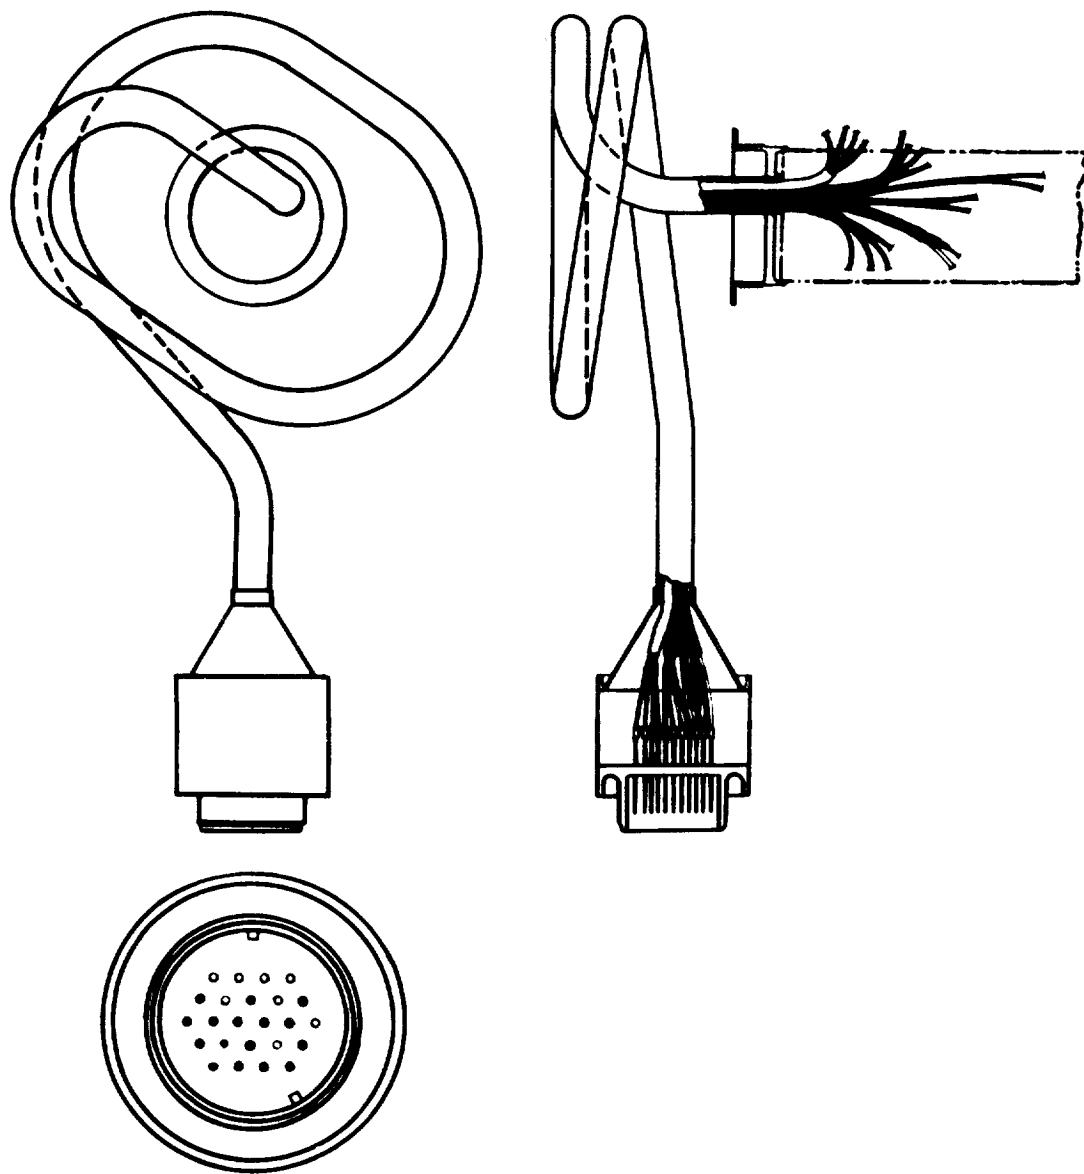
Figure D3-23.- Arrangement of electrical conduit.

A total of 18 wires pass through the electrical conduit, eight AWG no. 26's, four AWG no. 22's, and six AWG no. 20's. The conduit is shown in figure D3-23. At the start of the investigation some members of the Panel felt that the unorthodox detanking procedure used at KSC could have resulted in unacceptably high temperatures in this electrical conduit due to resistive heating of the heater wires. This possibility is discussed in a later section.

The design of this portion of the tank results in a configuration in which it is not possible to perform visual inspection of wiring after assembly. In consequence, the possibility of damage, in many cases undetectable by normal quality assurance procedures, is significant.
