APOLLO 16 MISSION

ANOMALY REPORT NO. 9

LUNAR ROVING VEHICLE ELECTRICAL SYSTEM METER ANOMALIES

MSC-07684

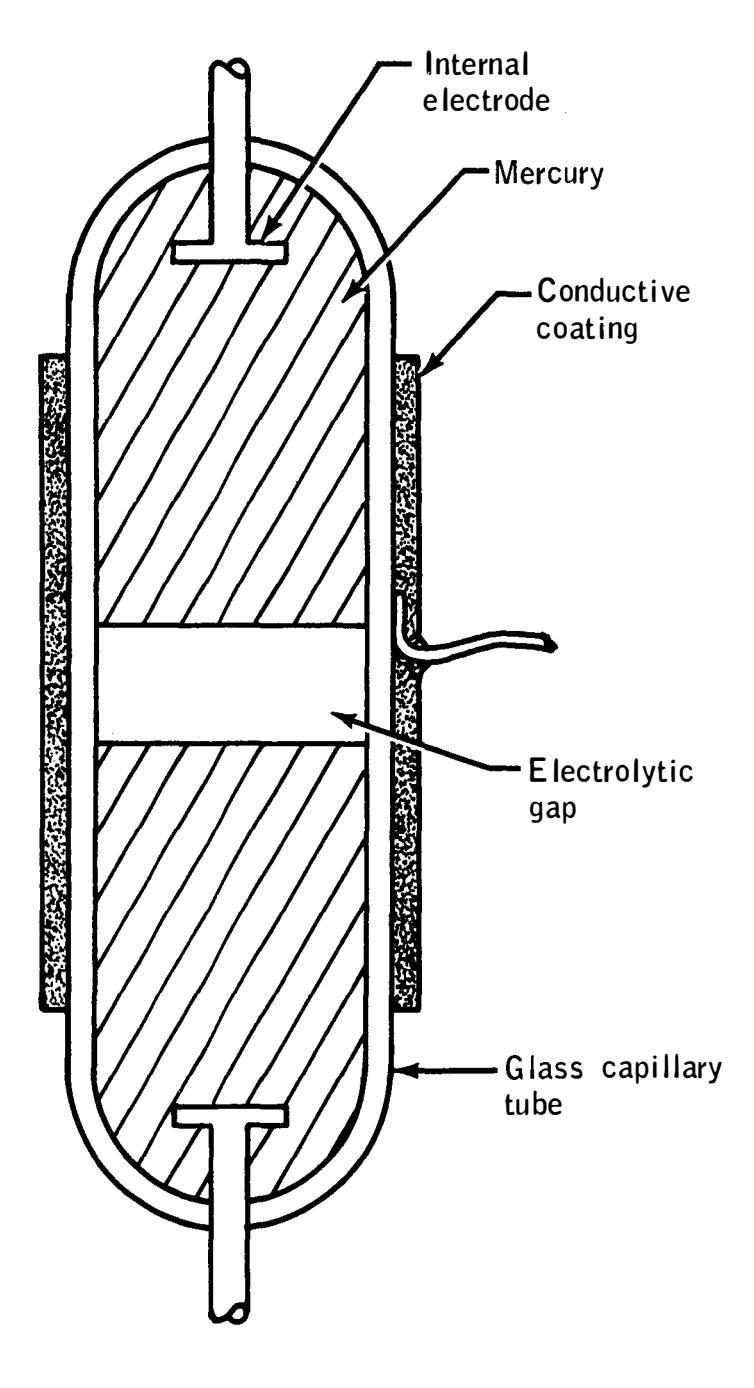
Figure 3.- Ampere - hour integrator.

The ampere-hour integrator (fig. 3) consists of a glass capillary tube which contains an electrode in each end and has an insulated external conductive coating. Between the two internal electrodes is a column of mercury with an electrolytic gap. When direct current flows between the internal electrodes, mercury is electroplated across the gap and the position of the gap moves. The position of the gap is then determined by the total coulomb charge which has been passed through the device. The voltage is also applied across the internal electrodes. The two segments of the mercury column and the external conductive coating constitute a capacitor voltage divider; consequently, the voltage on the external conductive coating is determined by the position of the electrolytic gap. This voltage is then proportional to the total coulomb charge passed between the internal electrodes, and thus, the total charge removed from the battery. This voltage drives a meter which is calibrated to indicate ampere-hours remaining in the battery.
