1.0 Purpose

The purpose of this report is to provide a record of the performance of the CSD (Crew Systems Division) furnished equipment during the Apollo 11 mission. This report will include preflight, inflight, and post-flight problems, activities, and performance.

2.0 Apollo 11 EMU Hardware and Crew Provisions GFE (Government-furnished equipment)

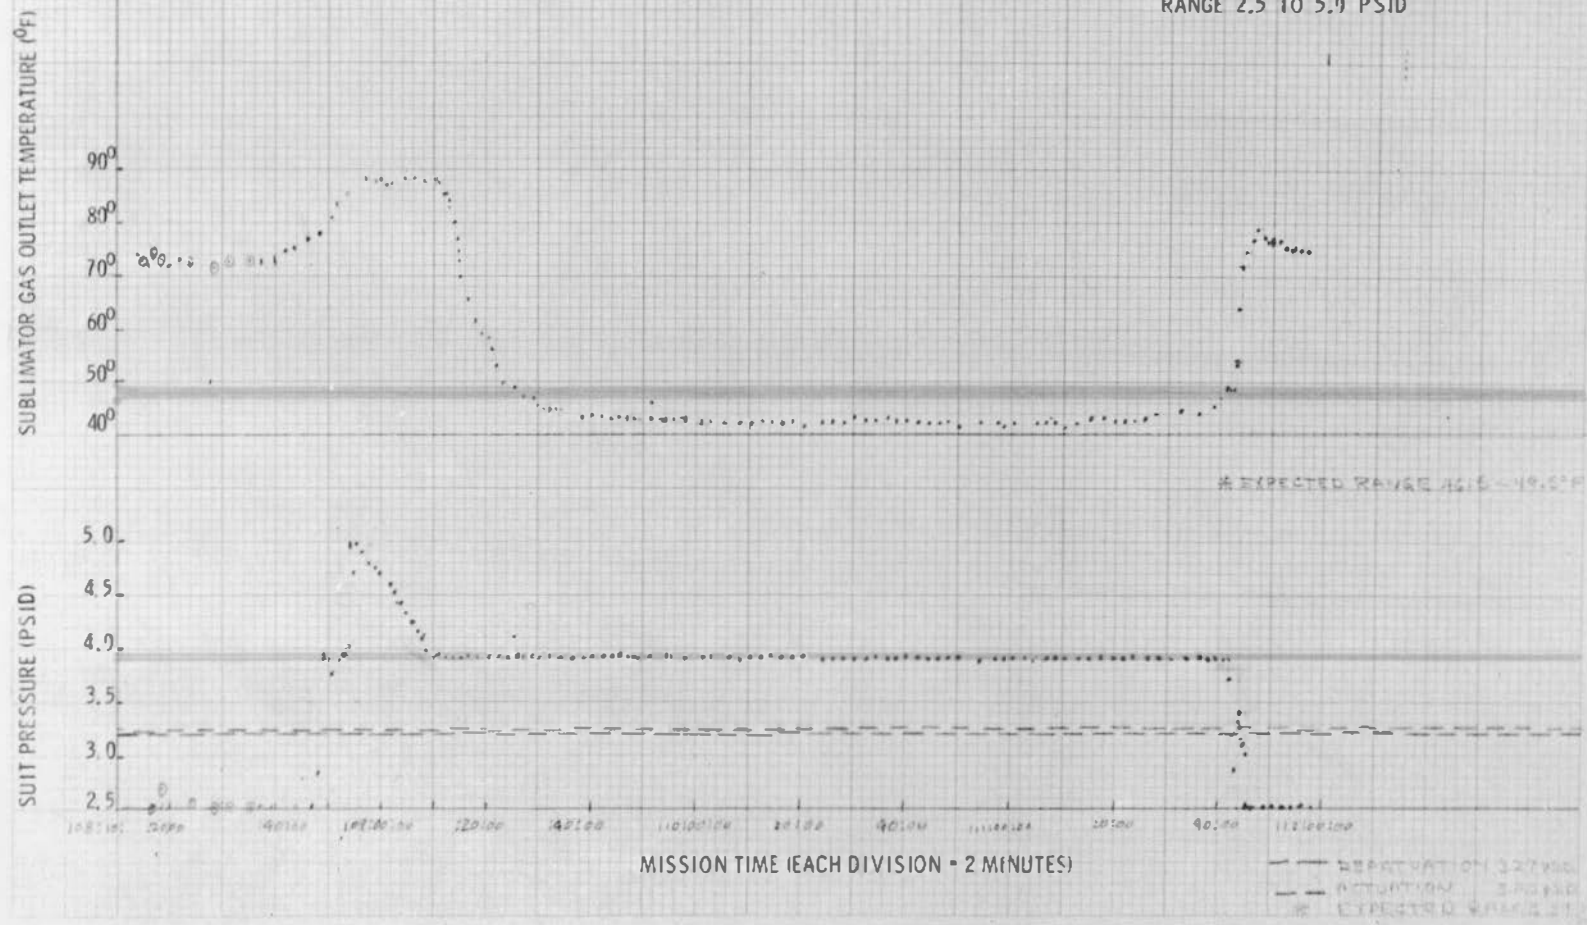
Figure 5

APOLLO II PLSS TELEMETRY (COP)
GT 8270T. SUBLIMATOR GAS OUTLET TEMP.
RANGE 40° TO 90° F
GT 8268P. PGA O₂ PRESSURE
RANGE 2.5 TO 5.0 PSID
