MSC-00171

APOLLO 11 MISSION REPORT

NATIONAL AERONAUTICS AND SPACE ADMINISTRATION MANNED SPACECRAFT CENTER HOUSTON, TEXAS November 1969

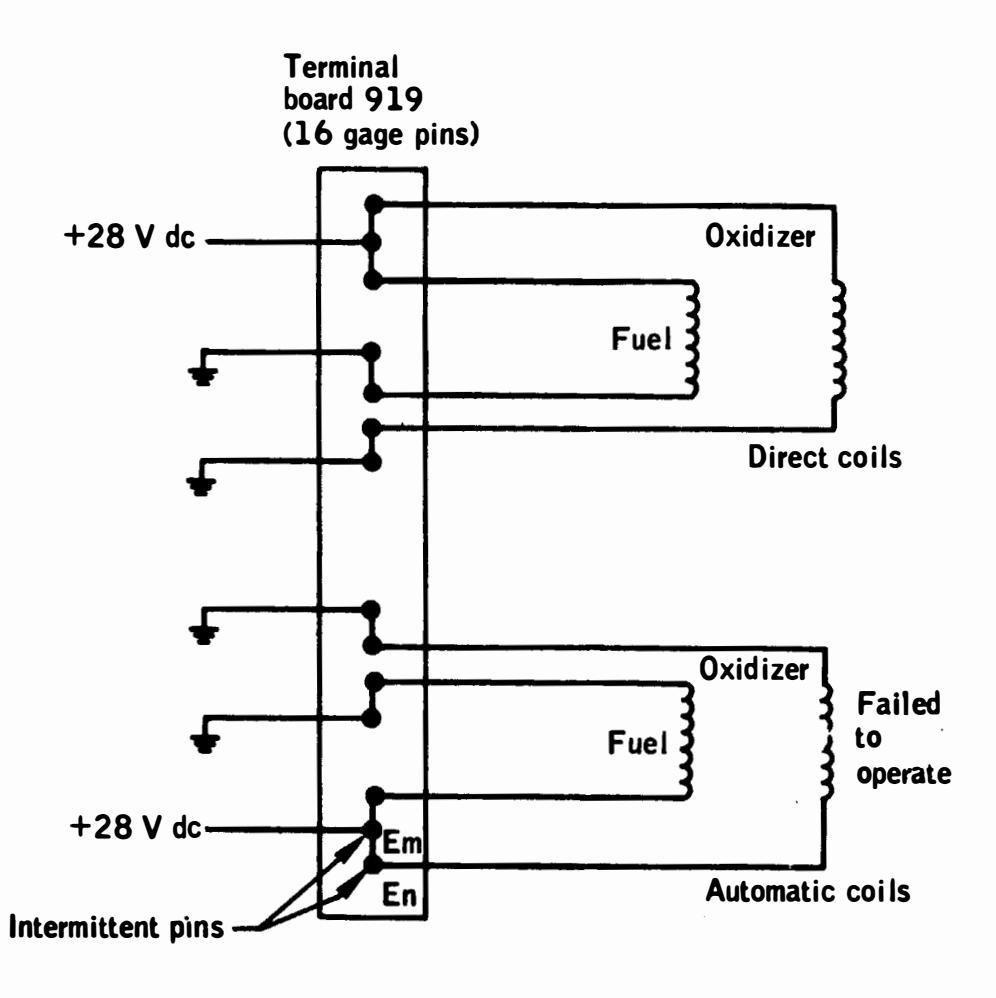
Figure 16-3.- Terminal board schematic for minus-yaw engine, command module reaction control system 1.

Postflight tests showed that two pins in the terminal board (fig. 16-3) were loose and caused intermittent continuity to the automatic coils of the engine valve. This type failure has previously been noted on terminal boards manufactured prior to November 1967. This board was manufactured in 1966.

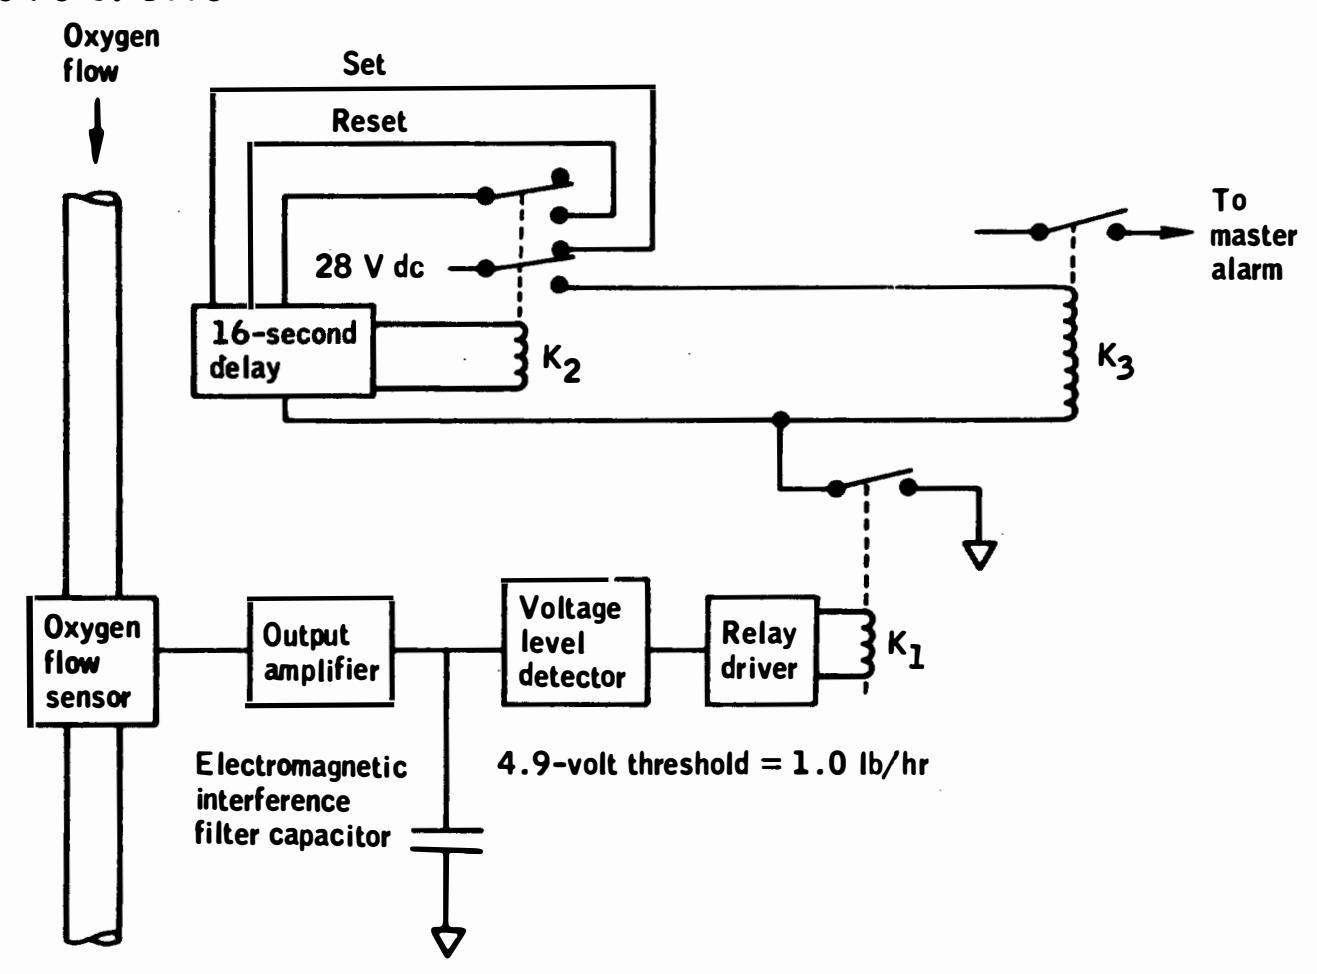
Figure 16-4.- Oxygen flow sensing circuit.

During the initial lunar module pressurization, two master alarms were activated when the oxygen flow rate was decreasing from full-scale. The same condition had been observed several times during altitudechamber tests and during subsequent troubleshooting. The cause of the problem could not be identified before launch, but the only consequence of the alarms was the nuisance factor. Figure 16-4 shows the basic elements of the oxygen flow sensing circuit.

Note in figure 16-4 that in order for a master alarm to occur, relay K1 must hold in for 16 seconds, after which time relays K2 and K3 will close, activating a master alarm.

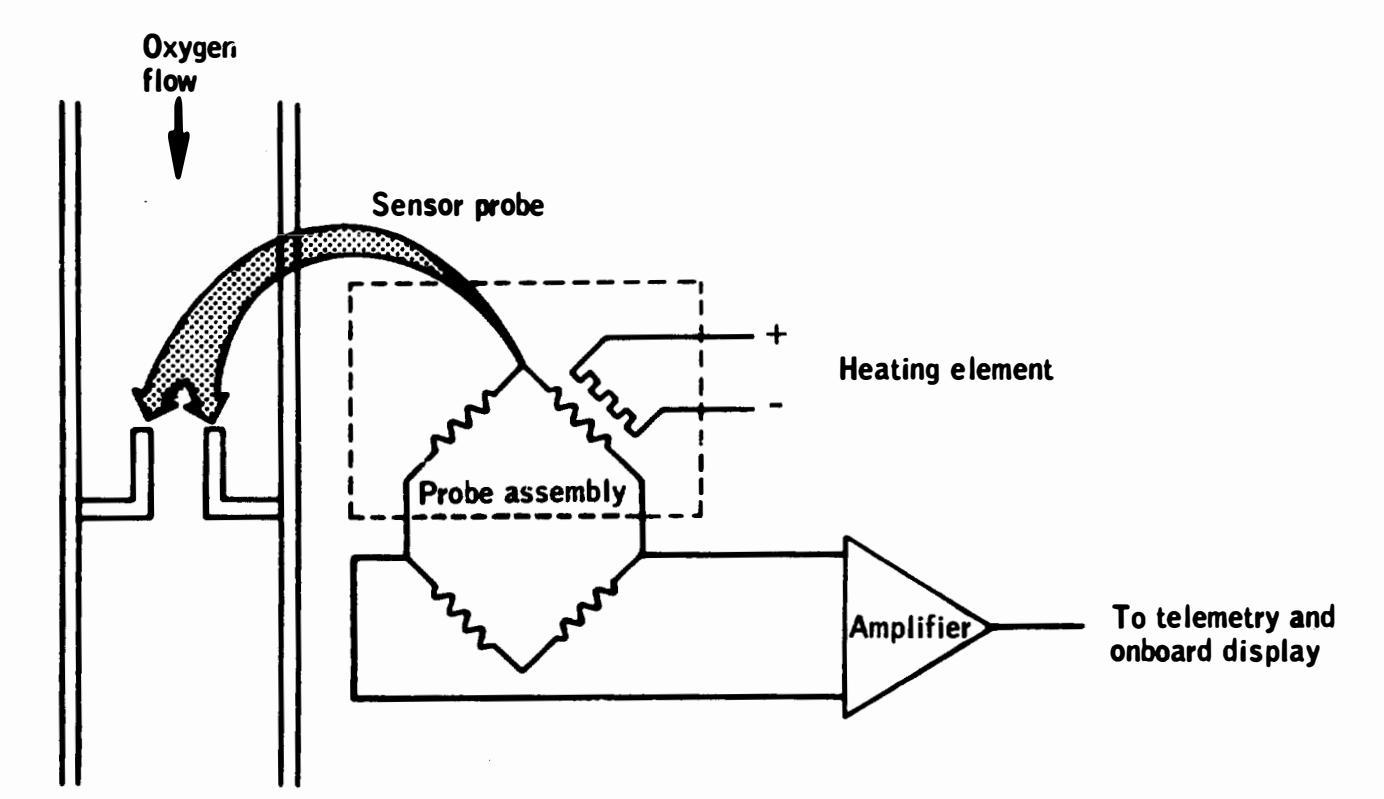
Figure 16-5.- Oxygen flow sensor.

Analysis of associated data indicated that the oxygen flow was normal, but that the indicated flow rate was negatively biased by approximately 1.5 lb/hr. Postflight tests of the transducer confirmed this bias, and the cause was associated with a change in the heater winding resistance within the flow sensor bridge (fig. 16-5). The resistance of the heater had increased from 1000 ohms to 1600 ohms, changing the temperature of the hot wire element which supplies the reference voltage for the balance of the bridge. Further testing to determine the cause of the potted resistance change is not practical because of the minute size of the potted resistive element. Depotting of the element would destroy available evidence of the cause of failure. Normally, heater resistance changes have occurred early in the 100-hour burn-in period when heater stability is achieved.

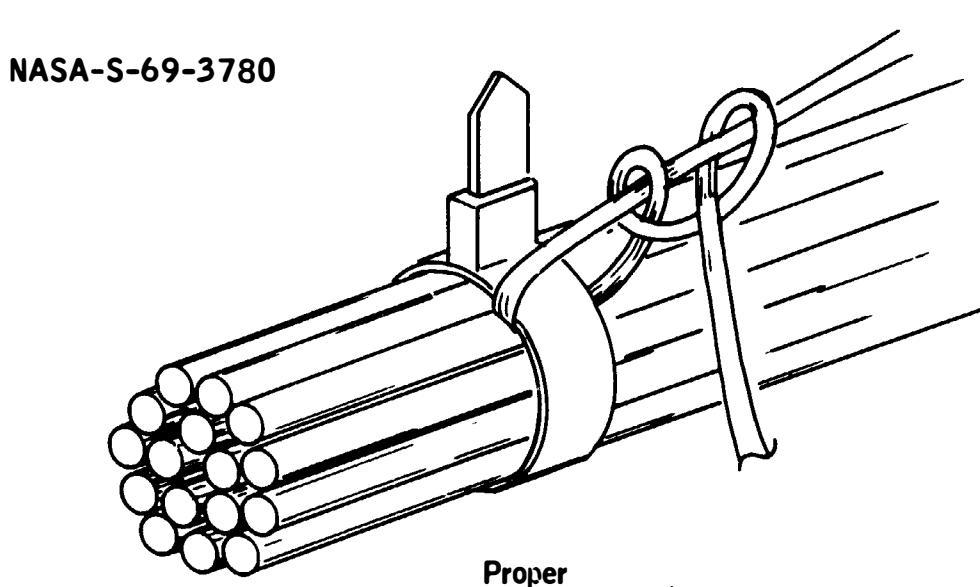
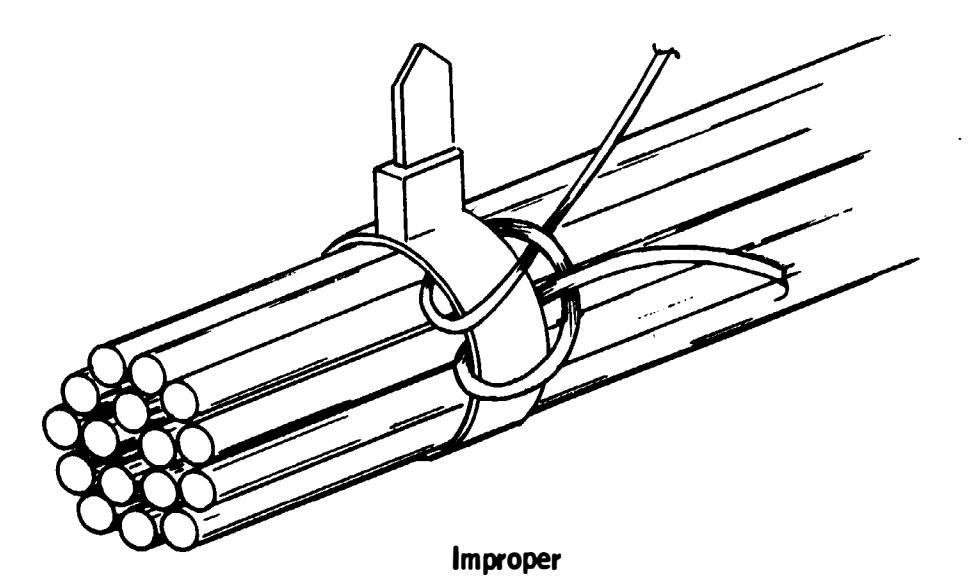
Figure 16-6.- Tie-wraps on lanyards.

The knots should be two closely tied half-hitches which secure the tie-wrap to the lanyard (fig. 16-6). Examination of the Apollo 10 lanyard indicates that these knots were not two half-hitches but a clove hitch (see figure). After the lanyard breaks the tie-wraps, if the fragment of tie wrap pulls out of the knot, the clove hitch knot can untie, thus lengthening the lanyard. Lengthening this lanyard as the umbilical cable pays out can allow transfer of some loading into the umbilical disconnects. Should a sufficient load be transferred to the disconnect fitting to cause shear pins to fail, a disconnect of the forward heat shield mortar umbilical could result prior to the mortar firing. This would prevent deployment of the forward heat shield separation augmentation parachute, and there would be a possibility of forward heat shield recovered from Apollo 10 confirmed that the mortar had fired and the parachute was properly deployed.

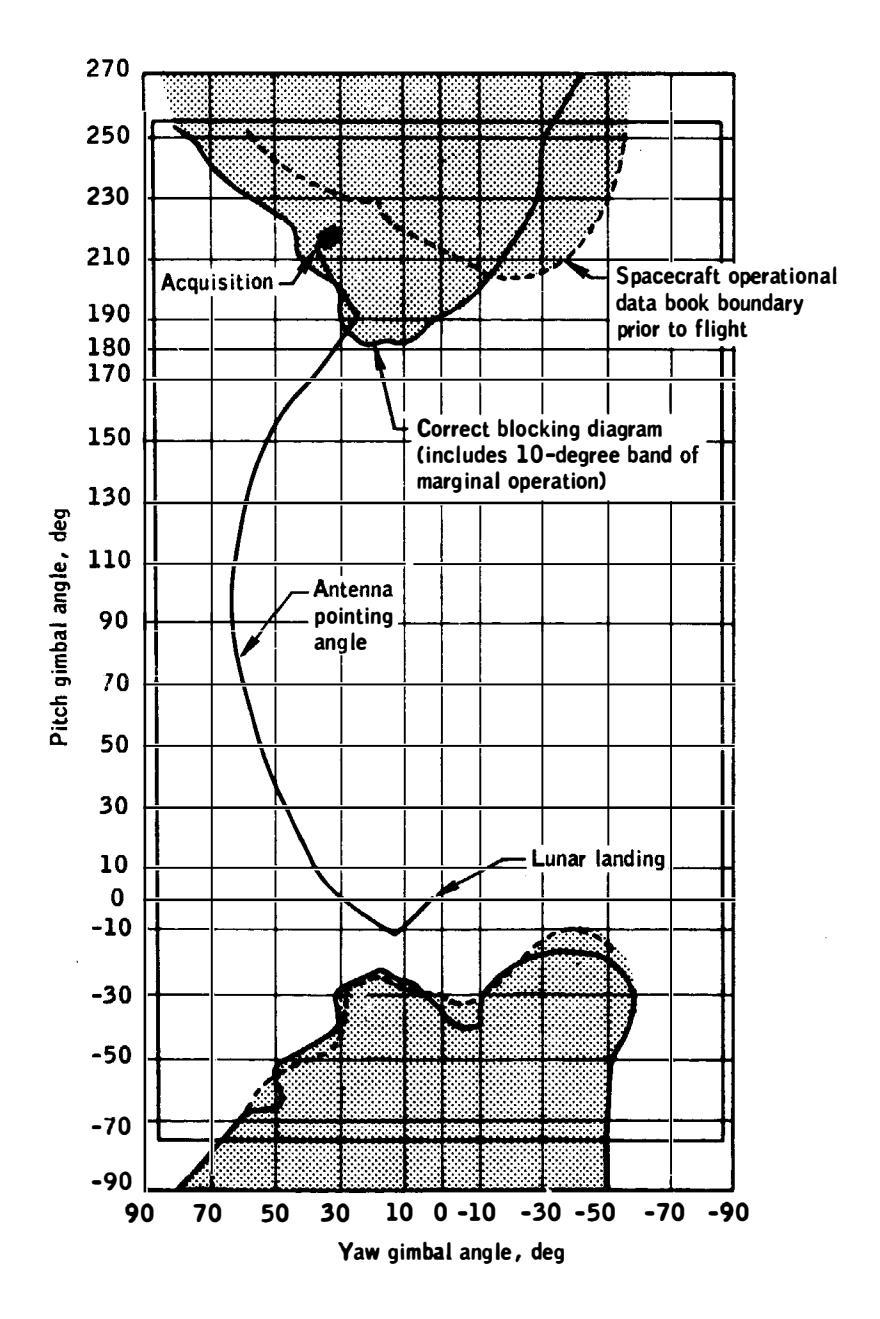
Figure 16-12.- S-band steerable antenna coverage restrictions.

When the steerable antenna was selected after acquisition on revolution 14, difficulty was encountered in maintaining communications. The downlink signal strength was lower than predicted and several times decreased to the level at which lock was lost. Errors were discovered in the antenna coverage restriction diagrams in the Spacecraft Operational Data Book for the pointing angles used. In addition, the diagram failed to include the thruster plume deflectors, which were added to the lunar module at the launch site. Figure 16-12 shows the correct blockage diagram and the one that was used in the Spacecraft Operational Data Book prior to flight. The pointing angles of the antenna were in an area of blockage or sufficiently close to blockage to affect the coverage pattern.

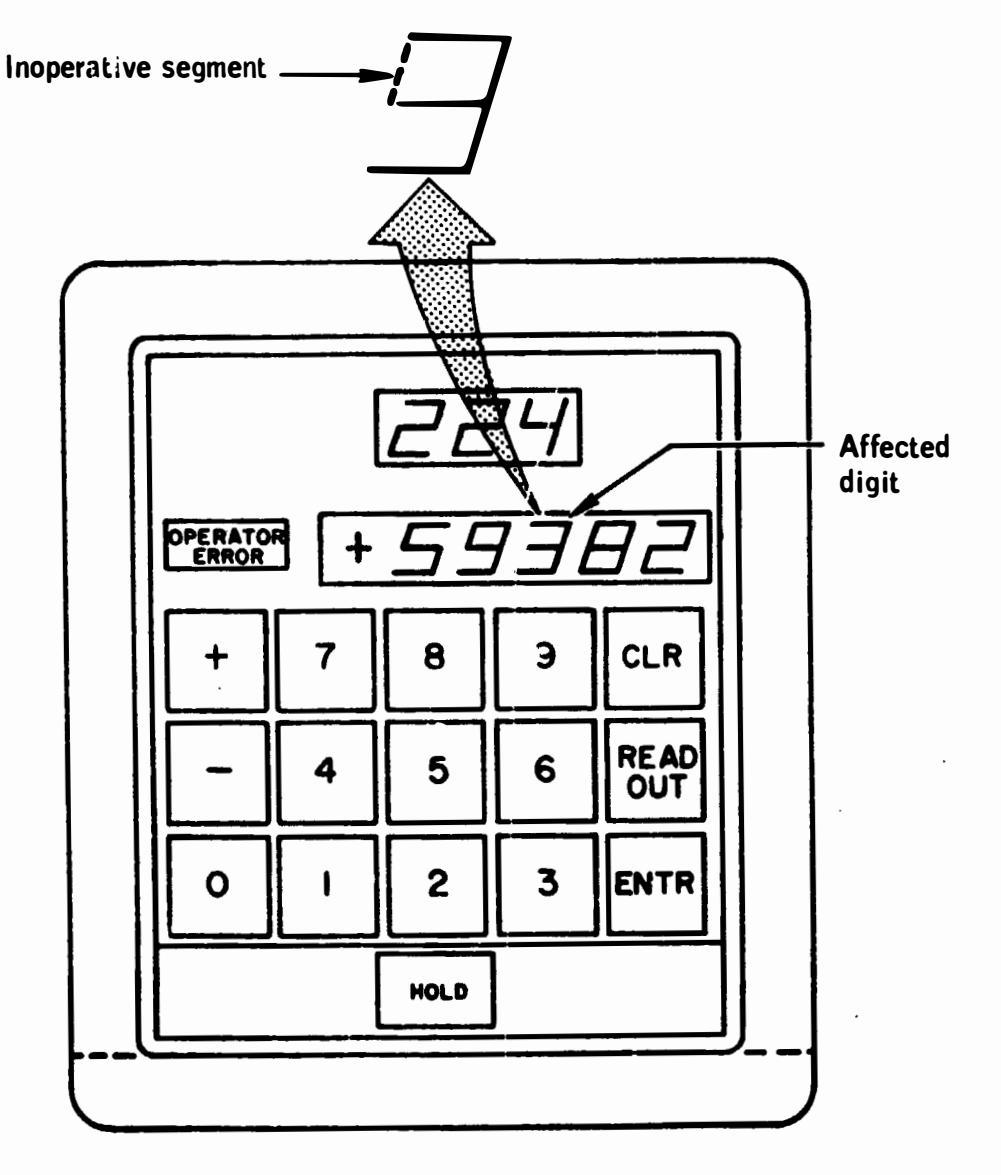
Figure 16-15.- Inoperative segment in one digit of data entry and display assembly.

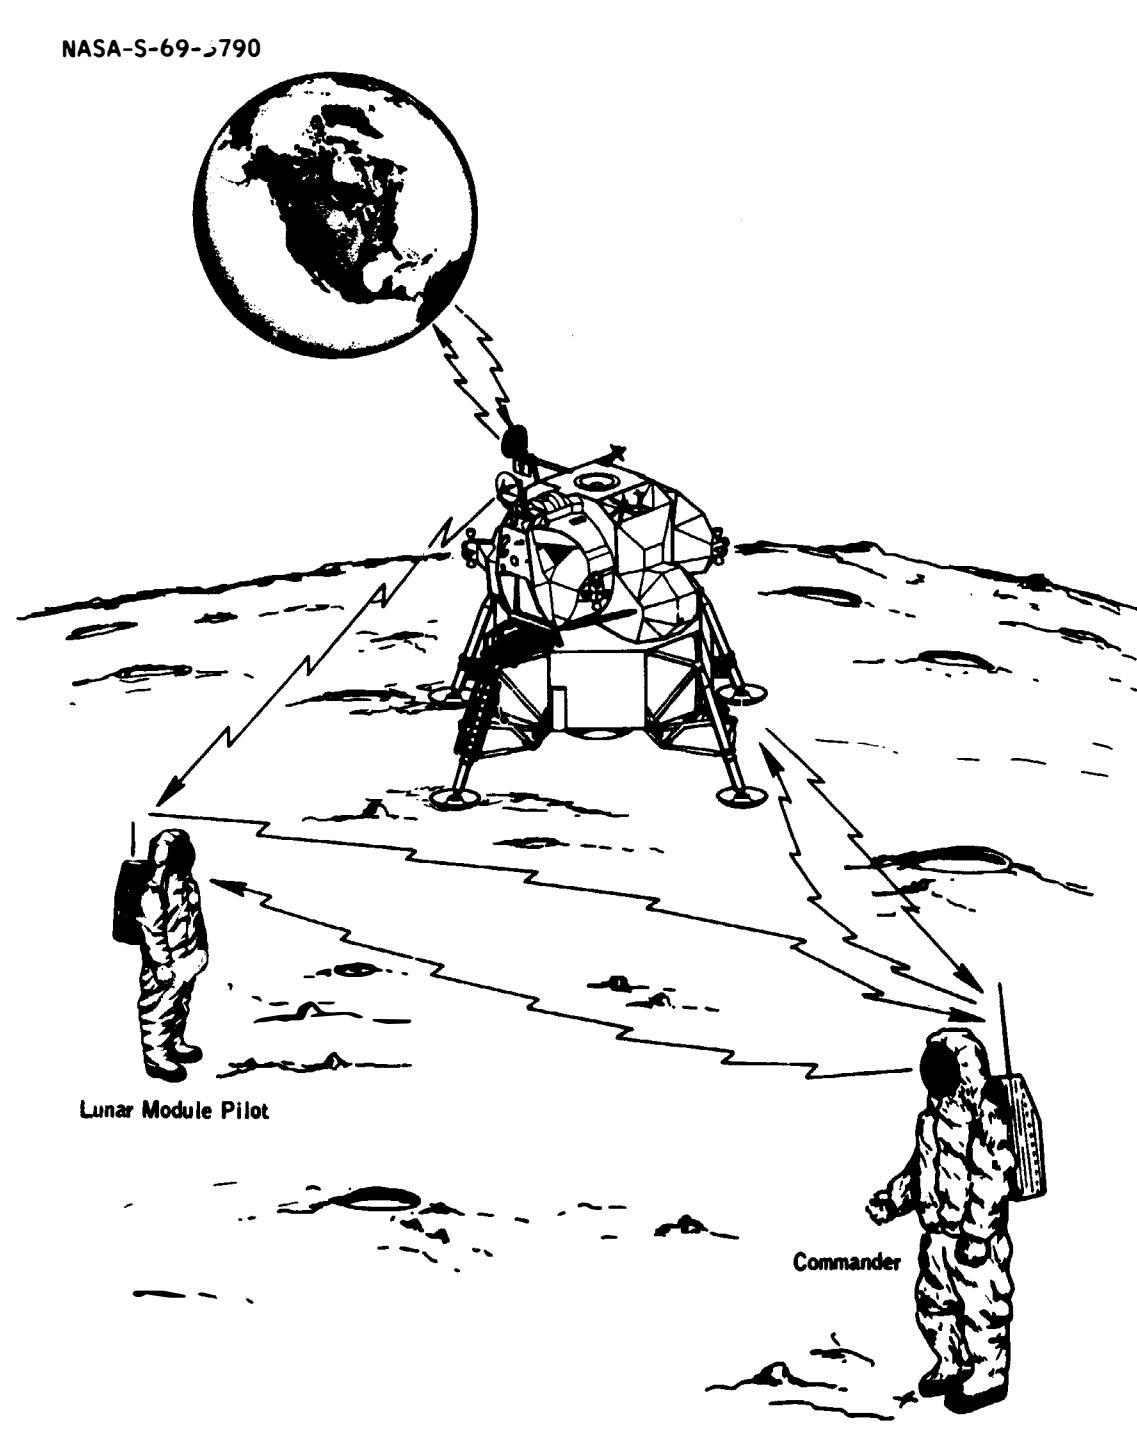
Figure 16-16.- Communications relays during extravehicular activity.

A voice turnaround (echo) was heard during extravehicular activity. At that time, the lunar module was operating in a relay mode. Uplink voice from the S-band was processed and retransmitted to the two extravehicular crewmen via the lunar module VHF transmitter. Crew voice and data were received by the lunar module VHF receiver and relayed to the earth via the lunar module S-band transmitter (see fig. 16-16). The echo was duplicated in the laboratory and resulted from mechanical acoustical coupling between the communications carrier earphone and microphone (fig. 16-17). The crew indicated that their volume controls were set at maximum during the extravehicular activity. This setting would provide a level of approximately plus 16 dBm into each crewman's earphones. Isolation between earphones and microphones, exclusive of air path coupling, is approximately 48 dB. The ground voice signal would therefore appear, at the microphone output, at a level of approximately minus 32 dBm. Assuming extravehicular communication keying is enabled, this signal would be processed and transmitted by the extravehicular communications system and would provide a level of approximately minus 12 dBm at the output of the lunar module VHF receiver. If the lunar module relay is enabled, this signal would be amplified and relayed to earth via S-band at a nominal output level.

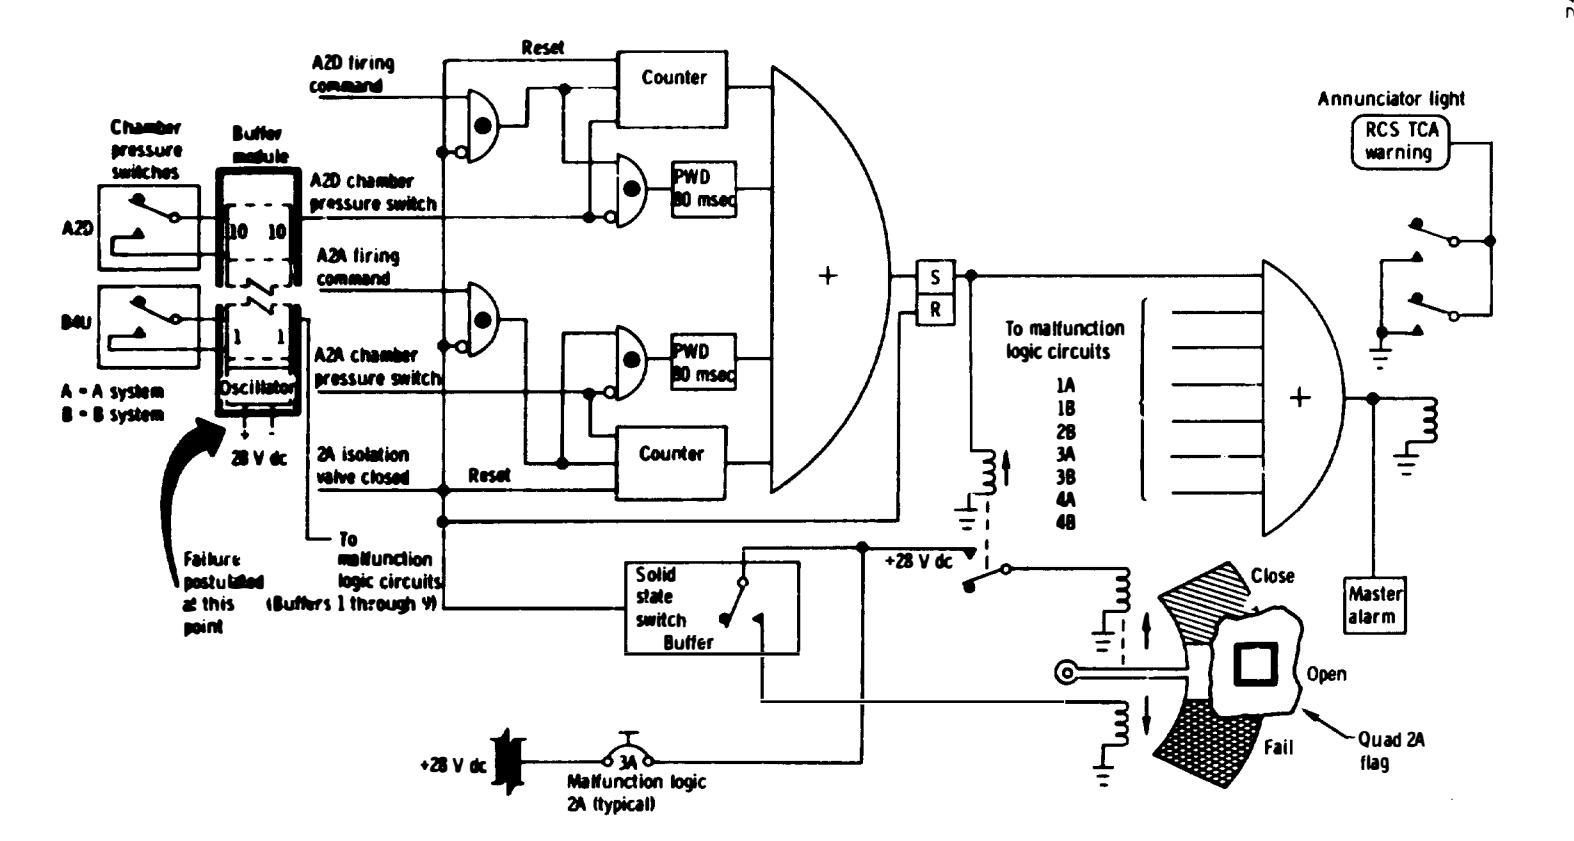
Figure 16-20. - Reaction control system malfunction detection circuits (caution and warning system).

The first two possible causes are highly unlikely because simultaneous multiple failures would have to occur and subsequently be corrected. The third possible cause is the most likely to have occurred where a single point failure exists. Ten of the sixteen engine pressure switch outputs are conditioned by the ten buffers in one module in the signal conditioner electronics assembly (fig. 16-20). This module is supplied with +28 V dc through one wire. In addition, the module contains an oscillator which provides an ac voltage to each of the ten buffers. If either the +28 V dc is interrupted or the oscillator fails, none of the ten buffers will respond to pressure switch closures. If engines monitored by these buffers are then commanded on, the corresponding warning flags will come up and a master alarm will occur.
