**NATIONAL AERONAUTICS AND SPACE ADMINISTRATION**

**APOLLO 13 MISSION REPORT**

**SEPTEMBER 1970**

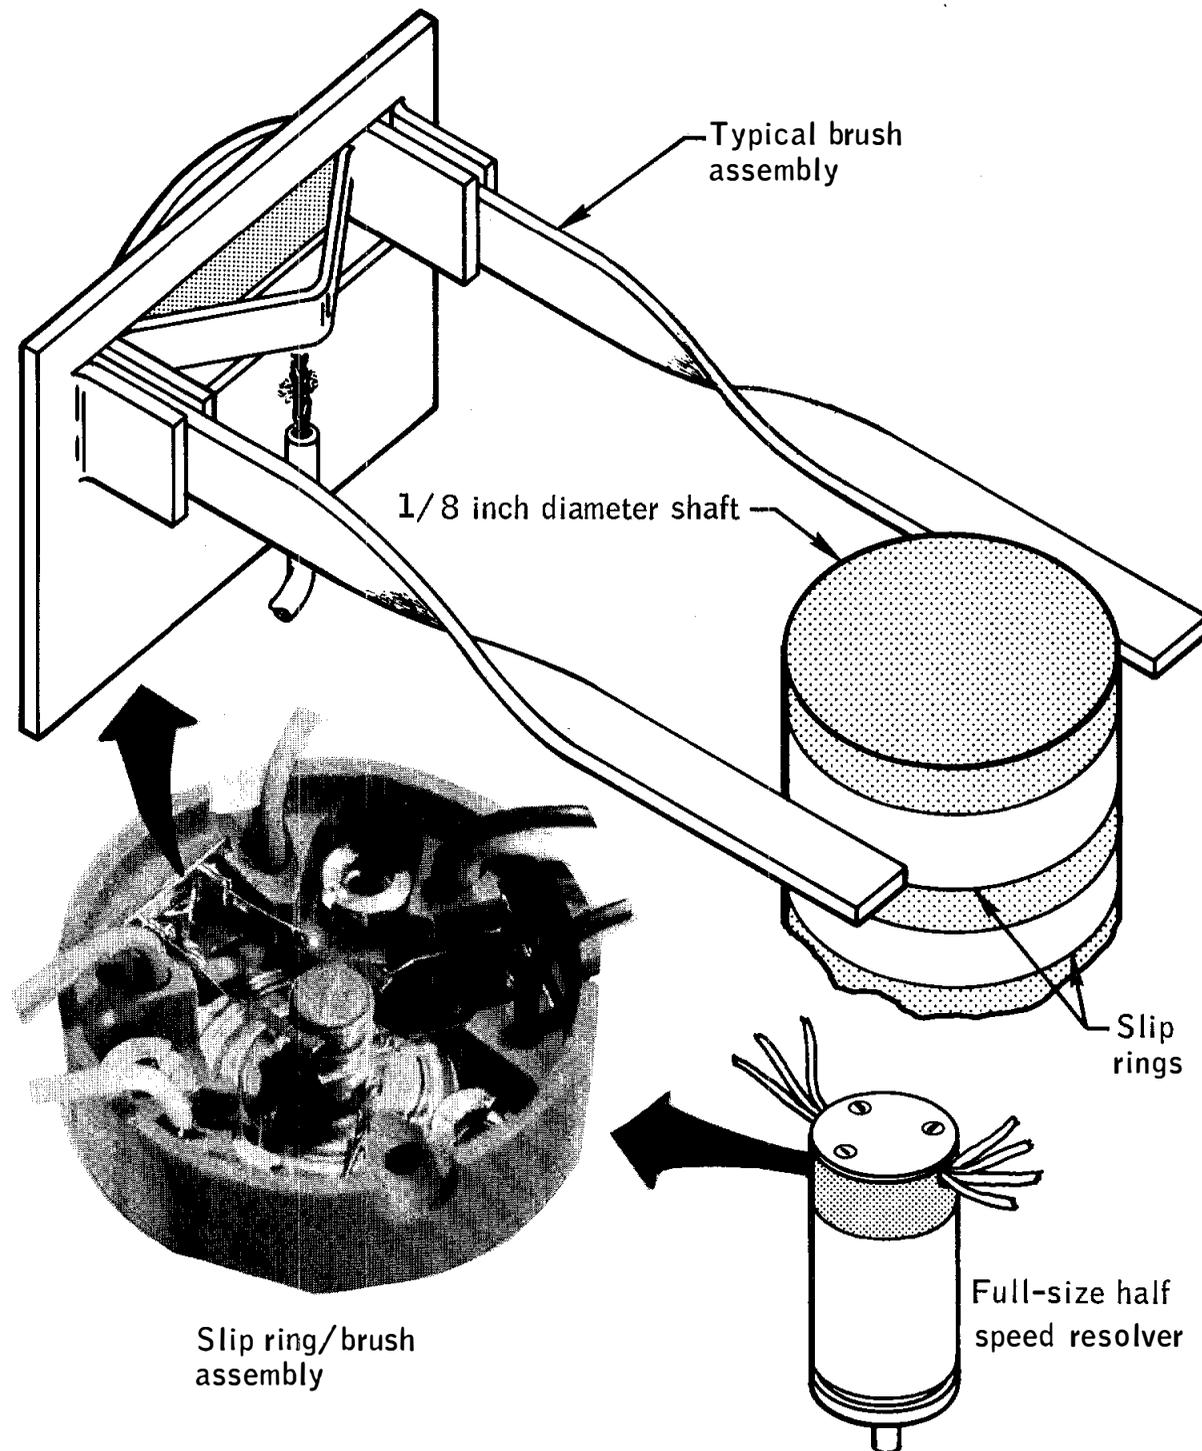
Figure 14-3.- Details of half speed resolver.

The most likely candidate is the half-speed resolver, which is used only for the shaft axis and only to provide an unambiguous zero reference. The reference voltage is applied to the rotor through slip rings (fig. 14-3), connected as shown in figure 14-4. If any resistance is present in the common ground path through the slip ring, a portion of the reference voltage will appear across the quadrature winding and induce a finite output (different than zero). Zero output is equivalent to zero degrees in shaft rotation.

Simulated changes in slip ring impedance were made on the half-speed resolver in the shaft loop (fig. 14-4). An impedance of 50 ohms produced an offset of approximately plus 0.5 degree in sextant shaft angle. The trunnion loop does not use this type of resolver or connection.

Some evidence of susceptibility to vacuum was exhibited in this class of resolvers during qualification testing when variations of approximately 5 ohms were observed in the slip ring resistance during thermal

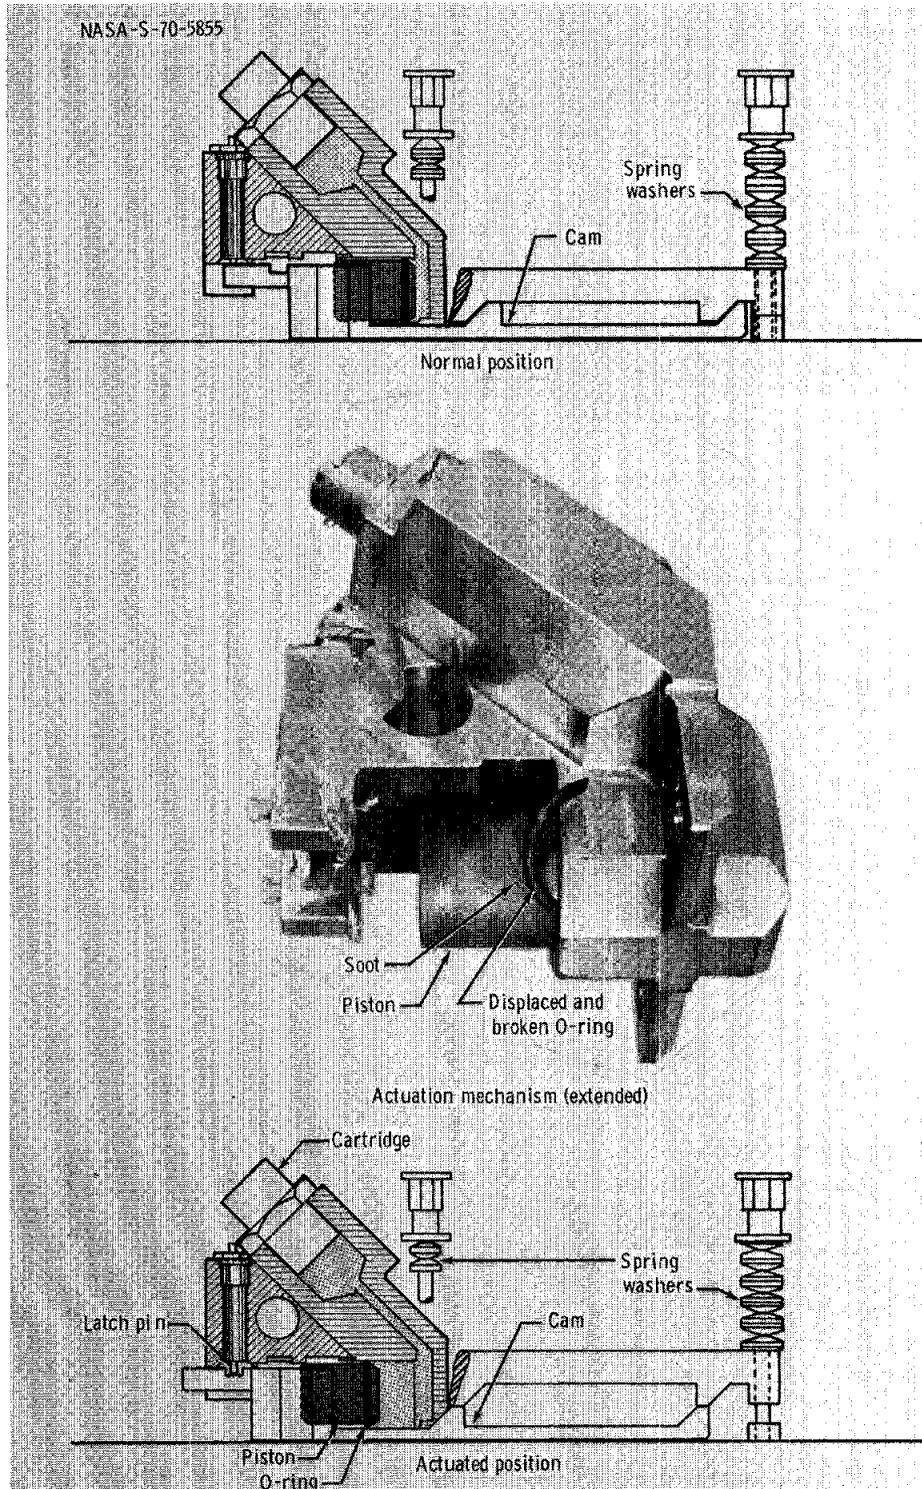
Figure 14-13.- Circuit interrupter.

During postflight inspection of the command module, propellant gas was noted to have escaped from the left-hand electrical circuit interrupter, mounted in the lower equipment bay, and deposited soot on adjacent equipment. The right-hand circuit interrupter showed no evidence of a gas leakage. The removed breech, showing the displaced O-ring and crushed attenuator block, is shown in figure 14-13.

The two interrupters open the electrical circuits about 30 milliseconds before the wires are severed by the command module/service module umbilical guillotine. As illustrated in the figure, a cam fork is moved by a piston, which is operated by propellant gas from redundant cartridges, to function a lift plate. Motion of this plate disconnects the male and female portions of electrical connectors located, respectively, in the lift plate and in the base plate of the interrupter. At the completion of the stroke, the fork is brought to rest by impacting and crushing an aluminum block mounted on the interrupter housing.

The worse-case tolerance buildup is when the fork contacts the attenuator block and the piston O-ring is 0.075 inch from entering the chamfer in the breech assembly. The O-ring enters this chamfer when the block has been crushed about 94 percent, at which point an O-ring displacement and accompanying gas escape could be expected. The factors which affect the degree of attenuator crushing are generally uncontrollable within narrow limits and include:

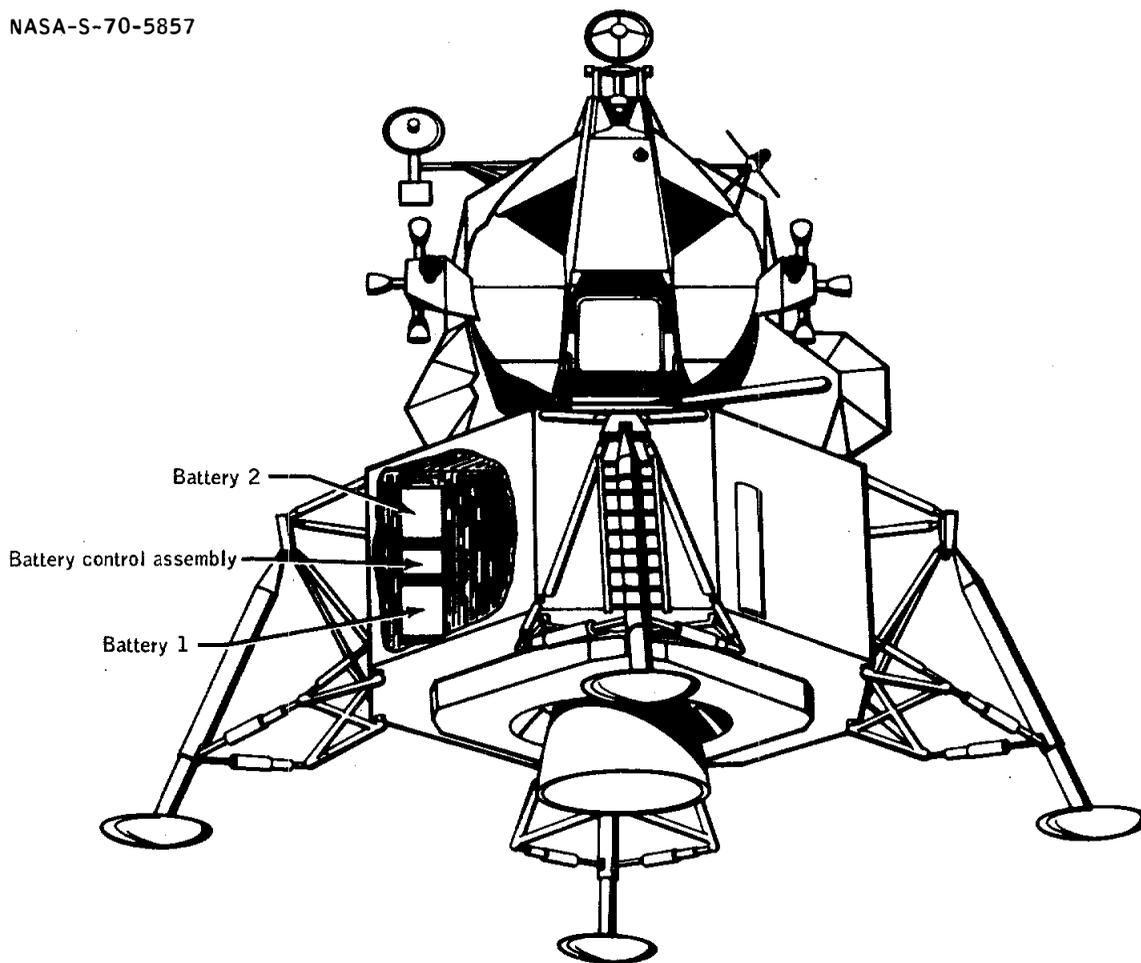
Figure 14-15.- Descent stage battery location.

At 97 hours 14 minutes, the crew reported a thumping noise and snowflakes venting from quadrant 4 of the lunar module descent stage (fig. 14-15). All four descent batteries experienced current transients at 97:13:53 for about 2 seconds, with corresponding drops in dc bus voltage (fig. 14-16). Also, the water glycol pressure differential for the heat transport system decreased momentarily, indicating that the glycol pump momentarily slowed down.

The thumping noise occurred at about the same time as the current spikes. The current spikes show that a momentary short circuit existed in the Lunar-Module-Pilot side of the dc electrical system, which includes descent batteries 1 and 2 (fig. 14-16). The current surge was not of sufficient duration either to open the balance-load cross-tie circuit breakers, to display a reverse current indication, or to trip a battery-off relay as a result of an overcurrent condition.

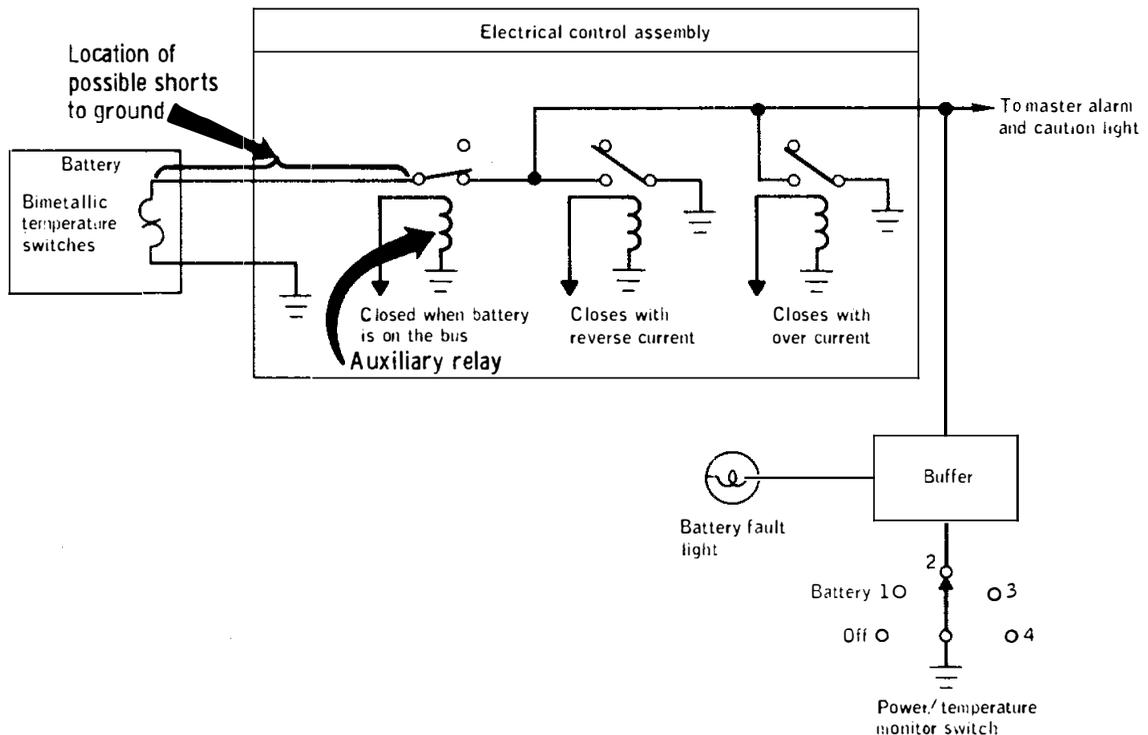
Figure 14-18.- Battery 2 malfunction circuit.

The battery malfunction light illuminated at about 100 hours with a corresponding master alarm. The malfunction, isolated to battery 2, could have been caused by an overcurrent, a reverse-current condition, an over-temperature condition, or possibly an erroneous indication. The logic for these malfunction conditions is shown in figure 14-18.

A battery overcurrent can be ruled out because automatic removal of the battery from the bus would have occurred.

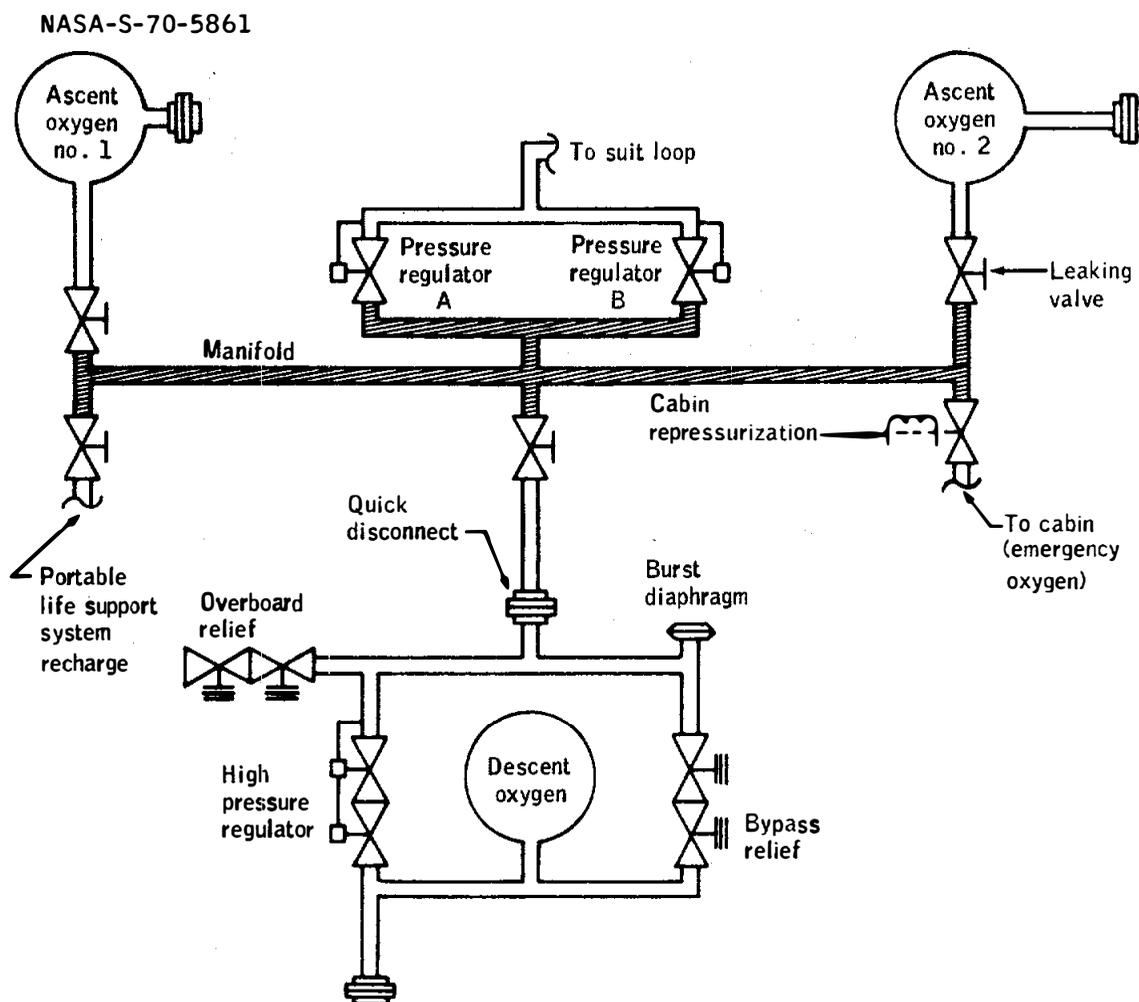
Figure 14-19.- Oxygen-supply system.

During the flight, the pressure in the ascent stage oxygen tank 2 increased, indicating a reverse leakage through the shutoff valve from the oxygen manifold (fig. 14-19) into the tank. The leak rate, with a maximum differential pressure of 193 psi, varied from about 0.22 lb/hr (70 000 scc/hr) to zero when the tank pressure reached manifold pressure. Allowable leakage for the valve in either direction is 360 scc/hr. Pre-flight test data indicate a reverse leakage of 360 scc/hr and no excessive leaking in the forward direction.

The internal portion of three valves of this type had been replaced previously on the spacecraft because of excessive leakage through the ascent oxygen tank 1 shutoff valve. In one valve, a rolled O-ring

(fig. 14-20) caused the leakage. When the valve is installed, the forward O-ring can be rolled and damaged when it passes the manifold port. In the other two valves, the cause was not identified and was assumed to be contamination.
