14.1.10 Data Recorder Tape Deterioration

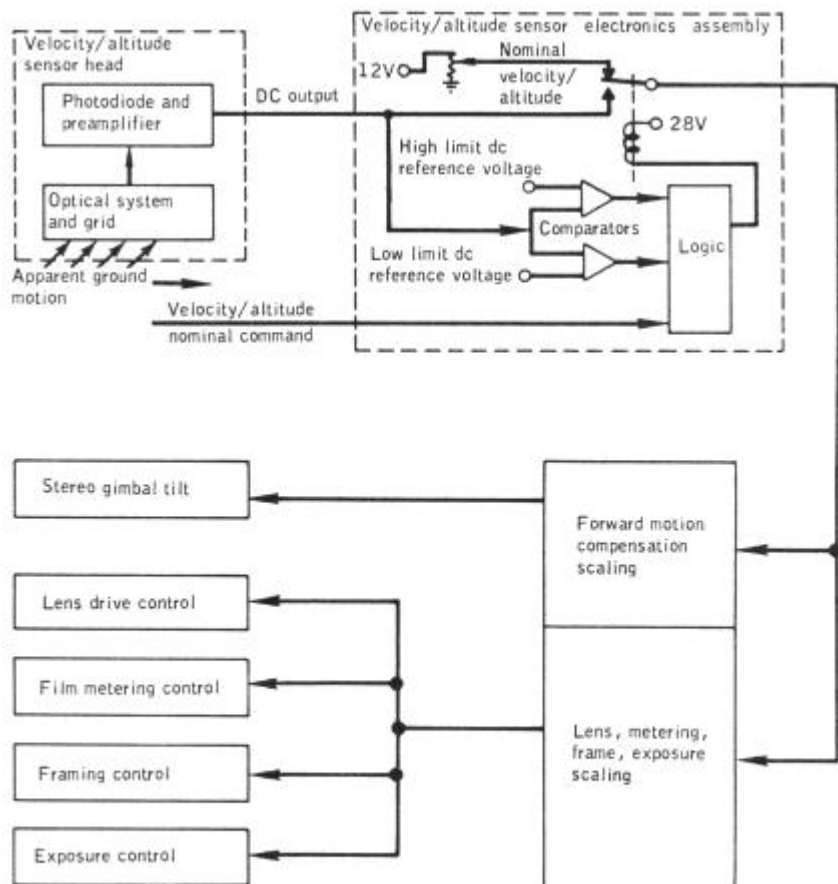
Breadboard tests and circuit analyses of the velocity/altitude electronics (**Fig. 14-36**) did not indicate failure. Tests were conducted in which endless belts of lunar scene photography from Apollo 8 and 15 were passed in front of velocity/altitude sensors. Sensors from the prototype and qualification units, and flight unit number 1 were used. By varying the illumination level, sensor performance somewhat similar to the Apollo 15 anomaly could be obtained.

Figure 14-36.- Velocity/altitude output circuitry.

The results of the tests, coupled with analyses of the basic sensor design, indicate that the problem is related to the optical signal-to-noise ratio. The remaining flight hardware will be modified to improve this ratio. The optical signal will be enhanced by increasing the lens aperture from f/4.0 to f/3-5 and by deleting the infrared filter. The optical noise (reflections) will be reduced by increasing the length of the lens hood and by repositioning the sensor so that the camera's forward plume shield will not be in the field of view of the sensor. In addition, a manual override of the velocity/altitude sensor will be provided on the remaining flight units. By using a three-position switch, two preselected velocity/altitude ratios will be provided, as well as the automatic function.
