14.3.2 Loss of Laser Altimeter Altitude Data

14.3.3 Slow Deployment Of Mapping Camera

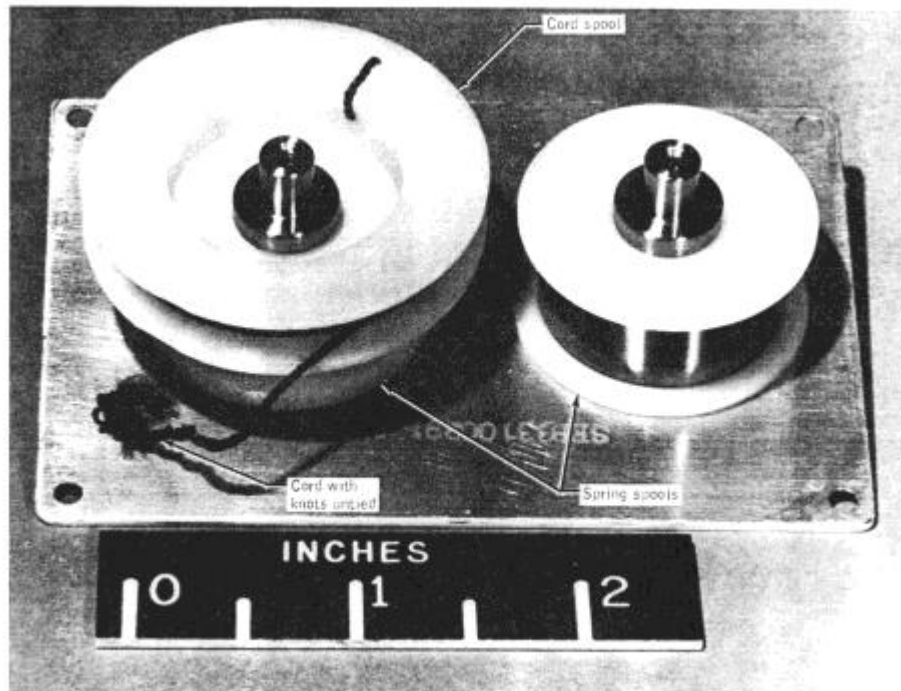
Both retractable tethers failed during lunar surface operations; the Commander's tether cord broke during the first extravehicular activity, and the tool clamp came off the end of the Lunar Module Pilot's tether. The Commander carried the standard 3/8-pound pull tether which consists of a case, a negator spring wound reel-to-reel on two spools, and a 30-pound cord wound on a spool mounted to one of the spring spools (**Fig. 14-52**).

The cord had broken against a sharp edge of the spring when an attempt was made to extend the tether after the jam. The failure mode with the release of the slack cord is repeatable. Disassembly of the Lunar Module Pilot's tether showed that both the bowline and the figure-eight knot attaching the cord to the clamp had untied (**Fig. 14-53**) and this allowed the cord to retract into the housing. Changing this knot to an improved clinch knot will provide a more secure and permanent attachment. Crew training will emphasize proper use of the tethers.
