## Lunar Roving Vehicle (LRV) Missing Fender Extension Saga

### **Extracts From Apollo Mission Flight Evaluation Reports**

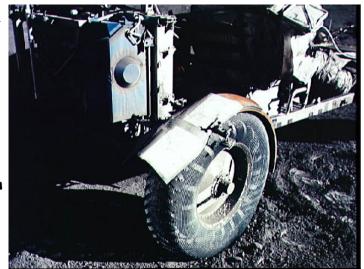
During Extravehicular Activity (EVA-1) at the LM prior to driving to ALSEP, the CDR inadvertently pulled off the right rear fender extension by catching it with the hammer carried in the right leg pocket of the Extravehicular Mobility Unit (EMU).

A fender extension was also lost on Apollo 15 and 16. A fender modification was incorporated for Apollo 17 to prevent the fender extension from being dislodged from its guides. The fix would have been effective except that the force applied was so great that it fractured the guide material.
