| | <p align="center">NASA Engineering and Safety Center Technical Assessment Report</p> | <p align="center">Document #: NESC-RP- 06-065</p> | <p align="center">Version: 1.0</p> |

**Fracture Mechanics Based Methods Development for
Composite Overwrapped Pressure Vessels (COPV) with
Metallic Liners**

July 8, 2010

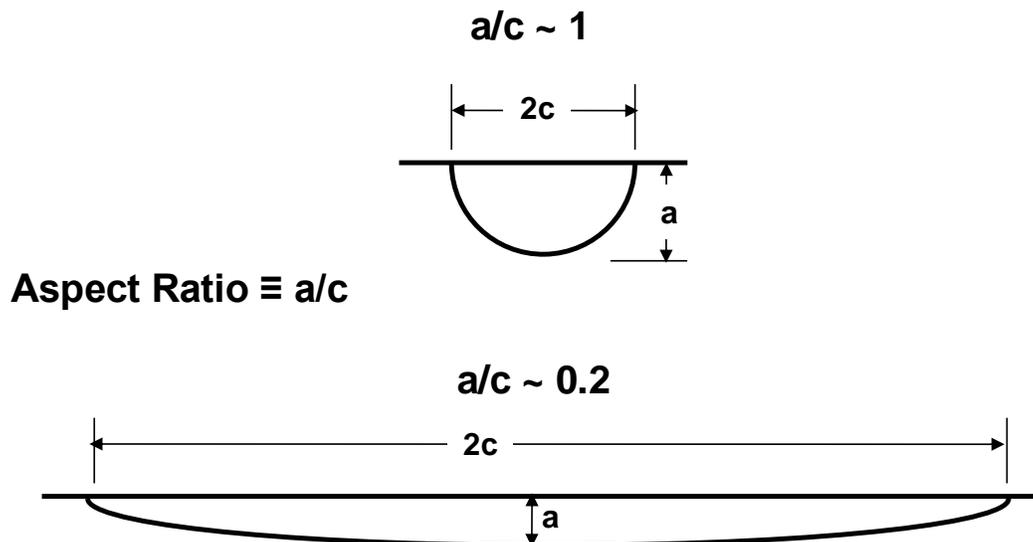
Figure 5.1-1. Schematic of crack shapes used in the uniaxial and COPV FCG rate tests

The resulting laser notches tended to be more rectangular shaped than semi-circular, as seen in Figure 6.1-3. However, the resulting fatigue cracks quickly grew to a semi-elliptical shape during precracking, but with a deeper aspect ratio than the original notch. The two desired crack shapes, shown in Figure 5.1-1, were obtained by changing the distance between the metal blocks that shield the laser and the processing time. The small semi-circular crack fronts ($a/c \sim 1$) were obtained by positioning the metal blocks 0.02 inches apart and laser processing time was selected to produce a notch depth of about 0.02 inches. The long shallow crack fronts ($a/c \sim 0.2$) were obtained by positioning the metal blocks 0.10 inches apart and reducing the laser processing time to produce a notch depth of about 0.01 inches.

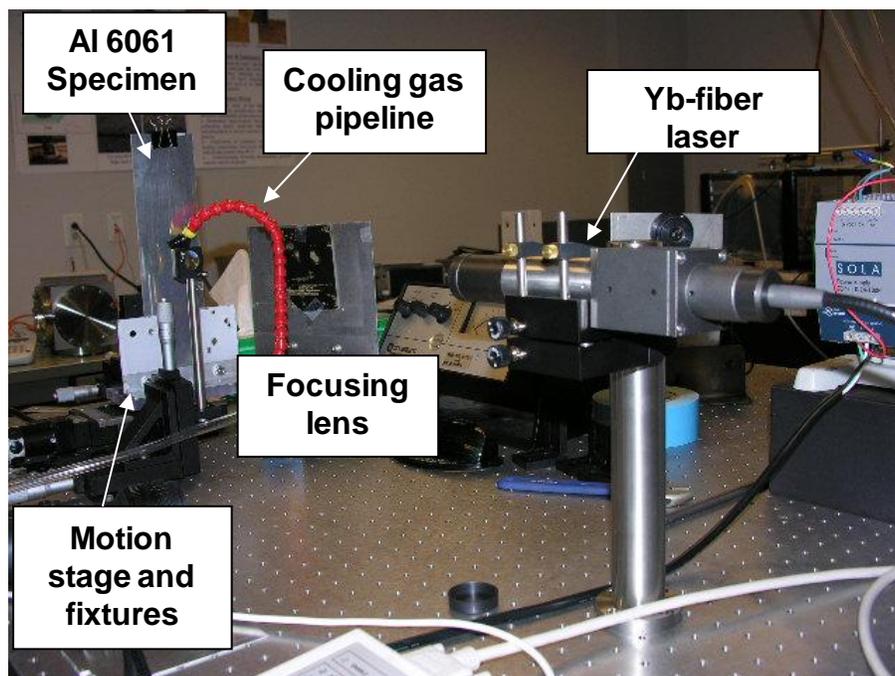
Figure 6.1-1. Laser notch test setup

The Yb-fiber laser delivers a high power 1.06 μm wavelength laser beam to the specimen via a flexible metal-sheathed single mode fiber cable. A repetition rate of 20 kHz and a pulse width of 50 ns were used in the micromachining process. A high laser energy density is required for micromachining because aluminum is highly reflective to the laser wavelength and a laser power of 16 W was employed. The laser beam was directed through a 50 mm focal length, plano-convex lens, and focused onto the specimen surface. A cooling gas pipeline was used to direct compressed air onto the specimen surface and remove the debris. The specimen was mounted on the 3-axis motion stage and moved in the direction perpendicular to the incident laser beam with a speed of 0.2 inch/s. Two metal blocks were used to shield the laser beam so that only the desired portion of the specimen was exposed to incident laser (micro notch length control). The specimen was translated a larger distance than the desired micromachined length to minimize the effect of extra laser exposure time during the initial acceleration and deceleration of the sample stage. Trial tests were conducted and the specimen was cross-sectioned to expose the micronotch in the depth direction. The depth of the micronotch was controlled by the laser processing time. By controlling the distance between the metal plates and the laser scanning time, the length and depth of the notch were then processed to the desired values.

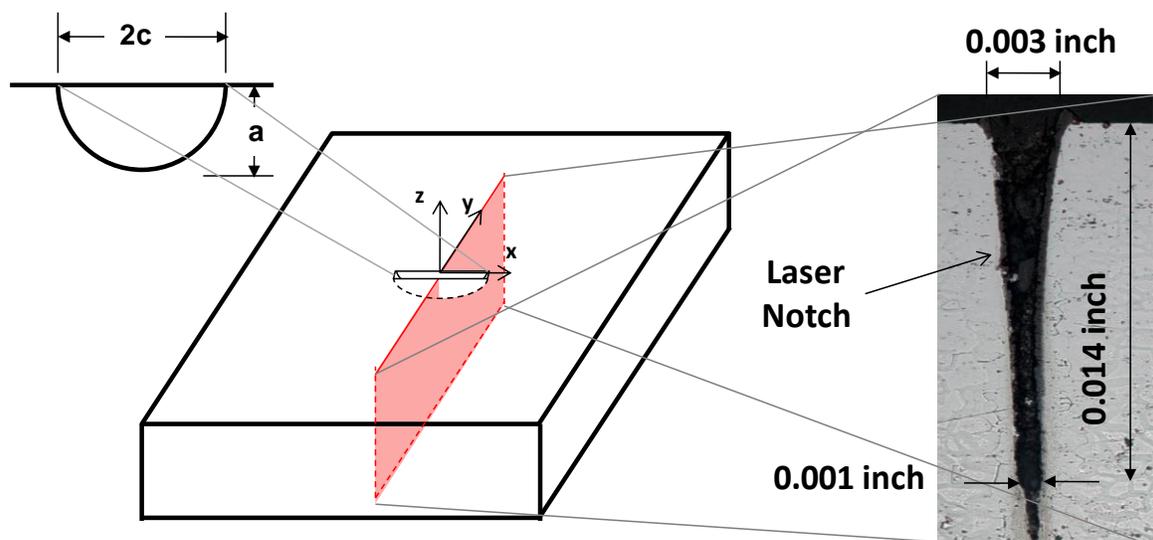
(a) Schematic of cross section

(b) Photograph of cross section

Figure 6.1-2. Cross section of a laser notch

sheet perpendicular to the direction of the notch and polishing the exposed surface, as shown in Figure 6.1-2 for a laser notch that was precracked. The root of this laser notch was about 0.001 inch. Beyond the end of the laser notch was a recast region that resulted from material melted by the laser that was not ejected from the notch, as shown in Figure 6.1-3. The recast region could potentially influence the measured FCG rates, so all notches were precracked beyond the recast region.

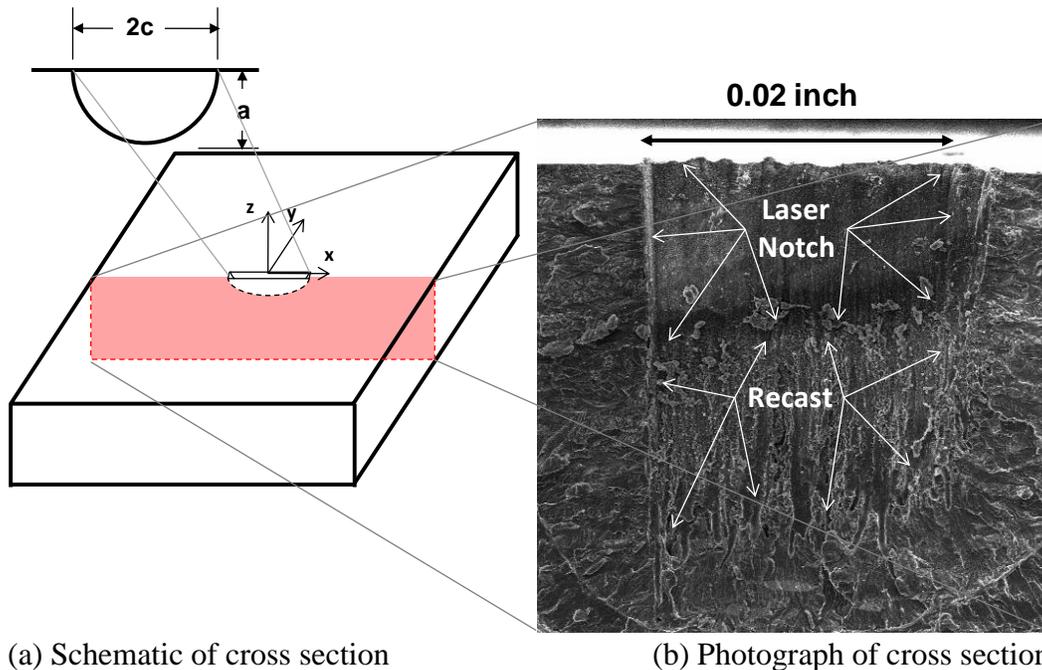
Figure 6.1-3. SEM photograph of a fatigue surface revealing the laser notch and the laser produced recast region

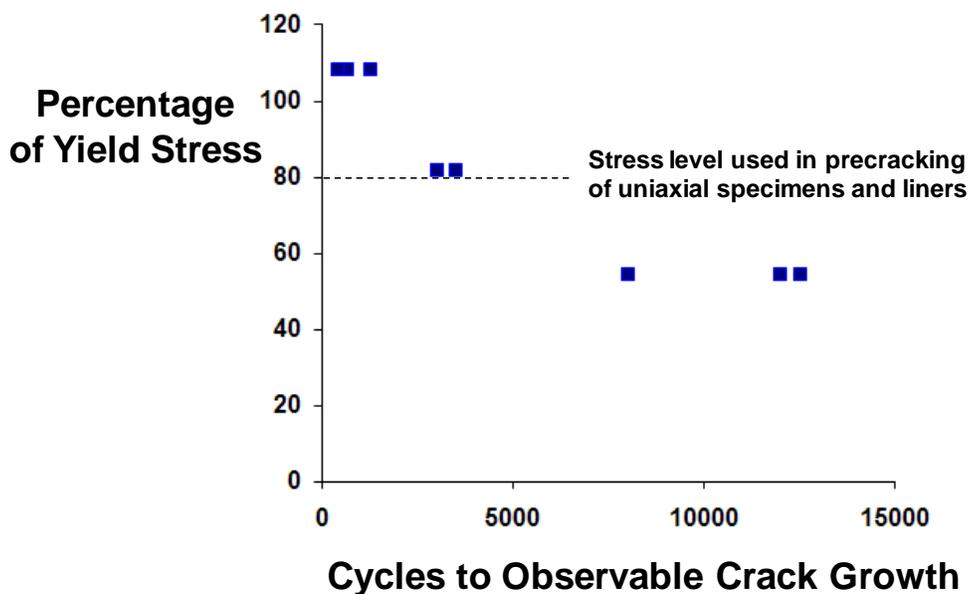
Figure 6.1-4. Number of fatigue cycles required to obtain visually apparent (with a 20x optical microscope) fatigue crack growth from a laser notch

Fatigue cracks behave differently than notches, even notches as sharp as those generated using the laser notching process, and thus cyclic loading (precracking) was required to nucleate true fatigue cracks. The loading frequency of the hydrostatic testing system was about 0.1 Hz, so crack nucleation in less than 5,000 cycles was desired to minimize the time required to precrack to less than a day. A series of tests were conducted to determine the stress level that nucleated a crack in the appropriate number of cycles. The fatigue crack nucleation was examined by fatigue cycling 0.05 inch thick coupons of 6061-T62 aluminum with small laser notches. The coupons were 3 inches wide and had a laser notch with $2c = 0.02$ inches and $a/c \sim 1$. The coupons were fatigue cycled at $R = 0.1$ with peak stresses that ranged between 50 percent and just over 100 percent of the net section material yield stress to develop a relationship between peak cyclic stress and cycles to initiation. Crack nucleation was defined as when cracks observable with a 20x magnification optical microscope (~ 0.001 inches) were present on both ends of the notch. The number of cycles required to initiate an observable fatigue crack decreased as the peak stress increased, but remained a significant value (400 to 1,200 cycles) at peak stresses just above the yield stress, as shown in Figure 6.1-4. This indicated that the notches did not behave like fatigue cracks even at strain levels that approached that of the autofrettage cycle. The number of cycles required to initiate an observable fatigue crack at a peak stress that was 80 percent of the material yield stress was about 3,000 cycles, and this stress level was selected for all precrack loading.

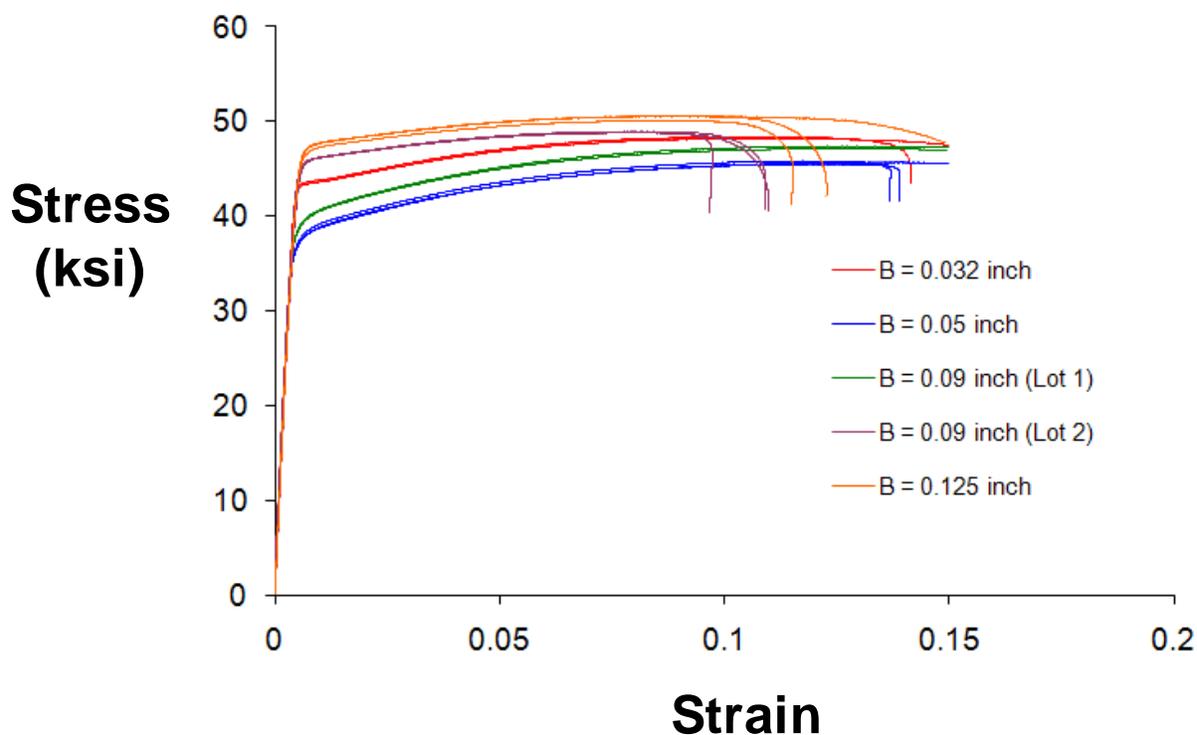
Figure 6.2-1. Stress-strain behavior of the material used in the uniaxial coupon tests that were conducted according to ASTM Standard E8 [ref. 3].

The uniaxial tests were conducted on 0.125 inch, 0.09 inch, 0.05 inch, and 0.032 inch thick sheets of 6061-T62 aluminum to characterize the material behavior. All of the 0.125 inch, 0.05 inch, and 0.032 inch thick coupons were obtained from individual sheets, and the 0.09 inch thick coupons were obtained from two different sheets (lot 1 and lot 2). Tensile tests, using ASTM Standard E8 [ref. 3], were conducted on coupons manufactured from each of the sheets, as summarized in Table 6.2-1. (Note the variability in yield stress (S_o), particularly between lot 1 and lot 2 of the 0.09 inch thick material.) Multiple tests were conducted for each sheet of material and the results reported in terms of engineering stress-strain as shown in Figure 6.2-1. No tests were conducted on the liner material, but the manufacturer provided a yield stress value of 41.5 ksi.

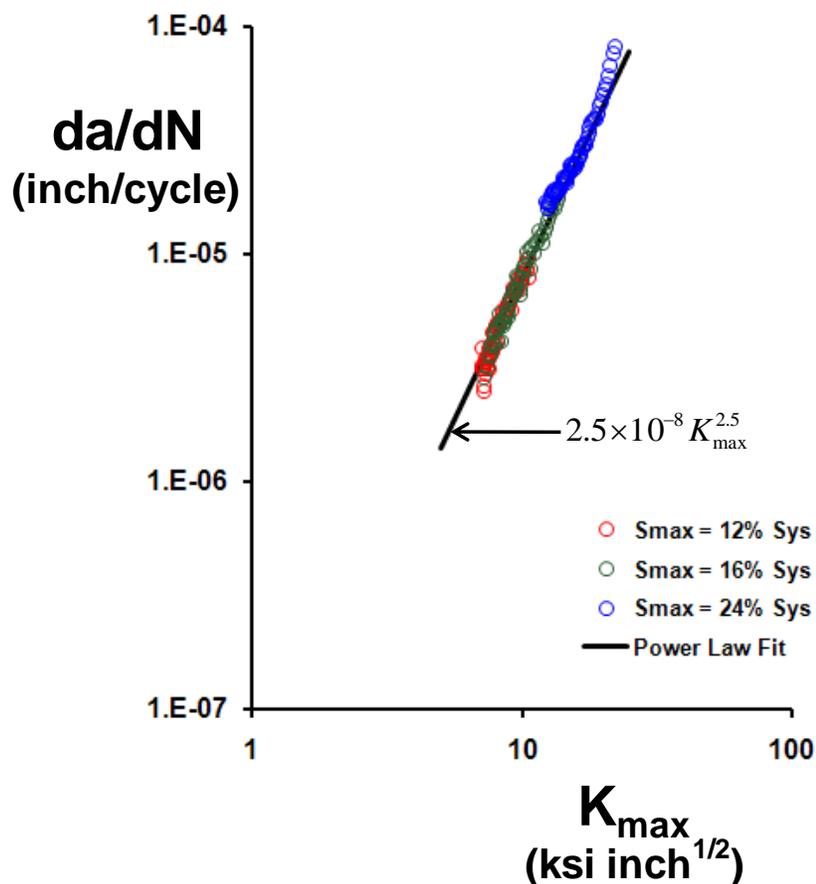
Figure 6.3-1. Linear elastic FCG rate results from the $M(T)$ tests that were conducted according to ASTM Standard E647 [ref. 4].

FCG rate tests were conducted under LFM conditions on the 0.09 inch thick 6061-T62 lot 2 aluminum to obtain the baseline FCG rate behavior. The tests and FCG rate measurements were made per ASTM E647 [ref. 4]. The tests were conducted on 3 inch wide middle crack tension (M(T)) coupons subjected to fully reversed loading ($R = -1$) and maximum stresses of 12 percent, 16 percent, and 24 percent of the material yield stress, 5.6 ksi, 7.4 ksi, and 11.1 ksi, respectively. The stress levels were selected to provide coverage of the power law crack growth region. The crack growth rate (calculated with a 3-point average) was plotted as a function of K_{max} , as shown in Figure 6.3-1. K_{max} was used rather than ΔK due to the negative stress ratios. A power law fit to the center portion of the data is also shown in Figure 6.3-1 and Equation 1. The data from the three tests are provided in Appendix A.

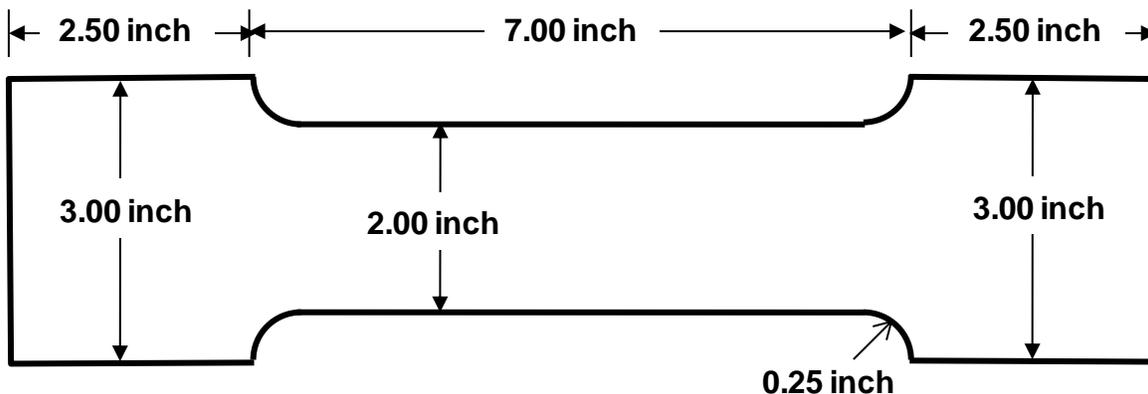
Figure 6.4-1. Dogbone coupon for uniaxial FCG testing

3. The cracked uniaxial coupons were machined into a 2-inch wide dogbone coupon, as shown in Figure 6.4-1.
4. Guide plates were installed and extensometers were placed on the edges of the coupon to measure strain.

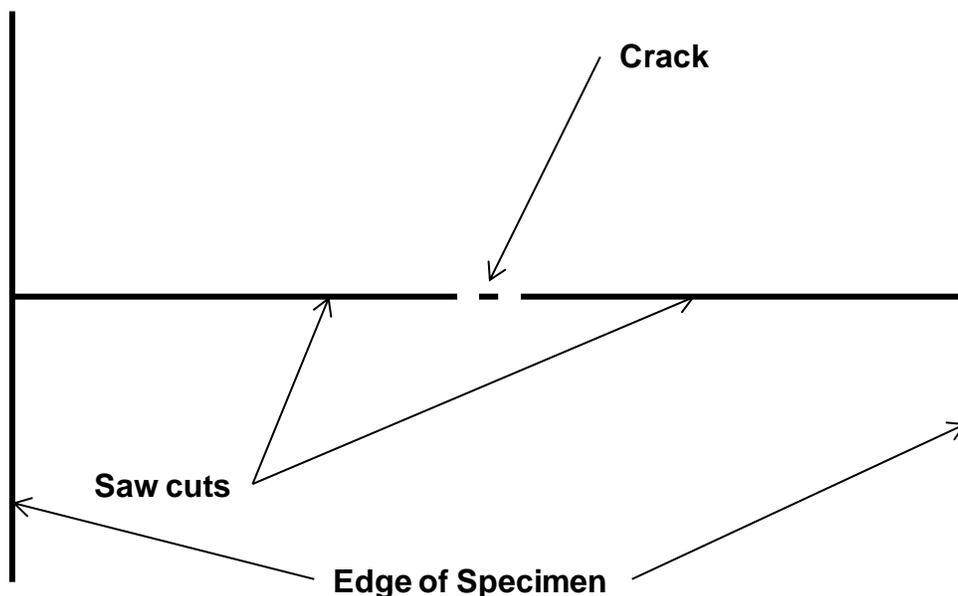
Figure 6.4-2. Schematic of saw cuts relative to the position of the fatigue crack

7. The coupon was removed from the test machine and saw cuts were made from the edge of the coupon to within 0.05 inches of the crack tips, as shown in Figure 6.4-2.

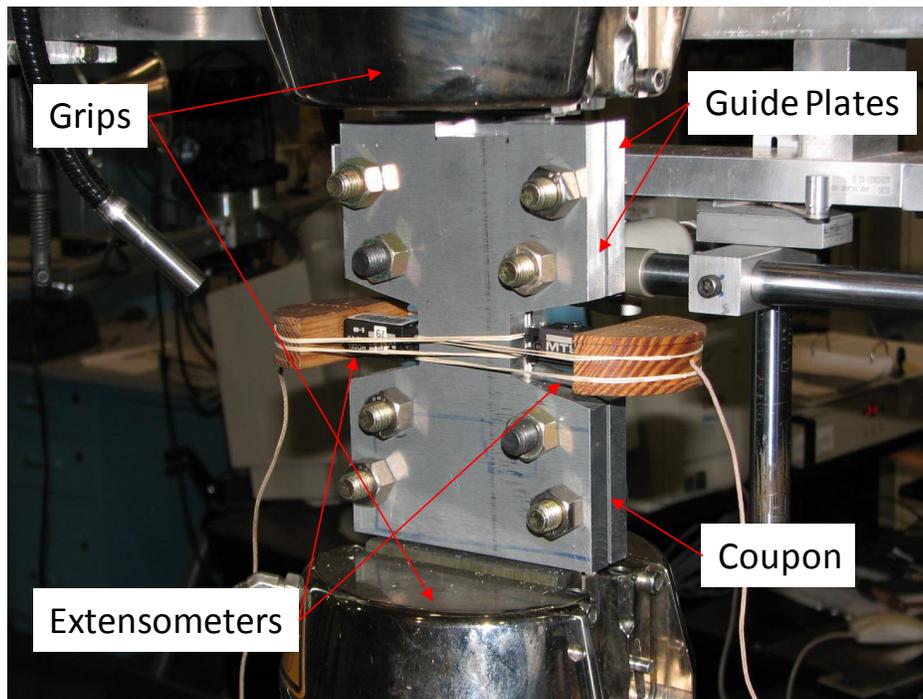
Figure 6.4-3. Photograph of guide plates with edge-mounted extensometers

Guide plates were necessary to prevent buckling of the thin sheet uniaxial coupons during the high negative loads required for compressive yield. The guide plates consisted of two 0.375 inch aluminum thick plates that sandwiched the coupon, as shown in Figure 6.4-3. The inner surface of the guide plates had a thin sheet of Teflon® tape to allow slippage between the guides and the coupon to minimize load transfer through the guides. The guide plates were hourglass shaped, with the center section about 1.95 inches wide. This was about 0.05 inches less than the width of the dogbone test section to allow extensometer contact. The length of the guide plates was sized to allow the gap between the guide plates and grips to be less than 0.01 inches at the minimum load. A larger gap would permit end buckling in the thinner coupons, as shown in Figure 6.4-4.

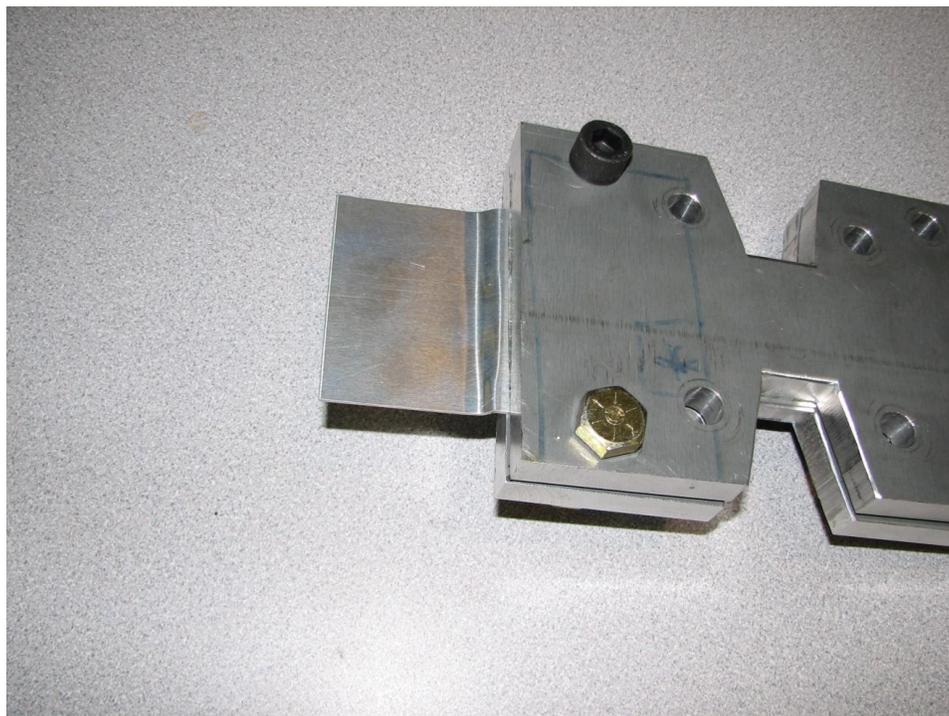
Figure 6.4-4. Example of end buckling in a 0.032-inch thick dogbone coupon

The 0.032-inch thick uniaxial coupons buckled between the guide plates and the grips with the smallest possible gap, so an additional restraint was developed for the thinnest coupons. The 0.375-inch thick guide plates were augmented with two 0.09-inch thick, discontinuous, sheets that were placed between the guide plates and the coupons, as shown in Figure 6.4-5. The 0.09-inch thick sheets were machined with the identical dimensions as the coupon except for the test region that was 0.05 inches narrower than the coupon to allow extensometer contact. The 0.09-inch thick sheets were discontinuous to prevent load transfer around the coupon, but provided sufficient stiffness in the gap between the guide plates and grips to prevent end buckling.

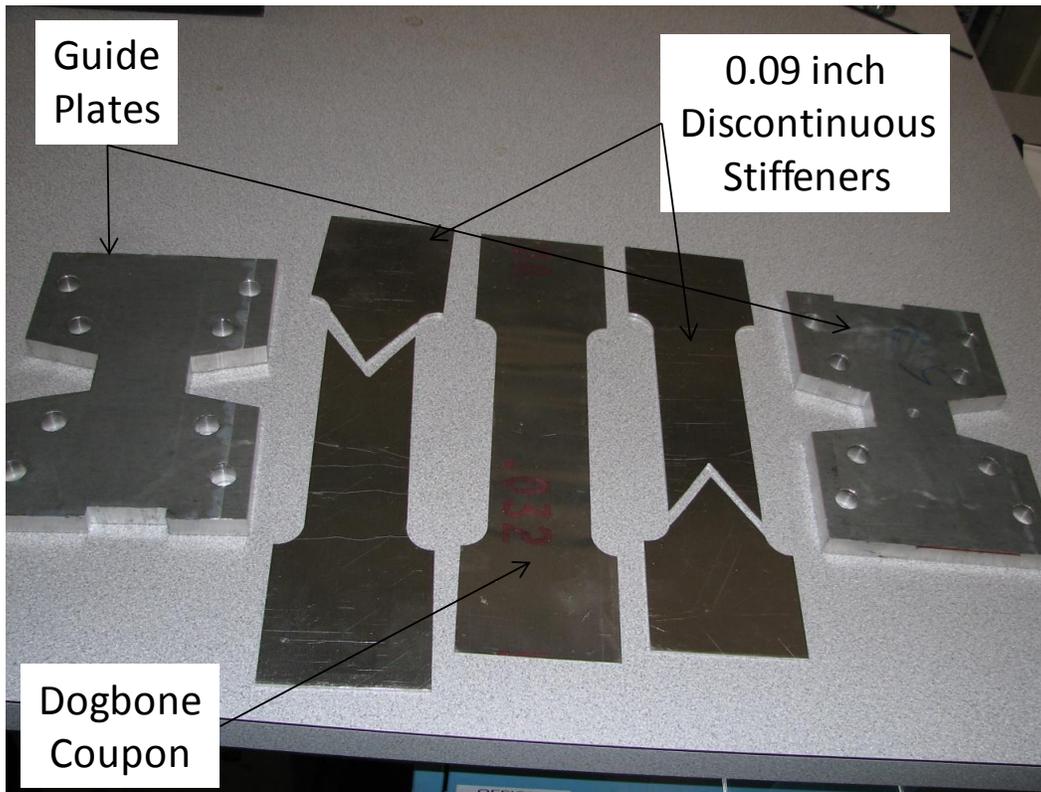
Figure 6.4-5. Guide plates, discontinuous stiffeners, and dogbone coupon

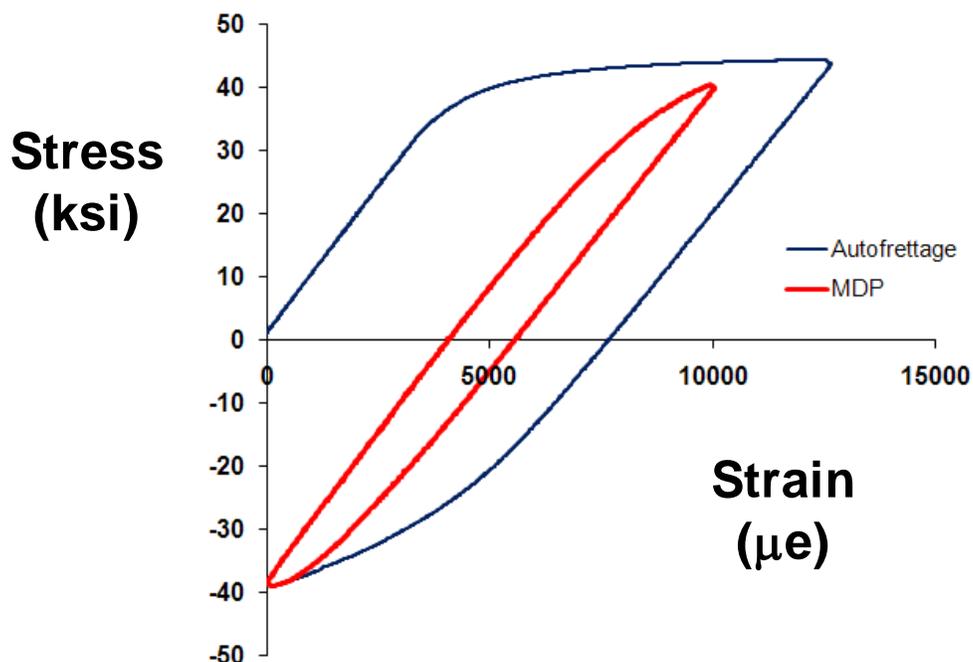
dogbone coupon. The subsequent unloading to zero strain resulted in compressive yielding. The second (MDP) cycle (loaded to 10,000 $\mu\epsilon$ and unloaded to 0 $\mu\epsilon$) resulted in both tensile and compressive yielding, but to a lesser extent than measured in the autofrettage cycle.

Figure 6.4-6. Typical stress-strain curve for a uniaxial fatigue test

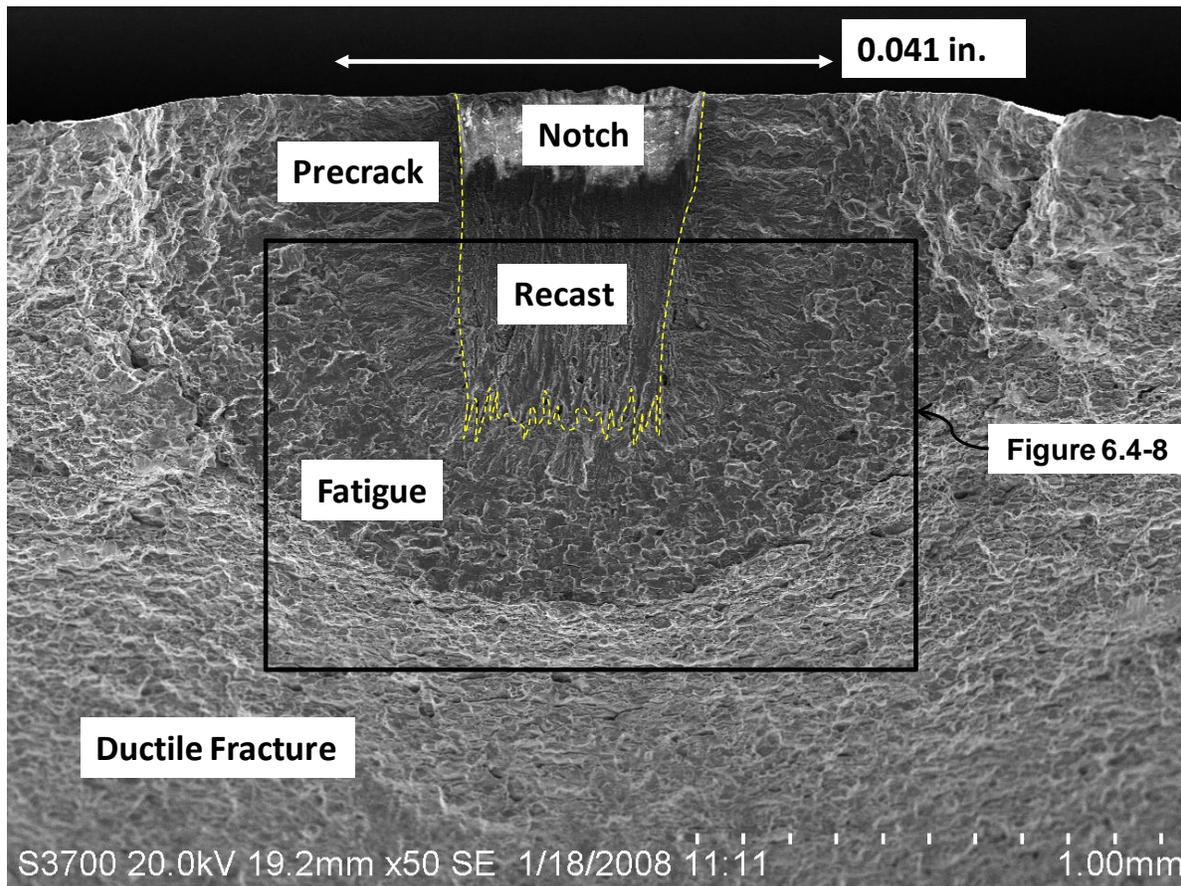
Figure 6.4-7. SEM photograph (50x) of a typical fracture surface (UNI-090-35-01) with the four regions identified. The dash lines highlight the recast region that is more apparent in Figure 6.4-8.

Post-test examination of the fracture surfaces revealed distinct differences between the regions created by laser notch, precracking, fatigue cyclic loading, and monotonic loading to failure. A SEM photograph of a typical fracture surface is shown in Figure 6.4-7. The laser notch region was irregular shaped in the depth direction with “fingers” of recast material that extended the effective depth of the notch beyond the desired 0.01 inches, as shown by the dashed line in Figure 6.4-7. This resulted in aspect ratios (a/c) greater than 1 for the semi-circular notches. The “fingers” in the recast region are seen more clearly in SEM photograph shown in Figure 6.4-8. The boundaries between the precrack and the fatigue regions and the fatigue and ductile fracture regions are also well-defined at the magnification shown in Figure 6.4-8, as illustrated by the filled and open triangles, respectively. These boundaries represent the crack front at the end of the precracking and the fatigue loading, respectively. The difference between the two boundaries was the extent of crack growth (Δa) due to the fatigue loading and the FCG rate (da/dN) could be calculated knowing the number of fatigue loading cycles (200 for this test). Crack growth due to the autofrettage cycle was not visible in the SEM photographs and was assumed to be small relative to the damage due to the subsequent 200 cycles. Figure 6.4-9 contains a higher magnification SEM photograph of the fracture surface showing apparent fatigue striations. Fatigue striations are microscopic marks on the crack surface that, under certain loading conditions, have been shown to provide a one-to-one correlation between the crack macroscopically measured crack growth rate and the distance between striation marks [ref. 5]. The FCG rate based on striation spacing width was measured in six locations, as shown in Figure 6.4-9. A comparison was made between the FCG rate calculated from the striation

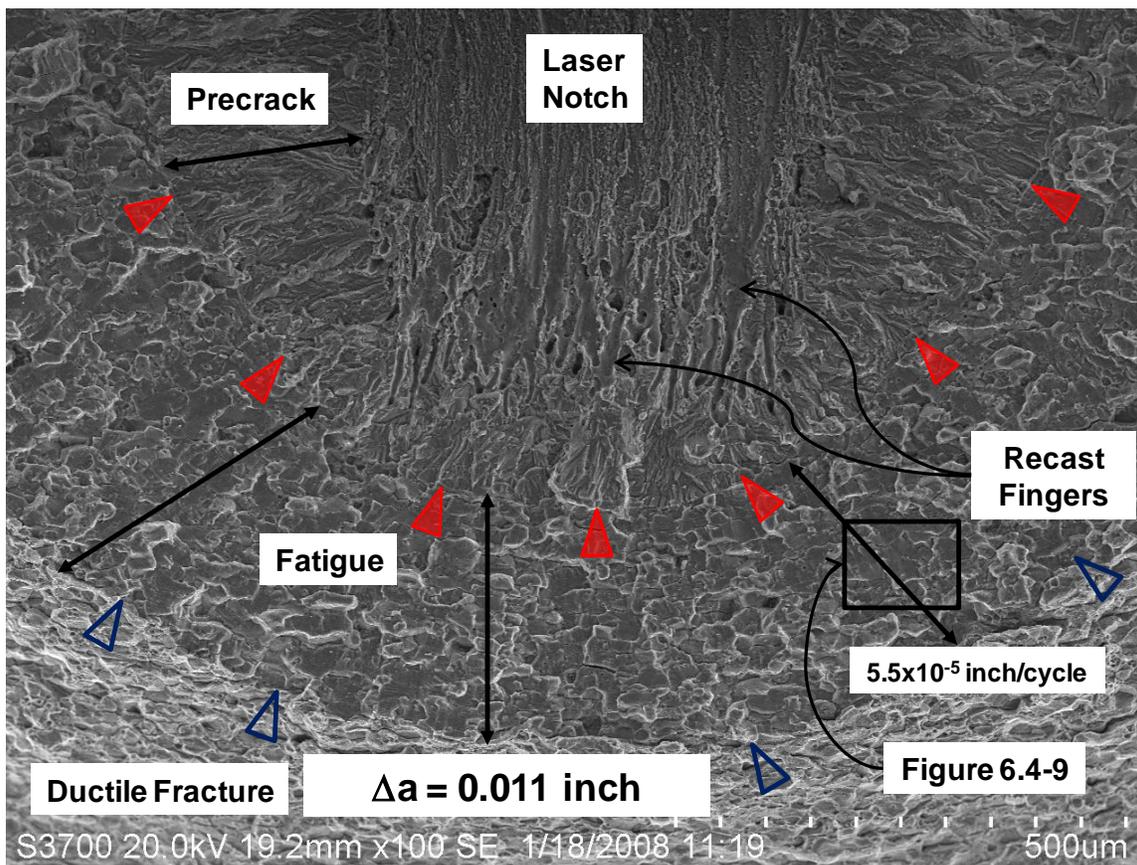
Figure 6.4-8. SEM photograph (100x) of a fracture surface (UNI-090-35-01) showing the maximum depth location

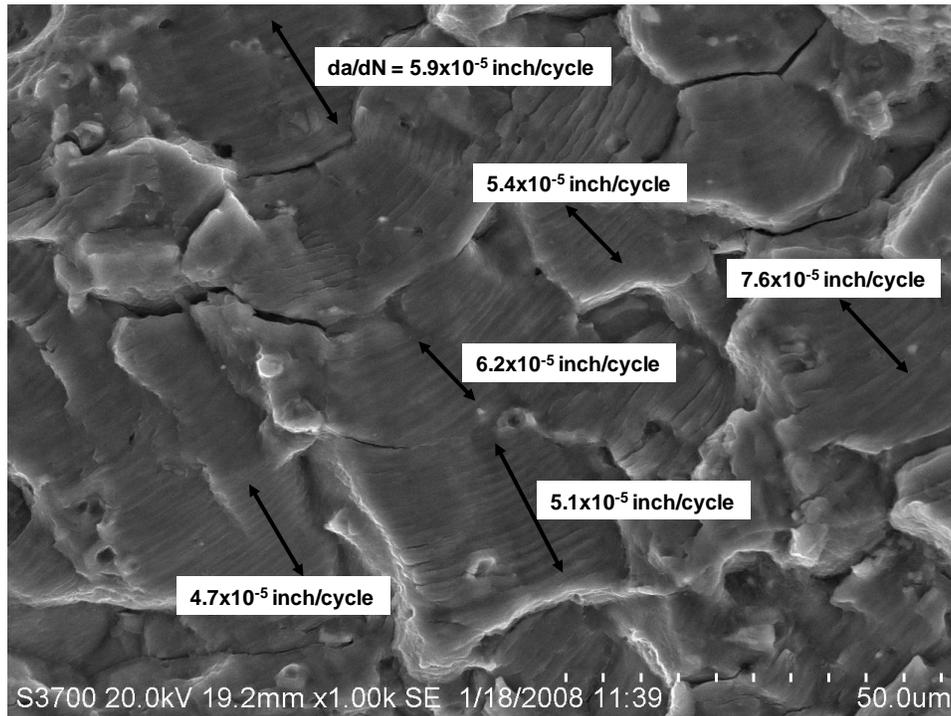
Figure 6.4-9. SEM photograph (1000x) of fracture surface (UNI-090-35-01) showing fatigue striations

spacing and overall FCG rate obtained from the distance between the crack fronts in the same region. The average striation FCG rate for the six measurement locations (5.8×10^{-5} inches/cycle) was slightly higher than the overall FCG rate measured from the distance between crack fronts (5.5×10^{-5} inches/cycle).

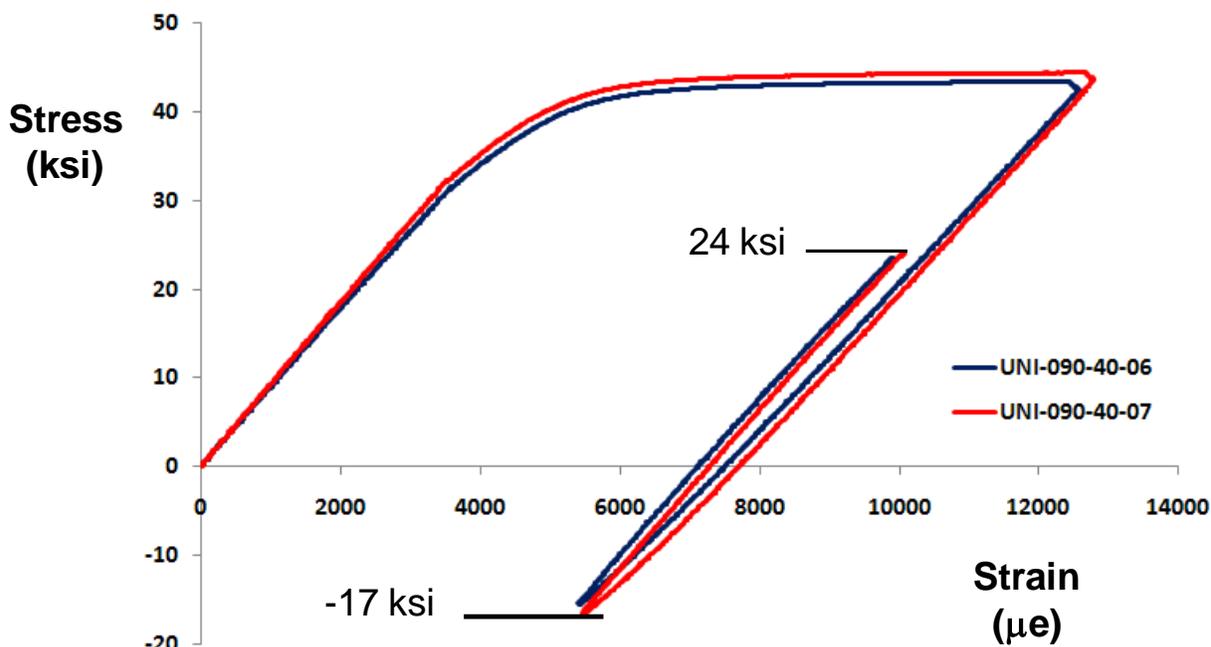
Figure 6.4-10. Stress-strain curve from the cyclic fatigue tests of coupons UNI-090-40-06 and UNI-090-40-07

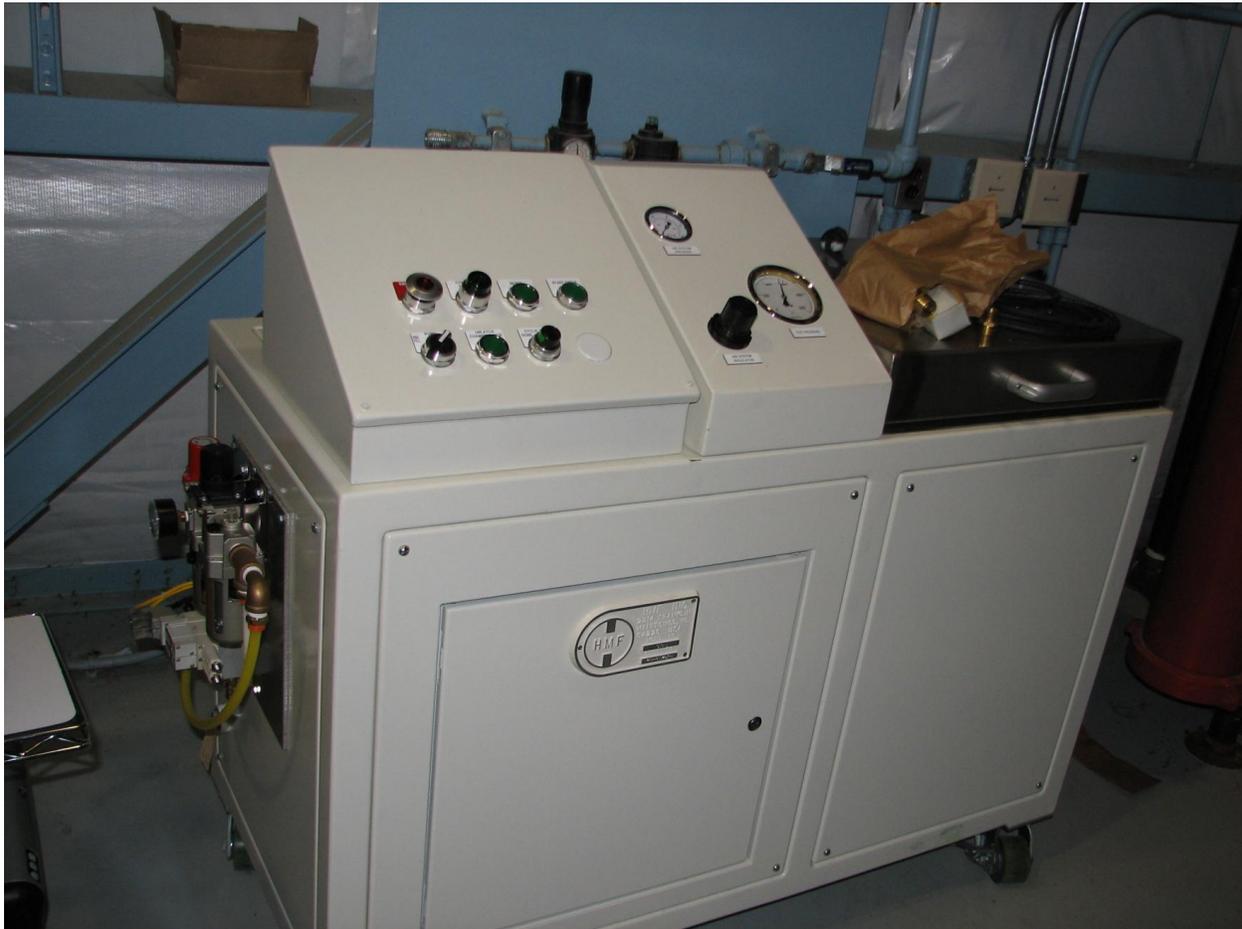
Figure 6.5-1. Hydrostatic testing system

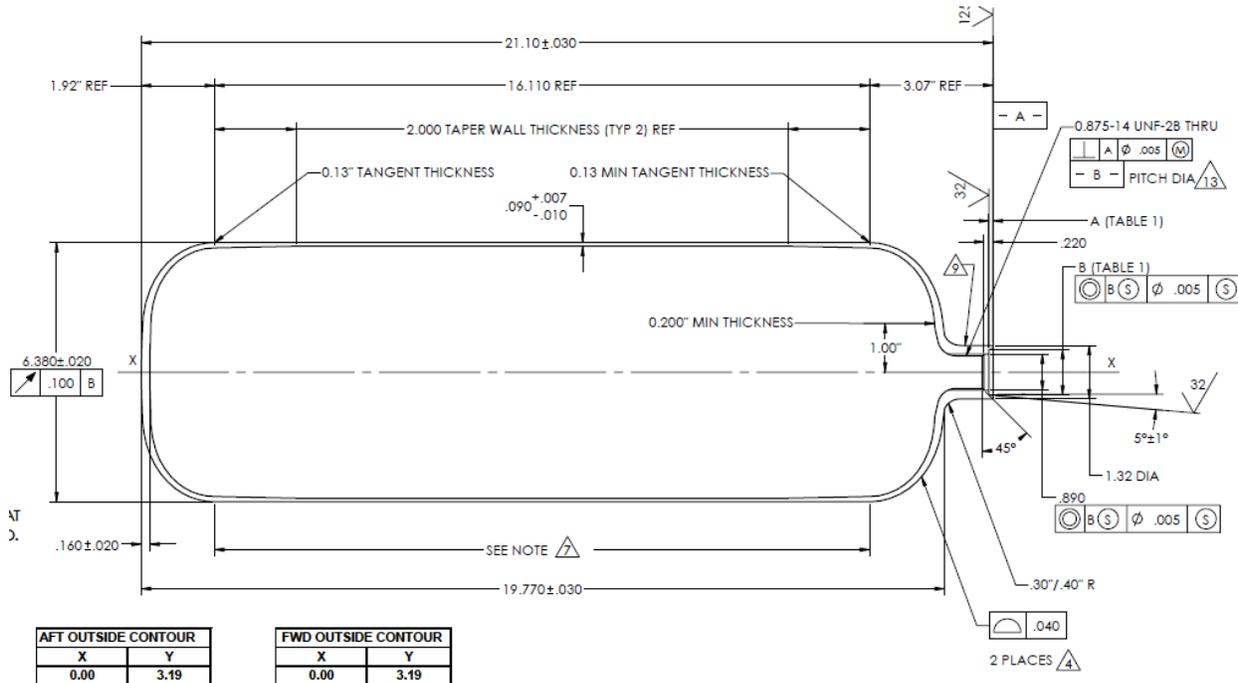
Figure 6.5-2. Schematic of the liner used in the pressurized COPV tests

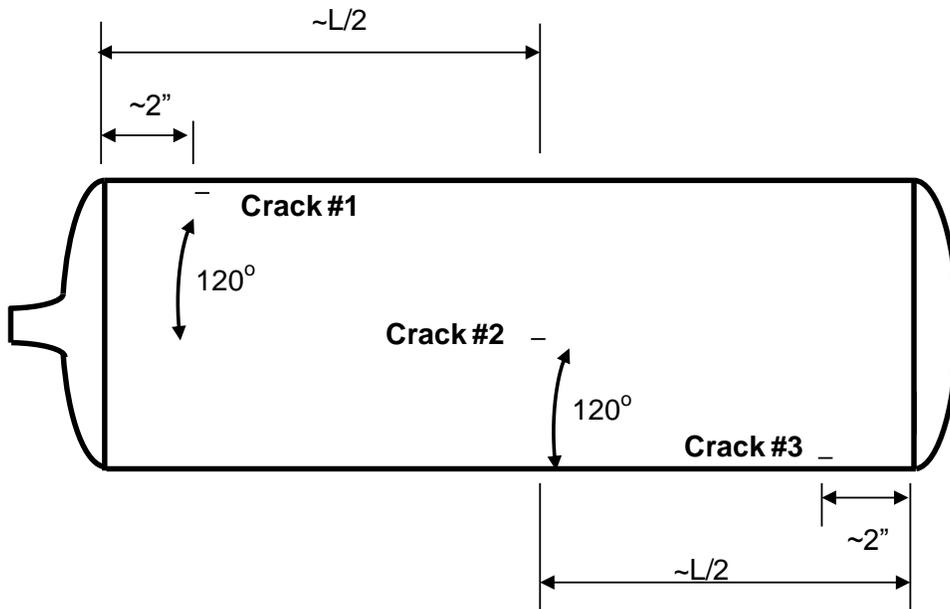
Figure 6.5-3. Schematic of the laser notch locations for the liners

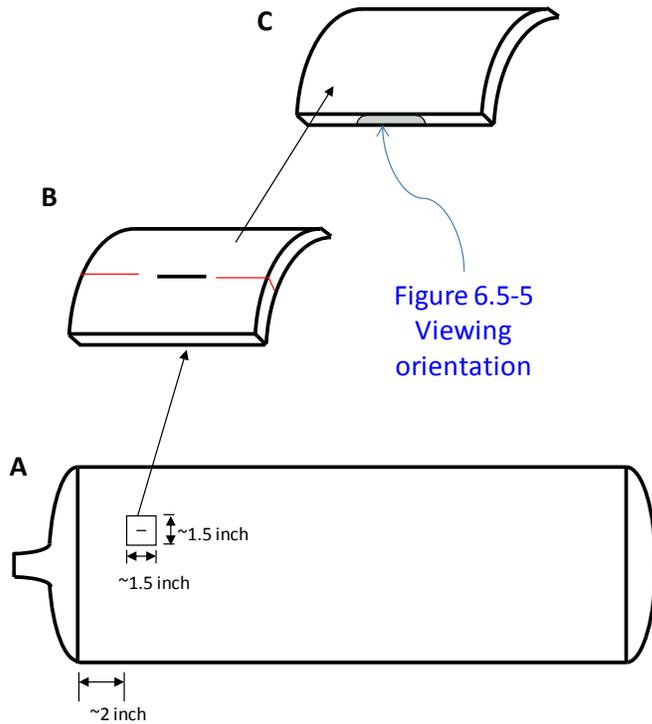
- a) A 1.5 inch by 1.5 inch square, containing the crack that grew through the thickness, was removed from the liner
- b) Two saw cuts (red lines) were made in line with the crack tips, but about 0.05 inch from the tips
- c) The remaining ligaments were broken in bending, revealing the surface of the fatigue crack

Figure 6.5-4. Procedure used to extract the fatigue crack that initiated from a manufacturing defect on the liner ID

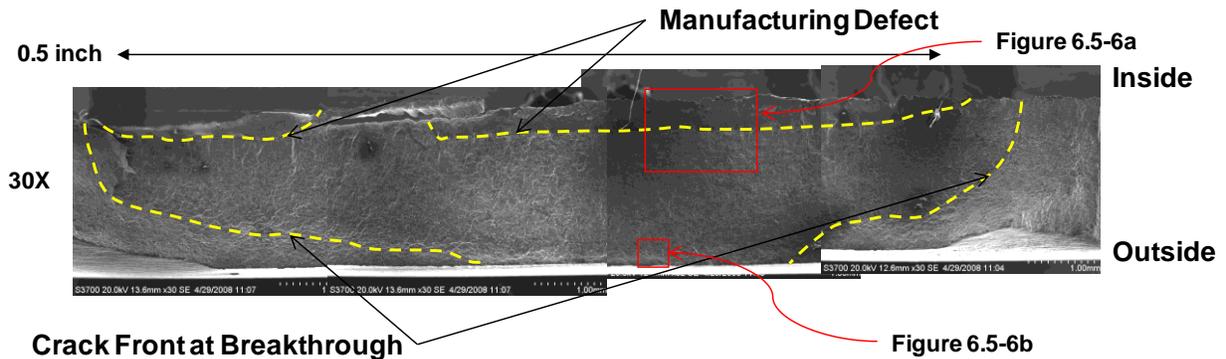
Figure 6.5-5. SEM photograph of a fatigue crack that nucleated from a liner manufacturing defect that leaked during precracking. The dashed lines highlight the crack front boundaries.

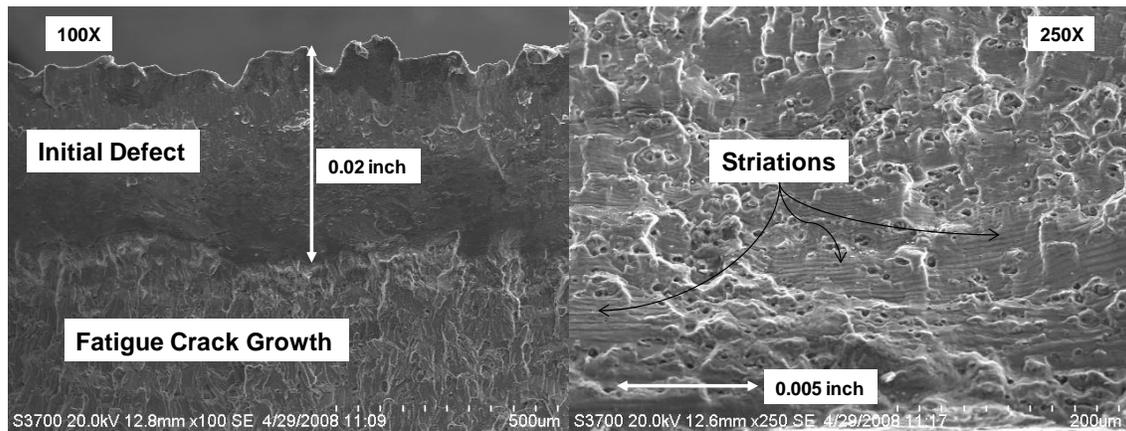
a. SEM Photograph of manufacturing flaw b. SEM Photograph of fatigue striations near the leaks site

Figure 6.5-6. Higher magnification SEM photographs of the fatigue crack shown in Figure 6.5-5.

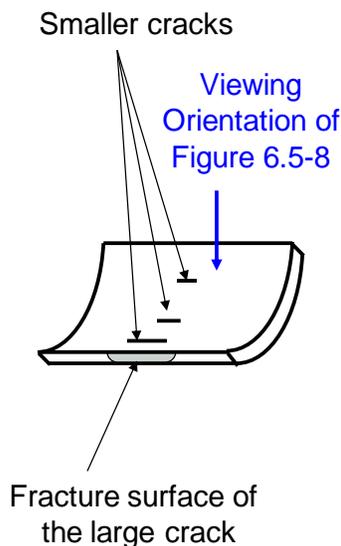
- a) The 1.5 inch by 1.5 inch cutout, described in Figure 6.5-4, was broken into two pieces along the large crack
- b) One fracture surface from the large crack that broke through the thickness was exposed on one edge of the cutout
- c) Additional smaller cracks, parallel to the large crack, were observed on the inside surface
- d) Note that the smaller cracks were exposed to bending stresses during the separation of the fracture surfaces, so the crack opening may be unnaturally large

Figure 6.5-7. Procedure used to view the smaller fatigue cracks that nucleated from manufacturing defects on the liner ID

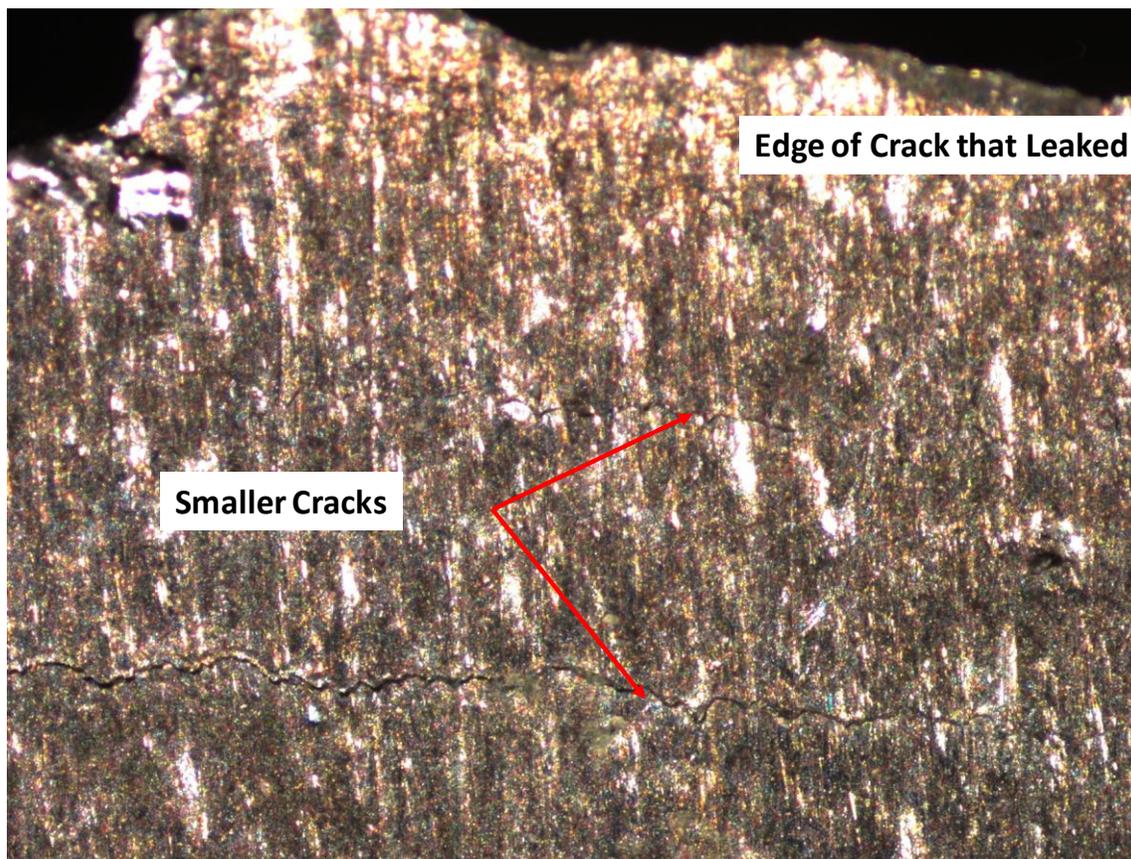
Figure 6.5-8. Optical photograph of two small cracks that were parallel to the liner crack that leaked during precracking

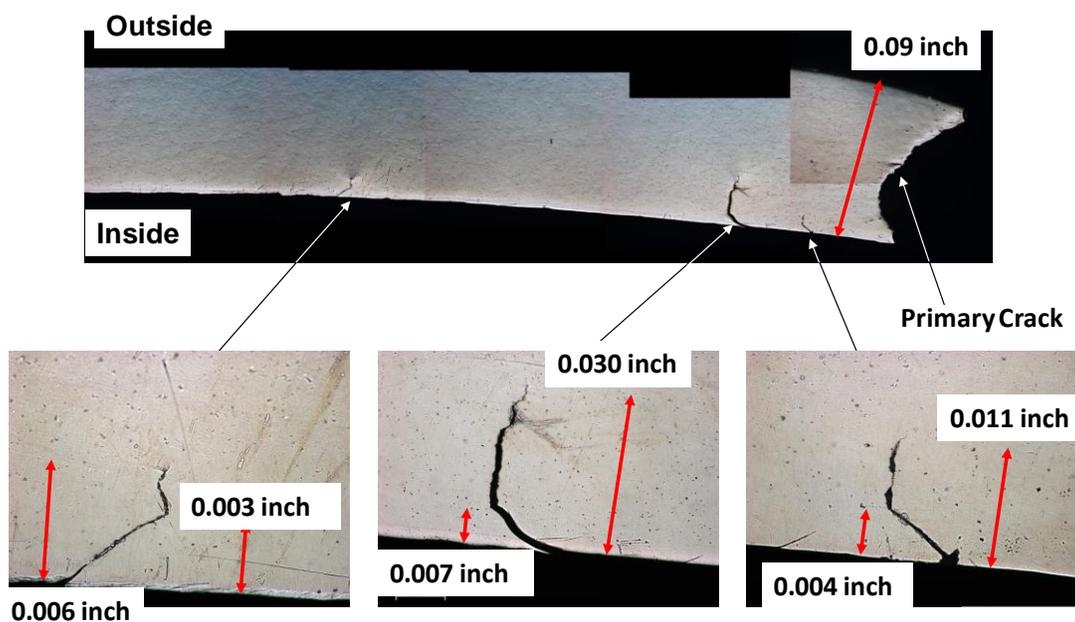
Figure 6.5-10. SEM photographs of fatigue cracks that initiated from manufacturing defects.

c) This view revealed the through-the-thickness shape of the cracks at one point, as shown in Figure 6.5-10
