| | <p align="center">NASA Engineering and Safety Center Technical Assessment Report</p> | <p align="center">Document #: NESC-RP- 06-065</p> | <p align="center">Version: 1.0</p> |

**Fracture Mechanics Based Methods Development for
Composite Overwrapped Pressure Vessels (COPV) with
Metallic Liners**

July 8, 2010

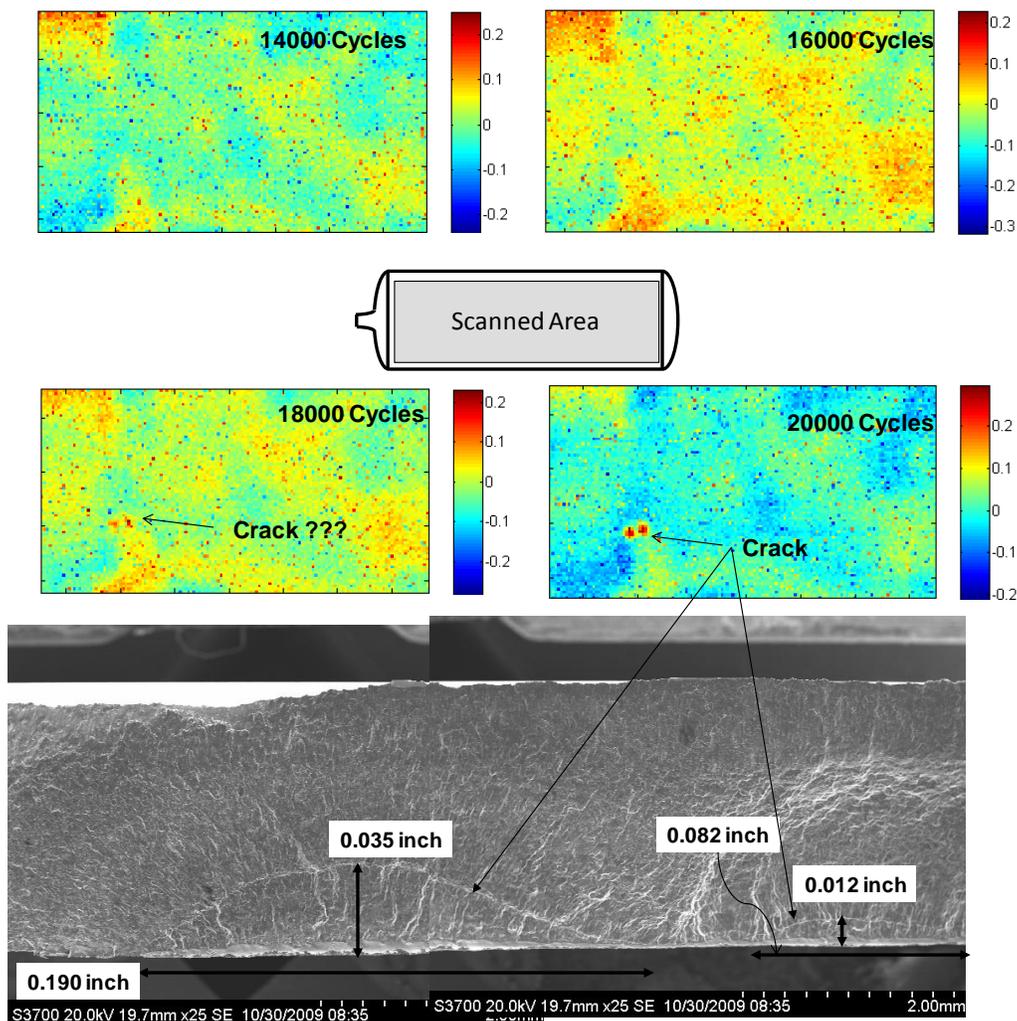
Figure 6.5-11. The results of the eddy current scan of a bare liner 18119 and the fracture surface corresponding to the location of the eddy current indications. The color indicates the relative intensity of the signal.

grown sufficiently to produce a very strong, localized signal that had a high likelihood of being an ID crack and the precracking was stopped. Two co-linear fatigue cracks, with a total length that was smaller than the probe diameter, were identified after the liner was wrapped and pressure tested. None of the liners leaked during the precracking process after the NDE inspections were implemented.

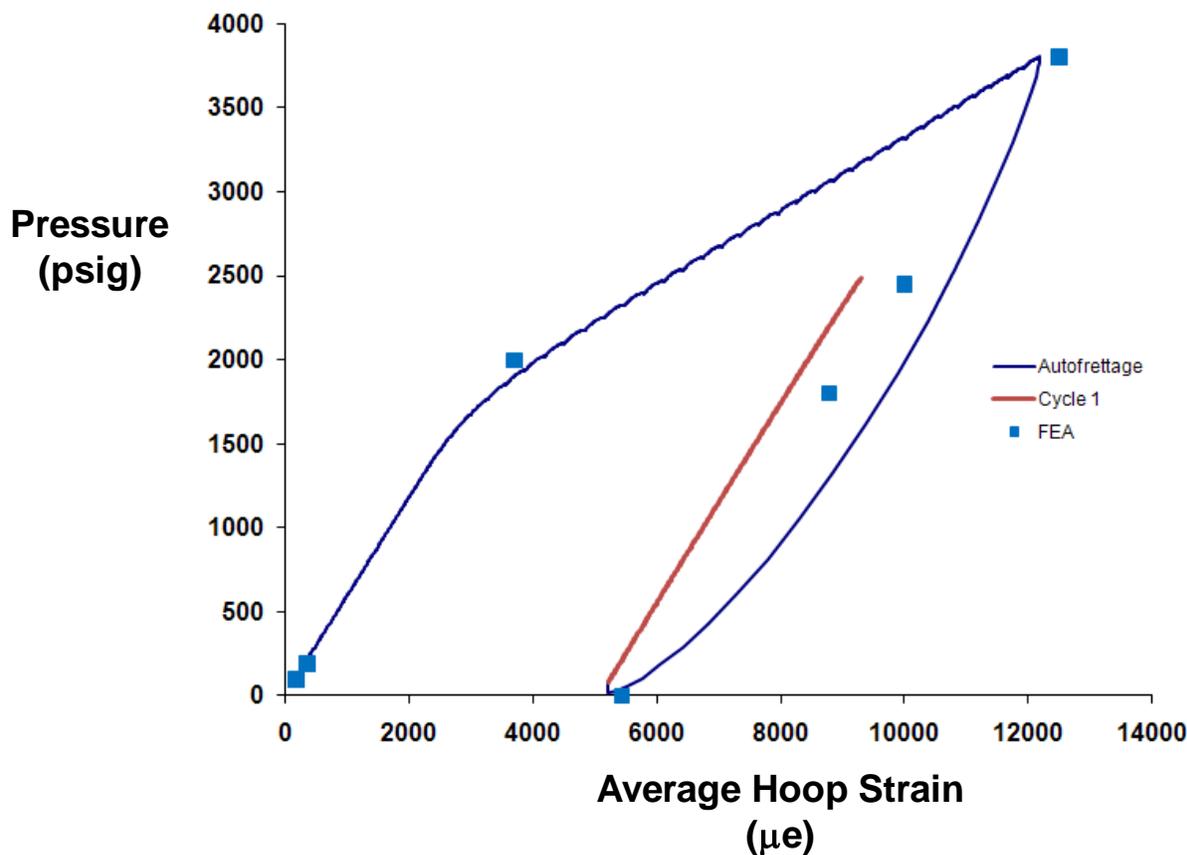
Figure 6.6-1. Predicted and measured hoop strain for a COPV subjected to an autofrettage and one MDP cycle

An elastic-plastic FEA was conducted to calculate the pressures necessary to obtain the required hoop strains in the liners [ref. 7]. The liner was modeled with eight node axisymmetric elements. Four elements were used across the thickness of each layer. The boundary conditions for the analysis consisted of a pressure load on the liner ID and an axial load acting on the sidewall section. The material properties of the liner and composite are provided in Table 6.6-1. The results of the FEA are provided in Table 6.6-2. A COPV was instrumented with four strain gages, orientated in the hoop direction, along the center of the COPV and 90 degrees apart around the circumference. The measurements from the four strain gages are averaged and compared against the FEA, as shown in Figure 6.6-1.

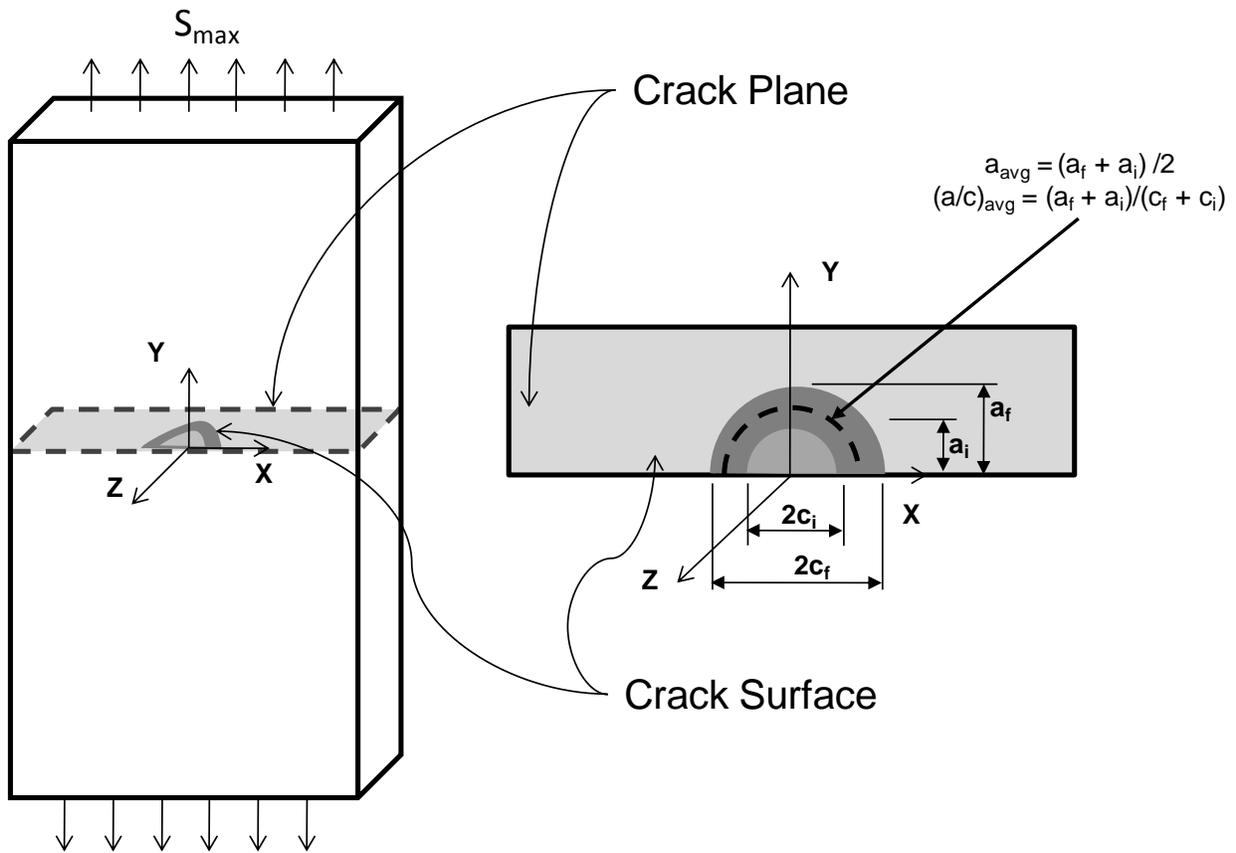
Figure 6.7-1. Definition of the average crack length for K calculations

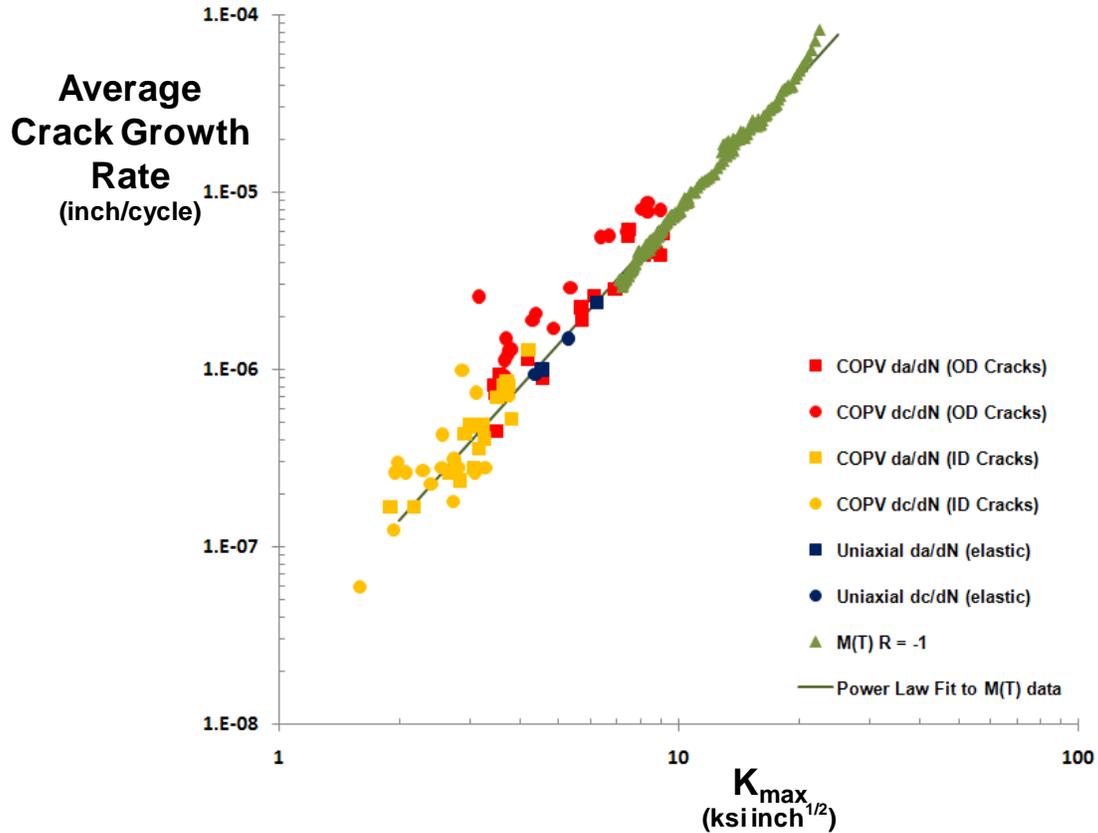
Figure 6.7-2. Average FCG rate as a function of the maximum K for all COPV tests

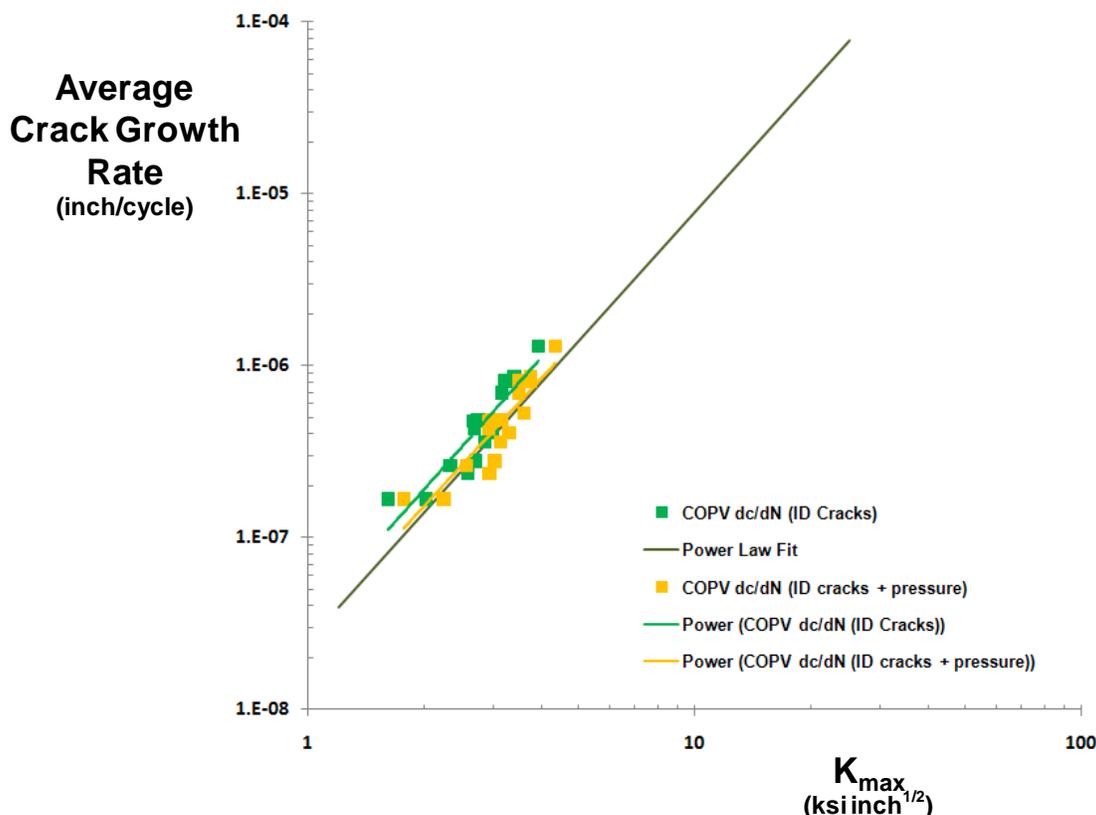
Figure 6.7-3. Average FCG rate for the COPV ID cracks in the depth direction with and without the approximation for the influence of the crack face pressure.

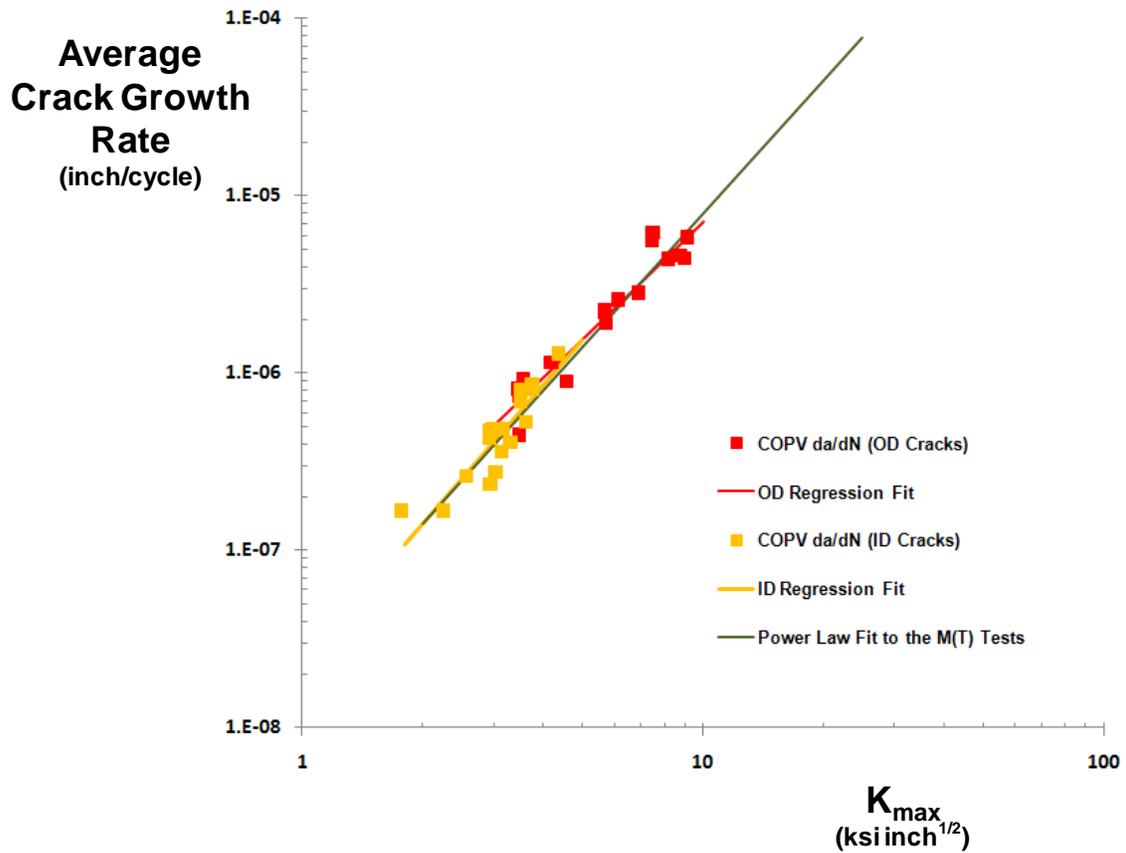
Figure 6.7-4. Regression power law fits to the FCG rate measurements in the depth direction for the OD and ID cracks in the COPV tests

Figure 6.7-4 contains the regression fits for the average FCG rates in the depth (da/dN) direction for the OD and ID cracks in the pressurized COPV tests. The regression fit for the average FCG rate for the OD cracks (red square symbols) for any given K_{max} within the range of the test data, resulted in a FCG rate within -30 to +10 percent of the rate determined from the fit to the power law region of the M(T) data. The regression fit for the average FCG rate for the ID cracks (yellow symbols), for any given K_{max} within the range of the test data, resulted in a FCG rate that was about +10 to -1 percent faster than that determined from the fit to the power law region of the M(T) data. The small differences between the regression fits and the power law relationship indicate that the small surface crack FCG rate in the depth direction correlates with the long crack through-the-thickness M(T) tests. In addition, the surface crack FCG data does not exhibit threshold behavior for K as low as $K_{max} = 1.7 \text{ ksi inch}^{1/2}$.

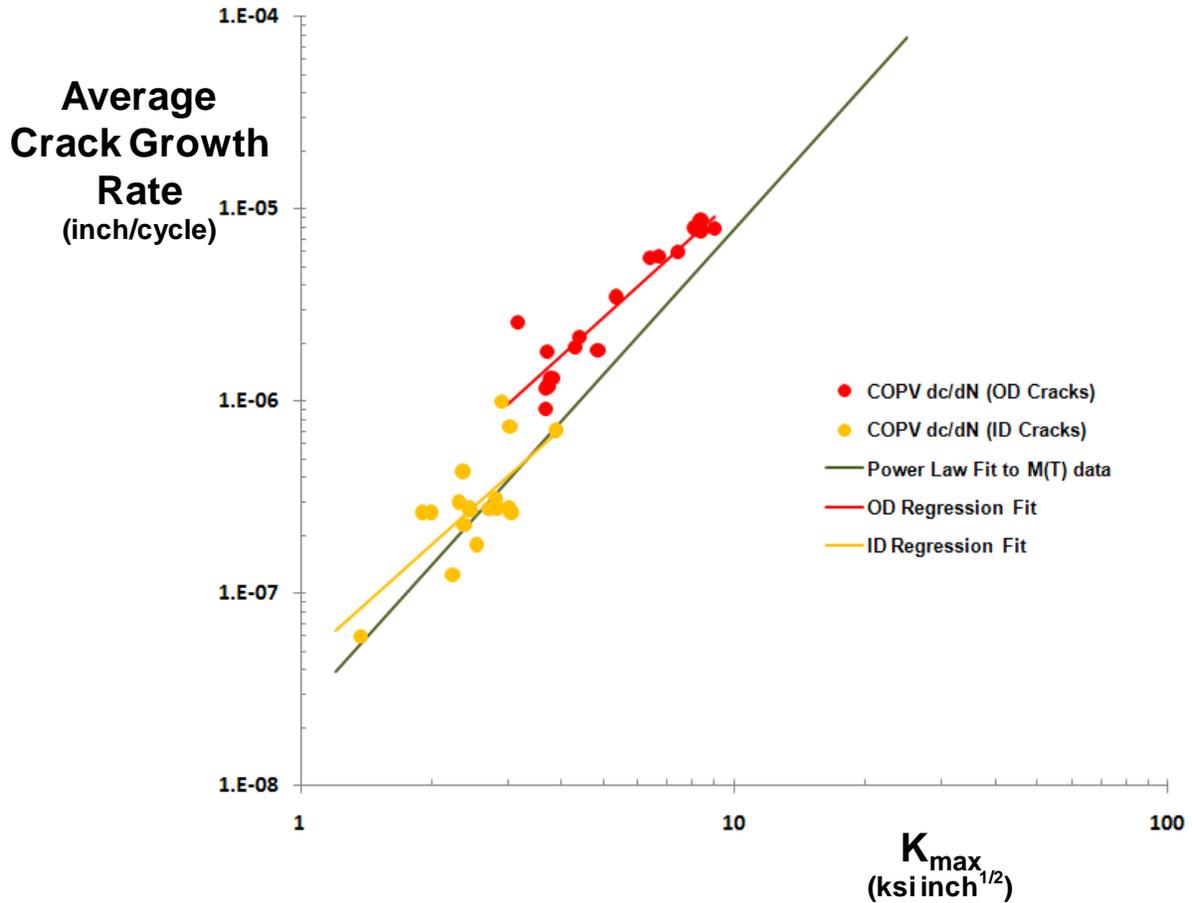
Figure 6.7-5. Regression power law fits to the FCG rate measurements in the surface direction for the OD and ID cracks in the COPV tests

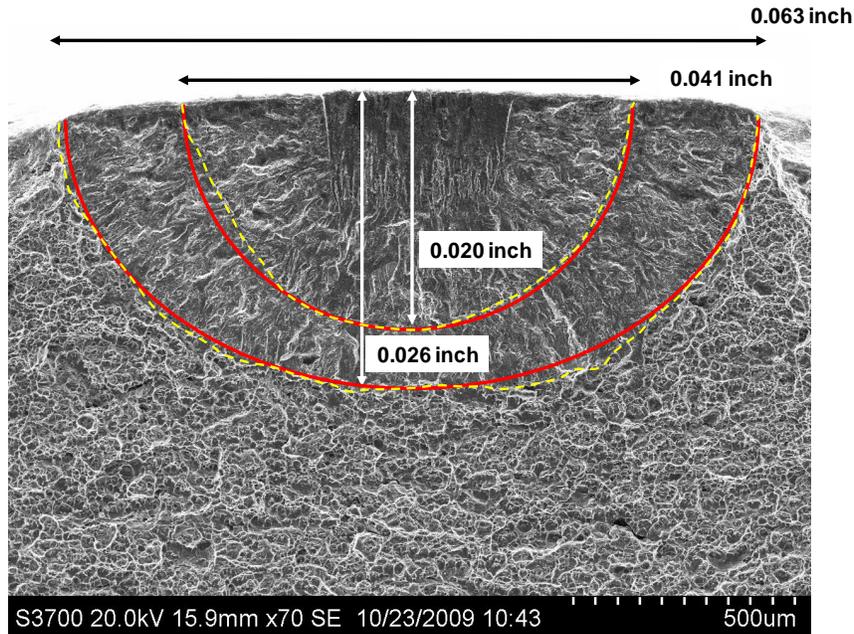
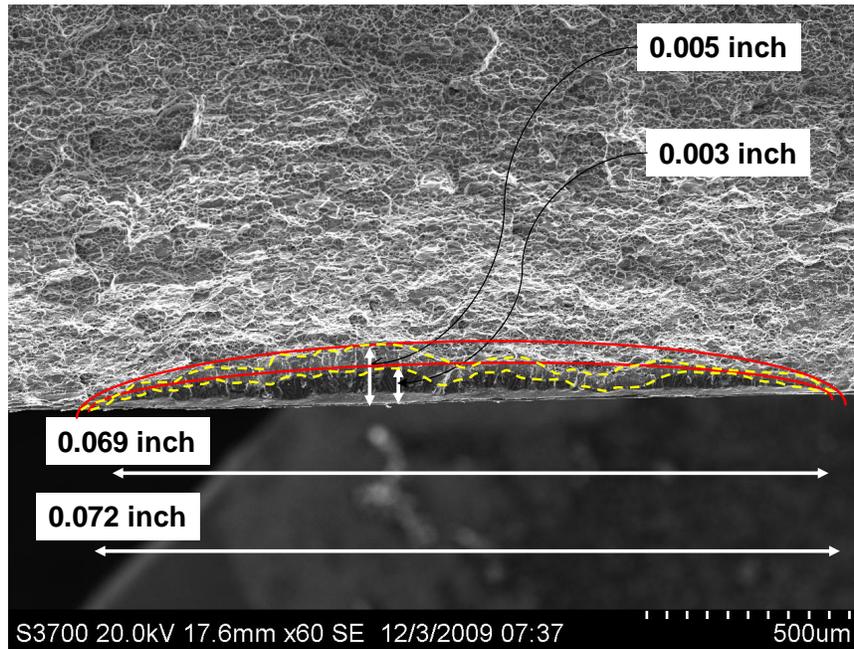
a. COPV 18103 crack OD02

b. COPV 18119 crack ID08

Figure 6.7-6. Semi-elliptical crack front assumptions for two fatigue cracks in COPVs

Figure 6.7-7. FCG rate data collected for the COPV and uniaxial tests with the results from the cracks fronts shown in Figure 6.7-6 identified

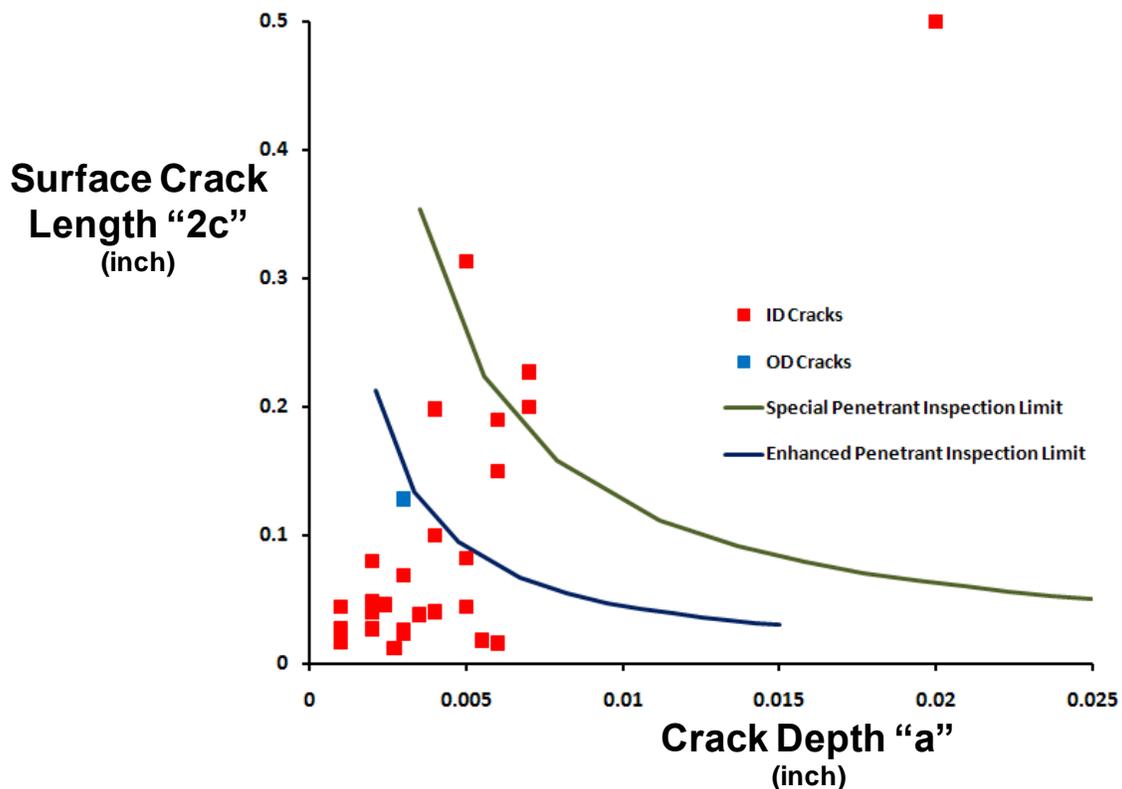
Figure 6.7-8. Crack lengths and depths of the ID and OD cracks that nucleated from manufacturing defects and inspection limits

of the total) exceeded the SPI limit and three others (~23 percent of total) also exceeded the EPI limit, as shown in Figure 6.7-8.

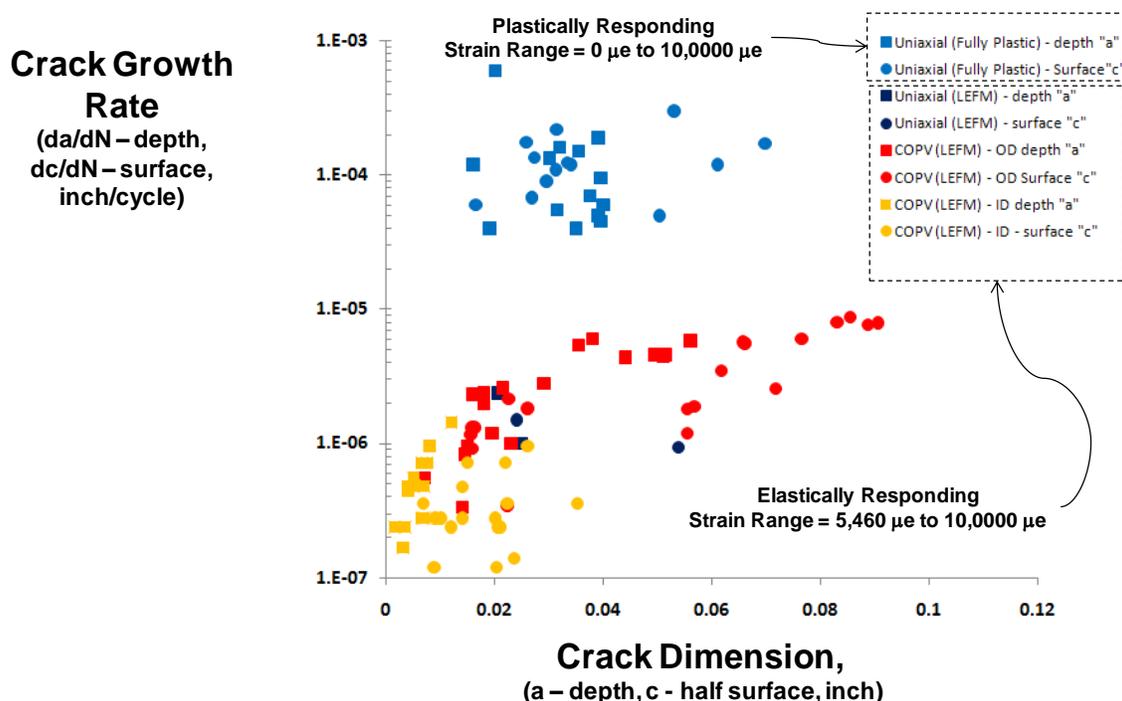
Figure 6.7-9. Comparison of the FCG rates from the fully reversed, fully plastic uniaxial tests and the results from the COPV tests. Plotted are da/dN and dc/dN for crack depth and half surface dimensions, respectively.

The uniaxial tests that were conducted under fully reversed ($R = -1$), fully plastic (both tensile and compressive cyclic yielding) conditions violate LEFM assumptions, thus K_{max} was not used to represent the crack tip driving force. A comparison of the measured FCG rates from the elastically responding COPV tests and from the fully reversed, fully plastic uniaxial tests was made on the basis of the crack dimension, as shown in Figure 6.7-9. The crack depth dimension (a) was used for the depth FCG rates (da/dN) and the surface half-crack dimension (c) was used for the surface FCG rates (dc/dN). The uniaxial tests were conducted with a single crack with aspect ratios that were approximately $a/c = 1$ and 0.2 and the thicknesses of 0.032 inch, 0.05 inch, 0.09 inch, and 0.125 inch were included in Figure 6.7-9. The data from the elastically responding COPVs included both the cracks that nucleated from laser notches and from manufacturing defects. The measured crack growth rates from the uniaxial tests, shown as blue

symbols, were more than an order of magnitude higher than those measured in the COPV tests. Note that the stress in the fully reversed, fully plastic uniaxial tests was about 50 percent greater than the hoop stress the elastically responding COPVs. Given this change in applied stress, LEFM assumptions using the long crack power law would only predict an increase in the FCG rate by about a factor of 3.

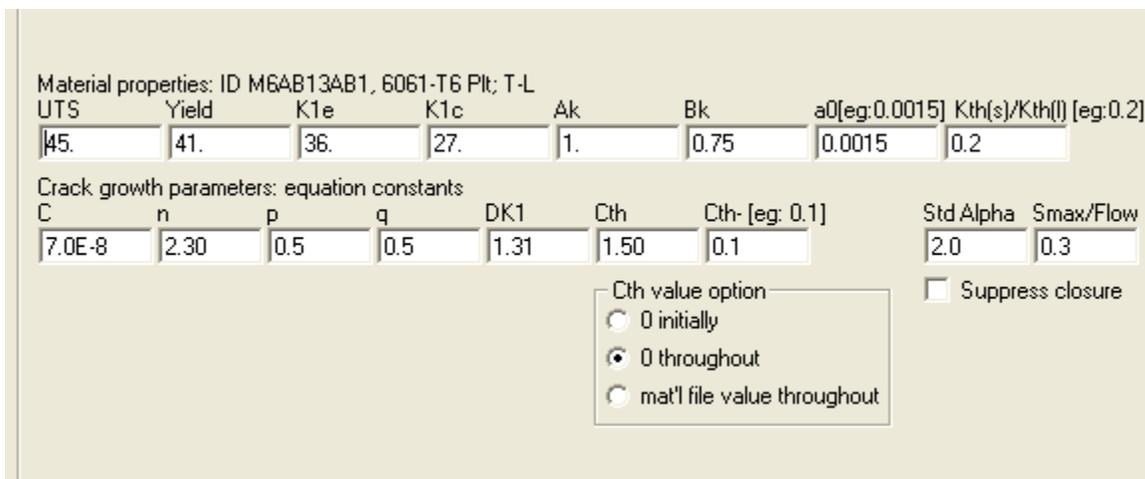
Figure 6.8-1. NASGRO® material model 13AB1 input parameters

factor range and is a function of R and the NASGRO® input parameters ΔK_1^* , C_{th} , and C_{th-} . The parameter K_c is a function of the NASGRO® input parameters K_{1e} , K_{1c} , A_k , and yield stress.

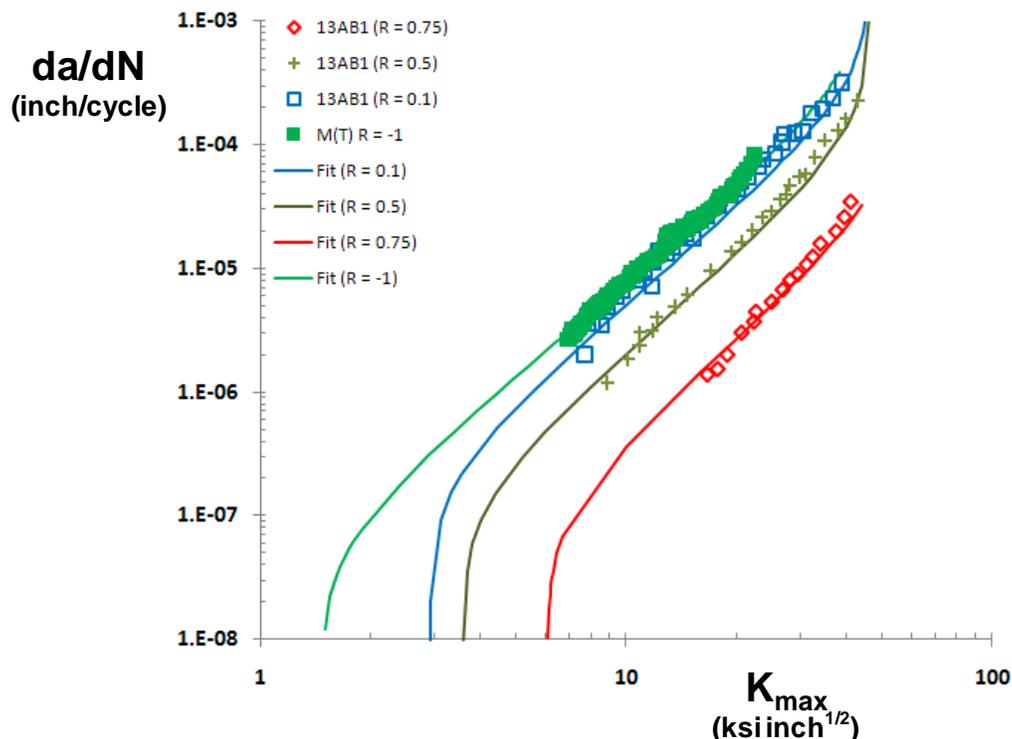
Figure 6.8-2. NASGRO® material model 13AB1 for 6061-T62 aluminum fit to data for four stress ratios

The results from the M6AB13AB1 material model are shown in Figure 6.8-2 for the data sets provided by the NASGRO® database ($R = 0.75, 0.5,$ and 0.1) along with the $R = -1$ data obtained from the M(T) tests shown in Figure 6.3-2. Note that the NASGRO® model exhibits a threshold where the FCG rate drops off sharply for the lower K values. However, the data used to generate the model parameters were all above the threshold region.

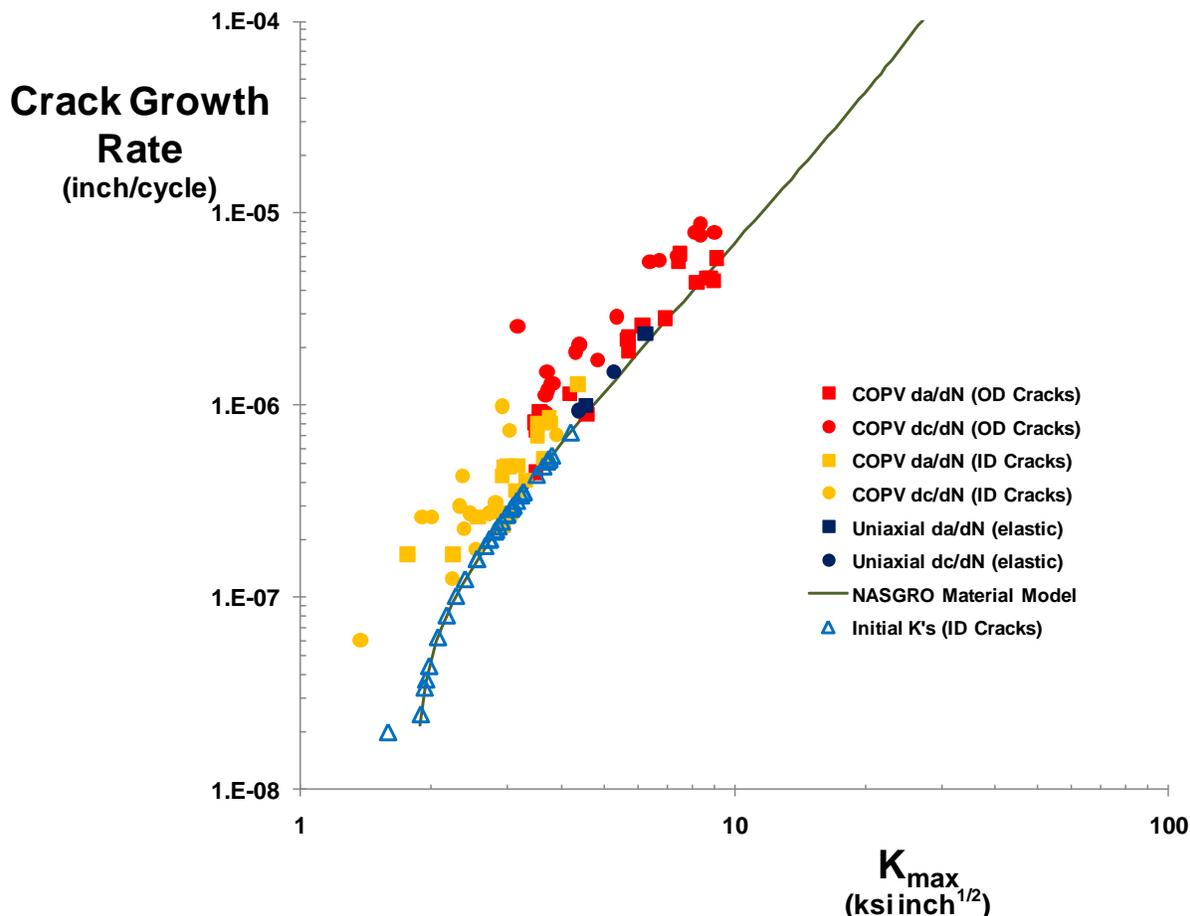
Figure 6.8-3. NASGRO® material model M6AB13AB1 for 6061-T62 aluminum for $R = -0.7$ and the measurements from the COPV tests

The average FCG rate measured for the individual cracks in the COPV tests and the NASGRO® material model for $R = -0.7$ are shown in Figure 6.8-3 as a function of K_{\max} . The majority of the FCG rates for the cracks in the COPVs were above the NASGRO® curve, indicating that the resulting NASGRO® predictions would predict less FCG than observed in the tests. The K for the starting length and shape of the COPV cracks and the associated FCG rates, as calculated by the NASGRO® material model, are shown as open symbols in Figure 6.8.3. The smaller initial crack lengths have K values that are in the threshold influenced region (shaded region) of the NASGRO® M6AB13AB1 material model and one crack is below ΔK_{th} . The average FCG rate measurements from the small ID cracks in the COPV tests do not exhibit a threshold behavior for $K_{\max} > 1.8$ ksi inch^{1/2}, $R = -0.7$. This indicates that the threshold extrapolation in the NASGRO® material model M6AB13AB1 may limit the crack growth rate at too high of a K or that the physically small cracks present in the COPV liners do not exhibit a ΔK_{th} behavior.

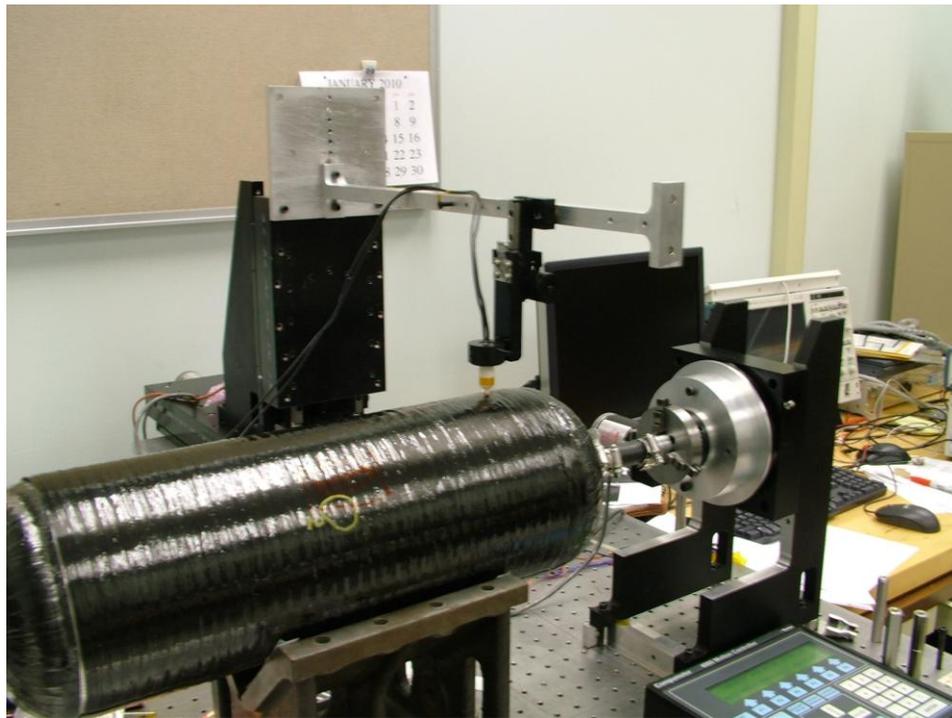
Figure 6.9-1. Photograph of the eddy current inspection system

The eddy current system consisted of an eddy current probe that scanned longitudinally along the COPVs and liners and a motor that automatically rotated the COPVs and liners, and is shown in Figure 6.9-1. The following types of inspections were performed:

1. Low frequency eddy current (~5 kHz) inspections were performed to locate ID cracks in bare liners.
2. High frequency eddy current (~100 kHz) inspections were performed to detect OD cracks in wrapped COPVs.
3. Low frequency eddy current (~5 kHz) inspections were performed to detect ID cracks in wrapped COPVs.
4. High frequency eddy current (~1 MHz) inspections were performed to detect ID cracks in COPVs that were sectioned to allow direct access to the ID surface.

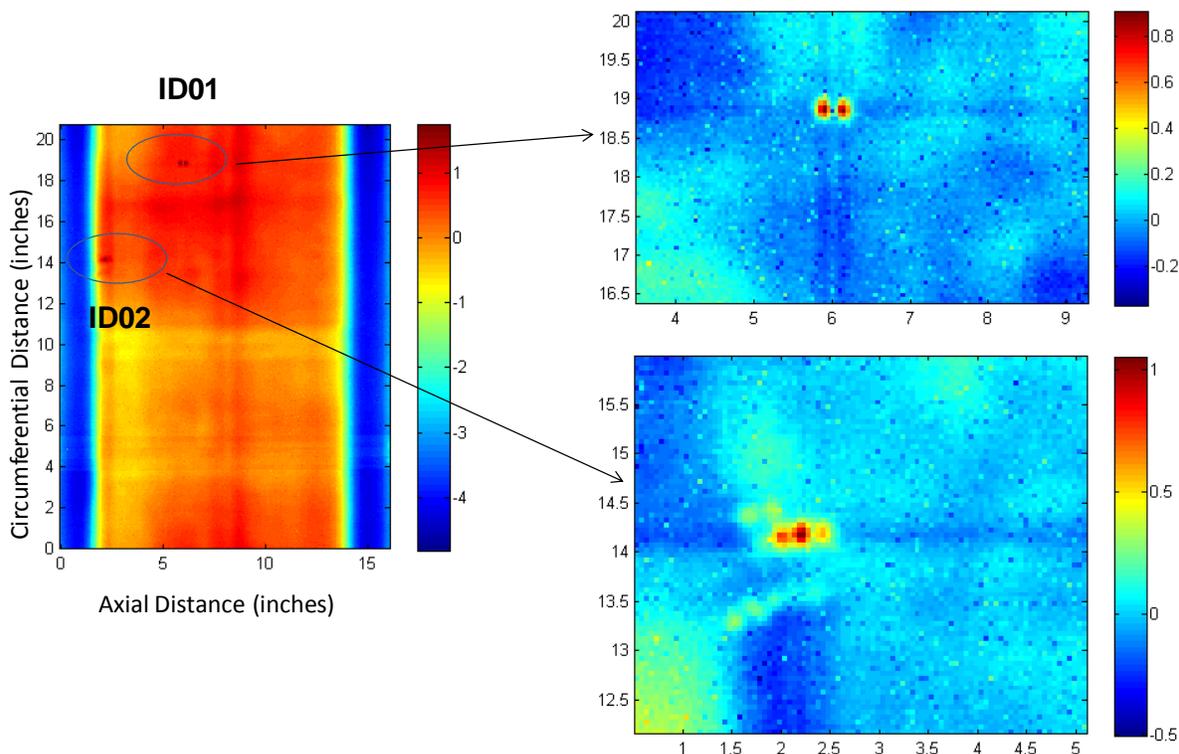
Figure 6.9-2. Eddy current scan of bare liner COPV 18115 after 10,000 precrack cycles

The eddy current results during the precracking of bare liner 18115 revealed two independent ID cracks located about 5 inches apart in the circumferential direction, as shown in Figure 6.9-2. The first crack, ID01, and second, ID02, cracks were located about 5 inches and 2 inches from the end of the cylindrical portion of the ported end of the liner, respectively. Crack ID01 was 0.125 inches long and 0.039 inches deep after precracking, as shown in Figure 6.9-3. Crack ID02 consisted of four co-linear cracks with a total length of 0.818 inches and a maximum depth of 0.036 inches, as shown in Figure 6.9-4. Liner 18115 was wrapped and the four co-linear cracks of ID02 rapidly coalesced and leaked after a few fatigue cycles.

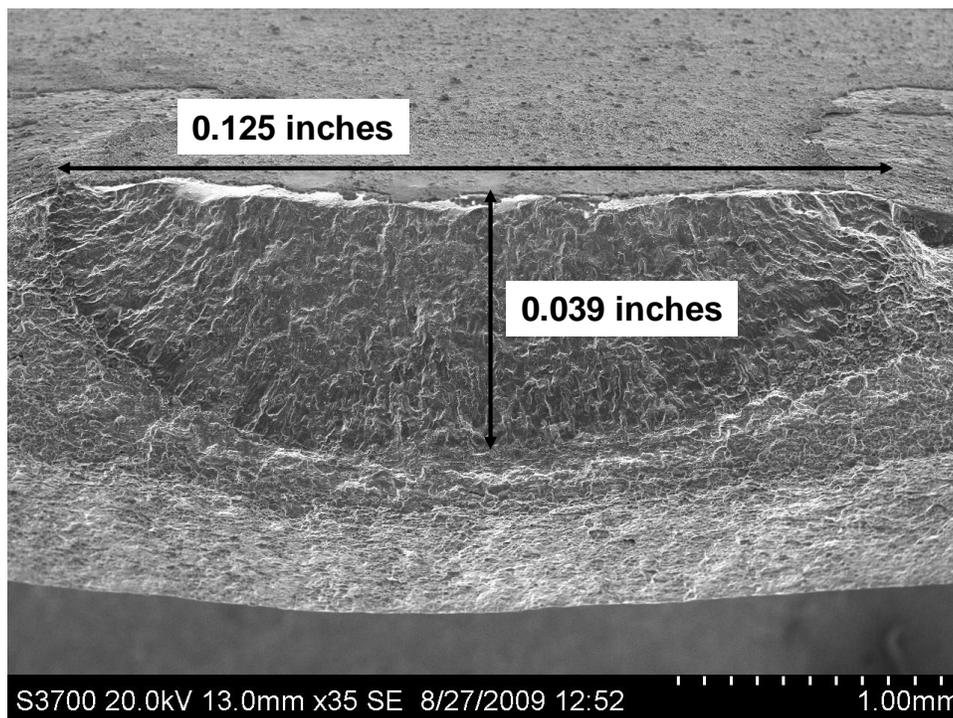
Figure 6.9-3. Crack ID01 of COPV 18115

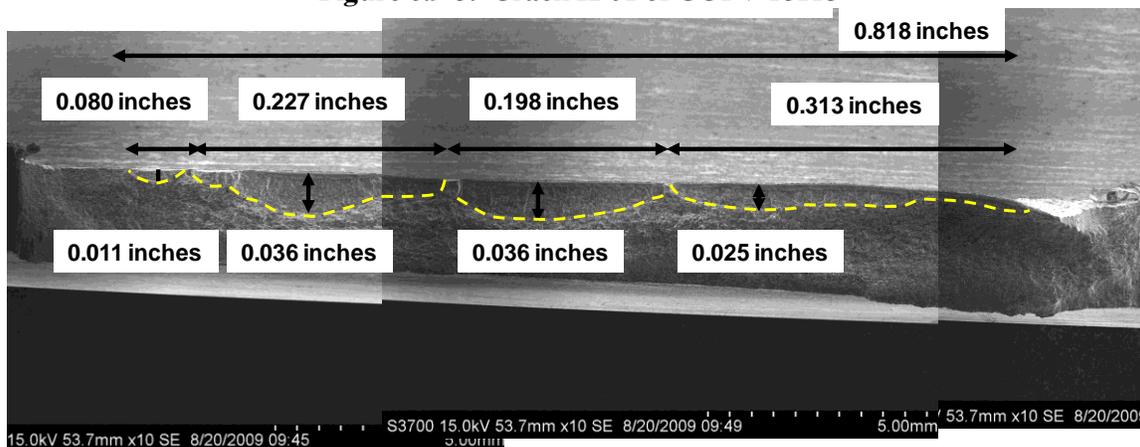
Figure 6.9-4. The four co-linear cracks that coalesced into crack ID02 of COPV 18115

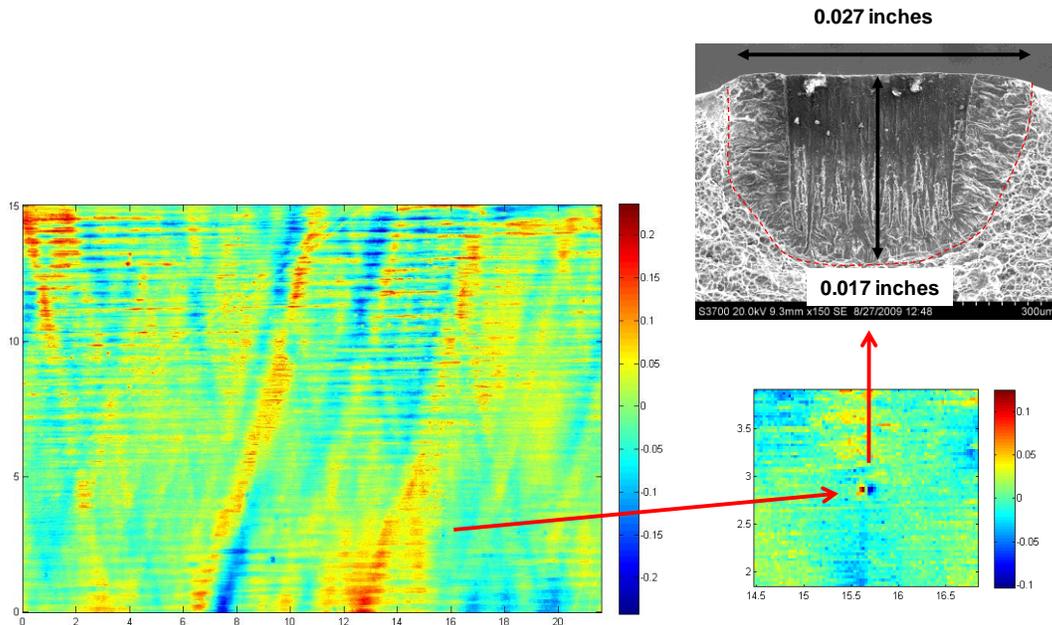
Figure 6.9-5. High frequency eddy current scan of wrapped COPV 18115

fatigue crack. Only one of the three small, semi-circular OD fatigue cracks of wrapped COPV 18115 was detected through the composite wrap, as shown in Figure 6.9-5. The detected crack (OD03) was located in the cylindrical section, near the un-ported end of the COPV. The detected crack was 0.027 inches long and 0.017 inches deep and not significantly different in size from the two cracks that were not detected. All three of the long, shallow OD cracks from COPV 18118 were detected through the composite overwrap, as shown in Figure 6.9-6. The cracks at the end of the precracking of 18118 were about 0.12 inches long by 0.035 inches deep, exceeding both the target length and depth of 0.1 inches and 0.01 inches, respectively.

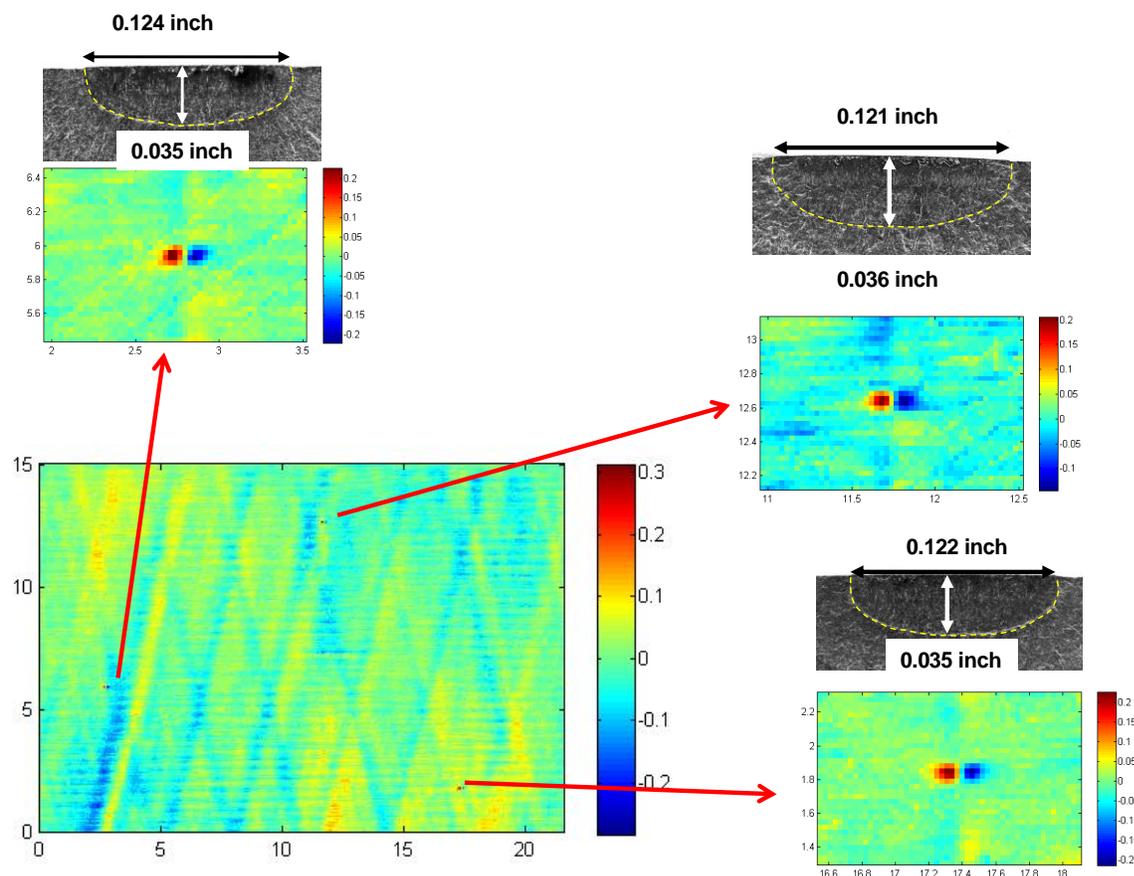
Figure 6.9-6. High frequency eddy current scan of wrapped COPV 18118 prior to fatigue testing

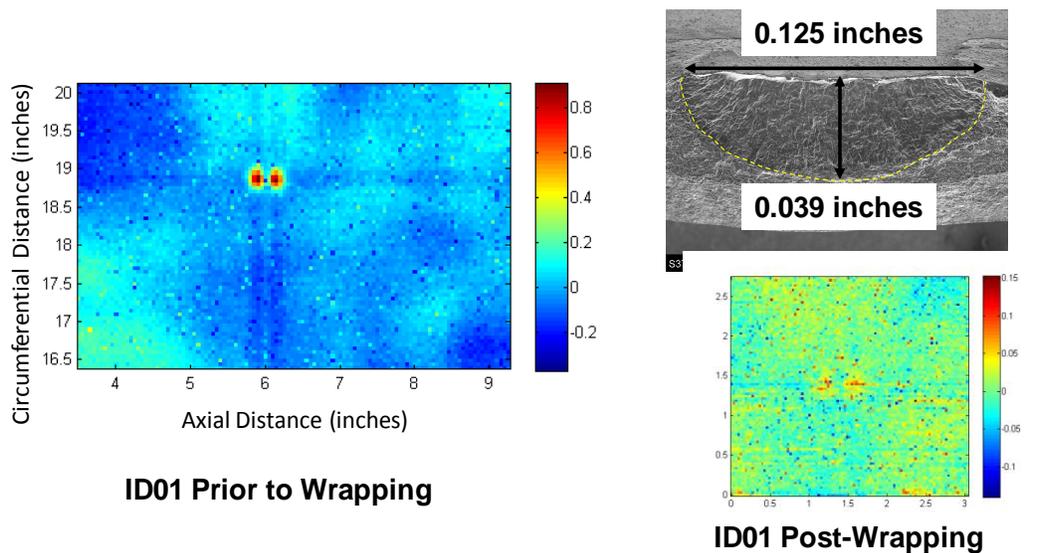
Figure 6.9-7. Low frequency eddy current scan of crack ID01 in the wrapped and un-wrapped COPV 18115 prior to fatigue testing

Low frequency (2 to 5 kHz) eddy current was used to inspect wrapped COPVs for ID cracks. The ID cracks were generated by precracking from manufacturing defects. COPV 18115 had two ID cracks that were detected in the bare liners and were rescanned after applying the composite overwrap. The crack ID01 was 0.125 inches long and 0.039 inches deep and was easily detected in the bare liner, but only marginally detectable in the post-wrap scan, as shown in Figure 6.9-7. The crack ID02 consisted of four co-linear cracks that may have been linked prior to the post-wrap fatigue cycling. The total crack length was 0.818 inches and the maximum crack depth was 0.036 inches. The post-wrapping inspection of ID02 was more detectable than that of ID01, as shown in Figure 6.9-8.

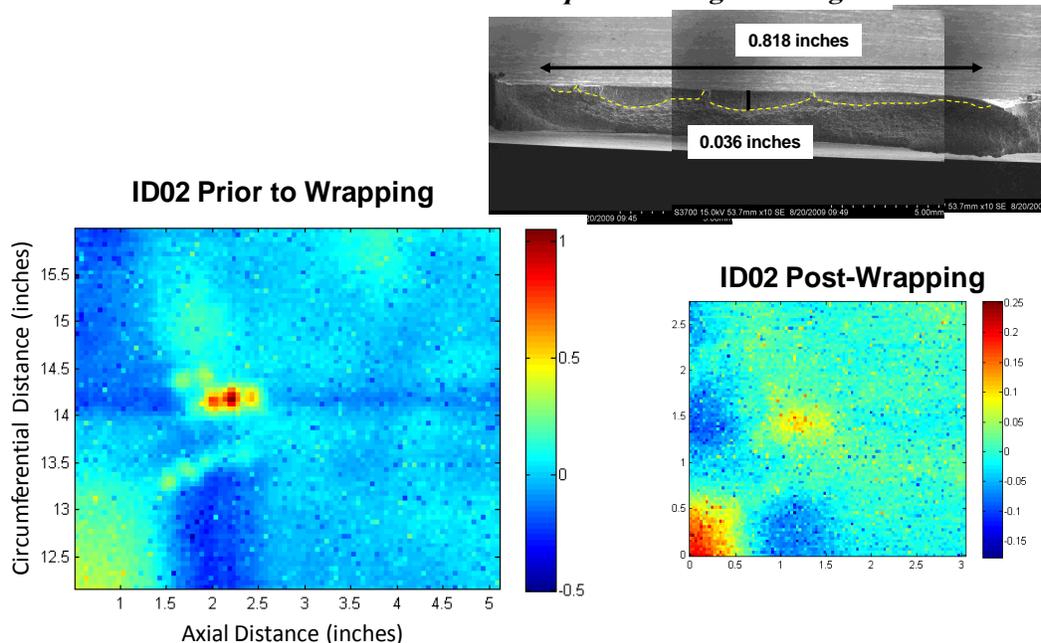
Figure 6.9-8. Low frequency eddy current scan of crack ID02 in the wrapped and un-wrapped COPV 18115 prior to fatigue testing

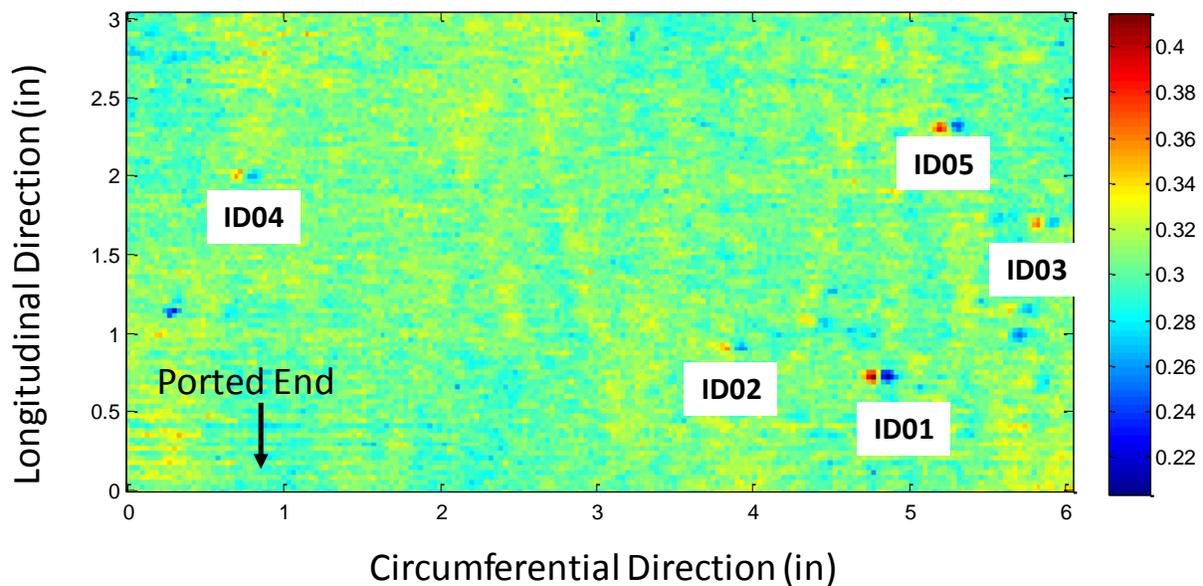
Figure 6.9-9. Five crack locations on the ID surface of COPV 18118 determined by post-test eddy current inspection of the ID surface

High frequency (1 MHz) eddy current was used to inspect the ID surface of tested COPVs for ID cracks that had previously not been detected either in the bare liner or wrapped liner from the OD surface. The tested COPVs were cut lengthwise in half and the known cracks were removed and examined. The exposed ID surface was directly inspected and five crack indications were detected, as shown in Figures 6.9-9 and 6.9-10. The five locations were destructively examined by cutting out small squares in the vicinity of the crack indications, identifying the cracks optically, making small saw cuts to within 0.05 inches of the crack tips, and fracturing the remaining ligaments. This method successfully located cracks at all locations except for ID03, where it was believed that a crack was present, but the fracture did not go through the crack plane. Cracks with surface lengths less than 0.05 inches and depths less than 0.008 inches were found at the remaining four locations and the fracture surfaces are shown in Figures C.42 – C.48 of Appendix C. Crack location ID01 had two nearly co-linear cracks, identified as ID01a and ID01b, as shown in Figure 6.9-11.

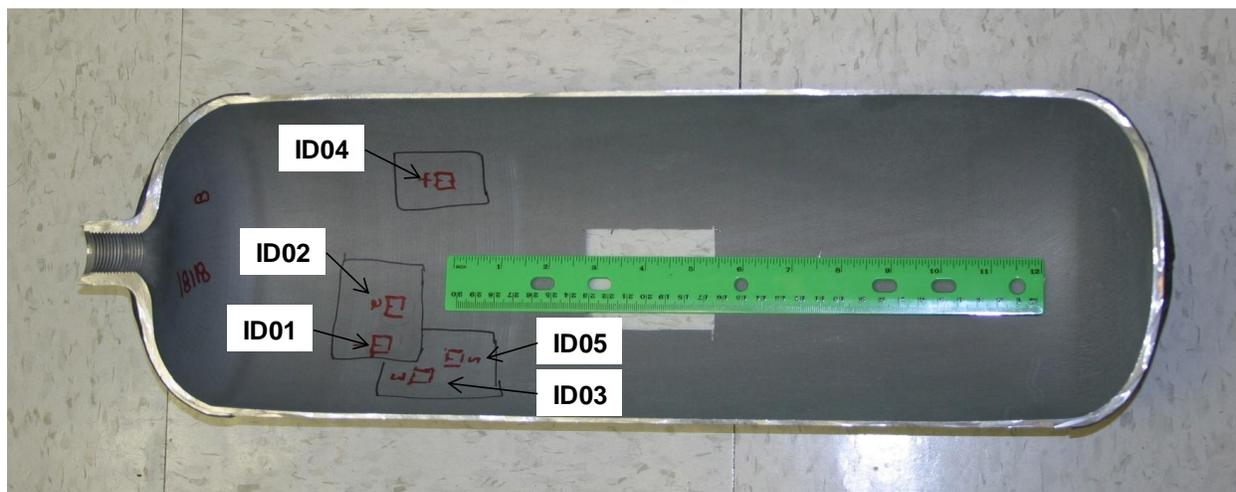
Figure 6.9-10. Location of the five ID cracks in COPV 18118 that were identified in the post-test eddy current inspection of the ID surface
