| | <p align="center">NASA Engineering and Safety Center Technical Assessment Report</p> | <p align="center">Document #: NESC-RP- 06-065</p> | <p align="center">Version: 1.0</p> |

**Fracture Mechanics Based Methods Development for
Composite Overwrapped Pressure Vessels (COPV) with
Metallic Liners**

July 8, 2010

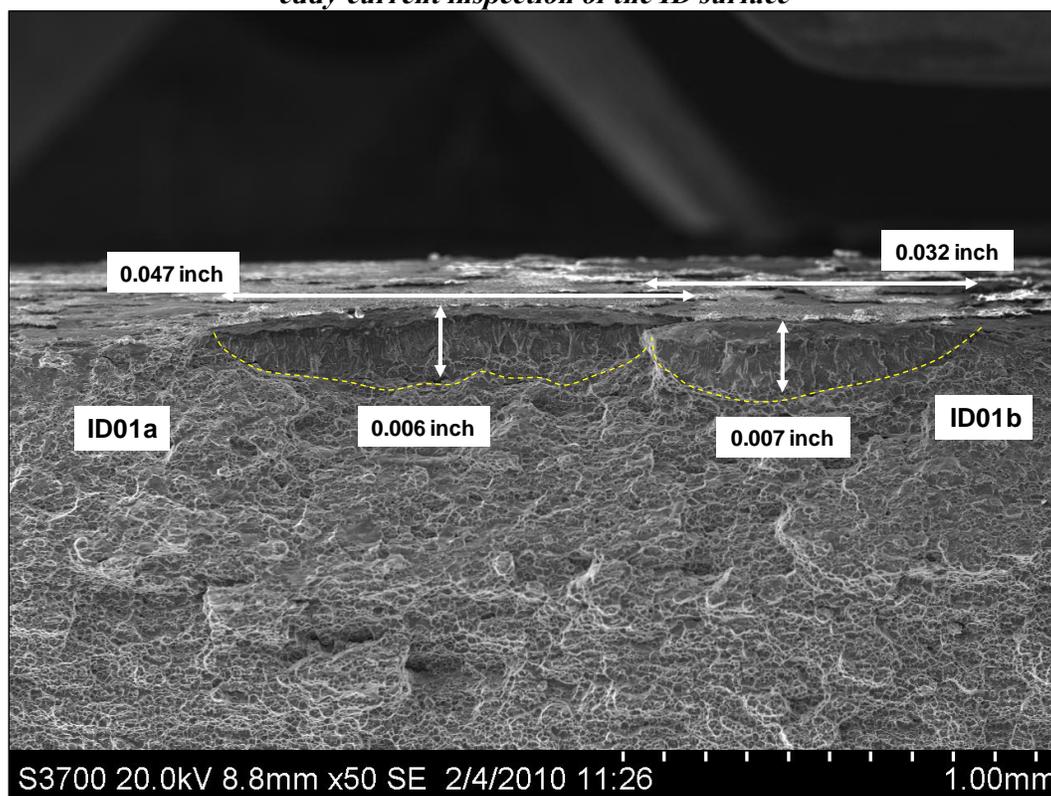
Figure 6.9-11. Photograph (50x) of the fracture surface of cracks ID01a and ID01b of COPV 18118

High frequency (1 MHz) eddy current was used to inspect the ID surface of tested COPVs for ID cracks that had previously not been detected either in the bare liner or wrapped liner from the OD surface. The tested COPVs were cut lengthwise in half and the known cracks were removed and examined. The exposed ID surface was directly inspected and five crack indications were detected, as shown in Figures 6.9-9 and 6.9-10. The five locations were destructively examined by cutting out small squares in the vicinity of the crack indications, identifying the cracks optically, making small saw cuts to within 0.05 inches of the crack tips, and fracturing the remaining ligaments. This method successfully located cracks at all locations except for ID03, where it was believed that a crack was present, but the fracture did not go through the crack plane. Cracks with surface lengths less than 0.05 inches and depths less than 0.008 inches were found at the remaining four locations and the fracture surfaces are shown in Figures C.42 – C.48 of Appendix C. Crack location ID01 had two nearly co-linear cracks, identified as ID01a and ID01b, as shown in Figure 6.9-11.

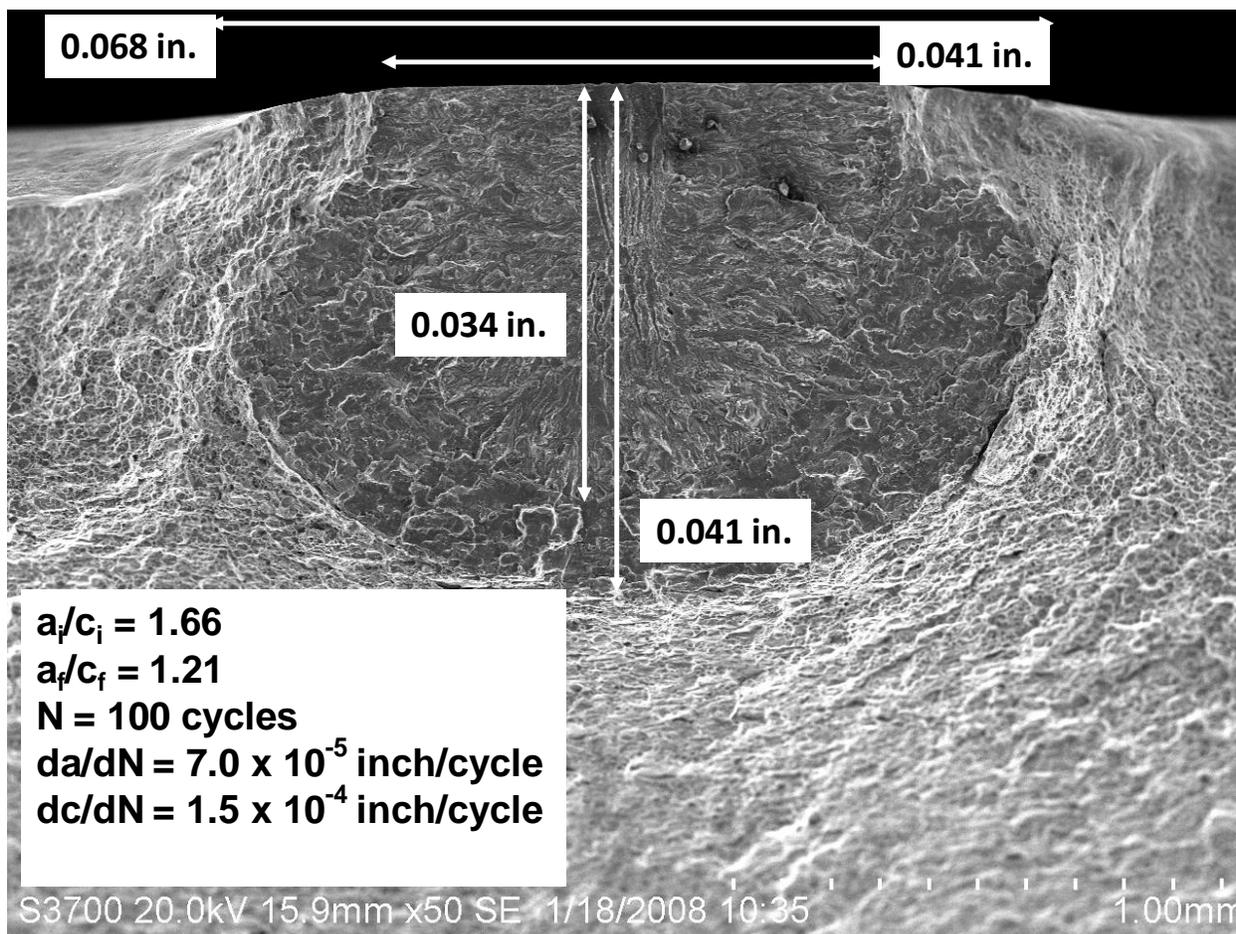
Figure B.1. SEM photograph (50x) of the fracture surface from uniaxial test UNI-125-35-01.

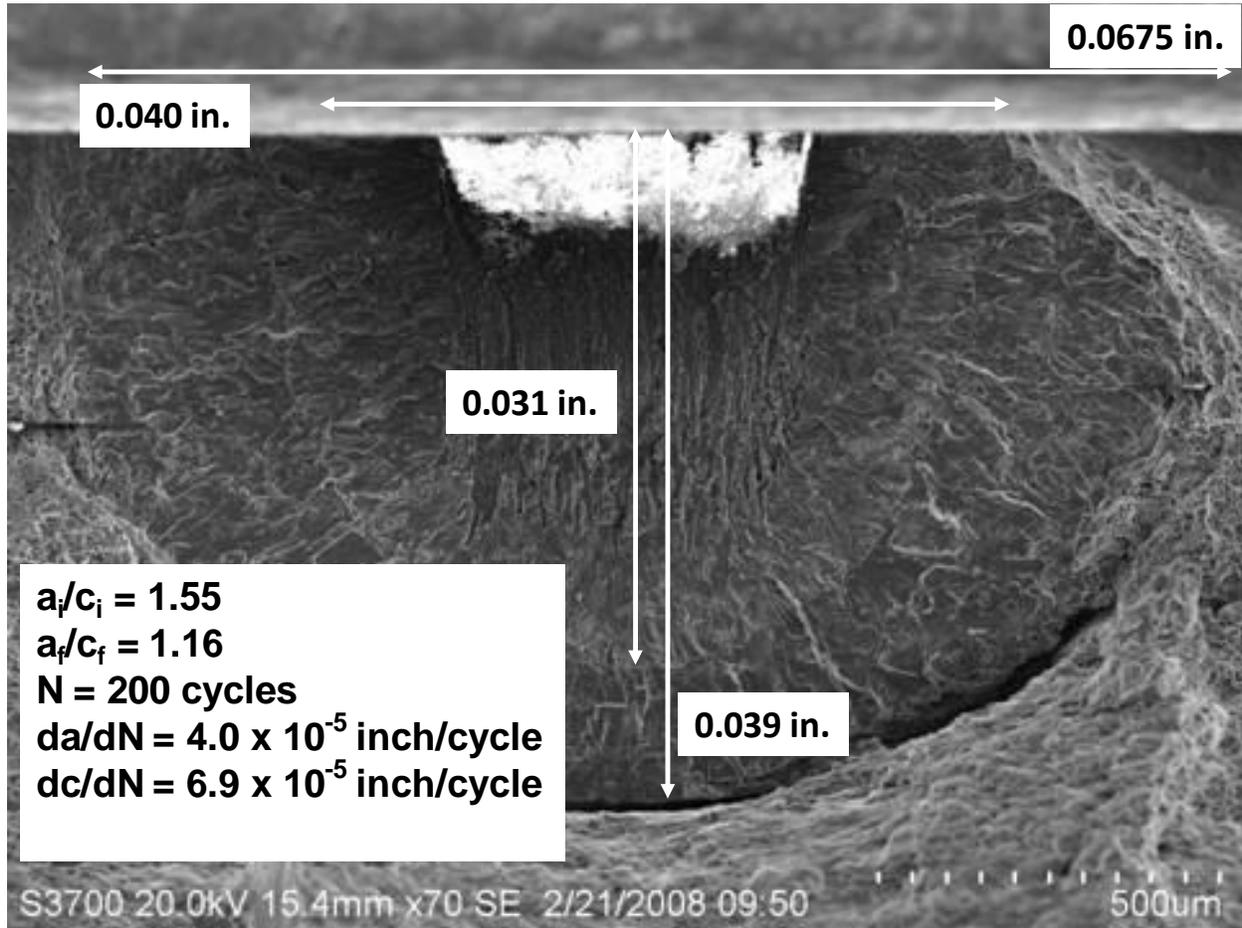
Figure B.2. SEM photograph (70x) of the fracture surface from uniaxial test UNI-125-35-02.

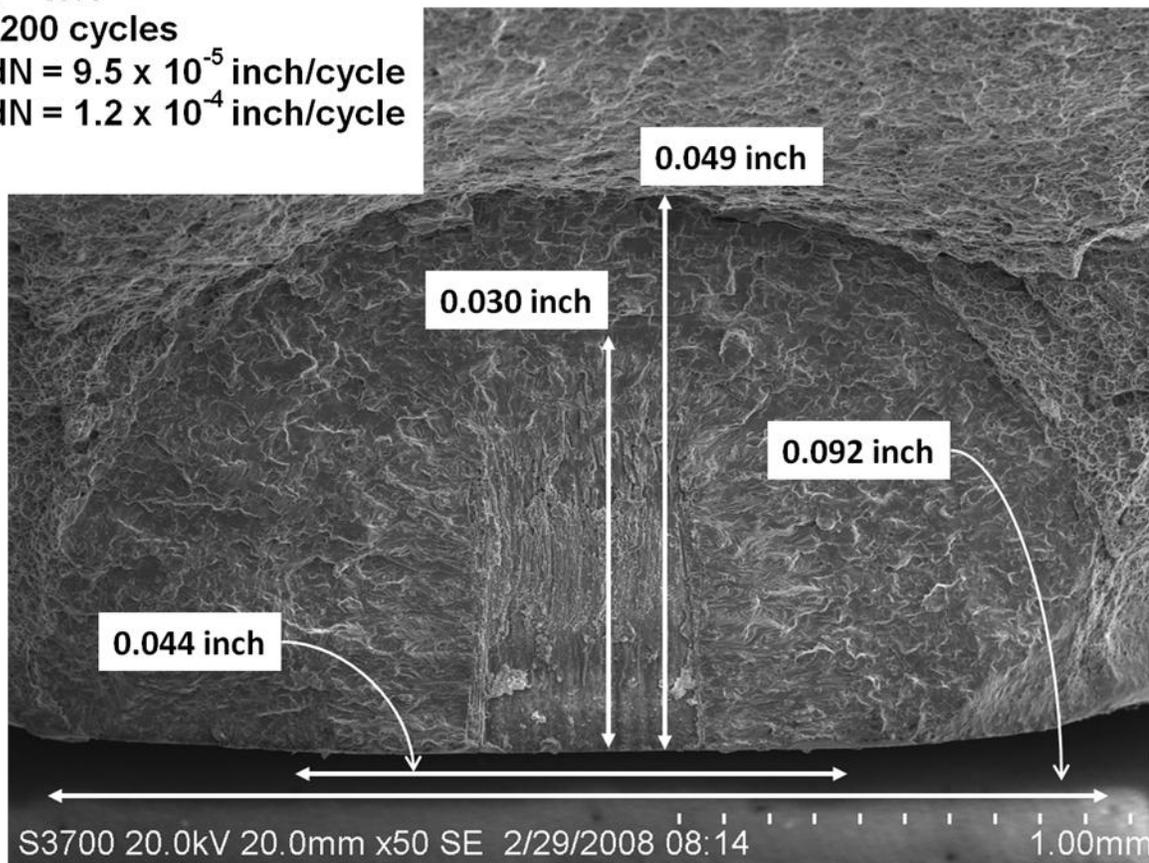
$a_i/c_i = 1.36$
 $a_f/c_f = 1.07$
 $N = 200$ cycles
 $da/dN = 9.5 \times 10^{-5}$ inch/cycle
 $dc/dN = 1.2 \times 10^{-4}$ inch/cycle

Figure B.3. SEM photograph (50x) of the fracture surface from uniaxial test UNI-125-35-03.

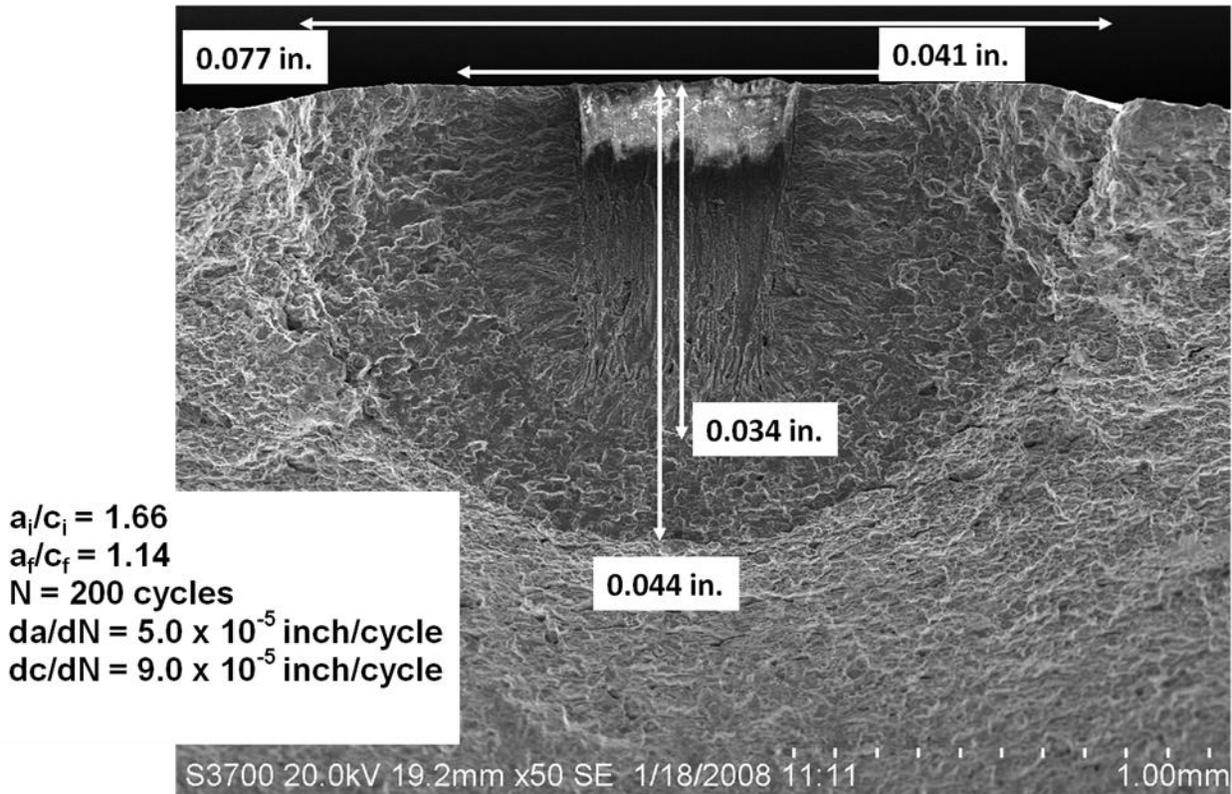
Figure B.4. SEM photograph (50x) of the fracture surface from uniaxial test UNI-090-35-01.

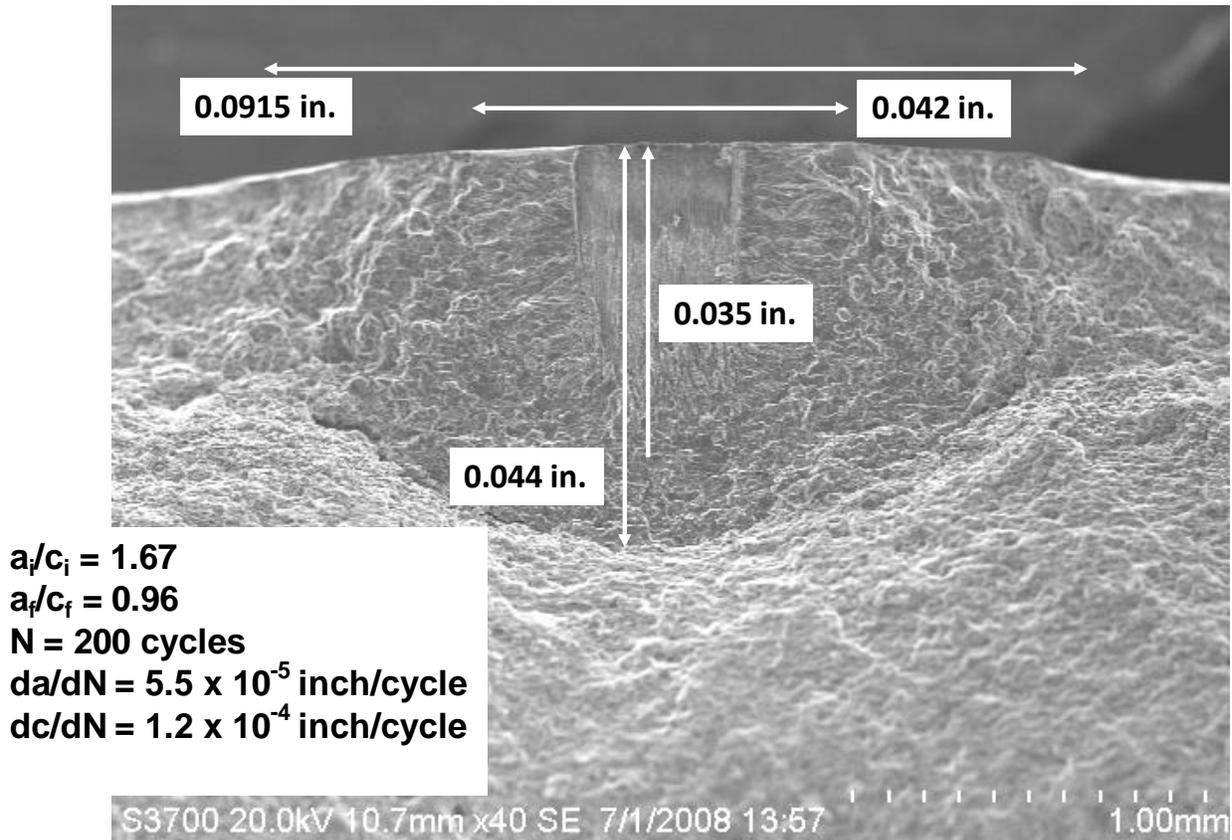
Figure B.5. SEM photograph (40x) of the fracture surface from uniaxial test UNI-090-35-02.

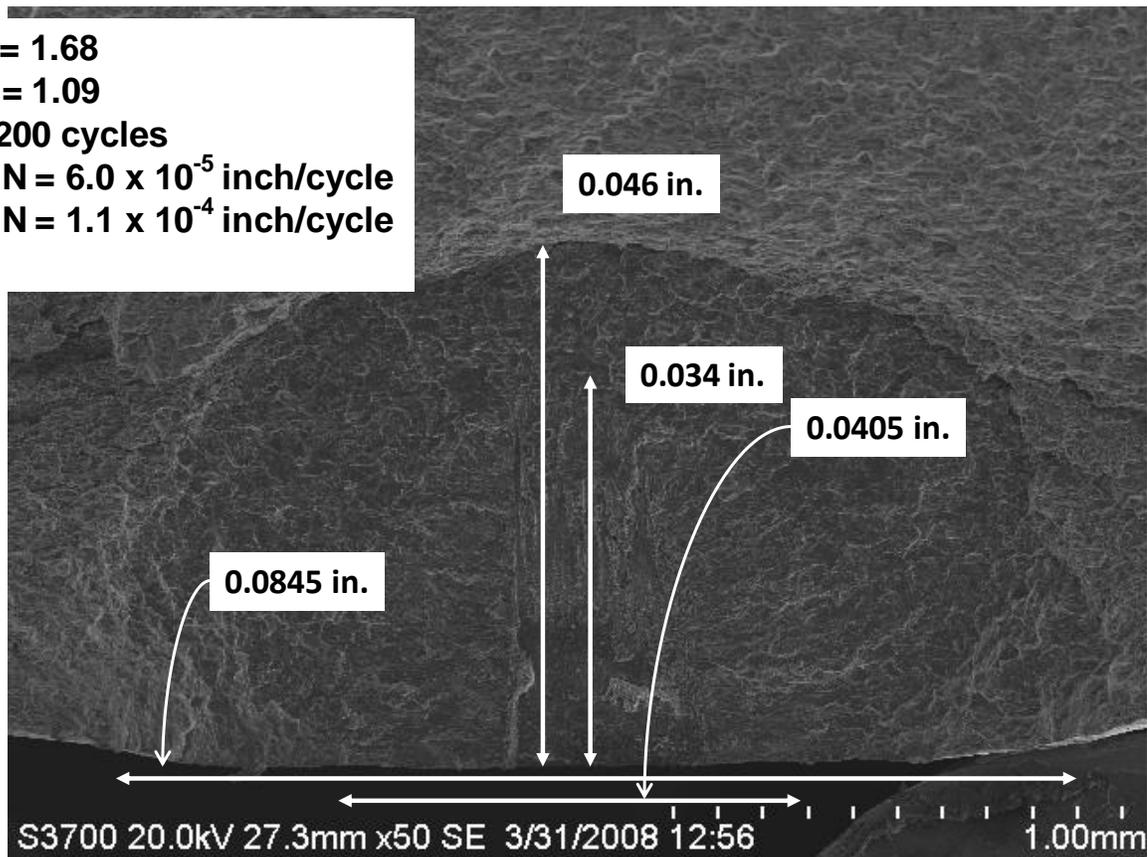
$a_i/c_i = 1.68$
 $a_f/c_f = 1.09$
 $N = 200$ cycles
 $da/dN = 6.0 \times 10^{-5}$ inch/cycle
 $dc/dN = 1.1 \times 10^{-4}$ inch/cycle

Figure B.6. SEM photograph (50x) of the fracture surface from uniaxial test UNI-090-35-03.

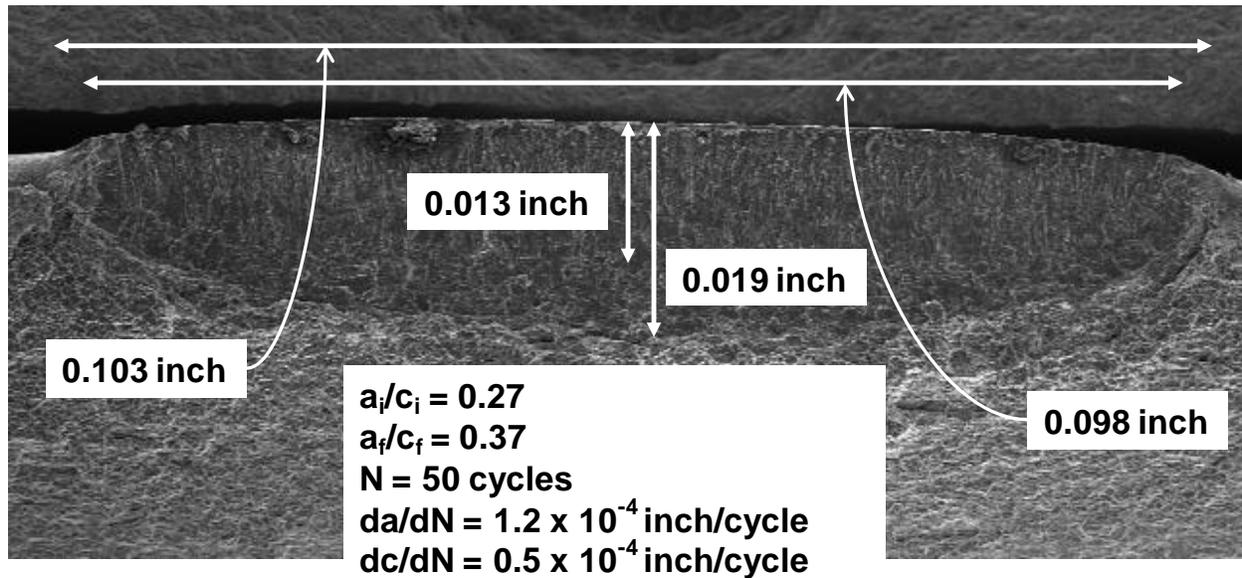
Figure B.7. SEM photograph (45x) of the fracture surface from uniaxial test UNI-090-36-01.

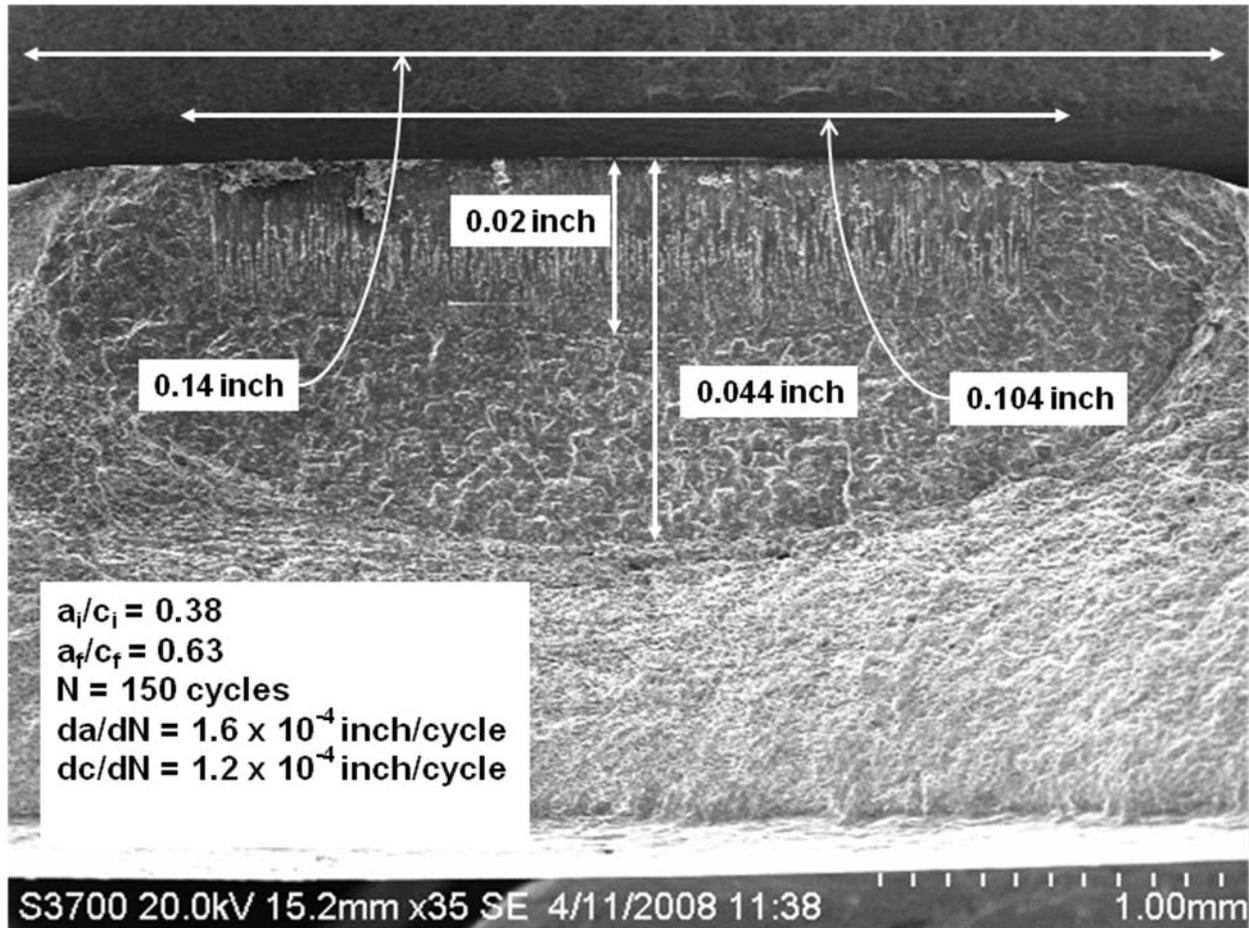
Figure B.8. SEM photograph (35x) of the fracture surface from uniaxial test UNI-090-36-02.

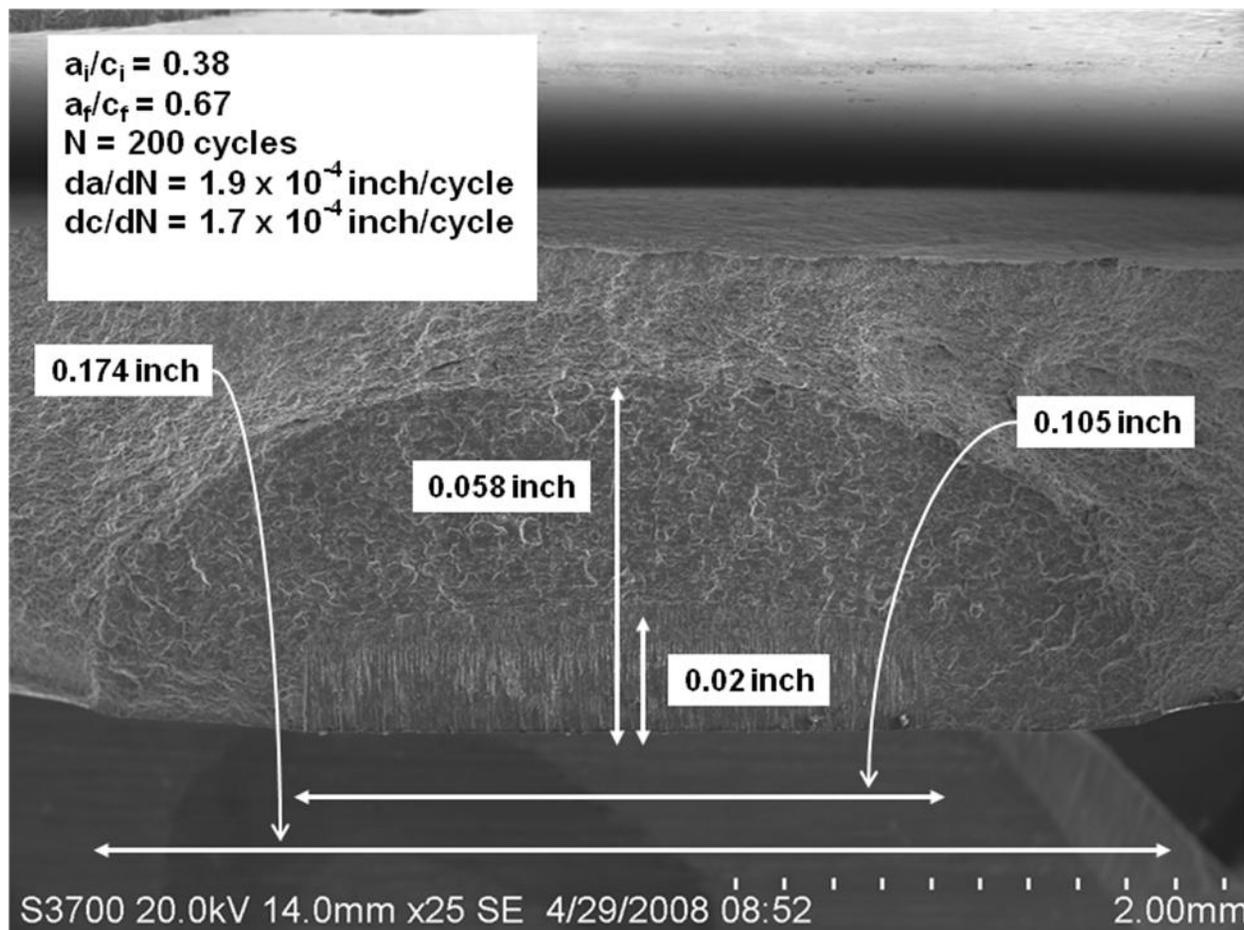
Figure B.9. SEM photograph (25x) of the fracture surface from uniaxial test UNI-090-36-04.

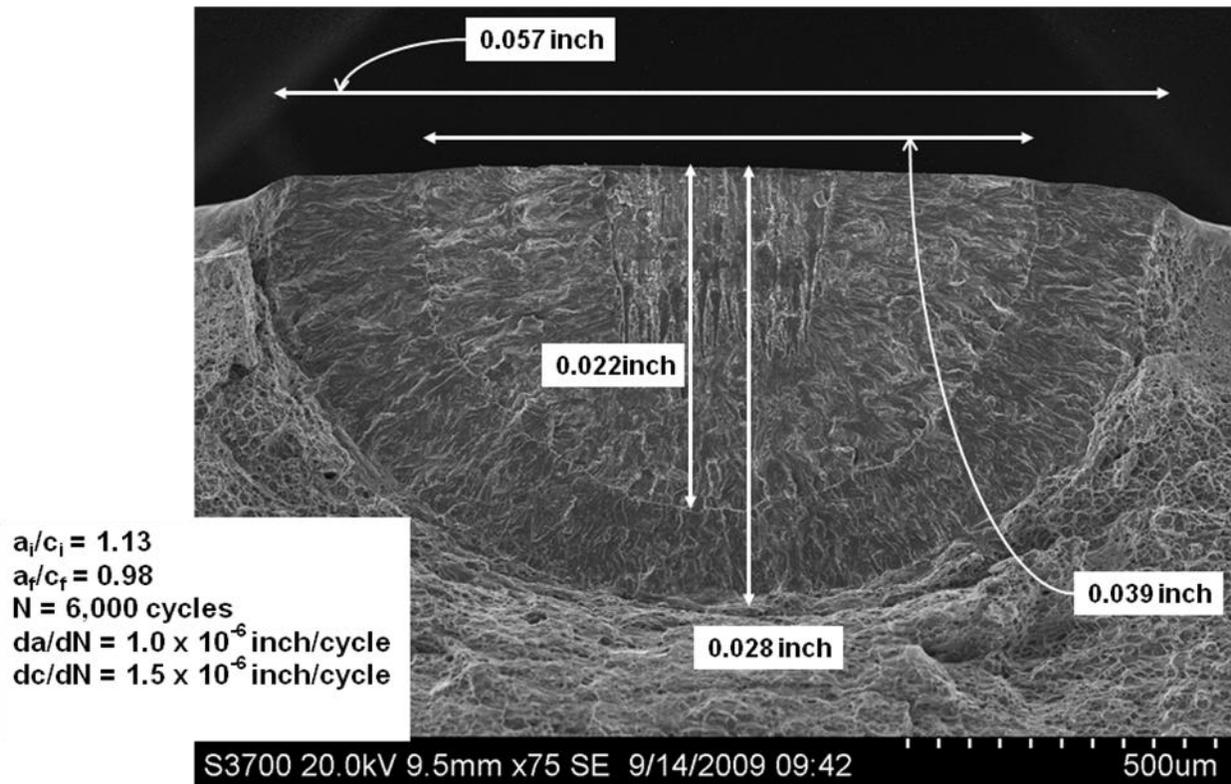
Figure B.10. SEM photograph (75x) of the fracture surface from uniaxial test UNI-090-40-06.

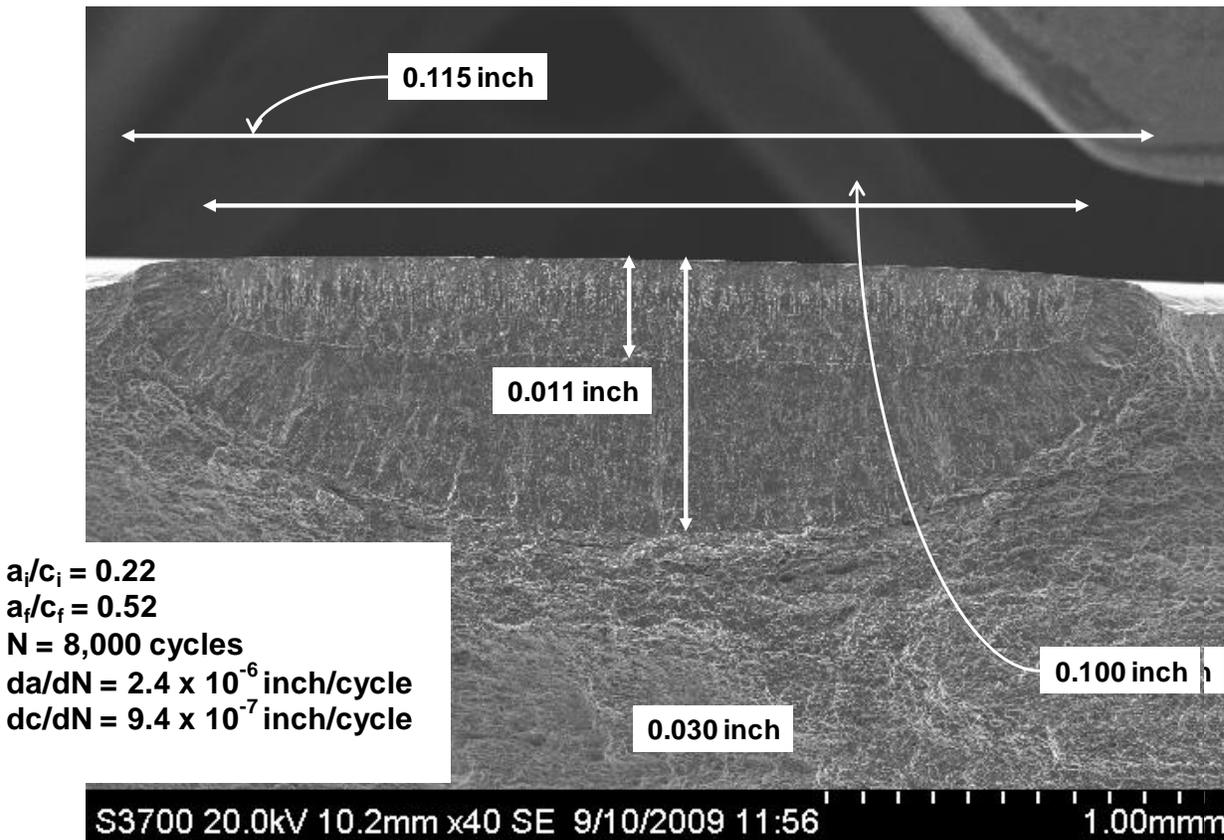
Figure B.11. SEM photograph (40x) of the fracture surface from uniaxial test UNI-090-40-07.

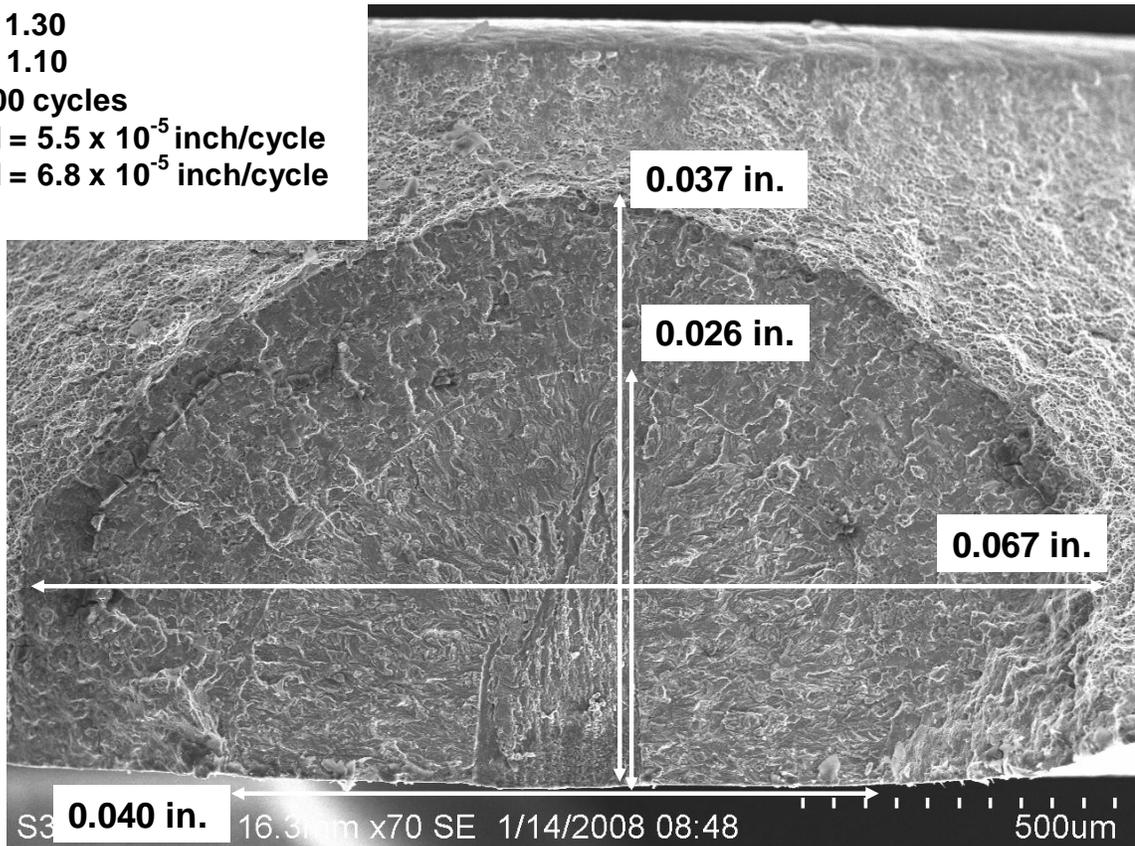
$a_i/c_i = 1.30$
 $a_f/c_f = 1.10$
 $N = 200$ cycles
 $da/dN = 5.5 \times 10^{-5}$ inch/cycle
 $dc/dN = 6.8 \times 10^{-5}$ inch/cycle

Figure B.12. SEM photograph (70x) of the fracture surface from uniaxial test UNI-050-35-01.

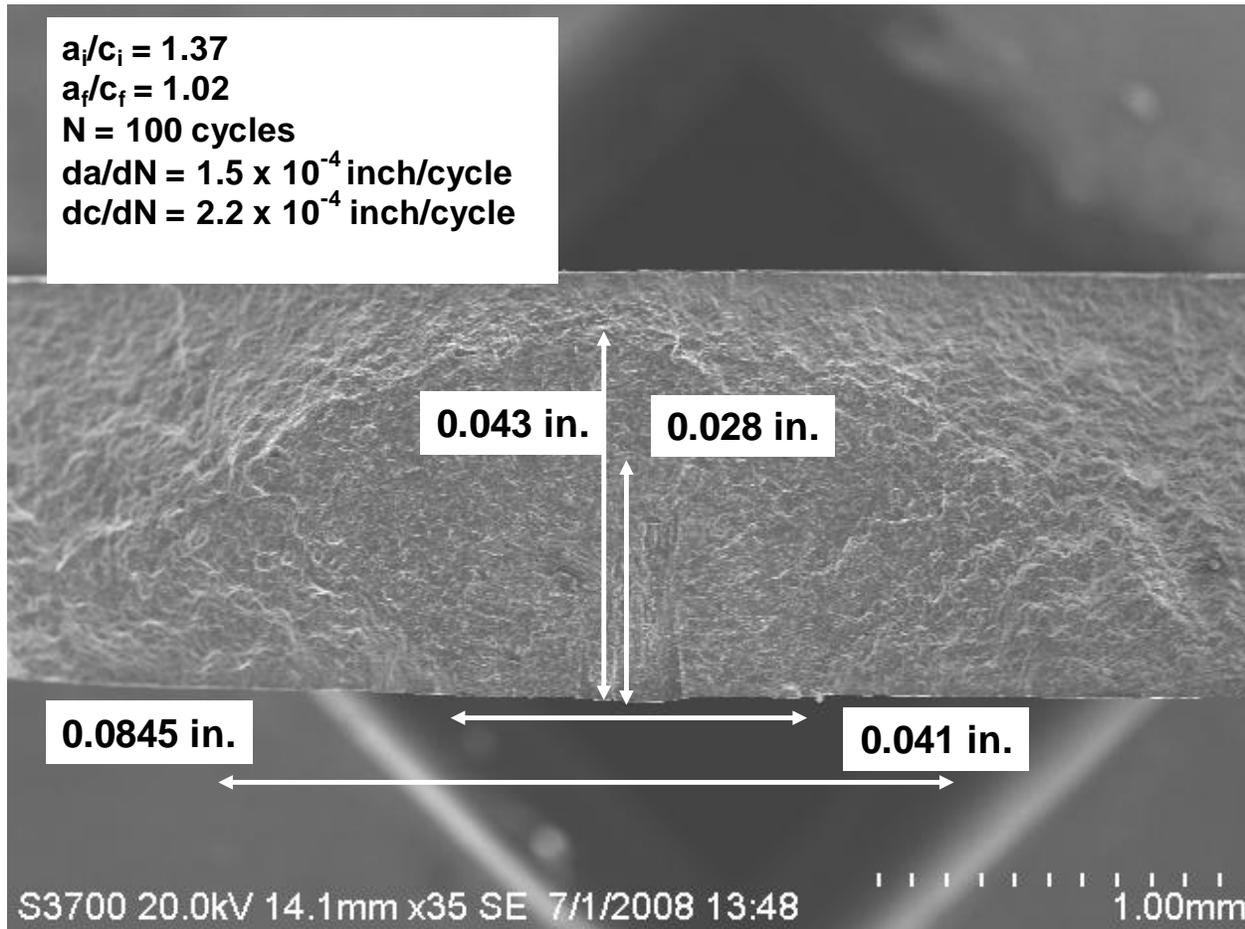
Figure B.13. SEM photograph (35x) of the fracture surface from uniaxial test UNI-050-35-04.

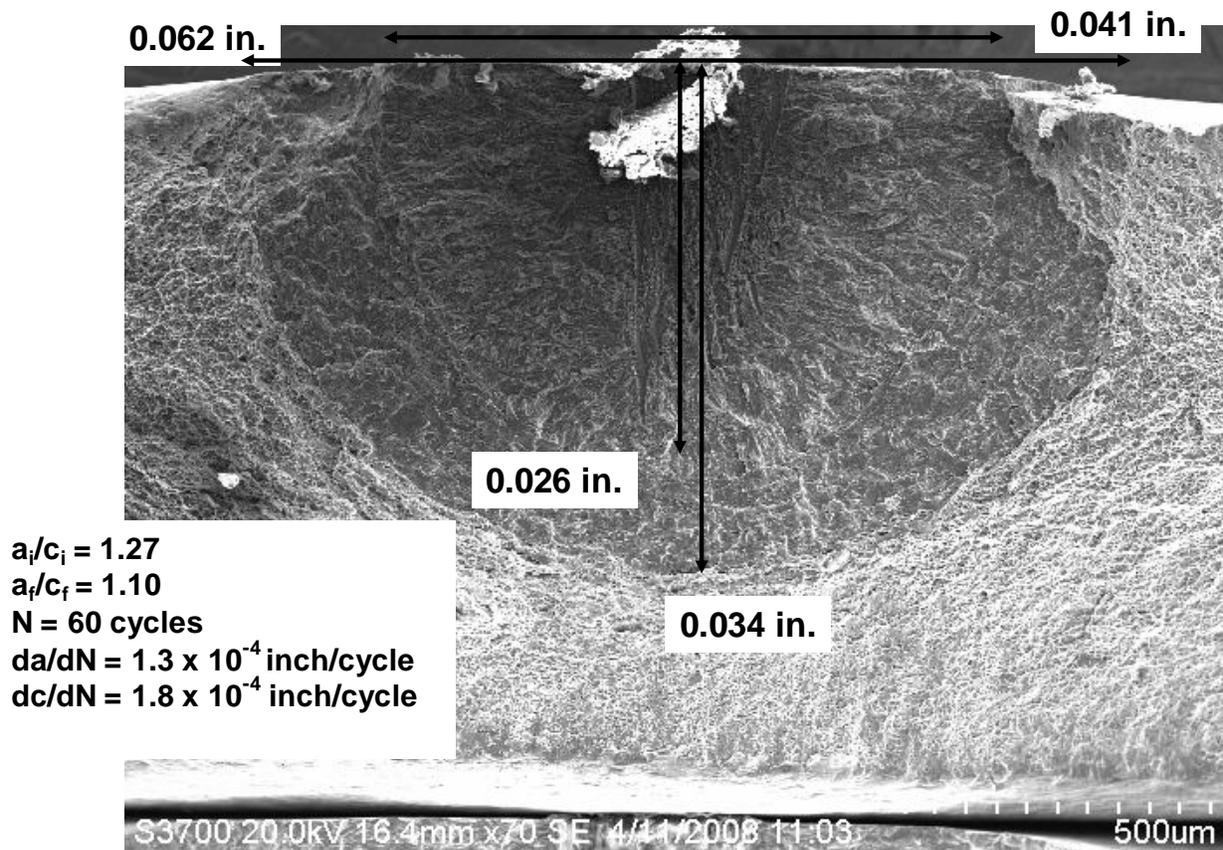
Figure B.14. SEM photograph (70x) of the fracture surface from uniaxial test UNI-050-35-05.

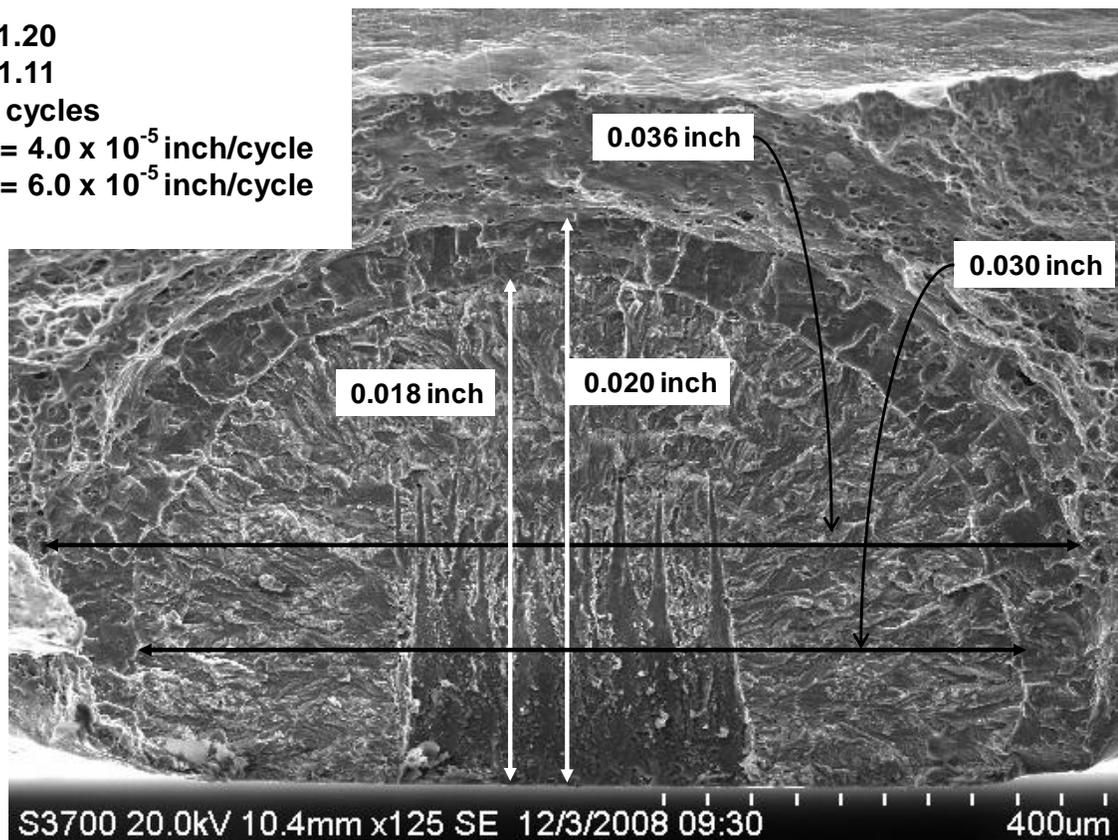
$a_i/c_i = 1.20$
 $a_f/c_f = 1.11$
 $N = 50$ cycles
 $da/dN = 4.0 \times 10^{-5}$ inch/cycle
 $dc/dN = 6.0 \times 10^{-5}$ inch/cycle

Figure B.16. SEM photograph (125x) of the fracture surface from uniaxial test UNI-032-37-03.

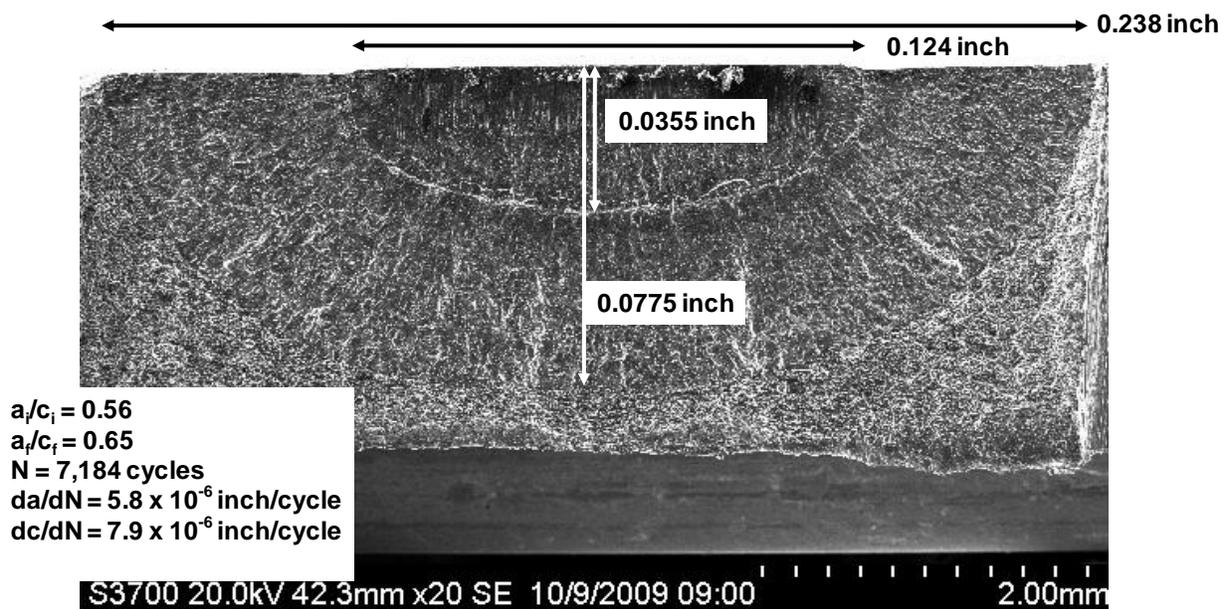
Figure C.1. SEM photograph (20x) of the fracture surface from crack #1 of COPV test 18118.

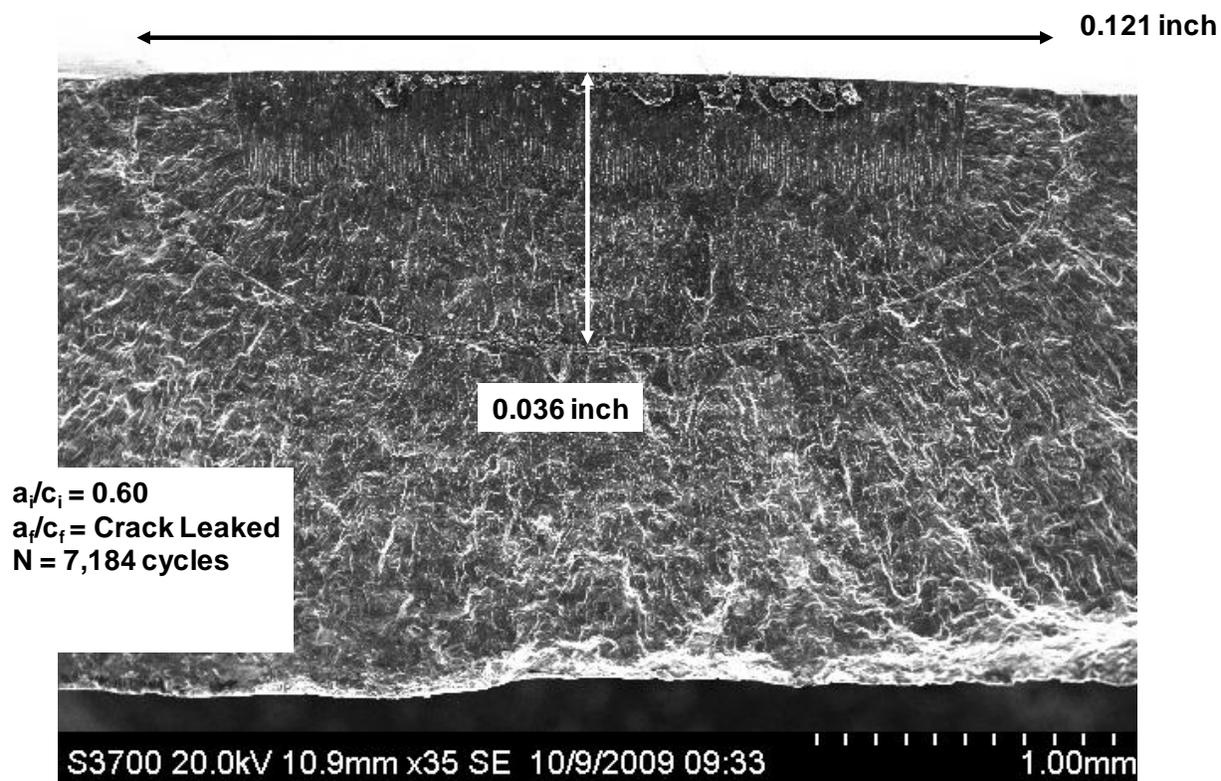
Figure C.2. SEM photograph (35x) of the fracture surface of crack #2 of COPV 18118. This cracked leaked after 7,184 fatigue cycles.

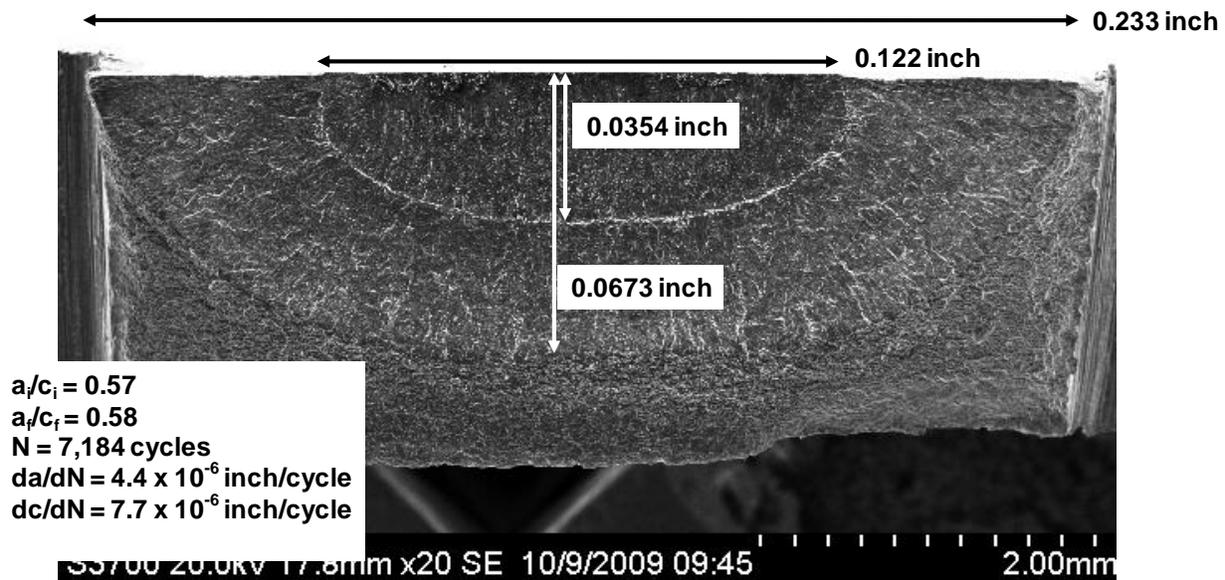
Figure C.3. SEM photograph (20x) of the fracture surface from crack #3 of COPV test 18118.

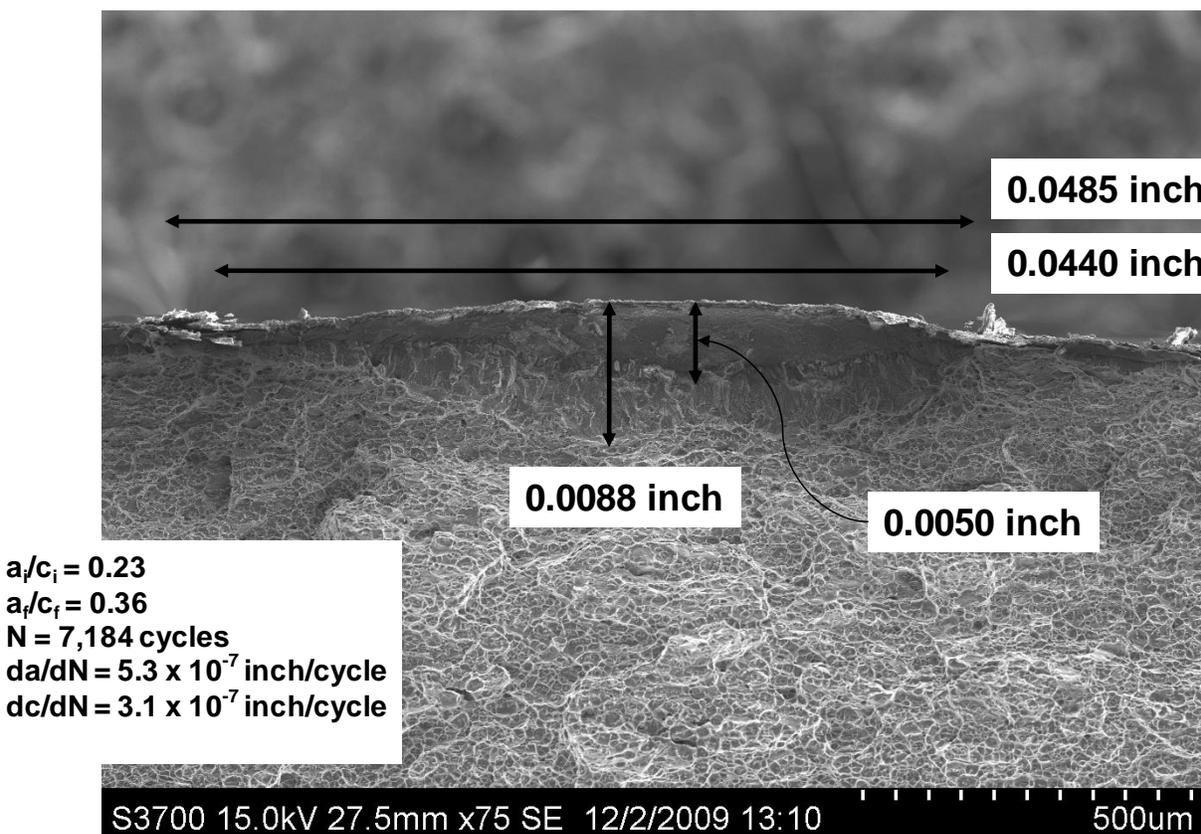
Figure C.4. SEM photograph (75x) of the fracture surface of an ID crack in COPV test 18118.

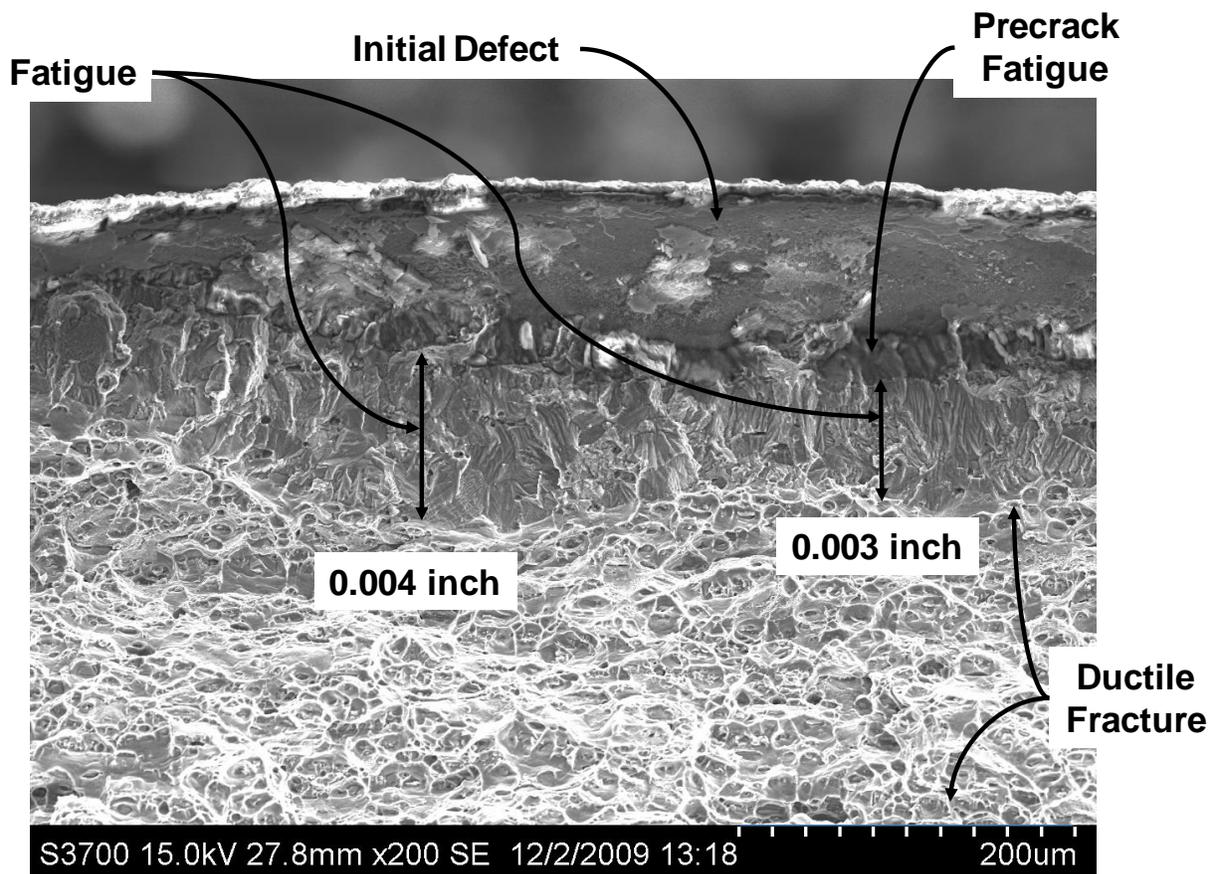
Figure C.5. SEM photograph (200x) of the fracture surface details for the ID crack in COPV test 18118.

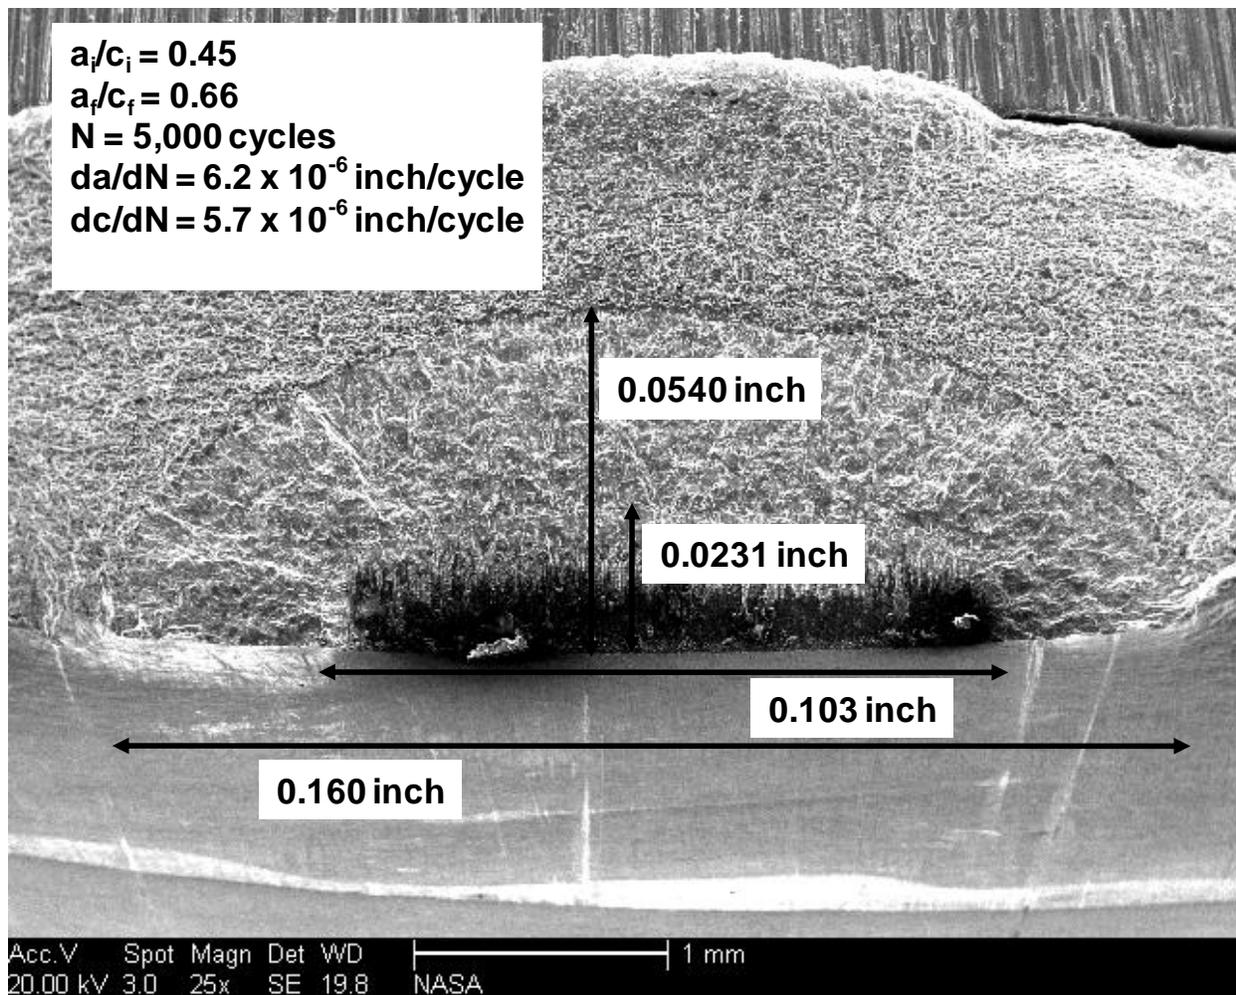
Figure C.6. SEM photograph (25x) of the fracture surface from crack #1 of COPV test 18117.
