| | <p align="center">NASA Engineering and Safety Center Technical Assessment Report</p> | <p align="center">Document #: NESC-RP- 06-065</p> | <p align="center">Version: 1.0</p> |

**Fracture Mechanics Based Methods Development for
Composite Overwrapped Pressure Vessels (COPV) with
Metallic Liners**

July 8, 2010

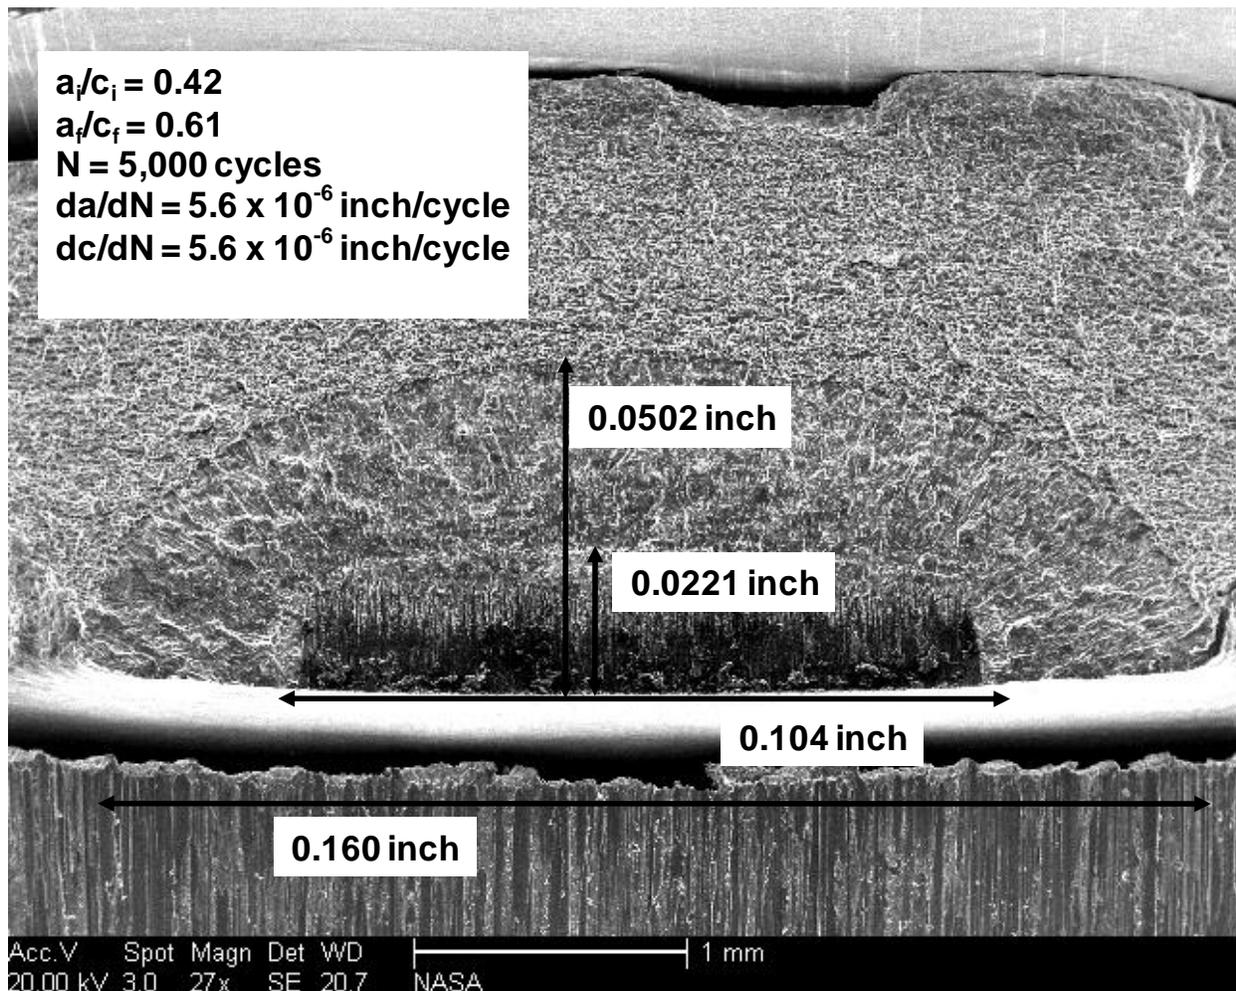
Figure C.7. SEM photograph (27x) of the fracture surface from crack #2 of COPV test 18117.

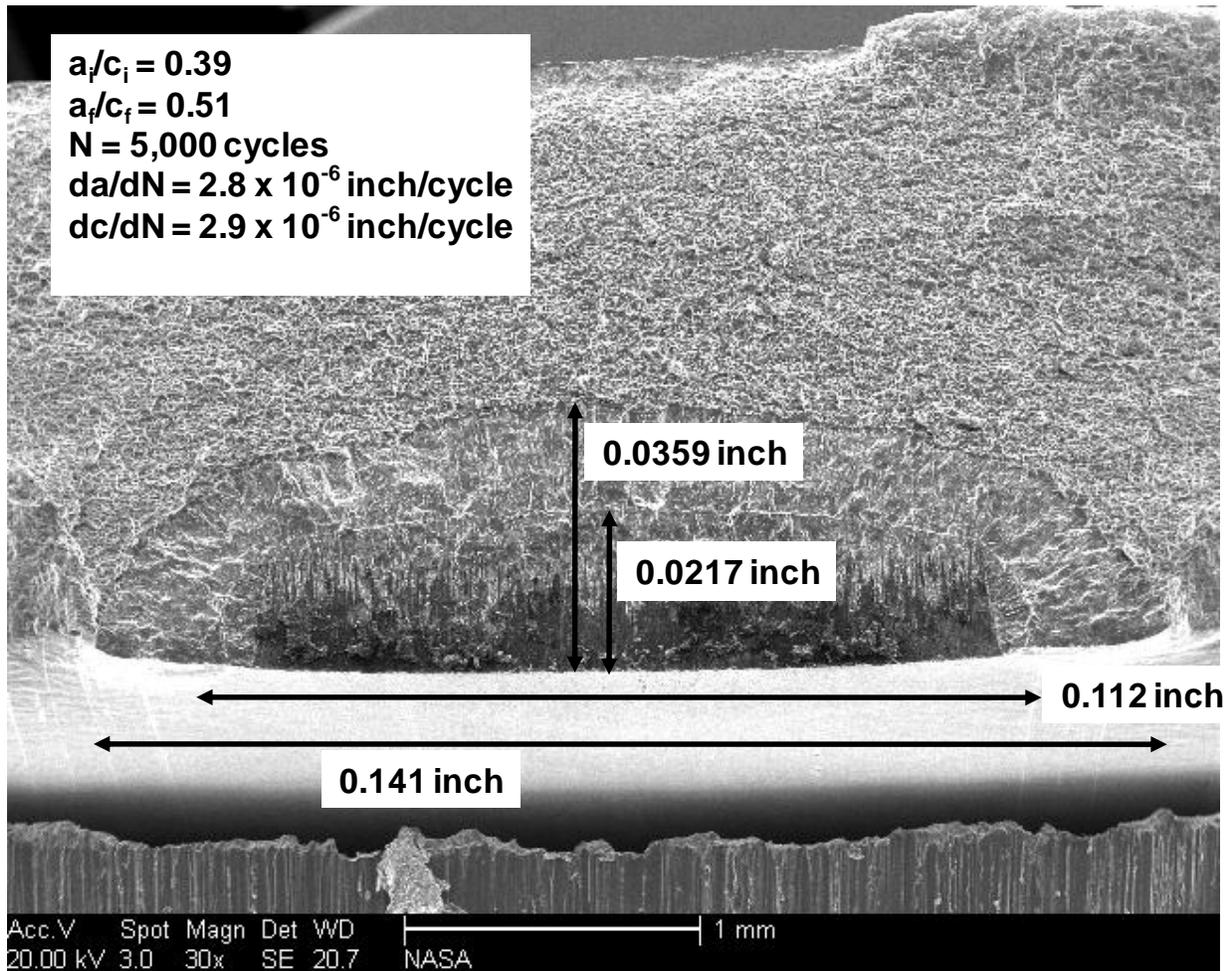
Figure C.8. SEM photograph (30x) of the fracture surface from crack #3 of COPV test 18117.

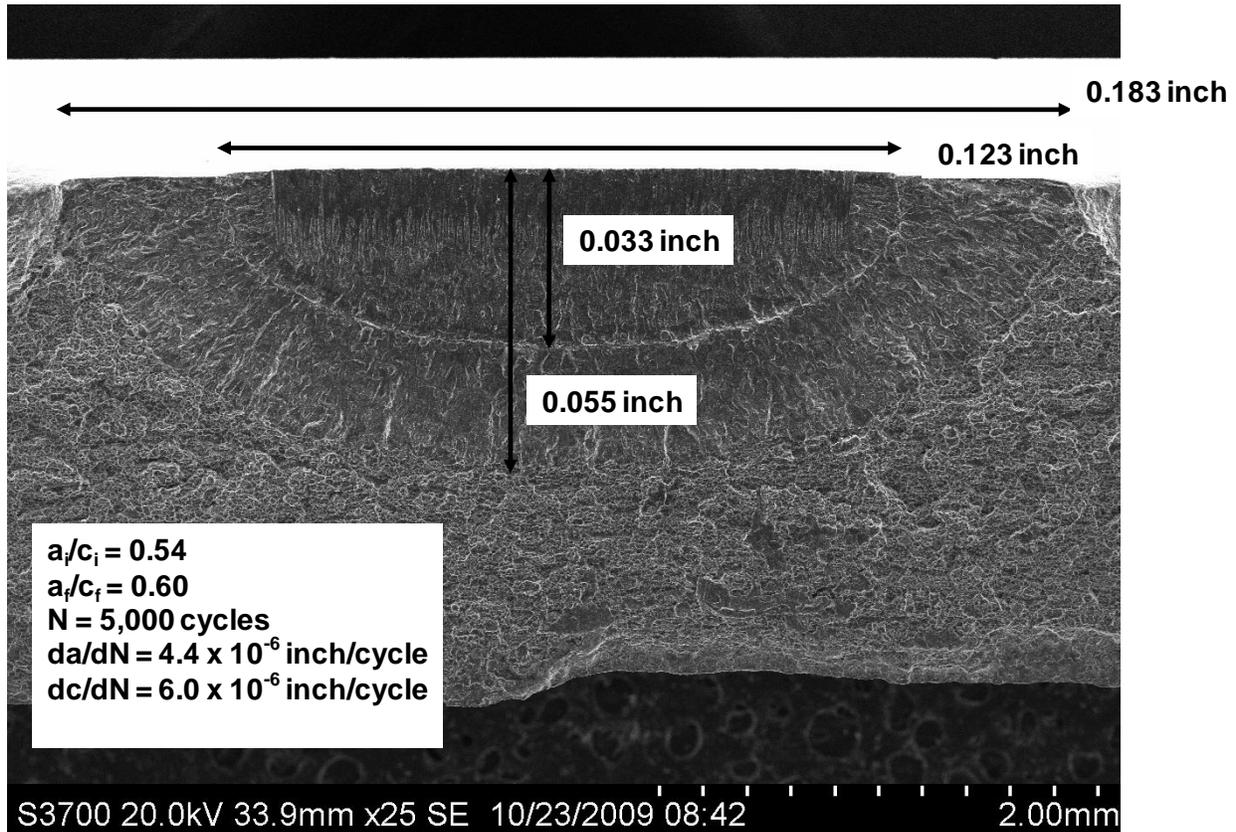
Figure C.9. SEM photograph (25x) of the fracture surface from crack #1 of COPV test 18107.

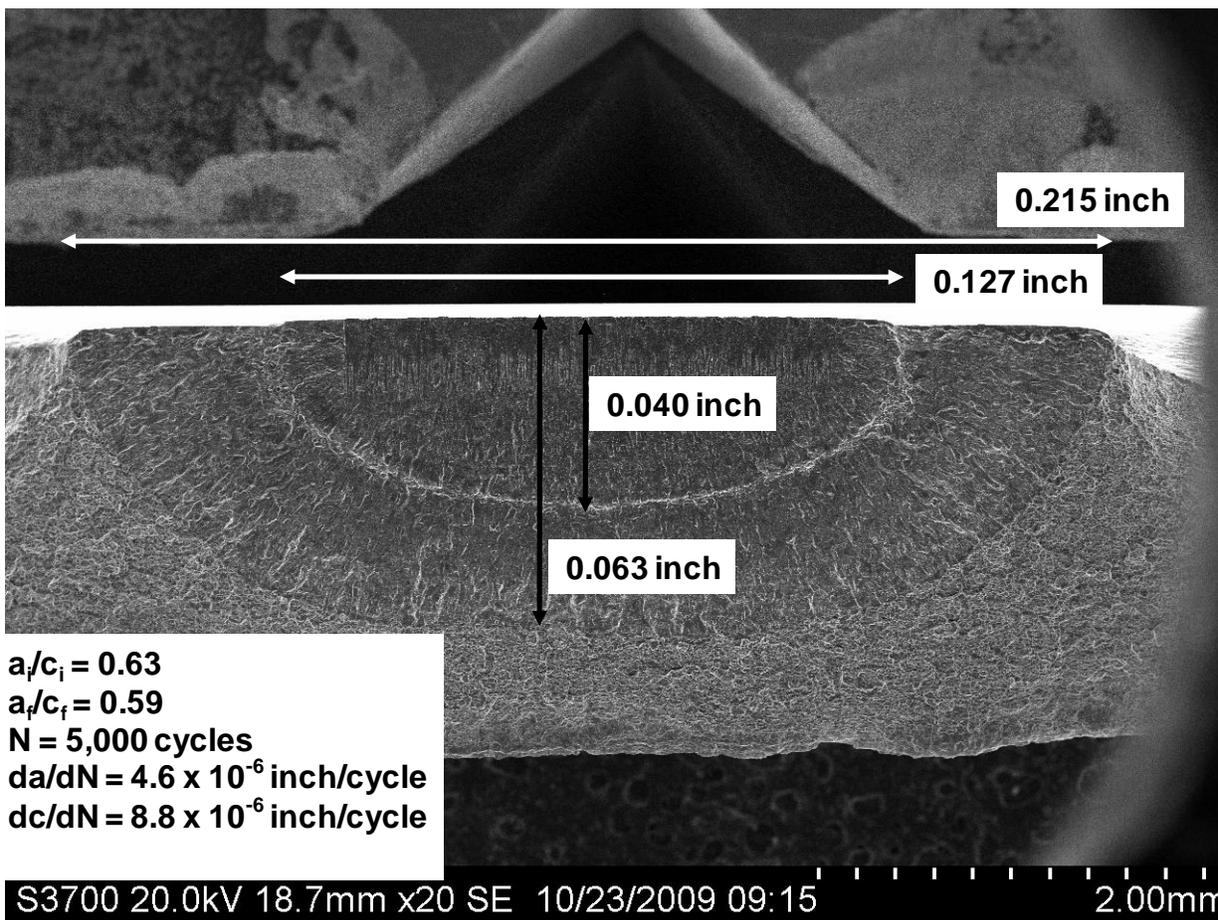
Figure C.10. SEM photograph (20x) of the fracture surface from crack #2 of COPV test 18107.

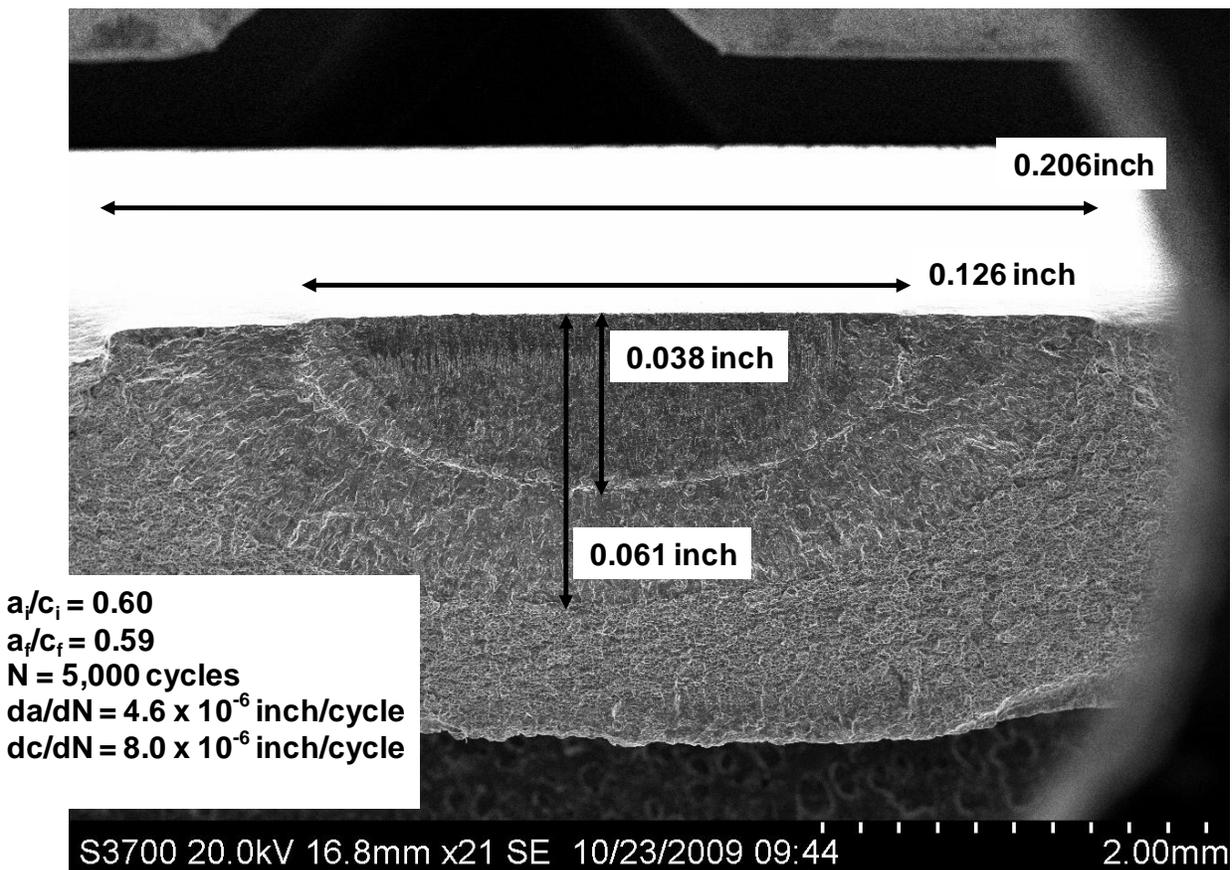
Figure C.11. SEM photograph (21x) of the fracture surface from crack #3 of COPV test 18107.

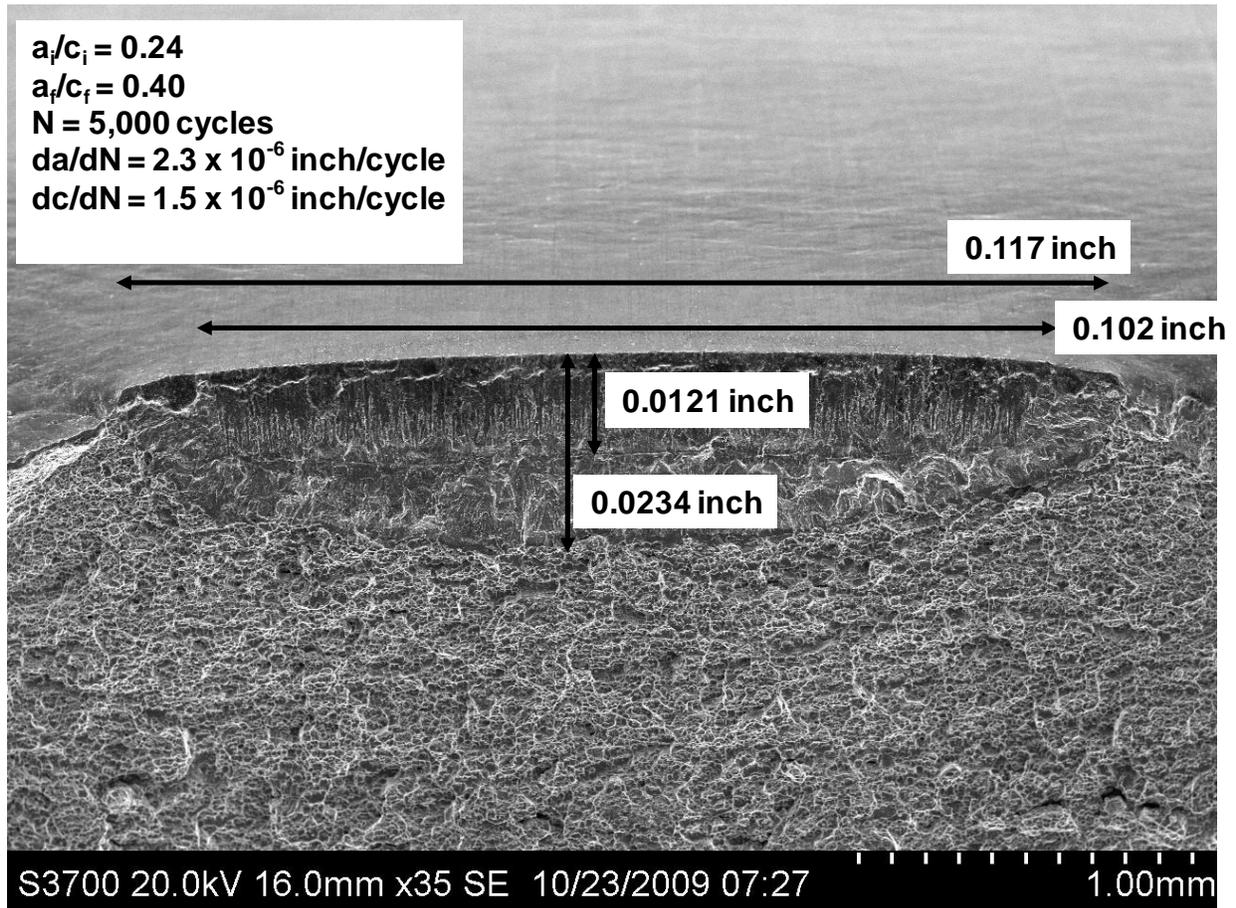
Figure C.12. SEM photograph (35x) of the fracture surface from crack #1 of COPV test 18105.

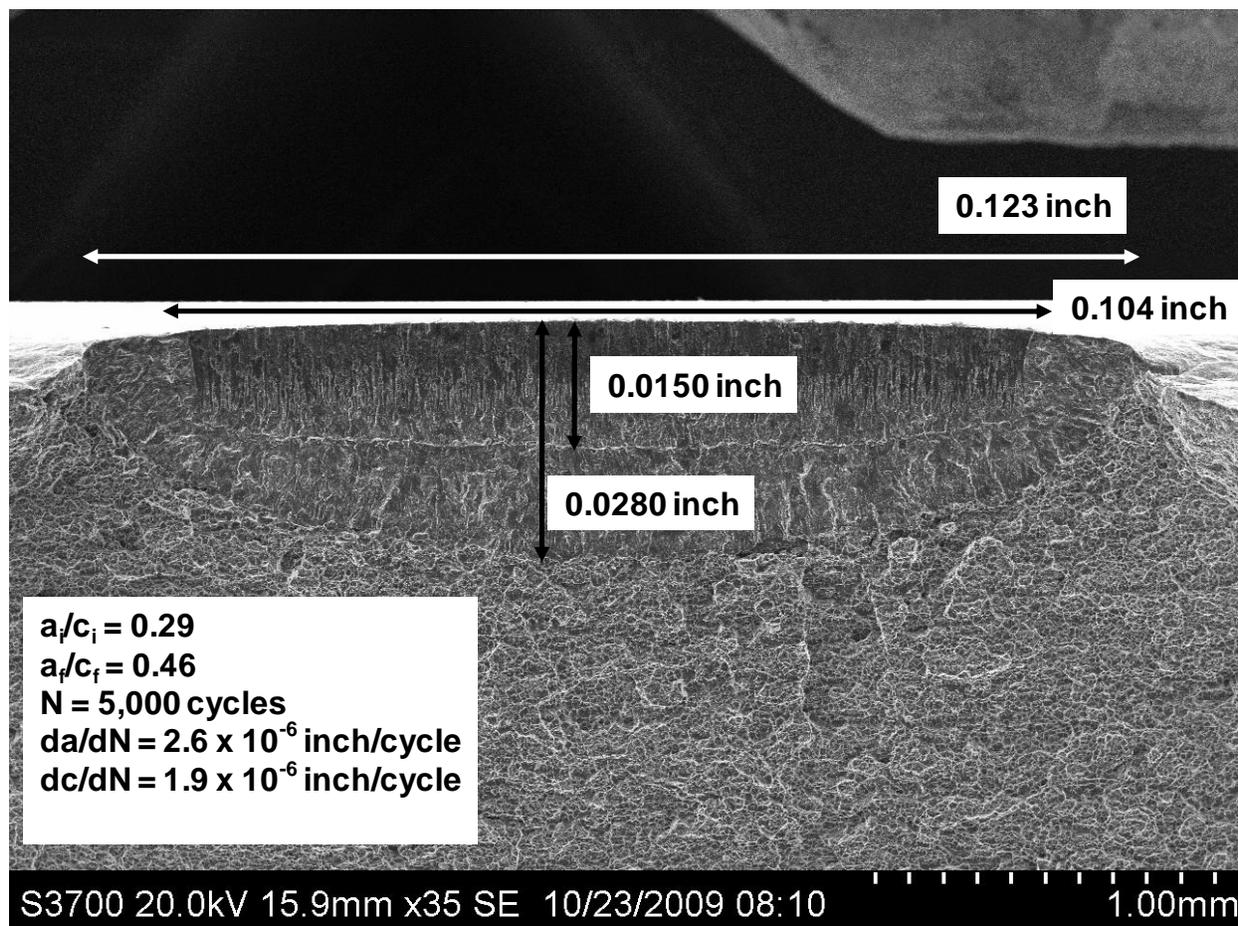
Figure C.13. SEM photograph (35x) of the fracture surface from crack #2 of COPV test 18105.

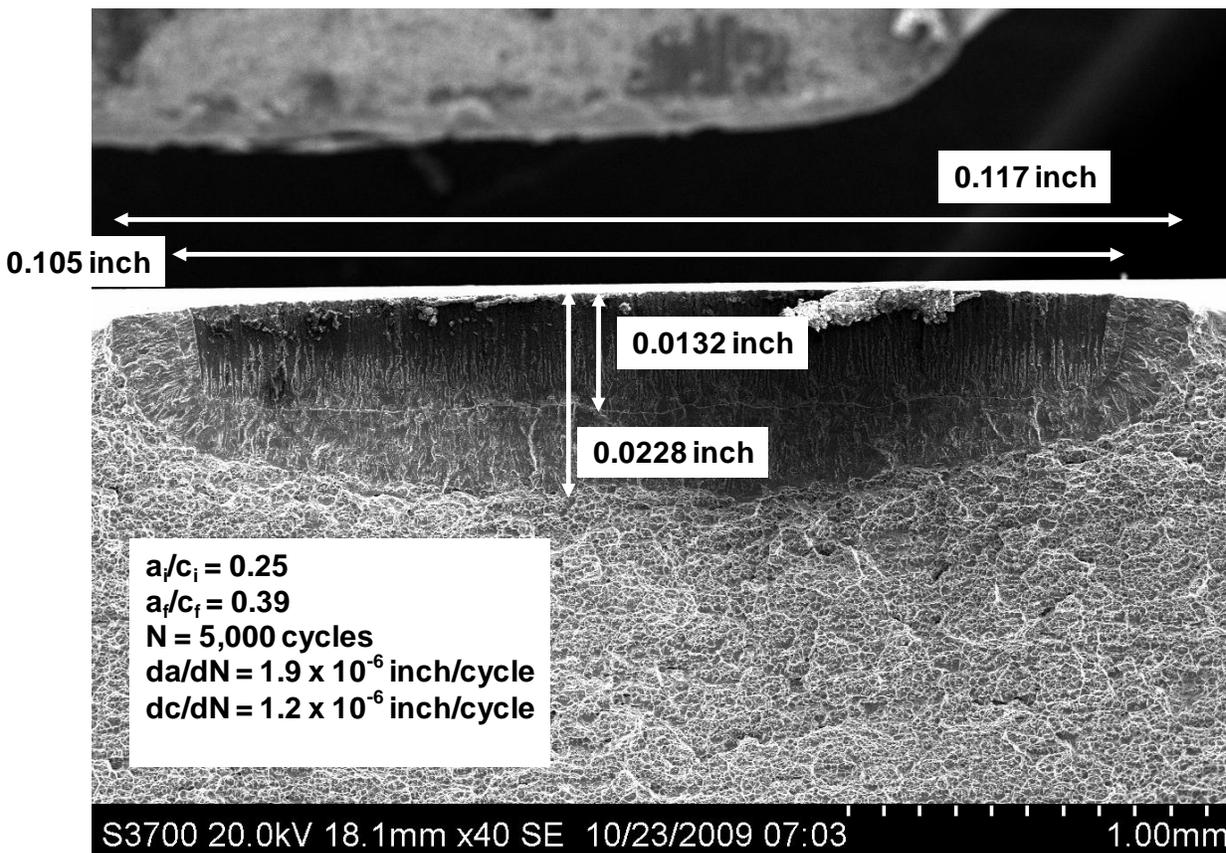
Figure C.14. SEM photograph (40x) of the fracture surface from crack #3 of COPV test 18105.

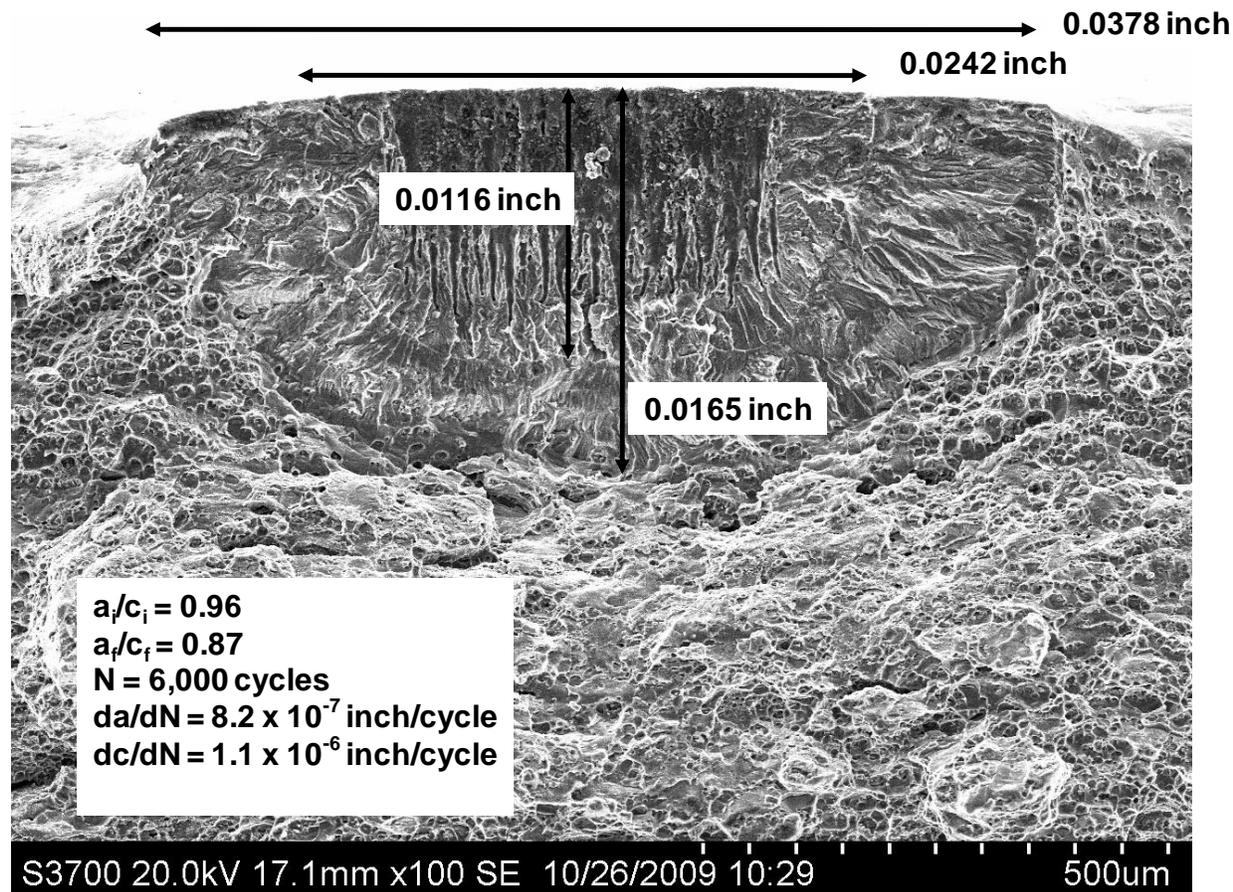
Figure C.15. SEM photograph (100x) of the fracture surface from crack #1 of COPV test 18103.

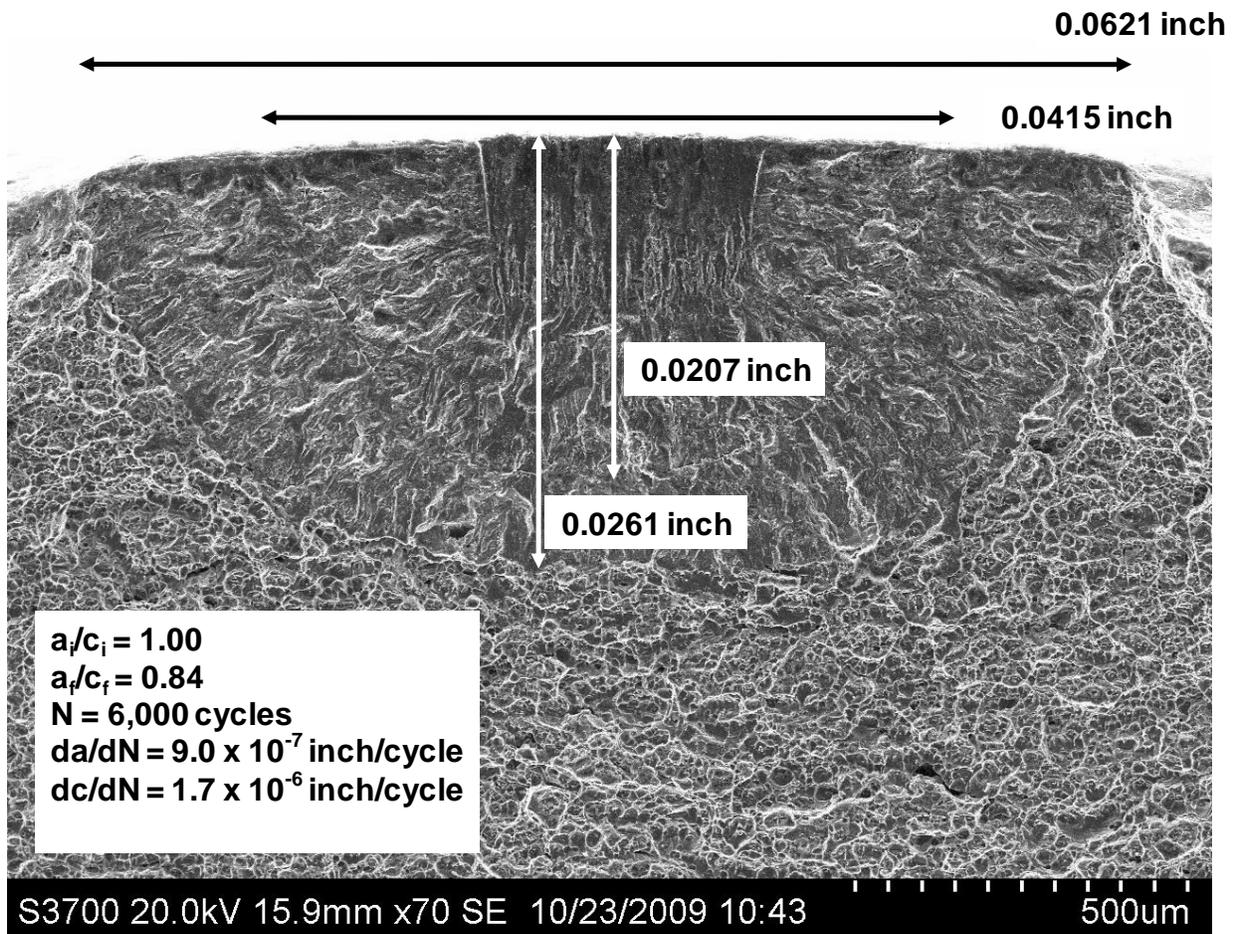
Figure C.16. SEM photograph (70x) of the fracture surface from crack #2 of COPV test 18103.

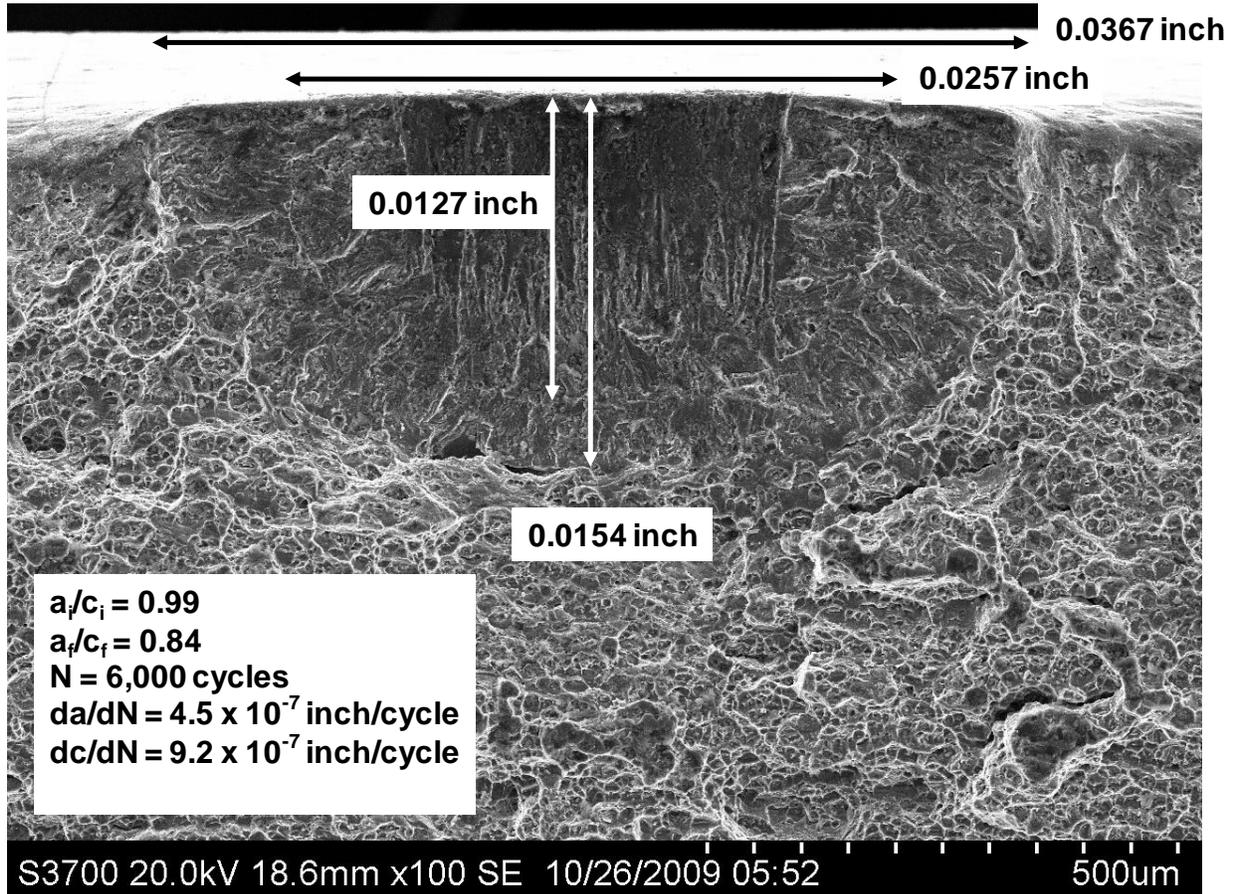
Figure C.17. SEM photograph (100x) of the fracture surface from crack #3 of COPV test 18103.

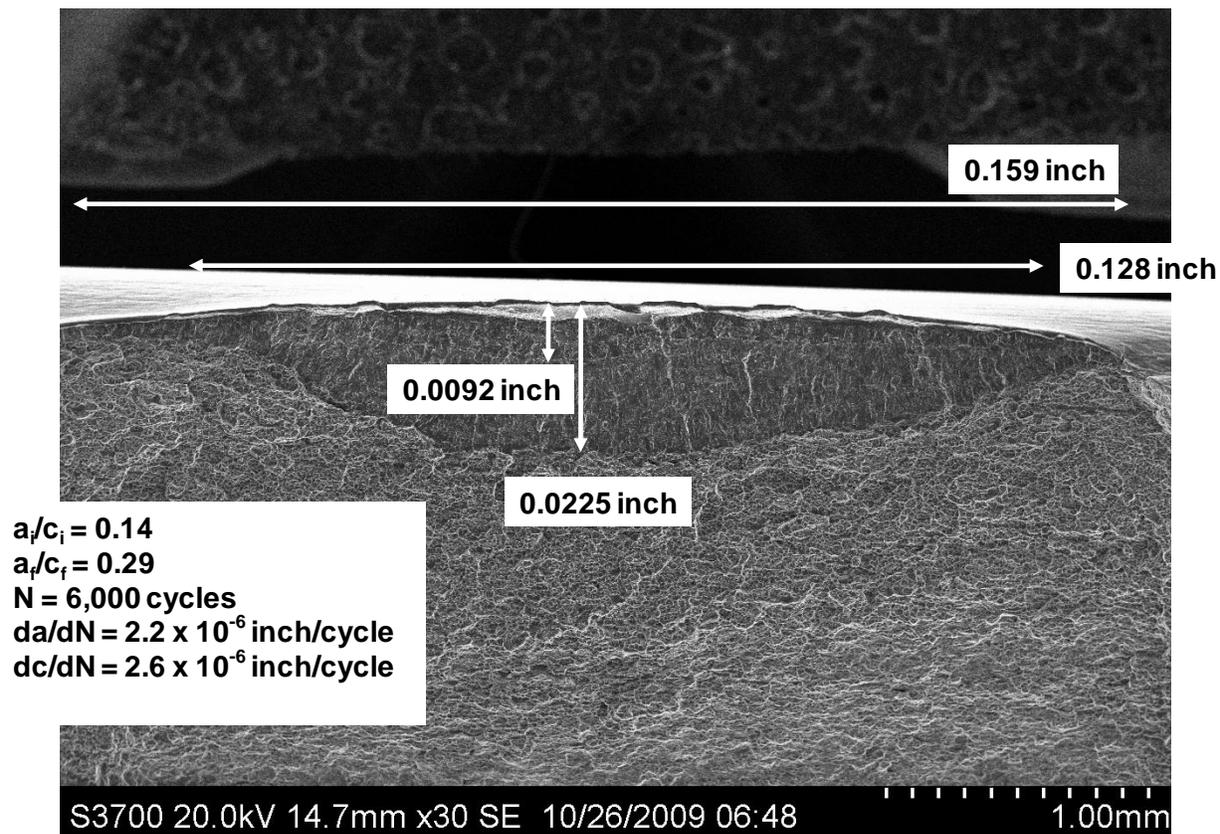
Figure C.18. SEM photograph (30x) of the fracture surface from exterior crack #1a of COPV test 18103 that initiated from a manufacturing defect.

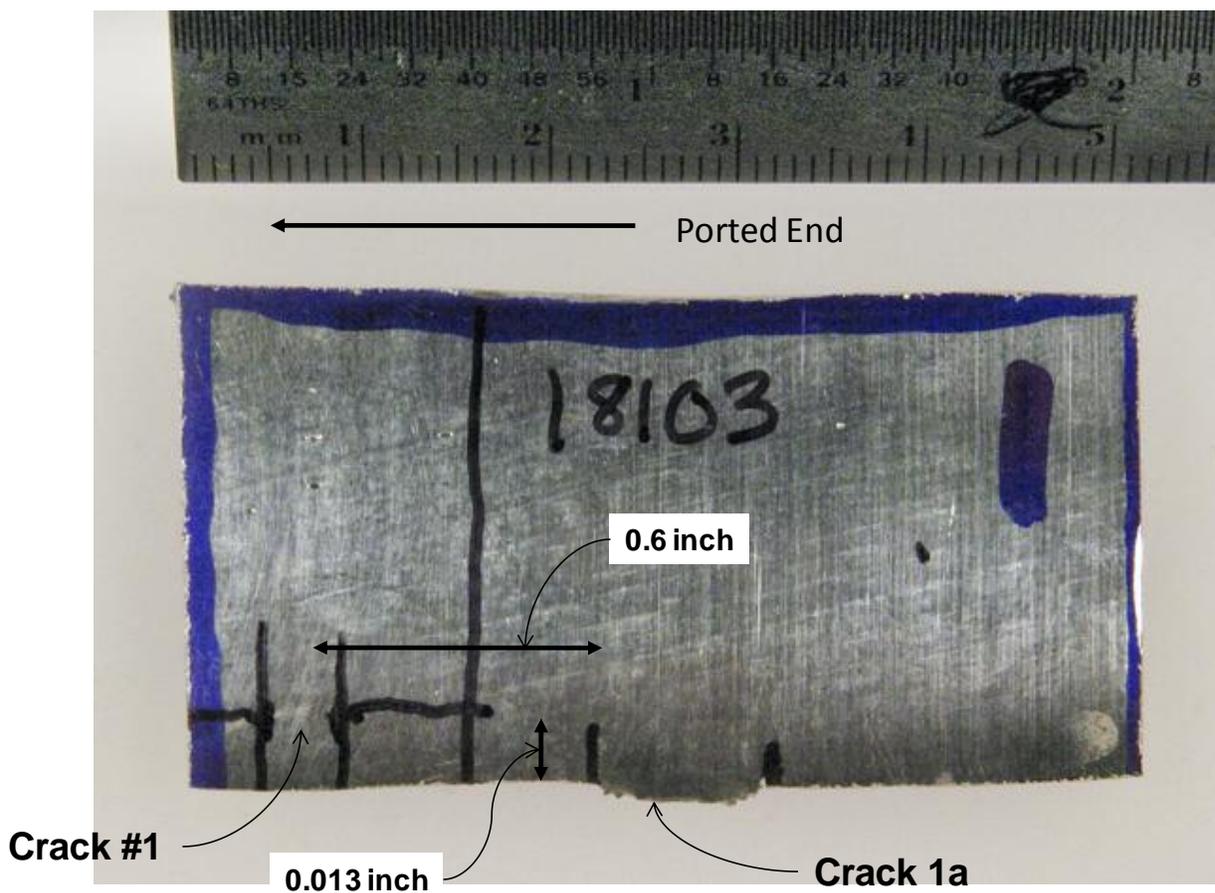
Figure C.19. Location of the exterior crack #1a that initiated from a manufacturing defect in COPV test 18103.

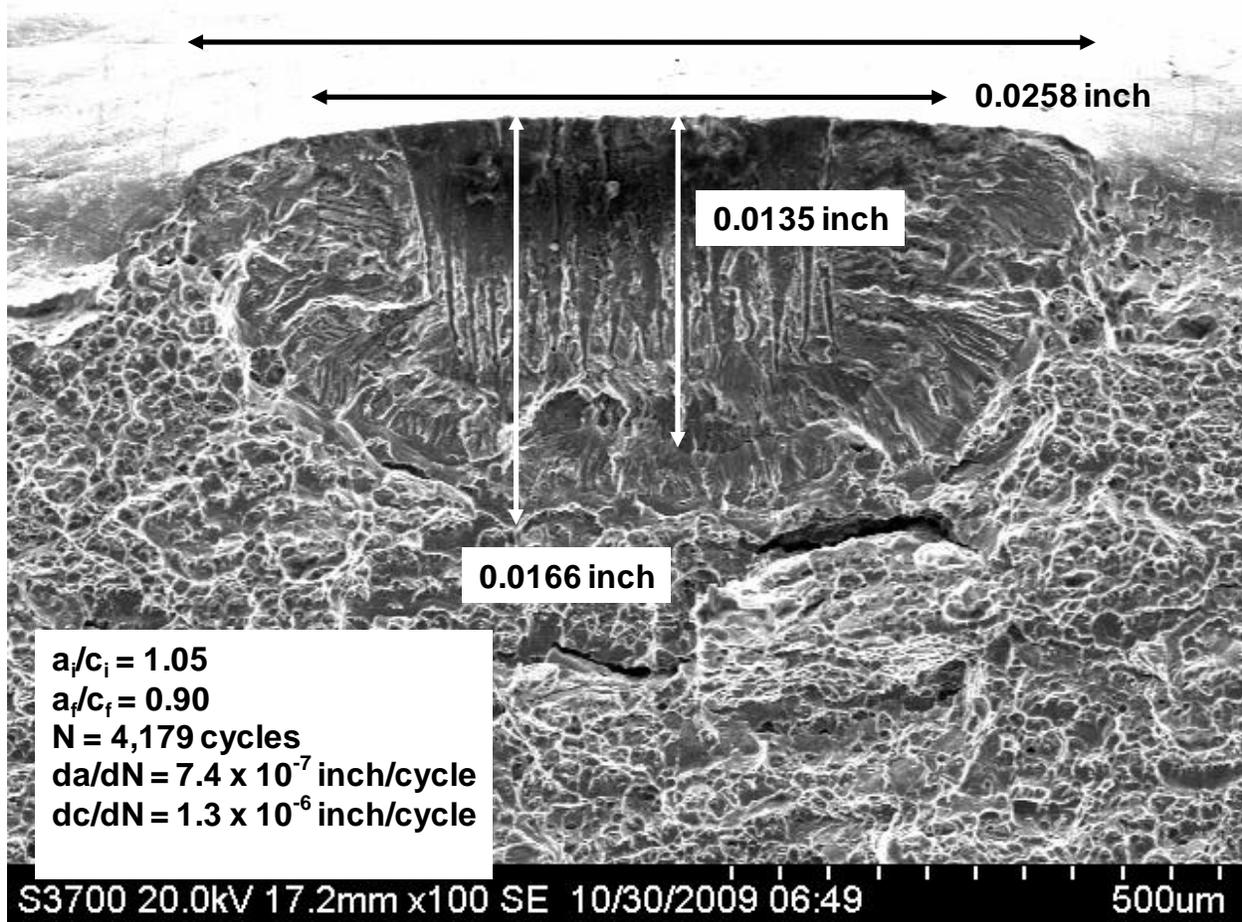
Figure C.20. SEM photograph (100x) of the fracture surface from crack #1 of COPV test 18119.

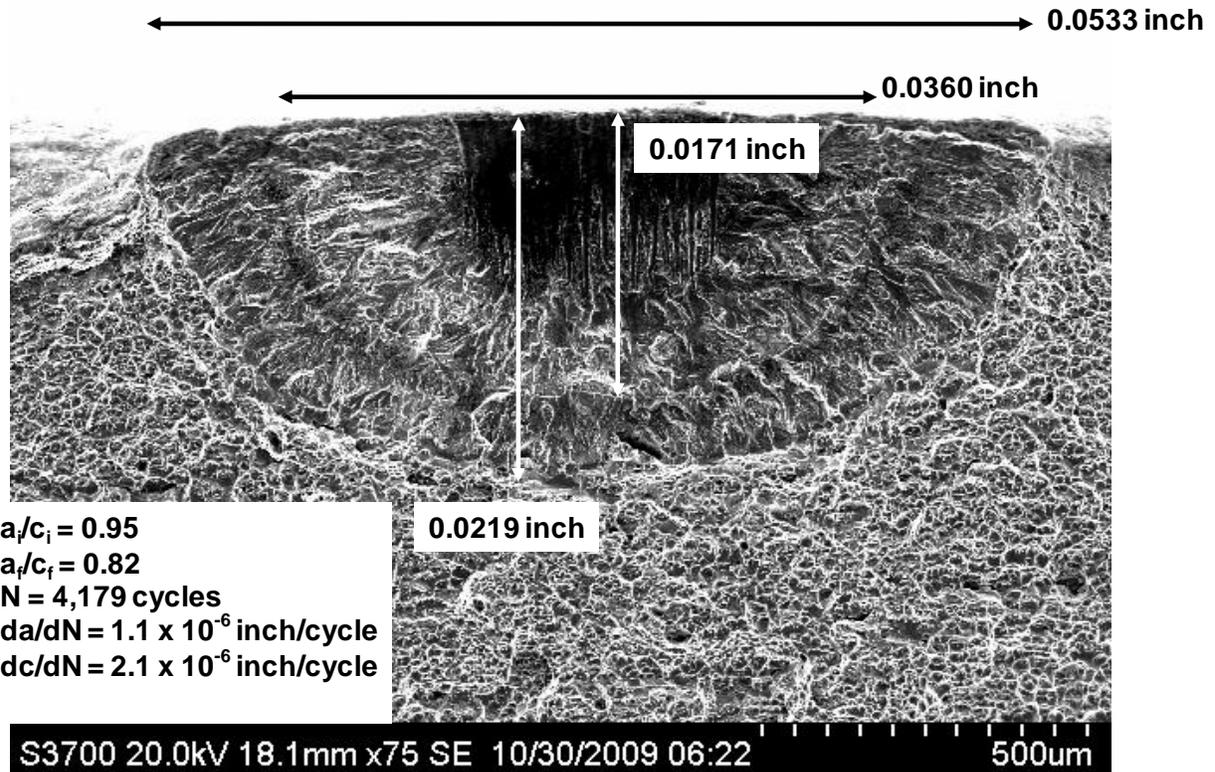
Figure C.21. SEM photograph (75x) of the fracture surface from crack #2 of COPV test 18119.

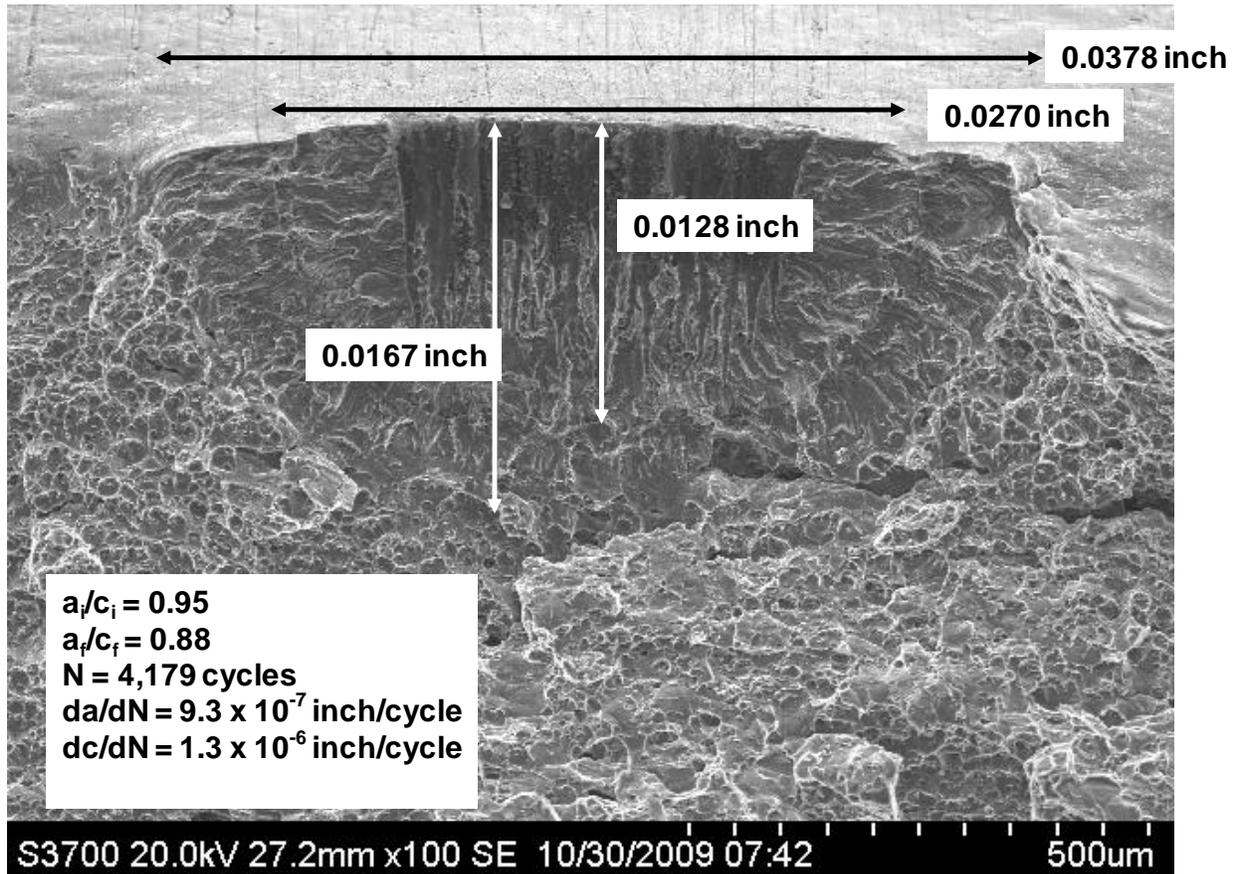
Figure C.22. SEM photograph (100x) of the fracture surface from crack #3 of COPV test 18119.

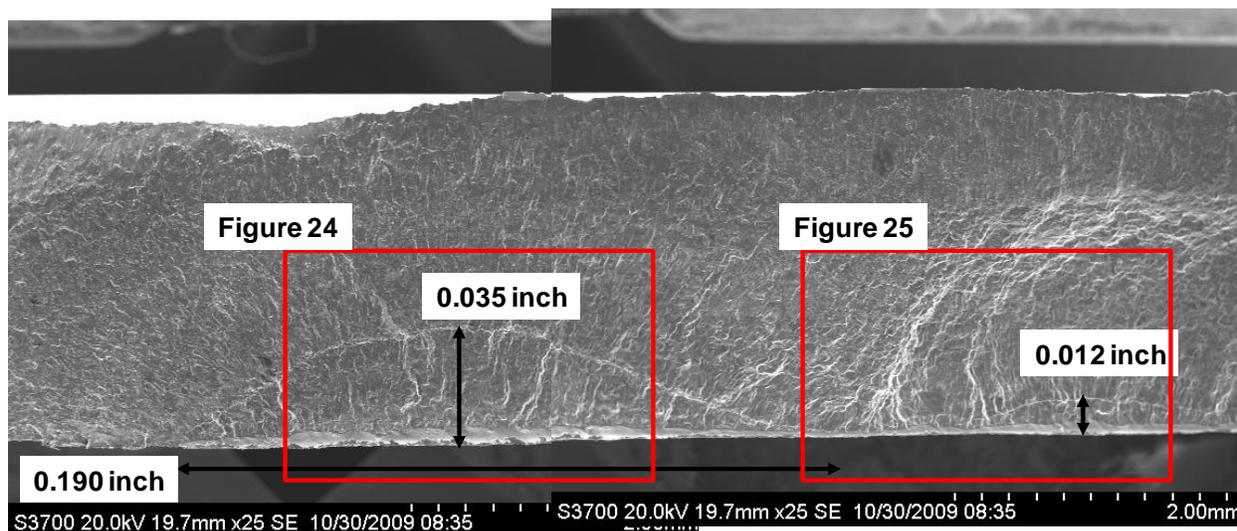
$a/c_i = 0.37$
 $N = 4,179$ cycles

Figure C.23. SEM photograph (25x montage) of the leak site that initiated from an interior manufacturing defect of COPV test 18119.

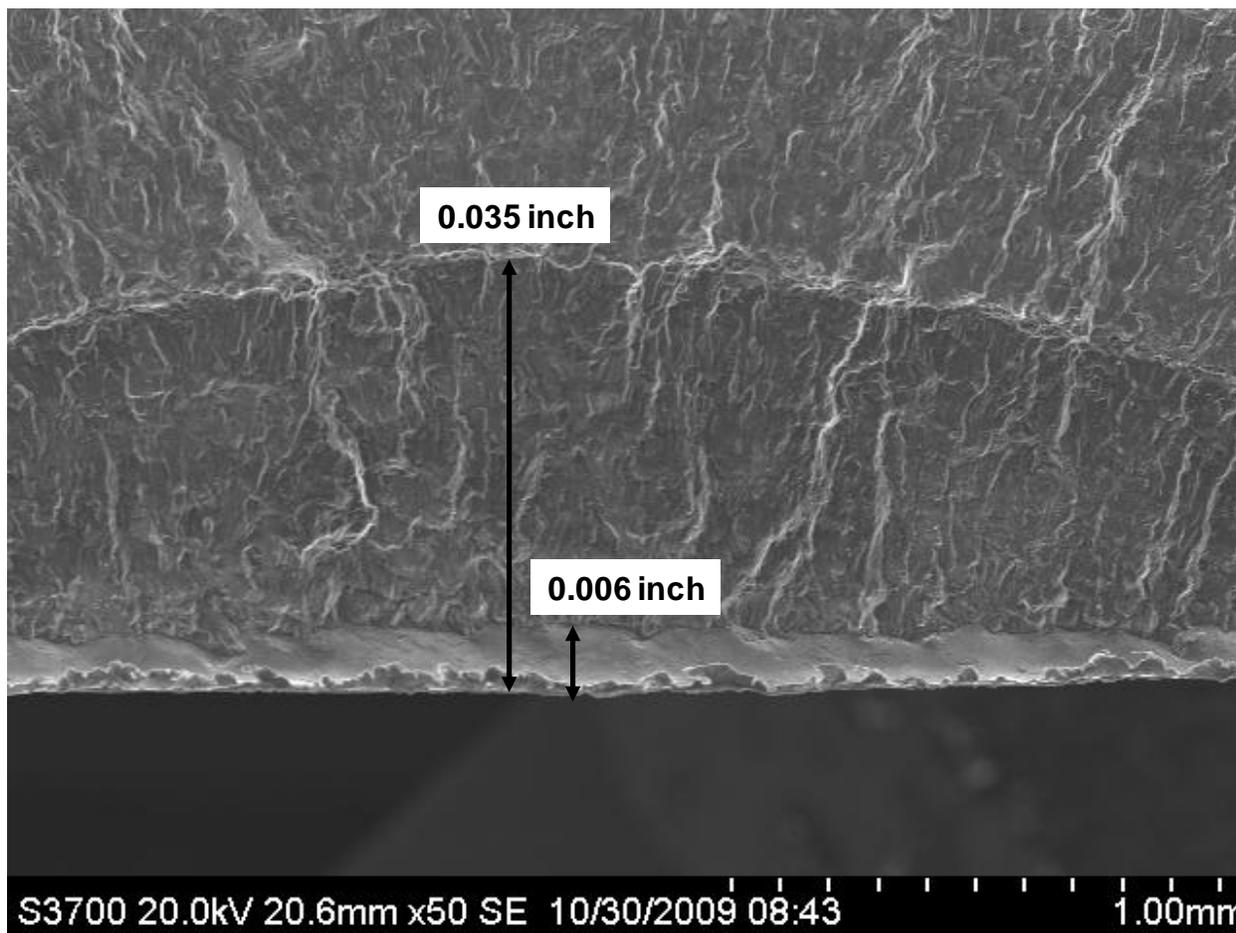
Figure C.24. SEM photograph (50x) of the large interior crack of COPV test 18119 that leaked during fatigue.

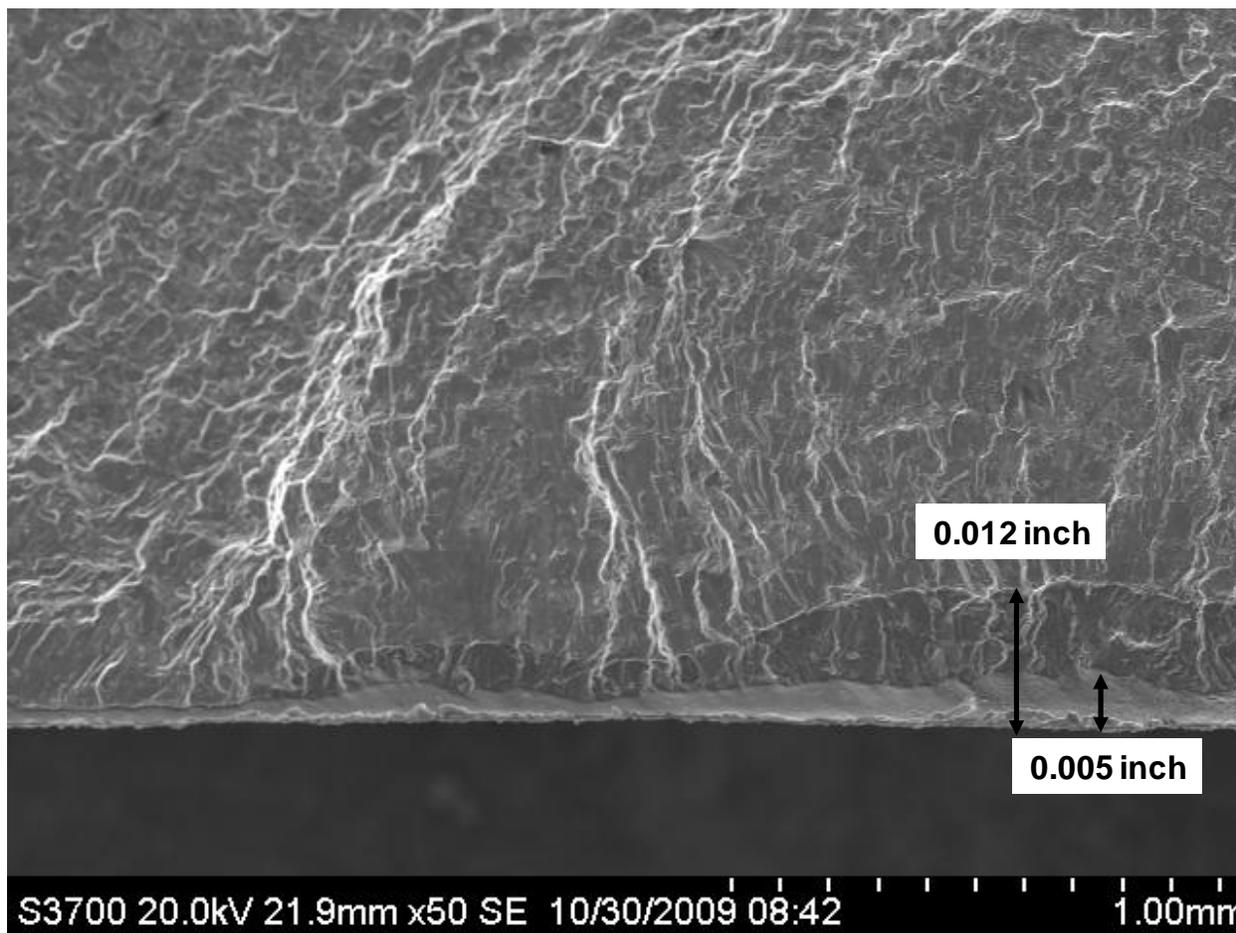
Figure C.25. SEM photograph (50x) of the smaller portion of the interior crack of COPV test 18119 that leaked during fatigue.

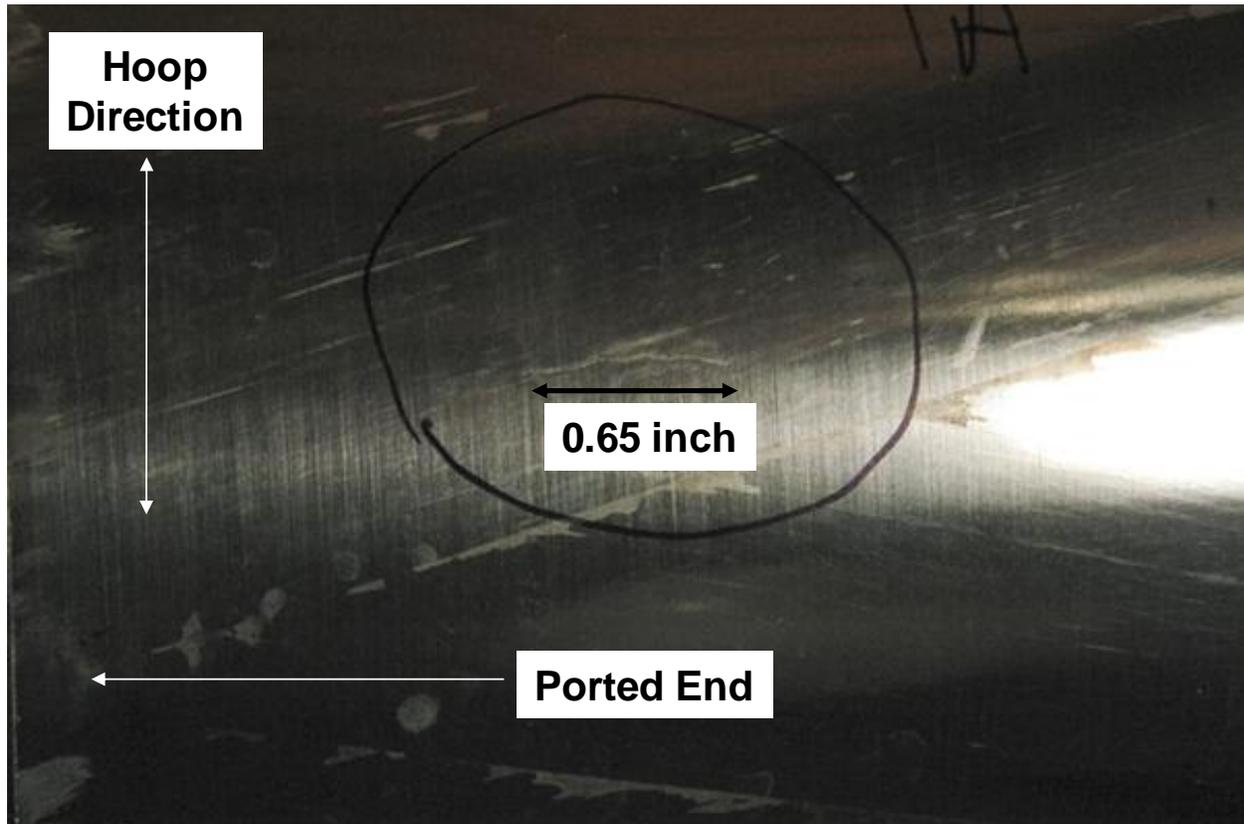
Figure C.26. Exterior view of the fatigue crack that initiated from an internal defect and leaked during the fatigue cycling of COPV test 18119.

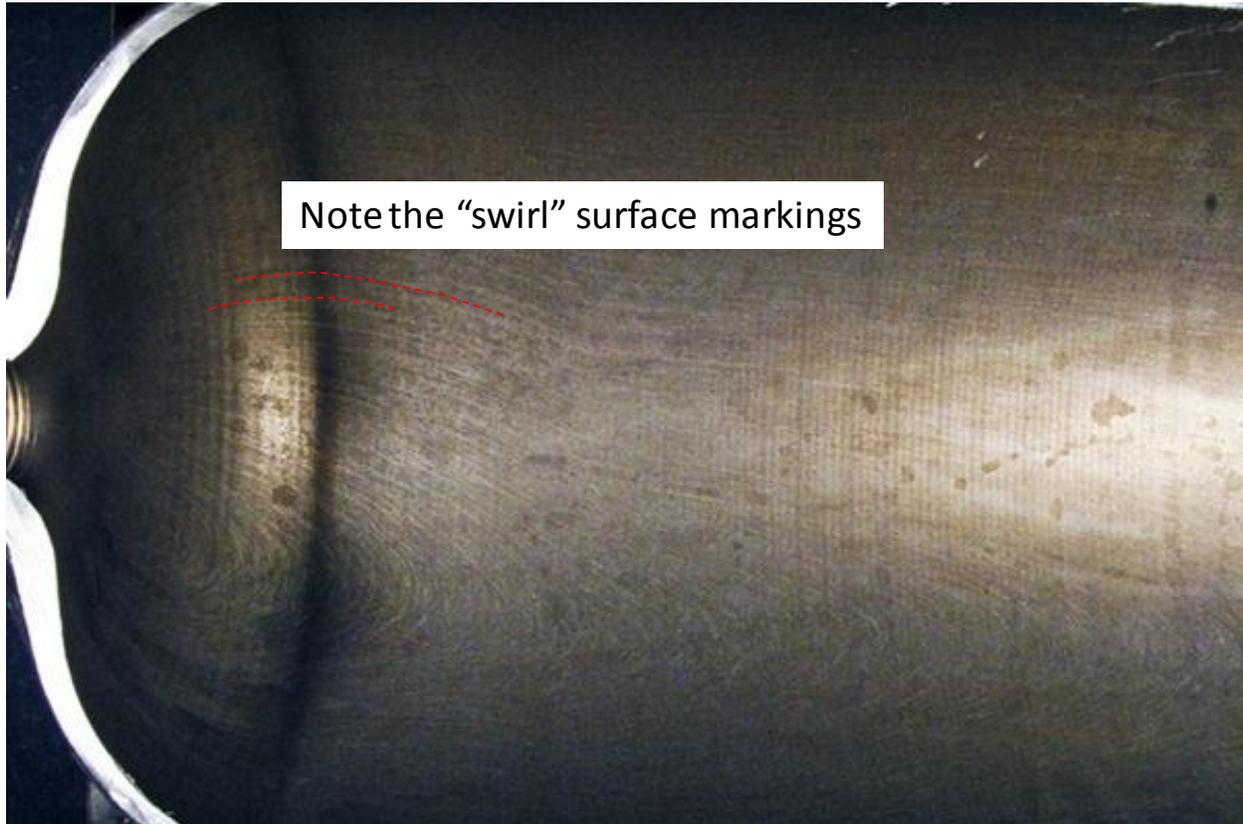
Figure C.27. View of the interior of the liner of COPV 18119 near the internal defect that initiated the crack that leaked during the fatigue cycling.
