| | <p align="center">NASA Engineering and Safety Center Technical Assessment Report</p> | <p align="center">Document #: NESC-RP- 06-065</p> | <p align="center">Version: 1.0</p> |

**Fracture Mechanics Based Methods Development for
Composite Overwrapped Pressure Vessels (COPV) with
Metallic Liners**

July 8, 2010

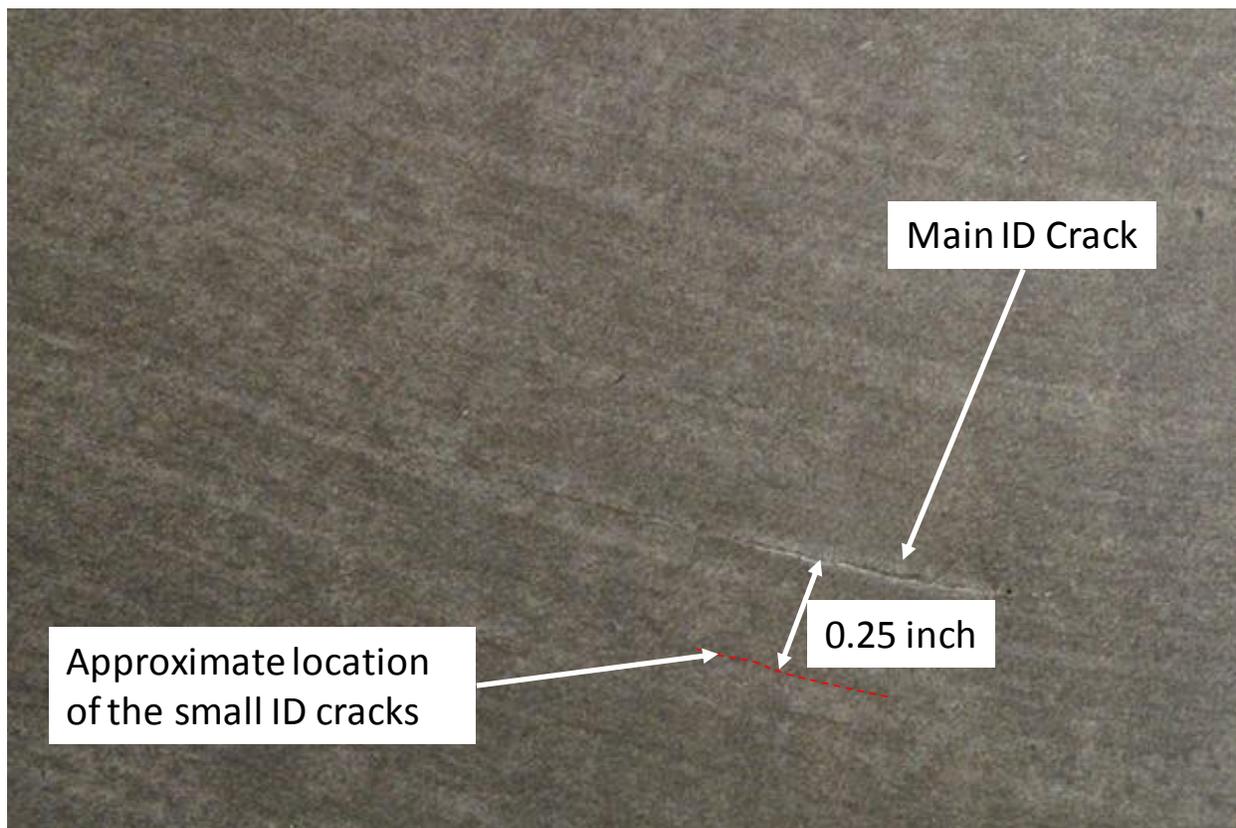
Figure C.28 Close up of the interior of the liner of COPV test 18119 showing the crack that leaked follows the “swirl” pattern on the interior surface and the approximate location of the smaller ID cracks.

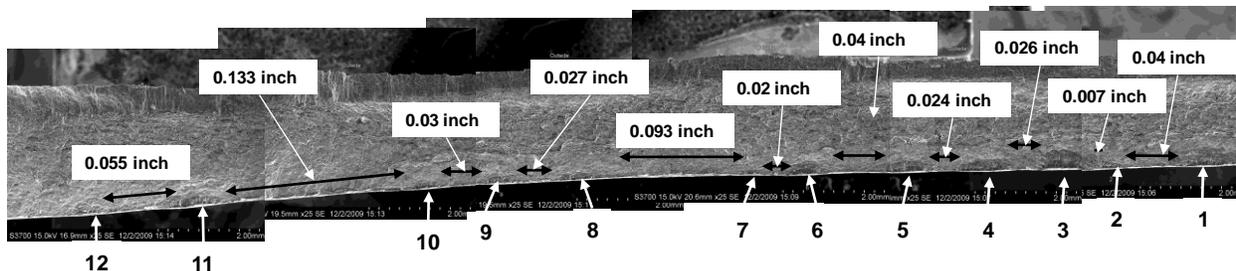
Figure C.29. SEM photograph (25x montage) of the location of the 12 small cracks found on the interior of the liner of COPV test 18119 and the approximate distances between the cracks.

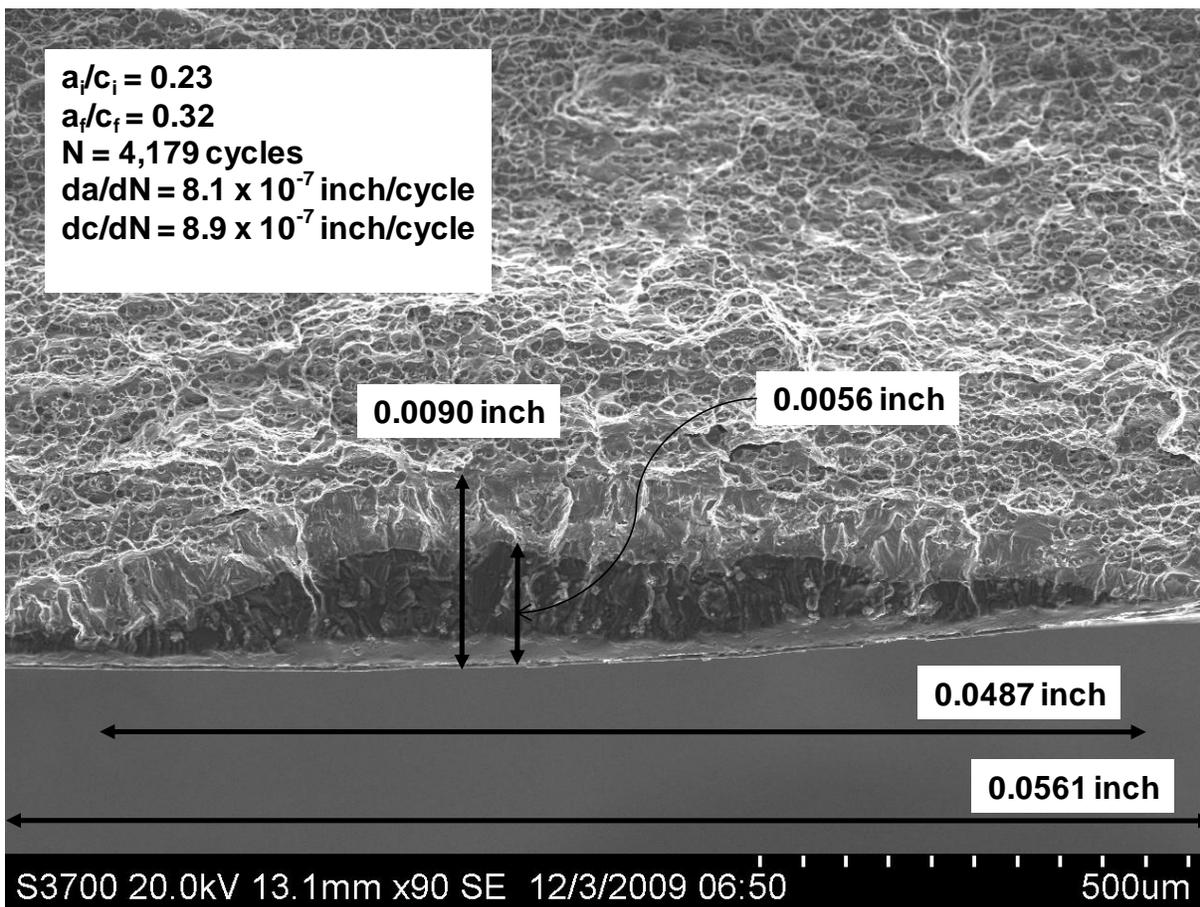
Figure C.30. SEM photograph (90x) of the interior crack ID1 found on the liner of COPV test 18119.

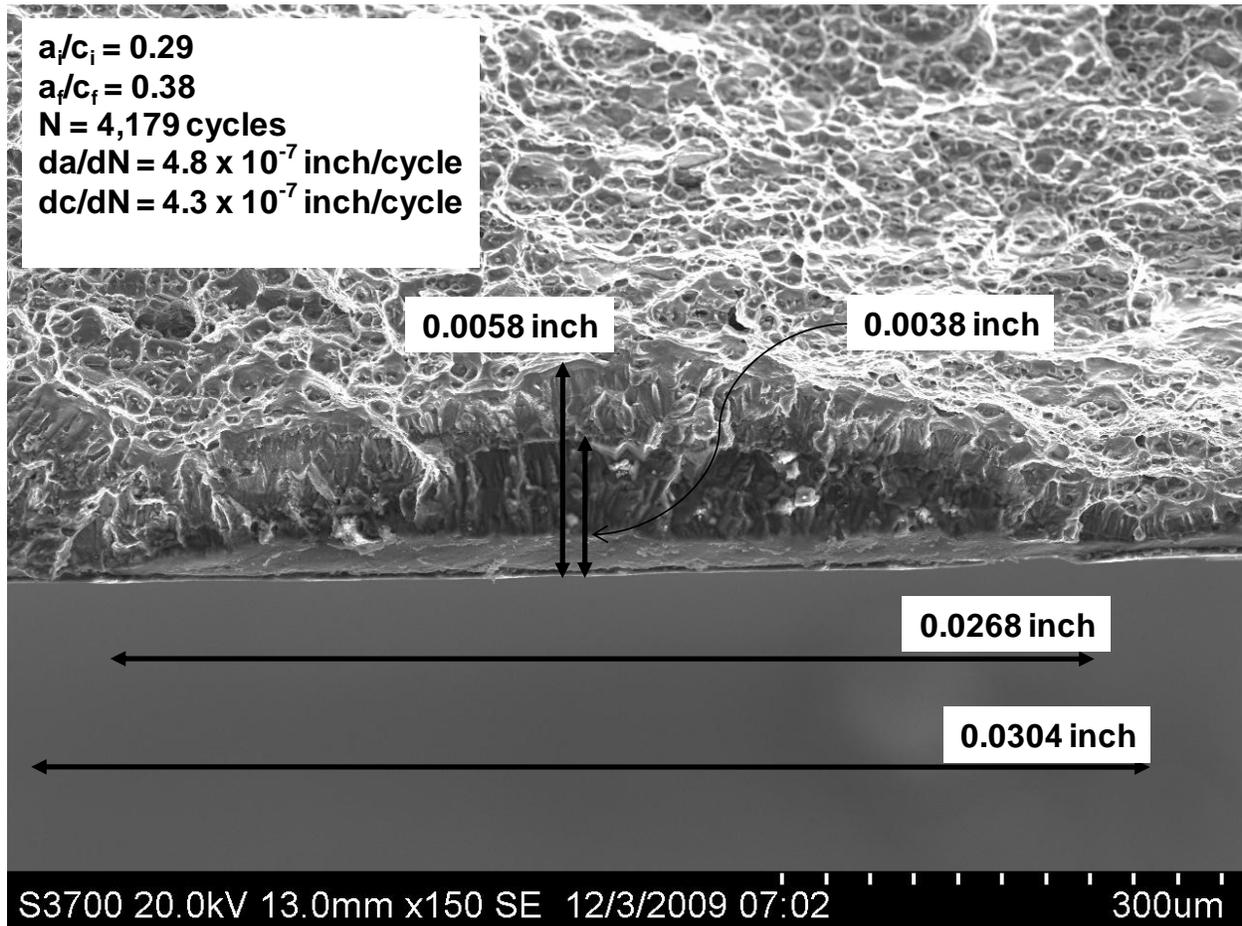
Figure C.31. SEM photograph (150x) of the interior crack ID2 found on the liner of COPV test 18119.

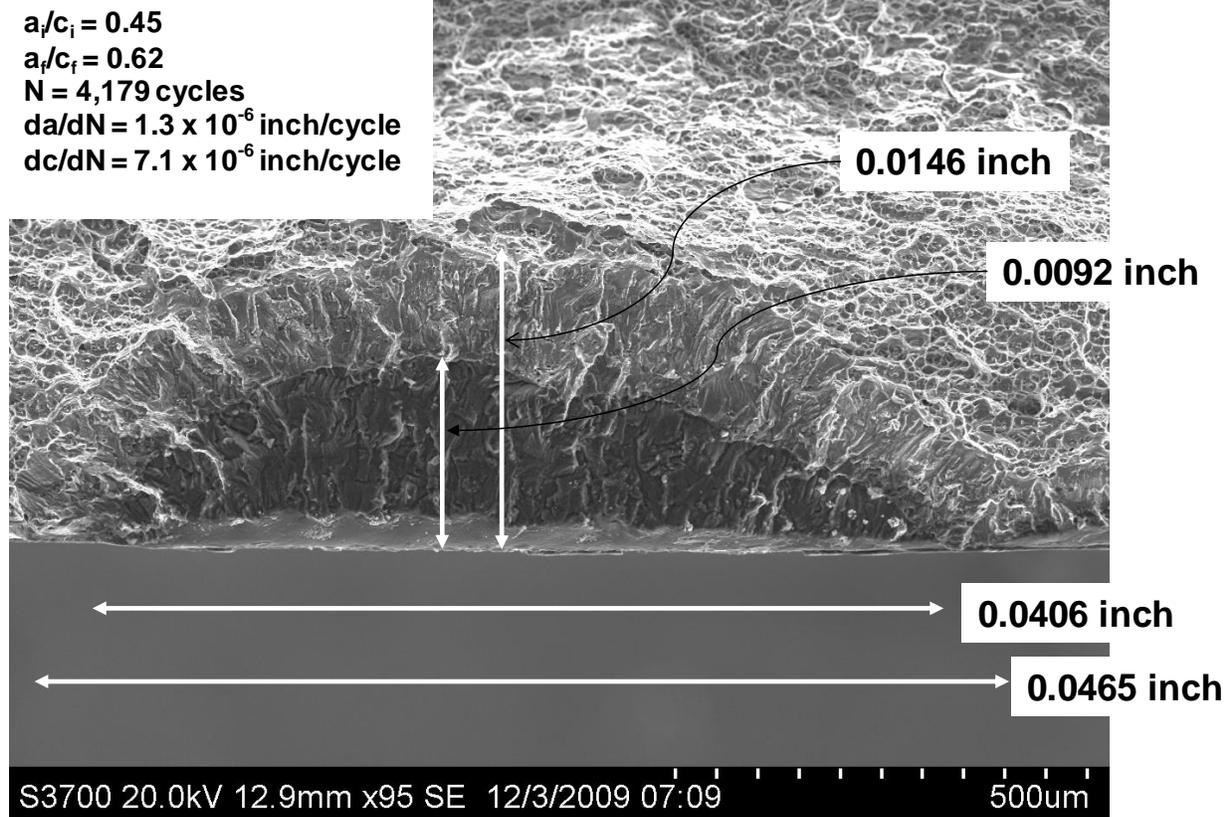
Figure C.32. SEM photograph (95x) of the interior crack ID3 found on the liner of COPV test 18119.

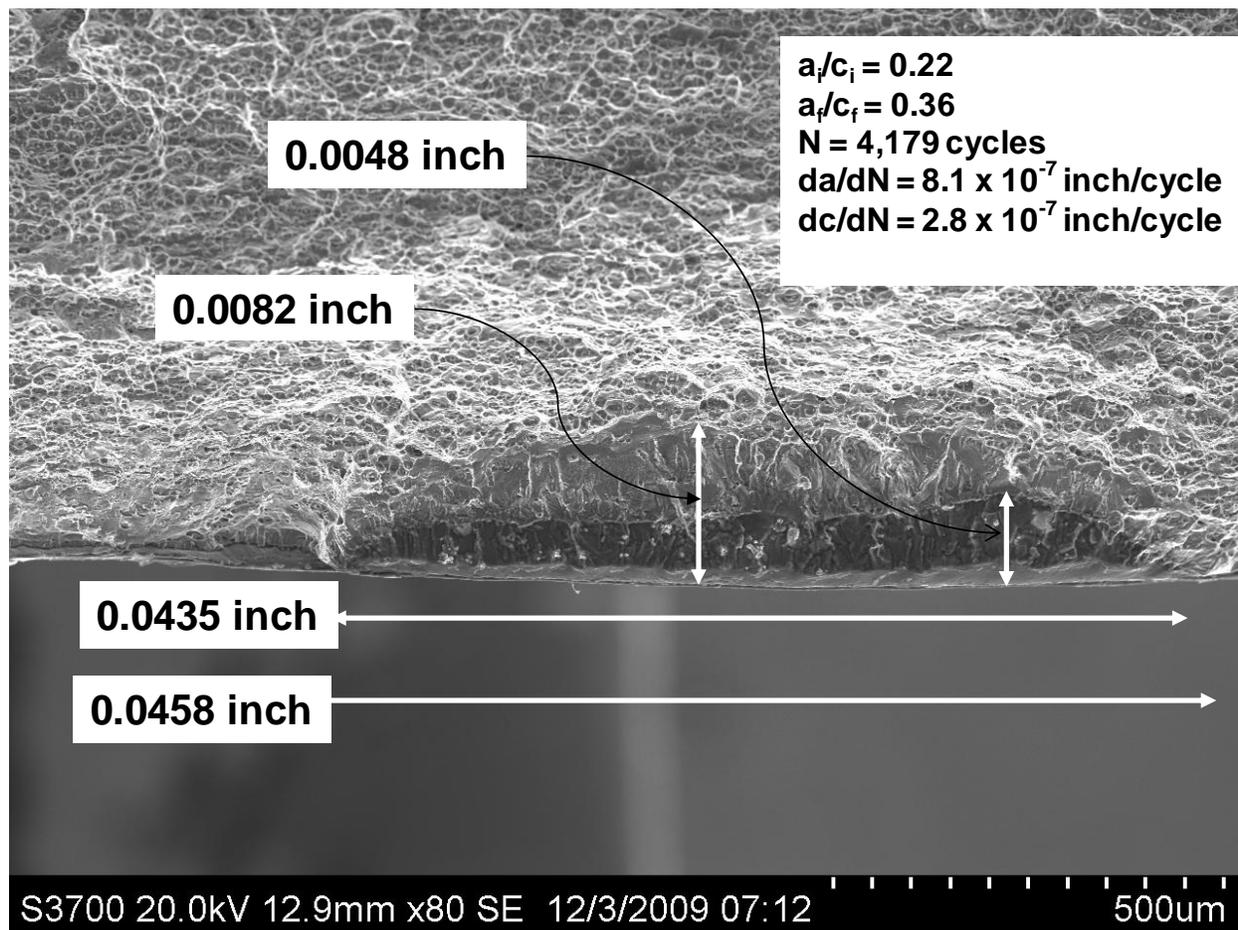
Figure C.33. SEM photograph (80x) of the interior crack ID4 found on the liner of COPV test 18119.

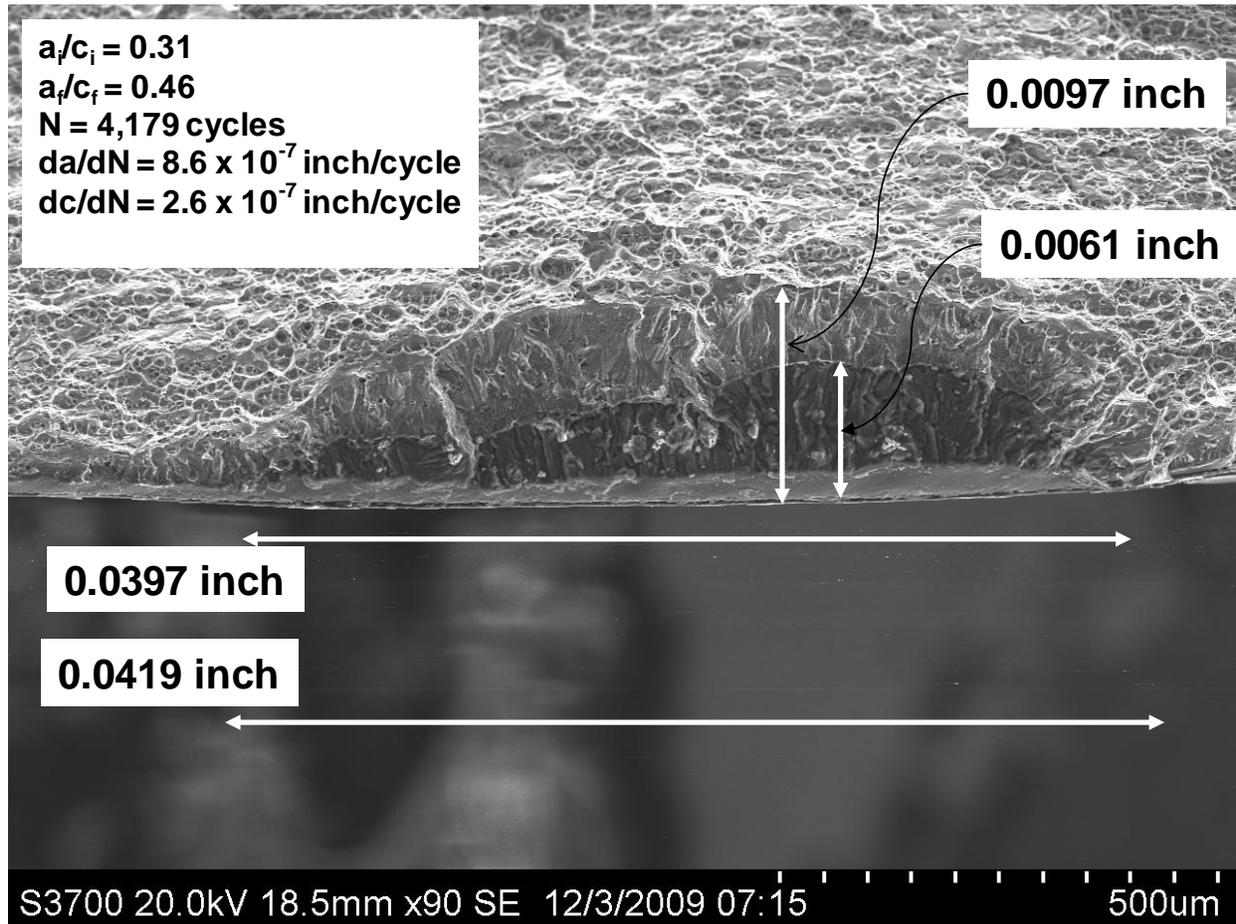
Figure C.34. SEM photograph (90x) of the interior crack ID5 found on the liner of COPV test 18119.

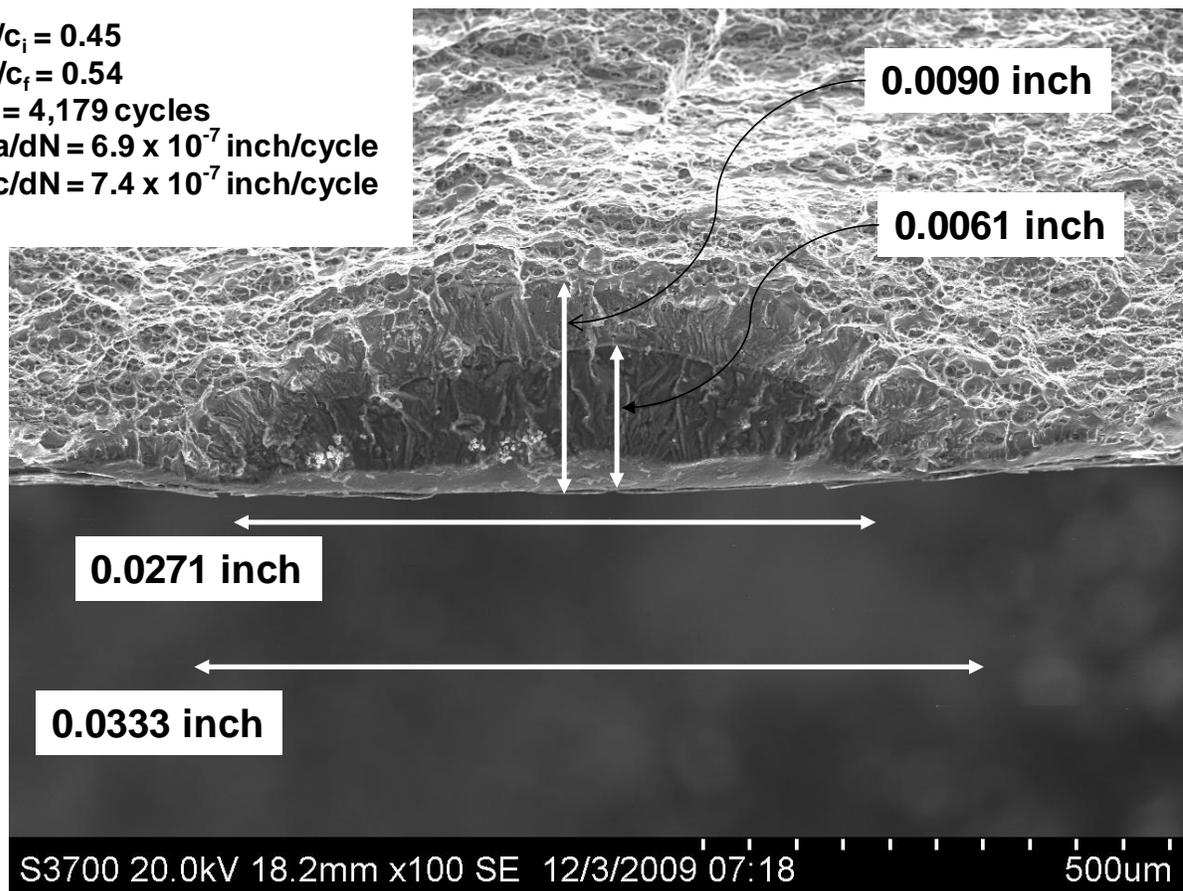
$$da/dN = 6.9 \times 10^{-7} \text{ inch/cycle}$$

$$dc/dN = 7.4 \times 10^{-7} \text{ inch/cycle}$$

Figure C.35. SEM photograph (100x) of the interior crack ID6 found on the liner of COPV test 18119.

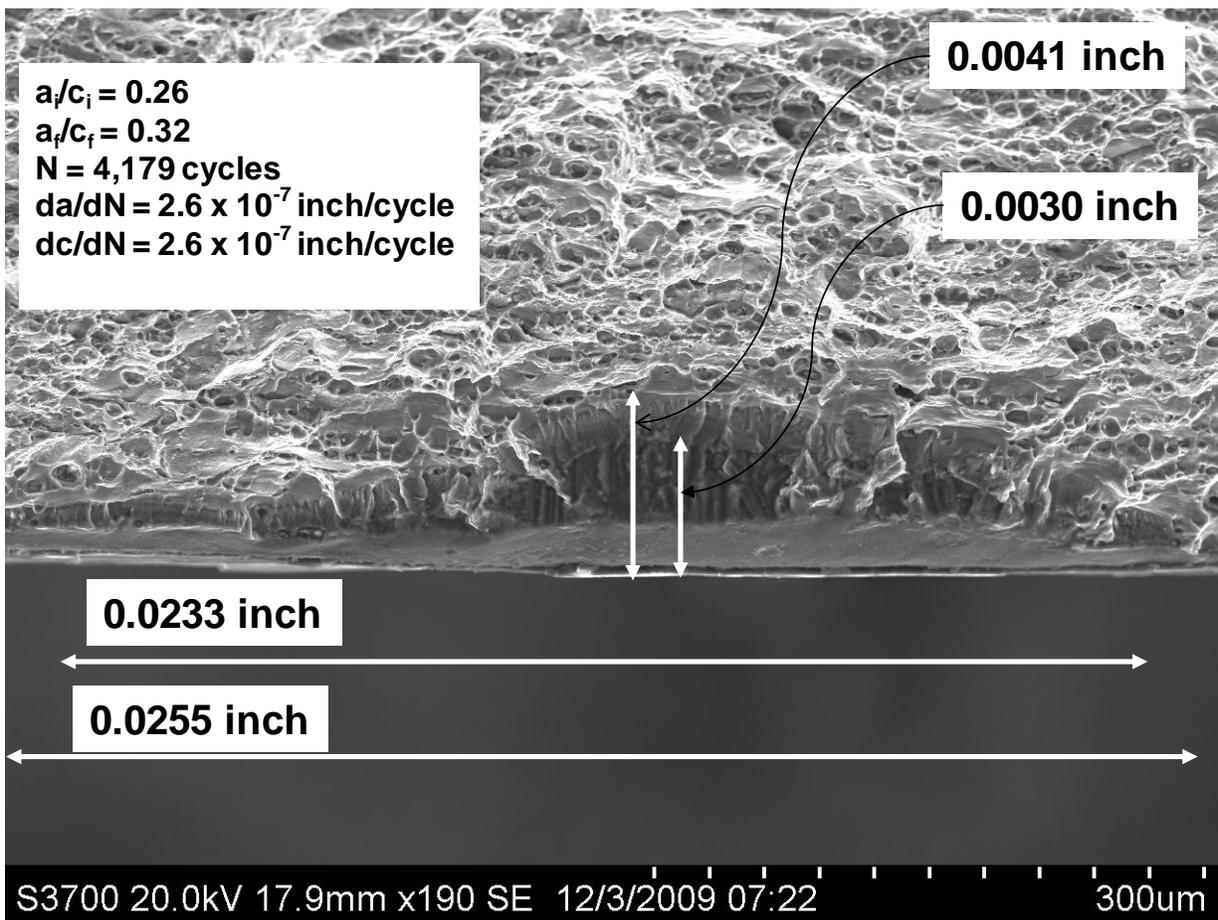
Figure C.36. SEM photograph (190x) of interior crack ID7 found on the liner of COPV test 18119.

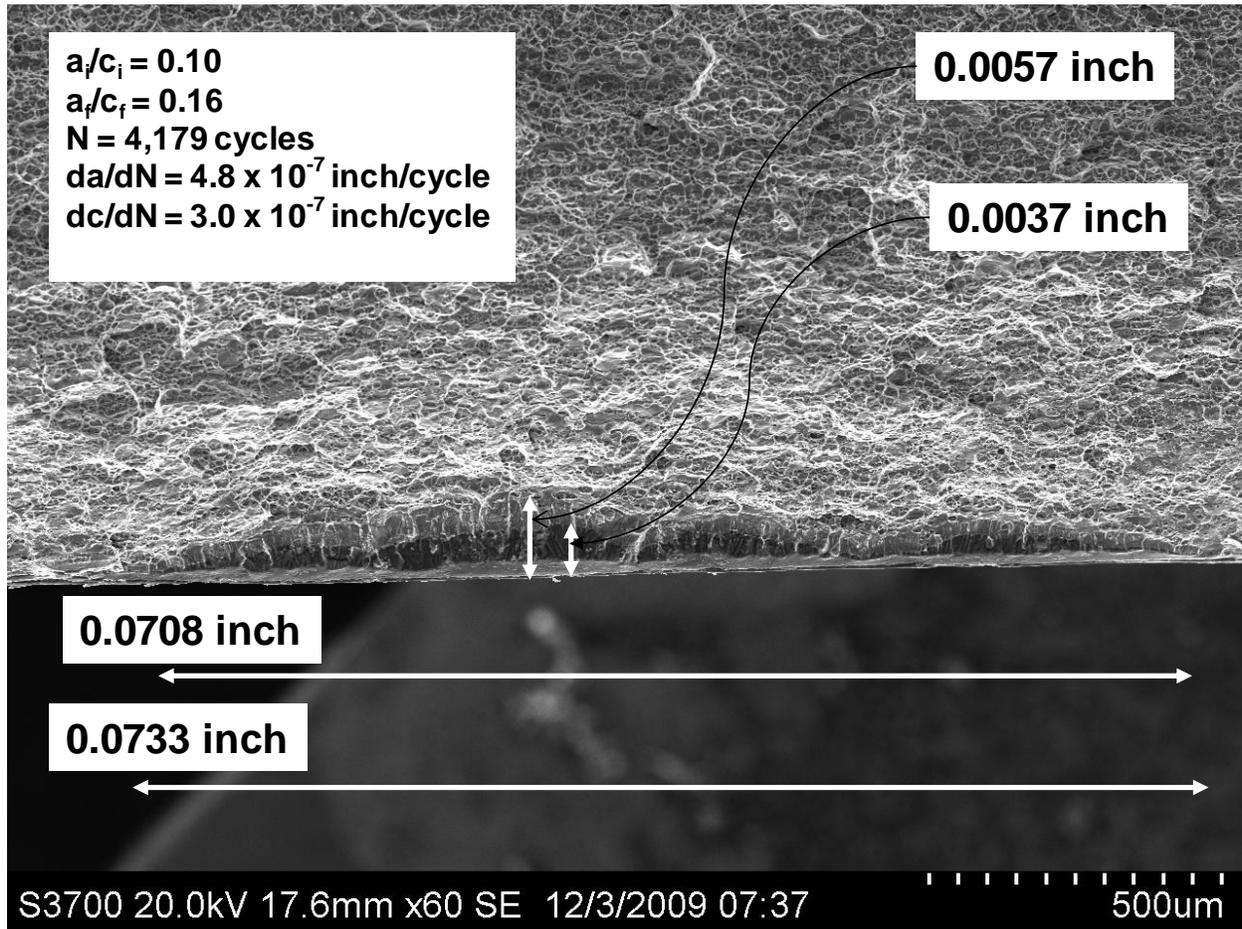
Figure C.37. SEM photograph (60x) of the interior crack ID8 found on the liner of COPV test 18119.

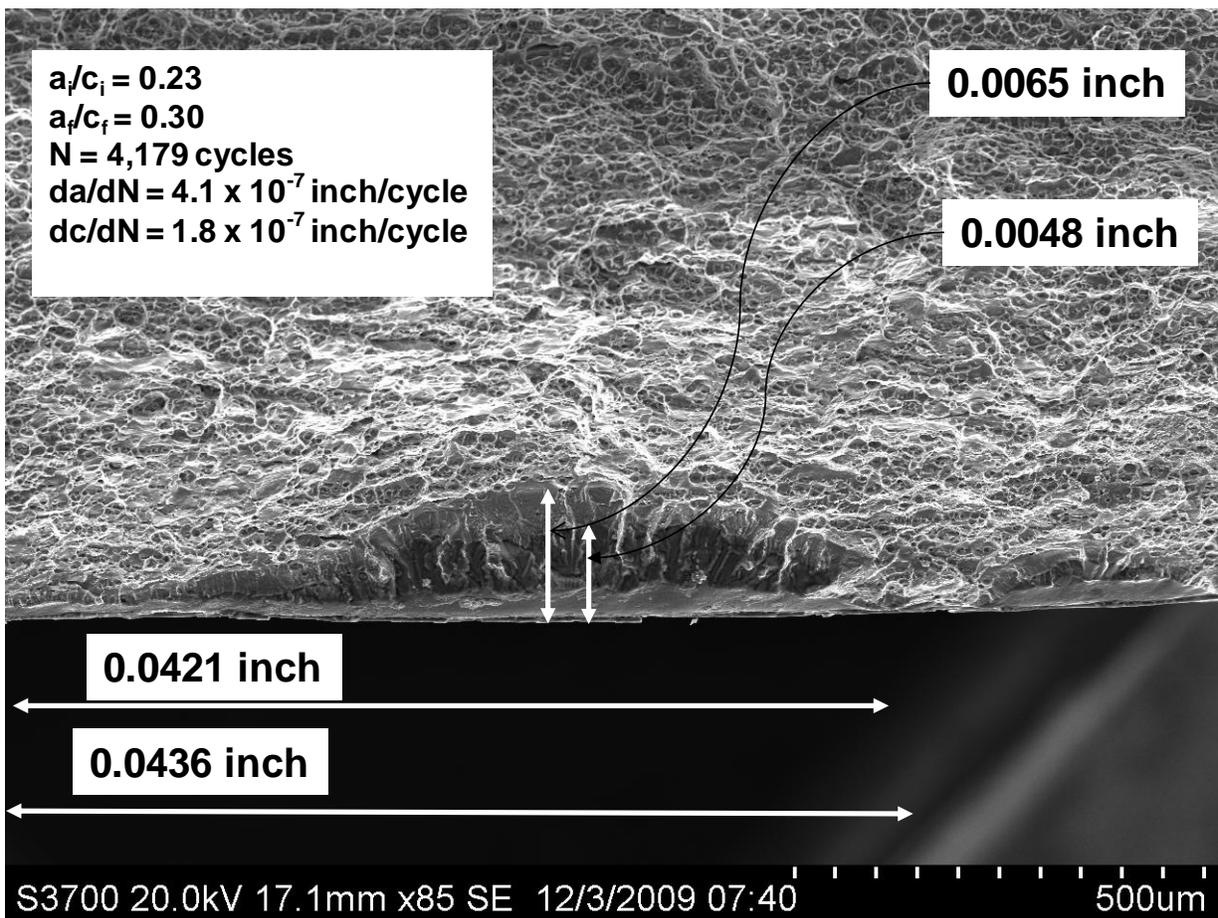
Figure C.38. SEM photograph (85x) of the interior crack ID9 found on the liner of COPV test 18119.

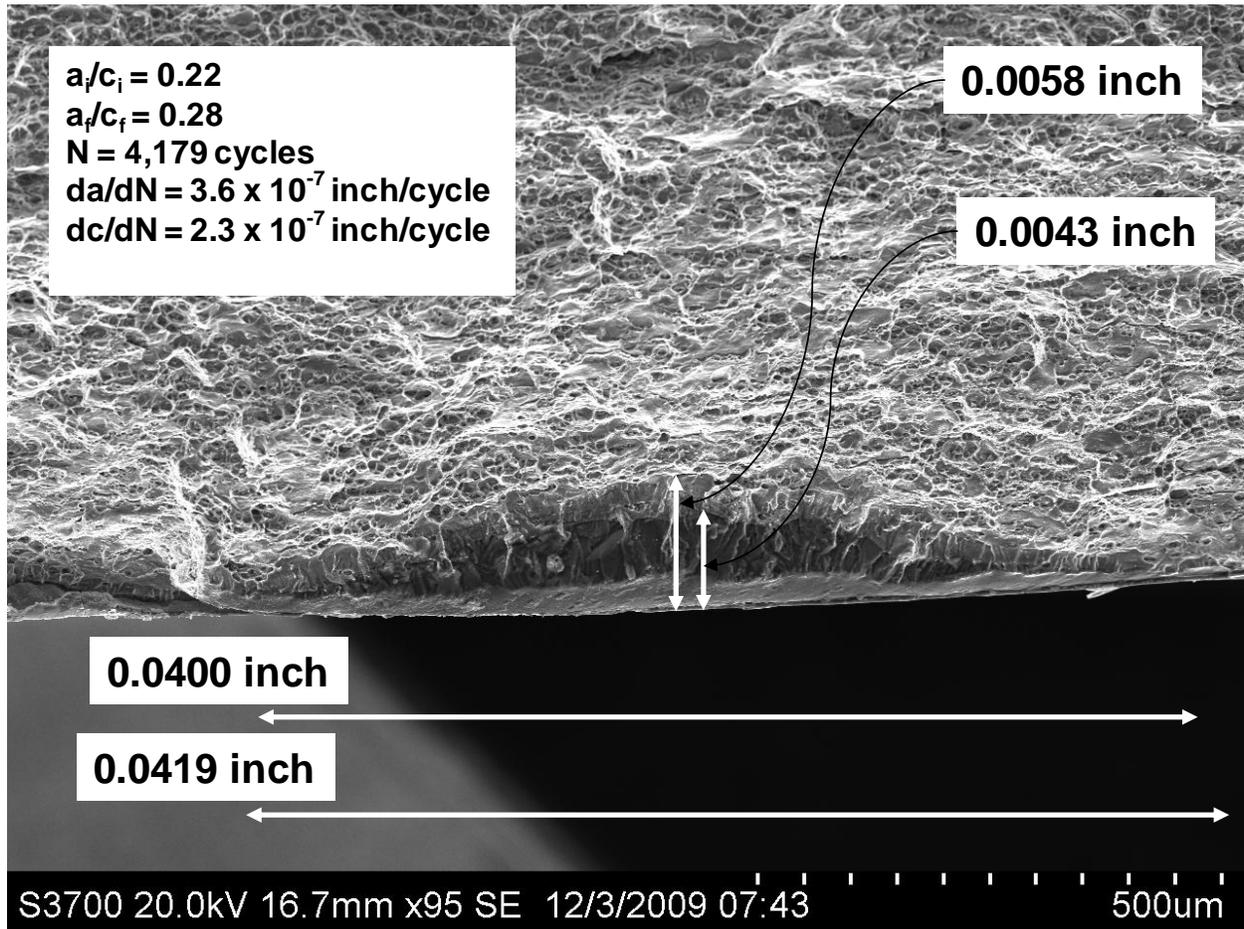
Figure C.39. SEM photograph (95x) of the interior crack ID10 found on the liner of COPV test 18119.

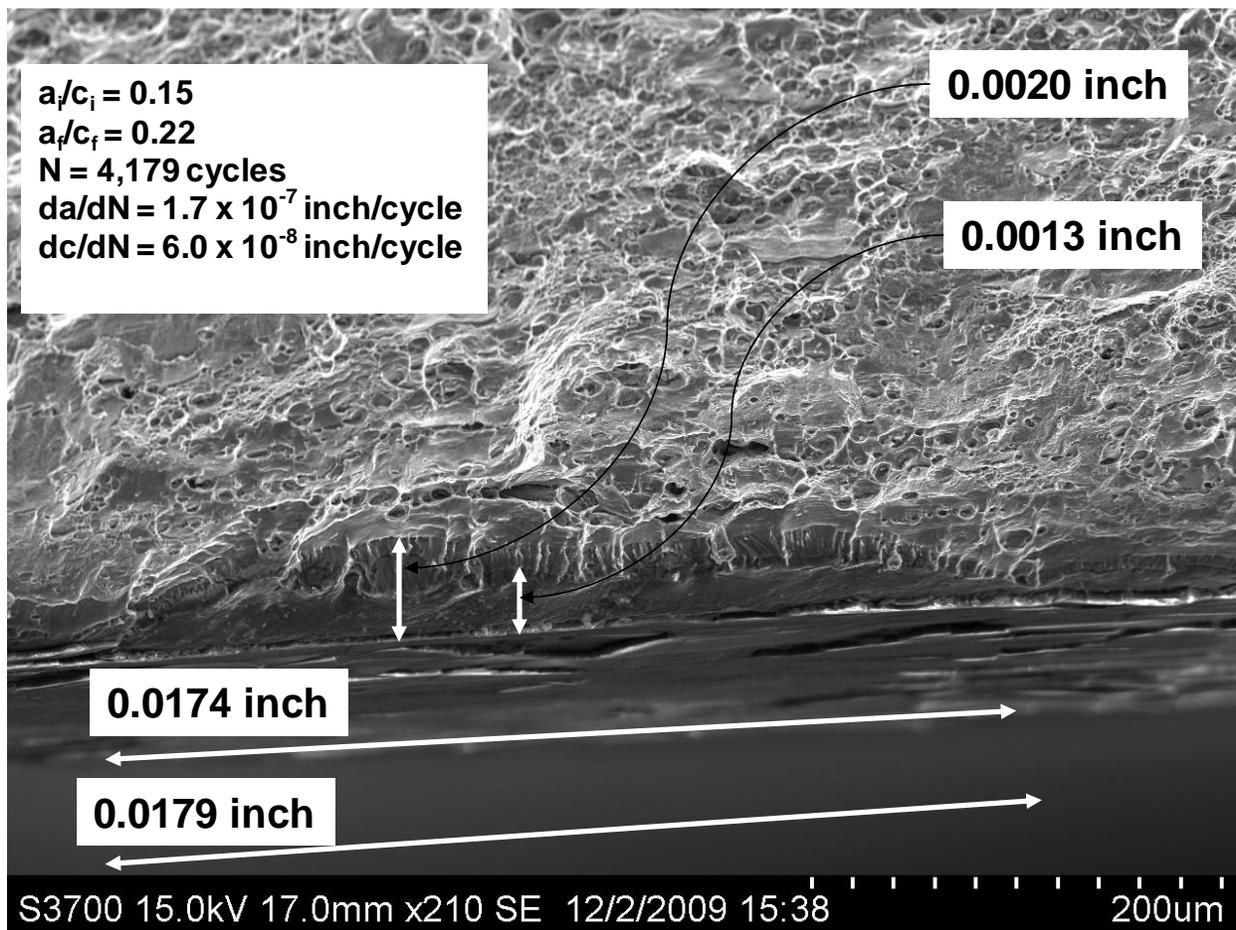
Figure C.40. SEM photograph (210x) of the interior crack ID11 found on the liner of COPV test 18119.

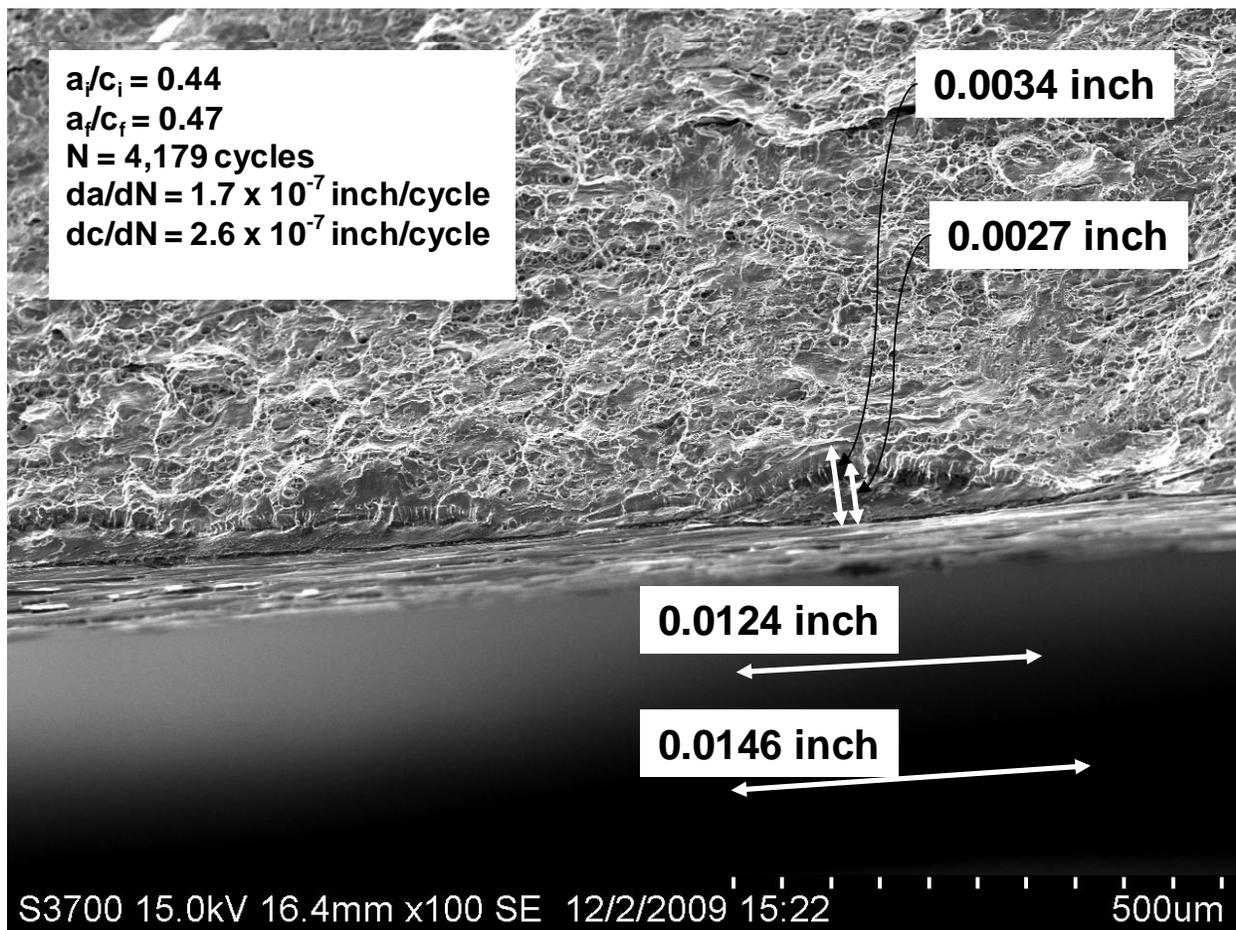
Figure C.41. SEM photograph (100x) of the interior crack ID12 found on the liner of COPV test 18119.

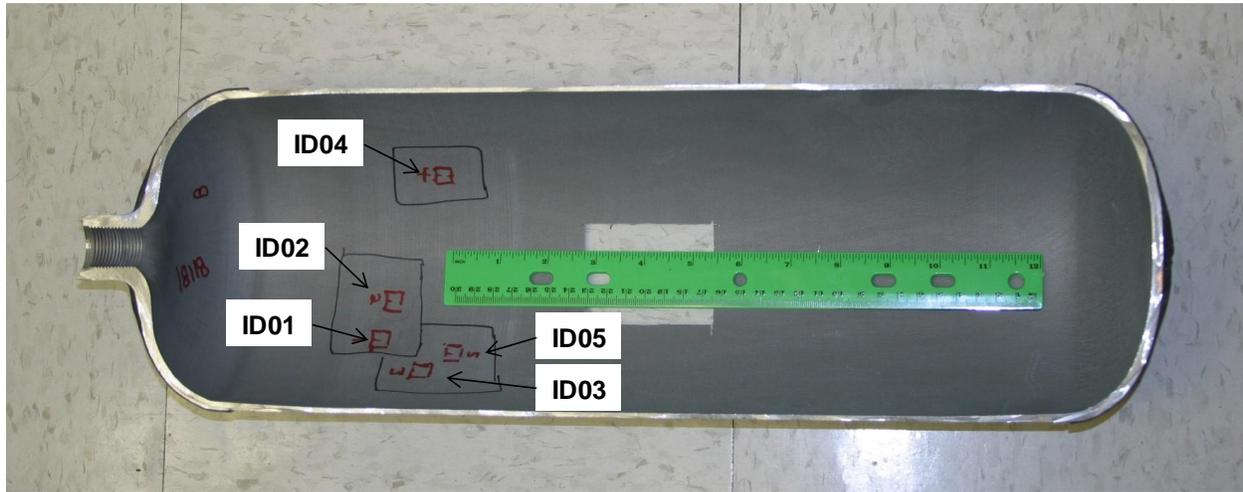
Figure C.42. Locations of the interior cracks found in the liner of COPV 18118.

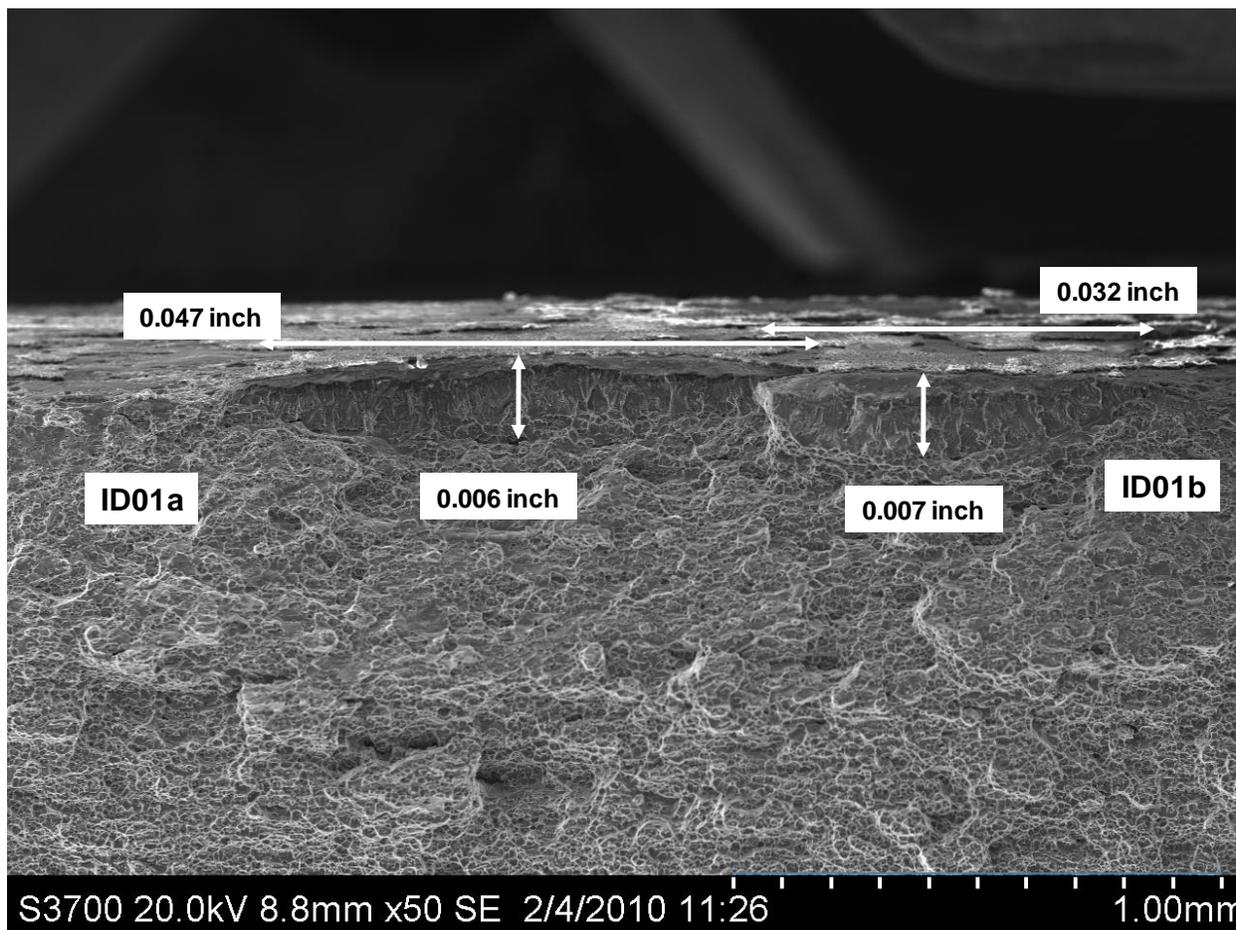
Figure C.43. SEM photograph (50x) of the interior cracks ID01a and ID01b found on the liner of COPV test 18118.

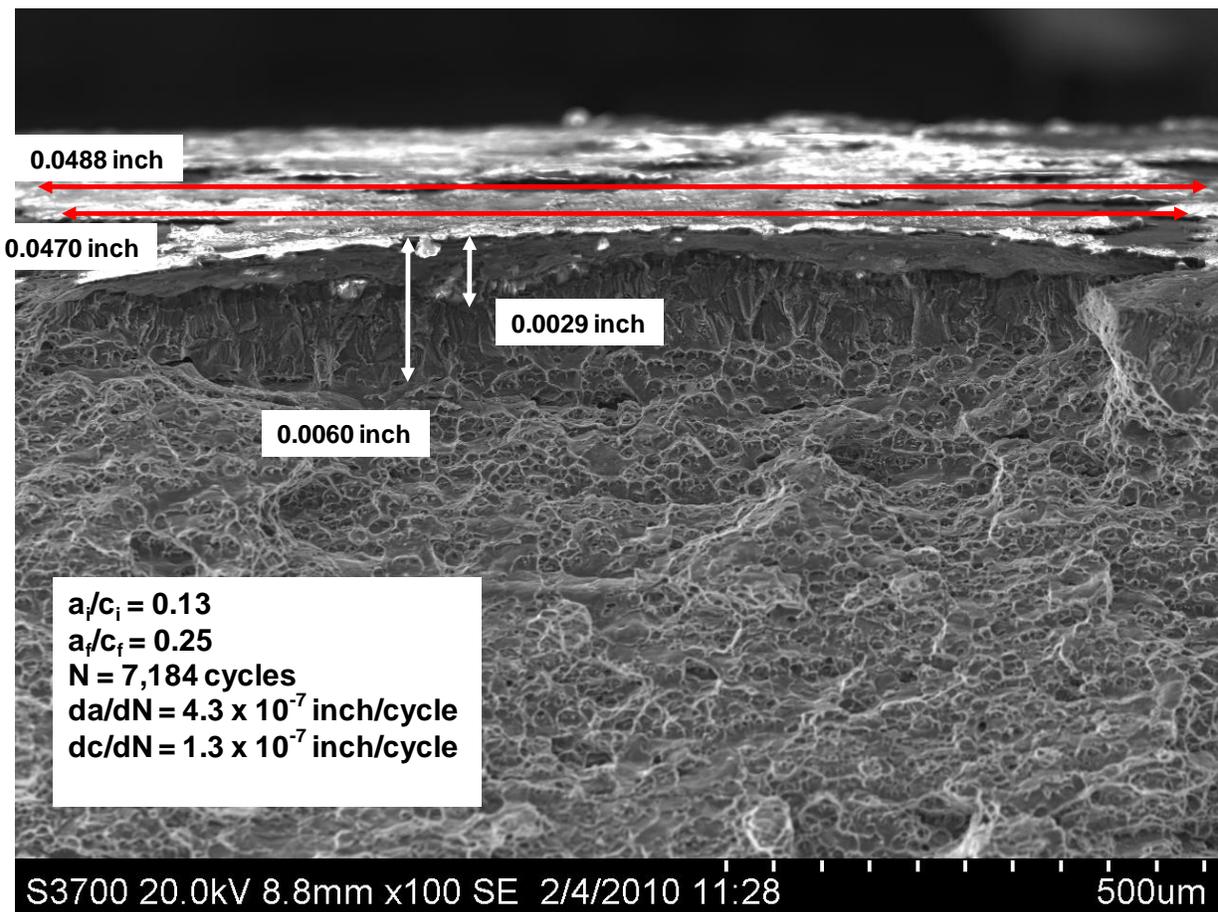
Figure C.44. SEM photograph (100x) of the interior crack ID01a found on the liner of COPV test 18118.

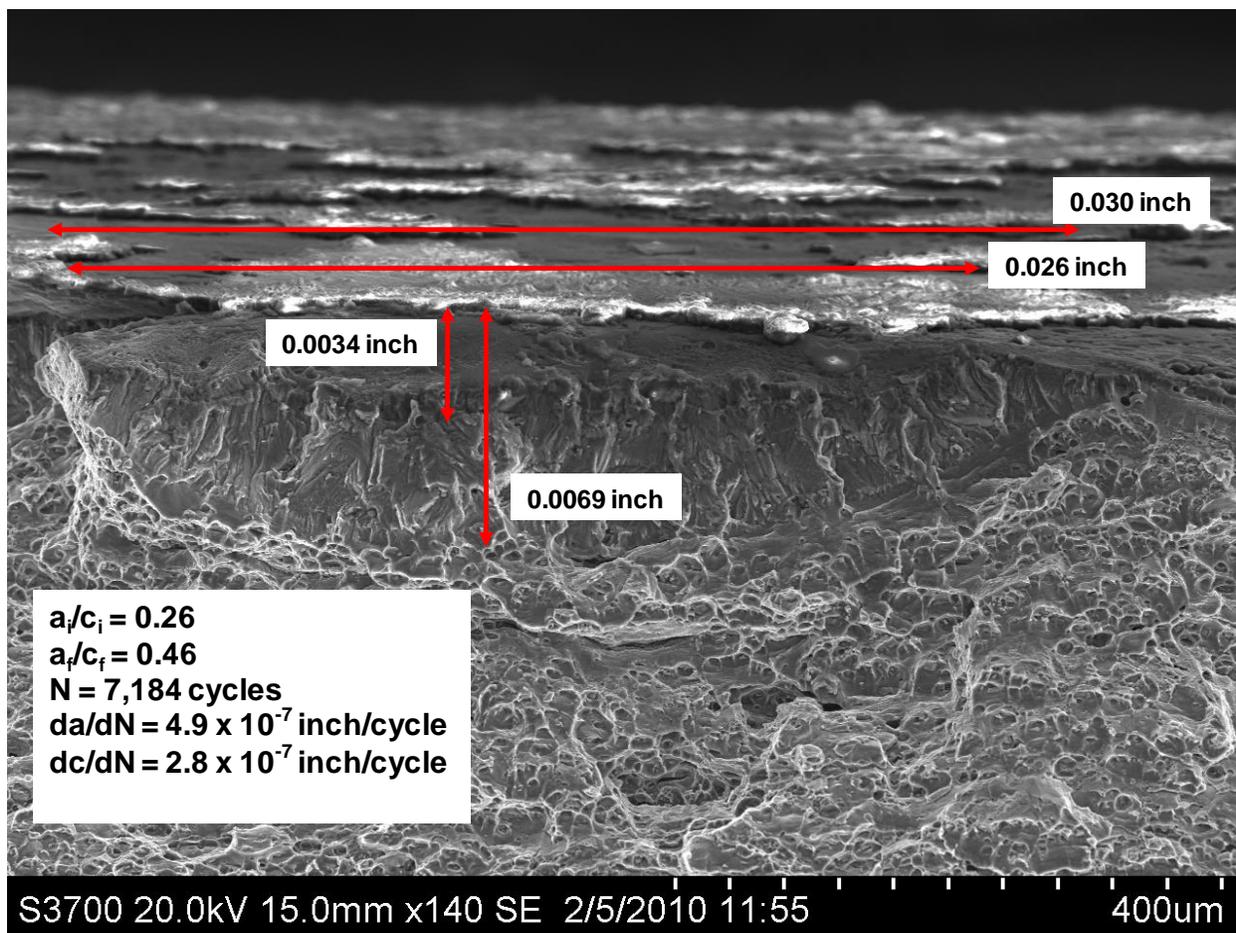
Figure C.45. SEM photograph (140x) of the interior crack ID01b found on the liner of COPV test 18118.

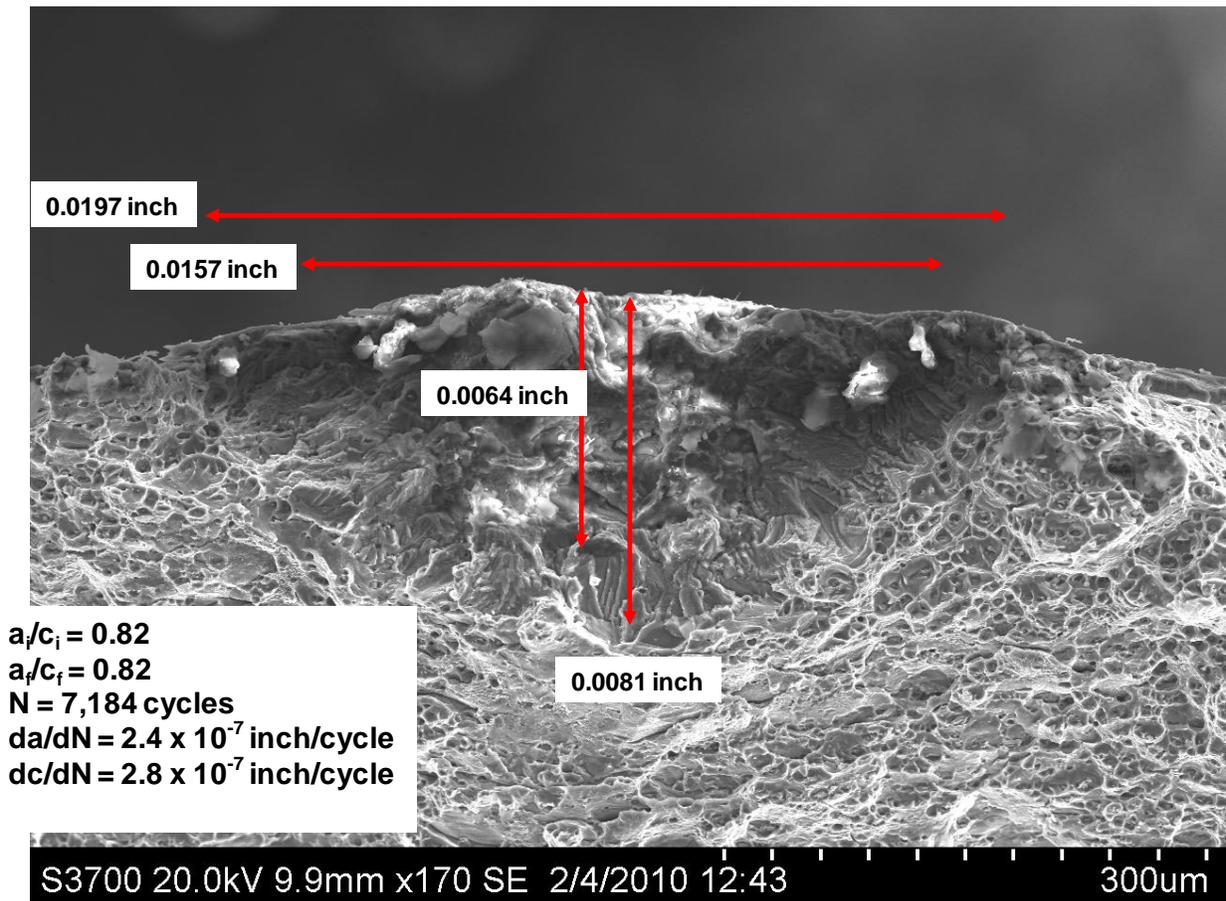
Figure C.46. SEM photograph (170x) of the interior crack ID02 found on the liner of COPV test 18118.

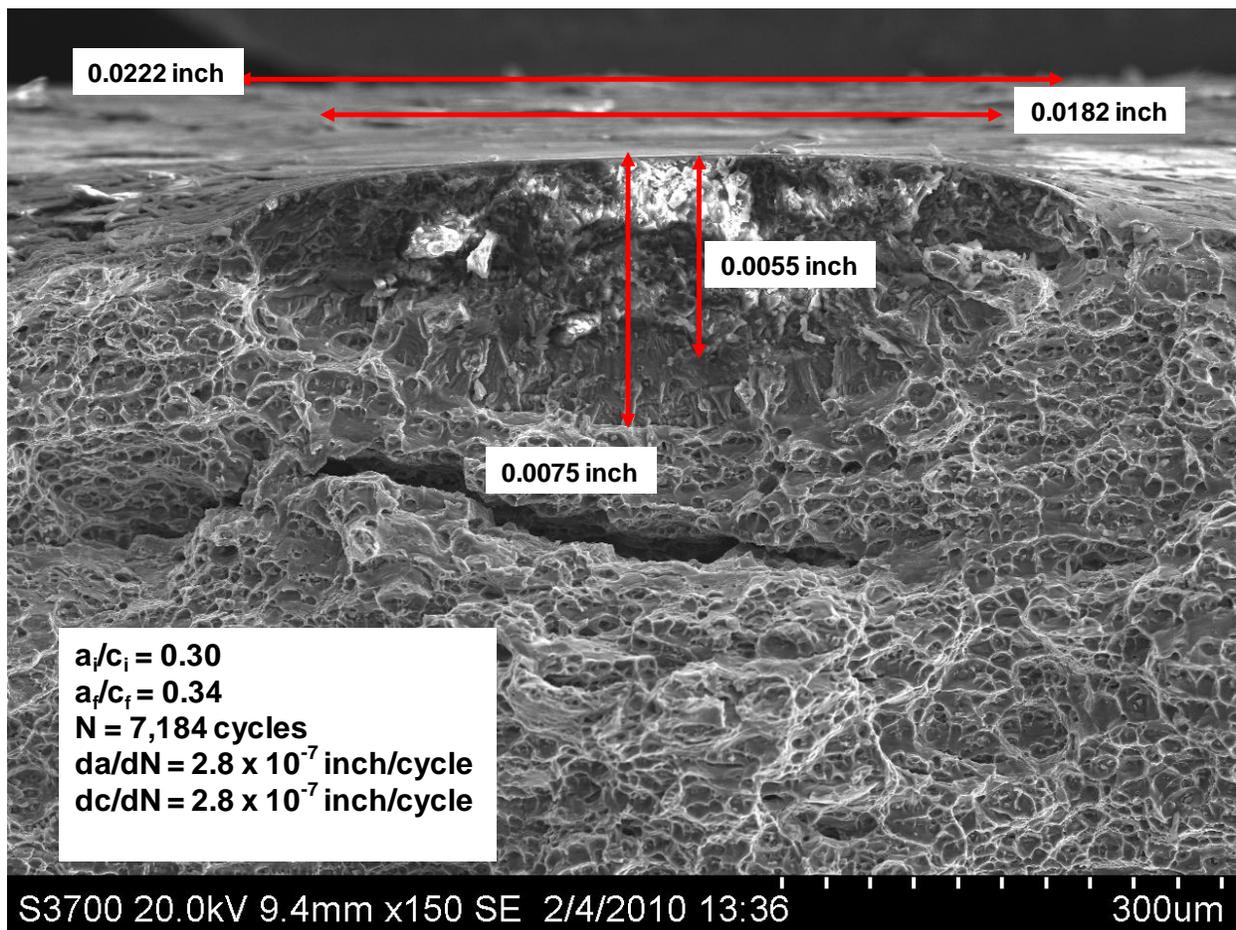
Figure C.47. SEM photograph (150x) of the interior crack ID04 found on the liner of COPV test 18118.

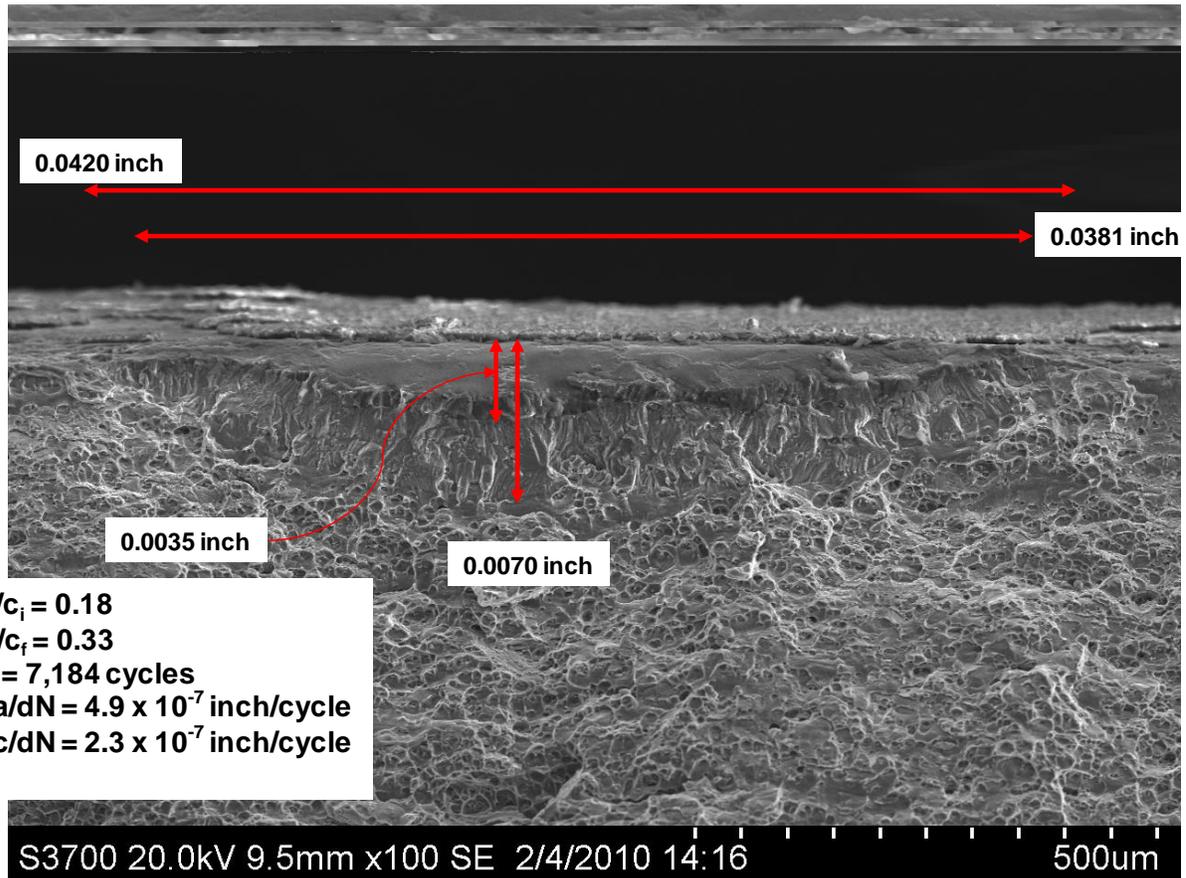
Figure C.48. SEM photograph (100x) of the interior crack ID05 found on the liner of COPV test 18118.
