Orion Inspection Planning - Lessons Learned Rev 4

**J. Michael Rollins Image Science and Analysis
Group (ISAG, JSC/KX, JETS contract)
john.m.rollins@nasa.gov (281-483-1262)
2014 In-space Inspection Workshop**

Inspection of Orion at ISS

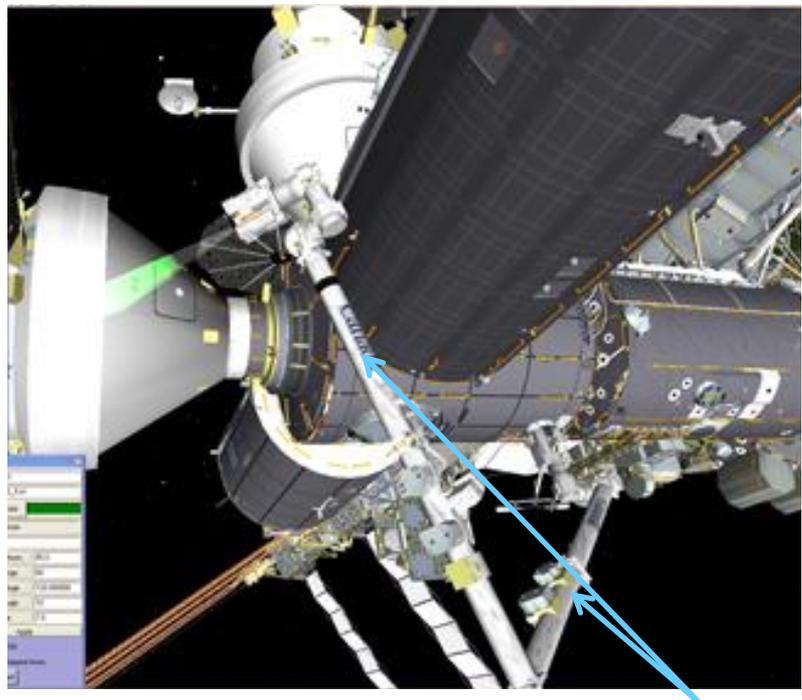
Survey Inspection of the MPCV at Node 2 Forward

Space Station Remote Manipulator System (SSRMS) arm, based at the Node 2 Power/Data Grapple Fixture (PDGF) with Latching End Effector (LEE)-based MSS Camera inspecting the Crew Module

Here, the SSRMS end-effector camera, a Mobile Servicing System (MSS) type, is being used for the survey inspection.

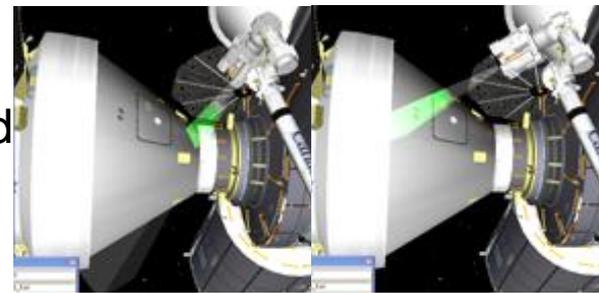
Starboard sweep

Here, the SSRMS has grappled Dextre, an ISS external robot which also has several MSS-type cameras.

The illuminators built near the MSS camera lines of sight have been more dependable on Dextre than on the SSRMS end effector.

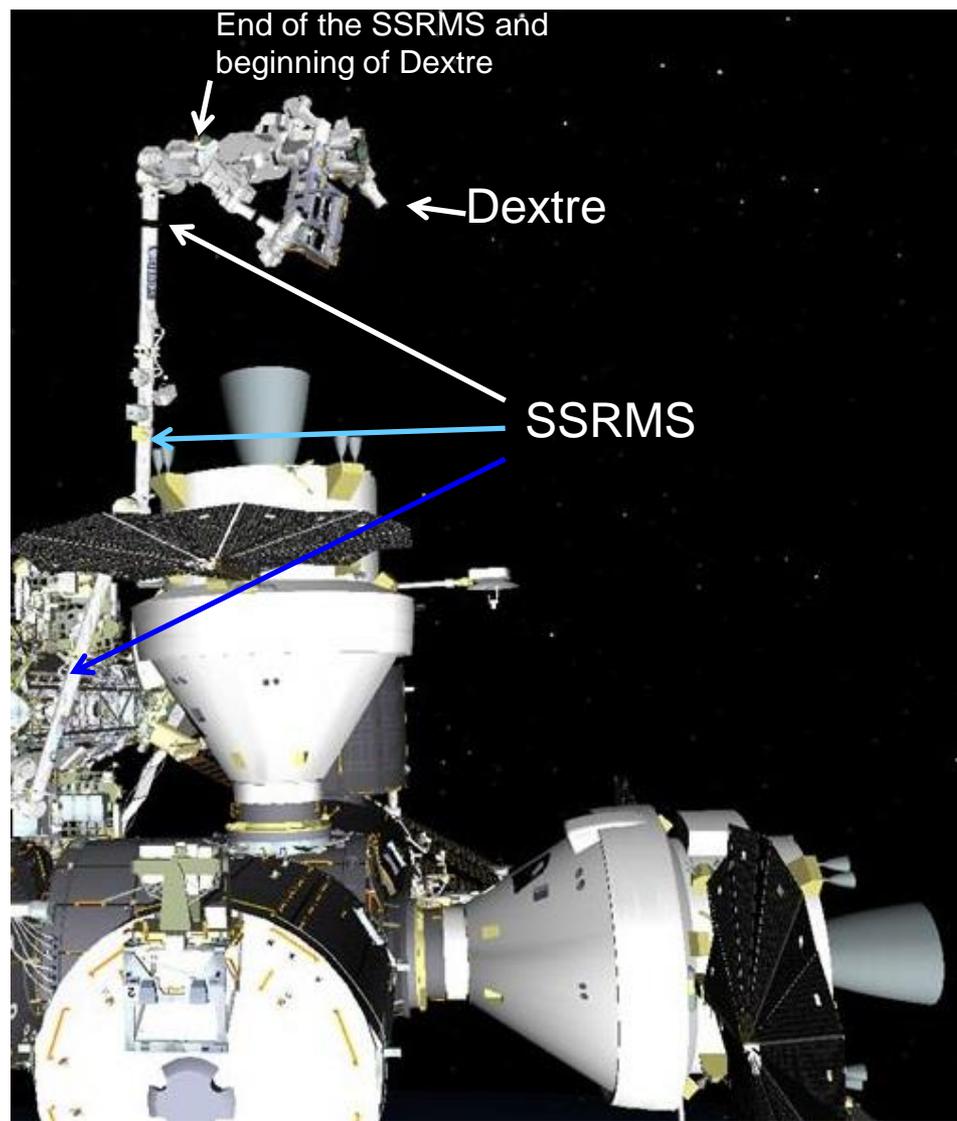
With the SSRMS based on the Mobile Base System (MBS) platform, there is ample margin in reach for a TPS survey by the SSRMS cameras alone. Here, Dextre is also shown, attached to the end of the SSRMS.

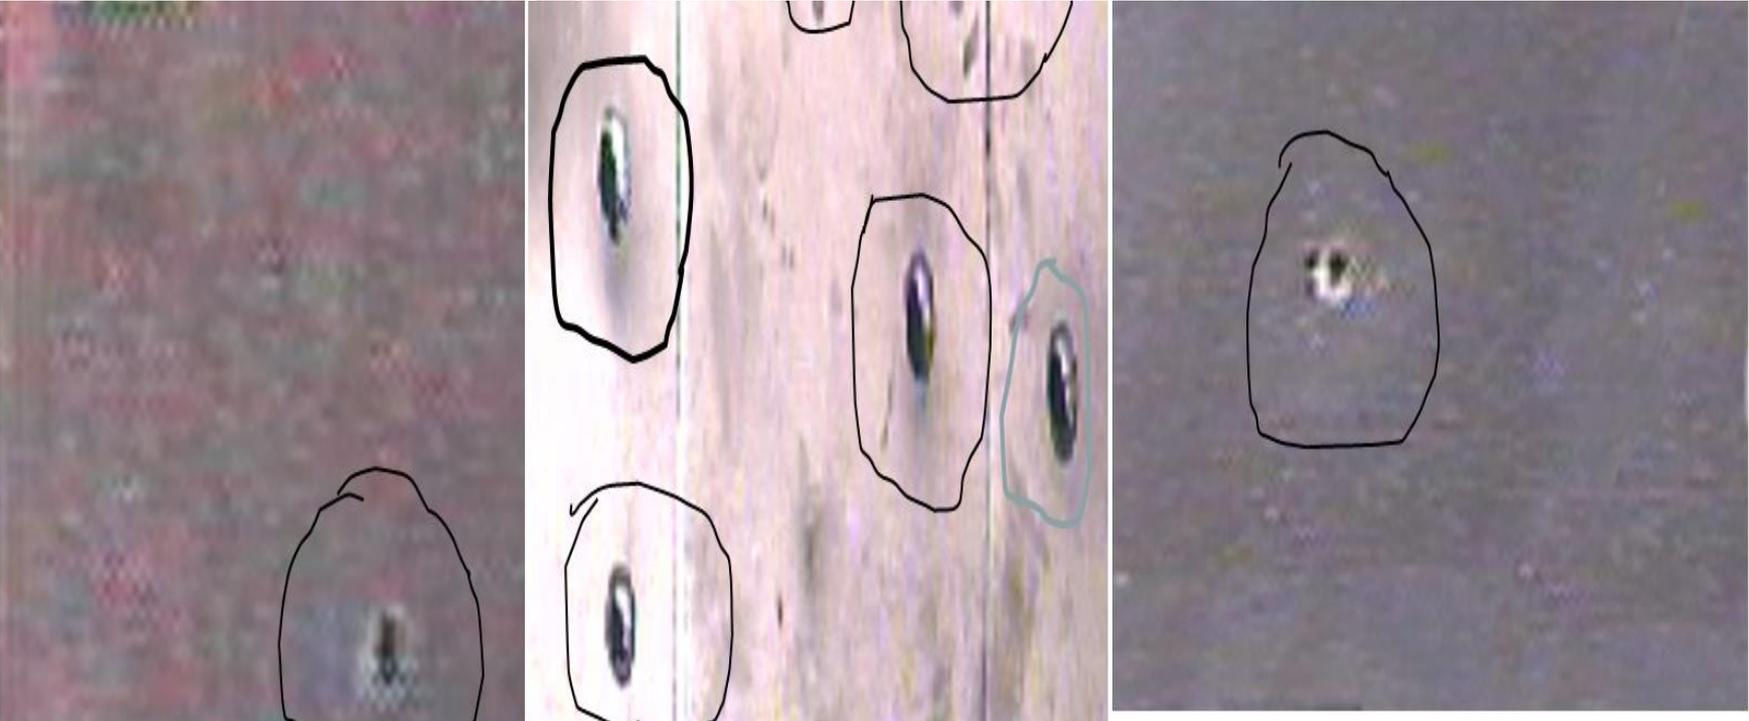
Sample MSS Camera Imagery under Mock Solar Illumination, with Screener Annotations

Example screener-annotated slide from a damage detection blind study in the Fall of 2010. The MSS images were captured under conditions equivalent to 10' range at full zoom (7.7 mm focal length) and simulated sunlight or MSS artificial illumination. The images were all subject to the degradation associated with the mockup ISS Video Baseband Signal Processor (VBSP)* which discarded an entire field of information (and therefore half of the vertical resolution). In 2013, the VBSP was replaced with newer technology with improved downlinked image quality.

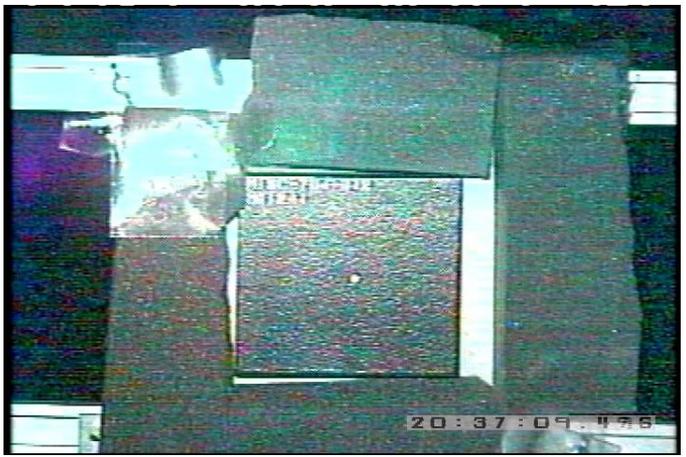
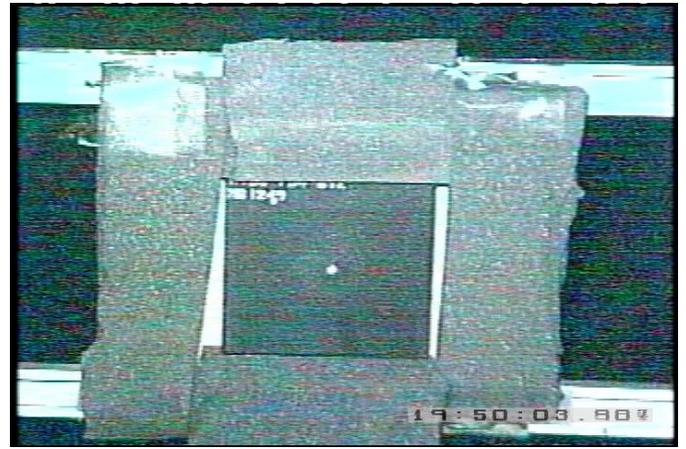
SSRMS and Dextre MSS-type Imager with Relevant* Line-of-sight (LOS) Illumination

Internal silica glows against entry hole rim, for both black and white (painted) tiles, given line-of-sight illumination. This gives evidence that **an actual entry hole is present**, and the suspect feature is not missed or considered just a blemish.

*Flight-similar illuminators were set up for this camera testing.

- High probability (>99%) of detection of critical damage likely with existing robotic ISS assets.
 - Full robotic-based surface coverage is anticipated.
 - High probability detection may require redundant, independent screening.
- White painted tile superior to black tile for MMOD damage detection
- Line-of-sight illumination preferable
 - Causes core material to “glow” through entry hole

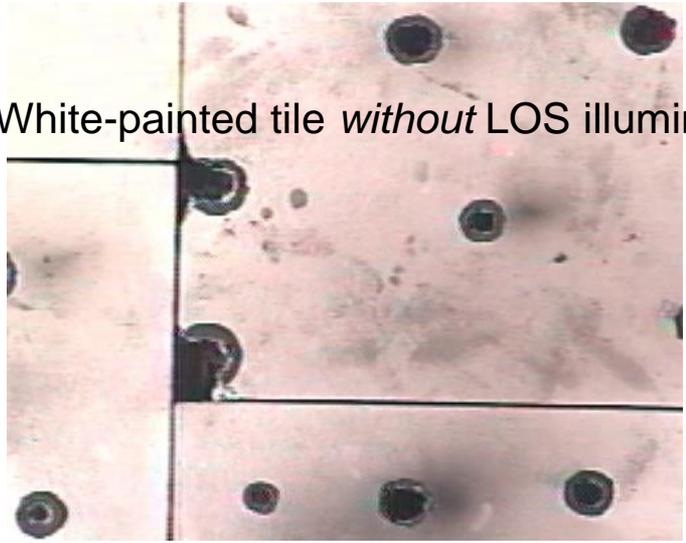
White-painted tile *without* LOS illumination

In 2010, white-painted tiles were considered the most likely after the first Orion mission.

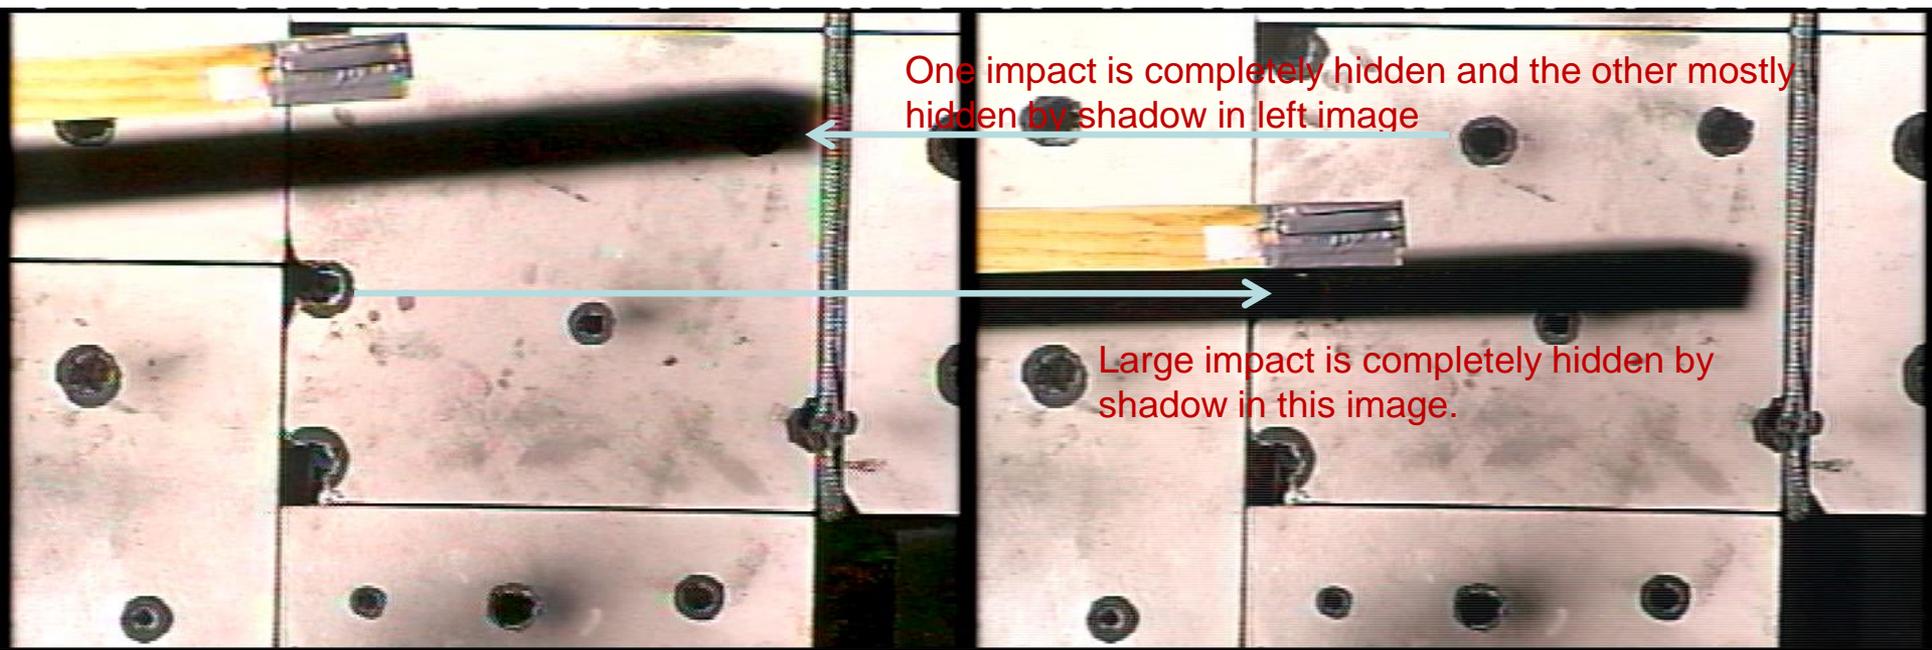
Problem: For MSS-type imagers, operating in daylight, passing shadows can completely obscure damage

Day with high-contrast “sun” shadow another entry hole and nearly covering a third (see left image for reference).

Day with high-contrast “sun” shadow covering an entry hole (see right image for reference).

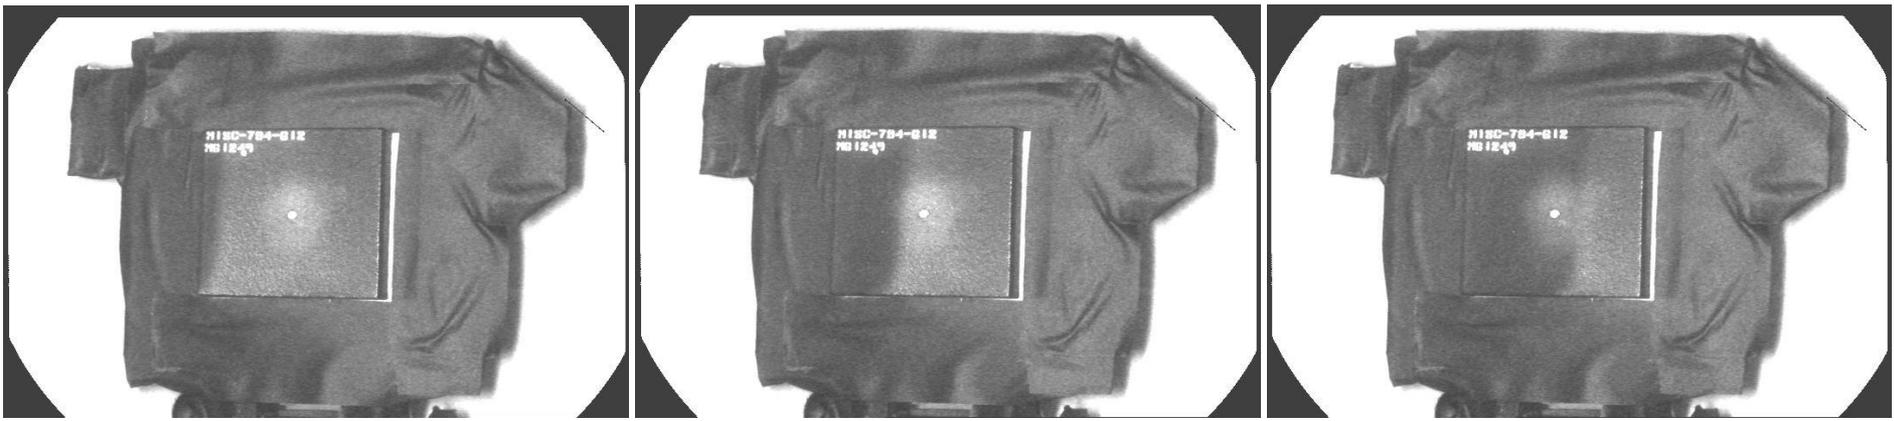
Sample LDRI Imagery

Sequences of "Level-1" LDRI Images for which a simulation of hardware shadowing the "sun" is demonstrated. Note that both tile impact features (the impact in the center and the impact adjacent to the serial numbers) remain clearly visible and detectable regardless of the progress of the shadow.

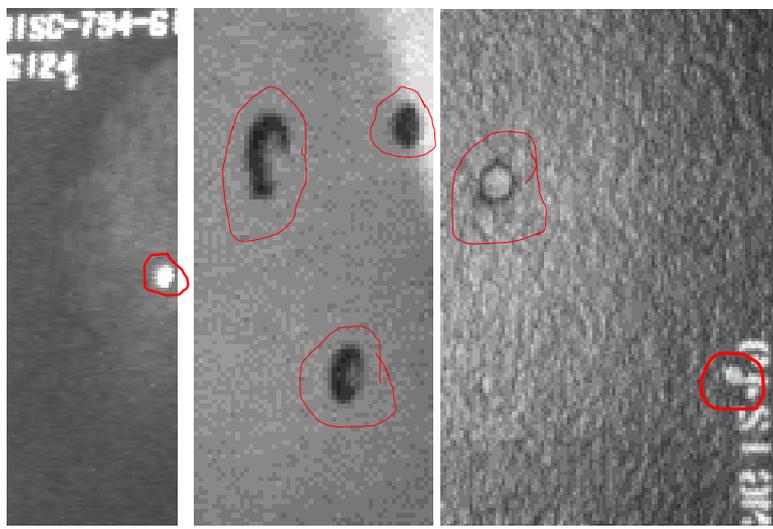
Example Hypervelocity-impact Entry Holes and Annotations by Screeners in Blind/Subjective Detection Testing. Note a small entry hole (diameter 0.19") in the upper-left by the serial numbers that was not circled. The larger entry hole in that image (the one that was circled) has a diameter of 0.27". The left and right images are of black tile cases and the center image shows a white tile. All three images have an impact with a diameter on the order of 0.25".

- **Derived Survey Inspection Criteria**
 - Must detect 0.25”-diameter entry hole. Entry holes smaller than that were not believed to be associated with any of the TPS failure criteria.

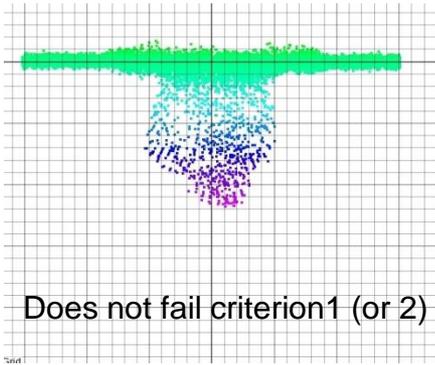
LCS* 3D Point Clouds: Elevation Views

Does not fail criterion1 (or 2)

- 1) Allowable depth of tile penetration (location dependent specific values)
- 2) Allowable area of Strain Isolation Pad (SIP) penetration (a specific value that was relevant during the study). The SIP is immediately under the tile.
- 3) Allowable degree of core buckling (currently zero core buckling allowed).

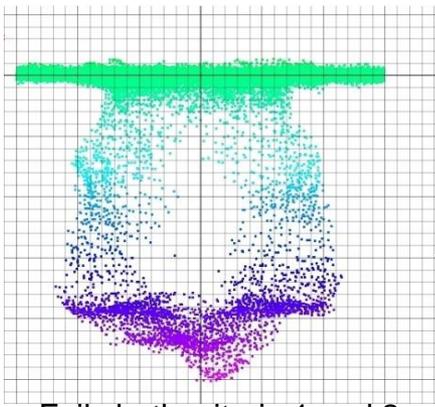
Fails both criteria 1 and 2

Top of SIP layer

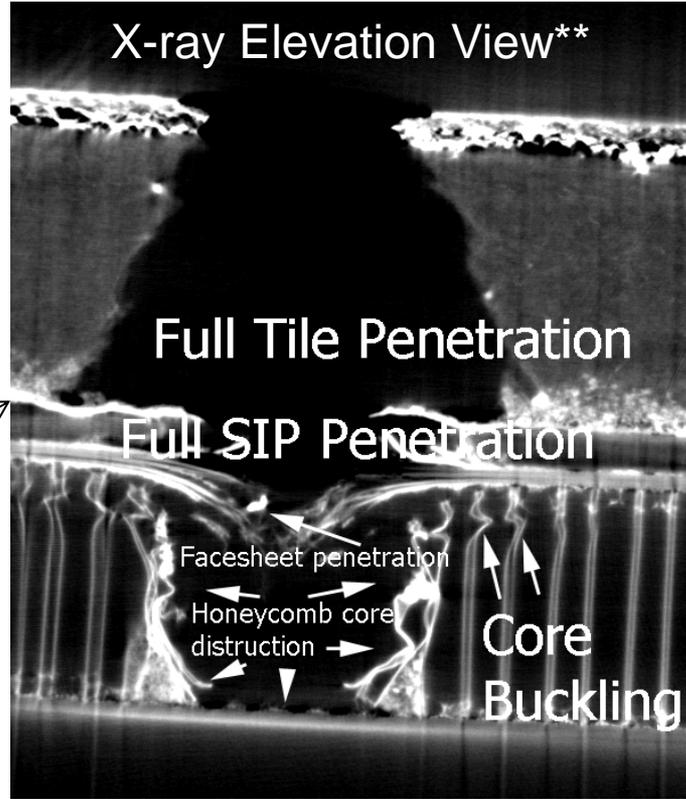
(Fails criterion 3 as well)

*The LCS flew on the Space Shuttle, but is not present on the ISS.

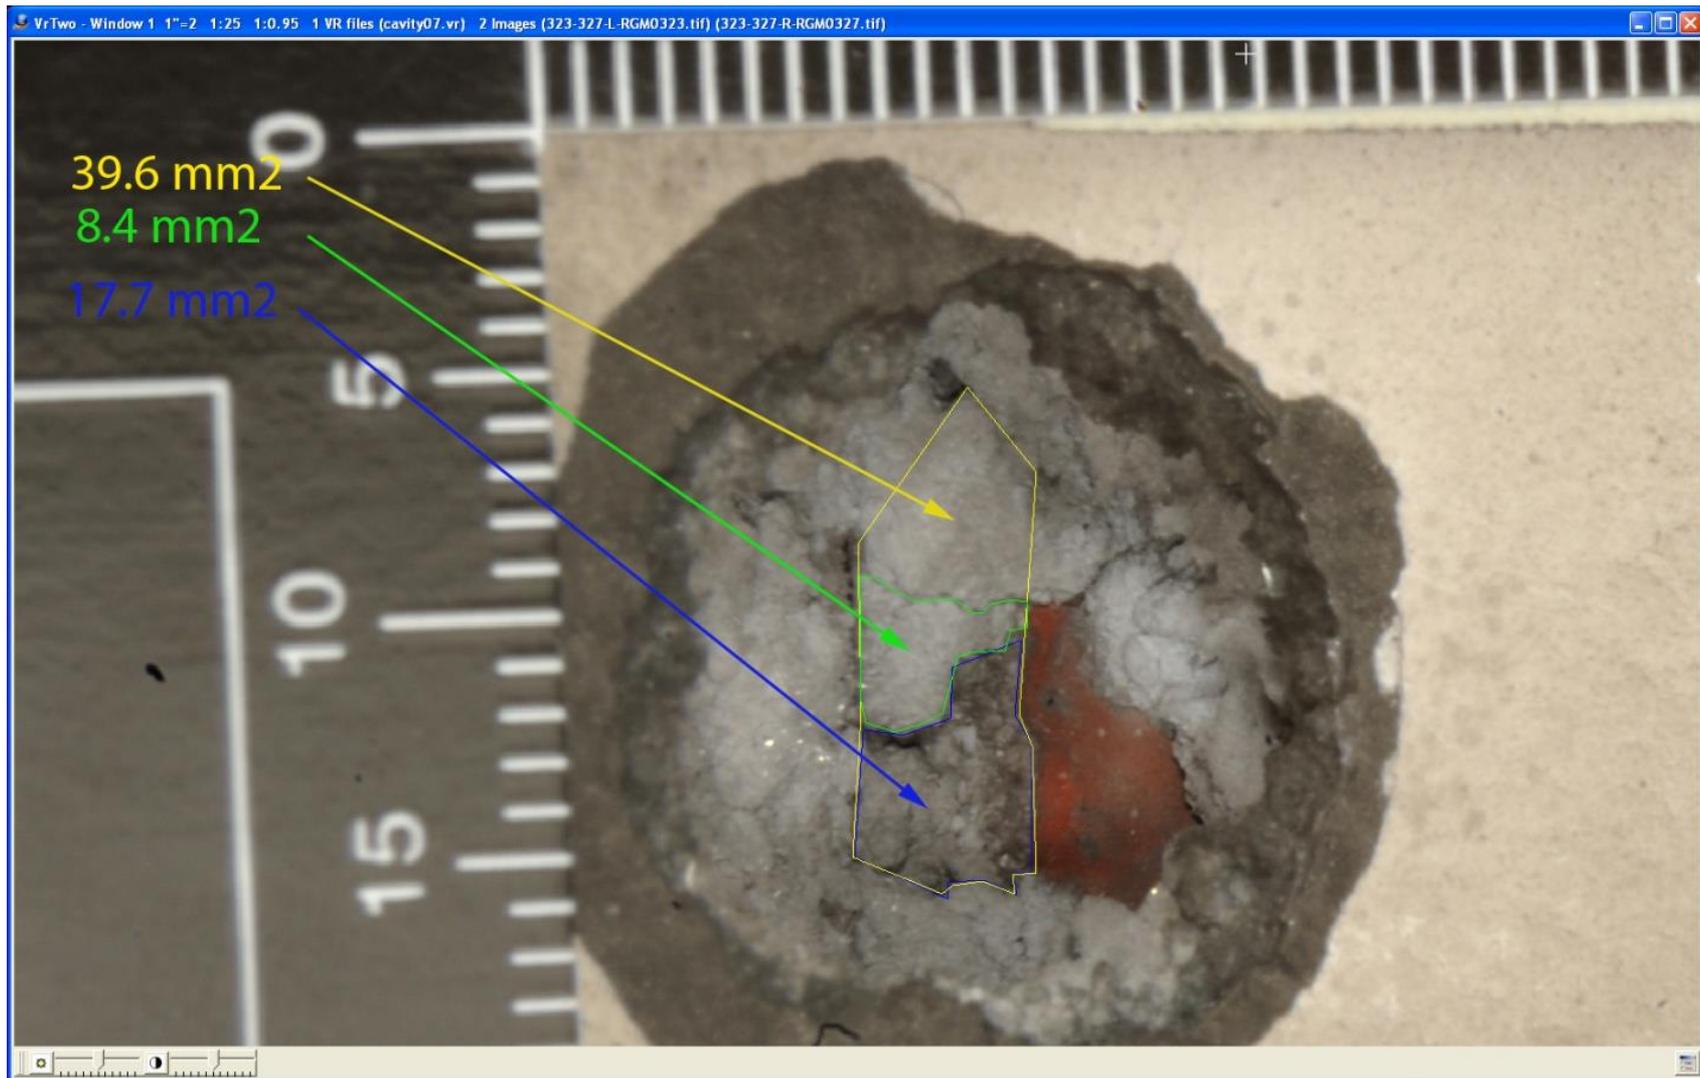
Damage Example: Image of Tile Damage Showing Various Material Layers Down to the Top of the SIP (Red)

Impact 7 single image, with image-analyst annotations obtained via stereo photogrammetry analysis of an image pair. The bottom segment, indicated with the blue arrow, has an area of 17.7 sq mm or 0.0274 sq. in.

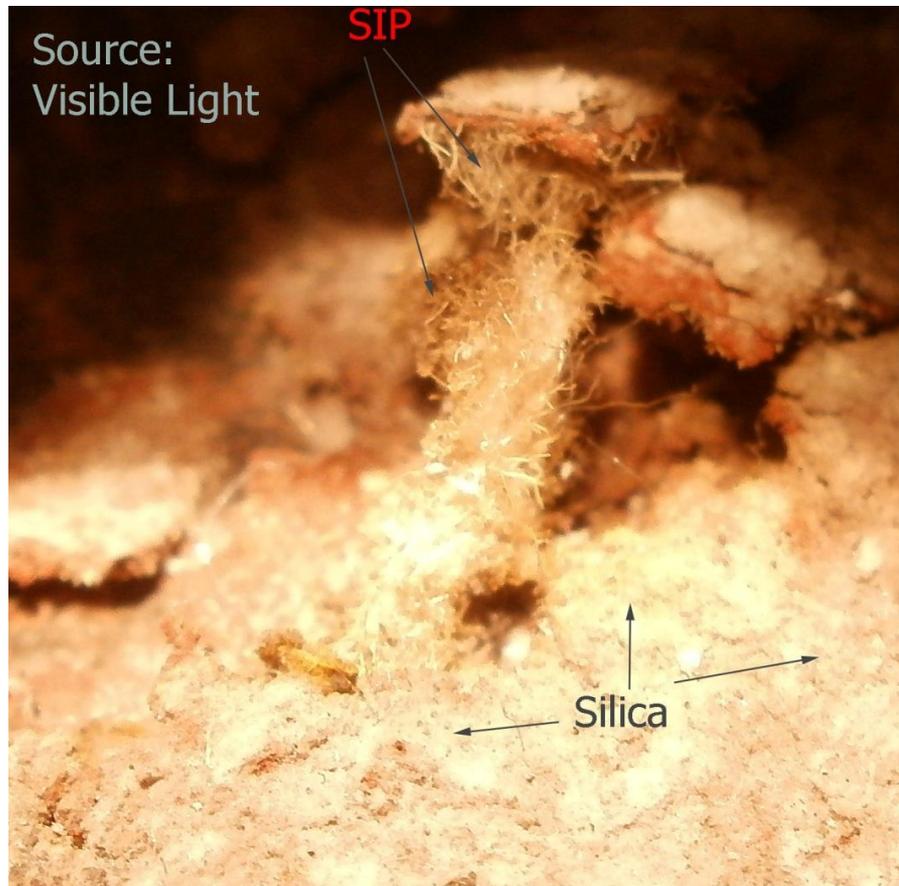
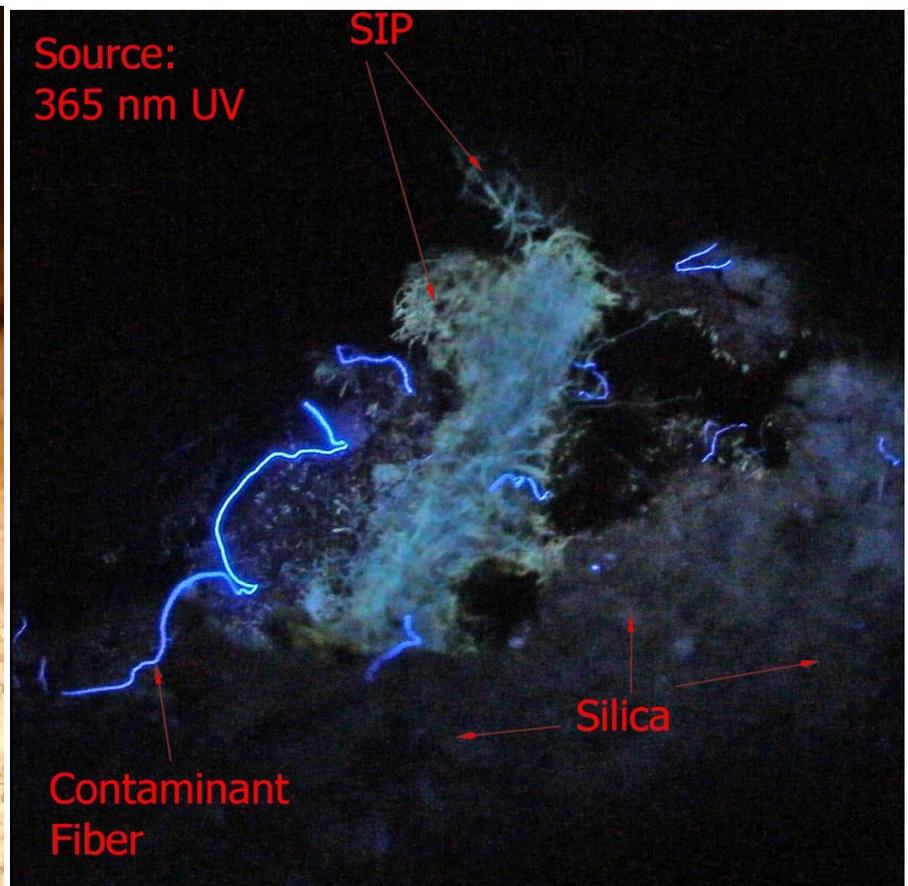
Additional ISAG Inquiry: Discernment of SIP from Tile Silica under 365 nm UV Illumination*

The same view of SIP and silica under visible illumination (left) and UV illumination centered at 365 nm (right). The UV illuminator did include some visible-band illumination, but the fluorescence of the SIP due to UV is distinct.

*Ground/lab capability, not ISS.

- UV illuminator recommended
 - At least one sub-surface material is fluorescent.
 - Penetrating sensor recommended (e.g. back-scatter Xray), when compact, robotically deployable, space qualified technology is ready.

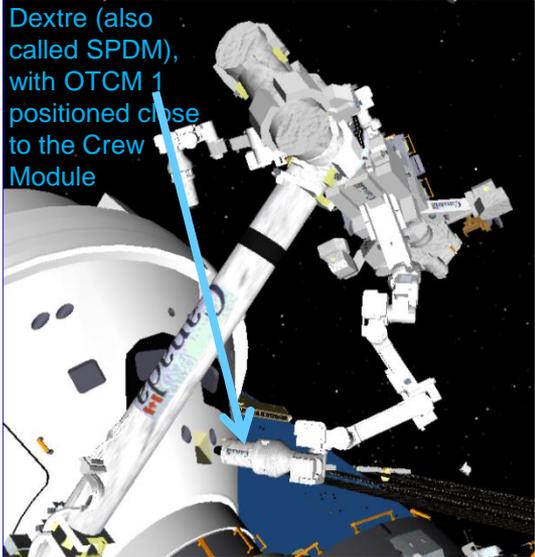
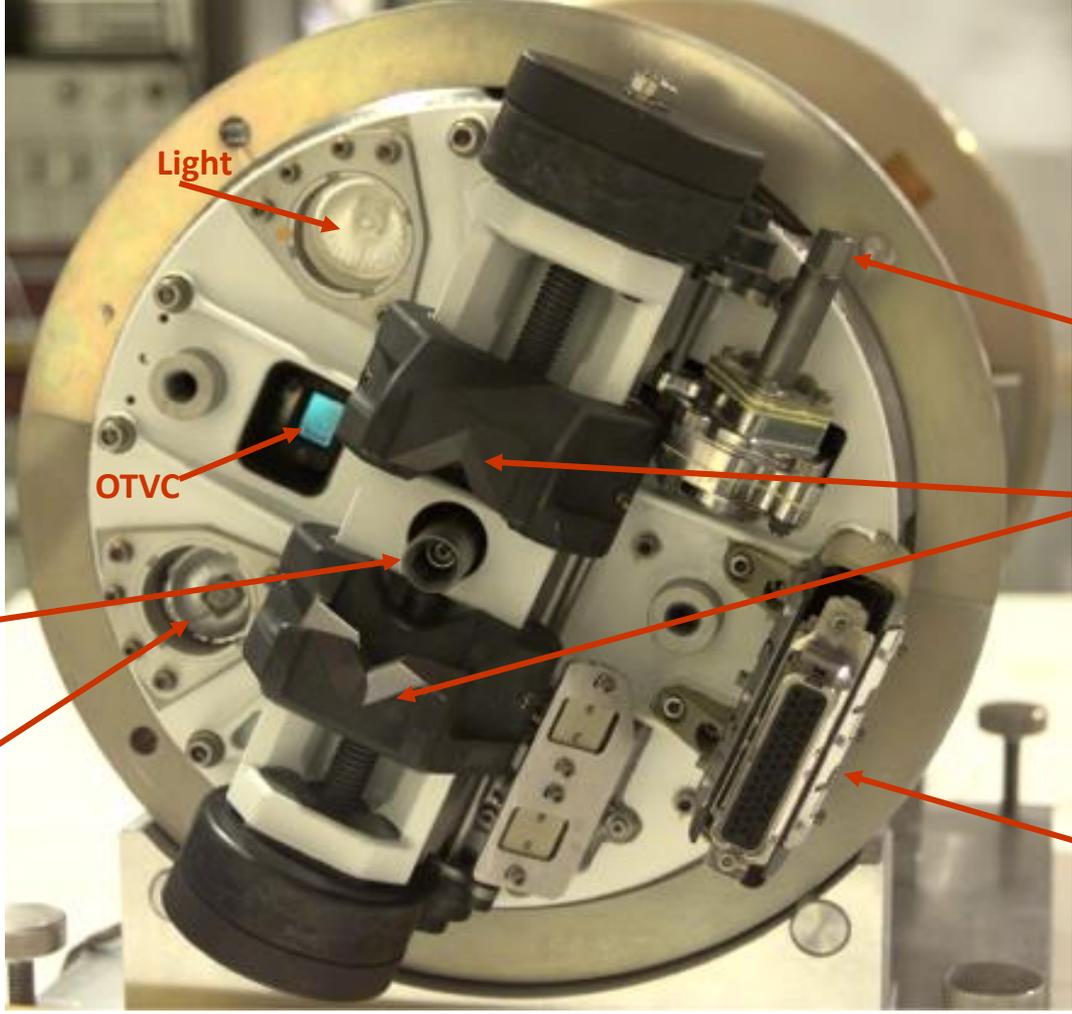
OTCM Roll Stereo

Using One OTVC As a Virtual Stereo Pair for ISS-based Focused Inspection.

Exploits high precision roll angle information.

Socket Drive

Light

OTVC

EVA Drive Bolt

Gripper

Umbilical

- On Dextre (SPDM), the OTVC is offset from the center axis of the OTCM.
- Rotating the OTCM both rotates AND translates the associated OTVC.
- Assume rotational information for OTCM is high-precision.
- Assume that rotating the OTCM has very little effect on position of the OTCM.
- Image surface anomaly from OTVC position 1
- Rotate OTCM
 - If necessary, allow any subsequent shaking of Dextre to dampen out
- Image surface anomaly from OTVC position 2.
- Orient the two OTVC images using stereo tools and Dextre joint-angle information.
- Produce stereo model of surface anomaly.

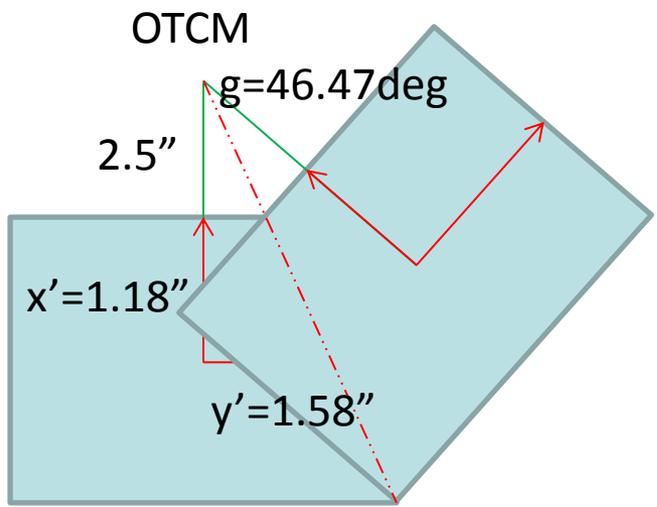
Rotational Geometry 16" Range

$$\tan(g/2) = y' / (2.5'' + x')$$

30 degree rotation -> B = 1.29 inches

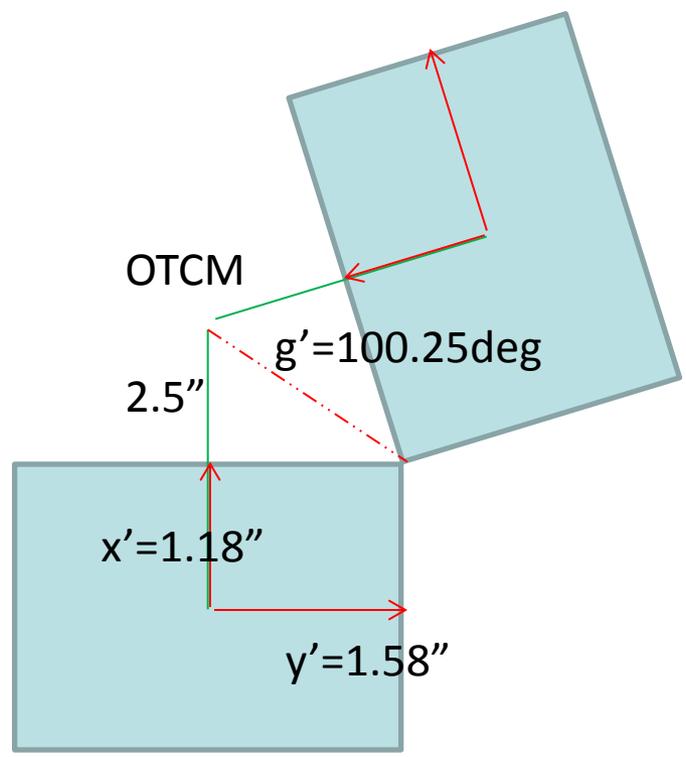
$$\tan(g'/2) = y' / (2.5'' - x')$$

g' is the maximum rotation angle with any image overlap

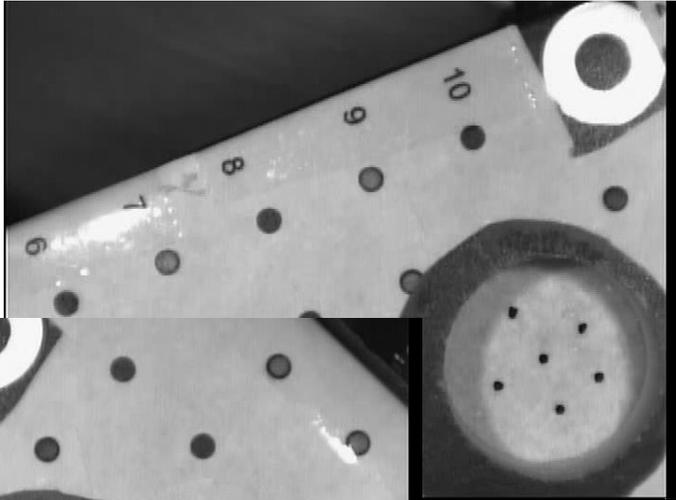
+24° Roll
1/125th second
Exposure

OTVC Imagery: Tile with Right-cylindrical Milled Cavities

- **Deep Cavity A (Depth TBD)**
- **Cavity is 2.5" offset from roll axis**

Note: For this imagery, a stand-alone OTVC camera (i.e. no robotics) was used, but the rolling was applied to the test article instead. The camera eyepoint was positioned 2.5" inches from the test article roll axis.

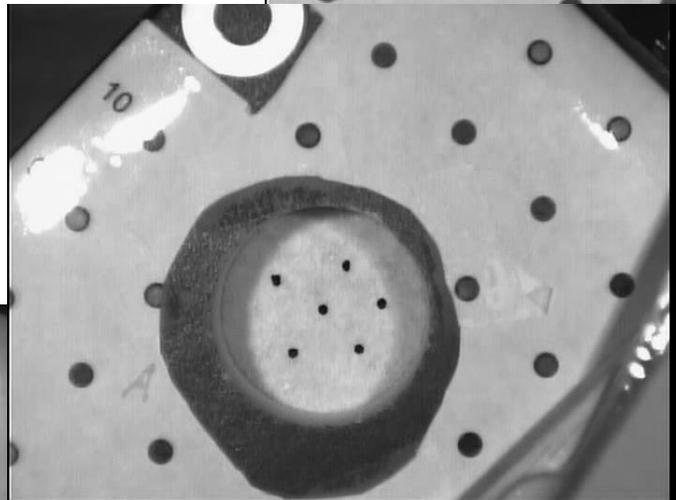
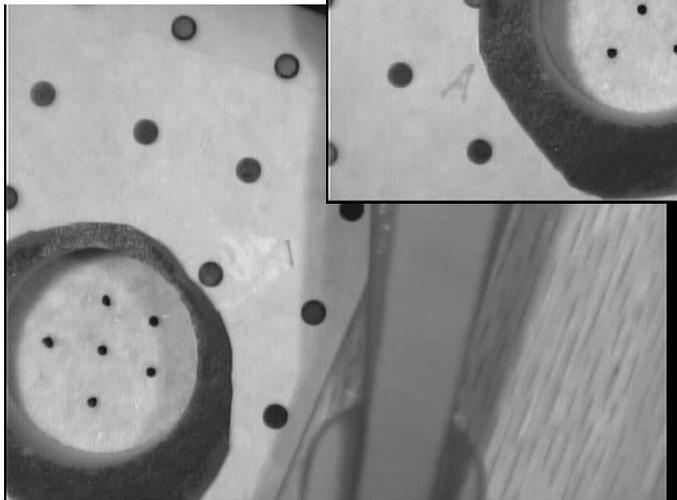
0° Roll
1/125th second
Exposure

-24° Roll
1/125th second
Exposure

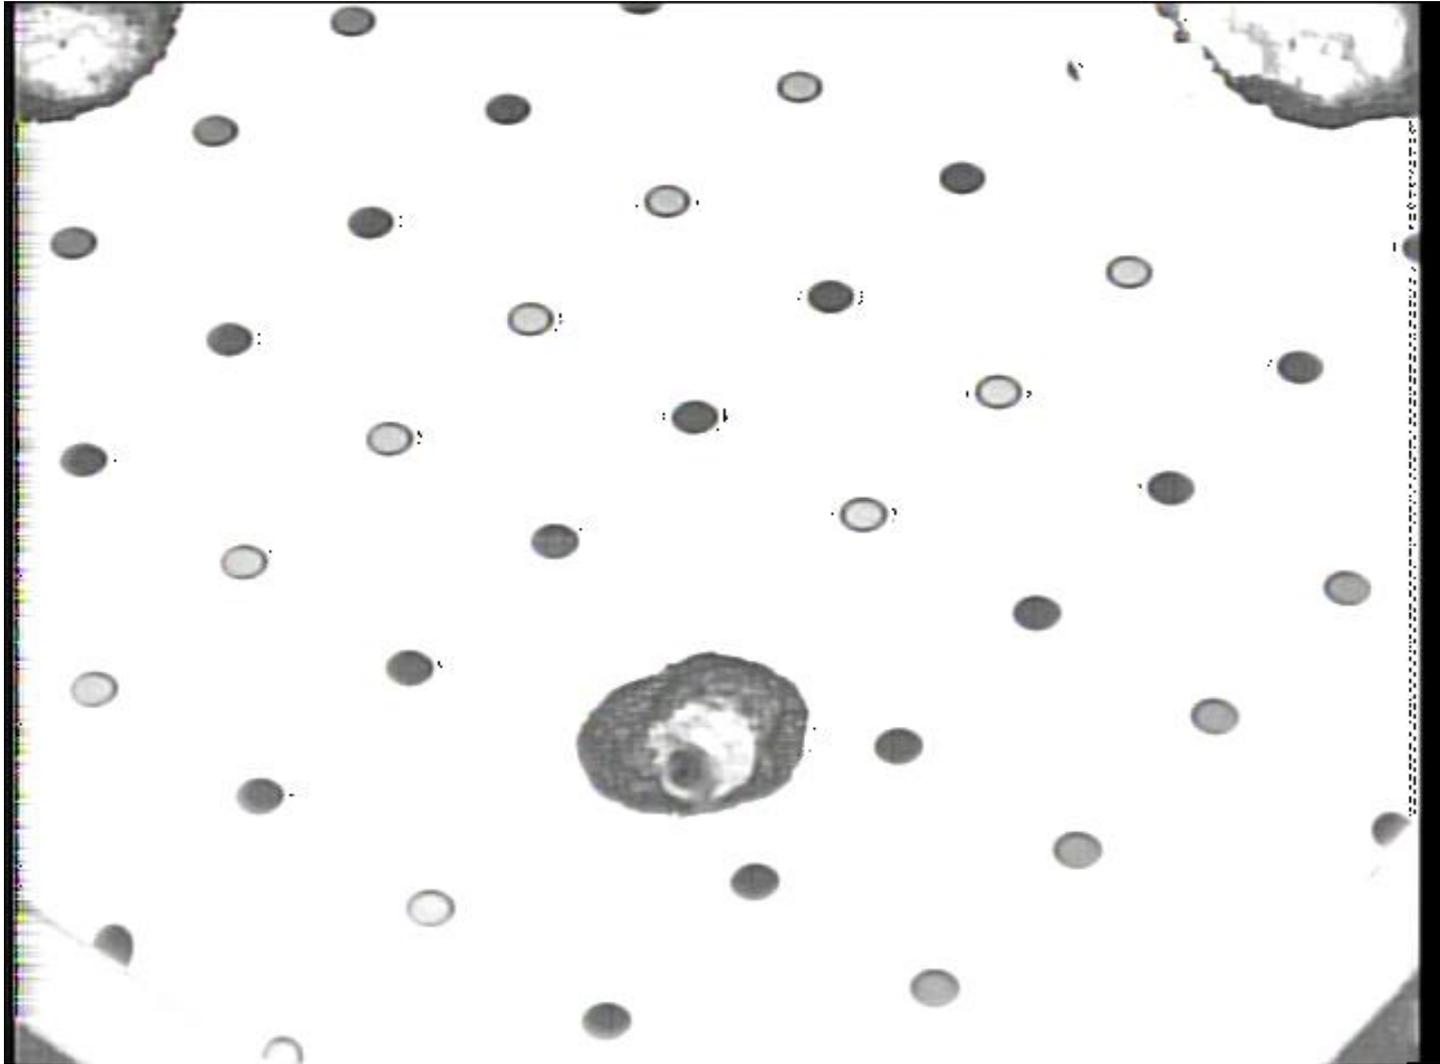
- **Tile damage feature that has an entry hole in the size range of interest, with a view to a deep “finger”.**
- **Difficult, but not impossible to illuminate lower portions of cavity (emphasized here)**
- **A piece of paper with spots at known centers has been overlaid on the tile to support photogrammetric truth measurements.**
- **Different exposures can be used to bracket shadows and highlights.**

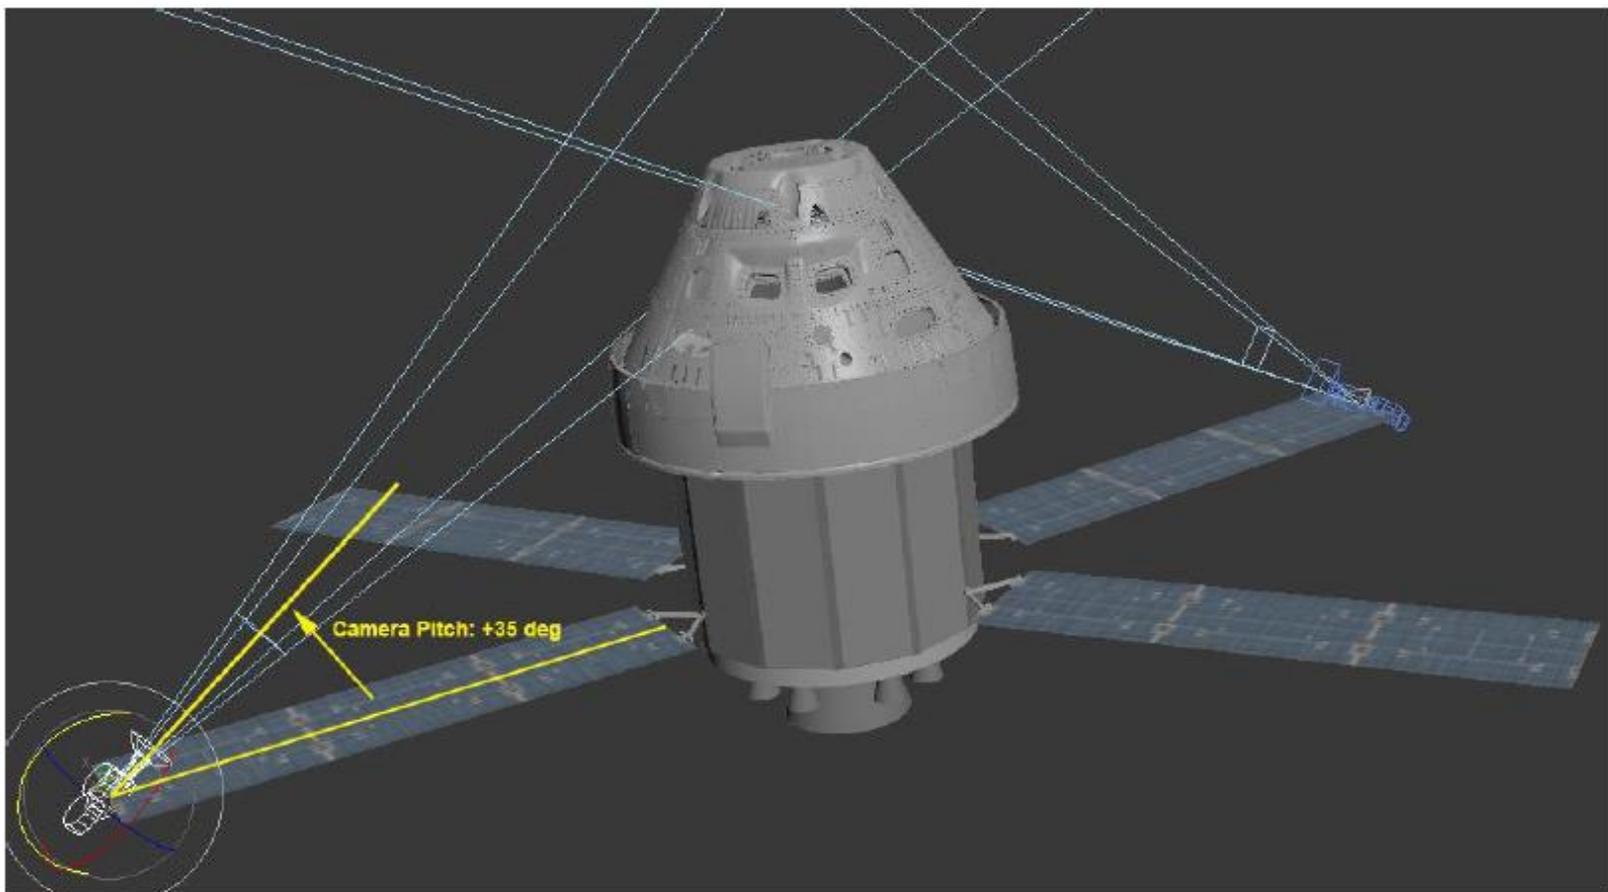
TPS Inspection from SA Cameras

Orion Multi-purpose Crew Vehicle (MPCV), with Crew Module (CM – Top) and European Service Module (SM – lower, with solar arrays). Cameras and sample viewing volumes for a camera-to-array pitch under strong consideration

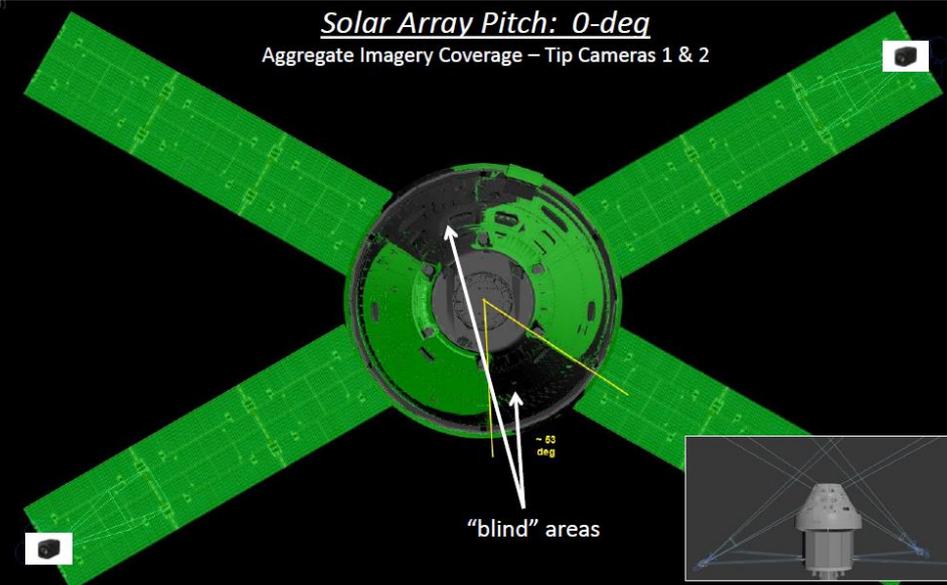
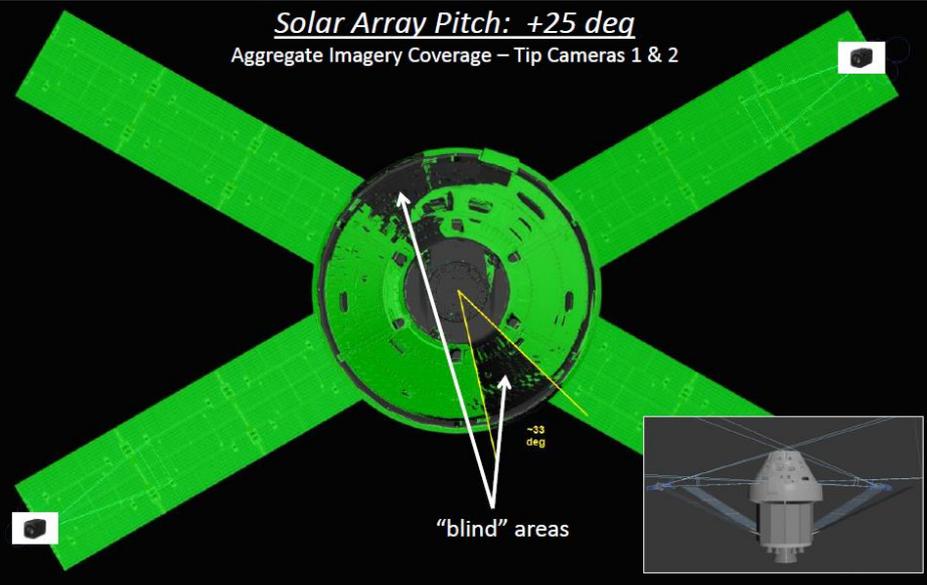
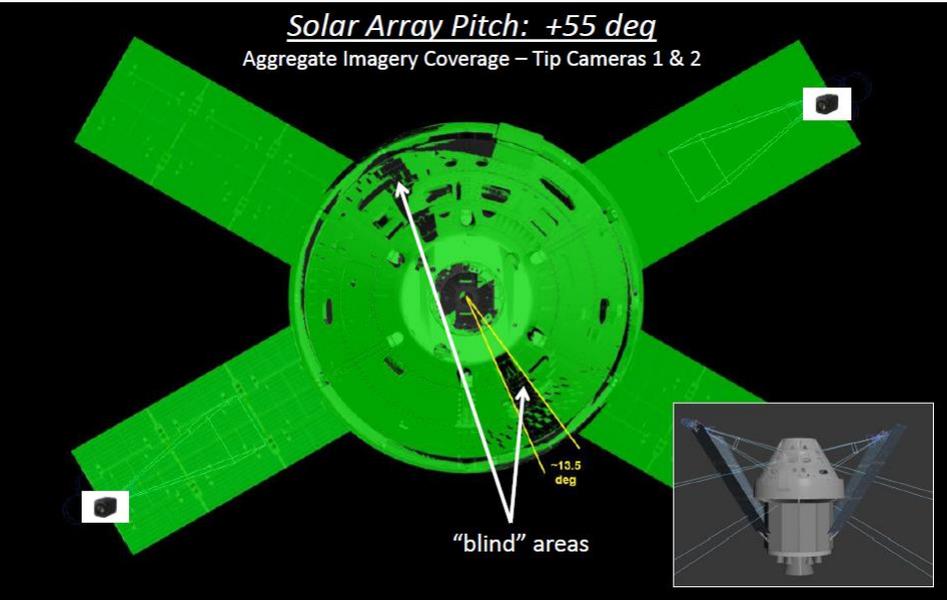
Camera Line-of-sight Evaluation

(Green Does Not Necessarily Mean Resolution Requirements are Met)

Camera line-of-sight evaluation for 3 different array pitches
Assumes camera-to-array pitch of 35°

Note: These results only apply to a very wide field-of-view lens setting. Zooming in for good detection resolution will constrain coverage and will require different array pitches and rolls.
