Operations & Maintenance Cost Study for NASA Facilities

Final Report for Administration Buildings

February 10, 2014

Operations & Maintenance Cost Study for NASA Facilities: Final Report for Administration Buildings

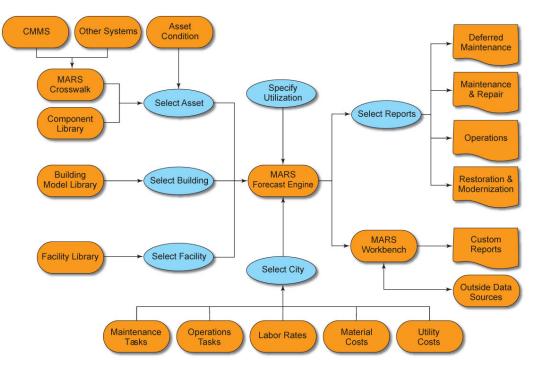
MARS Facility Cost Forecast System

The project employed the MARS Facility Cost Forecast System to provide cost information. Now in its eighth version, MARS is a facility cost modeling tool developed by CBRE | Whitestone and used by many federal and commercial agencies.

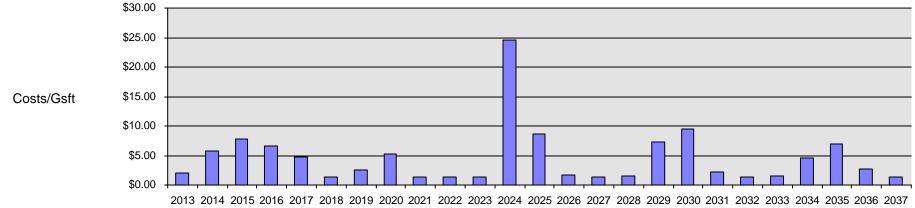
M&R Costs by System per Year Chart

Notes: A value of "0.00" means cost of more than \$.000 but less than \$.005 per gsft. All costs expressed in (\$) 2012 per gsft. Based on a 50-Year Forecast.
