INVESTIGATION OF CATASTROPHIC FRACTURING AND CHEMICAL REACTIVITY OF LIQUID-FILLED TANKS WHEN IMPACTED BY PROJECTILES OF HIGH VELOCITY

by Francis S. Stepka, Robert P. Dengler, and C. Robert Morse Lewis Research Center Cleveland, Ohio

TECHNICAL PREPRINT prepared for Seventh Hypervelocity Impact Symposium Sponsored by the Tri-Service Committee on Hypervelocity Impact Tampa, Florida, November 17-19, 1964

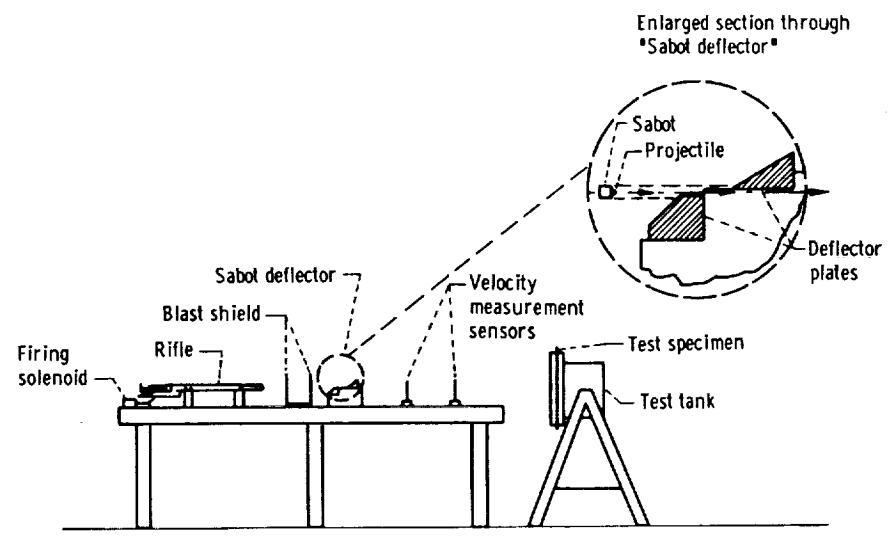
Figure 1. - Schematic drawing of apparatus for impact into liquid-filled tank by high-velocity projectile.

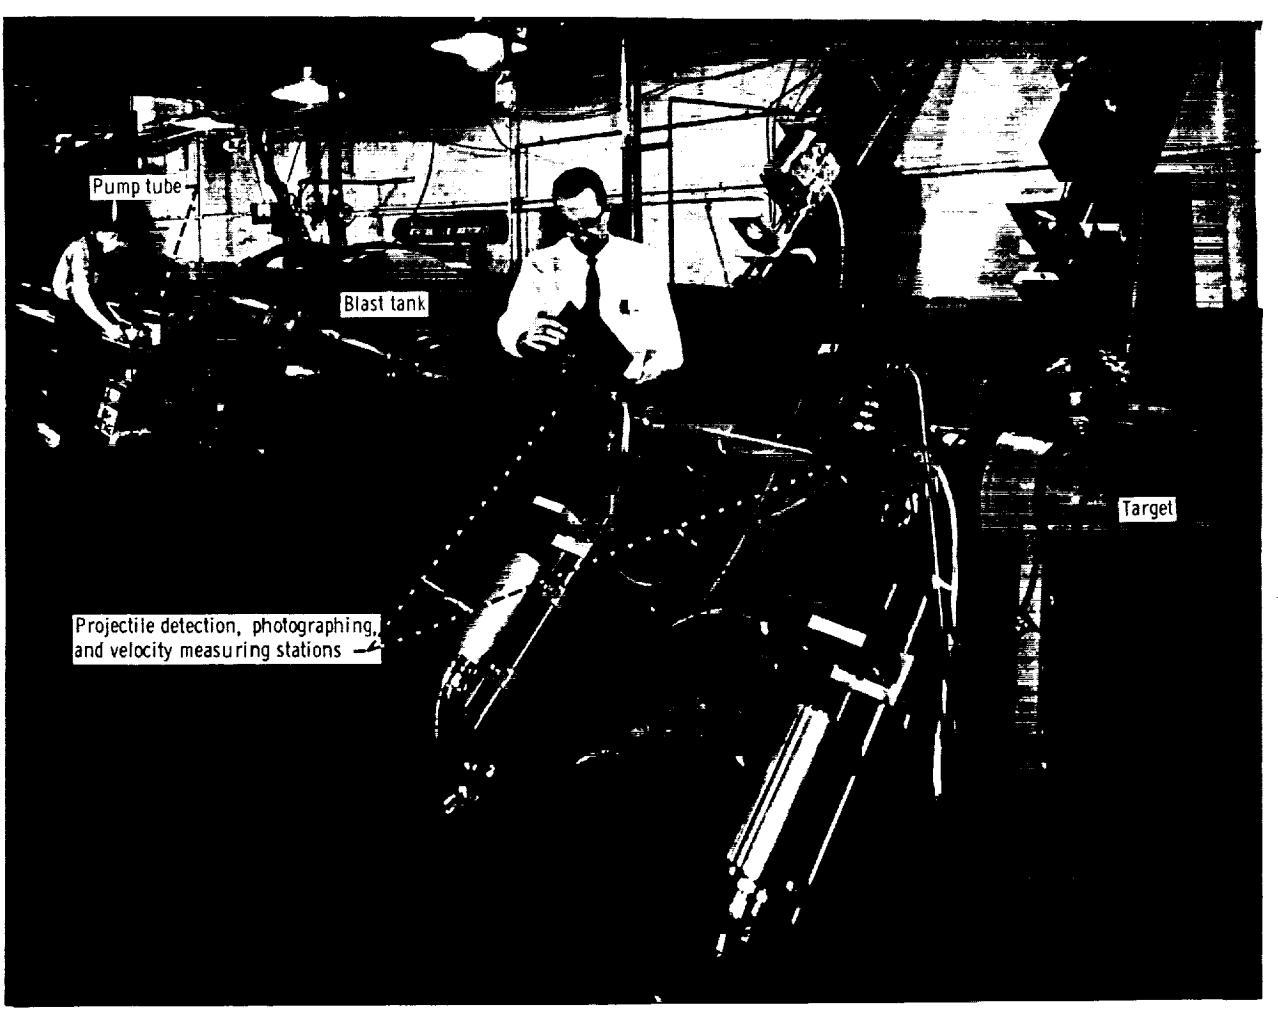
Figure 2. - NASA Lewis Research Center light-gas gun facility.

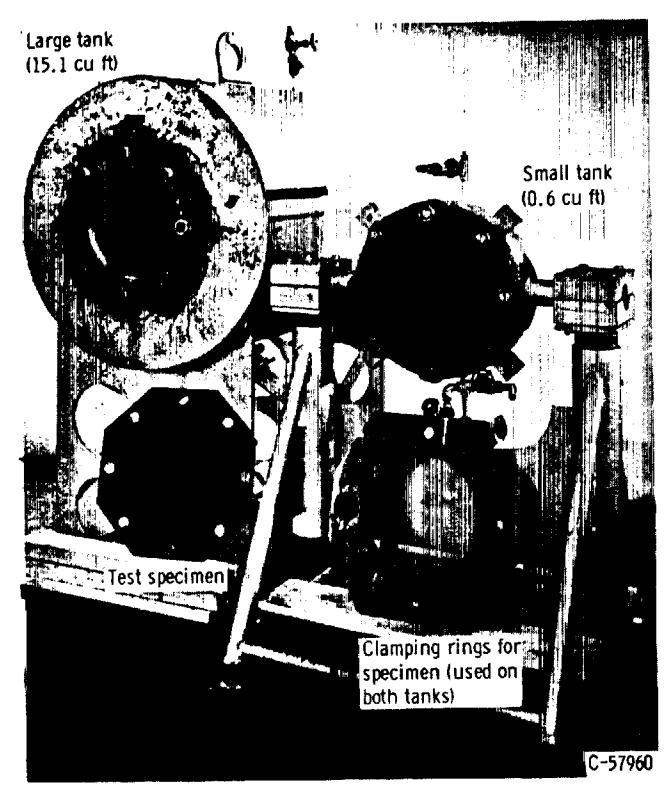
Figure 3. - Cylindrical tanks used in investigation of fracture by high-velocity projectiles.

Two types of tanks were employed in the investigations. One type was a cylindrical metal tank design (figs. 3 and 4) with one end removable and easily replaced. These ends constituted the test specimens to be impacted. This type of tank permitted the investigation of the factors affecting wall fracture and/or possible chemical reactions of different tank-wall materials and contained propellants. The active test section of the test specimens on the tanks to study the wall-fracture problem was a disk 11 inches in diameter. The specimens on the tanks to study the chemical reactivity problem were 5 inches in diameter.

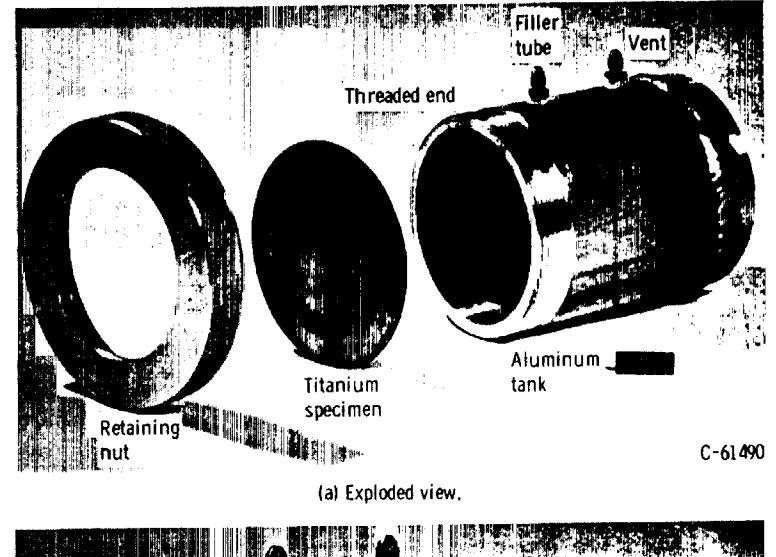
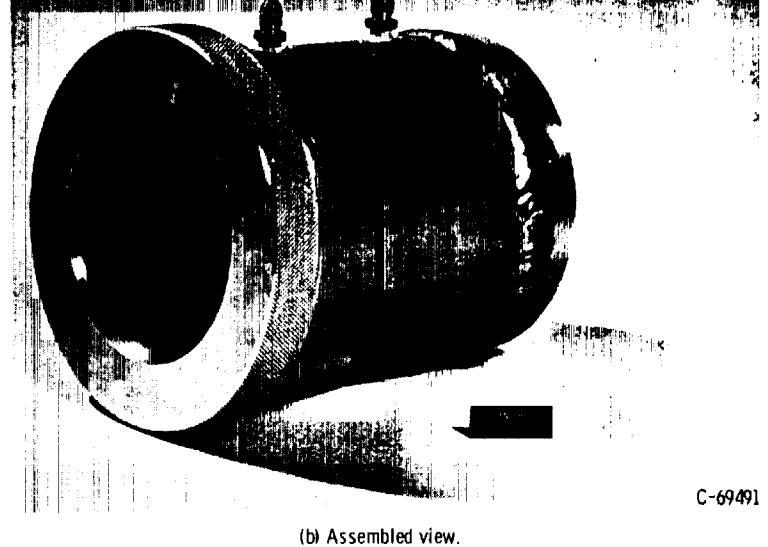
Figure 4. – Cylindrical tank used for the investigation of chemical reactions of various wall-propellant combinations.

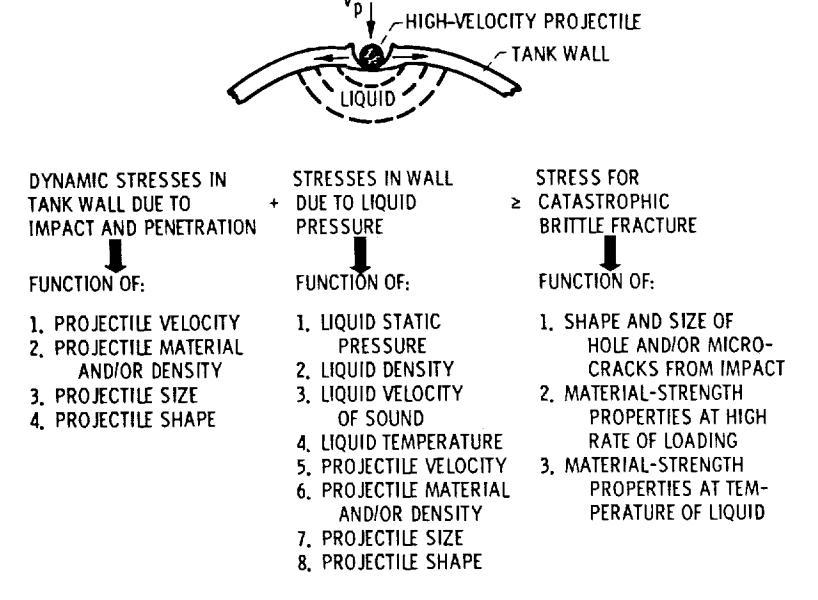
Figure 5. - Factors affecting catastrophic fracture of liquid-filled tanks of given thickness and material impacted by high-velocity projectiles.

Prior to conducting the experimental phase of the investigation, an analysis was made of the impact process into liquidfilled tanks to determine factors that may contribute to wall fracture. A description of the impact process and a summary of the factors expected to affect wall fracture are presented in the following paragraphs.

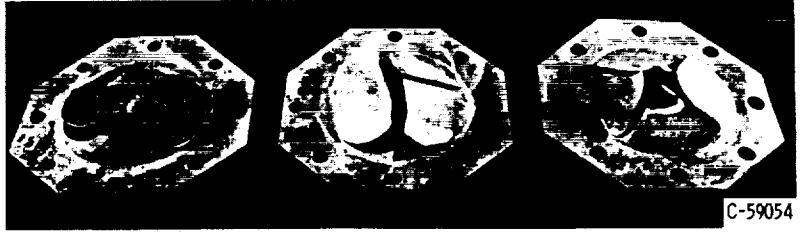
(b) Impacts above critical velocity: fracture.

Figure 6. - Results of impacts by 7/32-inch spheres into prestressed specimens of 7075-T6 aluminum on water-filled tank.

A typical puncture and some typical fractures resulting from impacts of aluminum specimens on water-filled tanks are shown in figure 6. Examination of the fracture indicated that the plane of the fractures was generally at 45° to the plane of the specimen wall, indicating a shear failure. Many impacts were made into aluminum specimens by using projectiles of various sizes and materials to provide data so that the effect of the projectile parameters on the fracturing of the specimen could be determined. Data shown in figure 7 indicate that for impacts with 7/32-inch-diameter metal spheres (aluminum, steel, and tungsten carbide), there was a critical velocity below which only a puncture of the specimen resulted and above which a catastrophic fracture occurred. In addition, these data indicate that, as the density of the projectile decreased, a higher impact velocity was required to fracture the tank wall; however, the corresponding projectile kinetic energies decreased with projectile density. The critical velocities for the 7/32-inch spheres of tungsten carbide, steel, and aluminum impacting a stressed 1/32-inch-thick aluminum (7075-T6) specimen, as can be seen in figure 7, were 2850, 3300, and 5000 feet per second with corresponding projectile kinetic energies of 375, 260, and 215 foot-pounds. These velocities and energies are considerably greater than those required for simple puncturing of the specimens on a water-filled tank.

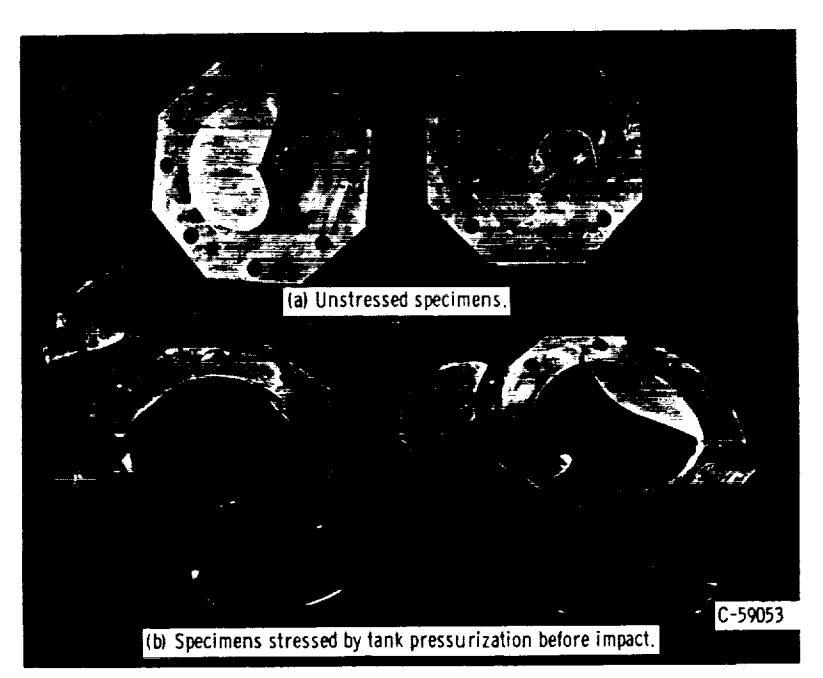
Figure 8. - Results of impacts by 7/32-inch spheres above critical velocities into 1/32-inch-thick specimens of 7075-T6 aluminum on liquid-nitrogen-filled tank.

Typical fractures of the stressed and unstressed 1/32inch-thick 7075-T6 aluminum specimens on a liquid-nitrogenfilled tank as obtained from impact by 7/32-inch-diameter spheres are shown in figure 8. Comparison with figure 6 shows that a much more severe fracturing of the stressed specimens was evident when the contained fluid was liquid nitrogen. There was often a complete rupturing of the specimens. Examination of the fractures indicated a brittle-type fracture, as evidenced by the fracture plane being perpendicular to the plane of the specimen wall.

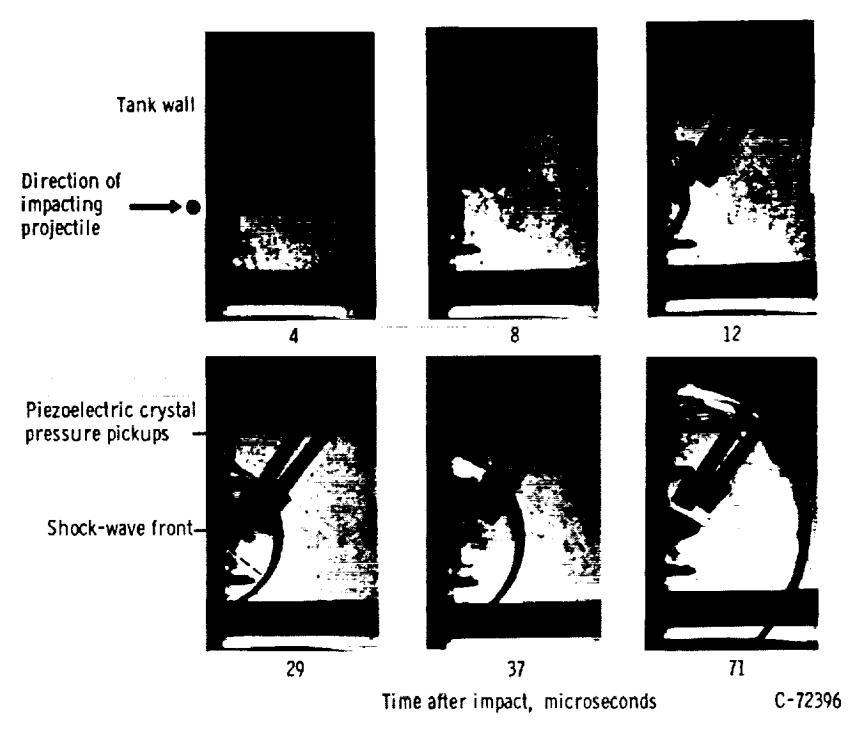
Figure 9. - Propagation of shock produced by high-velocity projectile impacting into a water-filled transparent plastic tank. (Impacting projectile: 7/32-inch aluminum sphere at velocity of approximately 6690 ft/sec.)

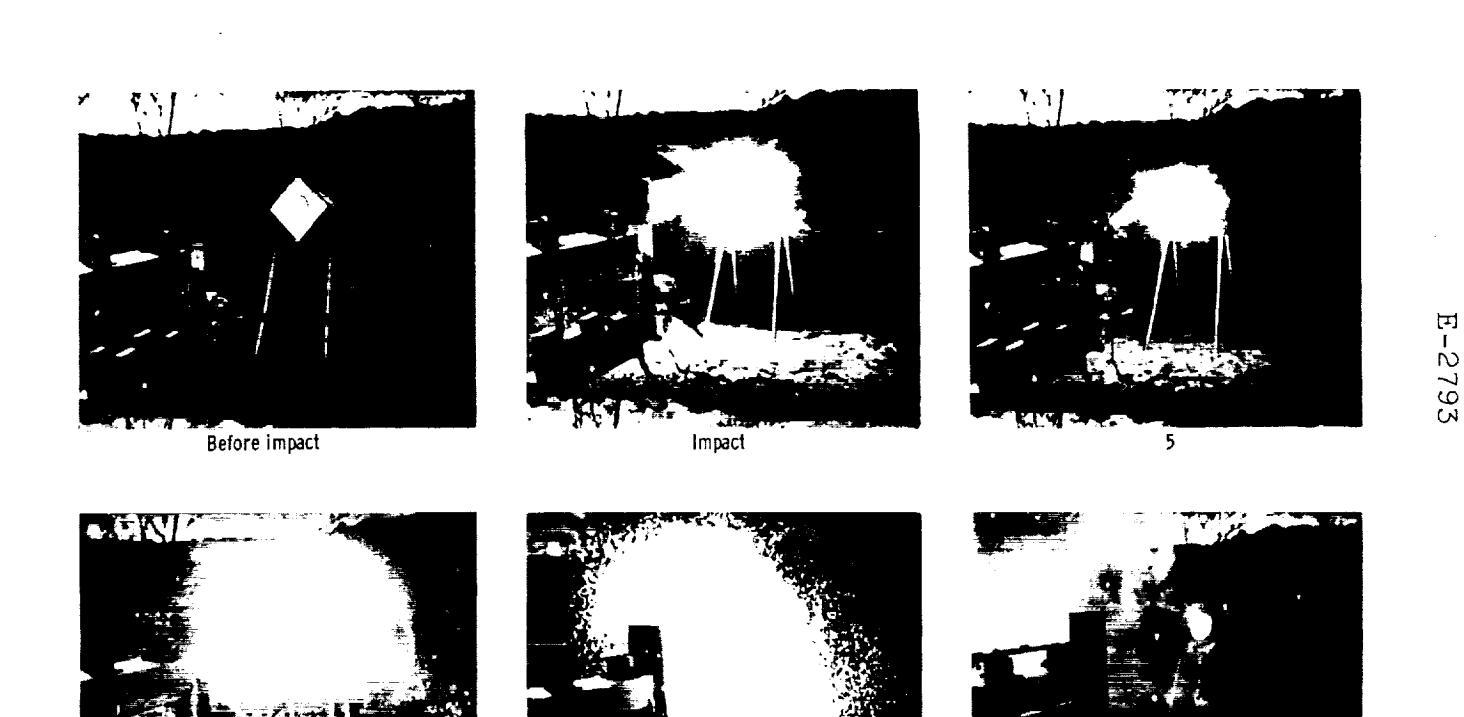
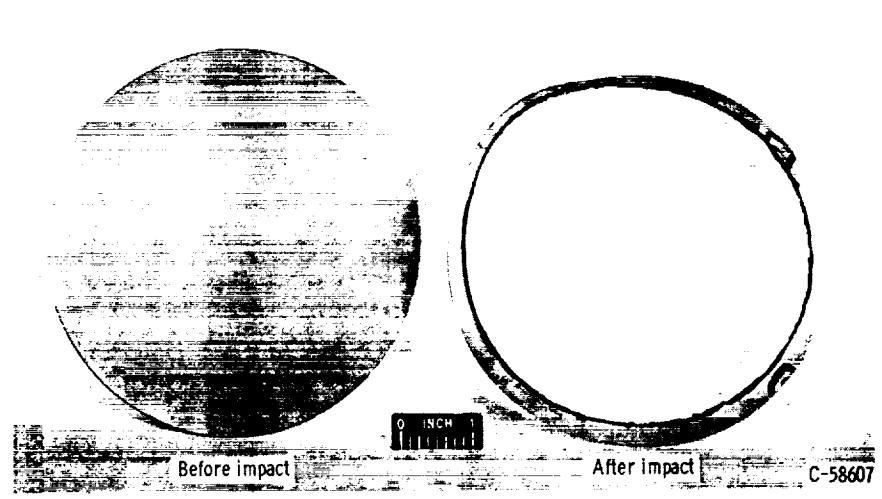
Time after impact, milliseconds Figure 11. - Selected frames from motion picture taken of typical impact and penetration of titanium wall of tank filled with liquid oxygen.

Visual recordings of impacts: As an aid to further the study of the titanium - liquid-oxygen reaction, high-speed motion pictures (with framing rates up to 6000 frames per sec) were taken of particle impacts and ensuing reactions. These motion pictures do not indicate the source or the cause of the reaction between titanium and liquid oxygen, but they do show that the reaction produced is by no means in a steady-state condition. The quasi-steady-state burning of the titanium is interrupted periodically by a number of flare-ups, explosions, or sudden releases of energy. As many as five violent flareups were detected in one sequence. These motion pictures also reveal that, once the reaction is started, it becomes highly exothermic and provides ample heat for sustaining the reaction until either the test specimen is consumed or the supply of oxygen is exhausted.

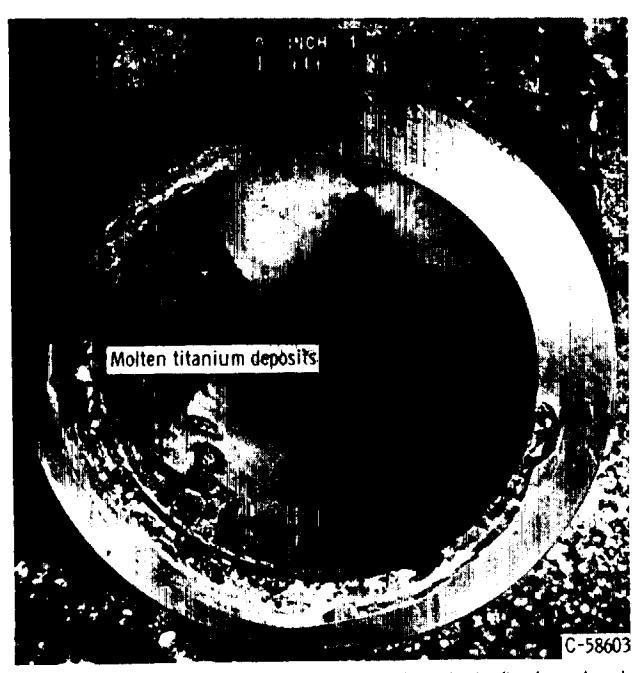
Figure 13. - Condition of liquid-oxygen-filled test tank after impact and penetration of titanium wall specimen.

The condition of the tank after a typical titanium liquid-oxygen reaction is shown in figure 13. Molten titanium, produced during the violent reaction that resulted, deposited on the retaining nut and the inside of the tank and caused the damage shown in the figure.

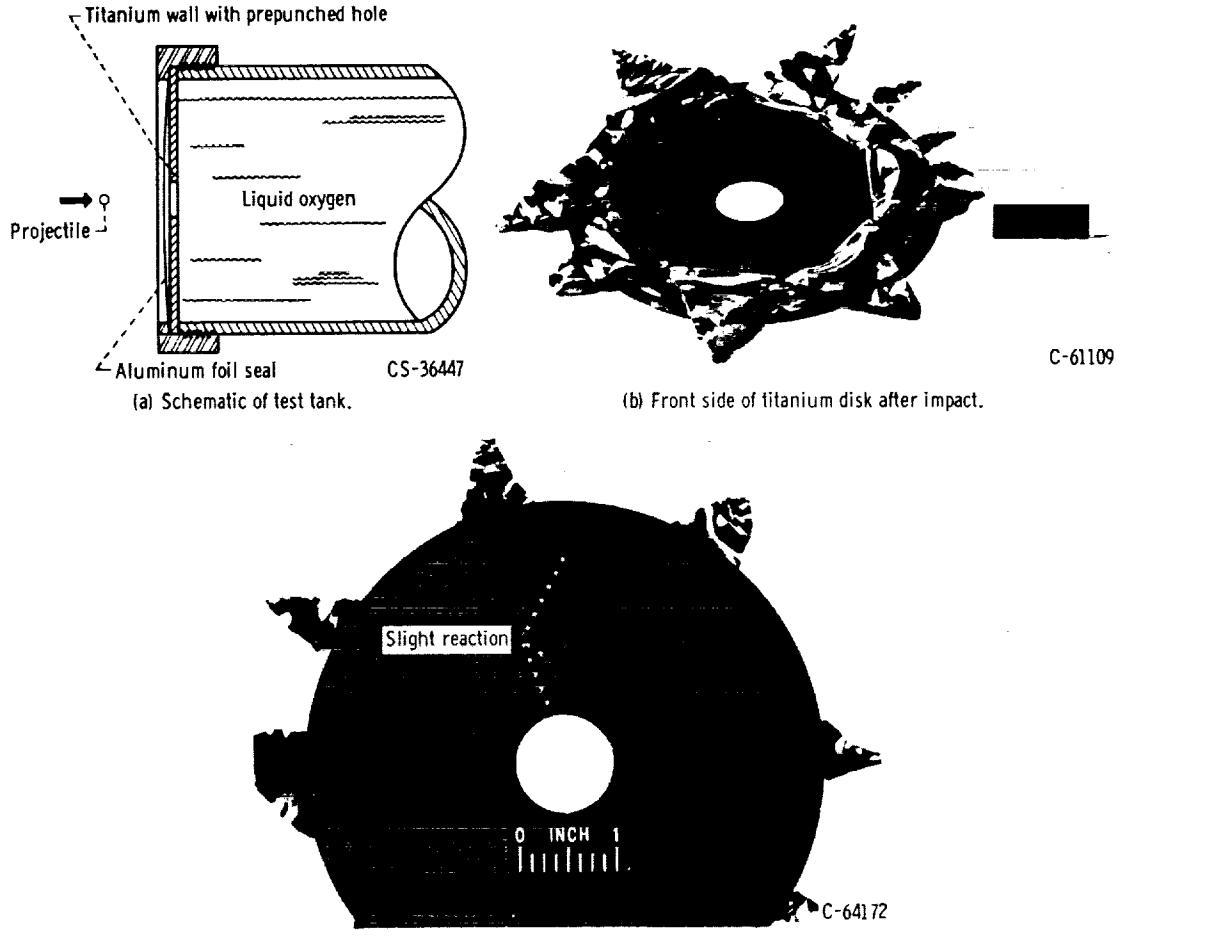
(c) Reverse side of titanium disk after impact.

Figure 15. - Impact test on prepunched titanium specimen covered with aluminum foil (test 20).

Test 20 was conducted by using a titanium specimen with a l-inch-diameter prepunched hole at the center (fig. 15). A 0.006-inch-thick sheet of aluminum foil was placed over the titanium disk, with both the aluminum and titanium being held in place by the retaining nut of the tank, thus allowing the tank to be filled with liquid oxygen. The rifle was bore sighted to impact at the center of the prepunched hole, which was outlined in the thin aluminum foil. Impact by a steel sphere produced the results shown in figures 15(b) and (c). The aluminum foil ruptured and peeled back on itself (fig. 15(b)) as a result of the pressure forces generated in the liquid oxygen by the impact and penetration of the high-velocity sphere. It can be seen that the titanium test specimen was not consumed by any violent reaction with the liquid oxygen. Ιt was noted, however, that on the reverse side of the specimen (fig. 15(c)) some slight reaction did occur in several areas of the specimen.

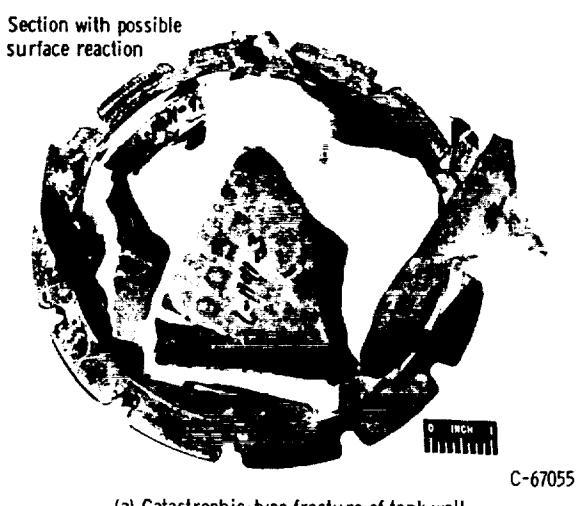
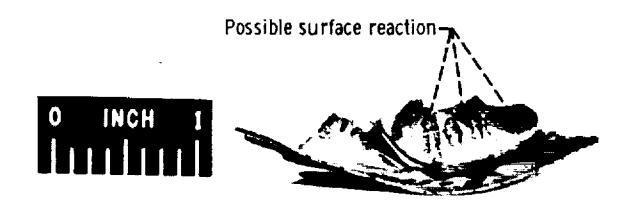
(a) Catastrophic-type fracture of tank wall.

(b) Section exhibiting possible surface reaction.

Figure I6. - Catastrophic-type fracturing and possible surface reaction resulting from impact and penetration of titanium tank wall in contact with liquid nitrogen tetroxide.

Impact of a 0.031-inch-thick wall specimen (test 36) by a 1/8-inch aluminum sphere at a velocity of 20,400 feet per second resulted in a rather violent catastrophic-type rupturing of the tank wall (see fig. 16(a)). In addition to this catastrophic fracturing of the specimen, a possible chemical reaction was detected (see fig. 16(b)). The reaction, however, was not sustained, and only the surface of the titanium specimen in a region near the hole or penetration made by the impacting projectile was affected. Only one other impact (test 37) resulted in any sign of chemical reactivity and this again was in the nature of a surface-type reaction near the hole produced by the impacting projectile.
