CLEVELAND, CHIO. MSC APOLLO 13 INVESTIGATION TEAM

FINAL REPORT

PANEL 6 RELATED SYSTEMS EVALUATION

Lunar Module

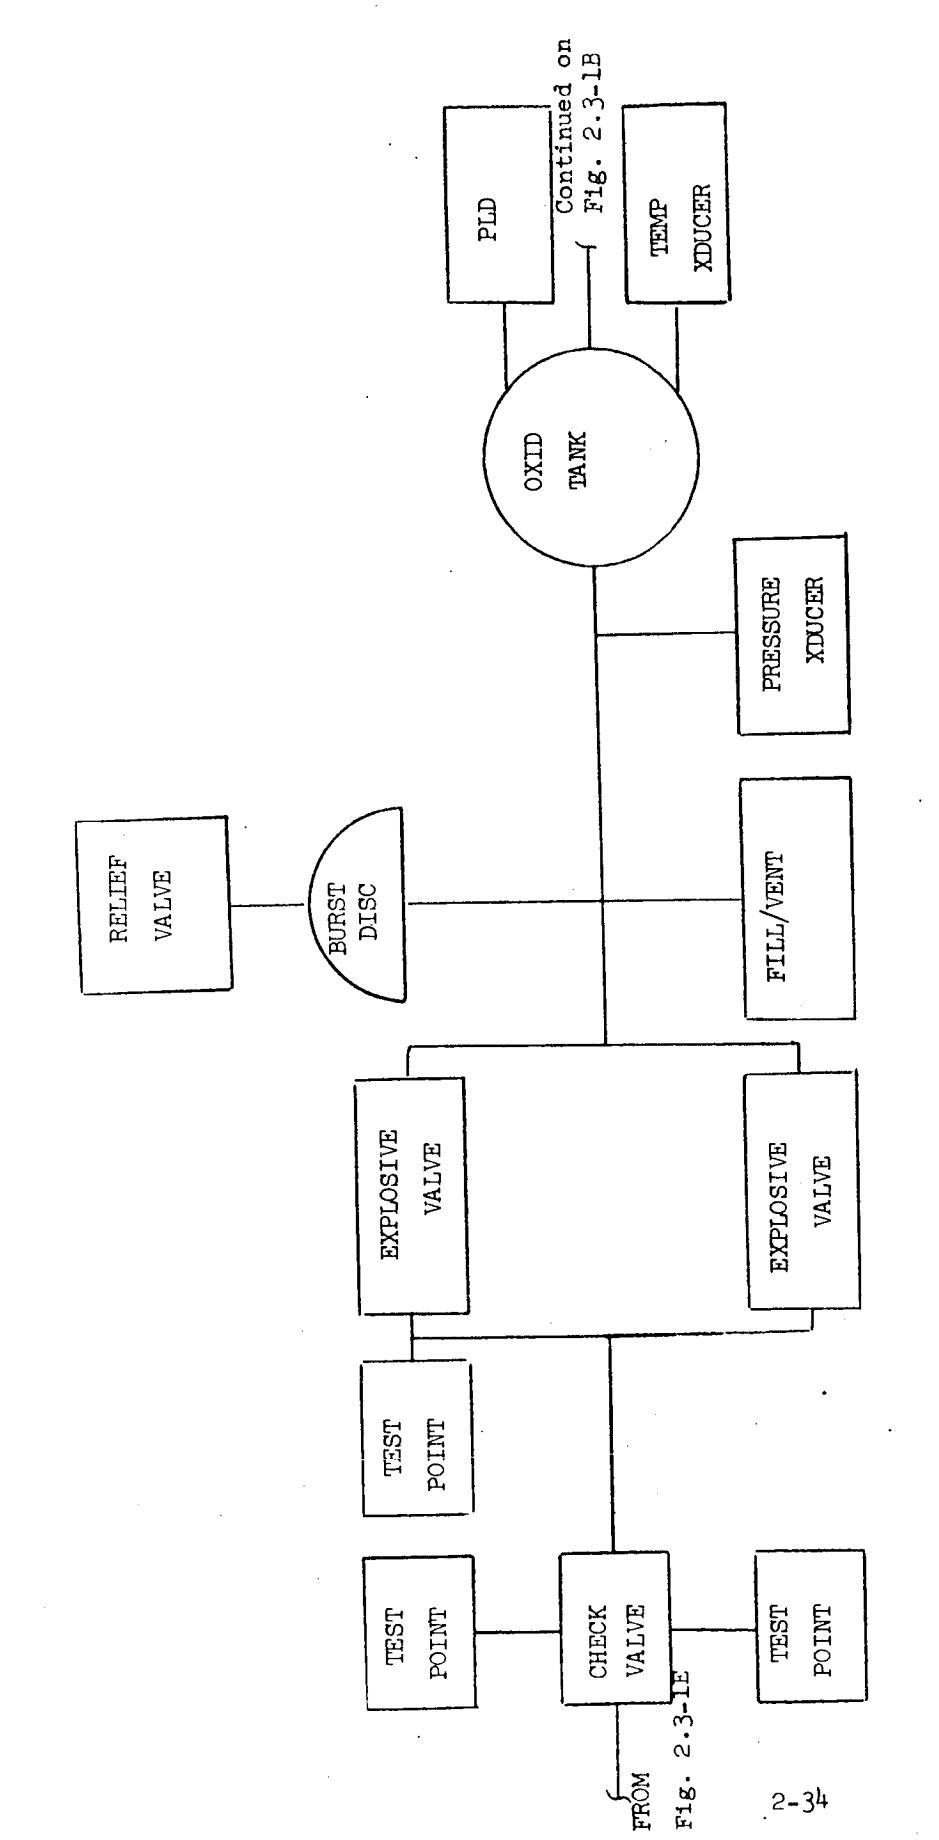
Figure 2.3-1A

The APS is shown schematically in Figure 2.3-1. Two ambient helium storage tanks, Figure 2.3-2, and two propellant tanks, Figure 2.3-3, comprise the pressure vessels in the system. The ambient helium storage tanks are located in the aft equipment bay. The propellant tanks are supported externally on the ascent stage along the \pm Y axis. Figure 2.3-4 shows a detail view of the propellant tank bottom. Figure 2.3-5 is a photograph showing an installed fuel tank (lower tank) and Figure 2.3-6 shows the helium tank installation (two larger tanks).

APS Oxidizer System

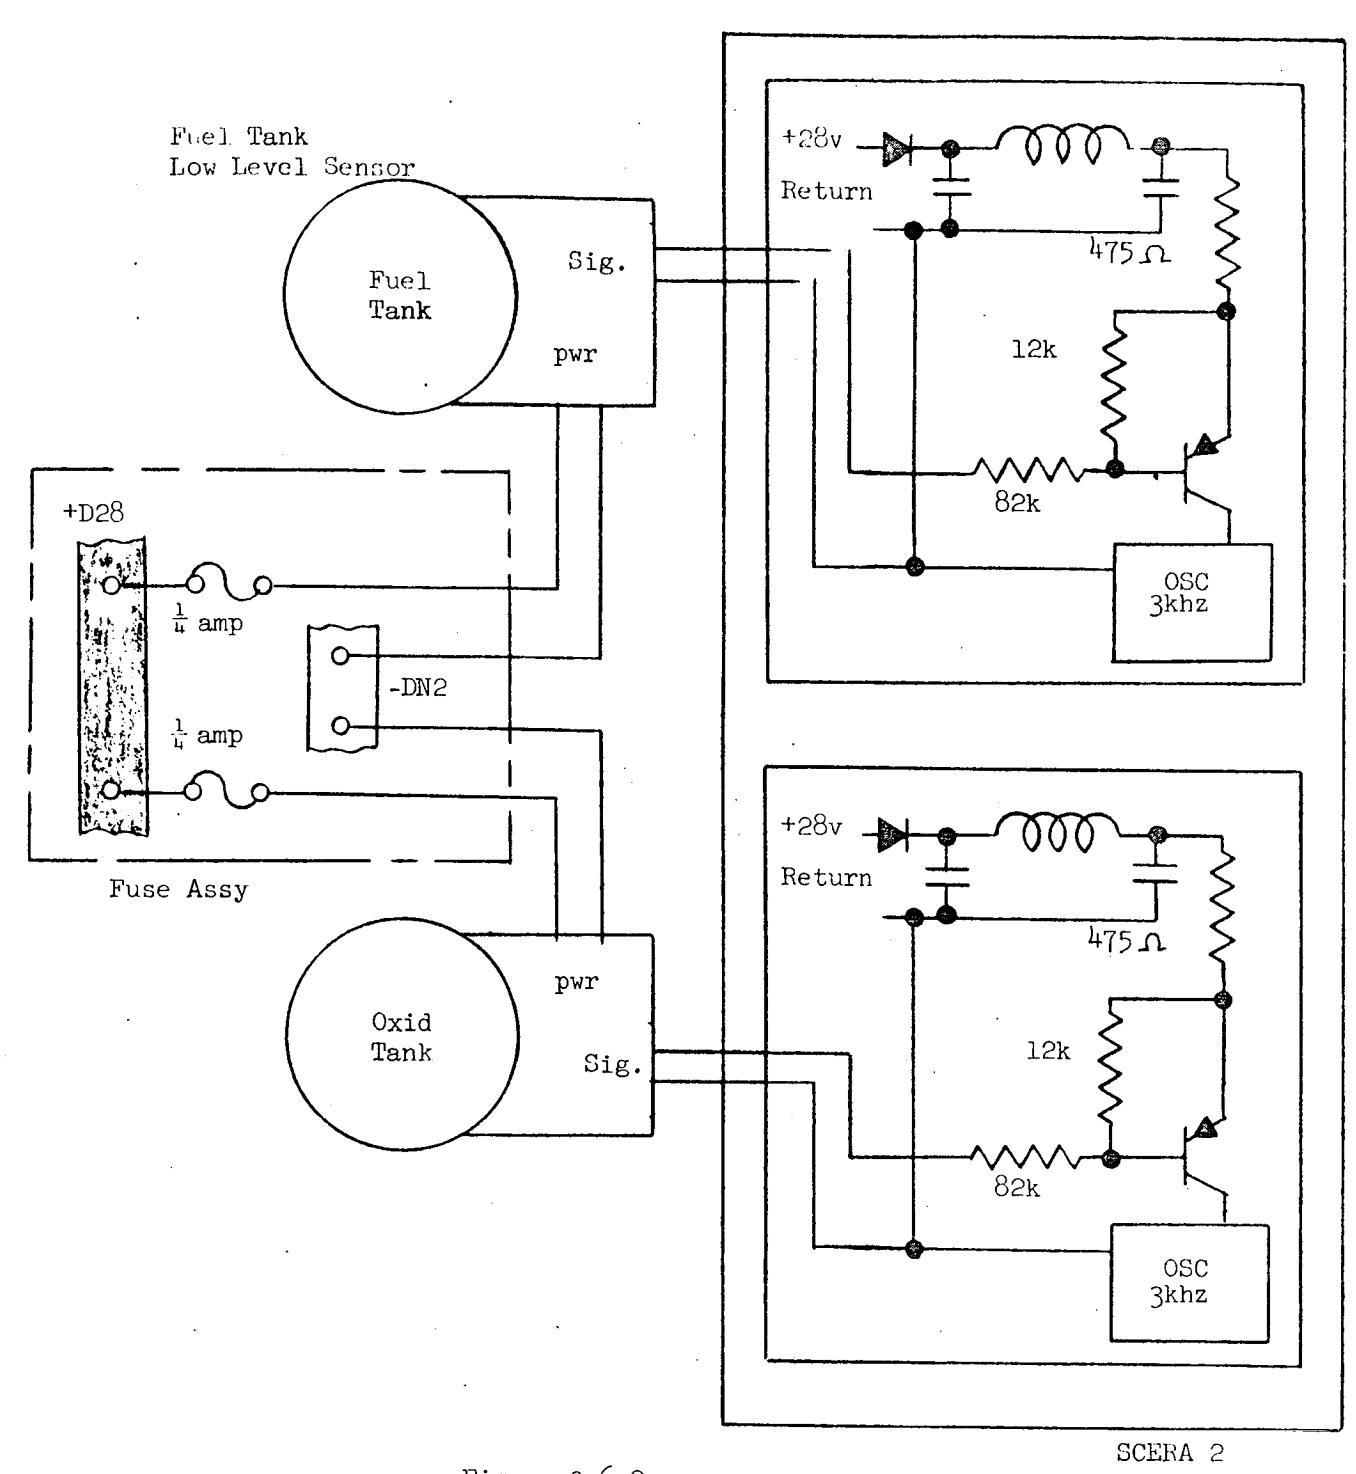
Figure 3.6-2 Propellant Level Detector Schematic

The propellant level detector is powered from the sensor power fuse assembly as shown in Figure 3.6-2. The normal power requirements are 8 ma at 28v (.22 watts). Two failure modes exist which would result in higher electrical energy inputs.

Failure of a capacitor in the electronics could result in 28 v being applied either directly across a 1K resistor or a forward biased diode. In the first case, the power dissipation increases to 0.9 watts, which would be transmitted to the tank and its contents. For the second case. the current would rapidly exceed the 250 ma rating of the fuse and the current flow would cease when the fuse opens.

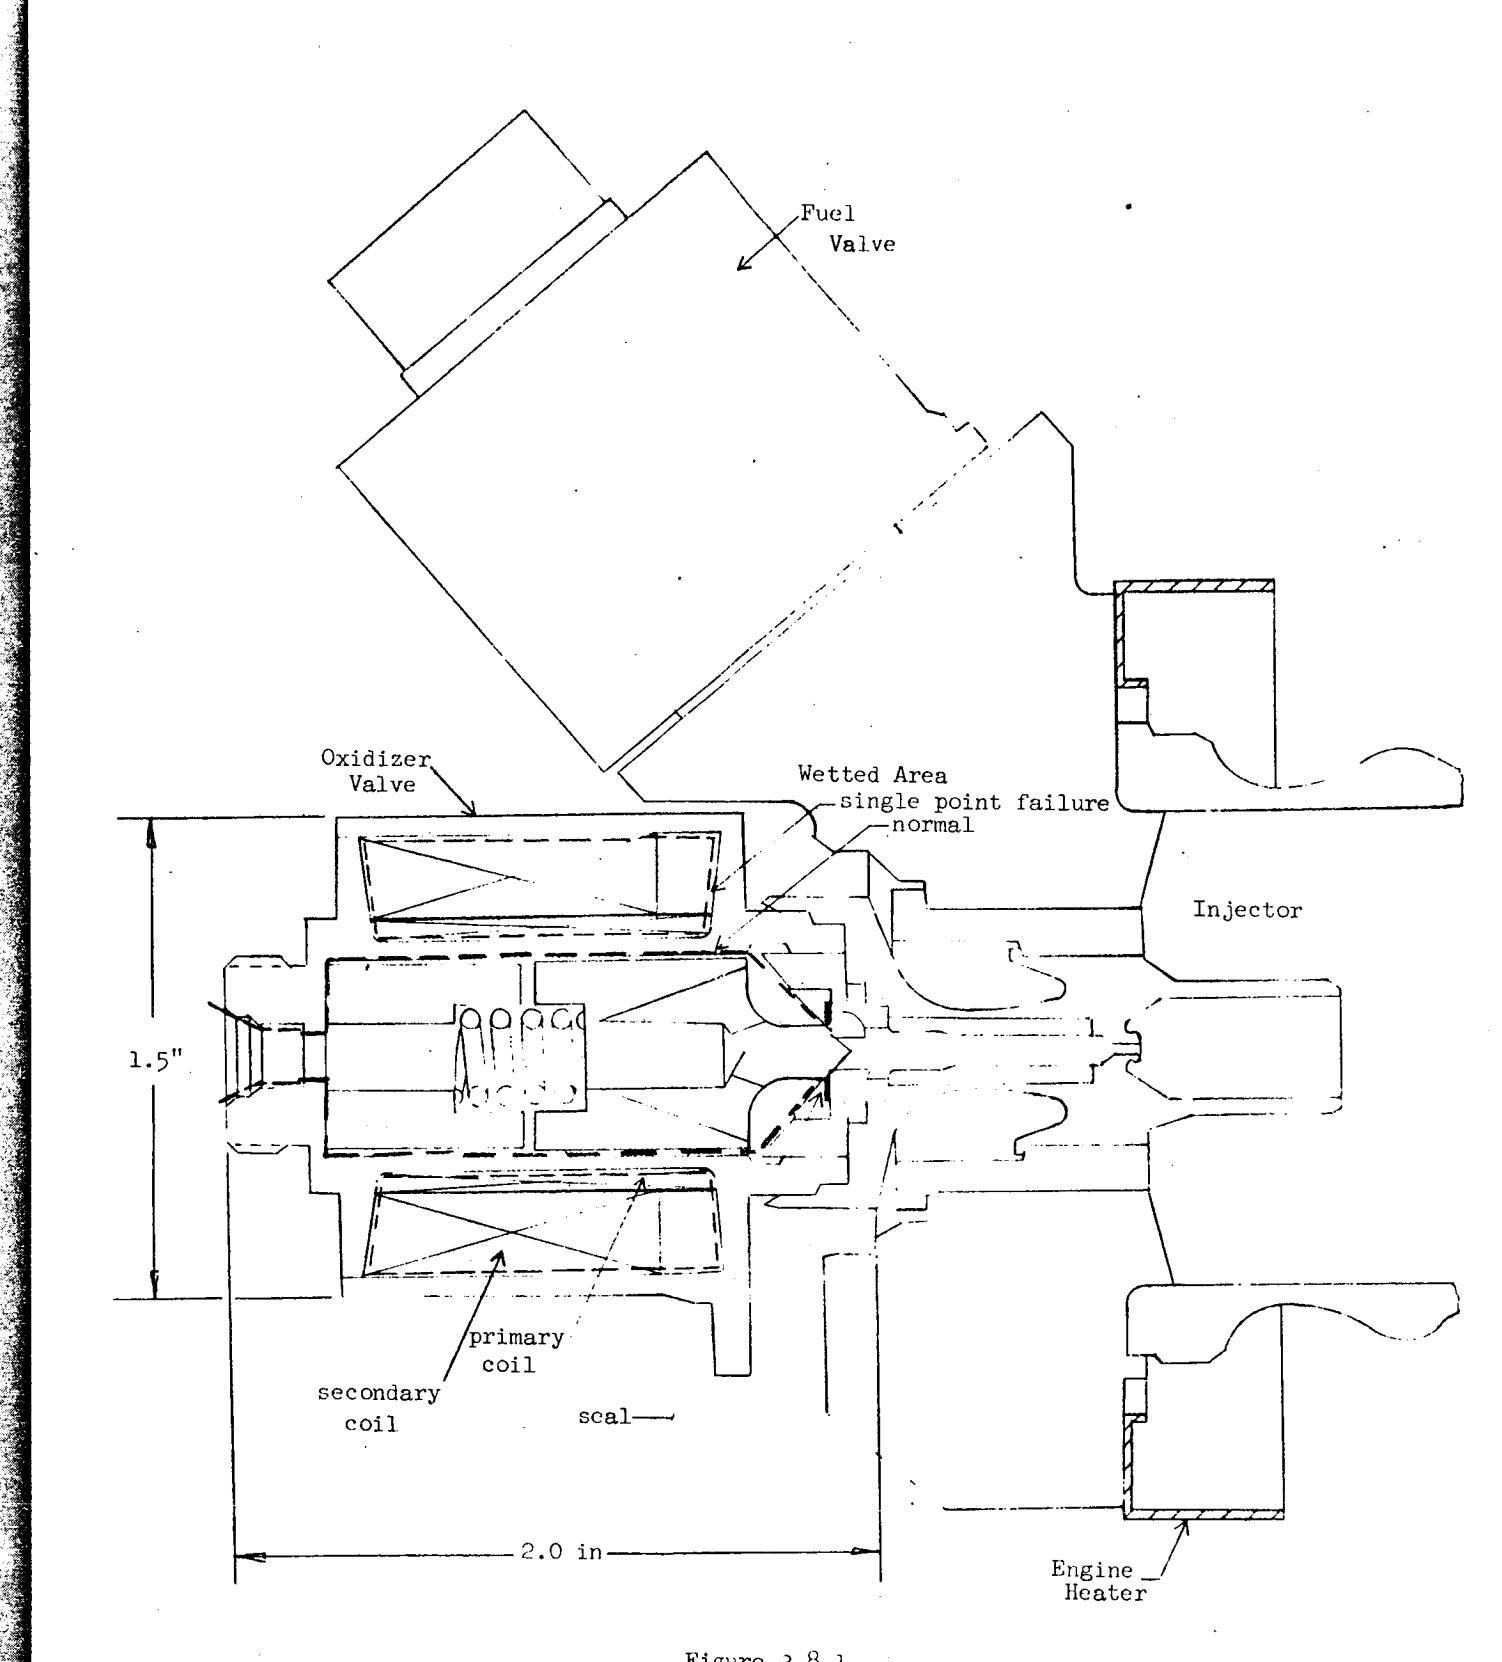
Figure 3.8-1 RCS Injection Valve

Normal injector operating current is 2 amps at 28 volts. As in the case of the solenoid valve, two failure modes exist which could result in heat input; partial coil short circuit or potting corrosion resulting in heat buildup and coil damage. However, when the injector valves operate, they provide a fluid path to the vacuum of space, hence electrically induced pressure buildup in the injector valve is impossible. The valve will operate for any short circuit up to the circuit breaker current limit, since the magnetic field is approximately constant for any partial coil short circuit (i.e. half the turns yields twice the current, hence the magnetic field is constant). If the engine fails to fire, the RCS caution and warning will advise the crew to open the circuit breaker. Therefore, the RCS injector valves cannot be considered a significant source of energy input.
