International Space Station Program Status

HEO NAC
July 29, 2013
Sam Scimemi
Director, International Space Station

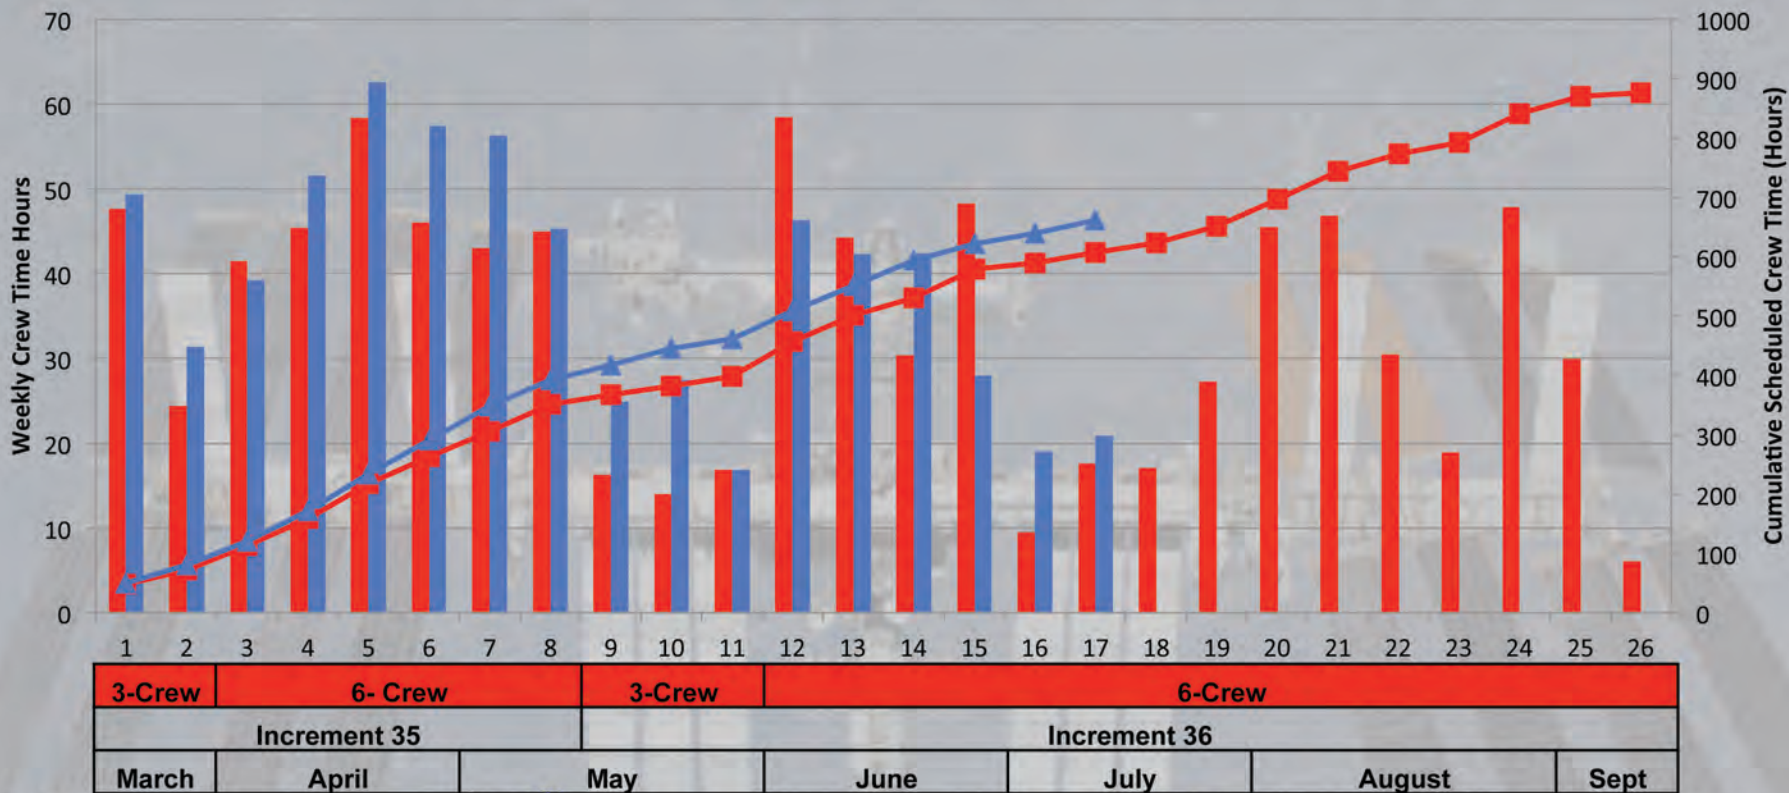
Inc 35-36 Utilization Crew Time

OOS Planned USOS Executed OOS Planned Cumulative USOS Cumulative Executed

Executed through Increment Wk (WLP Week) 17 =	16.0	of 24.2 work weeks (66.12% though the Increment)
USOS IDR Allocation:	875	hours
OOS USOS Planned Total:	876.49	hours
USOS Actuals:	661	hours
	75.54%	through IDR Allocation
	75.41%	through OOS Planned Total
Total USOS Average Per Work Week:	41.31	hours/work week

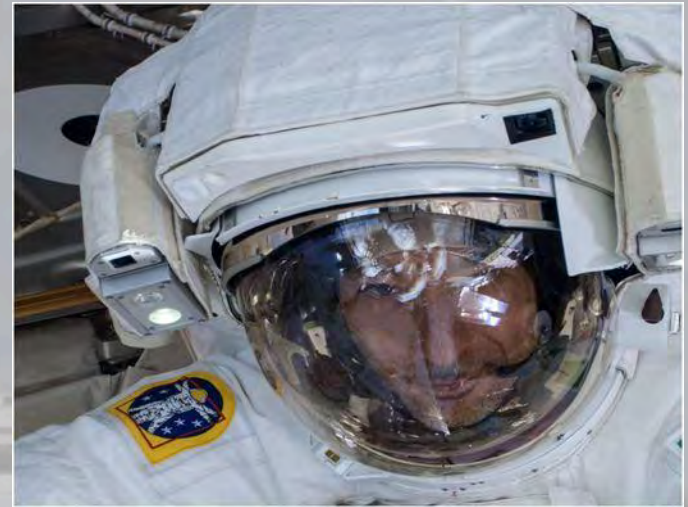
EVA 23 EMU 3011 Internal Water Leakage

- On 7/16/13, EV2/Luca Parmitano reported feeling water in his helmet at about 45 minutes into US EVA 23. Later in the EVA, EV1/Chris Cassidy confirmed a large amount of water inside the helmet. The crew were able to get EV2's helmet off and he was found to be in good health.

- Initial troubleshooting was executed on 7/17/13. It was determined that an estimated 1.8 lbs. of re-supplied feedwater was unaccounted for beyond nominal EVA usage, which is consistent with the crew reports of approximately 1.0-1.5 liters in the helmet by the end of the EVA. The Disposable In Suit Drink Bag (DIDB) was filled, folded and squeezed with no leaks. There were no leaks reported in the Liquid Cooling and Ventilation Garment (LCVG) and other water lines inside the Hard Upper Torso (HUT).
- .

- As a result of the troubleshooting, the most likely path of the water leak is through the helmet vent port. The remaining credible failure sources are located in the EMU Portable Life Support System (PLSS).

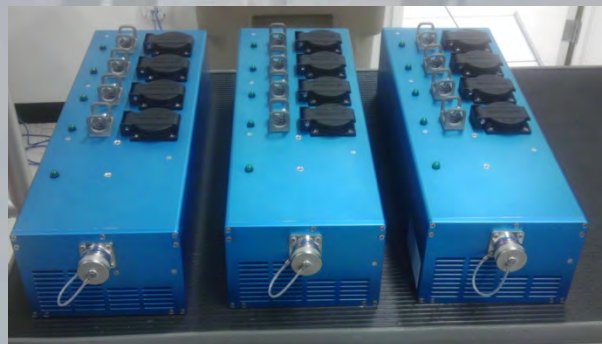
- The ISS power inverter (pictured below) comes in two models: 120Vdc-to120Vac and 28Vdc-to-120Vac respectively to support the primary power input voltages provided throughout the ISS (USOS and Russian Segments) and payload power interfaces.

- The 120Vdc-to120Vac power inverter provides power AC power provides: four (4) standard three prong AC power outlets and is capable of providing a total of 750W @ 60hz.

- The 28Vdc-to120Vac power inverter provides power AC power provides: four (4) standard three prong AC power outlets and is capable of providing a total of 400W @ 60hz.

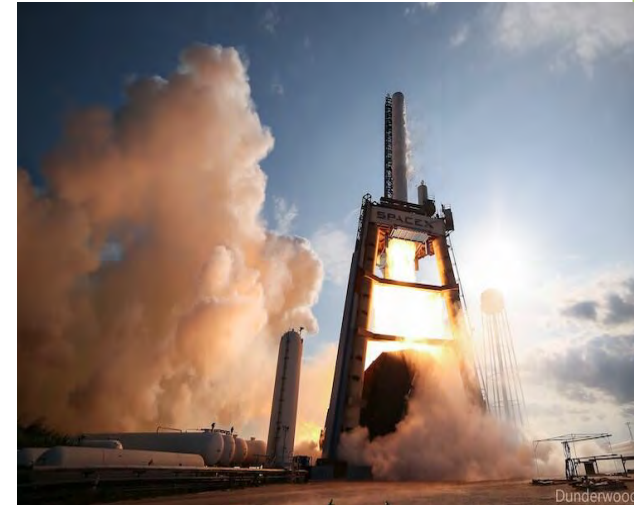
Falcon 9v1.1 Stage 1 testing
at McGregor, TX

- New Falcon 9 version 1.1 (F9v1.1) is undergoing qualification testing currently and will be utilized on the SpX-3 mission. Two to three commercial flights including the test flight are planned prior to use of the new launch vehicle configuration for the SpX-3 flight. The F9v1.1 rocket is planned to increase the upmass capability from 800 kg to 1580 kg of cargo.

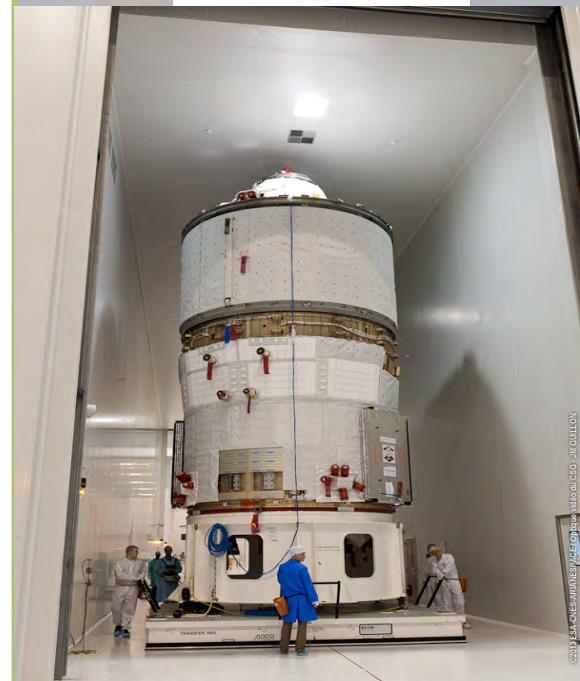
Albert Einstein (ATV4) being prepared for launch

- Plan in place to recover lost gyro with a reset of ATV computer during docked operations, no specific date set
 - Plan to re-integrate PDE 4 on July 8. ESA is investigating the ability to re-integrate the jet

- Utilizing other communication string options to get solid commanding via Tracking and Data Relay Satellite (TDRS) to ATV4

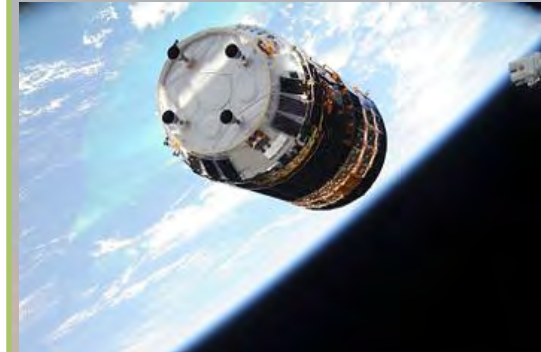
HTV3 on approach to ISS

- The HTV3 abort was caused by an interaction between the grapple fixture cam arms on the vehicle and the initial motion of the SSRMS during back away due to the relative positions of the HTV and the ISS. This interaction created rates on the HTV vehicle that, when checked on board the HTV, indicated the HTV would leave its designed departure corridor and thus it initiated an abort per joint safety requirements.

- No damage was done to the ISS. NASA has assessed a number of options to eliminate this interaction to mitigate risk of an abort on future vehicles and is implementing a modified SSRMS release approach to incorporate a delay in the start of initial SSRMS back away. Implementation is on schedule and includes refining visual cues for the crew to monitor the release as well as potentially adjusting SSRMS configuration parameters to provide a smooth separation between the SSRMS and the vehicle.
