EA AND SUPPORTING SERVICES  
FOR THE TAMU SPACE INSTITUTE  
LEASE AT JSC

**NASA Johnson Space Center / TAMU Space Institute Historic Resources Survey**  
Surveyed by SWCA Environmental Consultants | Houston, Harris County, Texas

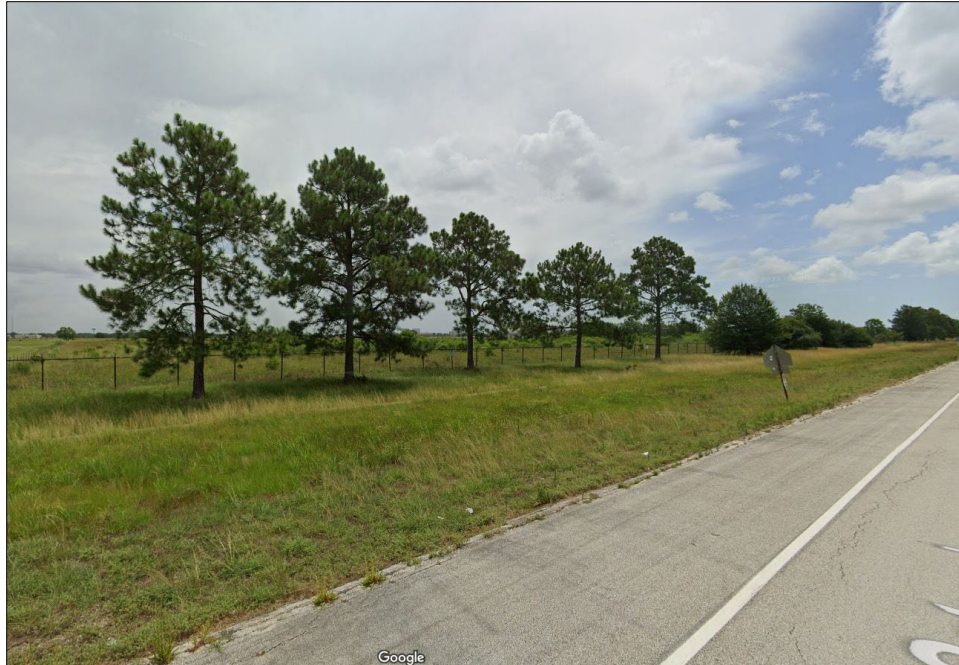
**Figure 8. Street view of the western half of the project area near the southwest corner of the project area, as depicted in July 2023, view facing north (Google Earth 2024).**

By the late twentieth century, most of the study area remained relatively unchanged except for the construction of residential neighborhoods to the northwest and southwest extents of the study area (see Figure 5). According to modern aerial imagery, the project APE is a relatively flat, undeveloped pasture bound by Saturn Lane to the southwest, a channelized Cow Bayou drainage to the southeast, and an antennae test range to the northeast (Figures 8 and 9) (Google Earth 2024).

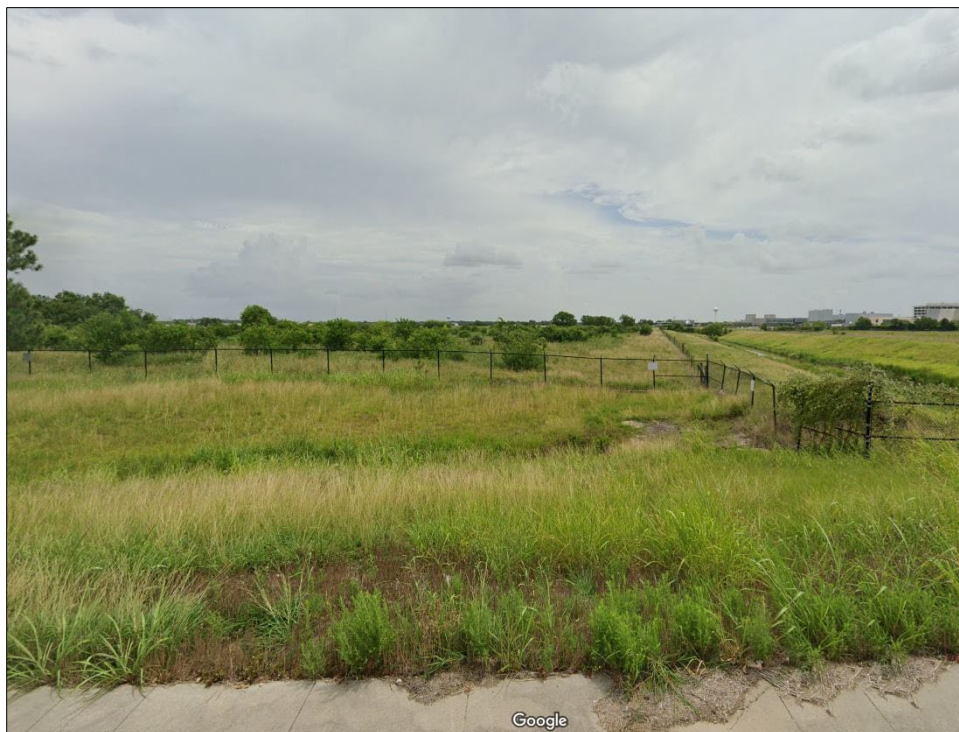
**Figure 9. Street view of easternmost extent of the project APE, as depicted in July 2023, view facing north. Note Cow Bayou in the right of frame (Google Earth 2024).**

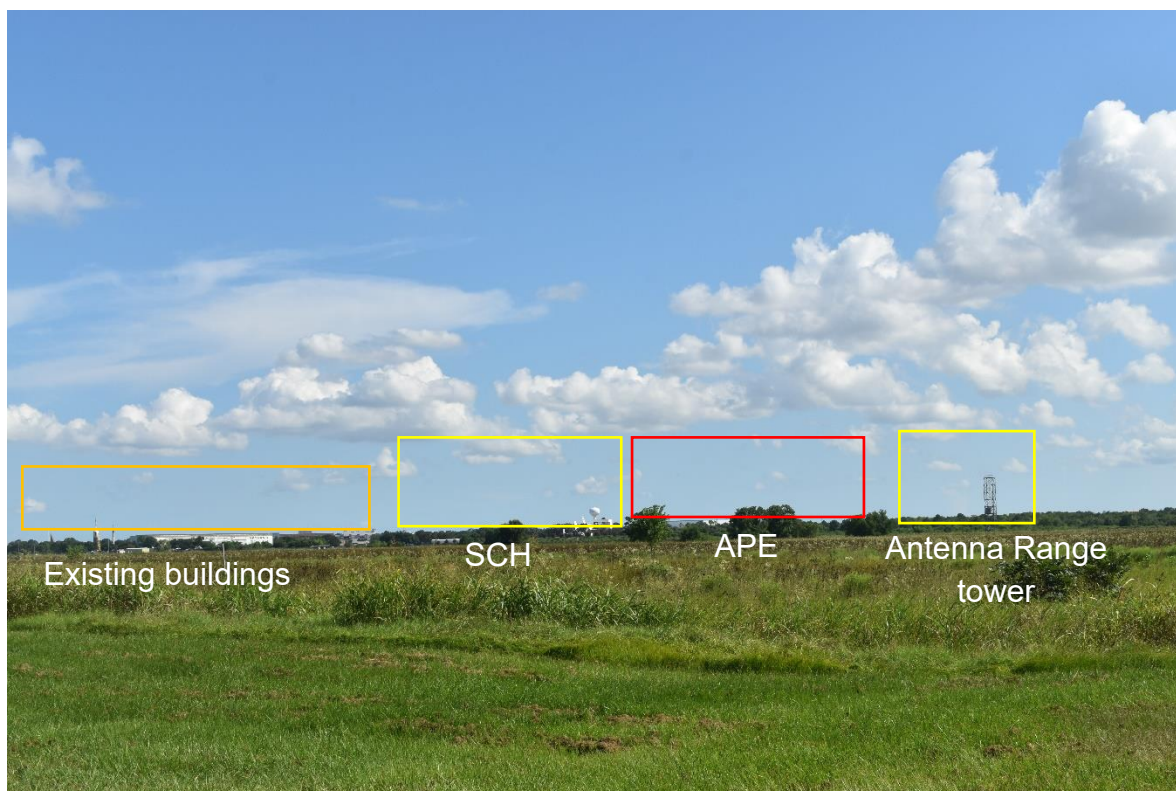
Figure E-14. Annotated view toward APE from Building 425 (400s area), view facing south.

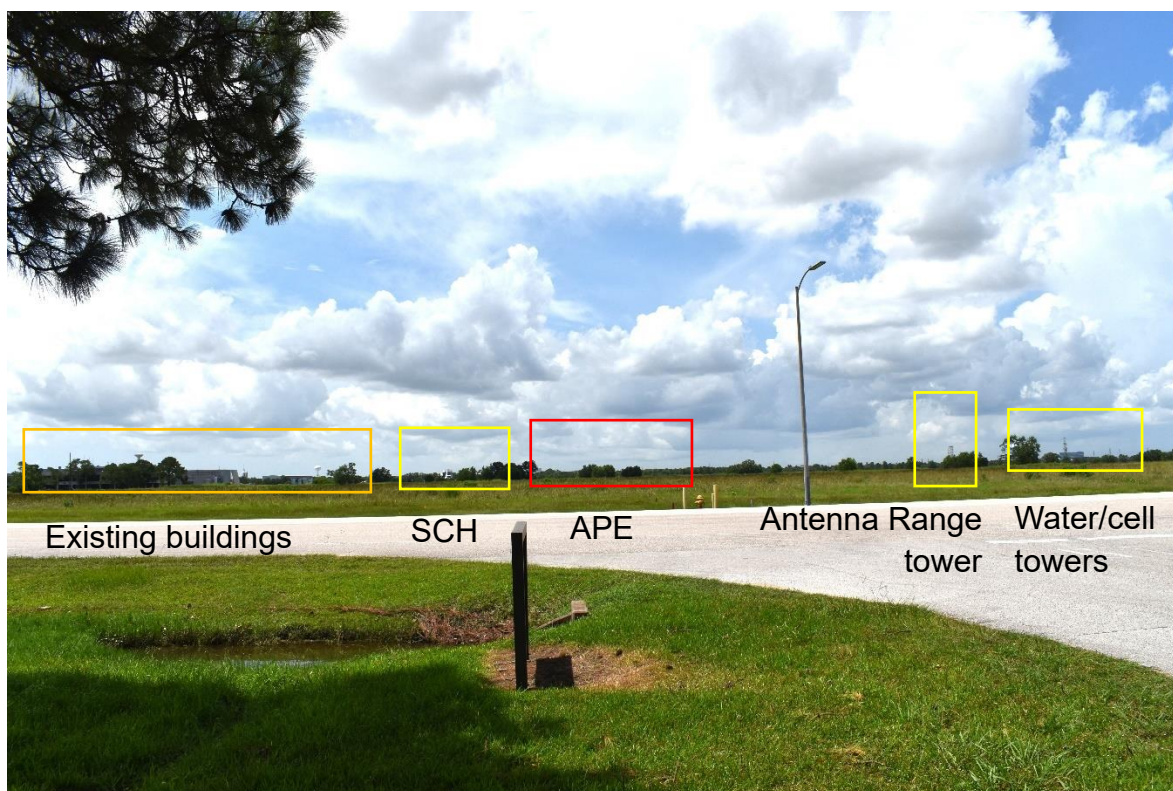
Figure E-16. Annotated view toward APE from Building 350 on Linkage Road, view facing southwest.

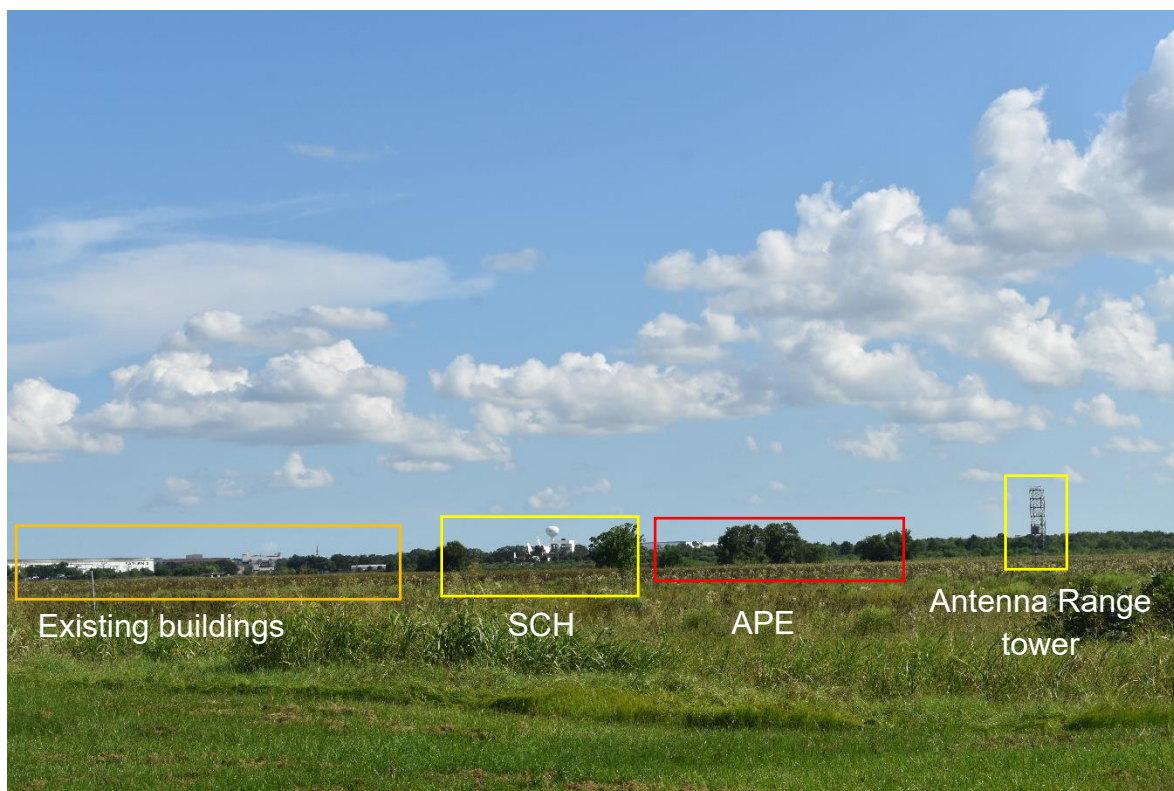
Figure E-18. Zoomed annotated view toward APE from Building 350 on Linkage Road, view facing southwest.

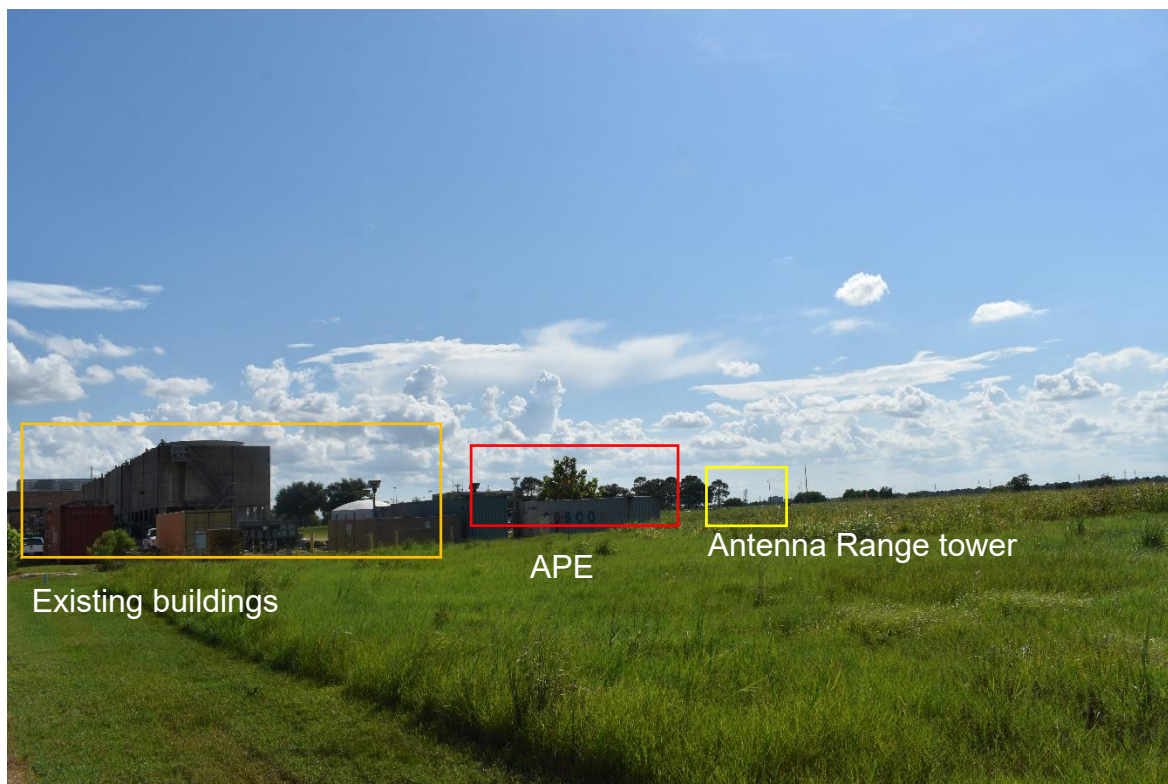
Figure E-20. Annotated view toward APE from NASA water tower, view facing southwest.

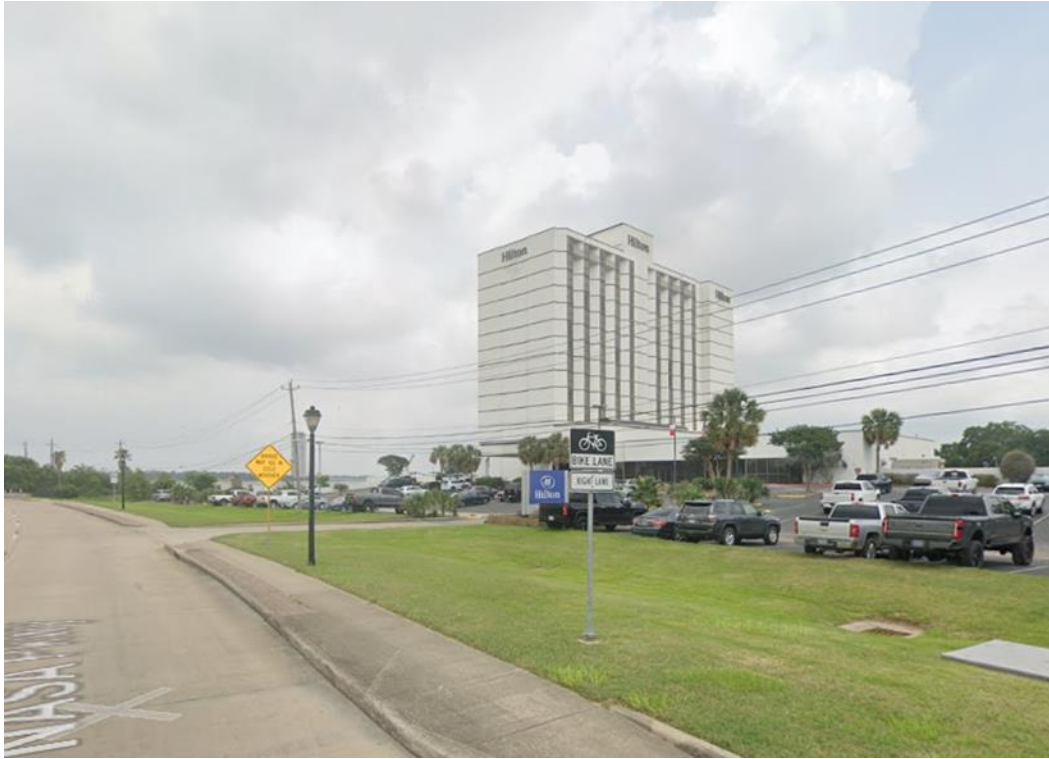
Figure E-33. View of the 1982 Hilton Clear Lake Hotel, facing northeast (Harris CAD 2024). The Hilton Hotel is a comparable building (taller than the proposed project) in the JSC vicinity.

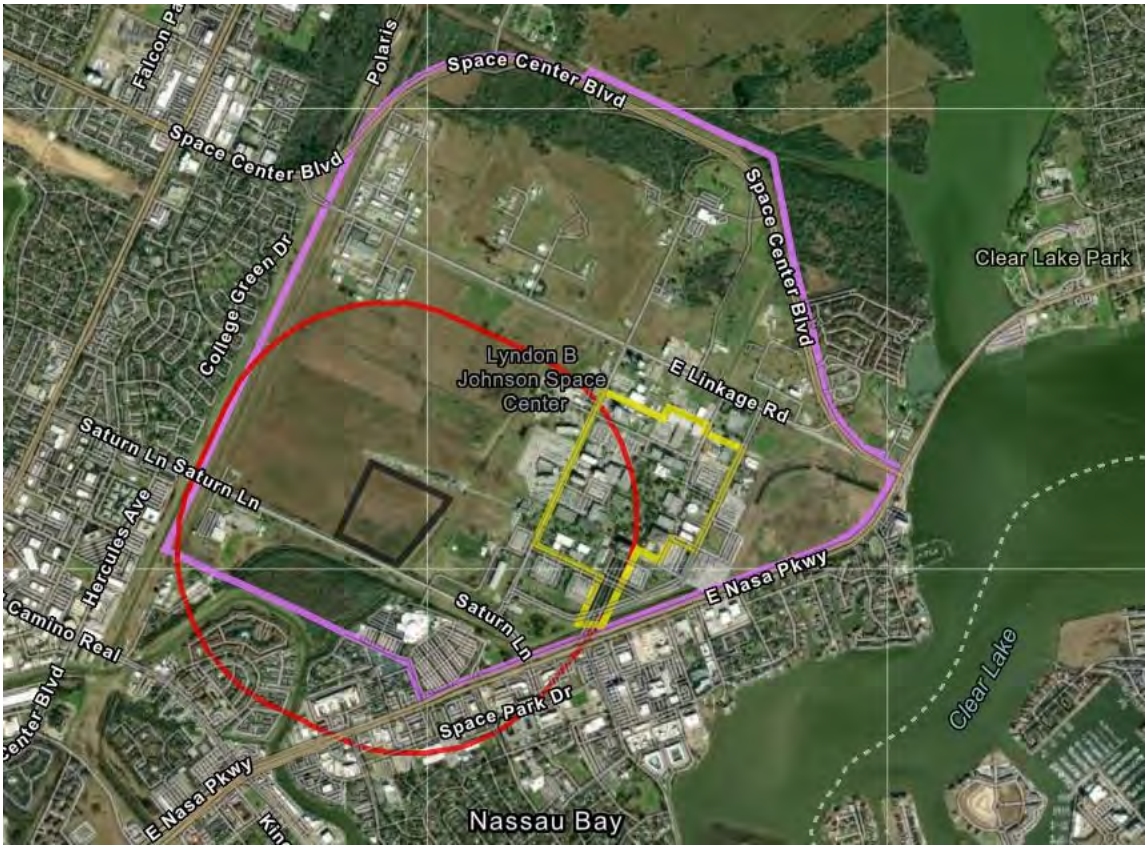
Aerial view of the historic district (in purple) with the heritage zone (in yellow) and the direct area of potential effects (APE) in black and indirect APE in red (ESRI 2024).

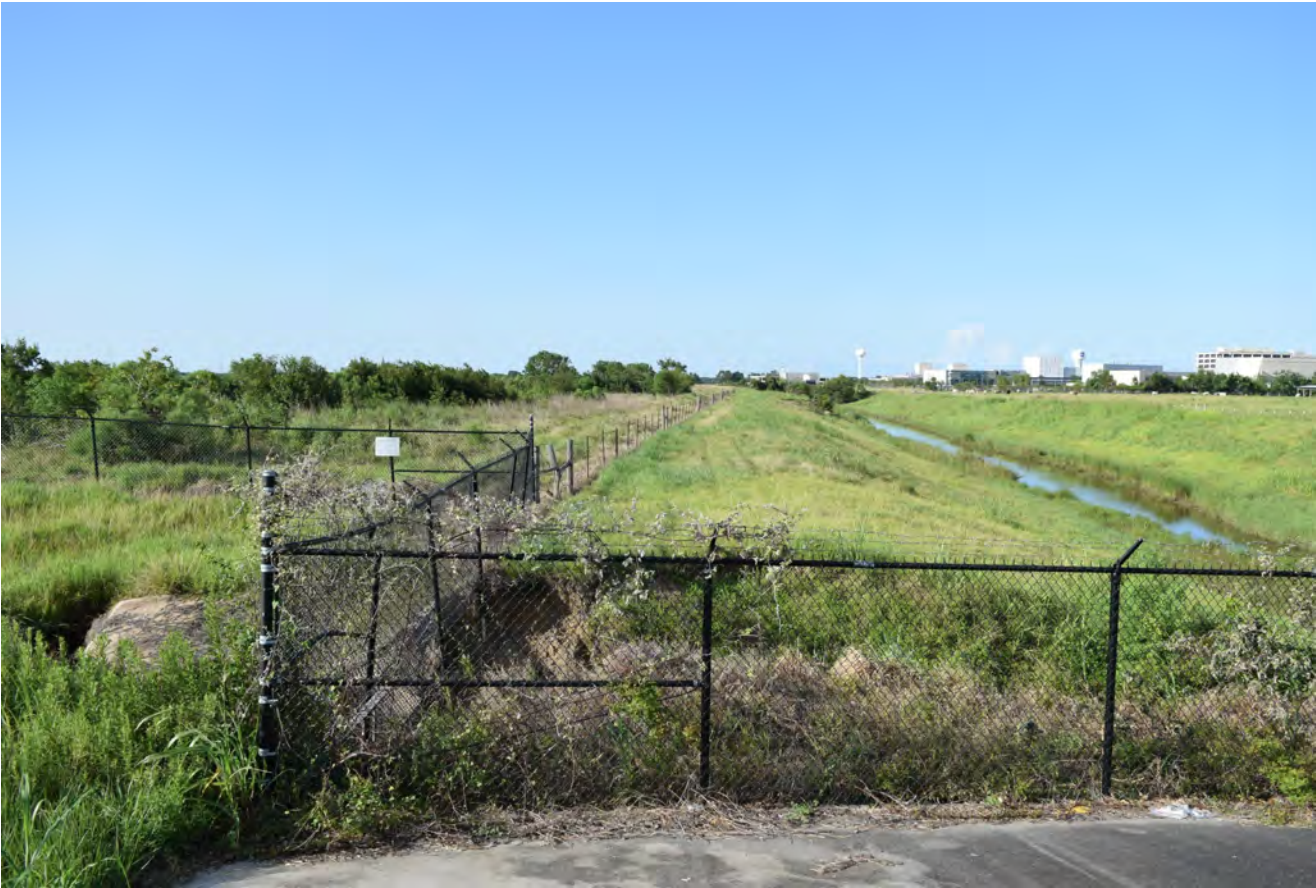
View facing northeast

Resource 864 is the NASA JSC Drainage System. The JSC campus is equipped with several large drainage ditches around the perimeter of the historic core. One of these ditches is the channelization of Cow Bayou and an east tributary running along Saturn Lane. This ditch has an even slope and shoulder layout with grassy banks and a small creek filled with water. The 50-Year Survey noted the drainage ditch (noted as Resource 864) as potentially contributing to the historic district (NASA 2017:454). The 50-Year Survey did not specify the limitations of the drainage system. This portion of the drainage system runs along Cow Bayou and the southern segment of Saturn Lane, running northeasterly along NASA Parkway.

The JSC Drainage System was an important development in the campus master plan and has continued to be key in managing the hydrology of the campus. The ditch system appears unaltered, retaining all aspects of integrity. In accordance with the potentially contributing recommendations made during the 50-Year Survey, SWCA affirms this drainage ditch system as a potential contributing resource to the historic district as an intact example of early environmental campus planning efforts for the JSC campus. The proposed project would have no direct impact nor would it have an adverse effect on this resource.

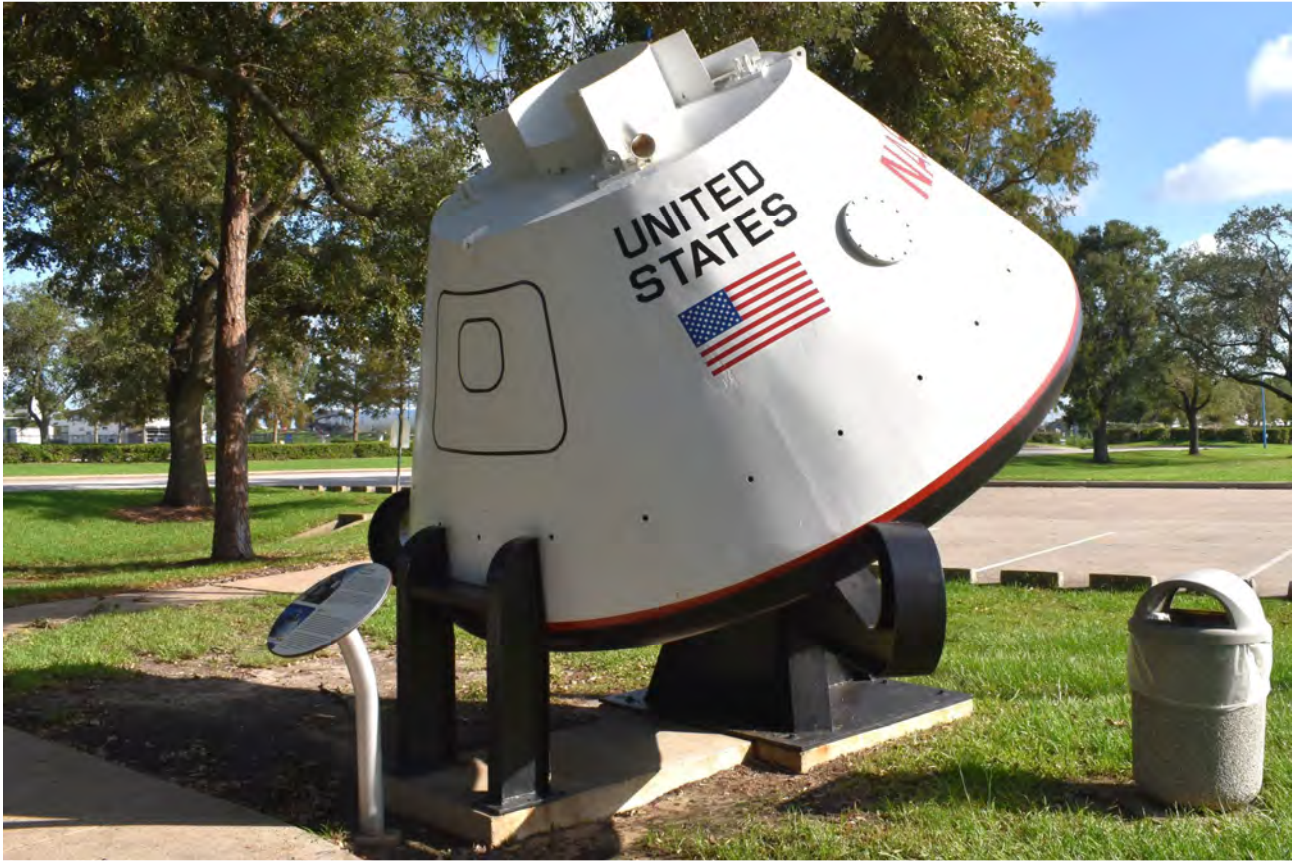
View facing northeast

Resource 0A is the Boilerplate (BP) K. The BP-K is a test spacecraft that was used in the Apollo program between 1966 and 1983 (NASA 2024). These command modules were known as boilerplates. NASA produced thousands of these for testing loads, handling characteristics, and system configurations to minimize damage to more expensive spacecraft. BP-K was produced by Ace Fabricating in Clute, Texas. NASA engineer John H. Kimzey performed fire extinguishing tests in this chamber. Following the 1967 Apollo fire, this module was key in modifying Apollo spacecraft for fire protection and for testing of the Space Shuttle Thermal Protection System (spacecraft insulation tiles). The 'K' in BP-K honors Kimzey's legacy. Following the end of testing in the 1980s, the BP-K was refurbished for public display as well as a tribute to NASA engineers at JSC. The module is on display in the T-38 Talon Park on the Space Center Houston portion of the JSC complex.

The BP-K was not included in the 2017 JSC 50 Year Survey. Like the nearby Space Shuttle Carrier and T-38-968 and T38-900, the BP-K contributes to the historic district as an installed spaceflight object for public historical interpretation. The BP-K is significant for its contributions to space exploration during the Apollo program, particularly for its innovation related to fire protection. Although the BP-K is no longer in use, the object retains all aspects of integrity. Its historical use can be easily understood. Therefore, SWCA recommends the BP-K eligible for the NRHP as a potentially contributing resource to the JSC Historic District. SWCA recommends a period of significance of 1966 to 1983, meeting Criteria Consideration G (1980-83) for exceptional significance related to the Apollo space program. The project would have no physical impact and would have no adverse effect to this contributing resource.

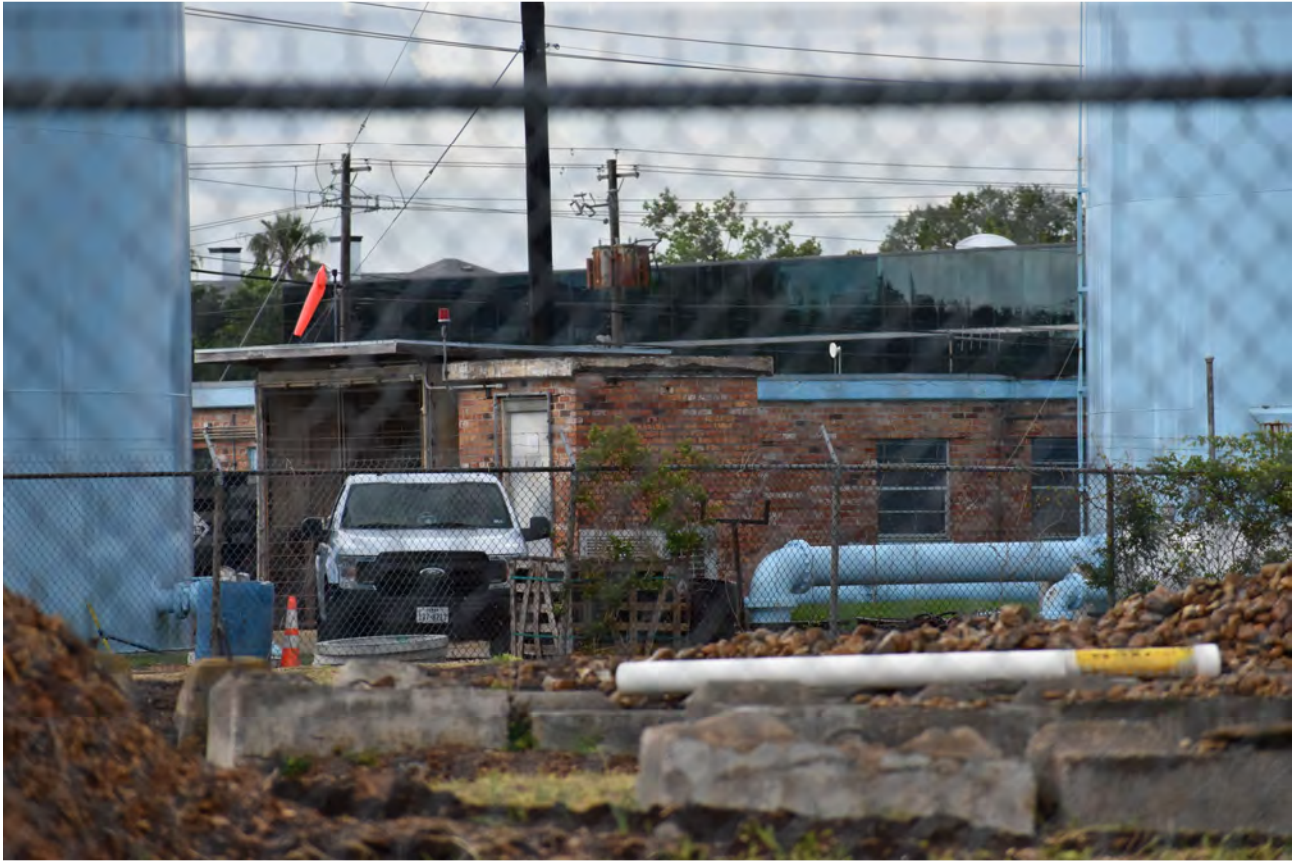
Resource 2A (Historic-age); behind Resource 2B; view facing northwest.

<b>Type:</b> Building	<b>Primary roof form:</b> Flat	<b>Roof material:</b> Tar or membrane	<b>Alterations:</b> Door(s) replaced (primary)
<b>Form:</b> Rectangular	<b>Porch:</b> N/A or None	<b>Primary materials:</b> Brick	
<b>Style:</b> No Style

The CLCWA complex is a common mid-twentieth century public works facility. Though this resource was partially obstructed, aerial imagery and field observations indicate that the building has integrity; however the resource is not significant. There are no significant individuals or known events associated with this resource or the CLCWA complex. New infill buildings lessen design integrity of the entire complex. This building does not possess distinctive design characteristics. A replaced primary door diminishes material integrity. The complex and resource are unlikely to yield information potential. Therefore, this resource is recommended not eligible for the NRHP under Criteria A, B, C, or D.

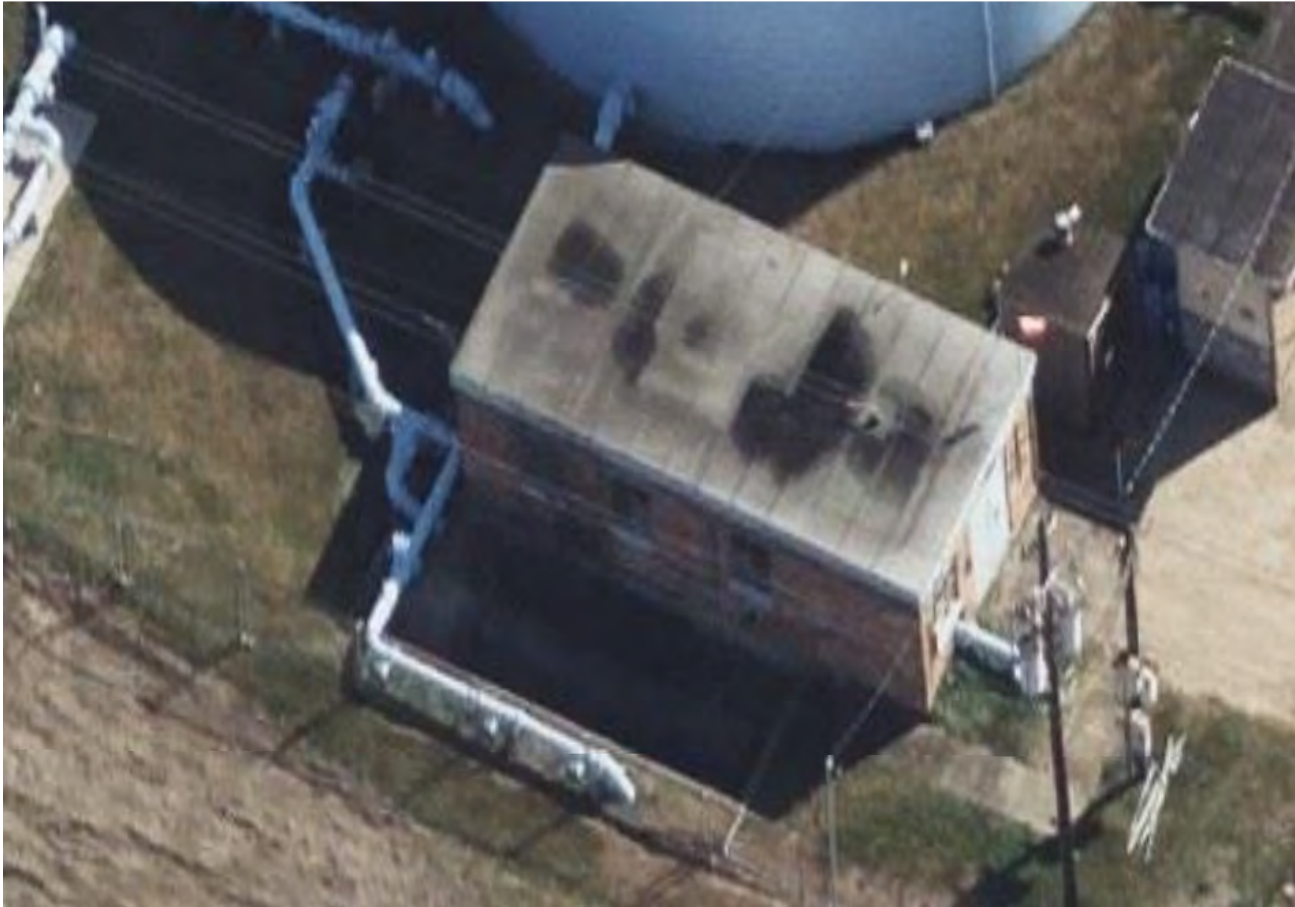
Resource 2A  
(Historic-  
age); oblique  
view facing  
southwest  
(Bing 2024)

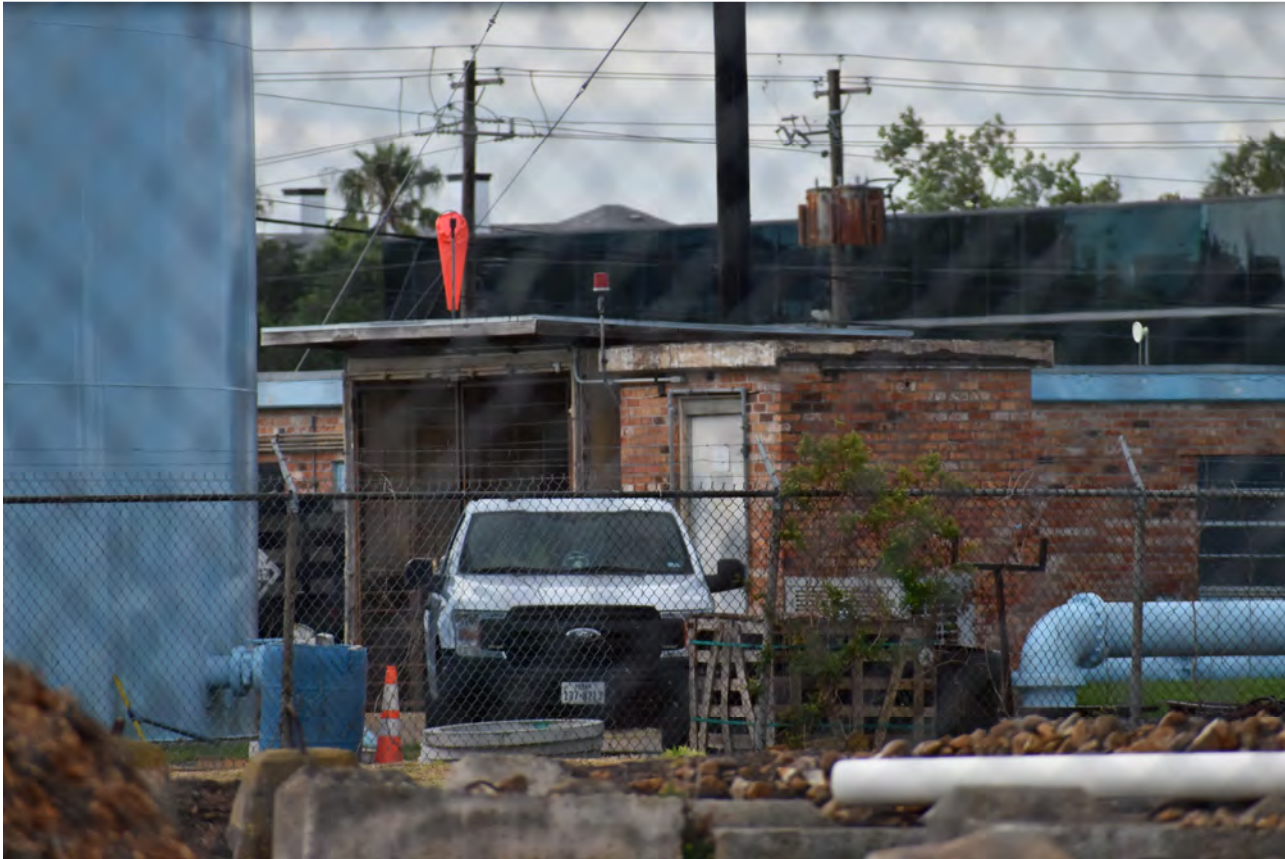
View facing  
northwest

<b>Type:</b> Building	<b>Primary roof form:</b> Shed	<b>Roof material:</b> Tar or membrane	<b>Alterations:</b> Addition to side elevation Door(s) replaced (primary)
<b>Form:</b> Rectangular	<b>Porch:</b> N/A or None	<b>Primary materials:</b> Brick	
<b>Style:</b> No Style

Although this resource was not completely visible from the right-of-way, research and available aerial imagery indicate there is no evidence this resource has significance. A side addition hinders design integrity and a replaced primary door lessens material integrity. This resource is unlikely to have information potential. Therefore, this resource is recommended not eligible for the NRHP under Criteria A, B, C, or D.

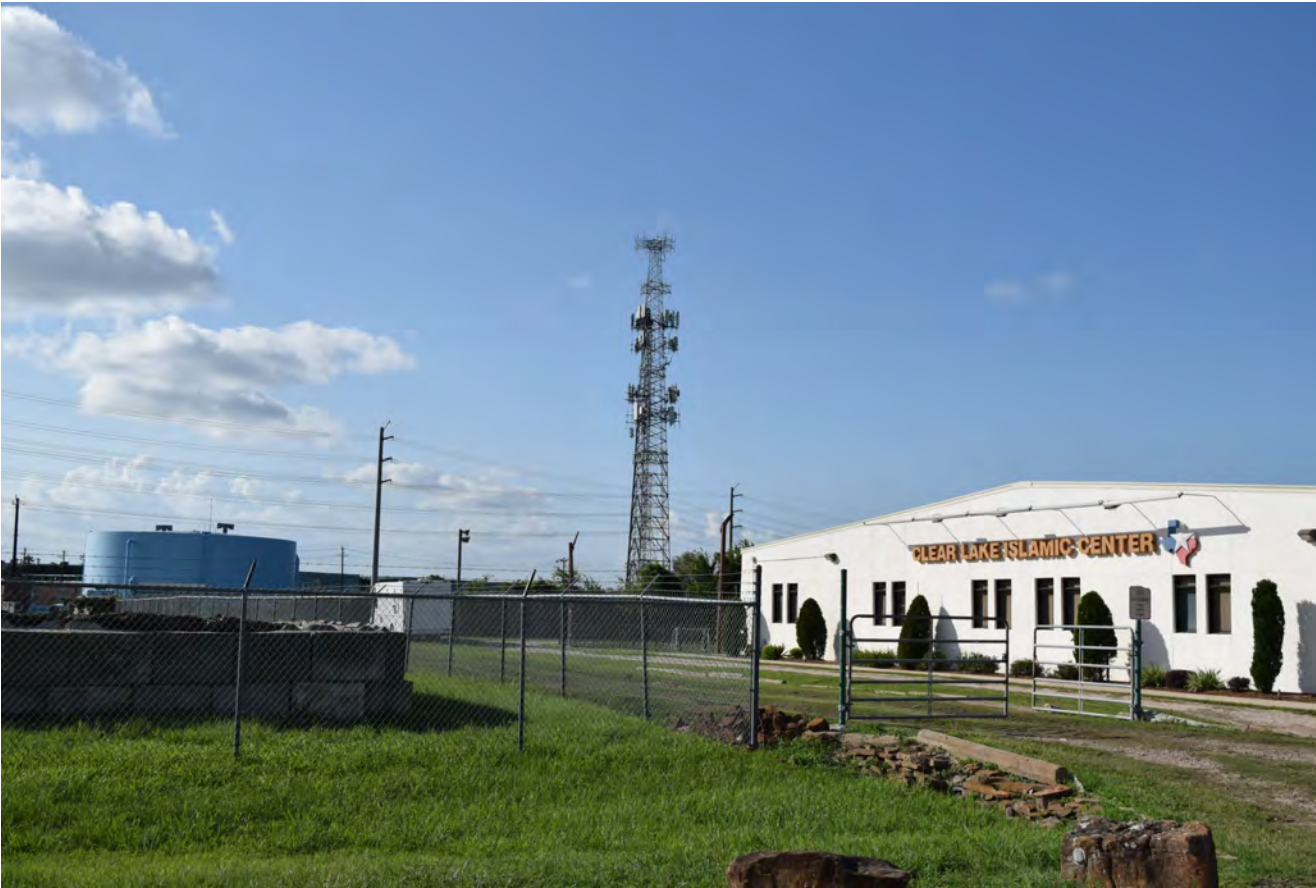
View facing northwest;  
resource on left

Though this resource appears to retain all its integrity, this resource is not associated with significant events or individuals. The structure does not possess distinctive elements and is not a work of a master. The resource is unlikely to yield information potential. Therefore, the resource is recommended not eligible for the NRHP under Criteria A, B, C, or D.

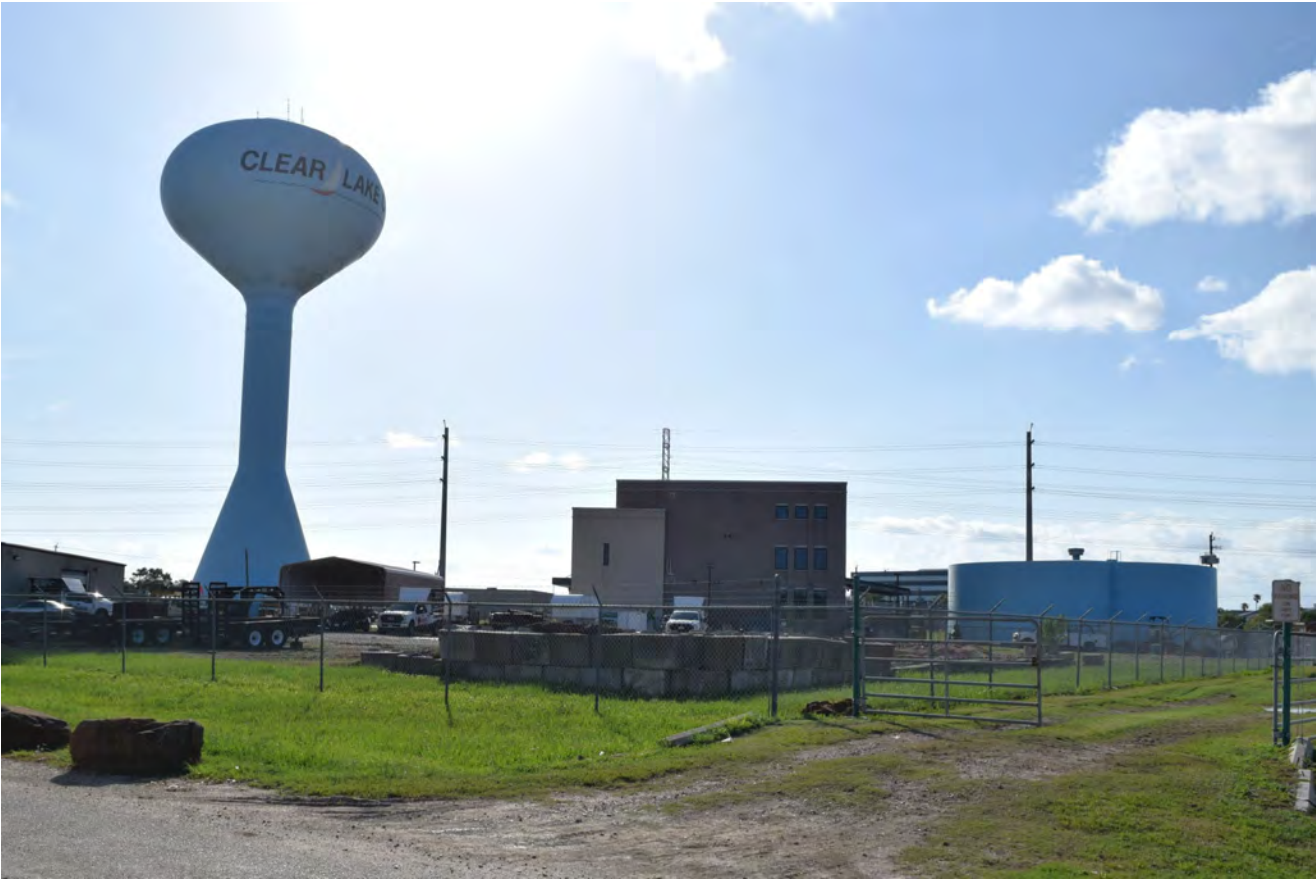
View facing northwest; resource on right

Though this resource appears to retain all its integrity, this resource is not associated with significant events or individuals. The structure does not possess distinctive elements and is not a work of a master. The resource is unlikely to yield information potential. Therefore, the resource is recommended not eligible for the NRHP under Criteria A, B, C, or D.

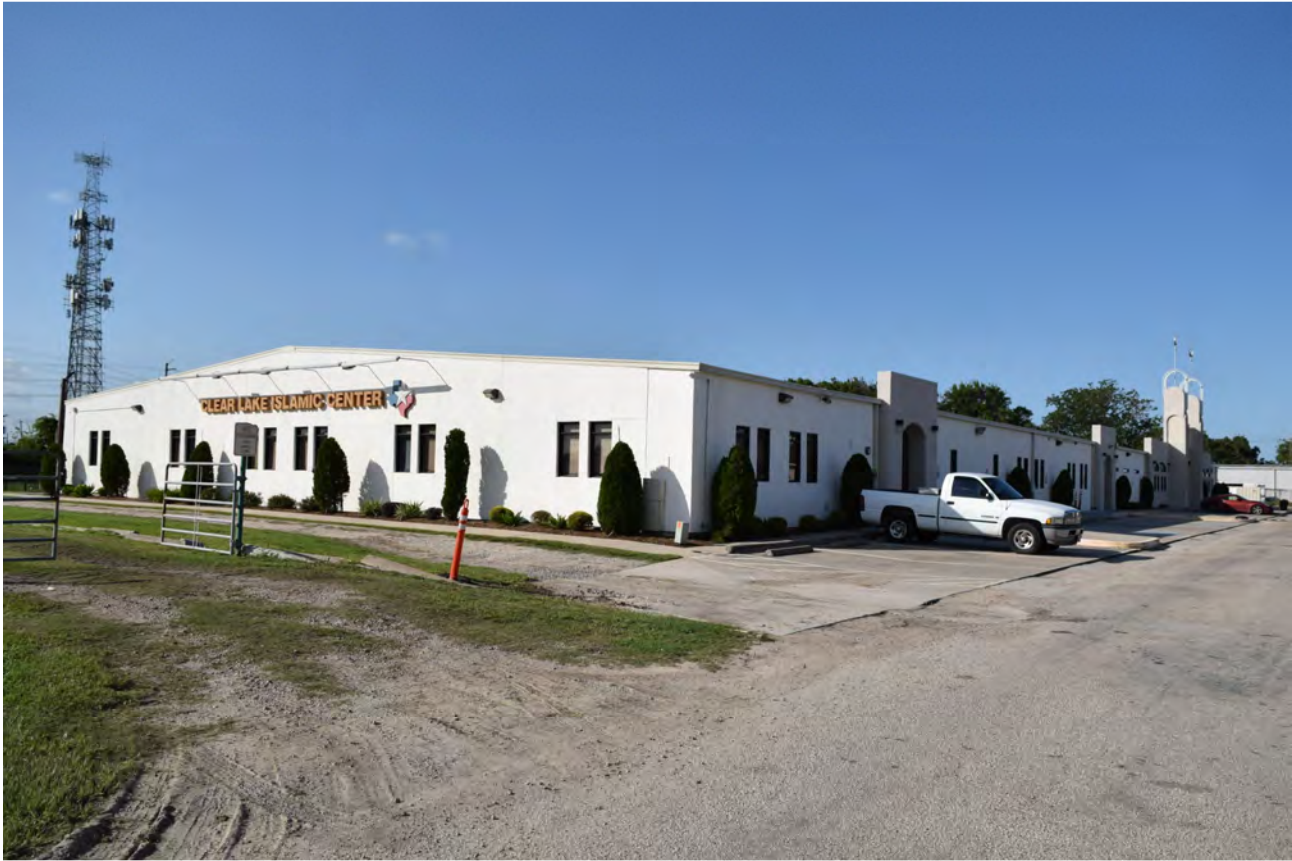
Resource 3A  
(Historic-age);  
view facing  
north

Type: Building	Primary roof form: Gable, side	Roof material: Metal	Alterations: Front facade altered Decorative features added Wall cladding replaced (some)
Form: Rectangular	Porch: Integrated partial-width	Primary materials: Stucco Permastone	
Style: No Style

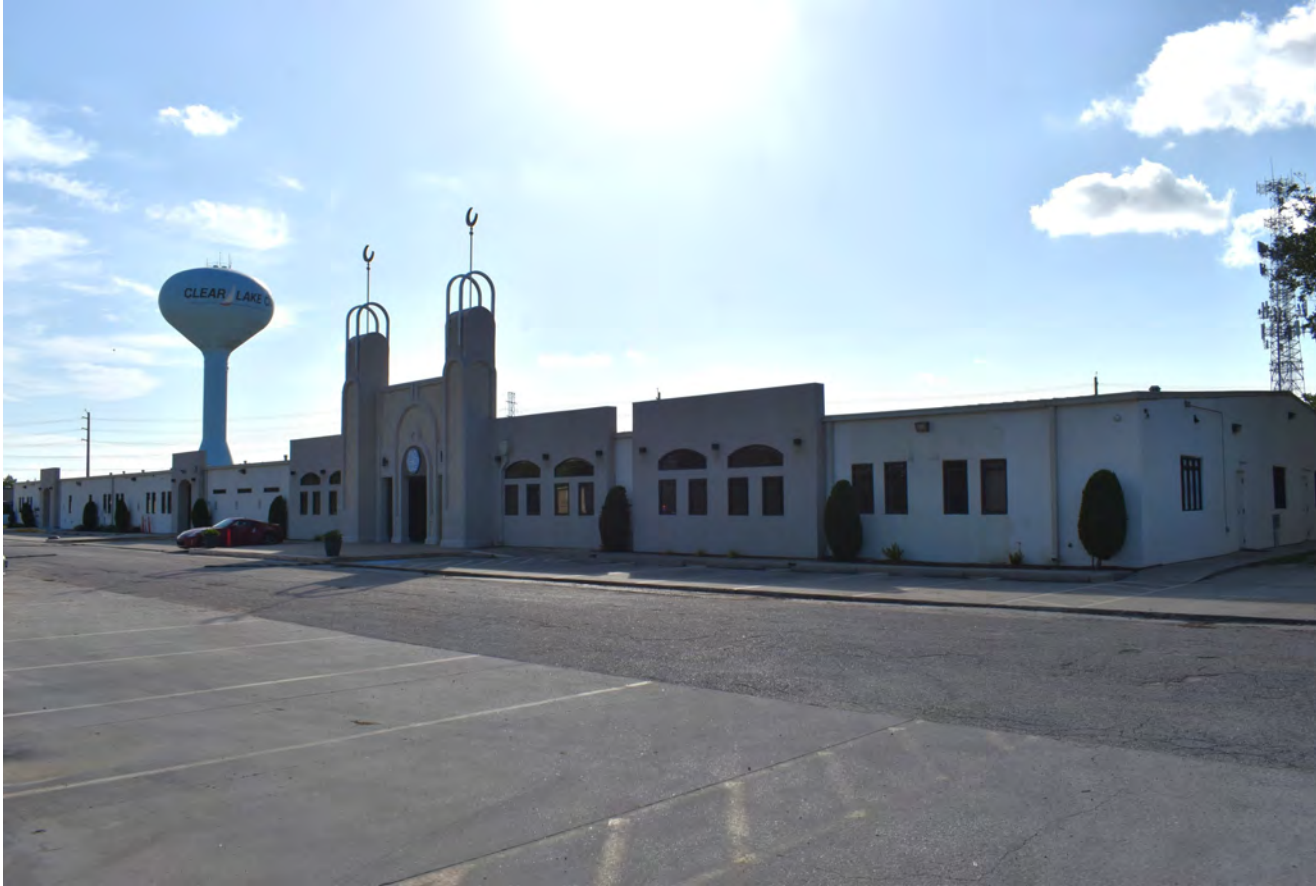
Resource 3A  
(Historic-  
age); view  
facing west

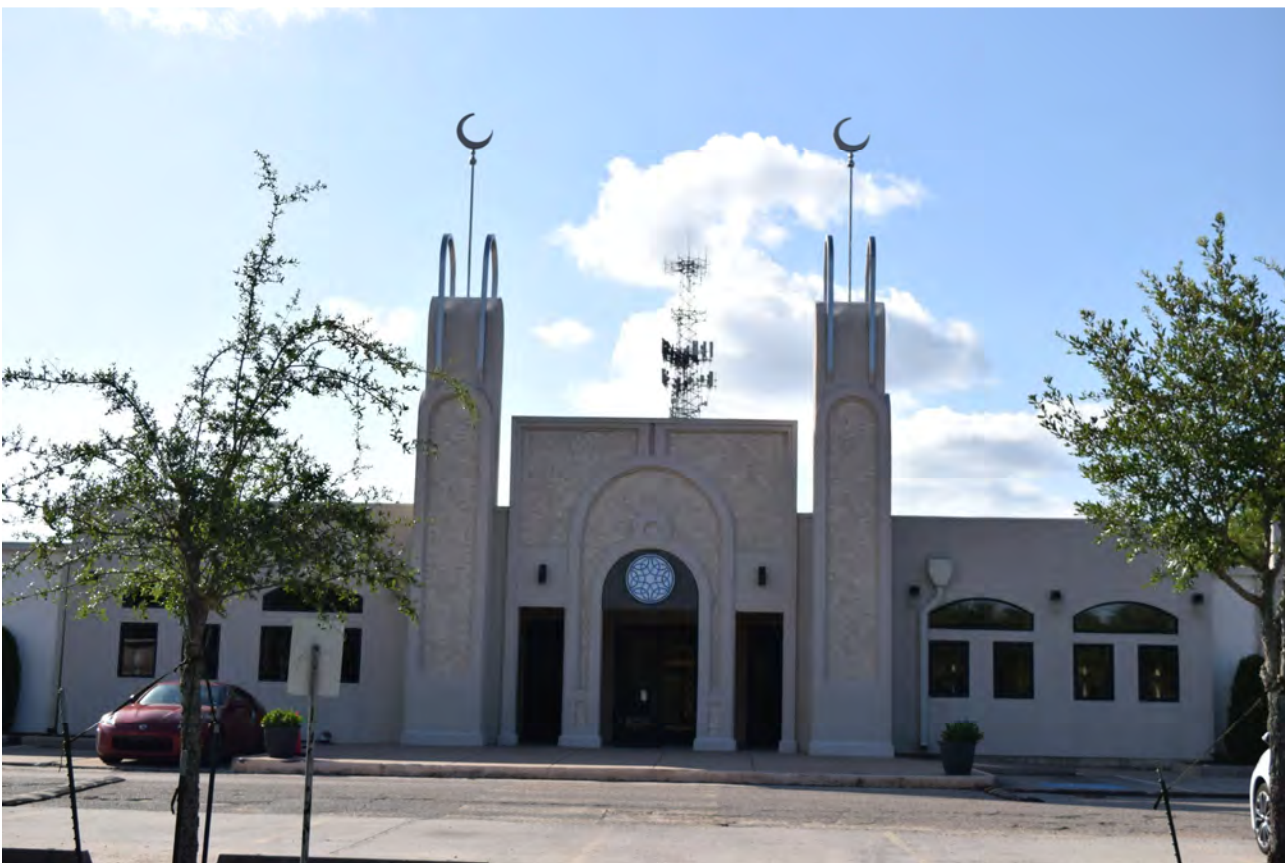
Resource 3A  
(Historic-  
age); view  
facing  
northwest  
towards  
entrance

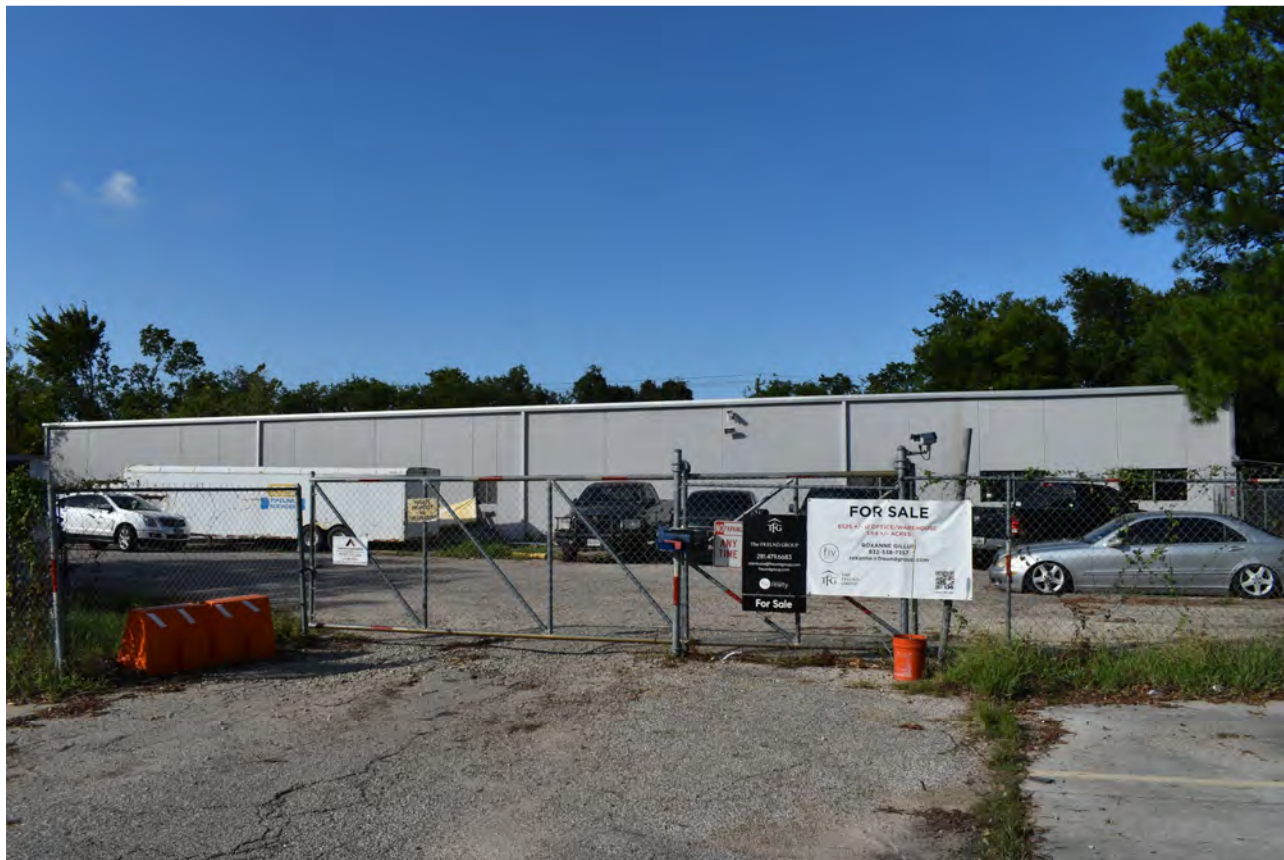
View facing northeast

<b>Type:</b> Building	<b>Primary roof form:</b> Gable, side	<b>Roof material:</b> Metal	<b>Alterations:</b> Addition to rear elevation Wall cladding replaced
<b>Form:</b> Rectangular	<b>Porch:</b> N/A or None	<b>Primary materials:</b> Stucco	
<b>Style:</b> No Style

This resource is not associated with significant events or individuals. The building does not possess distinctive elements and is not a work of a master. The resource is unlikely to yield information potential. Therefore, the resource is recommended not eligible for the NRHP under Criteria A, B, C, or D.

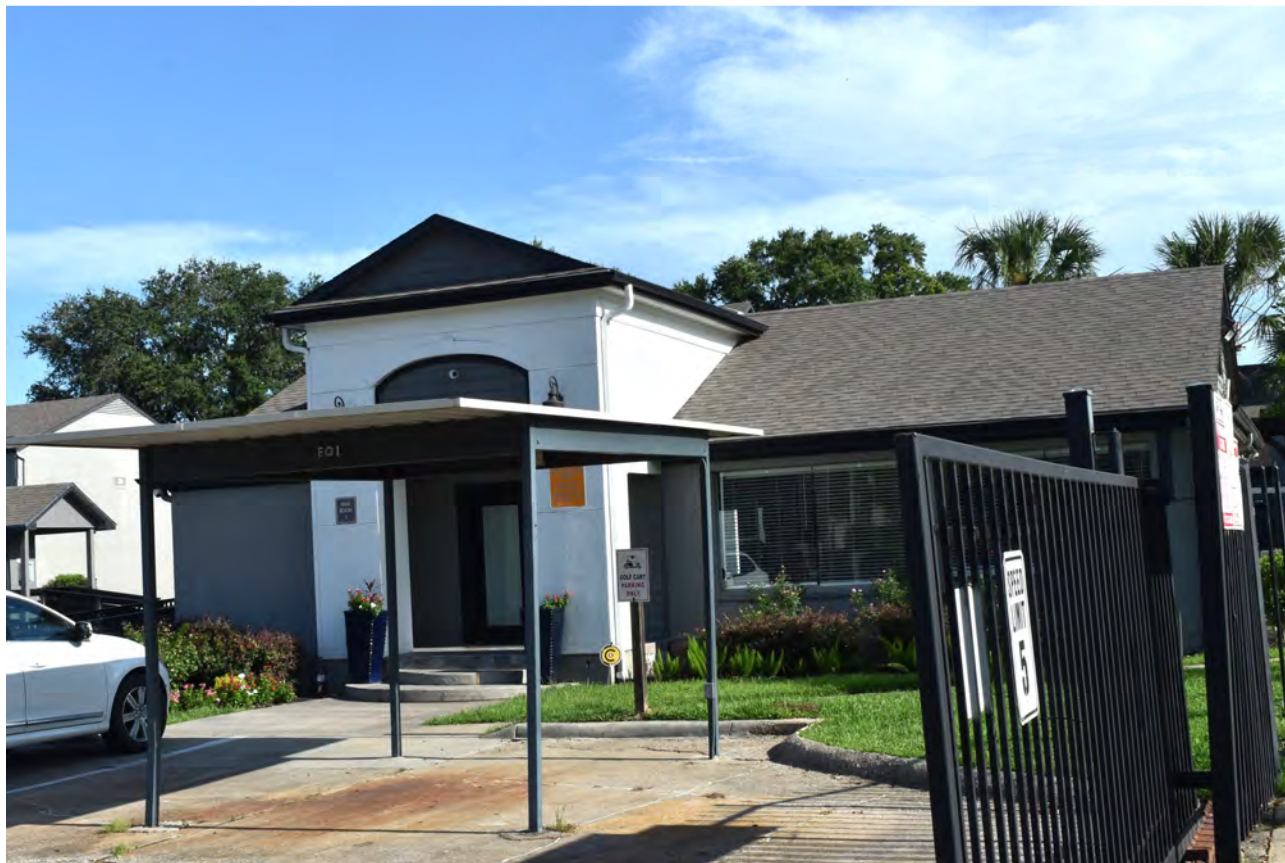
View facing southeast

**Alterations:**  
Addition to front façade  
Brick/stone painted  
Door(s) replaced (primary)  
Wall cladding replaced  
Window(s) replaced (all)

The Skylar Pointe Apartments is not associated with significant events or individuals. Although access to the entire apartment complex was limited, various alterations and additions were observed on most of the buildings. These alterations diminish integrity of design and materials. The design and planning of the apartment complex is not significant within the context of apartment complexes. Some of the buildings within the complex exhibit stylistic characteristics of the Shed style, but these architectural attributes are not significant or are considered the work of a master. The design and planning of the apartment complex is not significant within the context of apartment complexes. The complex are unlikely to yield information potential. Therefore, the apartment complex and this resource are recommended not eligible for the NRHP under Criteria A, B, C, or D.
