EA AND SUPPORTING SERVICES  
FOR THE TAMU SPACE INSTITUTE  
LEASE AT JSC

**NASA Johnson Space Center / TAMU Space Institute Historic Resources Survey**  
Surveyed by SWCA Environmental Consultants | Houston, Harris County, Texas

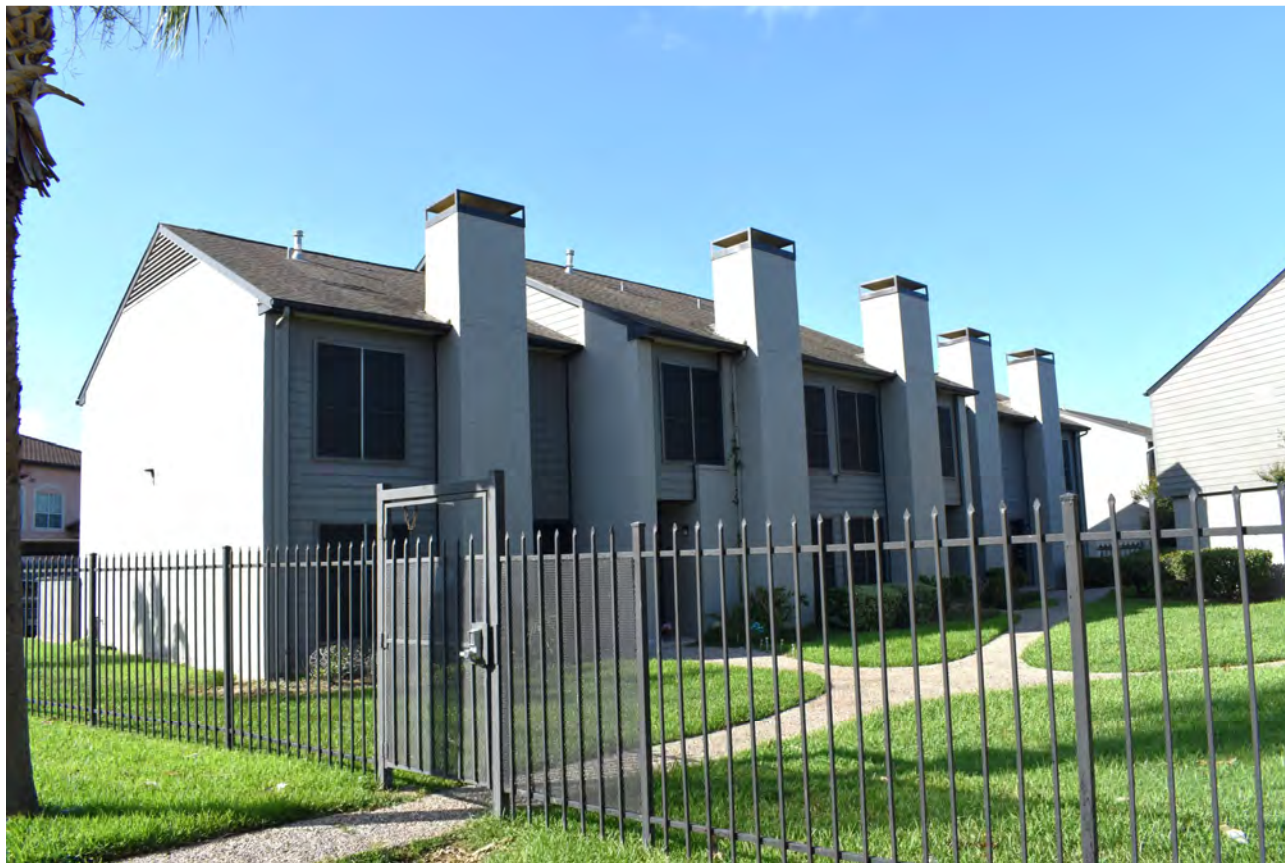
Resource 5D  
(Historic-age);  
view facing  
north

**Alterations:**  
Brick/stone painted  
Door(s) replaced (primary)  
Wall cladding replaced (some)  
Window(s) replaced (all)

This resource is not associated with significant events or individuals. The building does not possess distinctive elements and is not a work of a master. Painted brick and replaced materials diminish integrity of materials. The resource is unlikely to yield information potential. Therefore, the resource is recommended not eligible for the NRHP under Criteria A, B, C, or D.

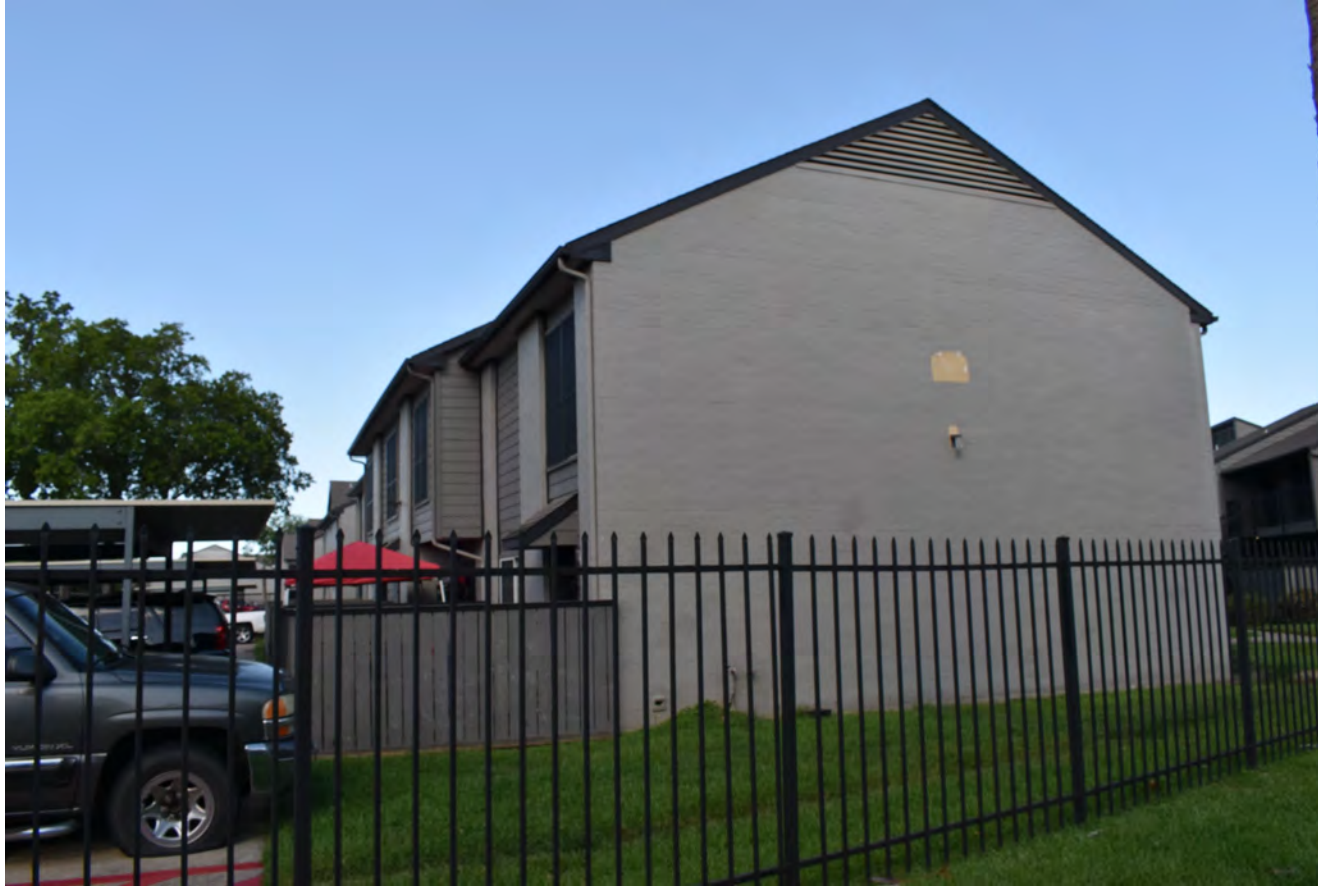
Resource 5D  
(Historic-  
age); view  
facing  
northeast

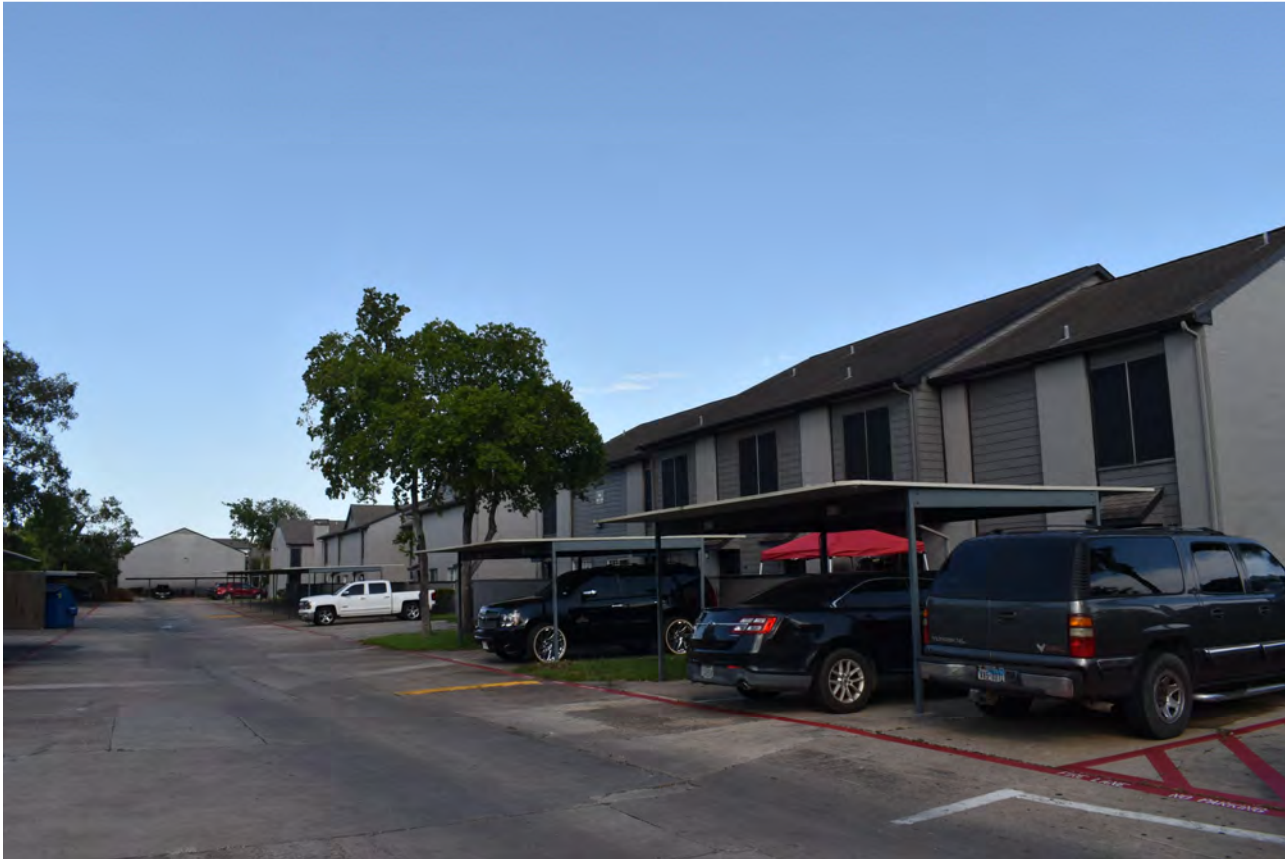
View facing  
northeast

**Alterations:**  
Brick/stone painted  
Door(s) replaced (primary)  
Wall cladding replaced (some)  
Window(s) replaced (all)

This resource is not associated with significant events or individuals. The building does not possess distinctive elements and is not a work of a master. Painted brick and replaced materials diminish integrity of materials. The resource is unlikely to yield information potential. Therefore, the resource is recommended not eligible for the NRHP under Criteria A, B, C, or D.

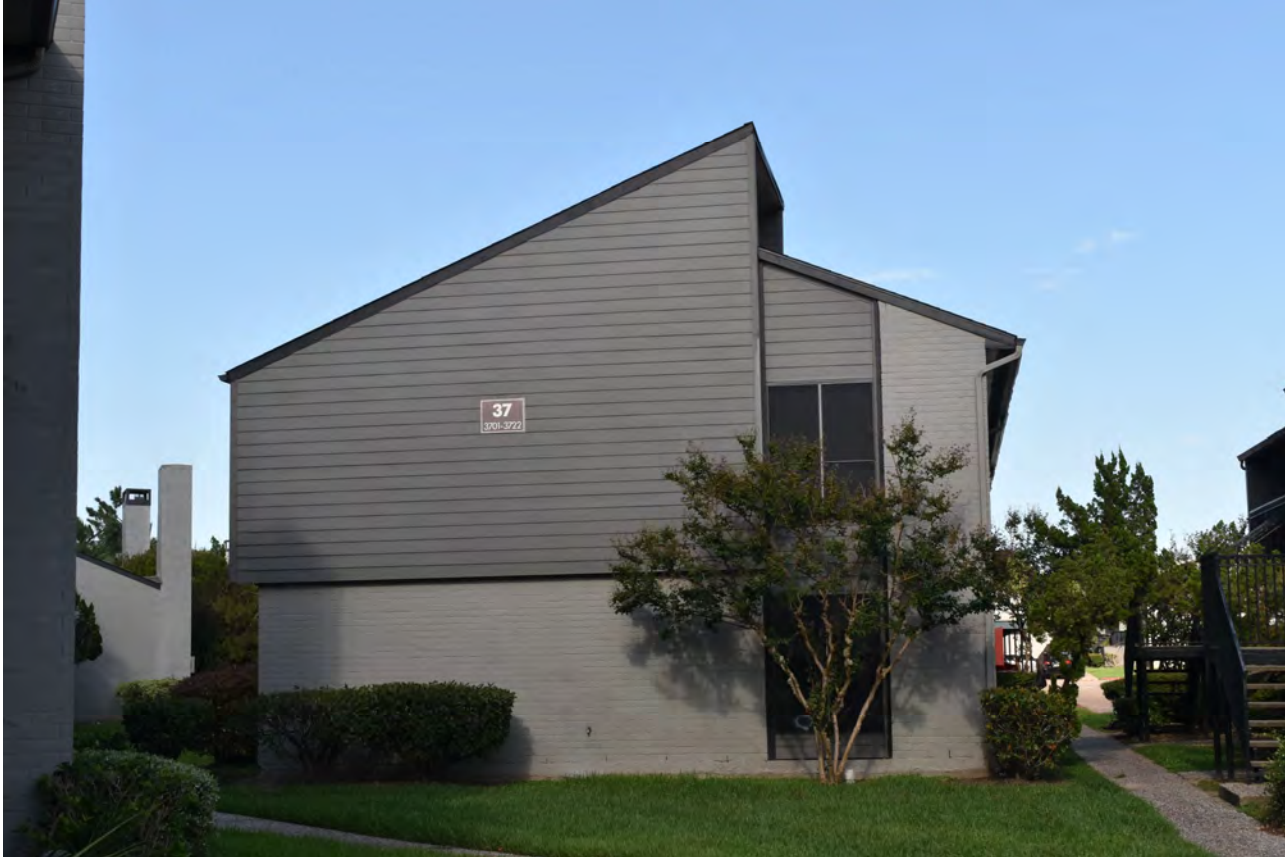
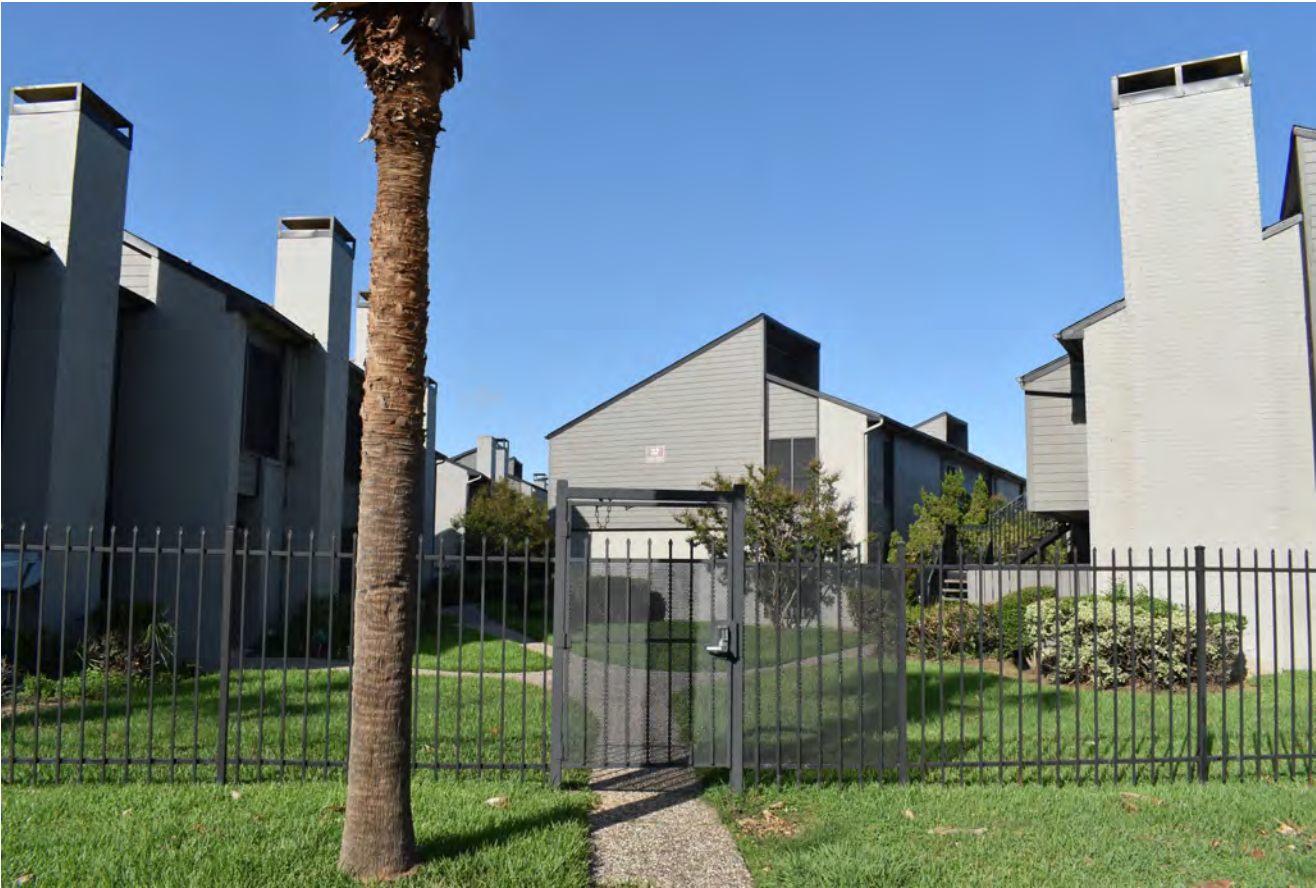
View facing east

**Alterations:**  
Brick/stone painted  
Door(s) replaced (primary)  
Wall cladding replaced (some)  
Window(s) replaced (all)

This resource is not associated with significant events or individuals. The building does not possess distinctive elements and is not a work of a master. Painted brick and replaced materials diminish integrity of materials. The resource is unlikely to yield information potential. Therefore, the resource is recommended not eligible for the NRHP under Criteria A, B, C, or D.

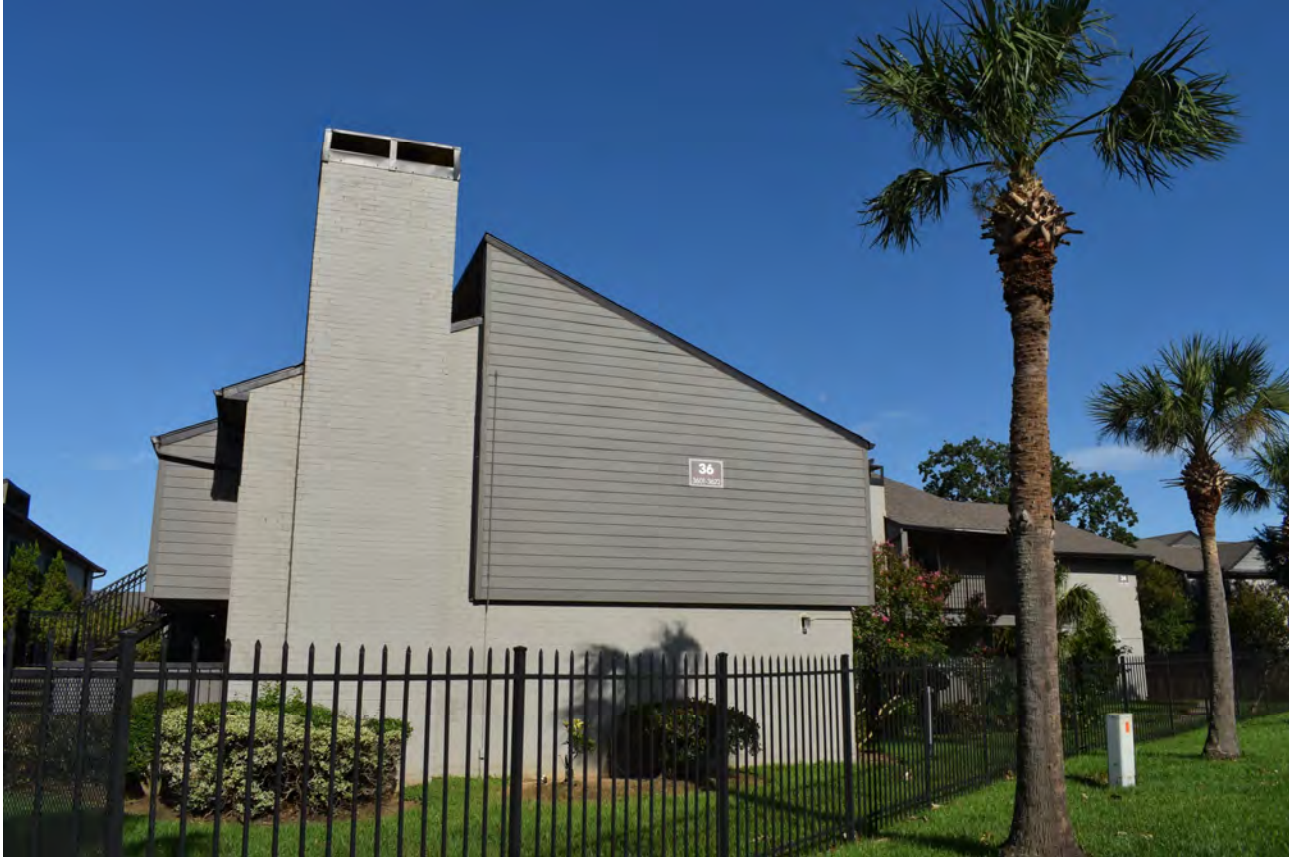
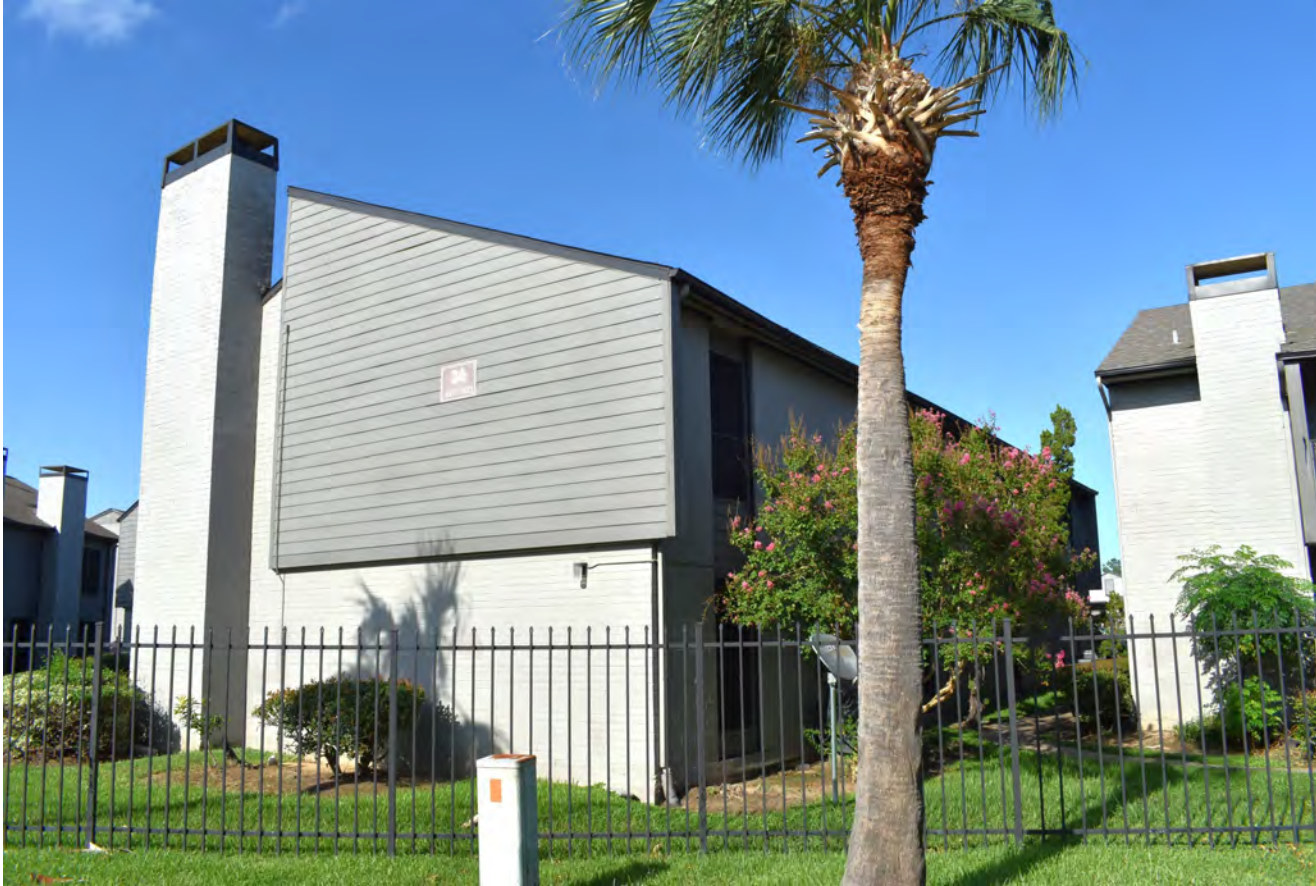
**Resource:** 5P      **Parcel:** 0402110000080  
**Name:** Skylar Pointe Apartments Building 36  
**Location:** 1110 El Camino Village Drive  
**Historic Function:** Domestic/Multiple dwelling  
**Current Function:** Domestic/Multiple dwelling

View facing southeast

**Alterations:**  
Brick/stone painted  
Door(s) replaced (primary)  
Wall cladding replaced (some)  
Window(s) replaced (all)

This resource is not associated with significant events or individuals. The building does not possess distinctive elements and is not a work of a master. Painted brick and replaced materials diminish integrity of materials. The resource is unlikely to yield information potential. Therefore, the resource is recommended not eligible for the NRHP under Criteria A, B, C, or D.

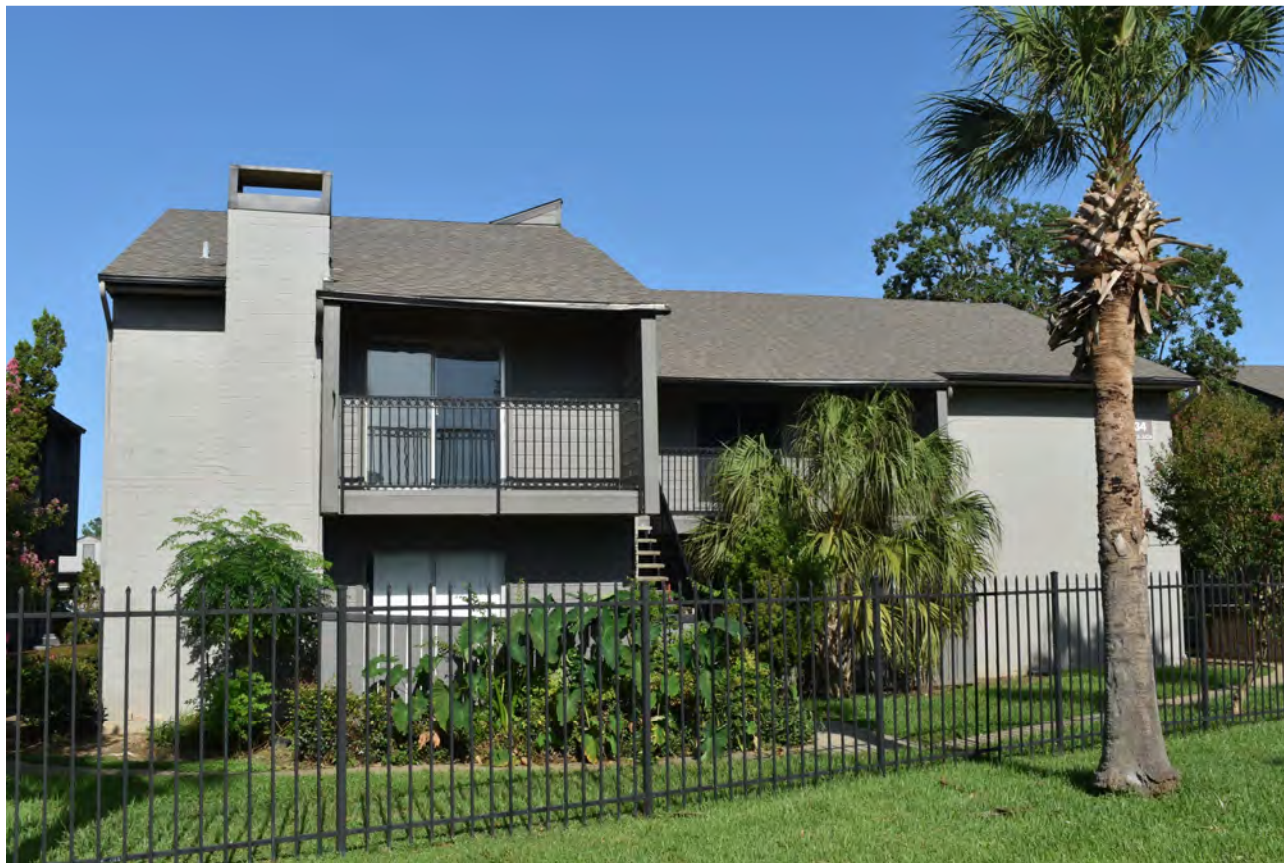
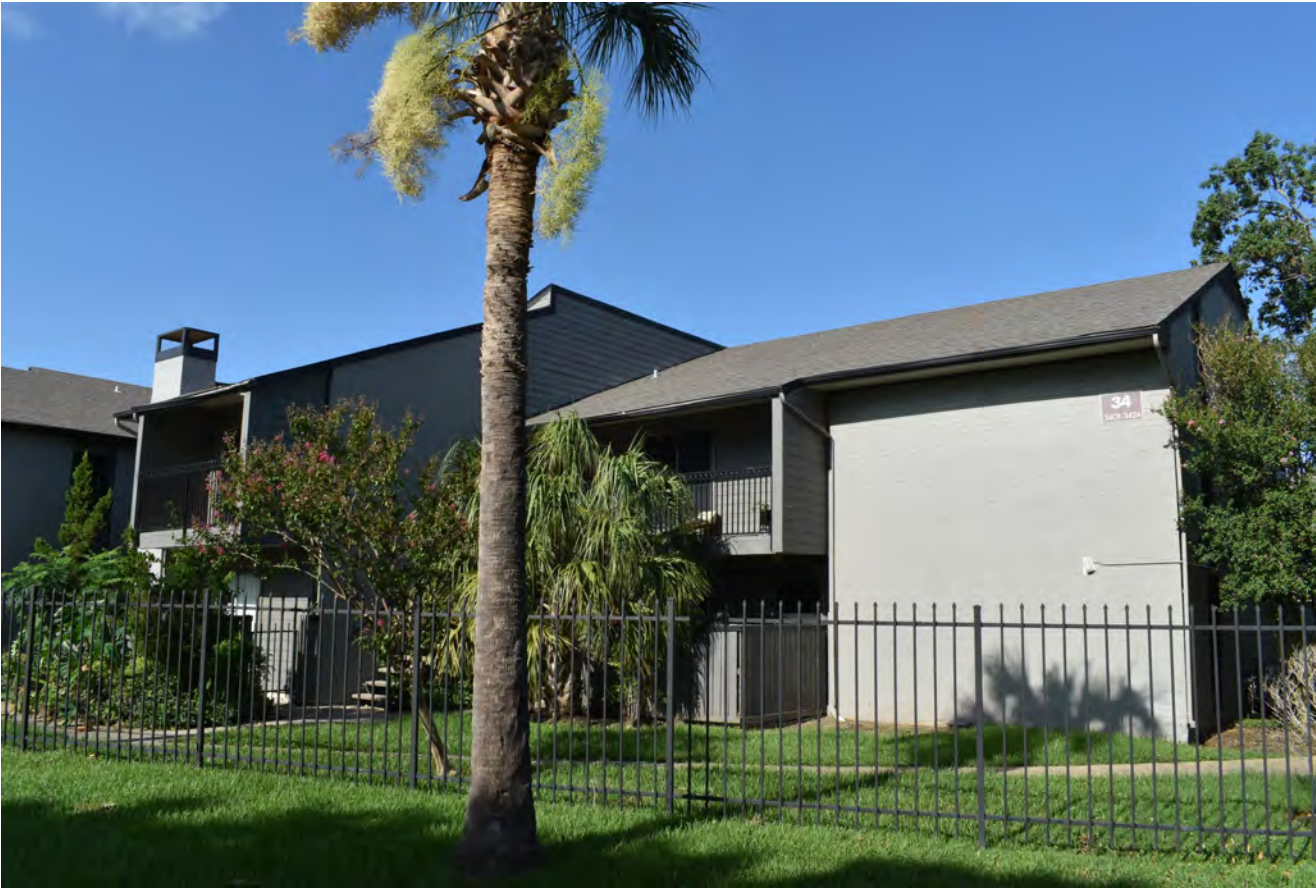
View facing east

**Alterations:**  
Brick/stone painted  
Door(s) replaced (primary)  
Wall cladding replaced (some)  
Window(s) replaced (all)

This resource is not associated with significant events or individuals. The building does not possess distinctive elements and is not a work of a master. Painted brick and replaced materials diminish integrity of materials. The resource is unlikely to yield information potential. Therefore, the resource is recommended not eligible for the NRHP under Criteria A, B, C, or D.

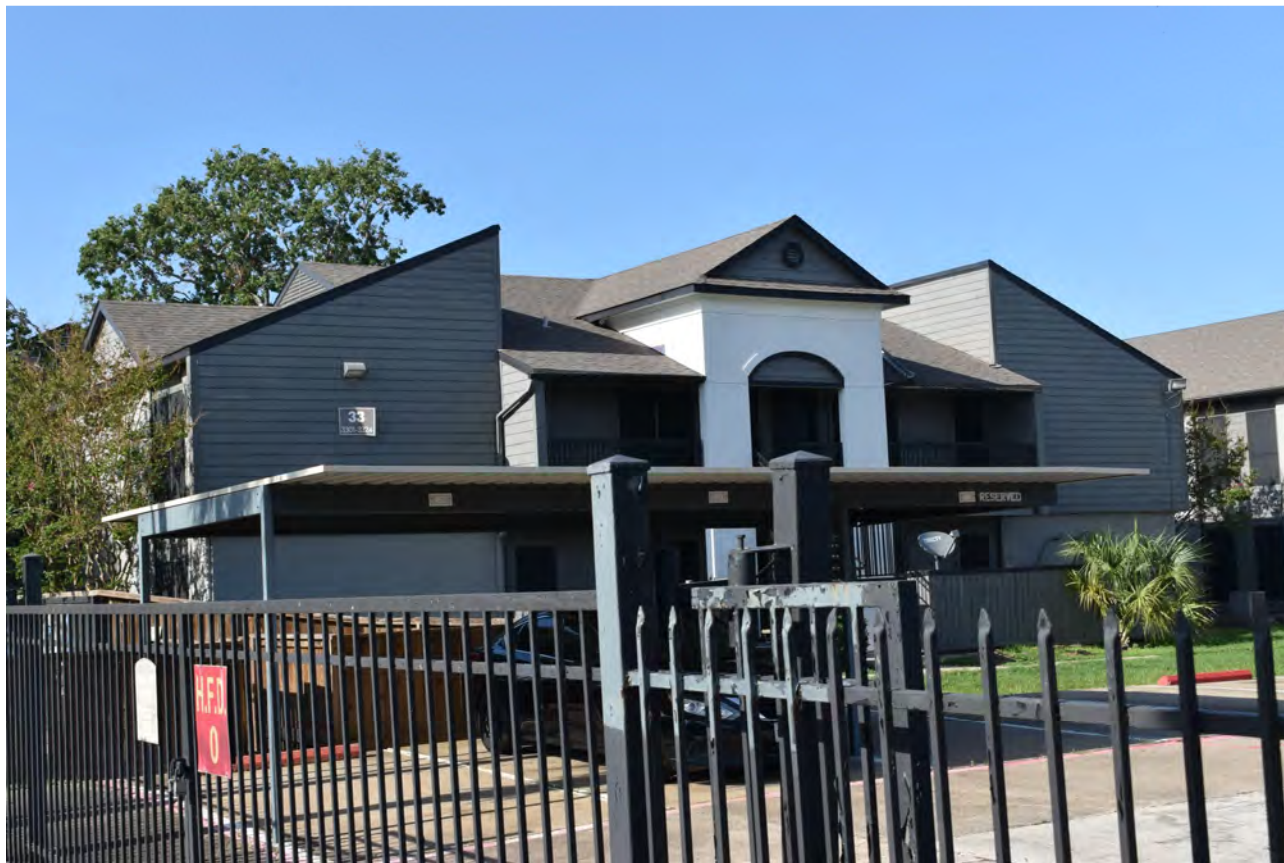
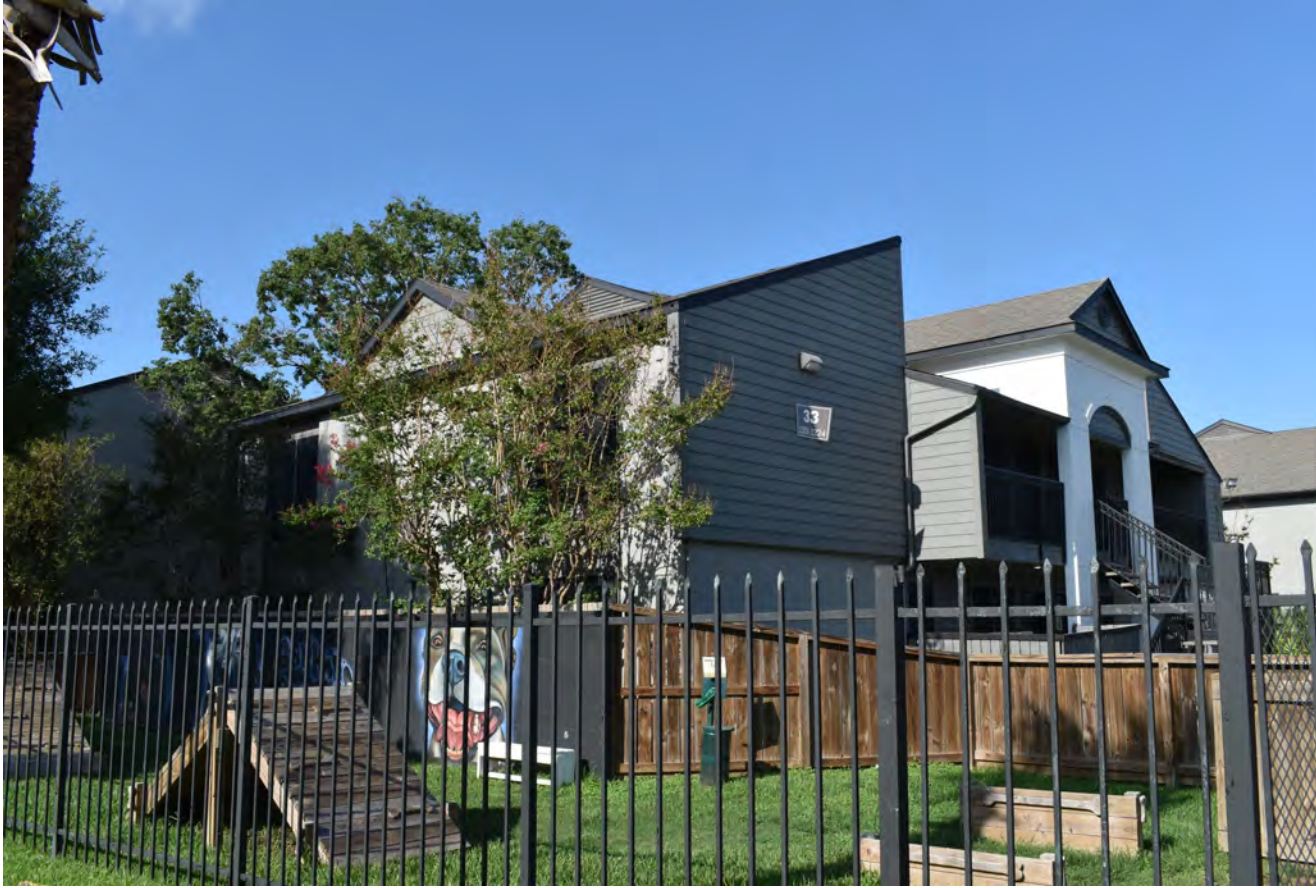
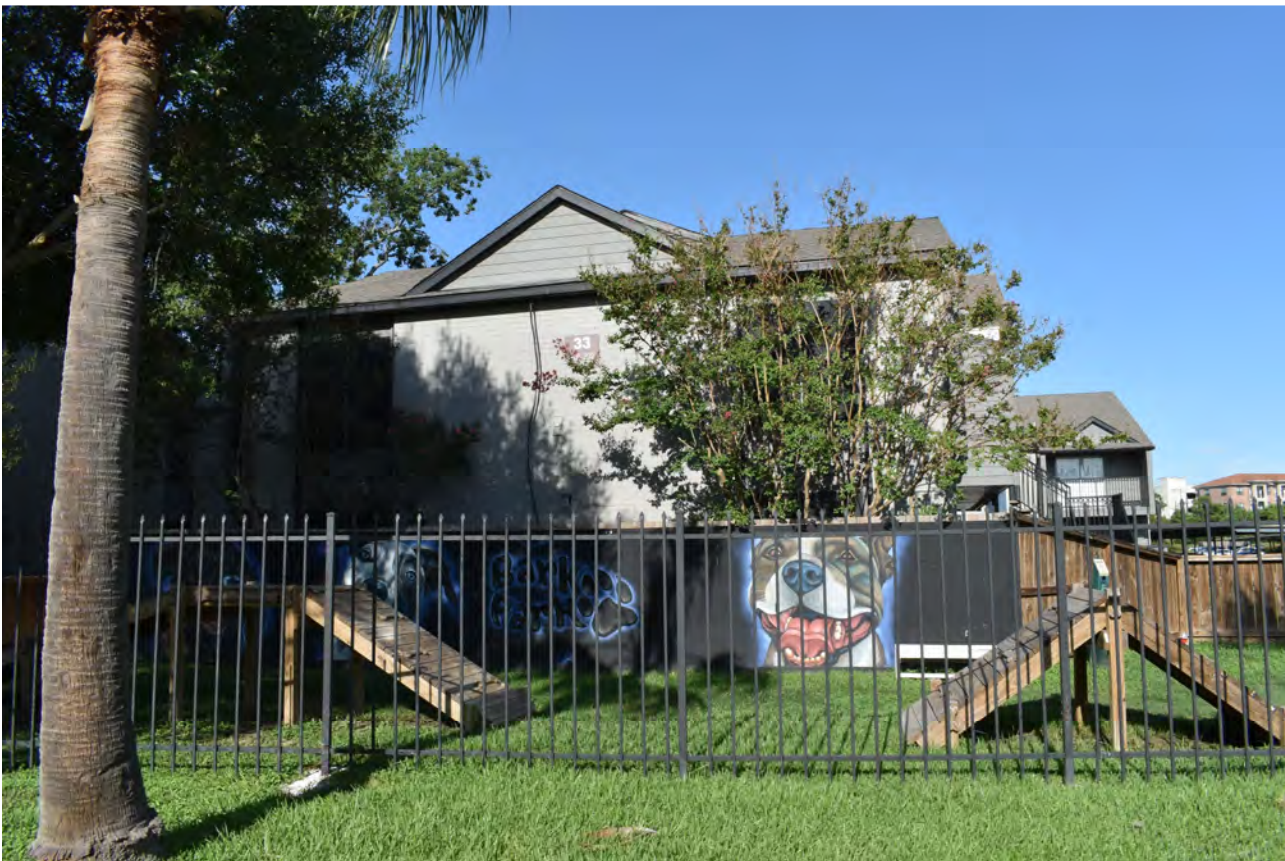
View facing  
northeast

**Alterations:**  
Brick/stone painted  
Door(s) replaced (primary)  
Wall cladding replaced (some)  
Window(s) replaced (all)

This resource is not associated with significant events or individuals. The building does not possess distinctive elements and is not a work of a master. Painted brick and replaced materials diminish integrity of materials. The resource is unlikely to yield information potential. Therefore, the resource is recommended not eligible for the NRHP under Criteria A, B, C, or D.

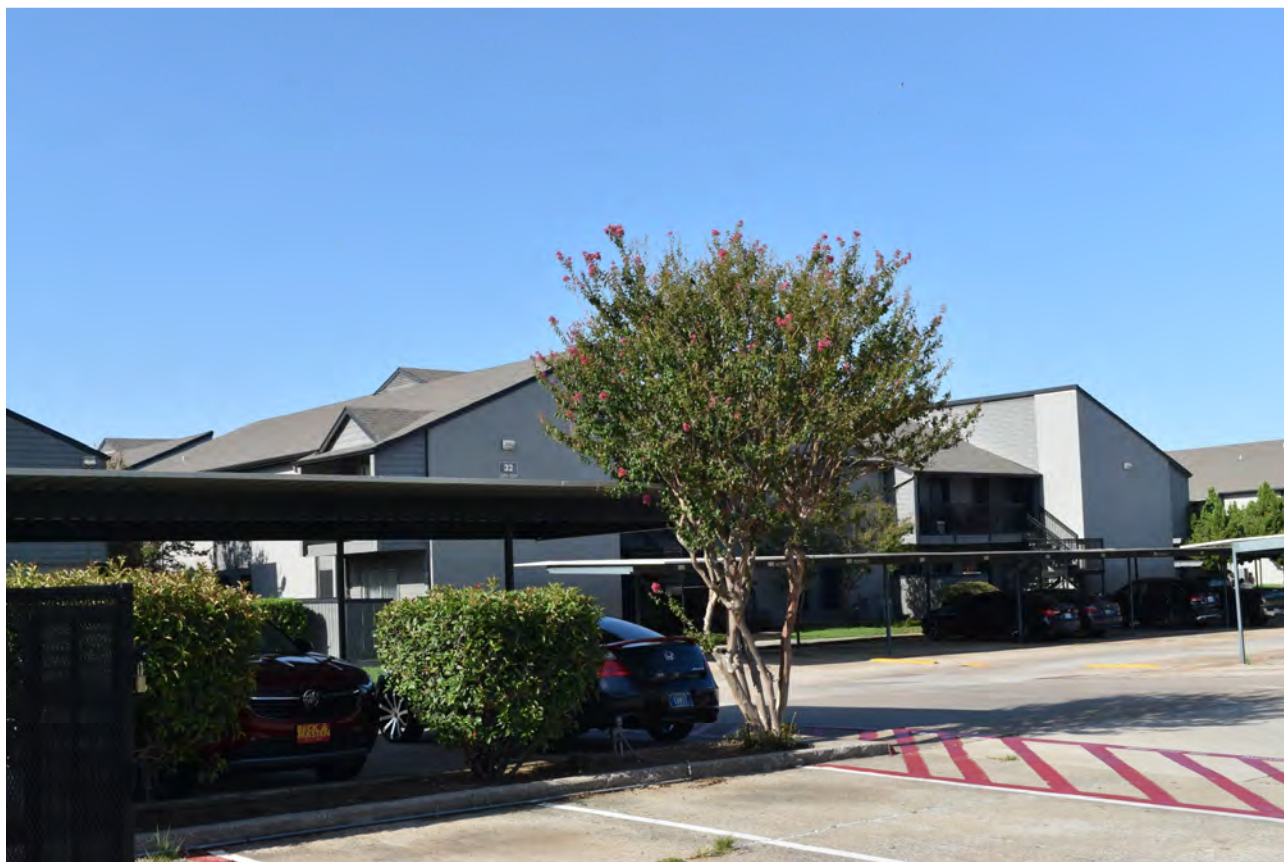
View facing  
northeast

**Alterations:**  
Brick/stone painted  
Door(s) replaced (primary)  
Wall cladding replaced (some)  
Window(s) replaced (all)

This resource is not associated with significant events or individuals. The building does not possess distinctive elements and is not a work of a master. Painted brick and replaced materials diminish integrity of materials. The resource is unlikely to yield information potential. Therefore, the resource is recommended not eligible for the NRHP under Criteria A, B, C, or D.

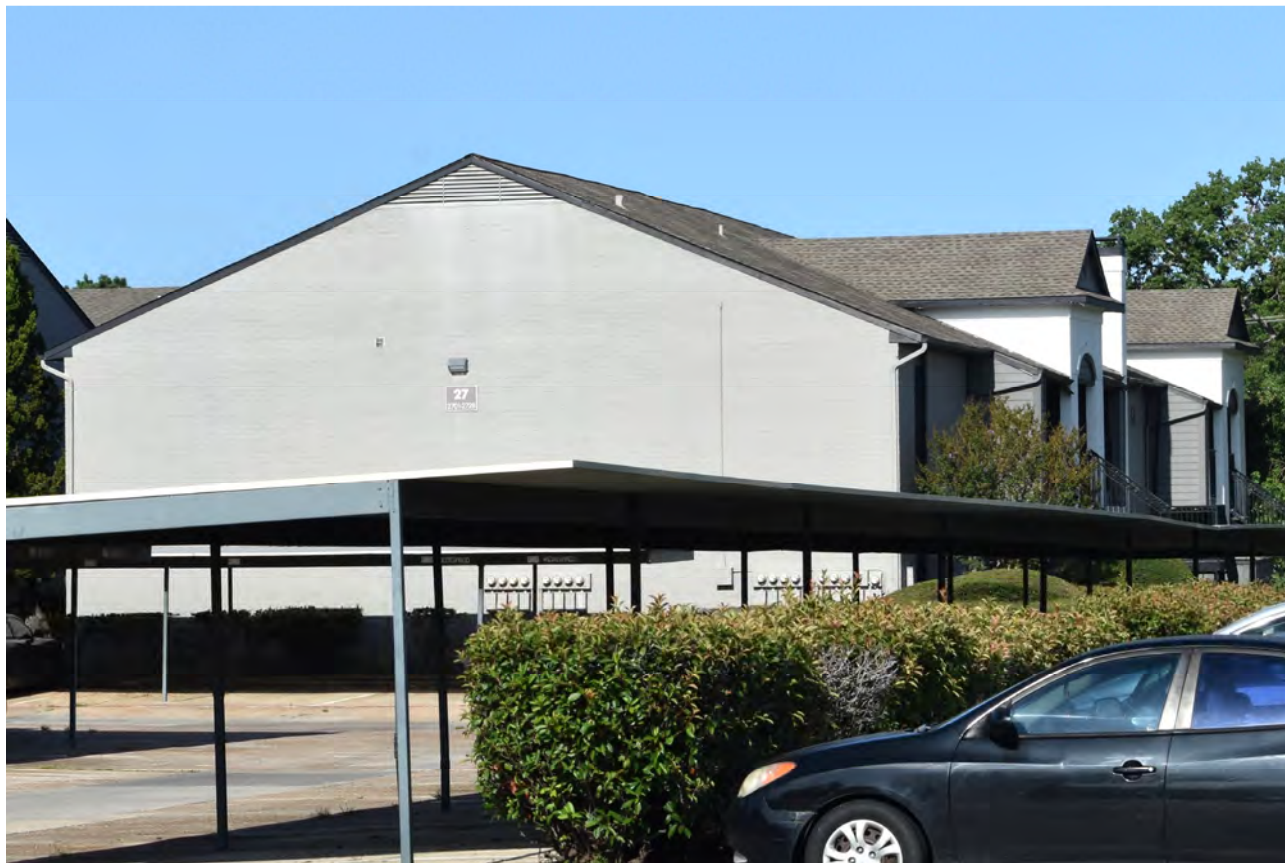
View facing east

**Alterations:**  
Brick/stone painted  
Door(s) replaced (primary)  
Wall cladding replaced (some)  
Window(s) replaced (all)

This resource is not associated with significant events or individuals. The building does not possess distinctive elements and is not a work of a master. Painted brick and replaced materials diminish integrity of materials. The resource is unlikely to yield information potential. Therefore, the resource is recommended not eligible for the NRHP under Criteria A, B, C, or D.

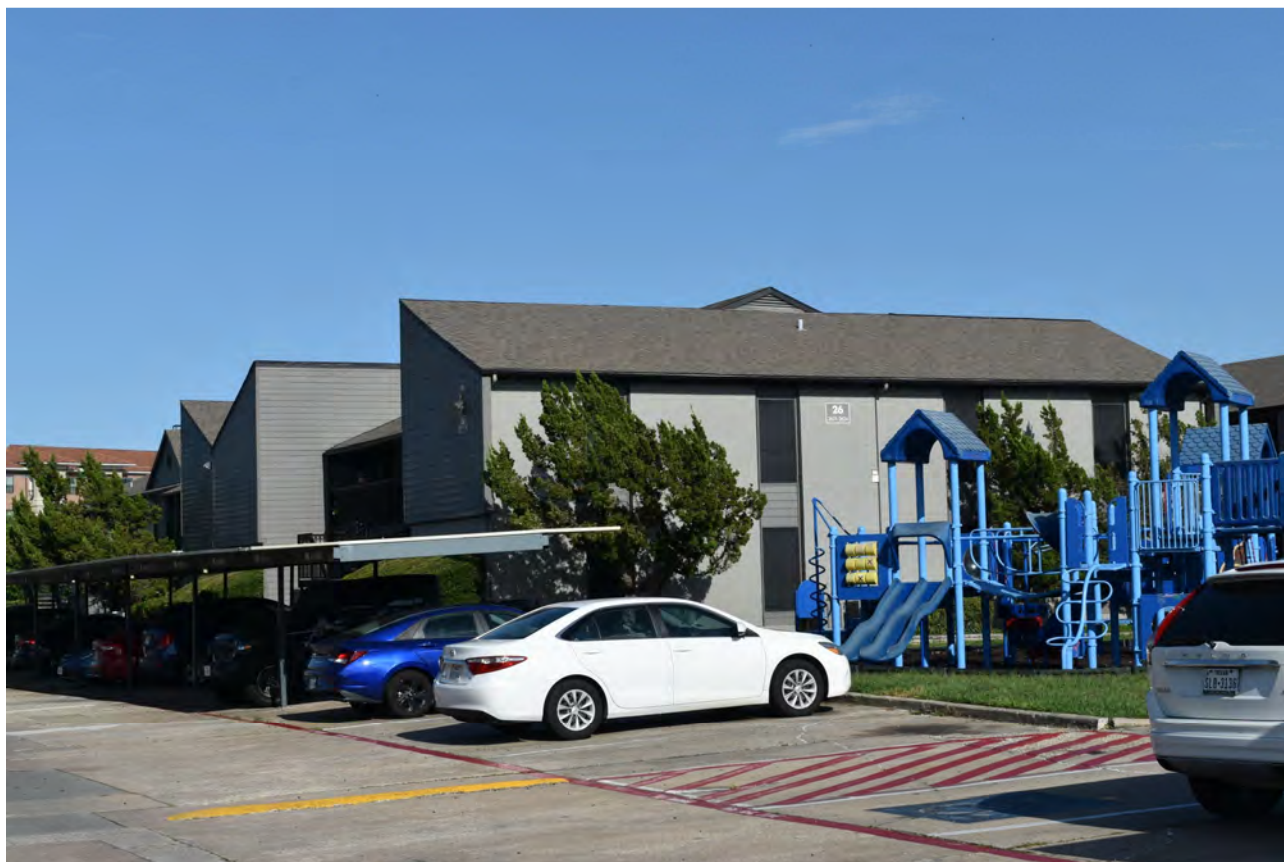
View facing southeast

**Alterations:**  
Brick/stone painted  
Door(s) replaced (primary)  
Wall cladding replaced (some)  
Window(s) replaced (all)

This resource is not associated with significant events or individuals. The building does not possess distinctive elements and is not a work of a master. Painted brick and replaced materials diminish integrity of materials. The resource is unlikely to yield information potential. Therefore, the resource is recommended not eligible for the NRHP under Criteria A, B, C, or D.

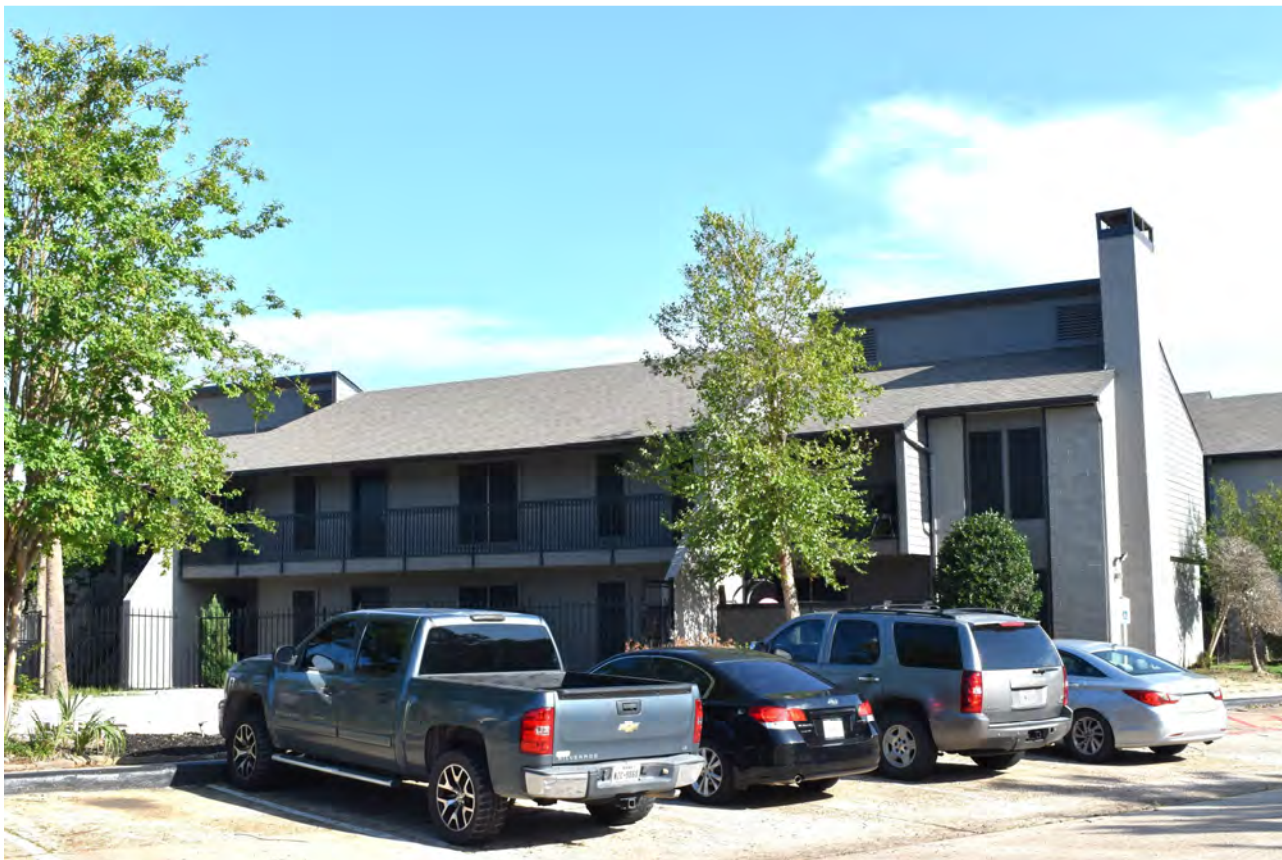
**Resource:** 5AH **Parcel:** 0402110000080  
**Name:** Skylar Pointe Apartments Building 17  
**Location:** 1110 El Camino Village Drive  
**Historic Function:** Domestic/Multiple dwelling  
**Current Function:** Domestic/Multiple dwelling

View facing southeast

**Alterations:**  
Brick/stone painted  
Door(s) replaced (primary)  
Wall cladding replaced (some)  
Window(s) replaced (all)

This resource is not associated with significant events or individuals. The building does not possess distinctive elements and is not a work of a master. Painted brick and replaced materials diminish integrity of materials. The resource is unlikely to yield information potential. Therefore, the resource is recommended not eligible for the NRHP under Criteria A, B, C, or D.

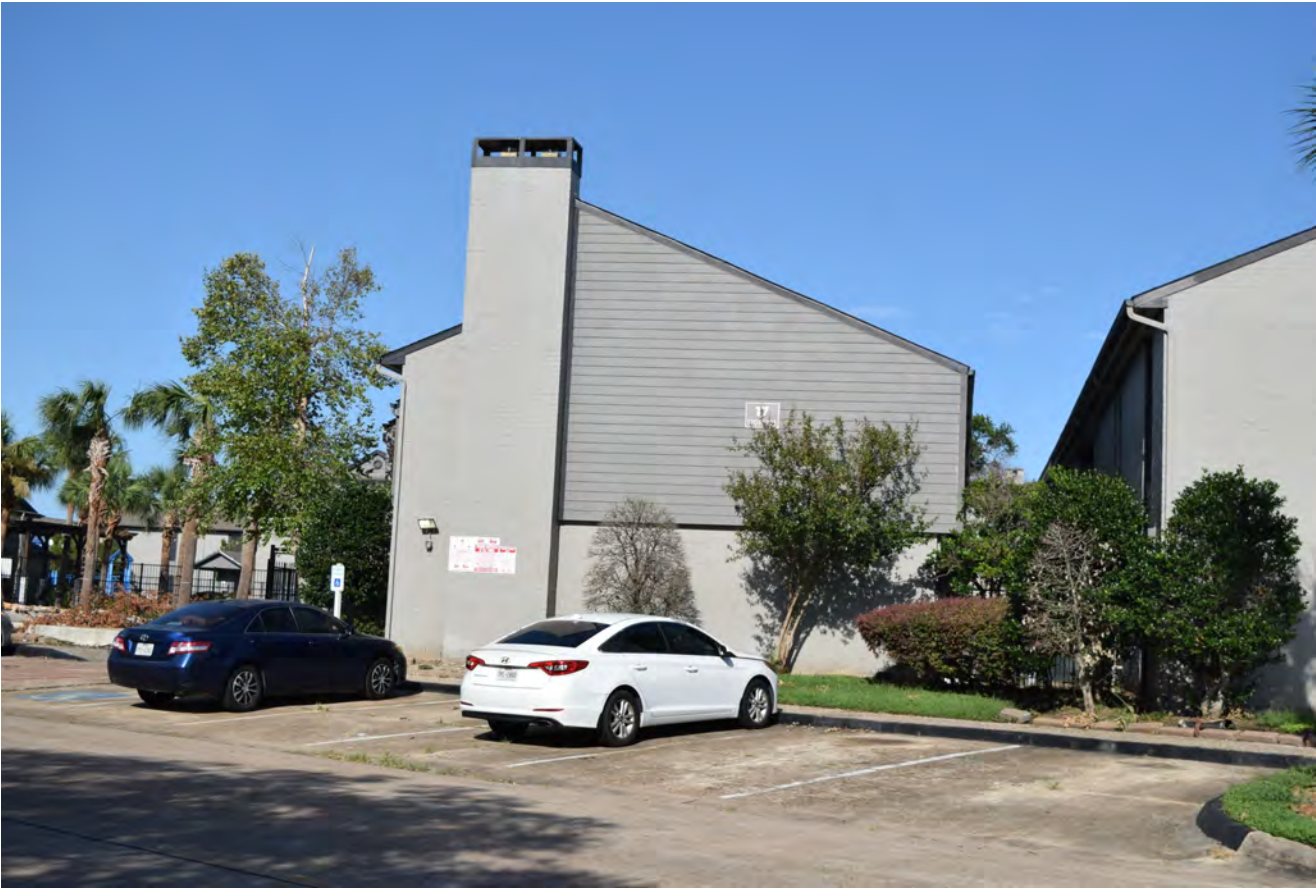
View facing east

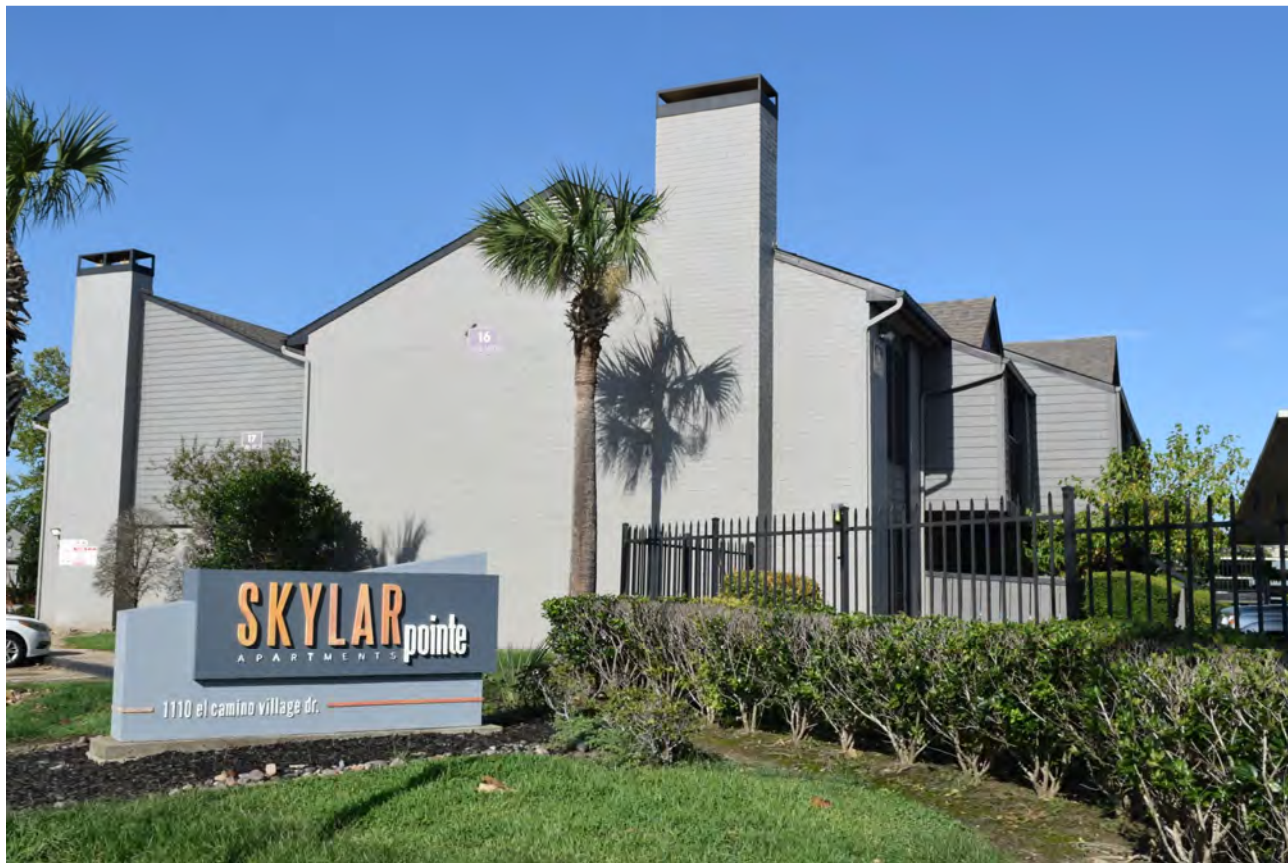
**Resource:** 5AI **Parcel:** 0402110000080  
**Name:** Skylar Pointe Apartments  
**Location:** 1110 El Camino Village Drive  
**Historic Function:** Domestic/Multiple dwelling  
**Current Function:** Domestic/Multiple dwelling

Resource 5AI  
(Historic-age)  
in background  
and Resource  
5DE  
(Nonhistoric-  
age); view  
facing east

**Alterations:**  
Brick/stone painted  
Door(s) replaced (primary)  
Wall cladding replaced (some)  
Window(s) replaced (all)

This resource is not associated with significant events or individuals. The building does not possess distinctive elements and is not a work of a master. Painted brick and replaced materials diminish integrity of materials. The resource is unlikely to yield information potential. Therefore, the resource is recommended not eligible for the NRHP under Criteria A, B, C, or D.
