EA AND SUPPORTING SERVICES  
FOR THE TAMU SPACE INSTITUTE  
LEASE AT JSC

**NASA Johnson Space Center / TAMU Space Institute Historic Resources Survey**  
Surveyed by SWCA Environmental Consultants | Houston, Harris County, Texas

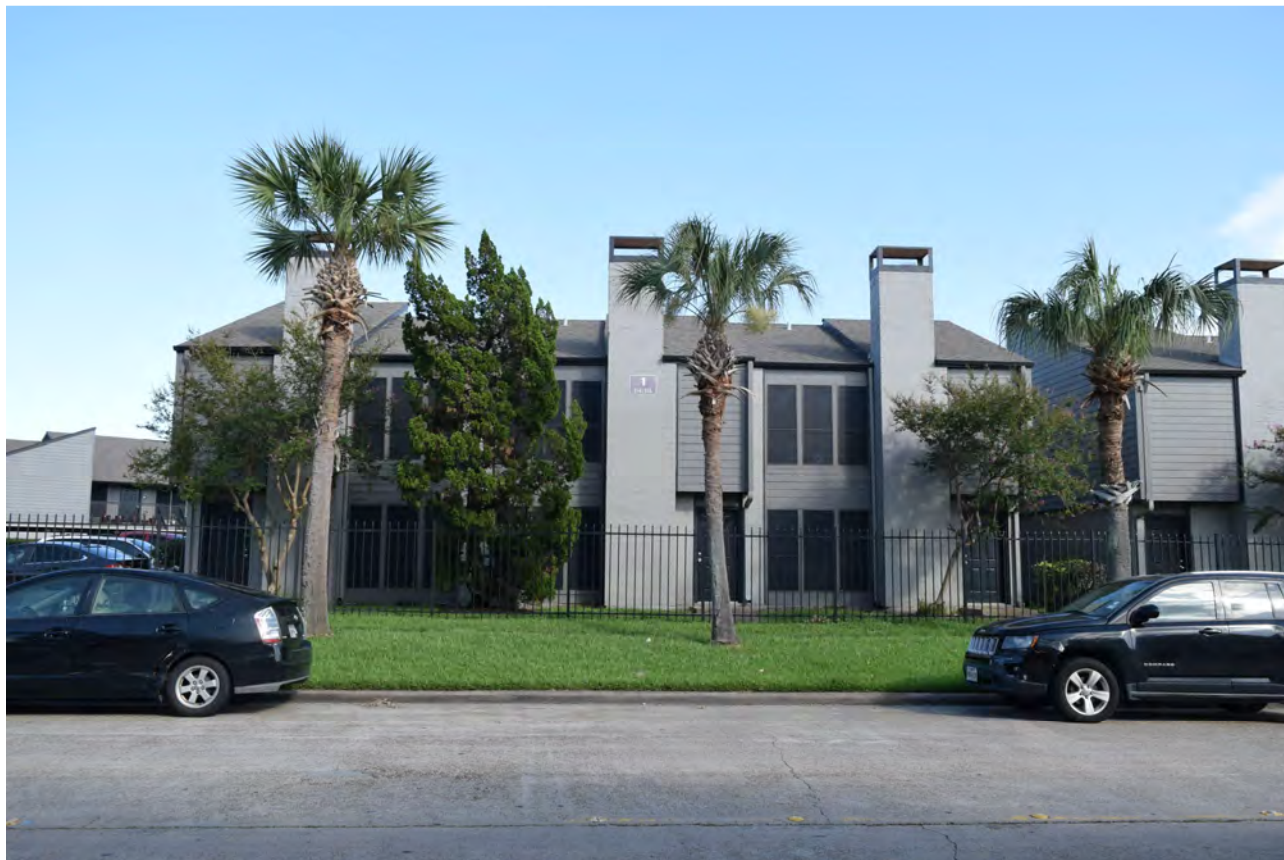
View facing  
northeast

**Alterations:**  
Brick/stone painted  
Door(s) replaced (primary)  
Wall cladding replaced (some)  
Window(s) replaced (all)

This resource is not associated with significant events or individuals. The building does not possess distinctive elements and is not a work of a master. Painted brick and replaced materials diminish integrity of materials. The resource is unlikely to yield information potential. Therefore, the resource is recommended not eligible for the NRHP under Criteria A, B, C, or D.

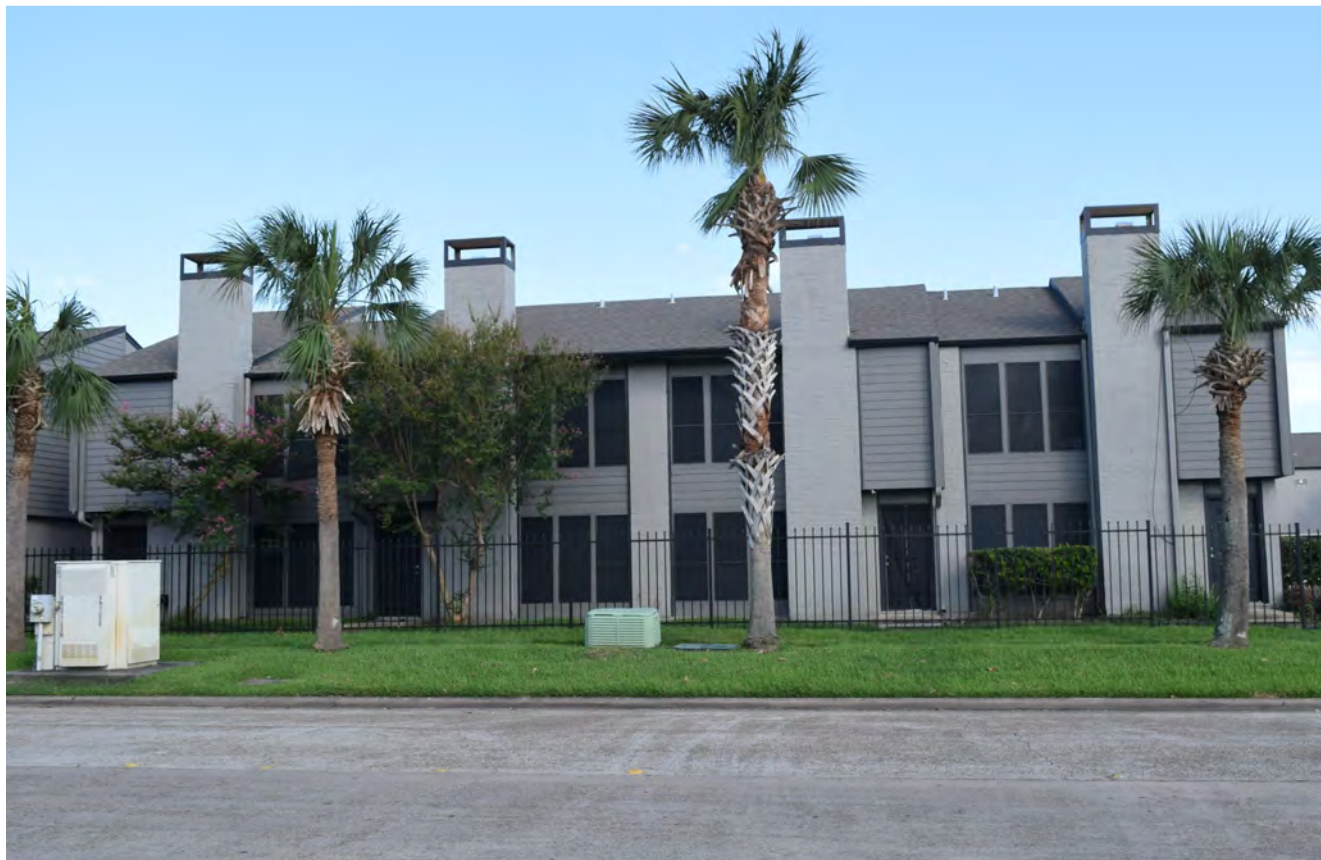
View facing northeast

**Alterations:**  
Brick/stone painted  
Door(s) replaced (primary)  
Wall cladding replaced (some)  
Window(s) replaced (all)

This resource is not associated with significant events or individuals. The building does not possess distinctive elements and is not a work of a master. Painted brick and replaced materials diminish integrity of materials. The resource is unlikely to yield information potential. Therefore, the resource is recommended not eligible for the NRHP under Criteria A, B, C, or D.

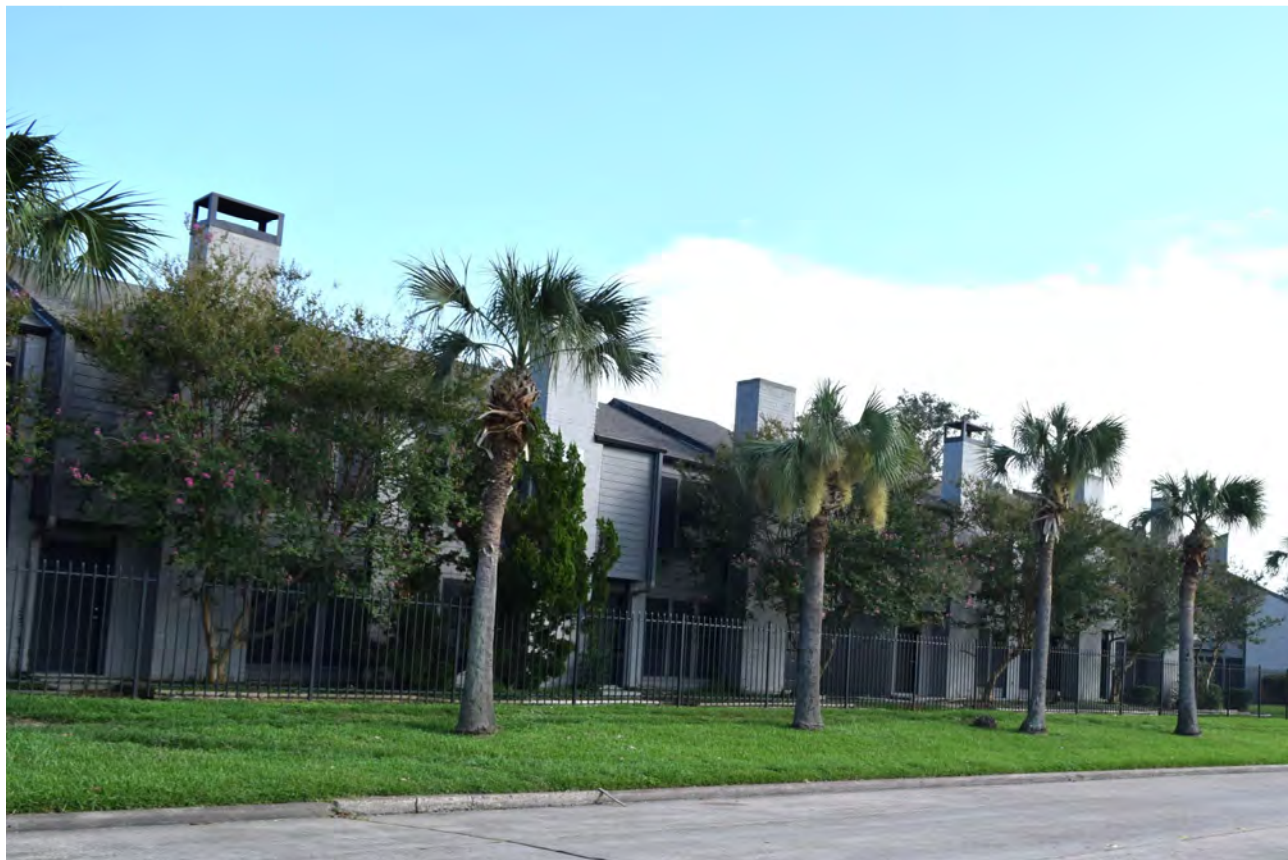
**Resource:** 5AN      **Parcel:** 0402110000080  
**Name:** Skylar Pointe Apartments Building 1B  
**Location:** 1110 El Camino Village Drive  
**Historic Function:** Domestic/Multiple dwelling  
**Current Function:** Domestic/Multiple dwelling

View facing south

**Alterations:**  
Brick/stone painted  
Door(s) replaced (primary)  
Wall cladding replaced (some)  
Window(s) replaced (all)

This resource is not associated with significant events or individuals. The building does not possess distinctive elements and is not a work of a master. Painted brick and replaced materials diminish integrity of materials. The resource is unlikely to yield information potential. Therefore, the resource is recommended not eligible for the NRHP under Criteria A, B, C, or D.

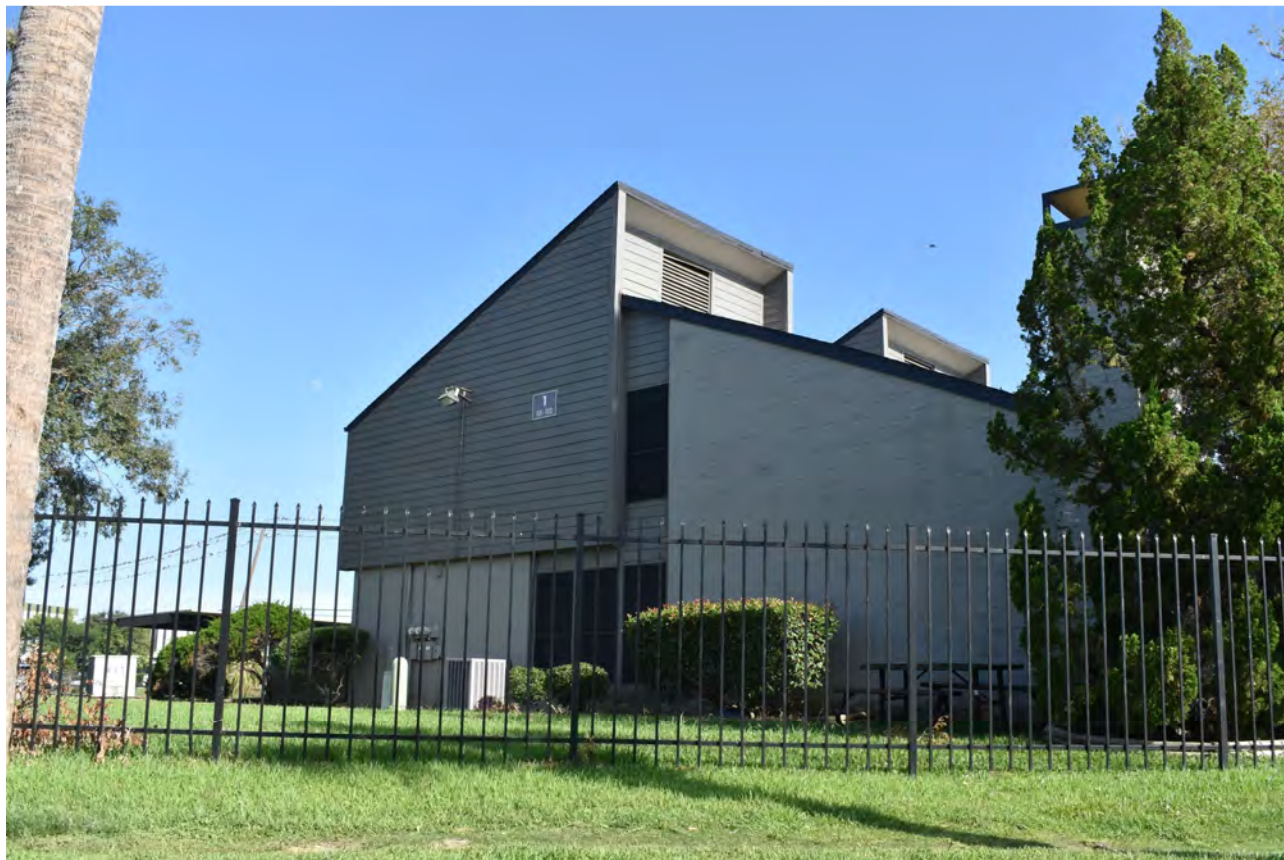
View facing southeast

**Alterations:**  
Brick/stone painted  
Door(s) replaced (primary)  
Wall cladding replaced (some)  
Window(s) replaced (all)

This resource is not associated with significant events or individuals. The building does not possess distinctive elements and is not a work of a master. Painted brick and replaced materials diminish integrity of materials. The resource is unlikely to yield information potential. Therefore, the resource is recommended not eligible for the NRHP under Criteria A, B, C, or D.

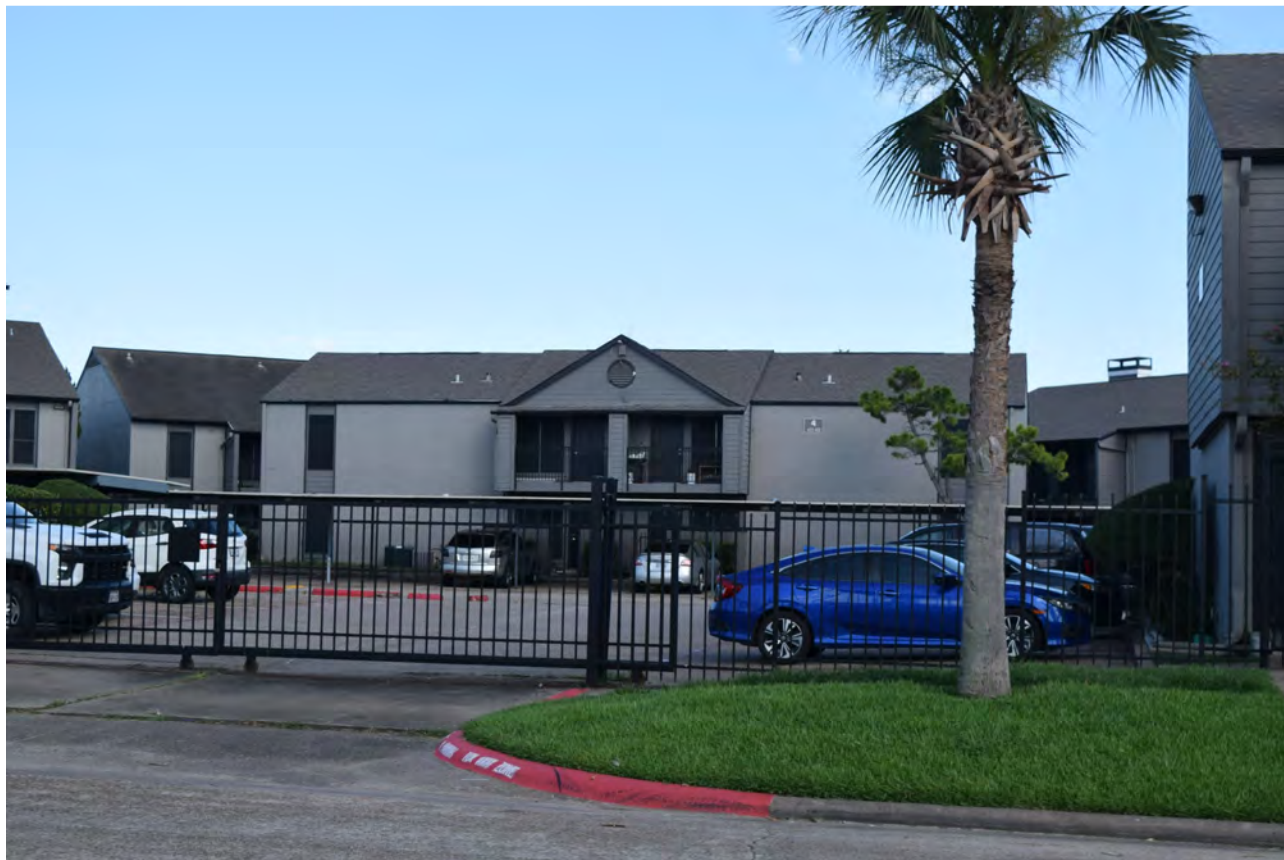
View facing southeast

**Alterations:**  
Brick/stone painted  
Door(s) replaced (primary)  
Wall cladding replaced (some)  
Window(s) replaced (all)

This resource is not associated with significant events or individuals. The building does not possess distinctive elements and is not a work of a master. Painted brick and replaced materials diminish integrity of materials. The resource is unlikely to yield information potential. Therefore, the resource is recommended not eligible for the NRHP under Criteria A, B, C, or D.

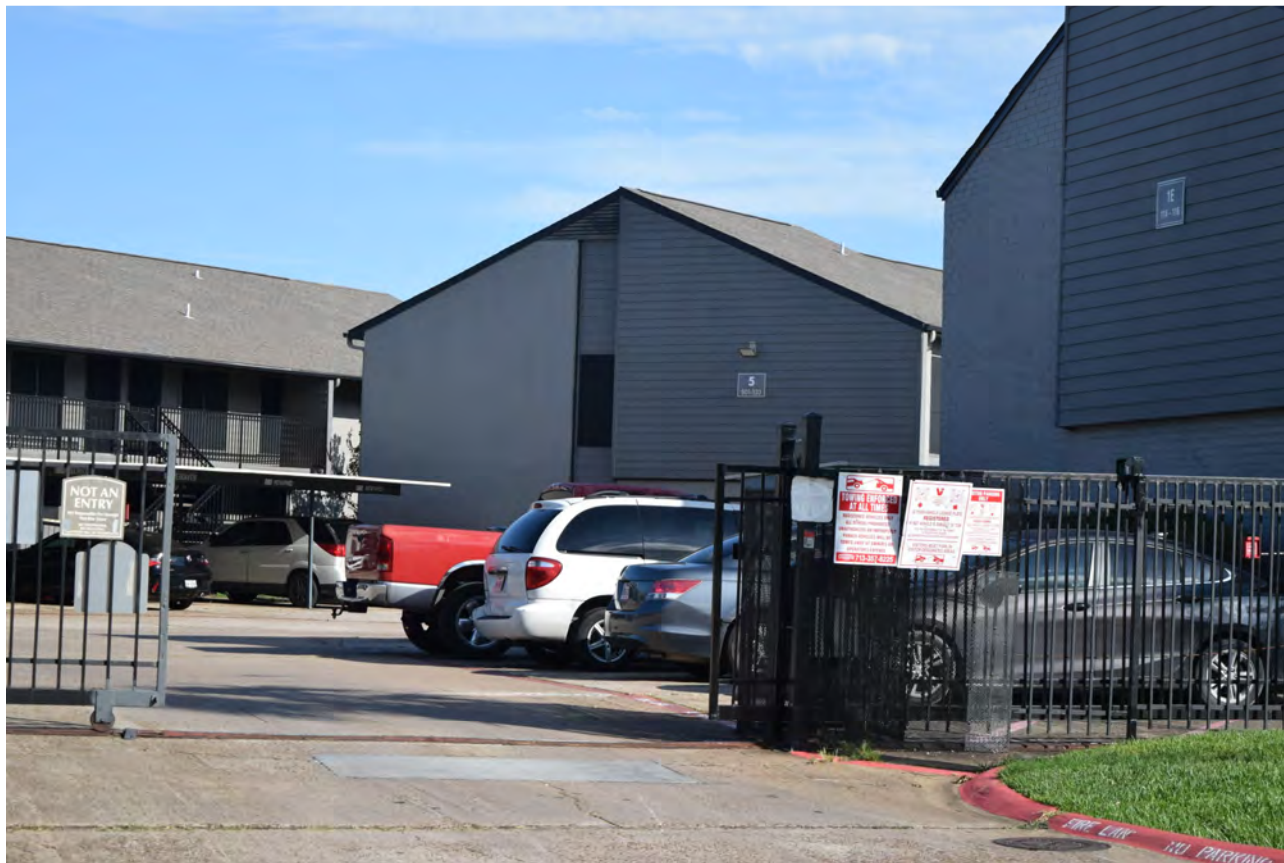
View facing south

**Alterations:**  
Brick/stone painted  
Door(s) replaced (primary)  
Wall cladding replaced (some)  
Window(s) replaced (all)

This resource is not associated with significant events or individuals. The building does not possess distinctive elements and is not a work of a master. Painted brick and replaced materials diminish integrity of materials. The resource is unlikely to yield information potential. Therefore, the resource is recommended not eligible for the NRHP under Criteria A, B, C, or D.

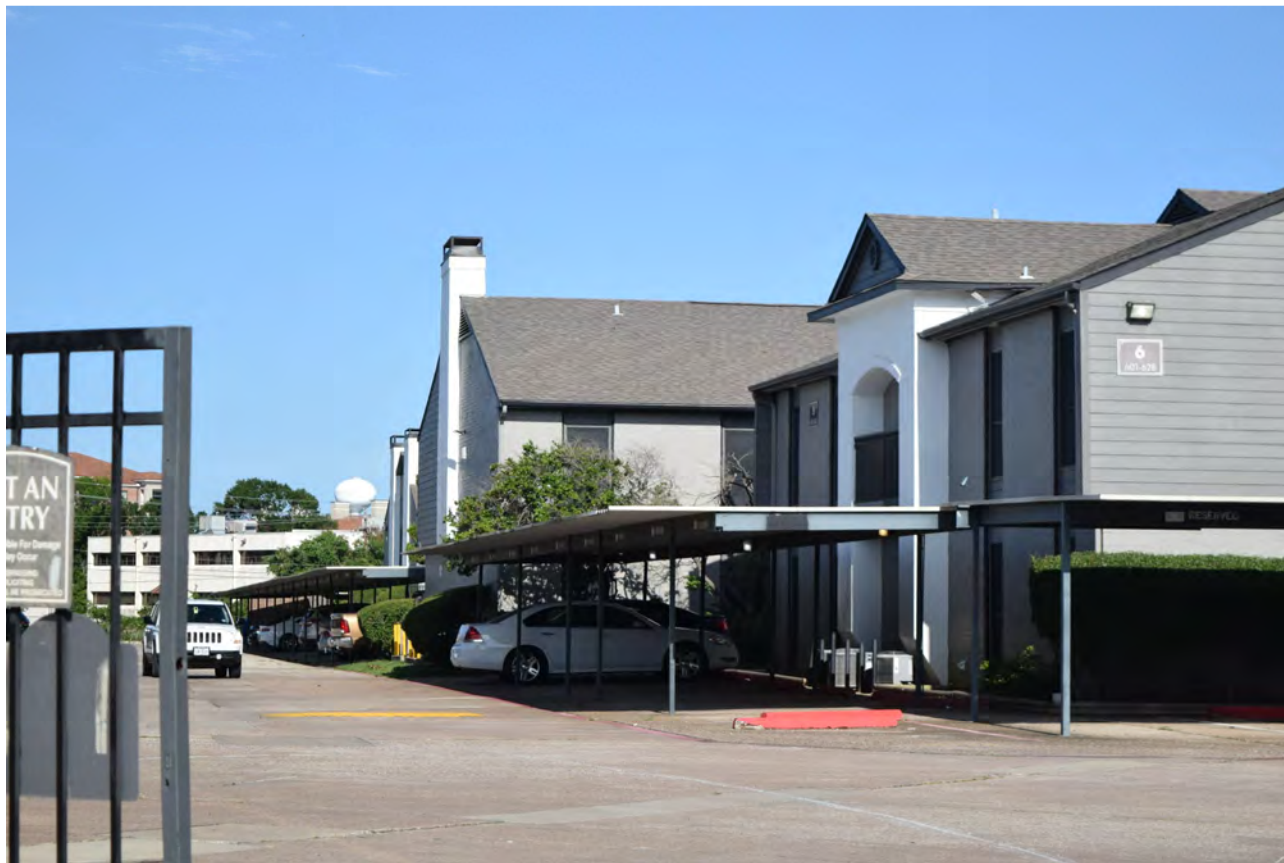
View facing southeast

<b>Type:</b> Building	<b>Primary roof form:</b> Gable, side	<b>Roof material:</b> Composition shingles	<b>Alterations:</b> Brick/stone painted Door(s) replaced (primary) Wall cladding replaced (some) Window(s) replaced (all)
<b>Form:</b> Rectangular	<b>Porch:</b> Integrated partial-width	<b>Primary materials:</b> Brick Engineered wood siding	
<b>Style:</b> No Style

This resource is not associated with significant events or individuals. The building does not possess distinctive elements and is not a work of a master. Painted brick and replaced materials diminish integrity of materials. The resource is unlikely to yield information potential. Therefore, the resource is recommended not eligible for the NRHP under Criteria A, B, C, or D.

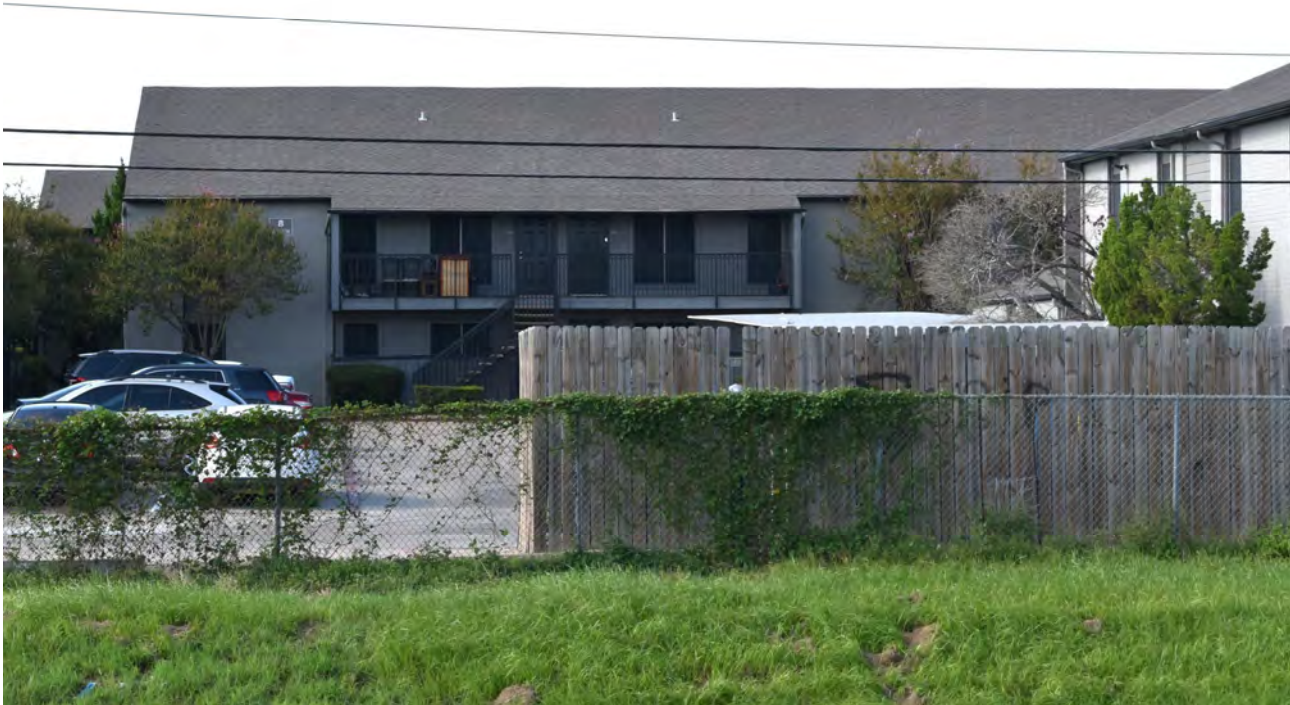
View facing  
north

**Alterations:**  
Brick/stone painted  
Door(s) replaced (primary)  
Wall cladding replaced (some)  
Window(s) replaced (all)

This resource is not associated with significant events or individuals. The building does not possess distinctive elements and is not a work of a master. Painted brick and replaced materials diminish integrity of materials. The resource is unlikely to yield information potential. Therefore, the resource is recommended not eligible for the NRHP under Criteria A, B, C, or D.

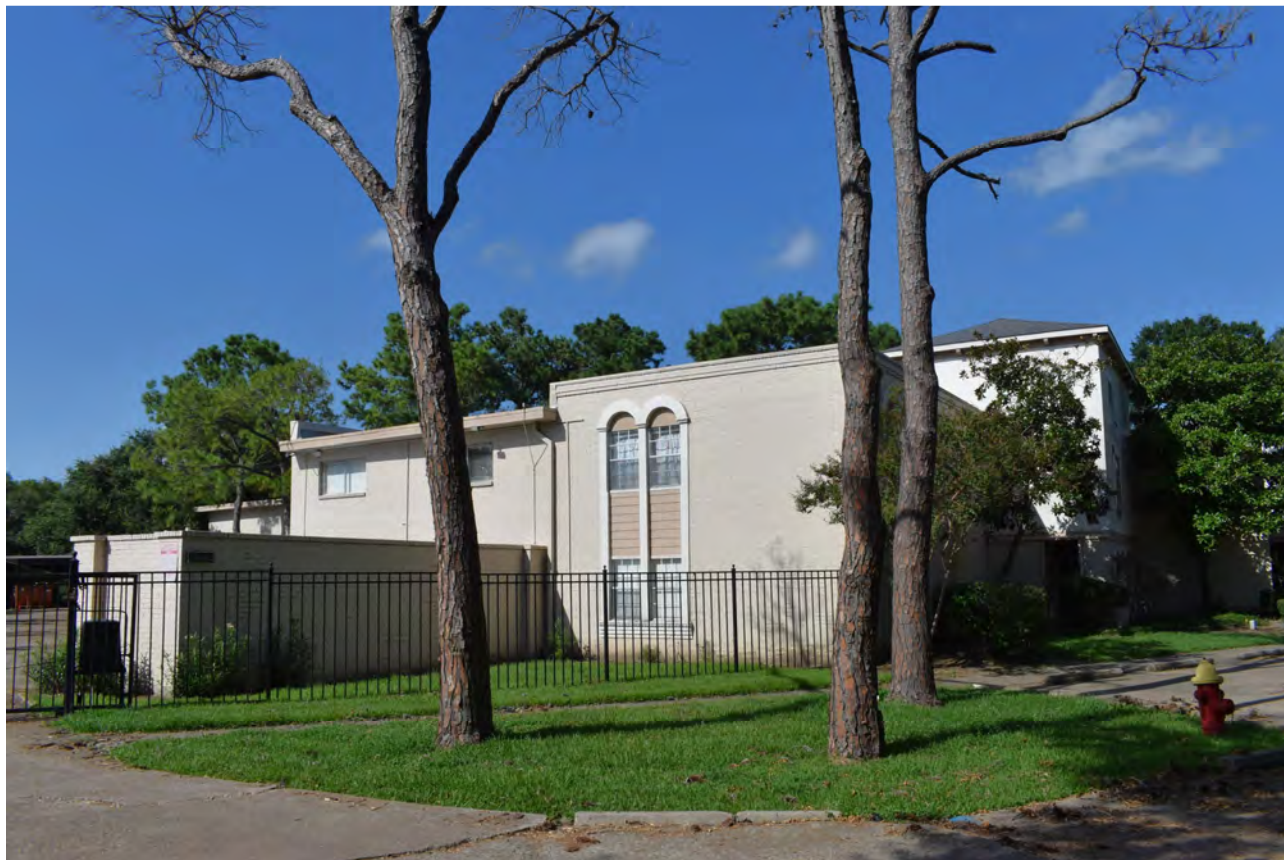
View facing northeast

<b>Type:</b> Building	<b>Primary roof form:</b> Flat w/parapet	<b>Roof material:</b> Composition shingles	<b>Alterations:</b> Brick/stone painted
<b>Form:</b> Rectangular	Hipped	Tar or membrane	Wall cladding replaced (some)
<b>Style:</b> Spanish Colonial Revival	<b>Porch:</b> Integrated partial-width	<b>Primary materials:</b> Brick	
		Engineered wood siding	
		Stucco

The Regatta Kings Park apartment complex is not associated with significant events or individuals. Although some of the buildings possess distinctive elements of Spanish Colonial Revival and Late Modern architecture styles, they are not significant within these architectural styles nor are they the work of a master. The design and planning of the apartment complex is not significant within the context of apartment complexes. Painted brick and replaced materials diminish integrity of materials. It is unlikely to yield information potential. Therefore, the apartment complex and this resource are recommended not eligible for the NRHP under Criteria A, B, C, or D.

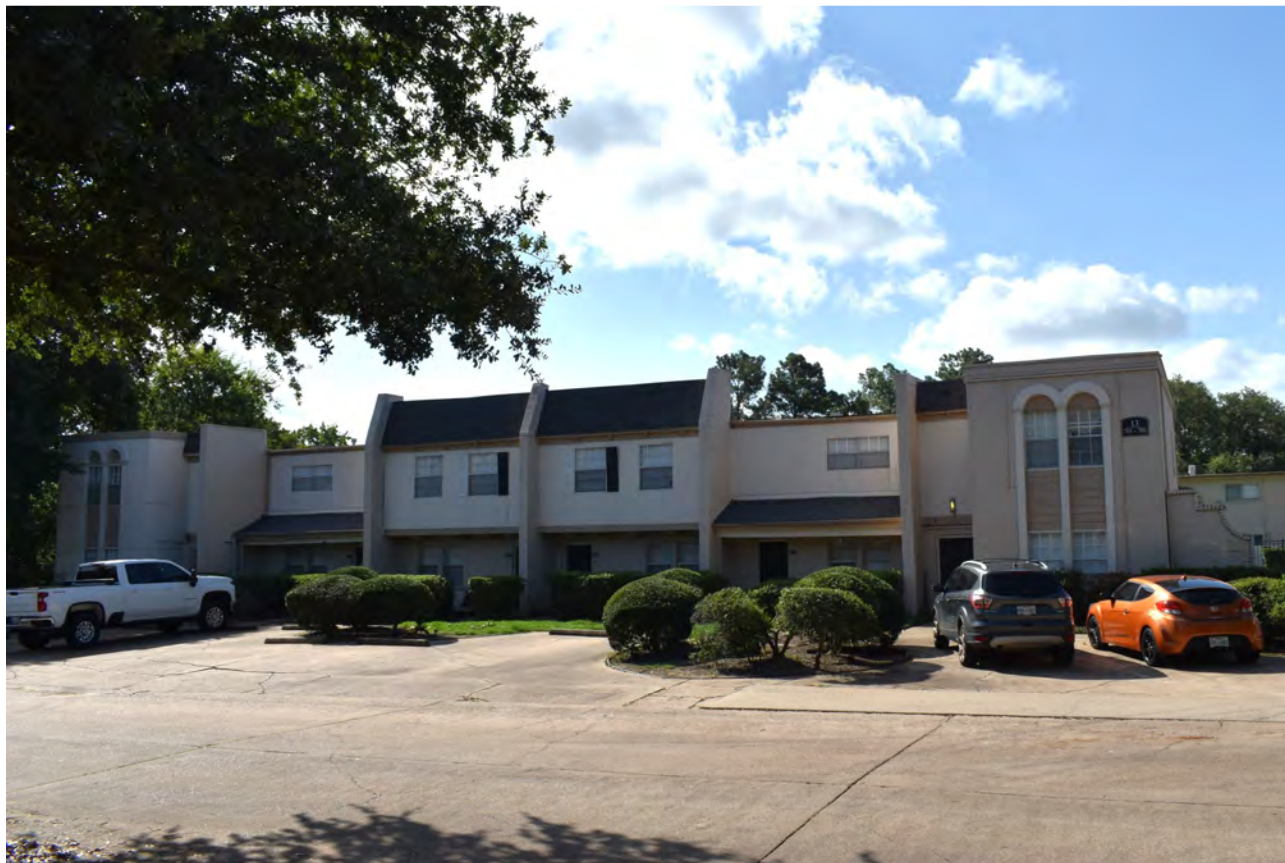
View facing  
northwest

**Alterations:**  
Brick/stone painted  
Door(s) replaced (primary)  
Wall cladding replaced (some)

This apartment building is not associated with significant events or individuals. Although the buildings possesses elements of the Spanish Colonial Revival style, it is not significant within the context of the architectural style nor is it the work of a master. Painted brick and replaced materials diminish integrity of materials. The resource is unlikely to yield information potential. Therefore, the resource is recommended not eligible for the NRHP under Criteria A, B, C, or D.

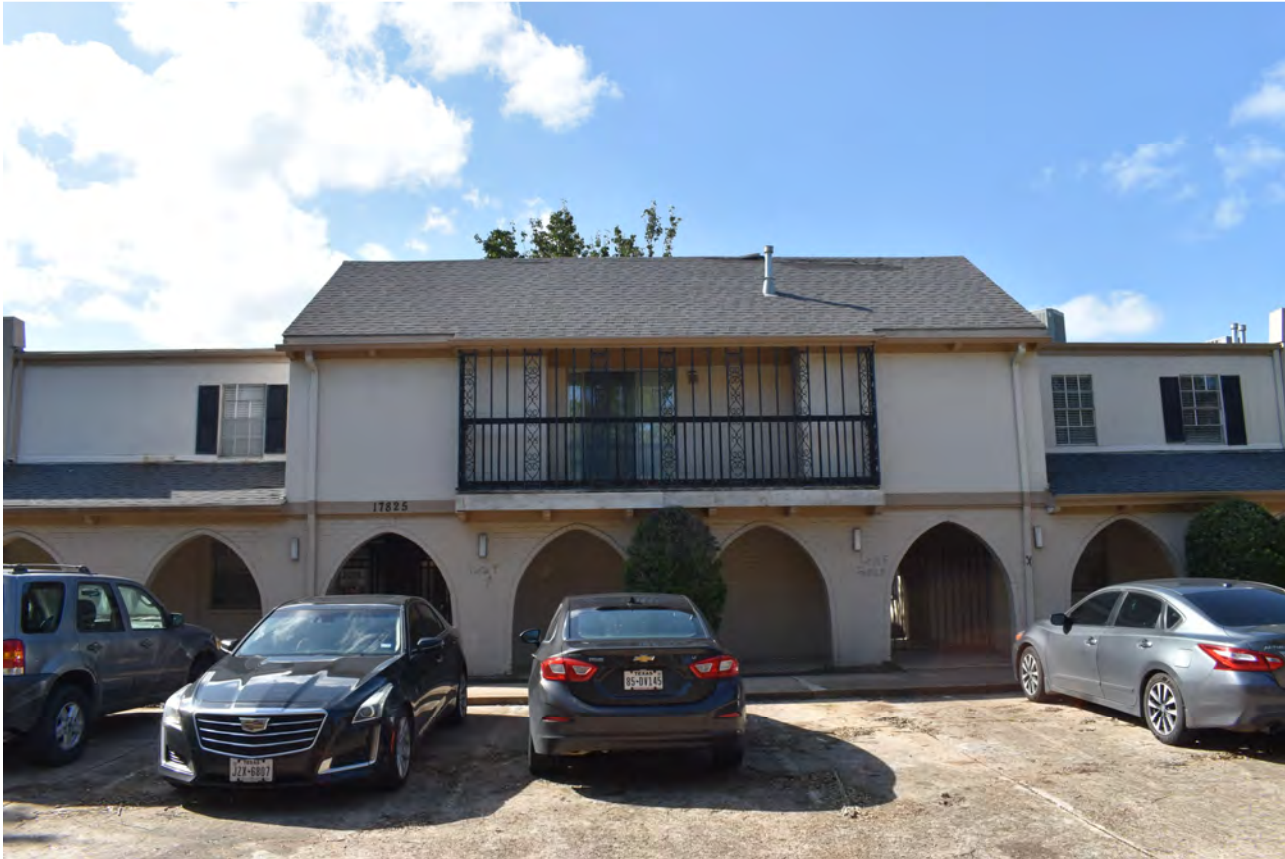
View facing  
northwest

<b>Type:</b> Building	<b>Primary roof form:</b> Flat w/parapet	<b>Roof material:</b> Composition shingles	<b>Alterations:</b> Brick/stone painted
<b>Form:</b> Rectangular	Gable, side	Tar or membrane	Windows replaced (some)
<b>Style:</b> Spanish Colonial Revival	<b>Porch:</b> Integrated partial-width	<b>Primary materials:</b> Brick Stone

This apartment building is not associated with significant events or individuals. Although the buildings possesses elements of the Spanish Colonial Revival style, it is not significant within the context of the architectural style nor is it the work of a master. Painted brick and replaced materials diminish integrity of materials. The resource is unlikely to yield information potential. Therefore, the resource is recommended not eligible for the NRHP under Criteria A, B, C, or D.

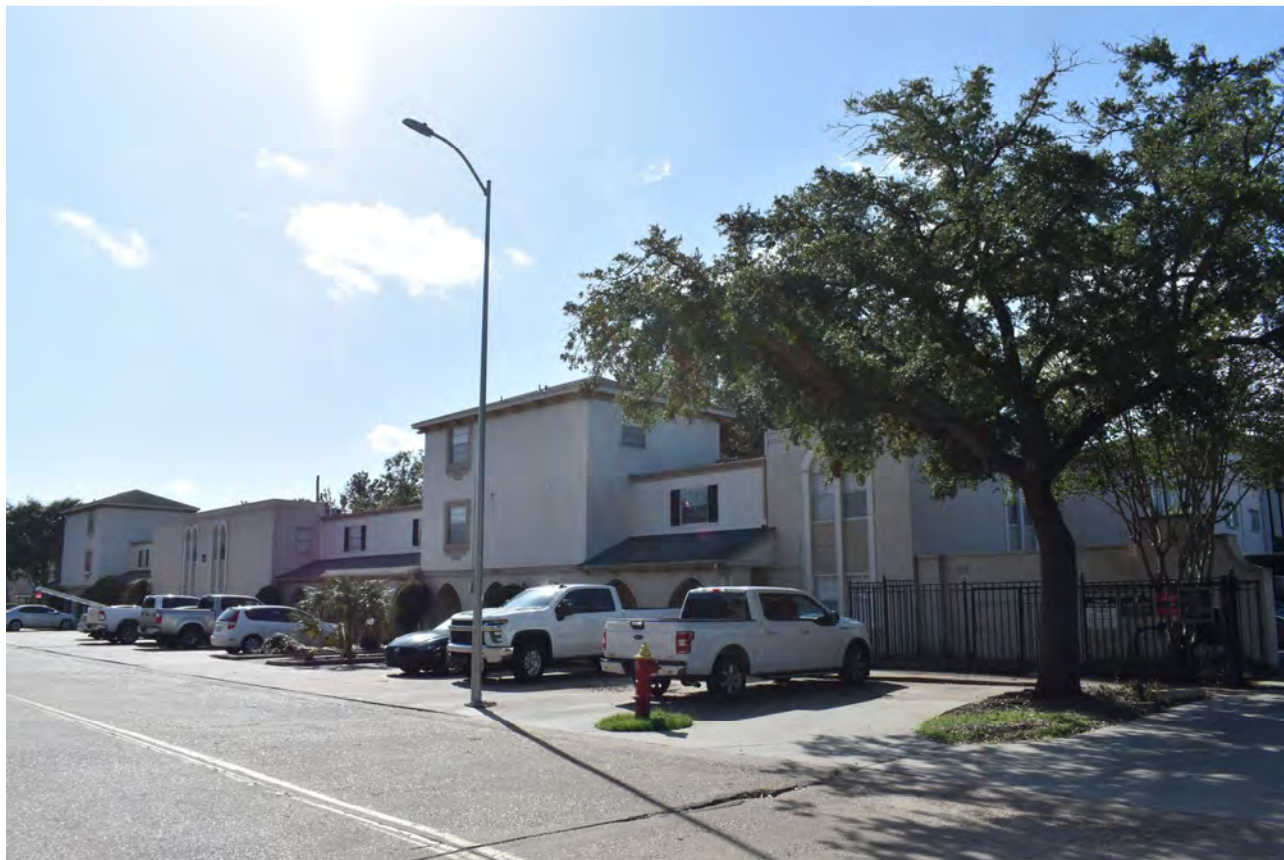
View facing  
northwest

<b>Type:</b> Building	<b>Primary roof form:</b> Flat w/parapet	<b>Roof material:</b> Composition shingles	<b>Alterations:</b> Brick/stone painted
<b>Form:</b> Rectangular	Hipped		Windows replaced (some)
<b>Style:</b> Spanish Colonial Revival	<b>Porch:</b> Projecting partial-width	<b>Primary materials:</b> Brick	
		Engineered wood siding	
		Stucco

This apartment building is not associated with significant events or individuals. Although the buildings possesses elements of the Spanish Colonial Revival style, it is not significant within the context of the architectural style nor is it the work of a master. Painted brick and replaced materials diminish integrity of materials. The resource is unlikely to yield information potential. Therefore, the resource is recommended not eligible for the NRHP under Criteria A, B, C, or D.

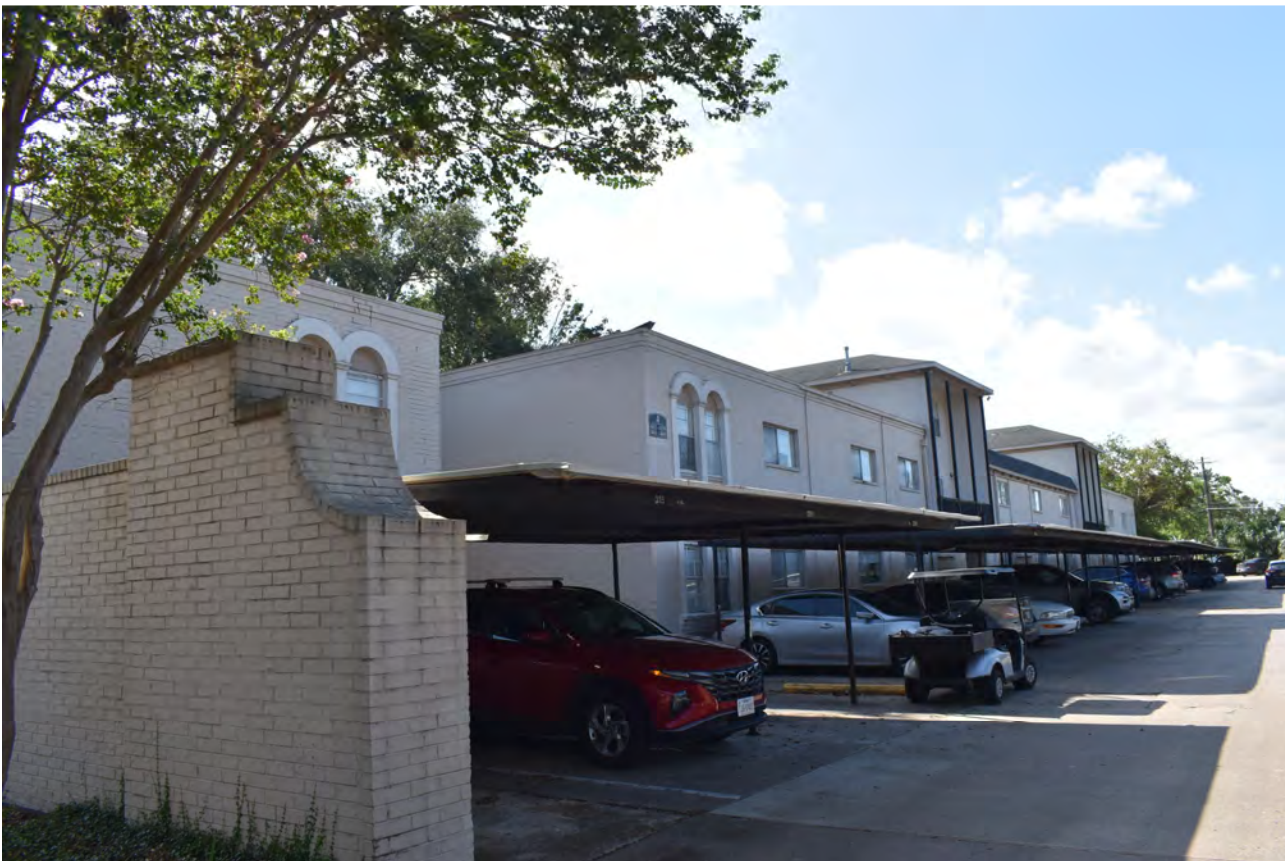
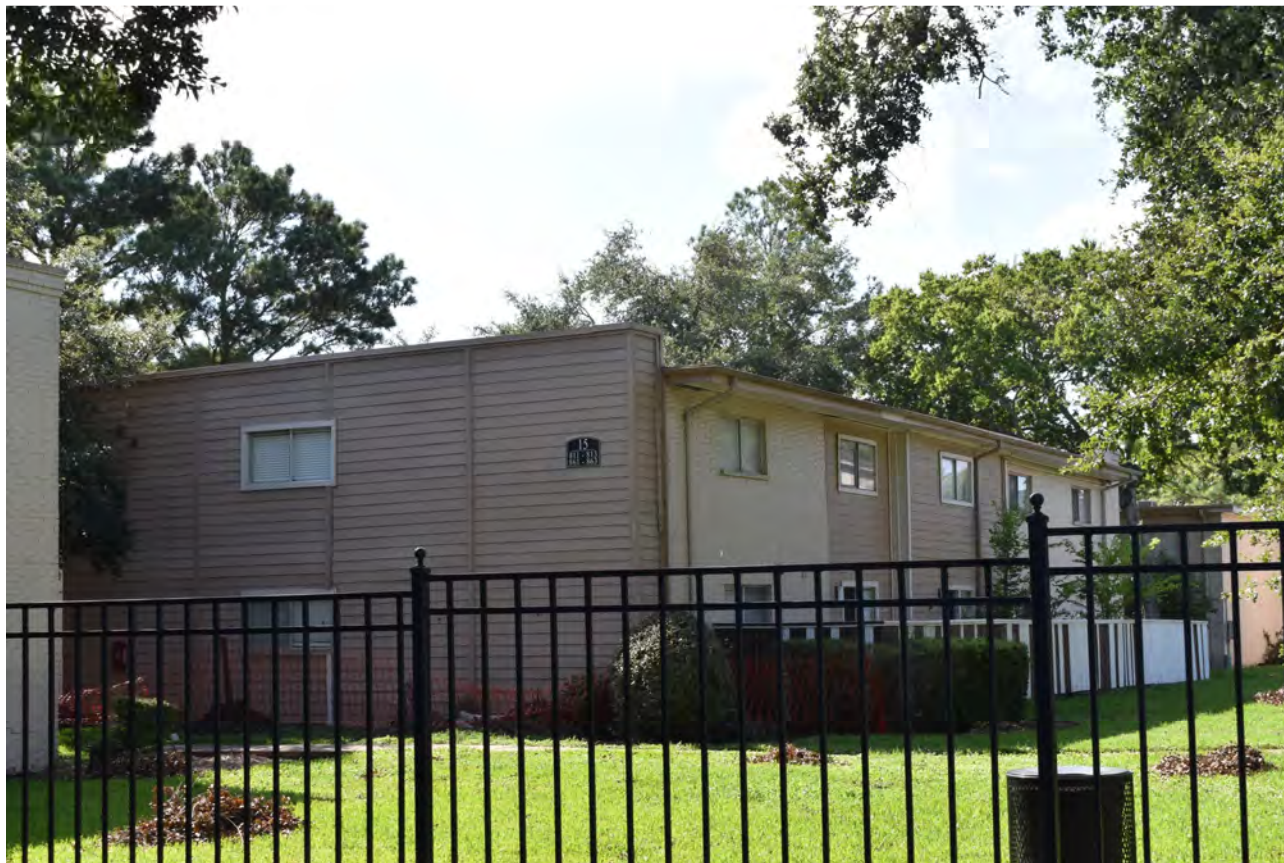
View facing  
northwest

View facing northwest

<b>Type:</b> Building	<b>Primary roof form:</b> Flat w/parapet	<b>Roof material:</b> Tar or membrane	<b>Alterations:</b> Brick/stone painted Wall cladding replaced (some)
<b>Form:</b> Rectangular	<b>Porch:</b> Unknown/Not visible	<b>Primary materials:</b> Brick Engineered wood siding	
<b>Style:</b> Late Modern

This apartment building is not associated with significant events or individuals. Although the buildings possesses elements of the Late Modern style, it is not significant within the context of style architecture nor is it the work of a master. Painted brick and replaced materials hinder integrity of materials. The resource is unlikely to yield information potential. Therefore, the resource is recommended not eligible for the NRHP under Criteria A, B, C, or D.

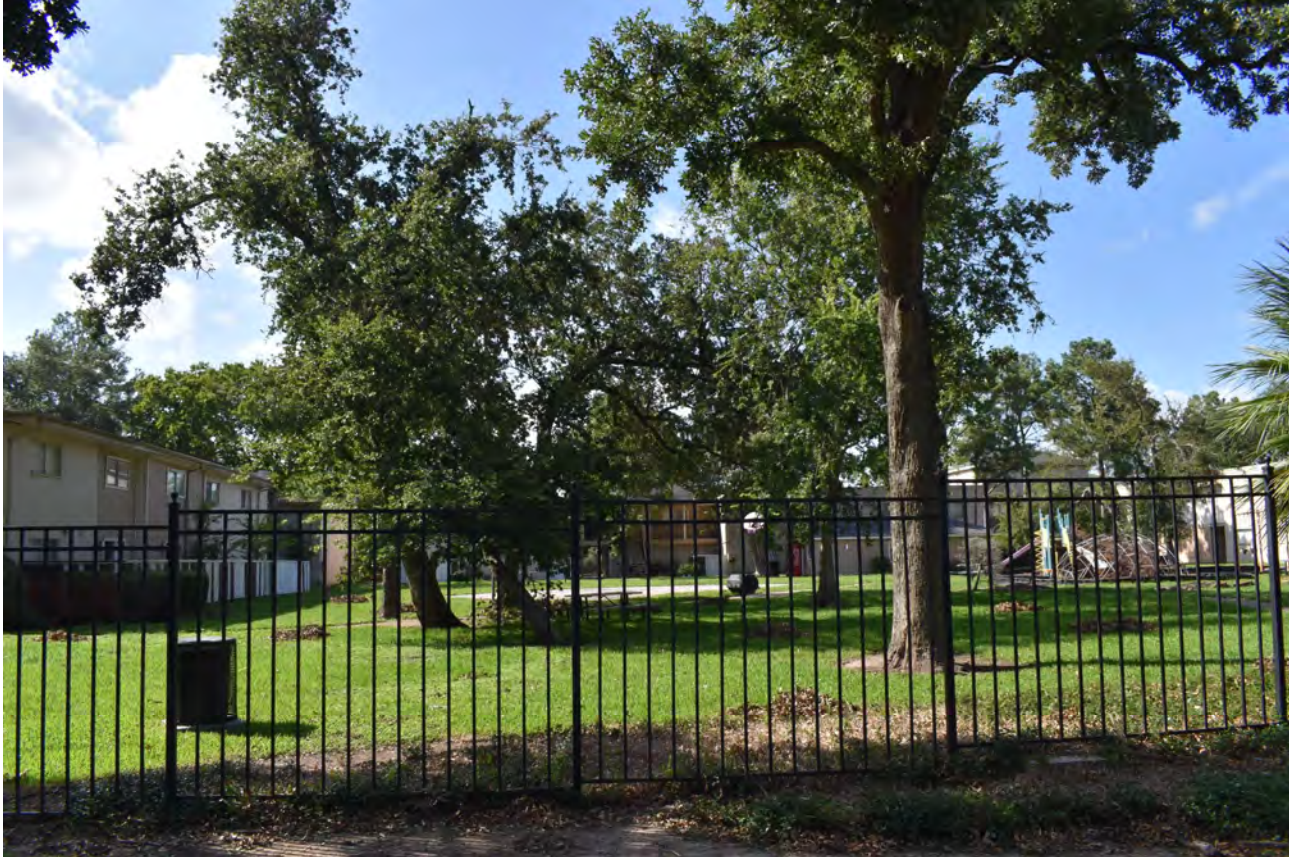
View facing  
northwest

Although this resource was not visible from the right-of-way, research and available aerial imagery indicate there is no evidence this resource has significance. There is no reason for this resource to have information potential. Therefore, this resource is recommended not eligible for the NRHP under Criteria A, B, C, or D.

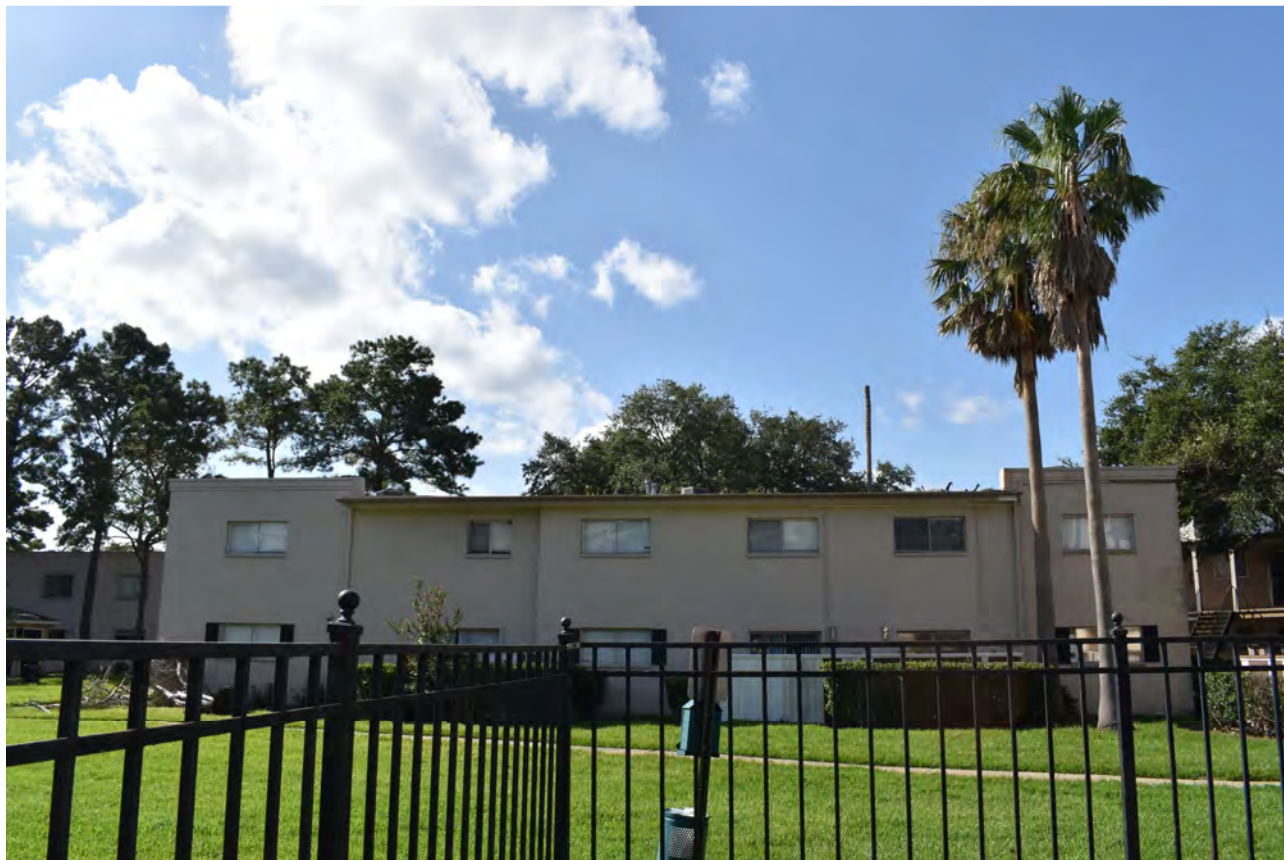
View facing north

This apartment building is not associated with significant events or individuals. Although the buildings possesses elements of the Late Modern style, it is not significant within the context of style architecture nor is it the work of a master. Painted brick lessens integrity of materials. The resource is unlikely to yield information potential. Therefore, the resource is recommended not eligible for the NRHP under Criteria A, B, C, or D.

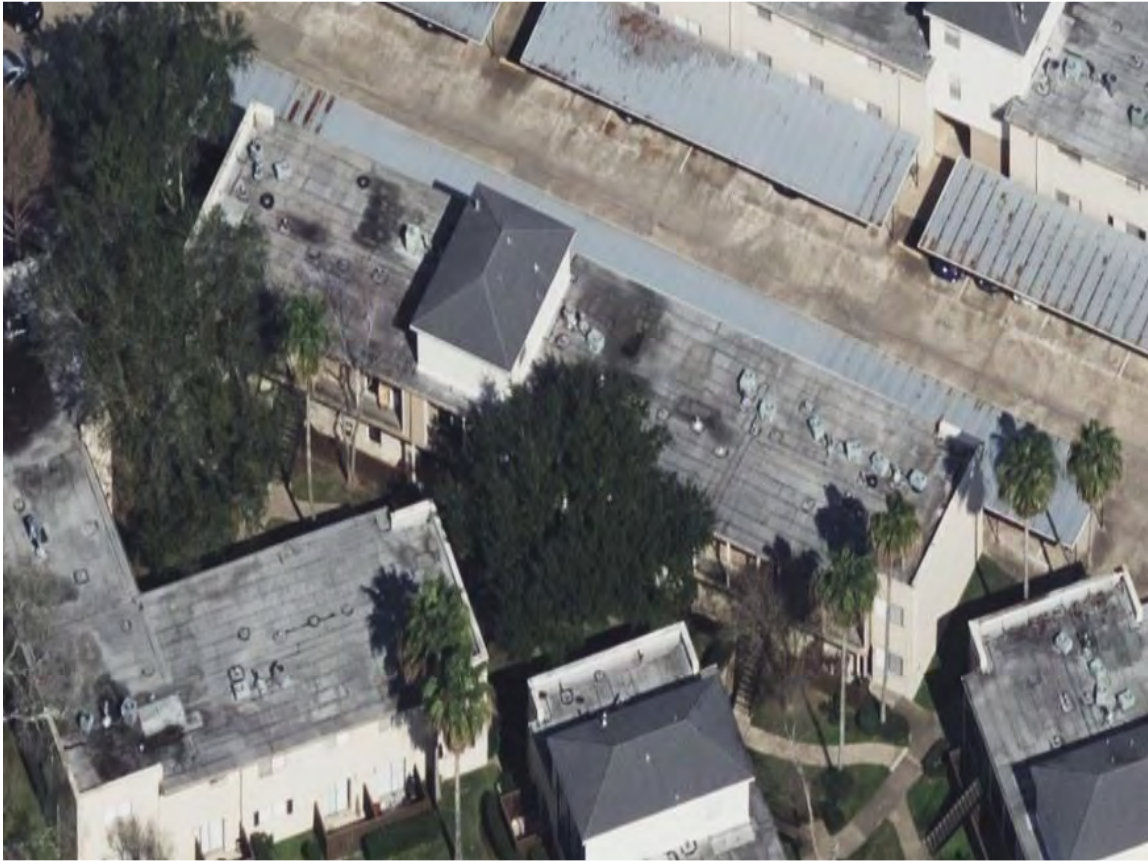
Oblique view  
facing north  
(Bing 2024)

Although this resource was not visible from the right-of-way, research and available aerial imagery indicate there is no evidence this resource has significance. There is no reason for this resource to have information potential. Therefore, this resource is recommended not eligible for the NRHP under Criteria A, B, C, or D.

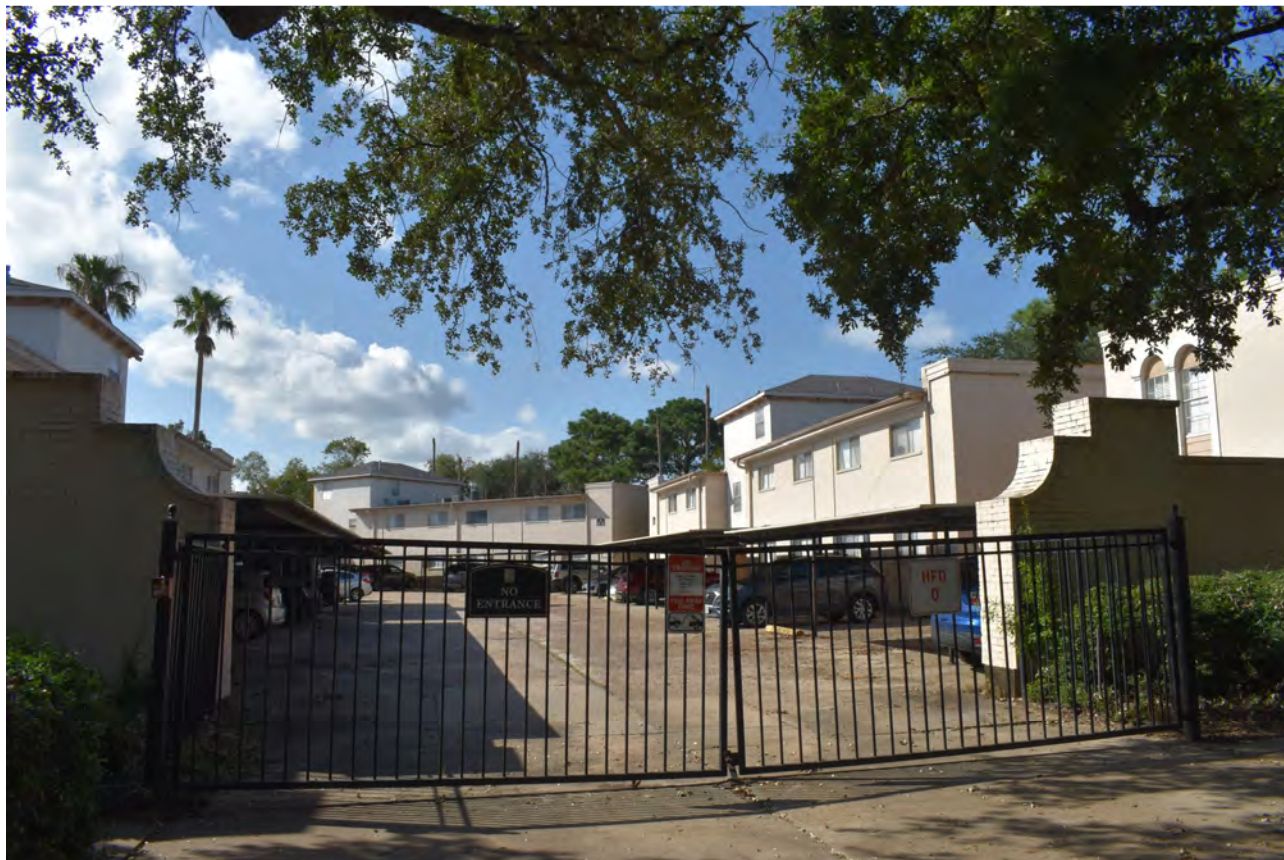
View facing north;  
Resource 6J in rear left center

Although this resource was not visible from the right-of-way, research and available aerial imagery indicate there is no evidence this resource has significance. There is no reason for this resource to have information potential. Therefore, this resource is recommended not eligible for the NRHP under Criteria A, B, C, or D.
