EA AND SUPPORTING SERVICES  
FOR THE TAMU SPACE INSTITUTE  
LEASE AT JSC

**NASA Johnson Space Center / TAMU Space Institute Historic Resources Survey**  
Surveyed by SWCA Environmental Consultants | Houston, Harris County, Texas

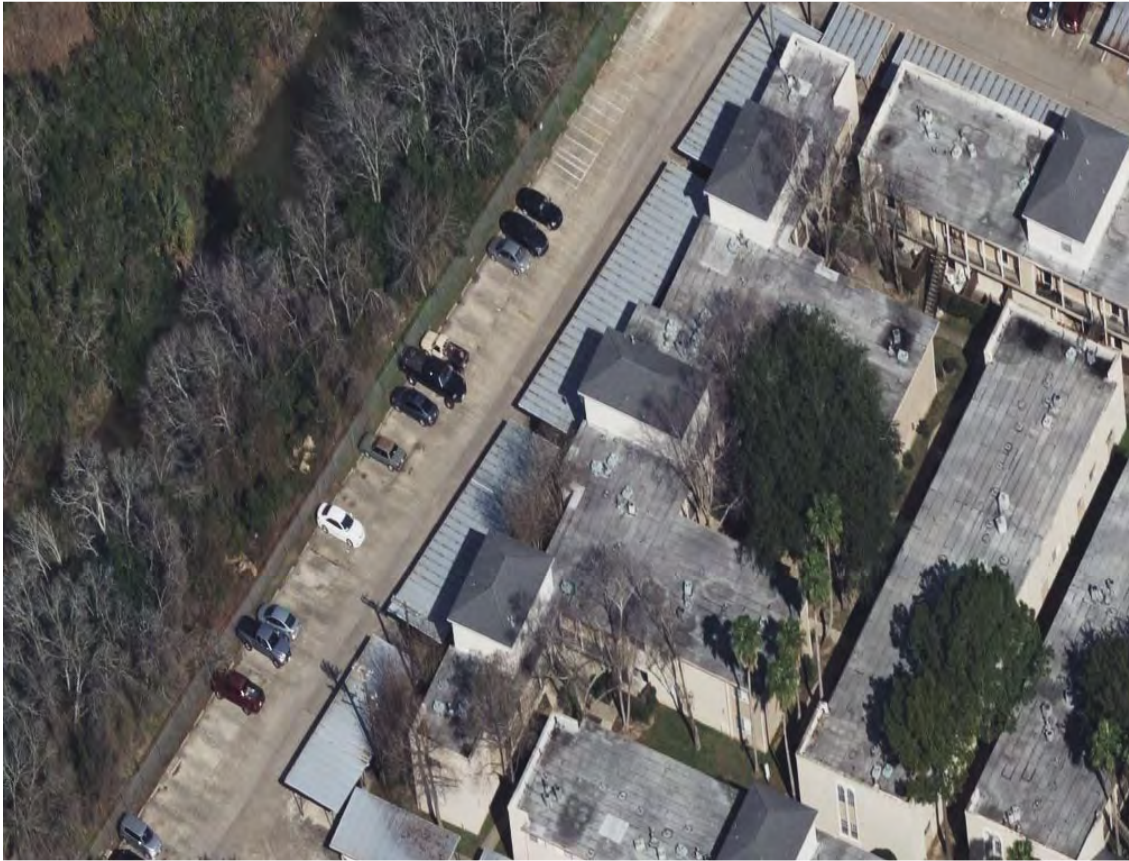
Oblique view  
facing north  
(Bing 2024)

Although this resource was not visible from the right-of-way, research and available aerial imagery indicate there is no evidence this resource has significance. There is no reason for this resource to have information potential. Therefore, this resource is recommended not eligible for the NRHP under Criteria A, B, C, or D.

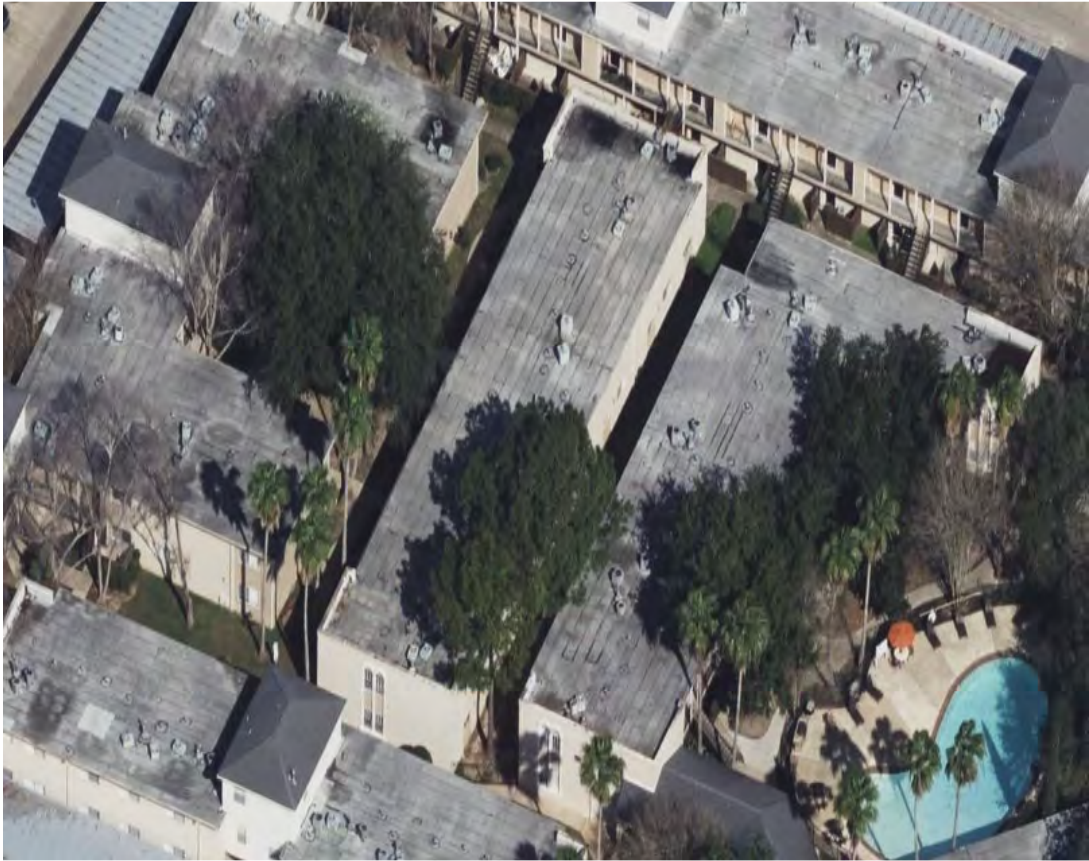
Oblique view  
facing north  
(Bing 2024)

Although this resource was not visible from the right-of-way, research and available aerial imagery indicate there is no evidence this resource has significance. There is no reason for this resource to have information potential. Therefore, this resource is recommended not eligible for the NRHP under Criteria A, B, C, or D.

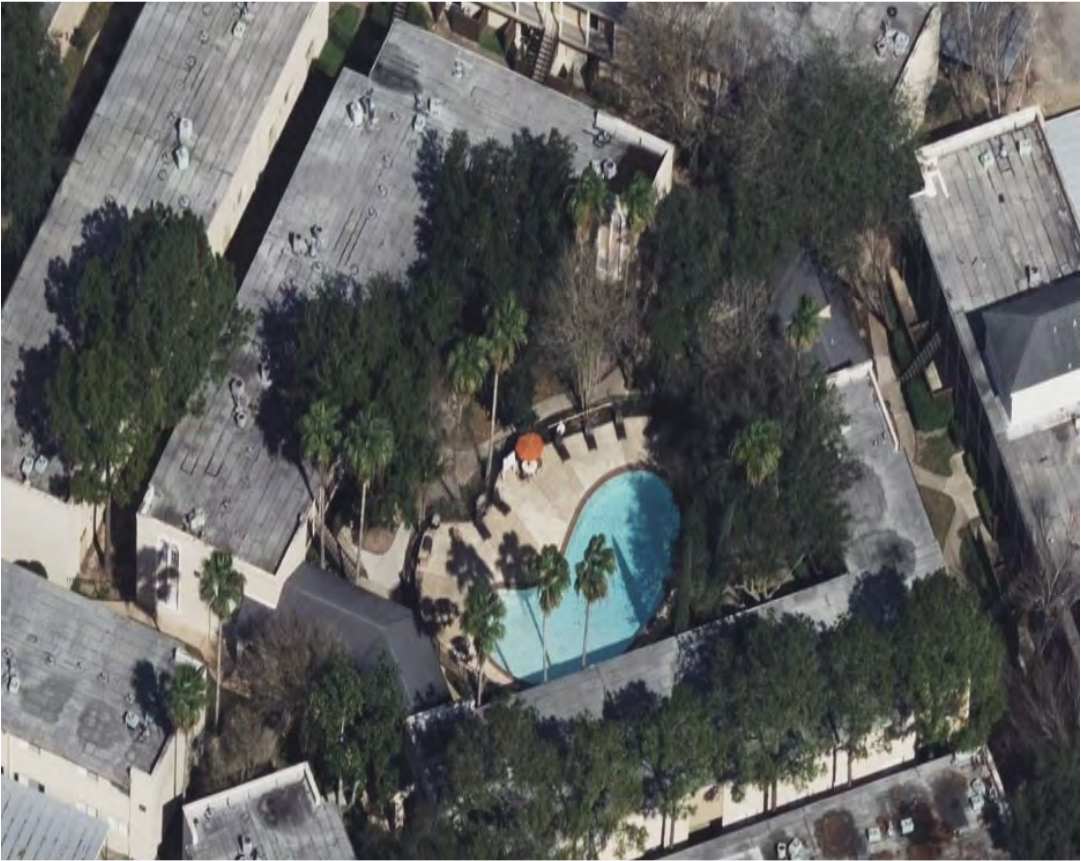
Oblique view facing north towards the building (surrounds the pool) (Bing 2024)

Although this resource was not visible from the right-of-way, research and available aerial imagery indicate there is no evidence this resource has significance. There is no reason for this resource to have information potential. Therefore, this resource is recommended not eligible for the NRHP under Criteria A, B, C, or D.

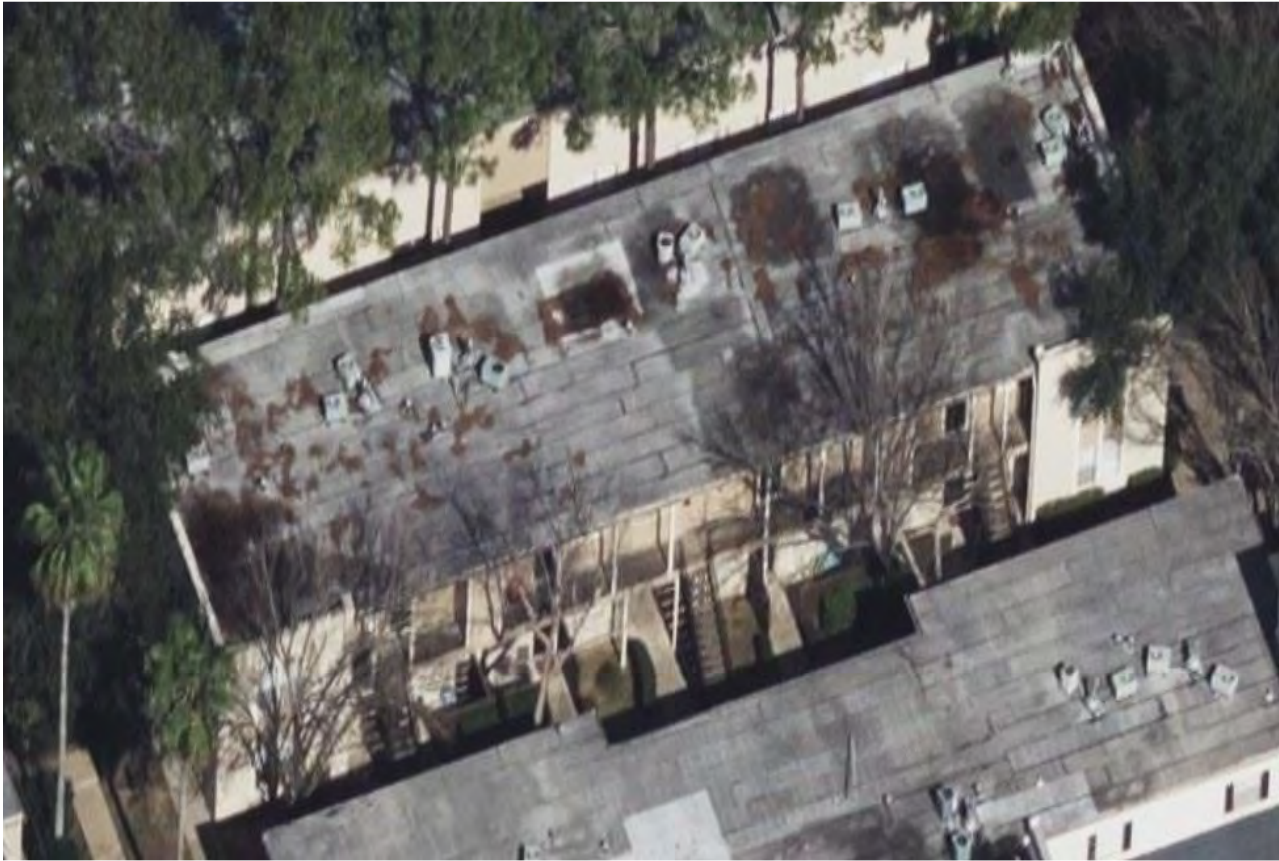
Oblique view facing north (Bing 2024)

Although this resource was not visible from the right-of-way, research and available aerial imagery indicate there is no evidence this resource has significance. There is no reason for this resource to have information potential. Therefore, this resource is recommended not eligible for the NRHP under Criteria A, B, C, or D.

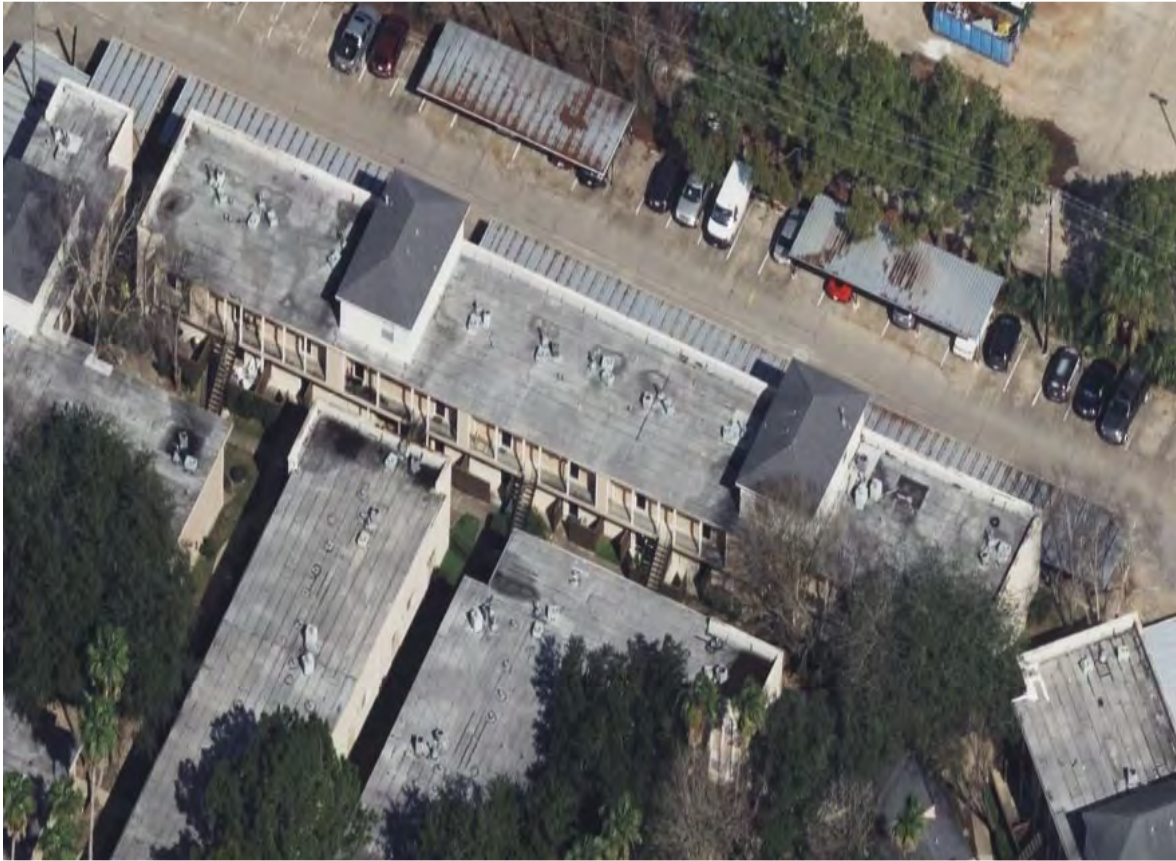
Oblique view facing north (Bing 2024)

Although this resource was not visible from the right-of-way, research and available aerial imagery indicate there is no evidence this resource has significance. There is no reason for this resource to have information potential. Therefore, this resource is recommended not eligible for the NRHP under Criteria A, B, C, or D.

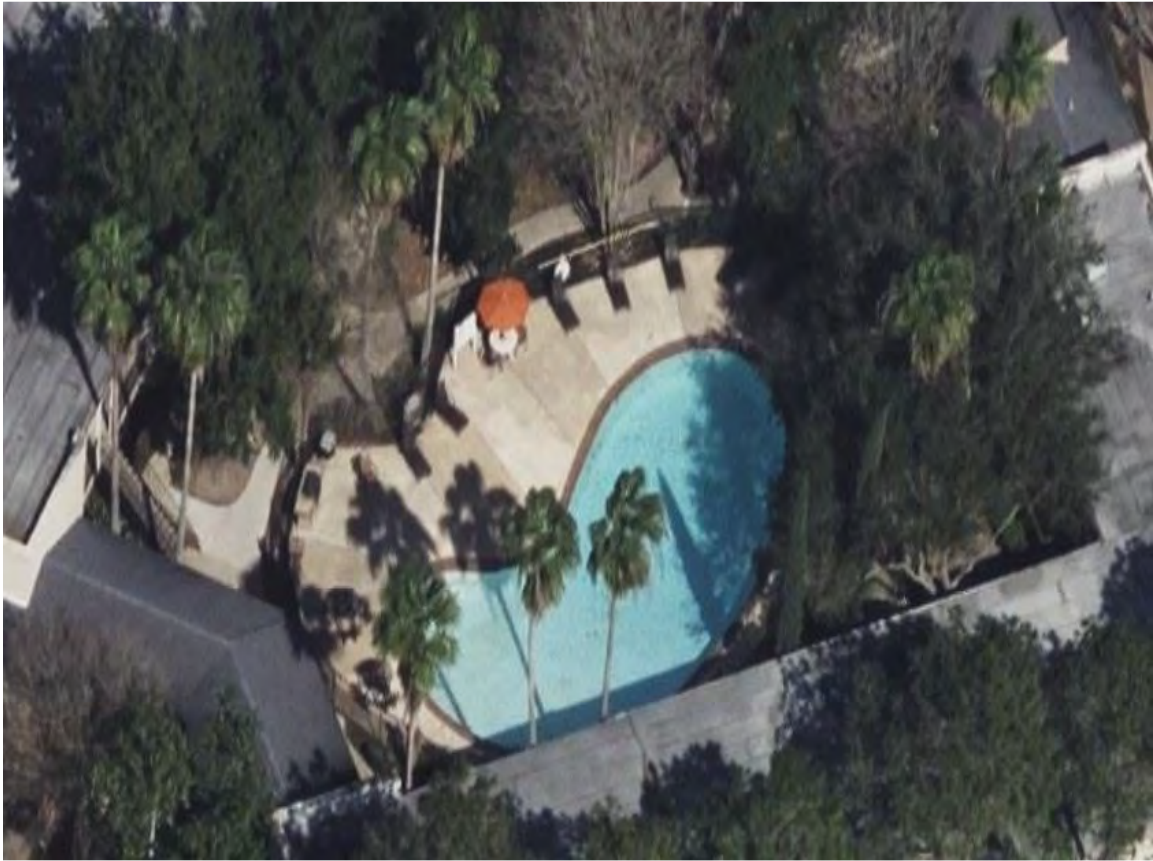
Oblique view  
facing north  
(Bing 2024)

Although this resource was not visible from the right-of-way, research and available aerial imagery indicate there is no evidence this resource has significance. There is no reason for this resource to have information potential. Therefore, this resource is recommended not eligible for the NRHP under Criteria A, B, C, or D.

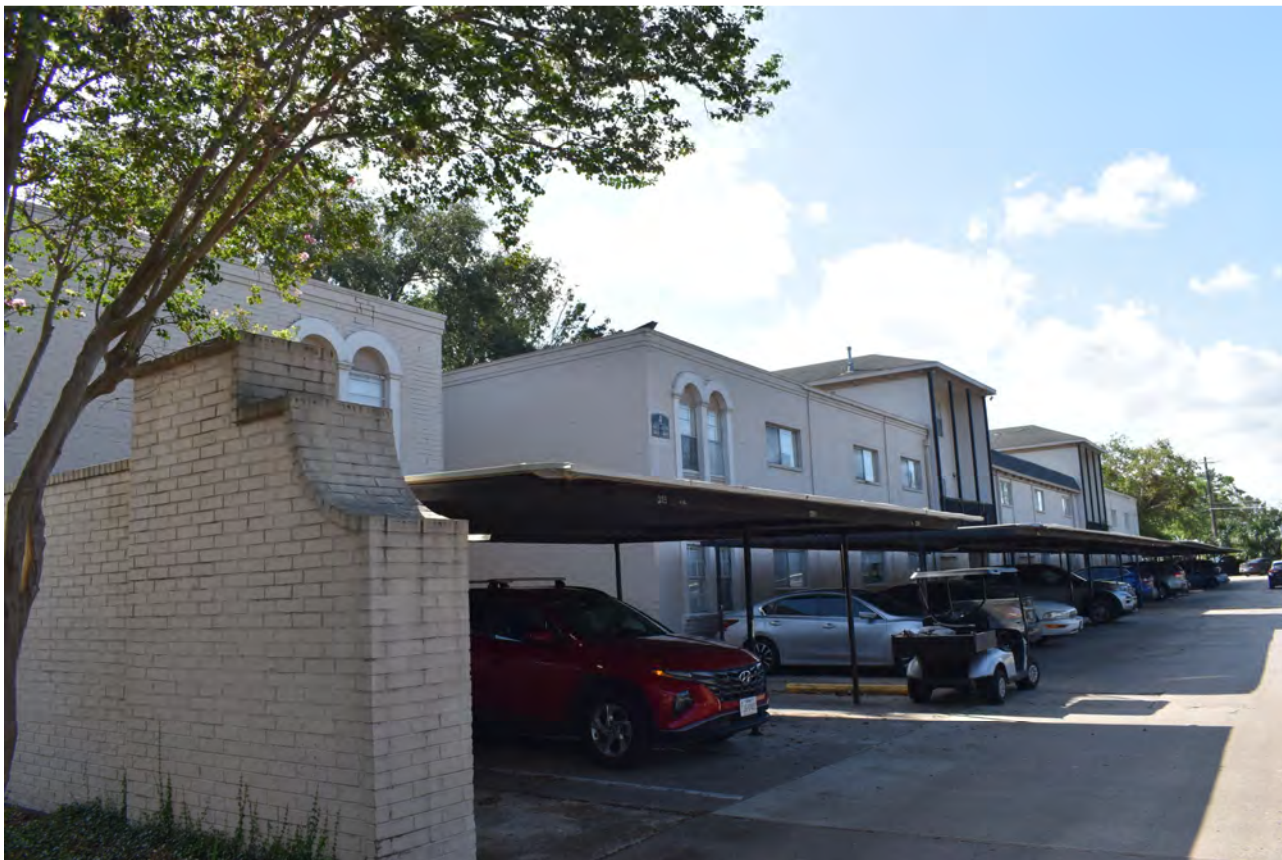
View facing northeast

<b>Type:</b> Building	<b>Primary roof form:</b> Flat w/parapet	<b>Roof material:</b> Composition shingles	<b>Alterations:</b> Brick/stone painted
<b>Form:</b> Rectangular	Hipped	Tar or membrane	Windows replaced (some)
<b>Style:</b> Spanish Colonial Revival	<b>Porch:</b> Integrated partial-width	<b>Primary materials:</b> Brick Stucco

This apartment building is not associated with significant events or individuals. Although the buildings possesses elements of the Spanish Colonial Revival style, it is not significant within the context of the style nor is it the work of a master. Painted brick and replaced materials diminish integrity of materials. The resource is unlikely to yield information potential. Therefore, the resource is recommended not eligible for the NRHP under Criteria A, B, C, or D.

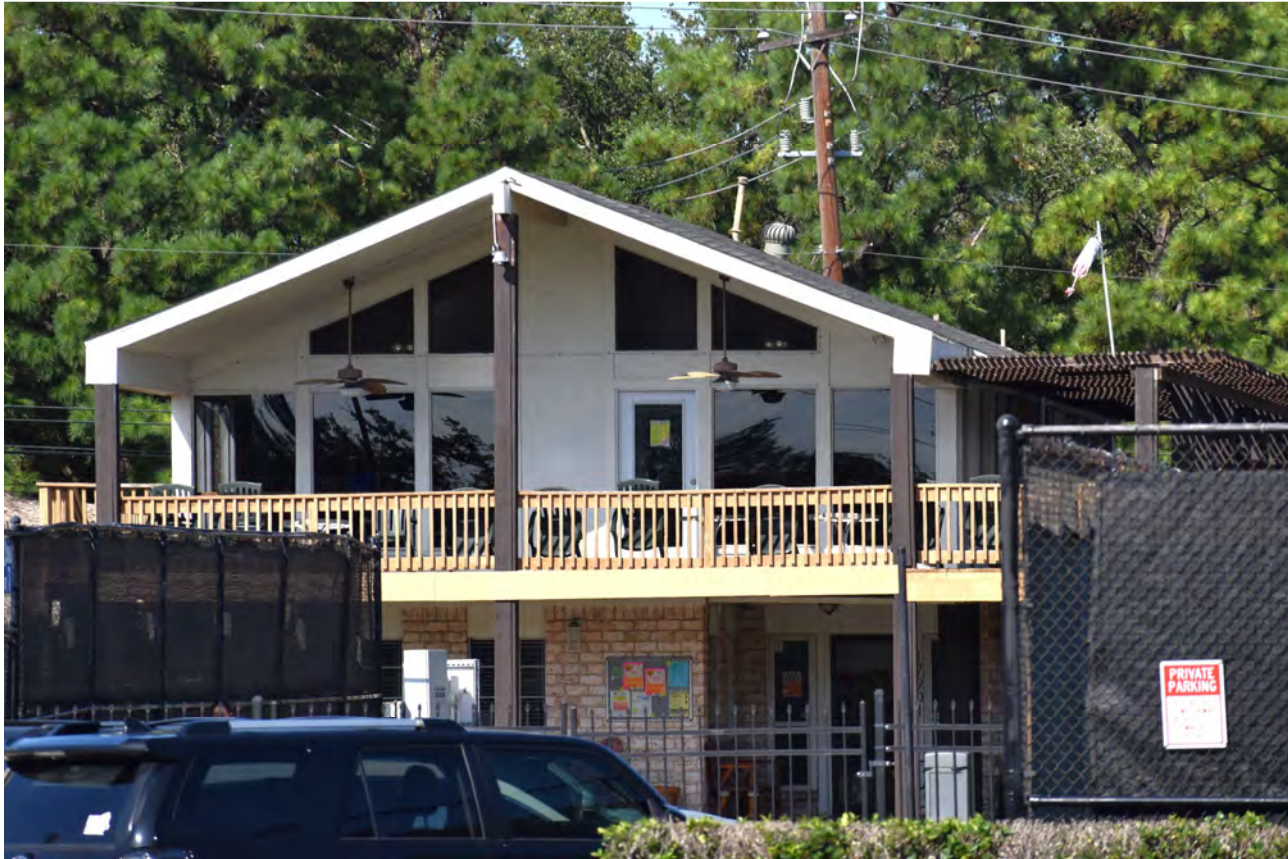
View facing northeast

<b>Type:</b> Building	<b>Primary roof form:</b> Gable, front	<b>Roof material:</b> Composition shingles	<b>Alterations:</b> Door(s) replaced (primary) Window(s) replaced (all)
<b>Form:</b> Rectangular	<b>Porch:</b> Projecting full-width	<b>Primary materials:</b> Stone Stucco	
<b>Style:</b> Late Modern

Although BARC has been a local staple since the mid-1970s, the tennis complex is not associated with significant events. Its partial founding by Jim Robinson is an interesting component of its history; however, Robinson's contributions to NASA are typical to many who lived and worked at NASA JSC during the 1960s and 1970s and resided in the Bay Area. His contributions to the BARC were focused on recreational as well as competitive events, but did not elevate to Olympic-level sportsmanship activities. The tennis clubhouse has Late Modern A-Frame-like design, which has some replaced materials that detract from its integrity. The overall complex is a grid system that does not feature any innovative design choices. The resource is unlikely to yield information potential. Therefore, the tennis complex and this resource are recommended not eligible for the NRHP under Criteria A, B, C, or D.

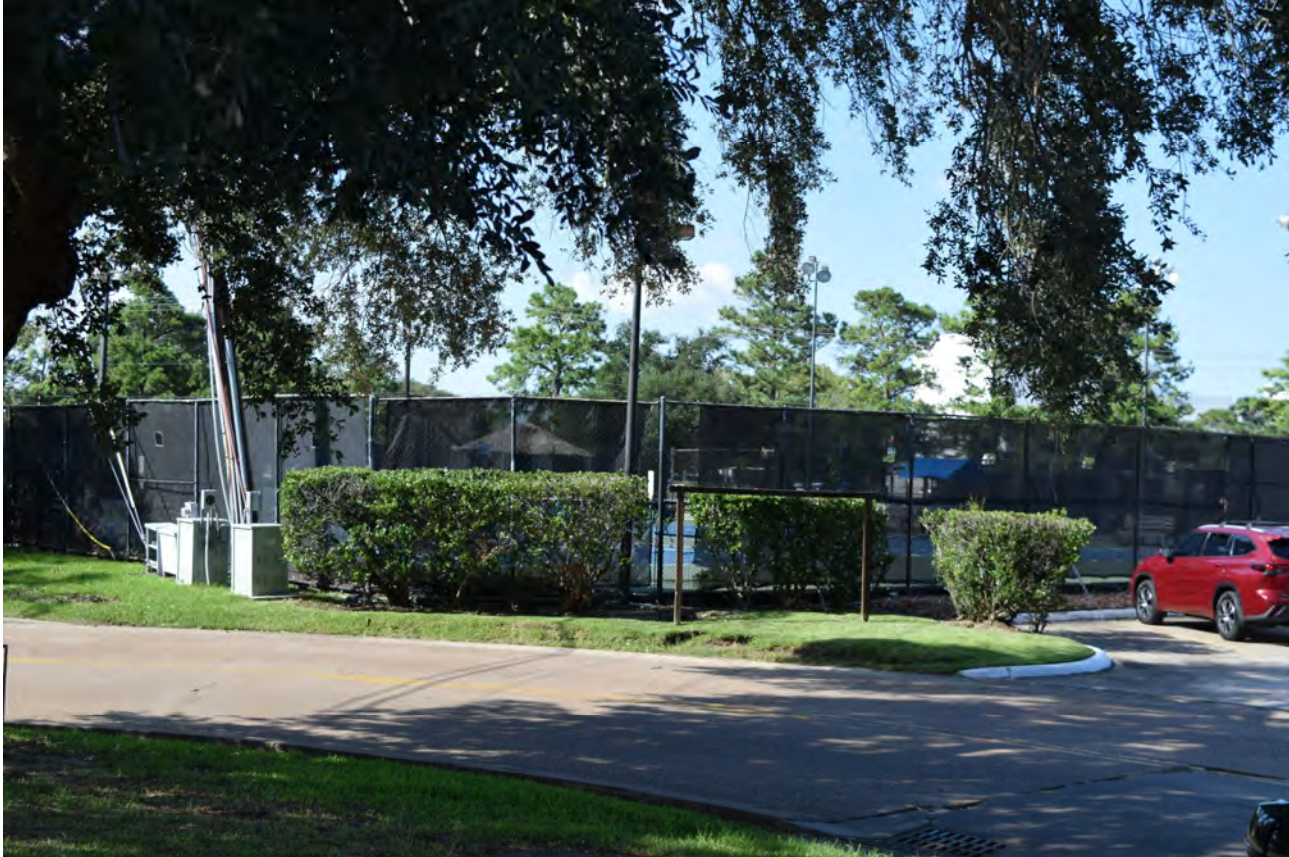
View facing  
northeast

Although this resource appears to retain most of its integrity, this resource is not associated with significant events or individuals. The building does not possess distinctive elements and is not a work of a master. The resource is unlikely to yield information potential. Therefore, the resource is recommended not eligible for the NRHP under Criteria A, B, C, or D.

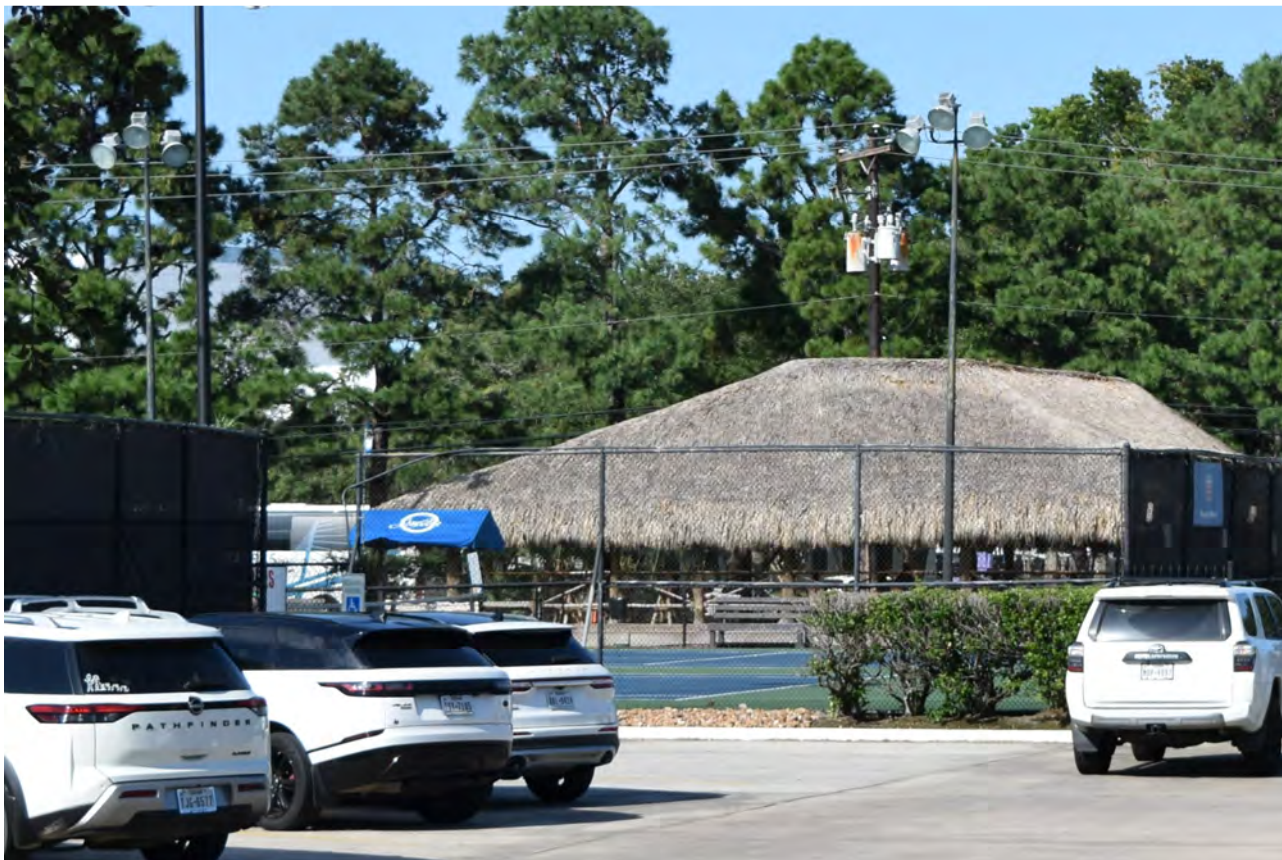
View facing  
northeast

Although this resource appears to retain most of its integrity, this resource is not associated with significant events or individuals. The building does not possess distinctive elements and is not a work of a master. The resource is unlikely to yield information potential. Therefore, the resource is recommended not eligible for the NRHP under Criteria A, B, C, or D.

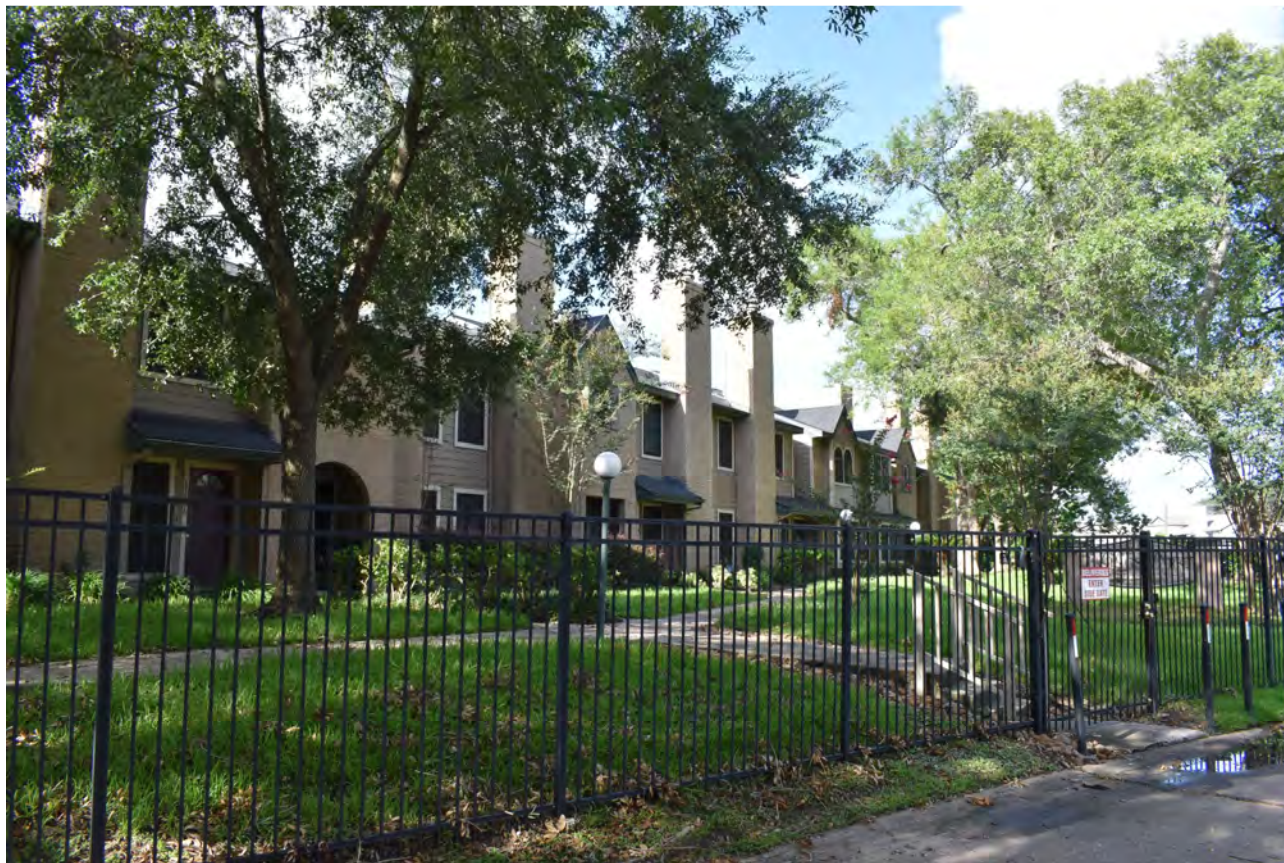
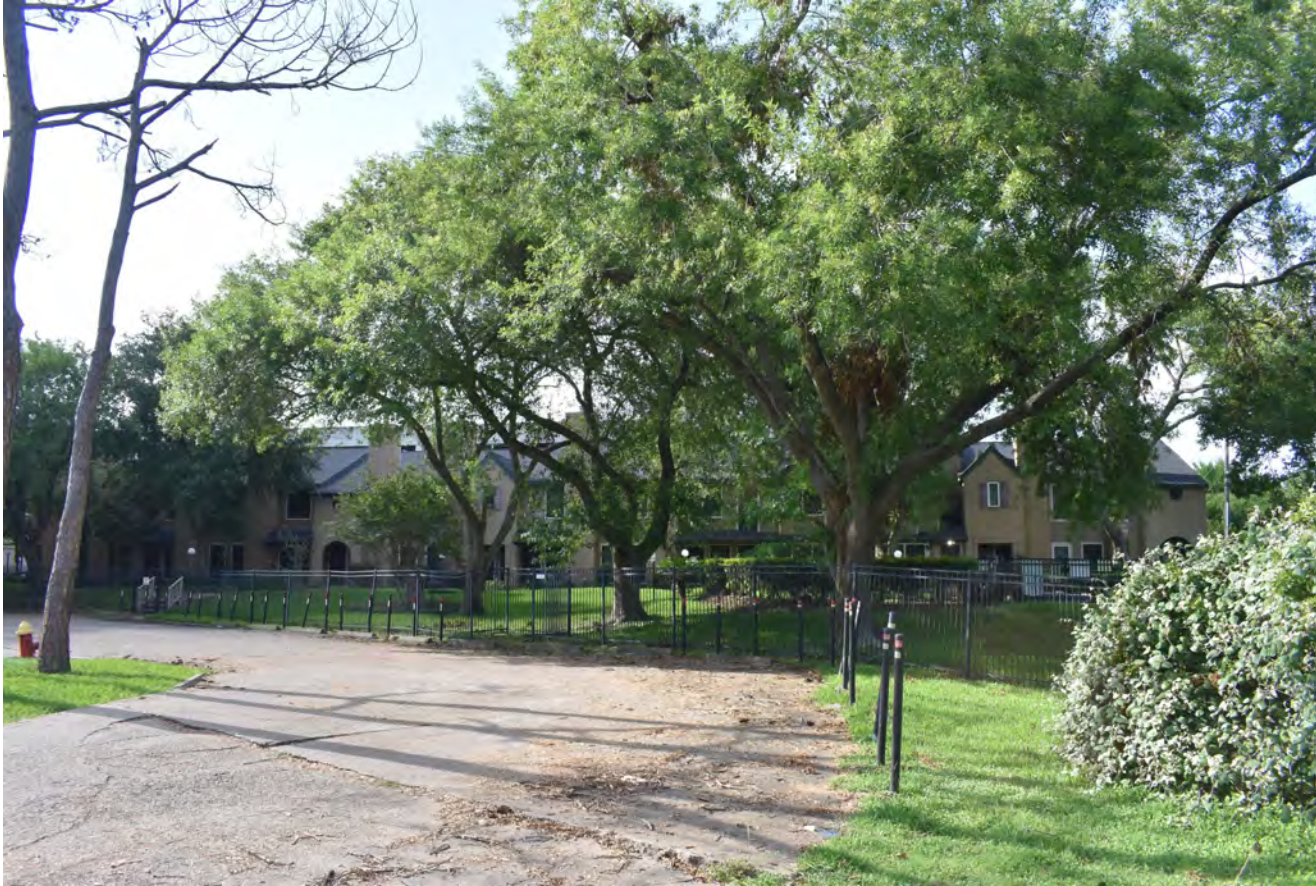
Resource 8A  
(Historic-age);  
view facing  
southwest

<b>Type:</b> Building	<b>Primary roof form:</b> Gable, side	<b>Roof material:</b> Composition shingles	<b>Alterations:</b> Door(s) replaced (primary) Wall cladding replaced (some) Windows replaced (some)
<b>Form:</b> Rectangular	<b>Porch:</b> Integrated stoop Projecting stoop	<b>Primary materials:</b> Brick Vinyl siding	
<b>Style:</b> Colonial Revival

Kings Park Townhomes is not associated with significant events or individuals. Although the building incorporates some Colonial Revival stylistic details, this design is not distinctive and is not a work of a master. The design and planning of the townhouse complex is not significant within the context of multiple dwelling complexes. Alterations including replaced doors, windows, and wall cladding, diminish material integrity. The resource is unlikely to yield information potential. Therefore, the townhouse complex and this resource are recommended not eligible for the NRHP under Criteria A, B, C, or D.

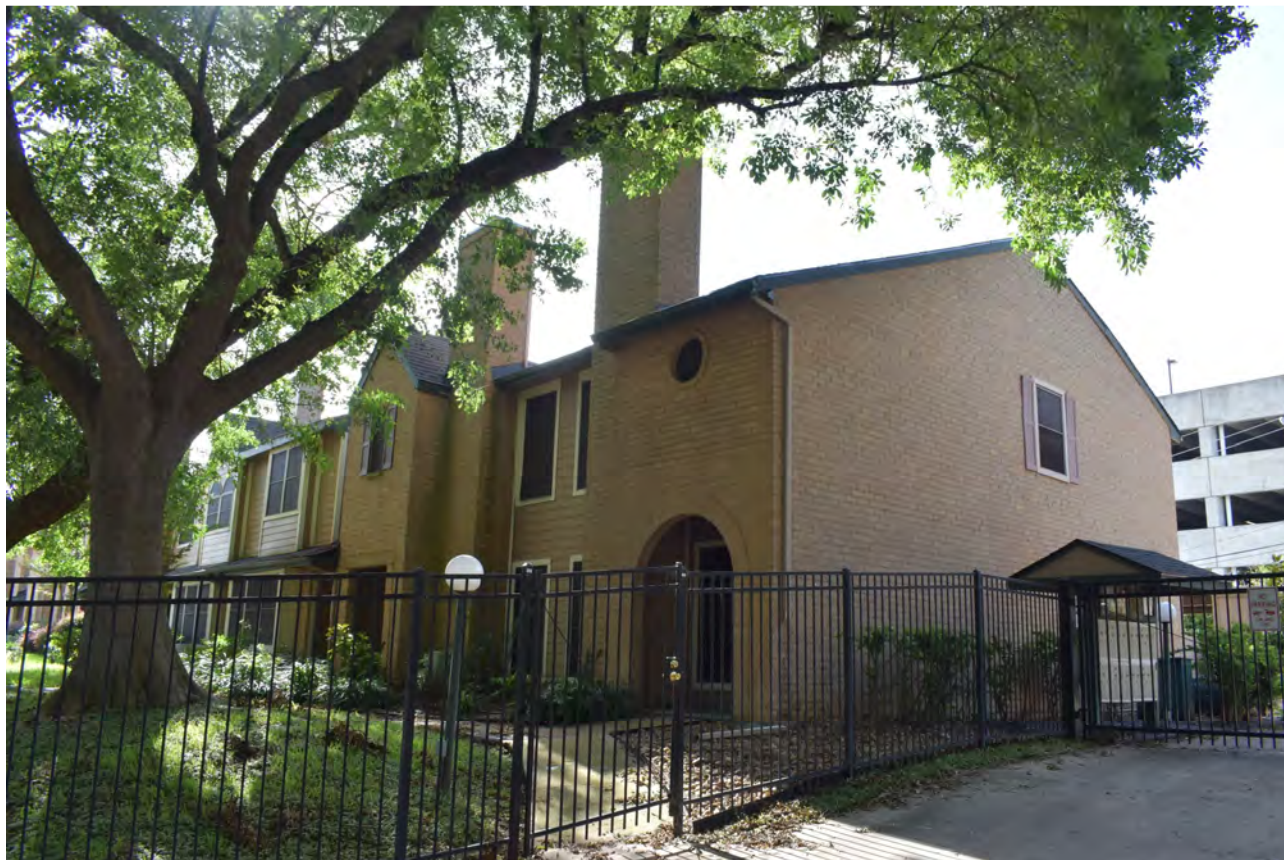
Resource 8B  
(Historic-age)  
and Resource  
8E  
(Nonhistoric-  
age mailbox  
shelter); view  
facing  
southeast

<b>Type:</b> Building	<b>Primary roof form:</b> Gable, side	<b>Roof material:</b> Composition shingles	<b>Alterations:</b> Door(s) replaced (primary) Wall cladding replaced (some) Windows replaced (some)
<b>Form:</b> Rectangular	<b>Porch:</b> Integrated stoop Projecting stoop	<b>Primary materials:</b> Brick Vinyl siding	
<b>Style:</b> Colonial Revival

This resource is not associated with significant events or individuals. The building does not possess distinctive elements and is not a work of a master. Replaced materials lessen material integrity. The resource is unlikely to yield information potential. Therefore, the resource is recommended not eligible for the NRHP under Criteria A, B, C, or D.

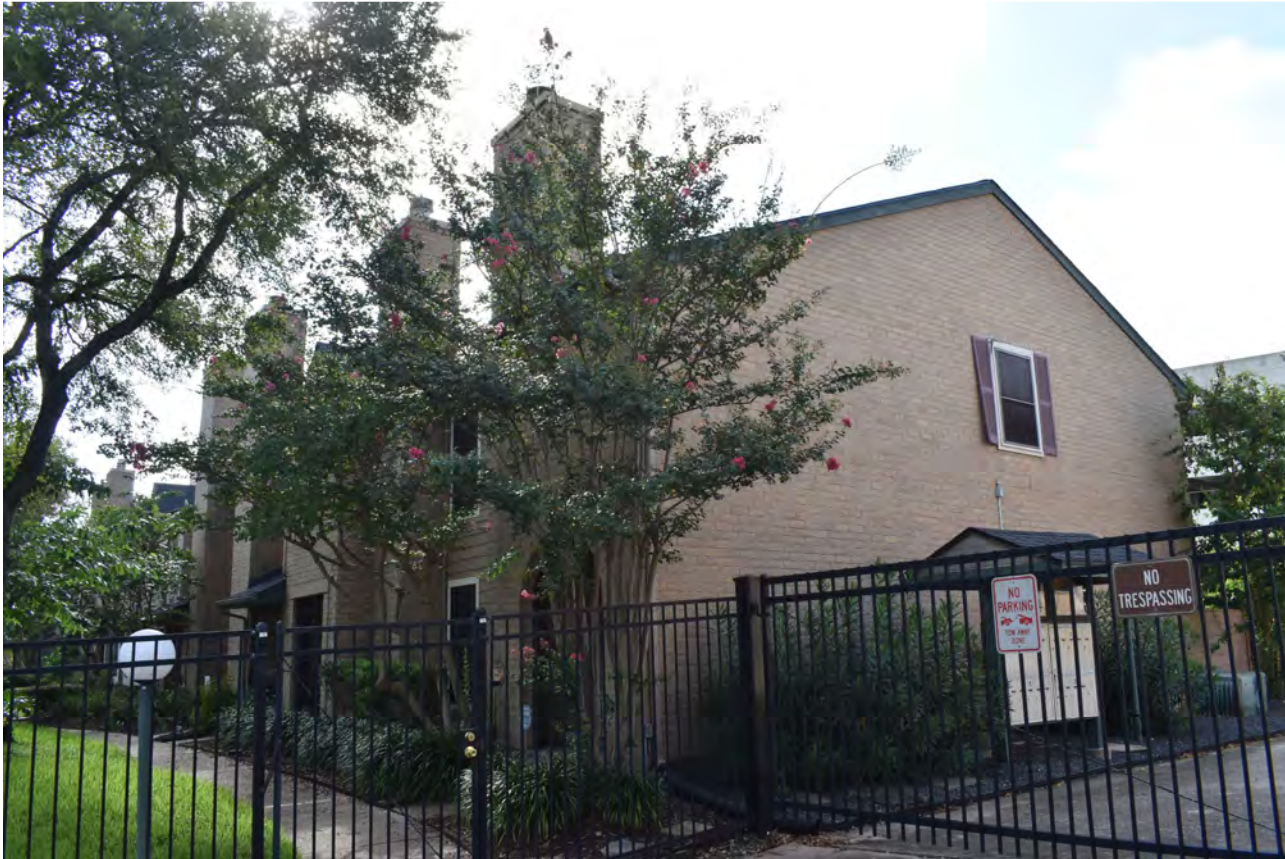
Resource 8C  
(Historic-age)  
and Resource  
8F  
(Nonhistoric-  
age mailbox  
shelter); view  
facing  
southeast

**Alterations:**  
Door(s) replaced (primary)  
Wall cladding replaced (some)  
Windows replaced (some)

This resource is not associated with significant events or individuals. The building does not possess distinctive elements and is not a work of a master. Replaced materials lessen material integrity. The resource is unlikely to yield information potential. Therefore, the resource is recommended not eligible for the NRHP under Criteria A, B, C, or D.

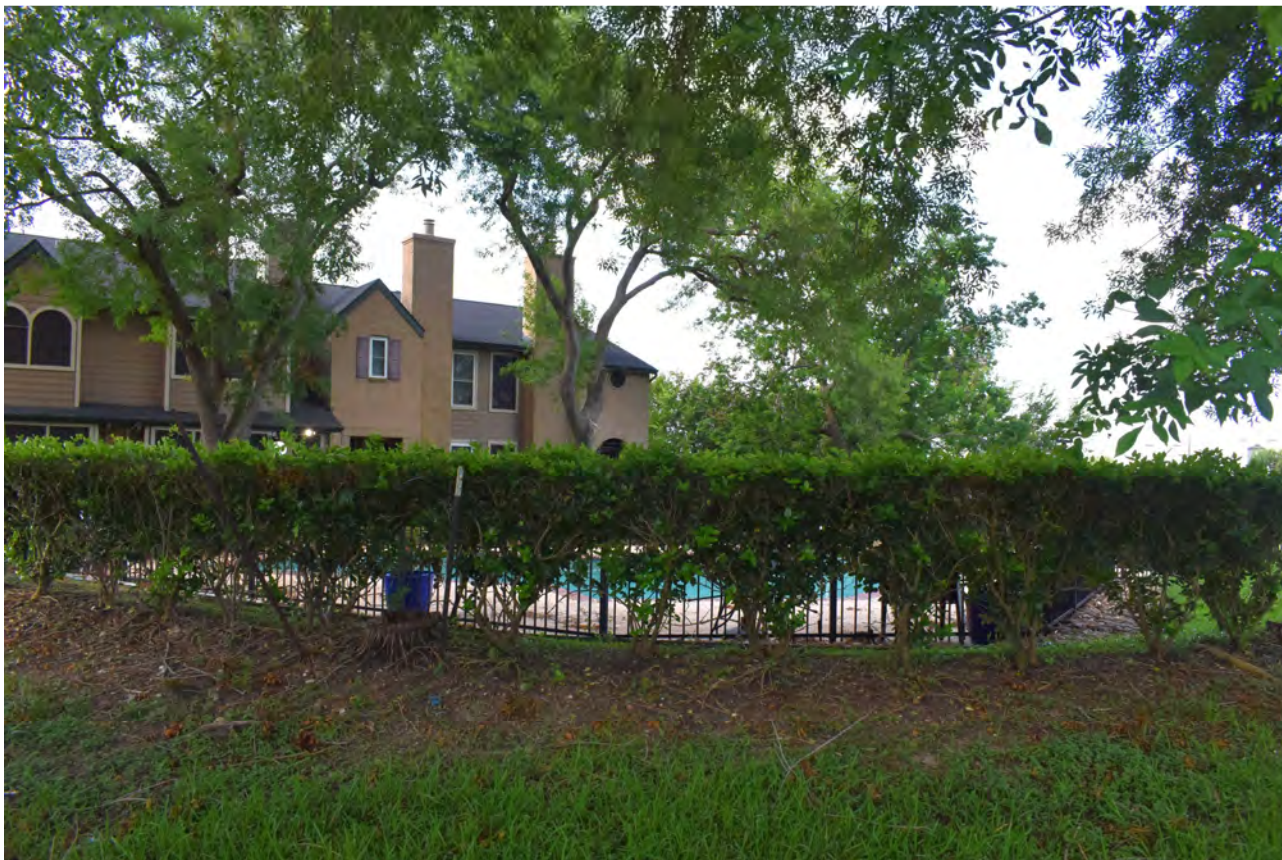
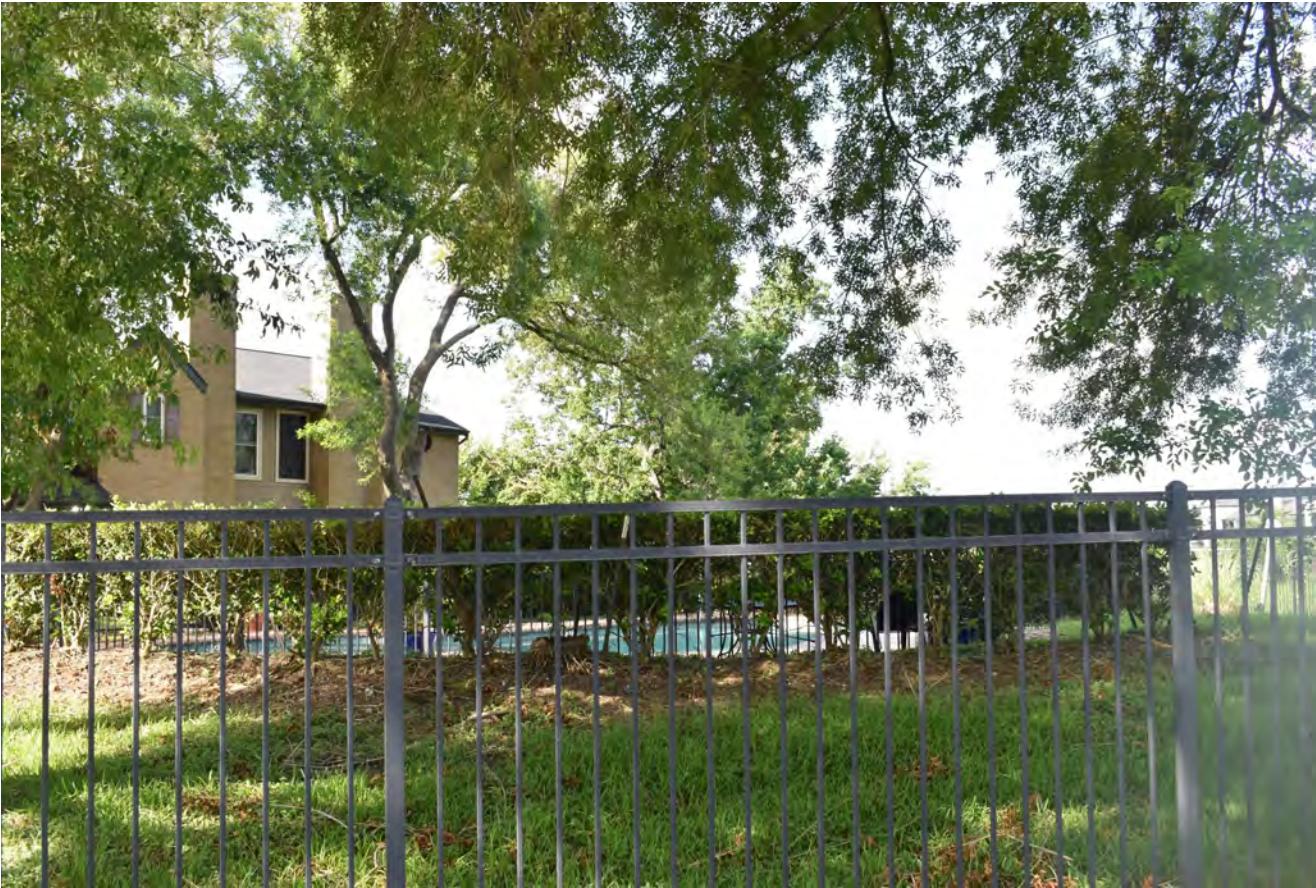
View facing southwest

Although this resource appears unaltered, there is no evidence to support its significance. This common swimming pool resource is not associated with significant events or individuals. The structure does not possess distinctive elements and is not a work of a master. The resource is unlikely to yield information potential. Therefore, the resource is recommended not eligible for the NRHP under Criteria A, B, C, or D.

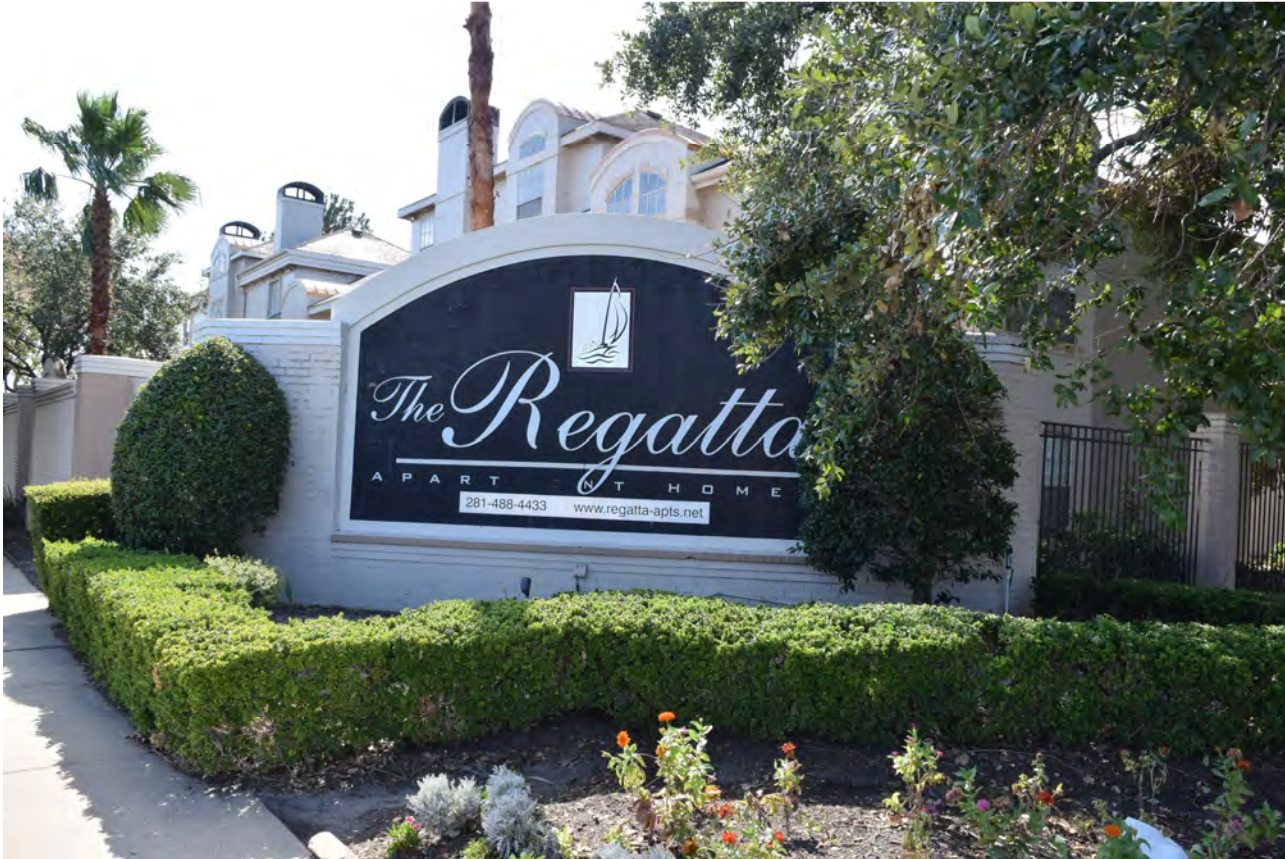
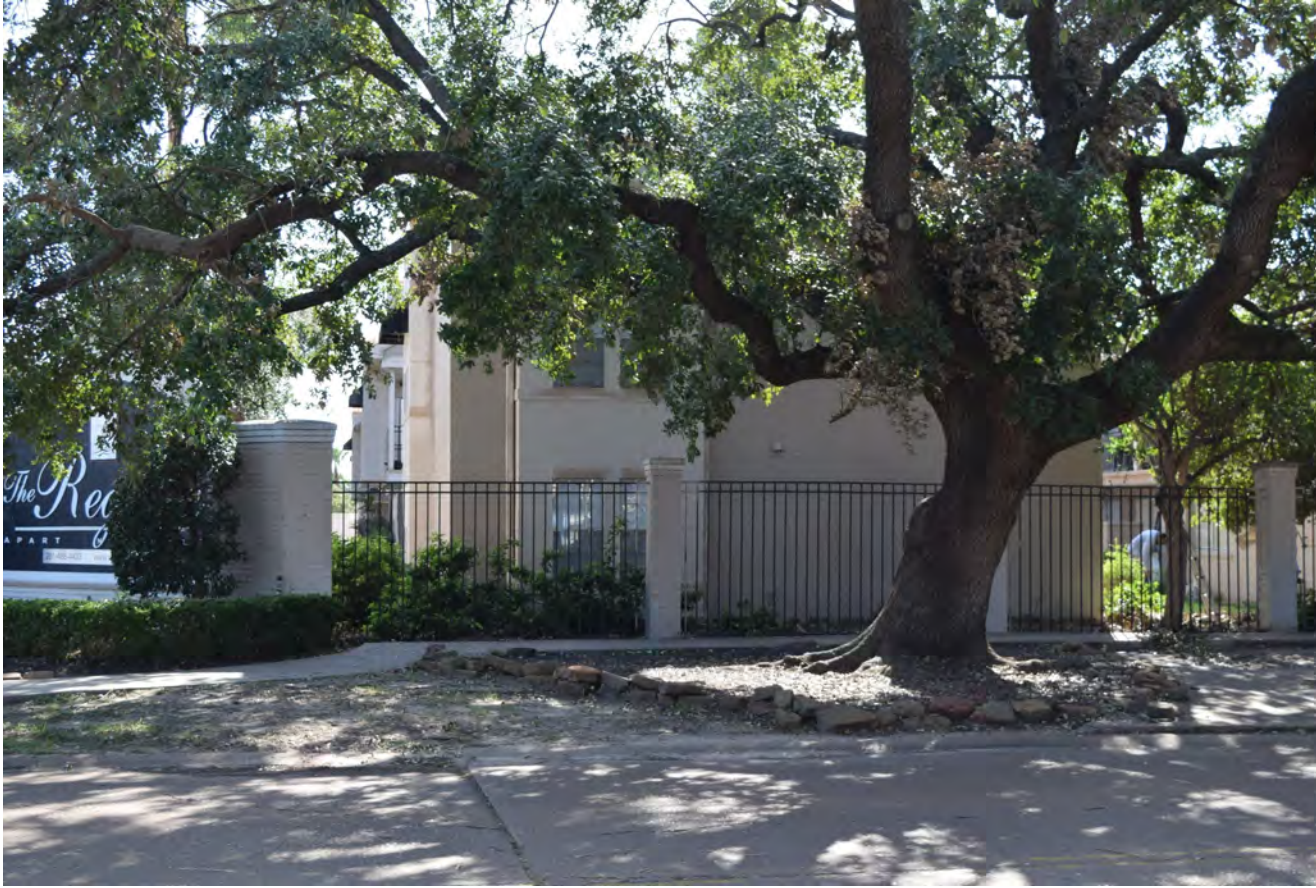
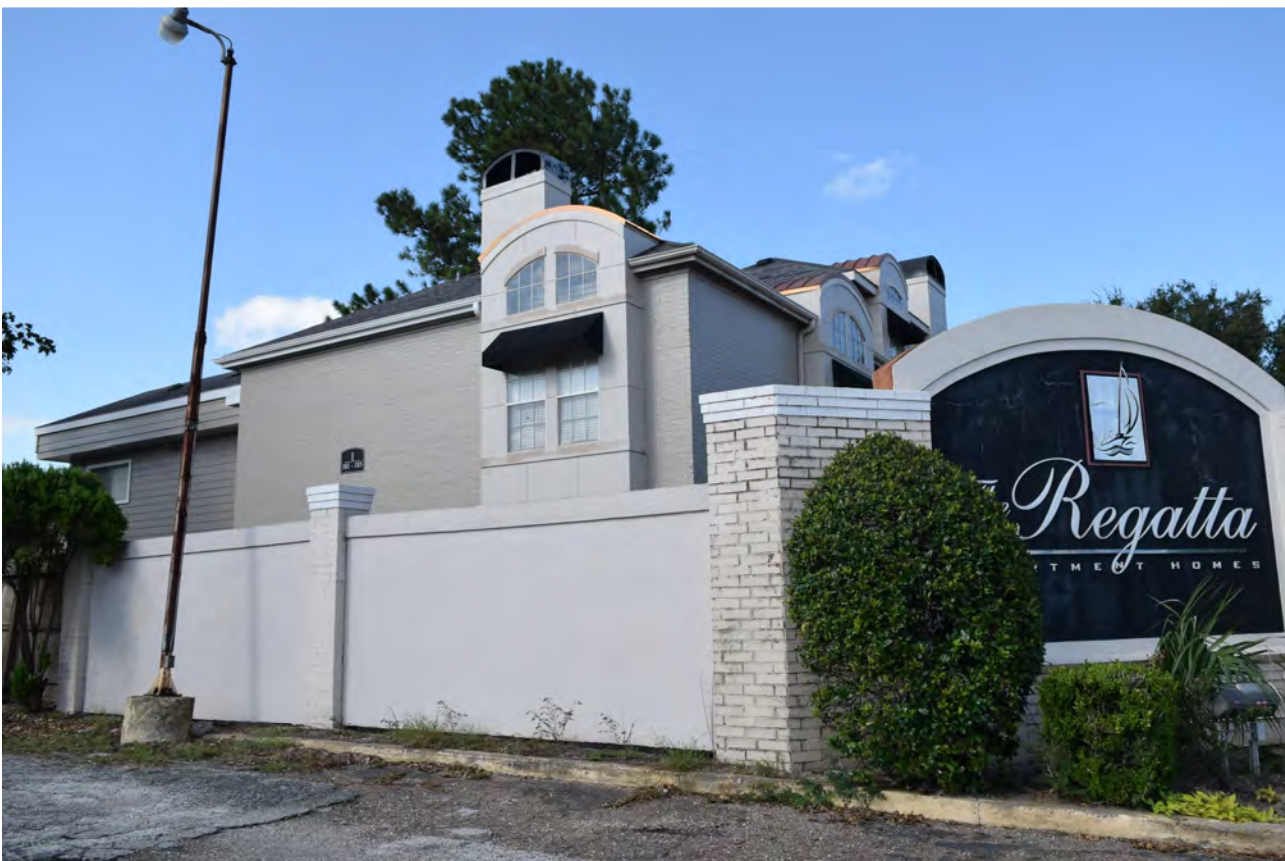
Resource 9A  
(Historic-age)  
in background  
and Resource  
9H  
(Nonhistoric-  
age) in  
foreground;  
view facing  
northwest

**Alterations:**  
Brick/stone painted  
Wall cladding replaced (some)  
Windows replaced (some)

This Regatta Apartments is not associated with significant events or individuals. Although some buildings evoke the Spanish Colonial Revival style, some do not feature any distinctive architectural characteristics that represents a cohesive style. Painted brick and replaced materials on the buildings diminish integrity of materials. The design and planning of the apartment complex is not significant within the context of apartment complexes. The resource is unlikely to yield information potential. Therefore, the resource is recommended not eligible for the NRHP under Criteria A, B, C, or D.
